## Summary Only

1234 Street name  
Anytown MN 55555

**Lakeland Home Inspections**

This is not the complete home inspection report. It is only the Summary Items.

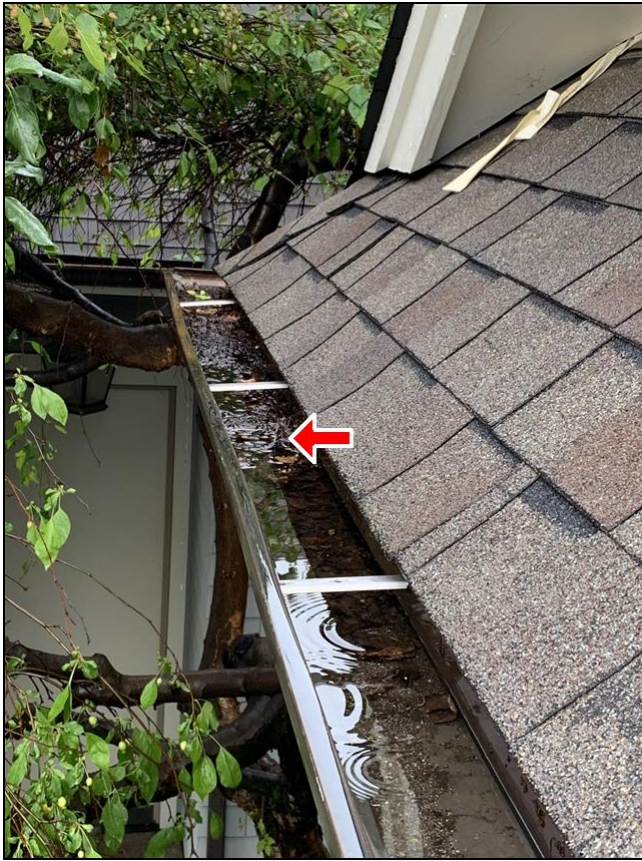
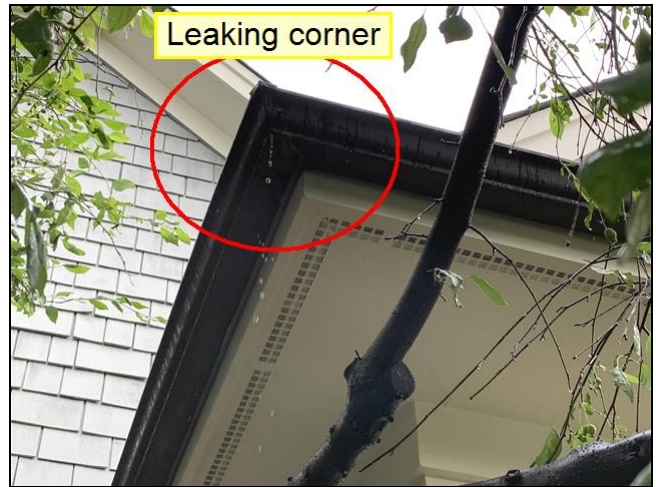
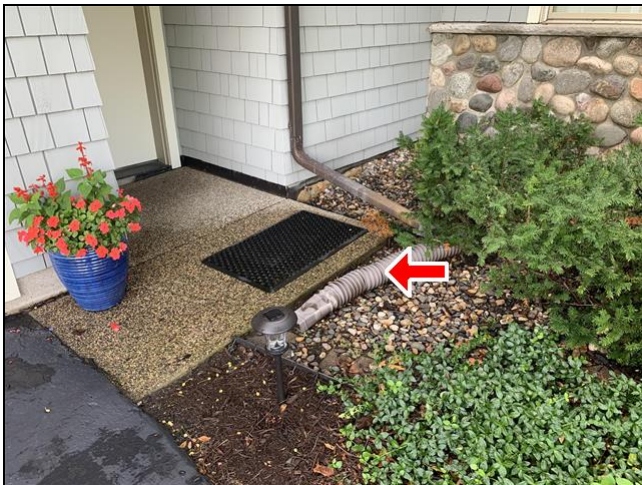
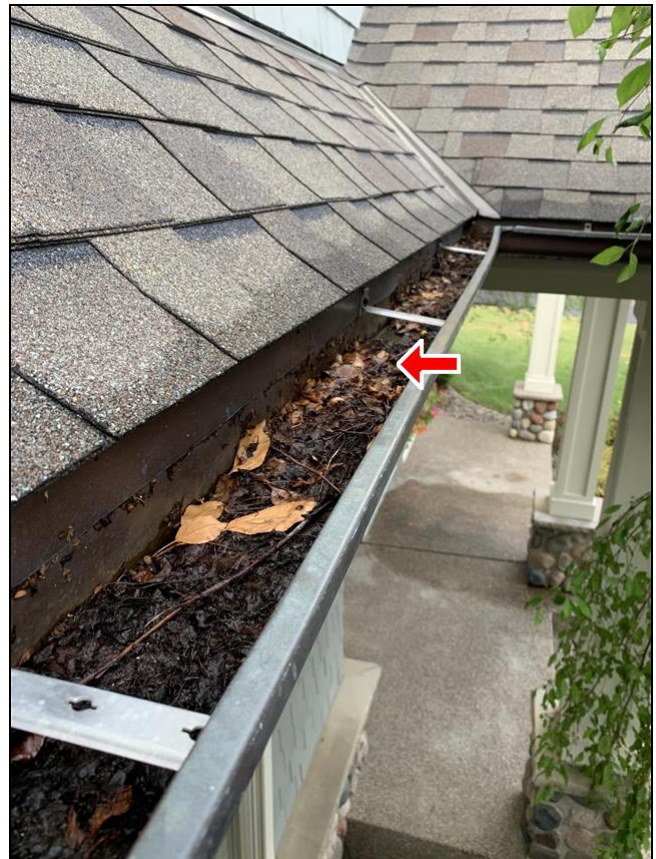
The gutters on the front of home are clogged and needs cleaning. Leaking corners were evident. The downspout in the front should be routed to another location.

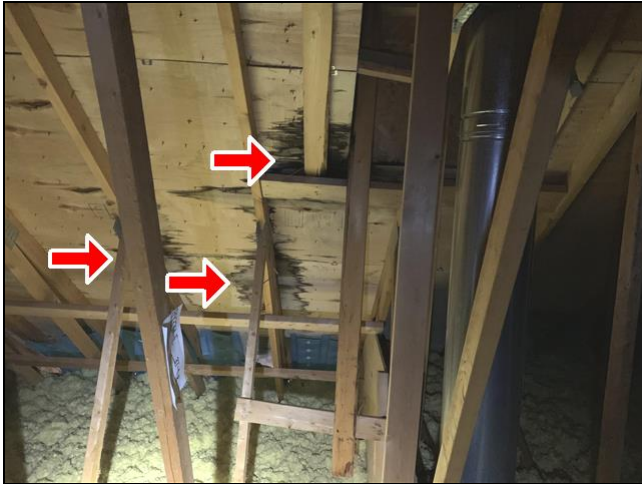
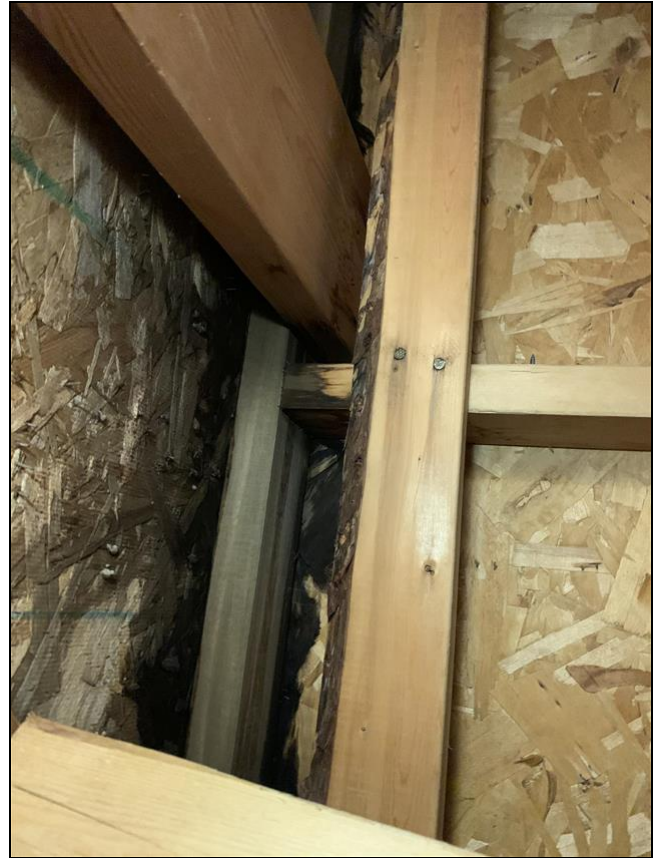
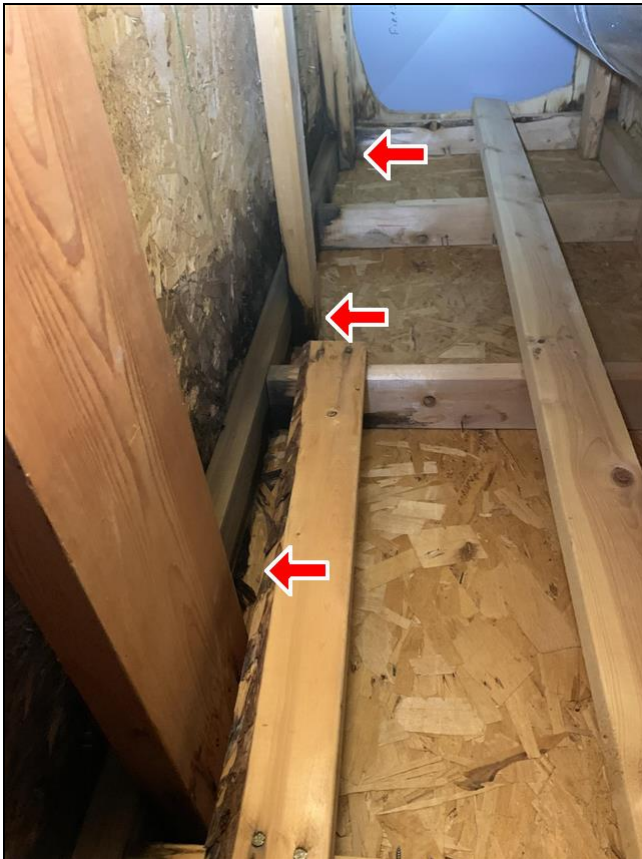
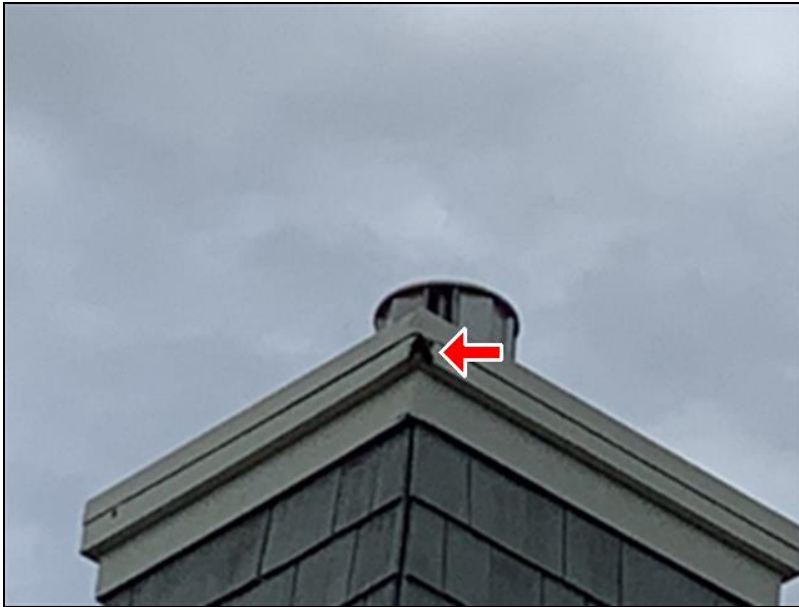
The chimney has some rotted trim resulting in leaks around the chimney chase and on the roof sheathing.

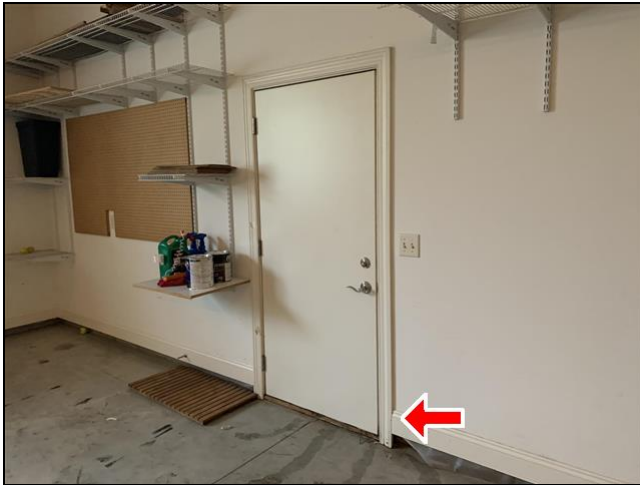
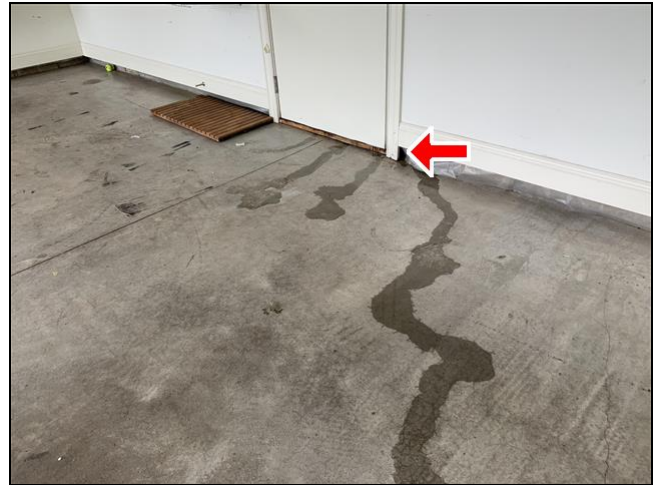
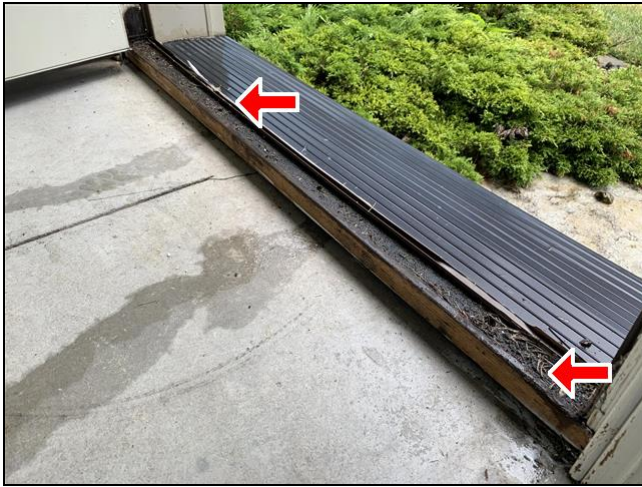
The garage service door threshold was rotted and deteriorated resulting in water intrusion.

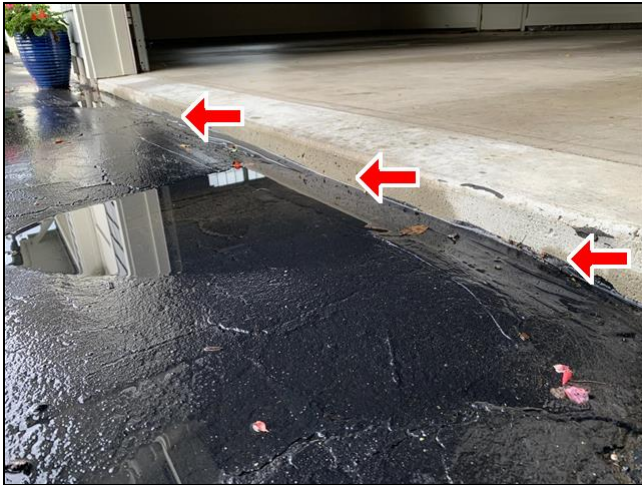
2.4 Item 1(Picture)

The driveway apron has settlement and will eventually need repair.

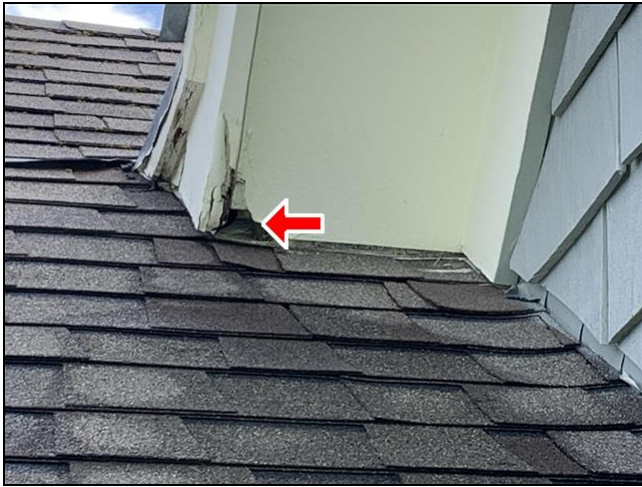
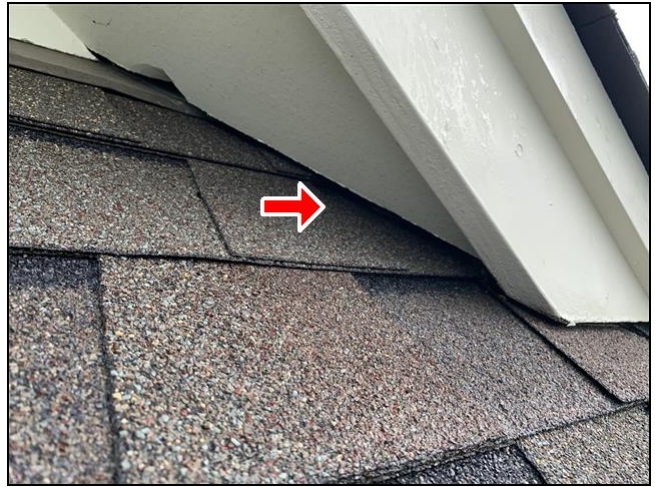
Gaps in the soffits are areas for rodent entry. Recommend sealing and gaps.

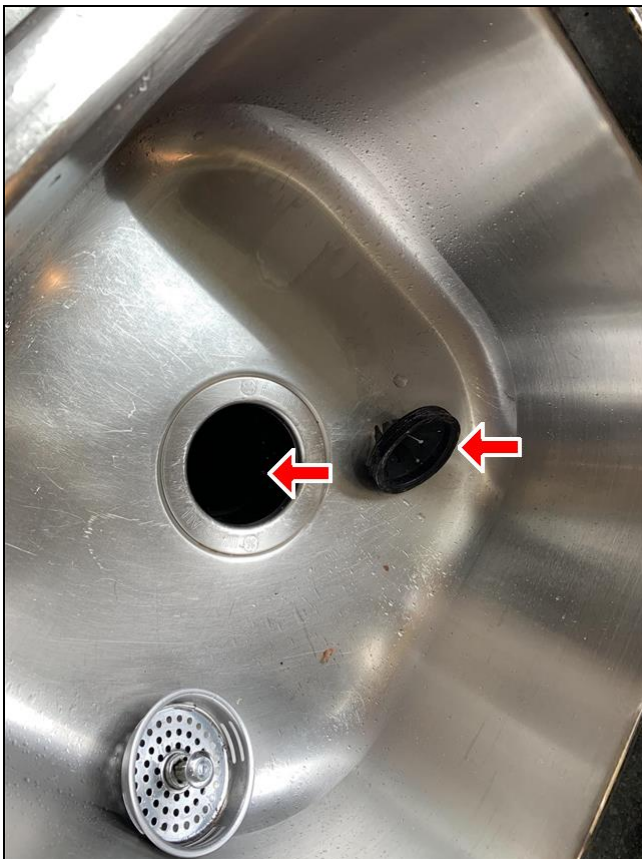
4.12 Item 1(Picture)

The disposal flange has failed and needs replacement.

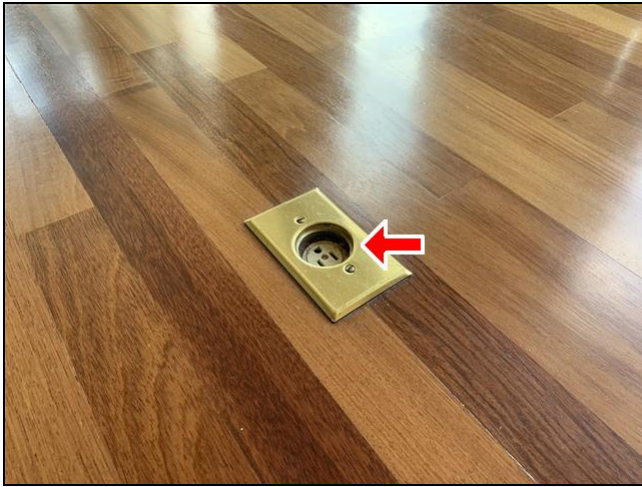
5.6 Item 1(Picture)

Floor outlet needs a cover plate

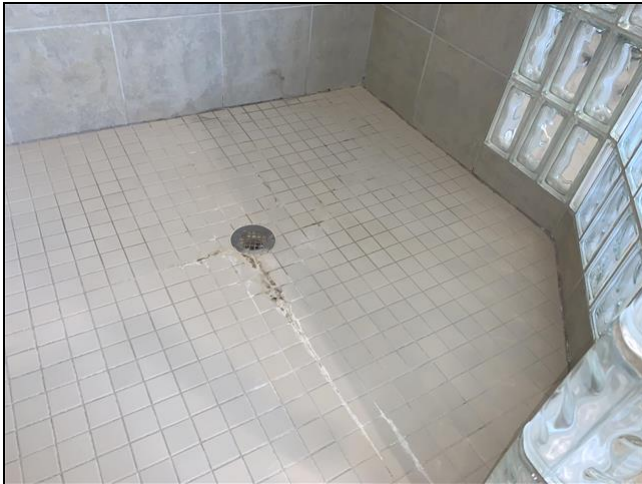
6.2 Item 1(Picture)

The master bath shower floor tiles are cracked and have been caulked. Replacement will likely be needed.

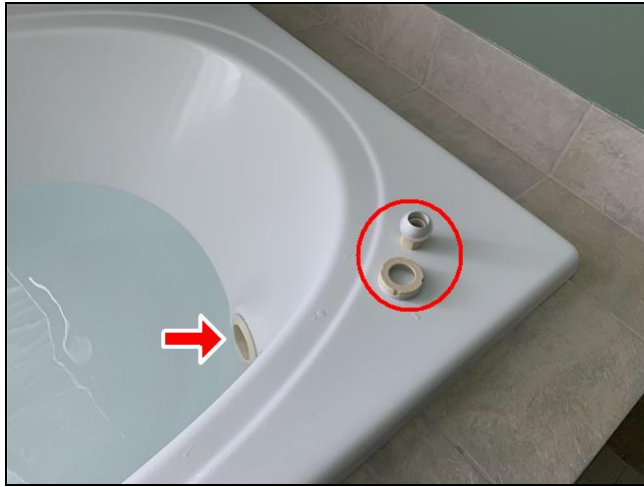
6.7 Item 1(Picture)

The master bath whirlpool tub jet port needs t be reconnected.

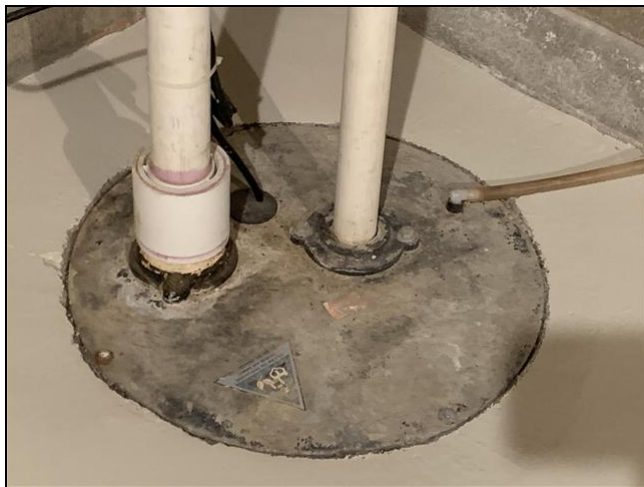
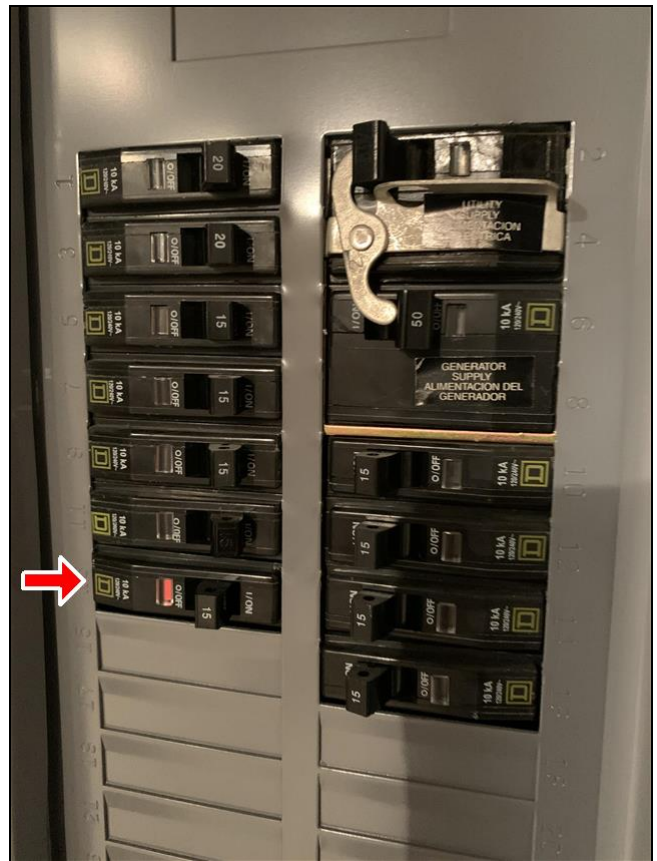
The sump pump did not operate properly, the circuit breaker trips. Sump pump replacement needed.

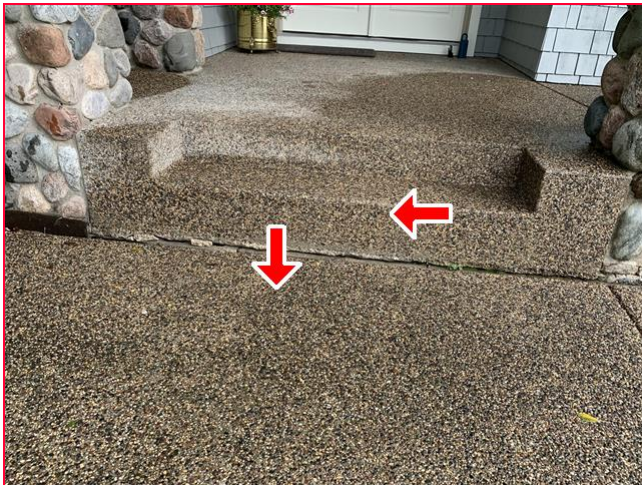
2.3 Item 1(Picture)

The front entry concrete has settled resulting in uneven steps. Trip hazard.

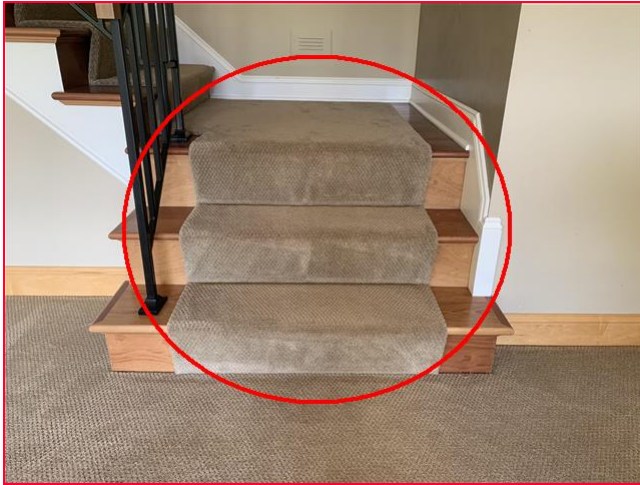
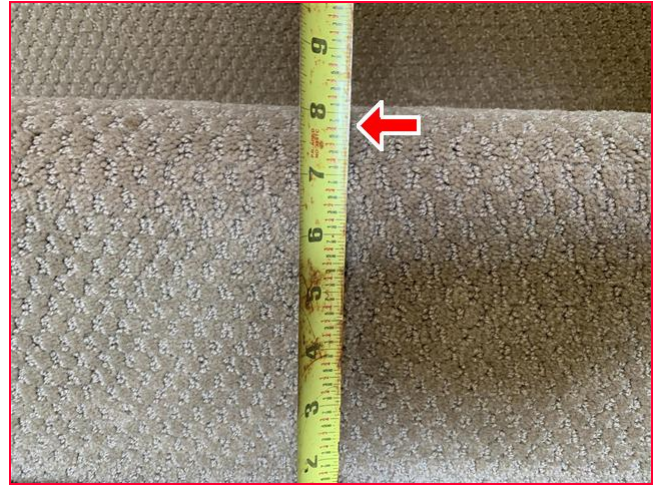
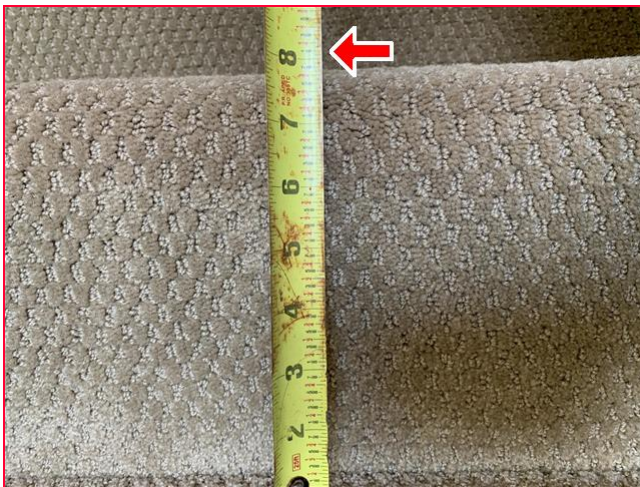
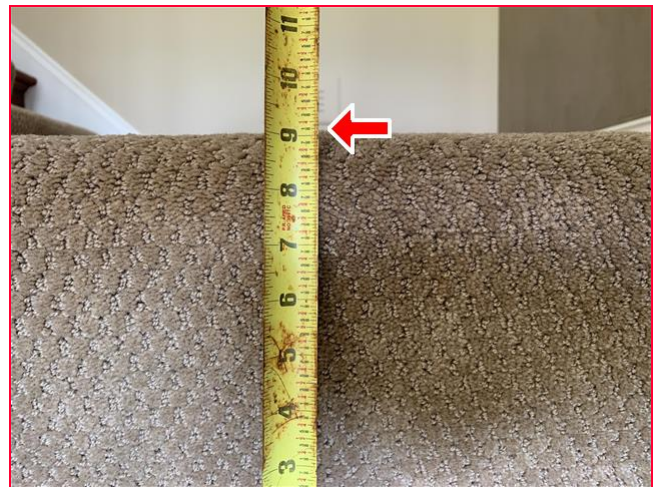
**+** The bottom 3 steps all have uneven heights. Trip hazard.
