Home Inspection Report

Property: 11019 Bridge House Road Windermere Florida 34786

Inspection Date: 11/28/18

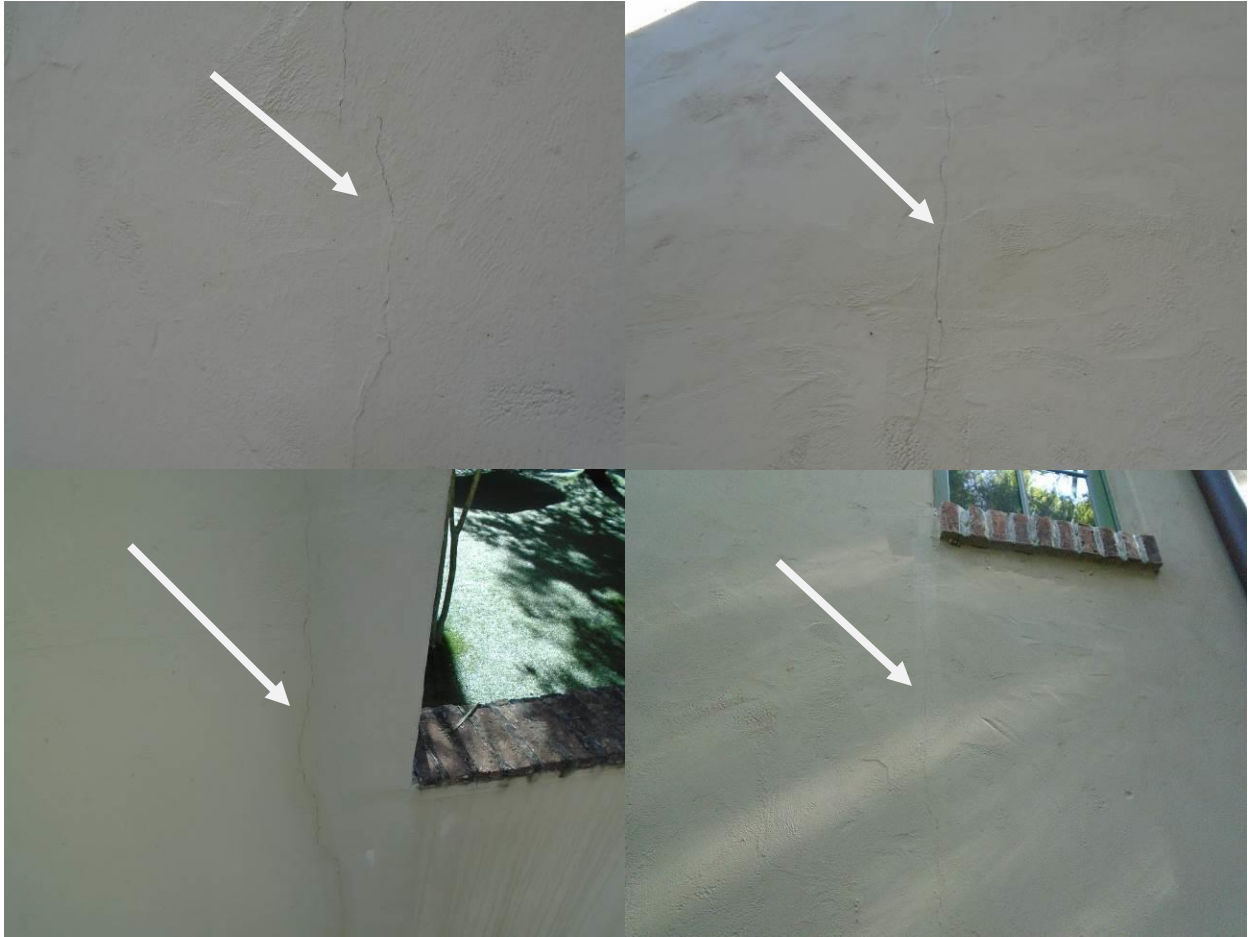
- Several stucco cracks. Recommend patching and painting these areas.

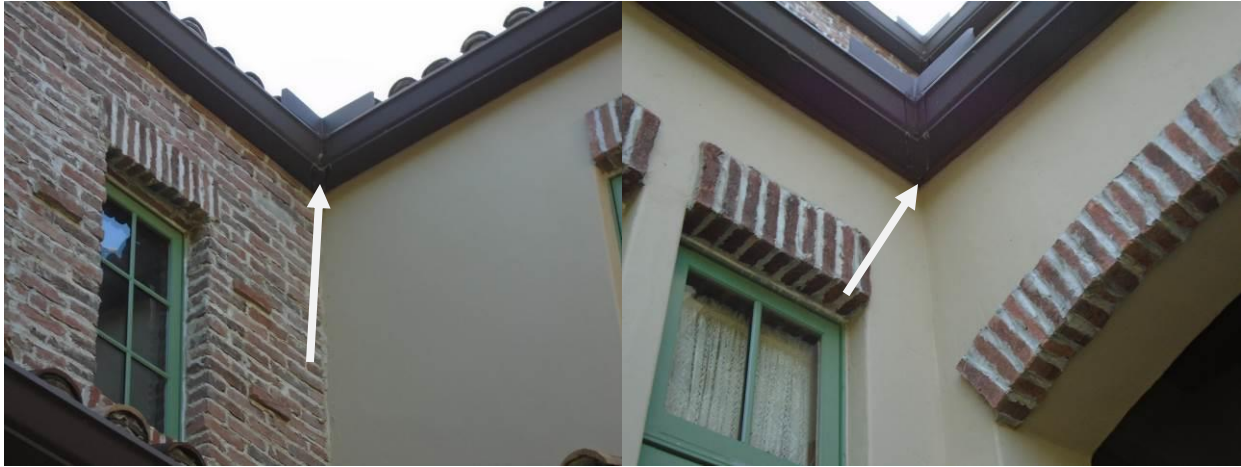
➤ Some of the gutter connections appear to be leaking.

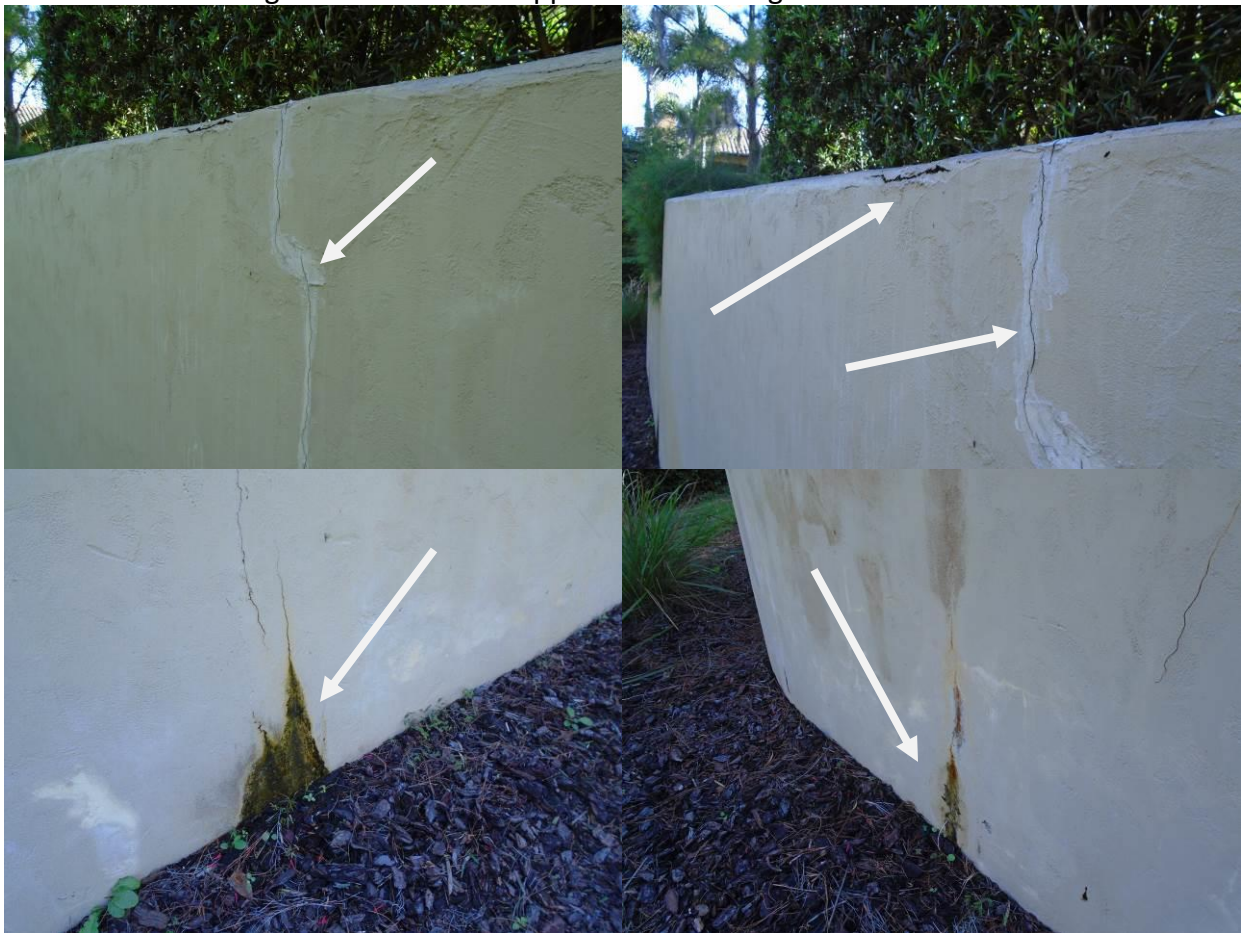
➤ Several cracks in the retaining wall on the back side of the pool. The wall is leaking water in some areas. Recommend further evaluation.

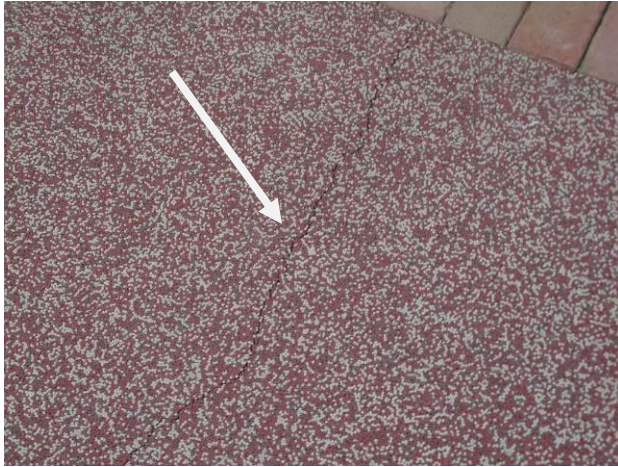
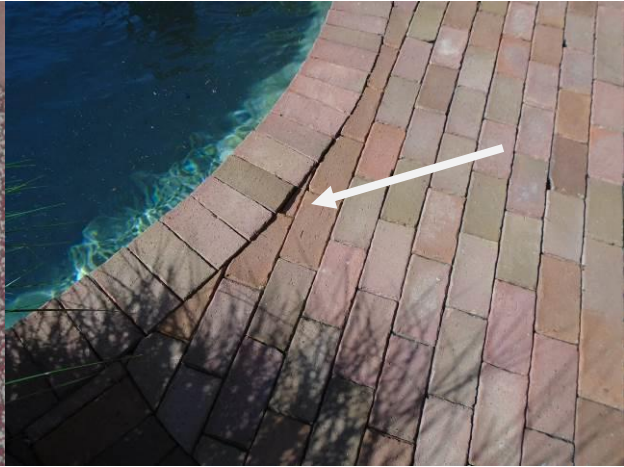
- Portions of the rubber flooring at the walk in entrance to the pool are cracked.
- Portions of the pavers around the pool have settled.

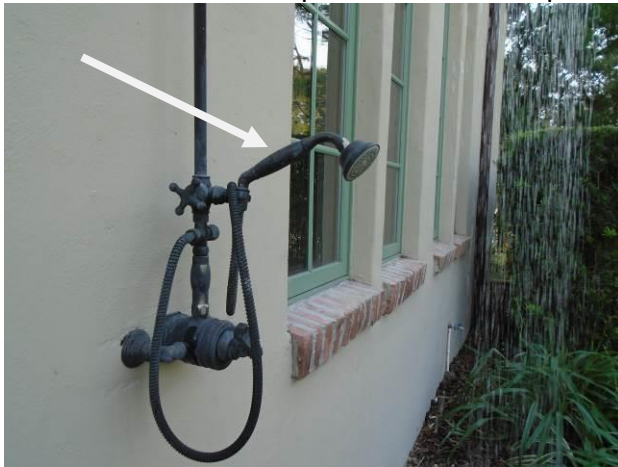
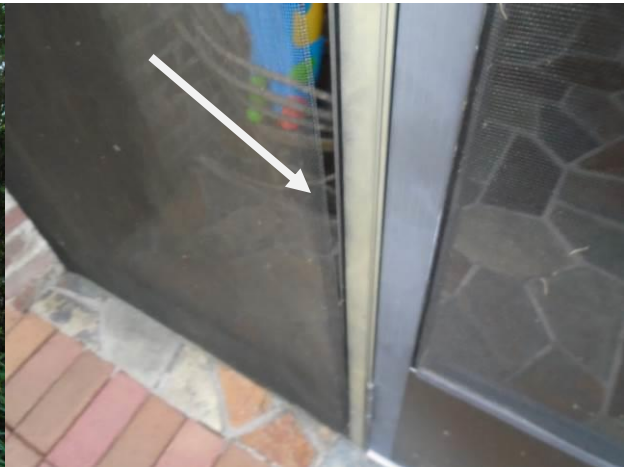
- Spray nozzle for the exterior shower does not operate.
- One of the patio screens is damaged.

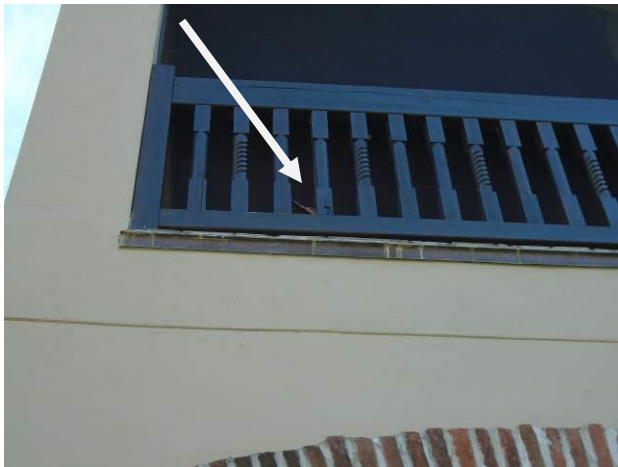
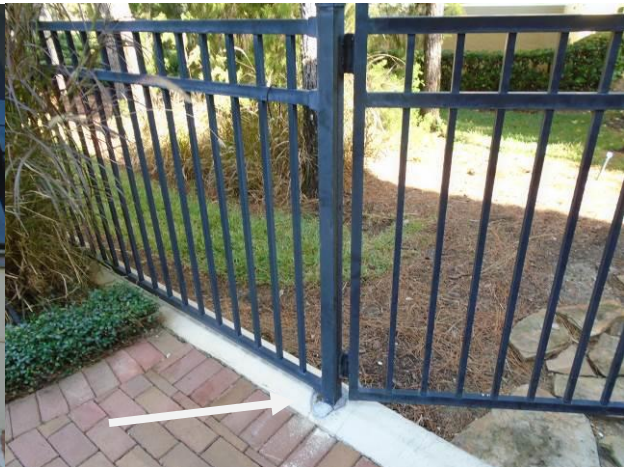
- One of the hand rail balusters off of the upper rear balcony is damaged.
- Support post for the right side pool gate is loose.

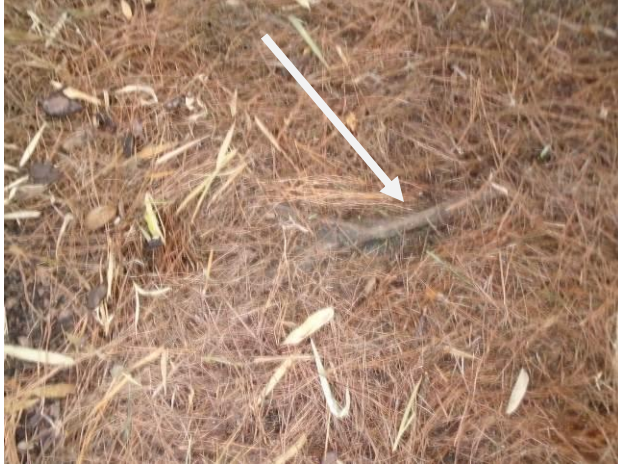
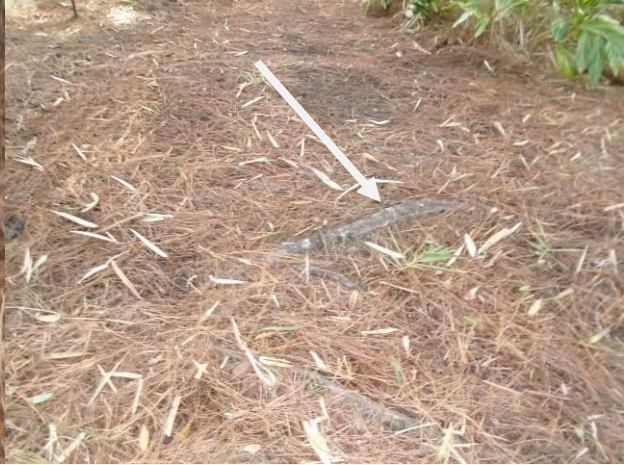
- Large tree roots on the left side of the house. Recommend monitoring these areas.

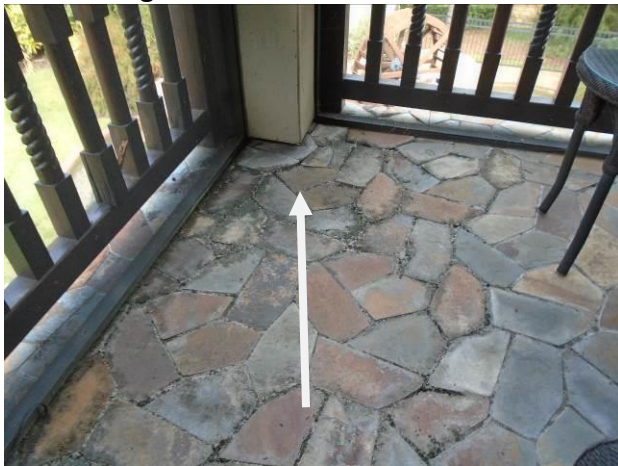
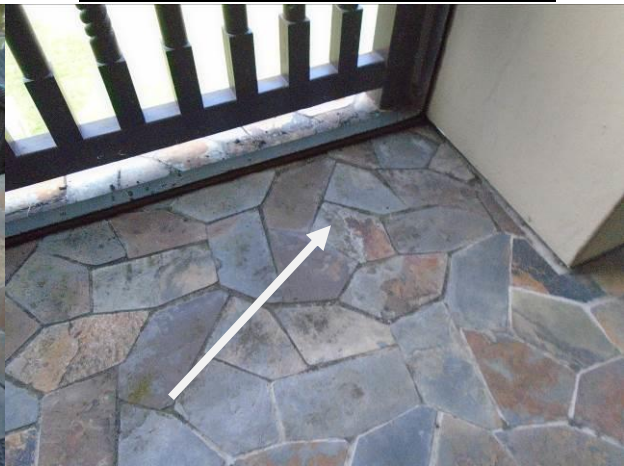
- Portions of the rear balcony floor appear to collect water. The floor and the ceilings below were tested with moisture detecting and infrared equipment and tested dry. Possible hidden damage below the floor. Recommend monitoring these areas.

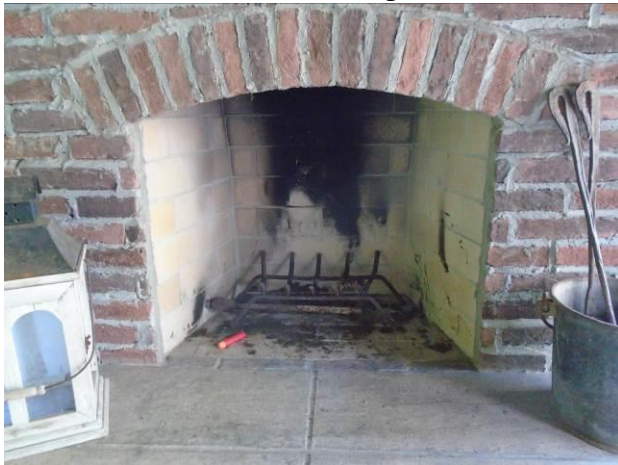
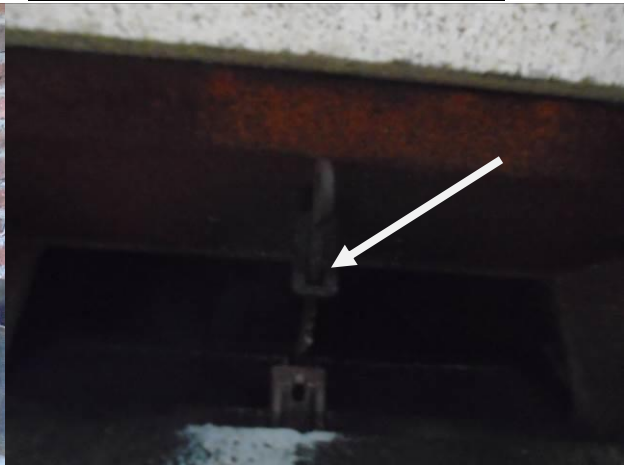
- At the time of inspection the fireplace chimney flue was covered with creosote. Damper is operable. Recommend having the flue cleaned and re-evaluated before operating the fireplace.

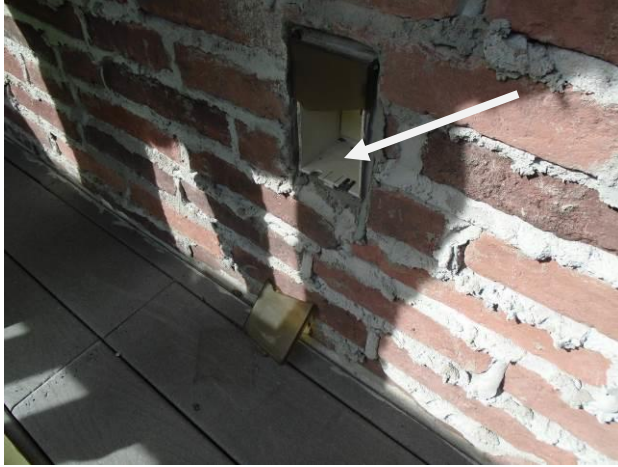
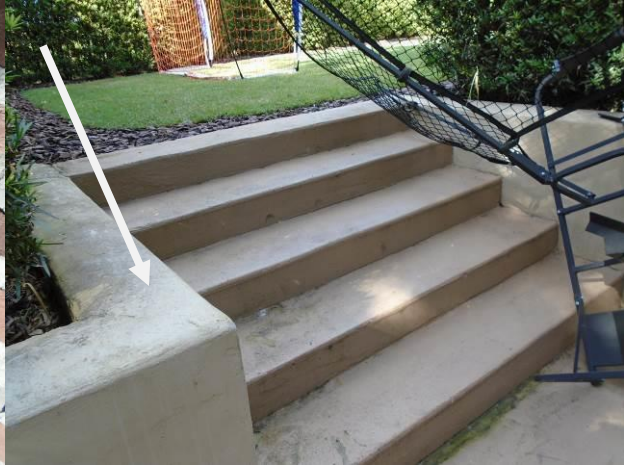
- Exterior outlet cover in the front balcony area is damaged.
- There is not a hand rail installed for the exterior staircase at the back left corner of the house.

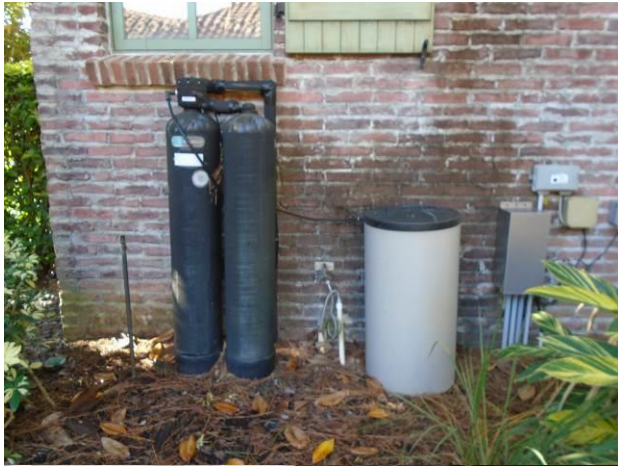
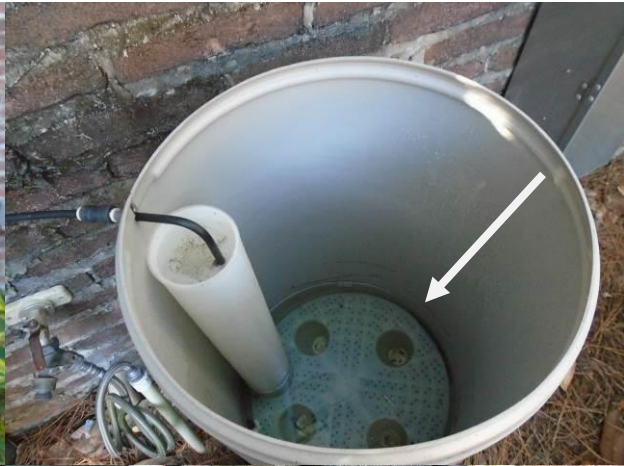
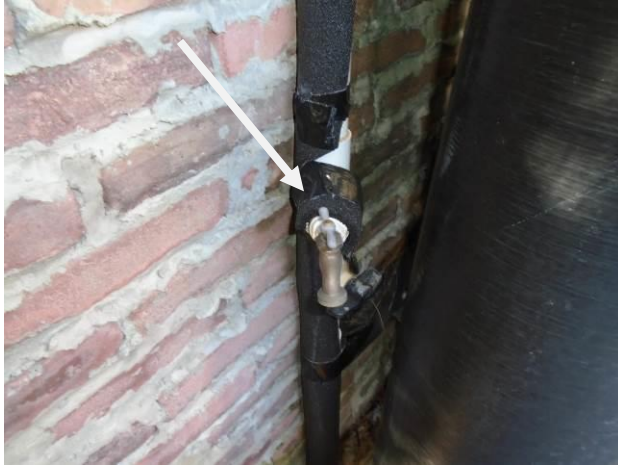
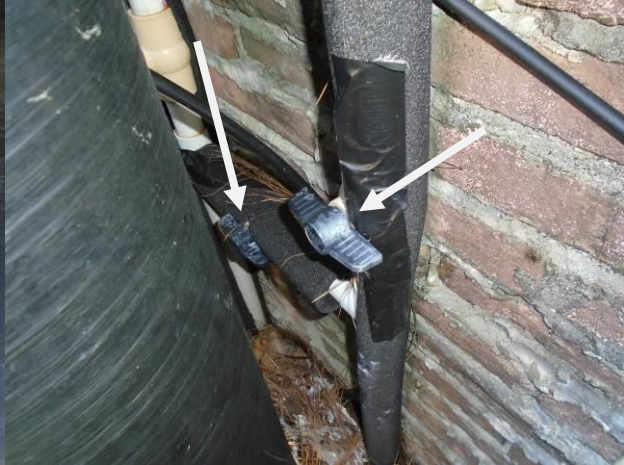
- Water softener does not operate. The tank is empty and all valves have been turned off. Recommend further evaluation by a qualified contractor.

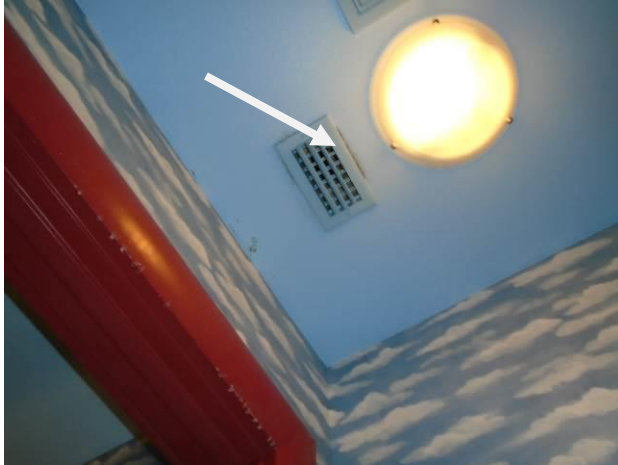
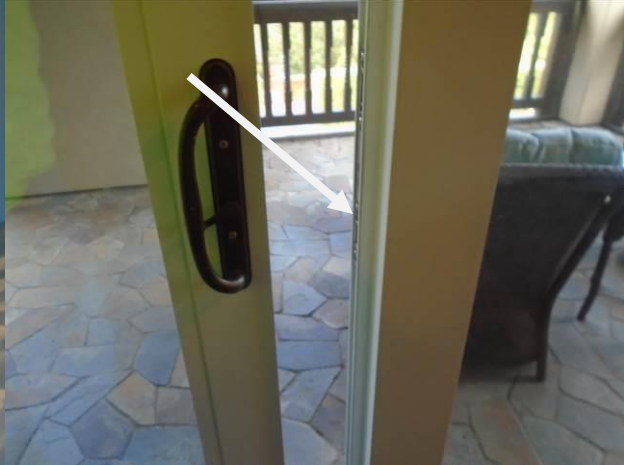
- Minor surface mold around the air return vent in the upstairs front right corner bathroom.
- Upstairs rear balcony doors do not lock.

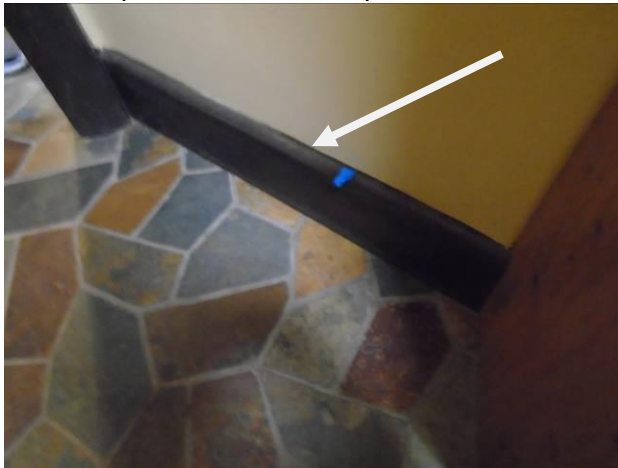
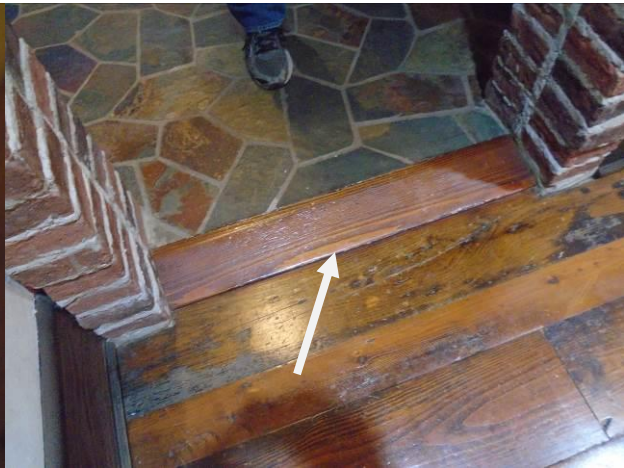
- Base board is slightly separated from the wall in the pantry.
- Uneven surfaces at the front entry to the kitchen. (Trip hazard)

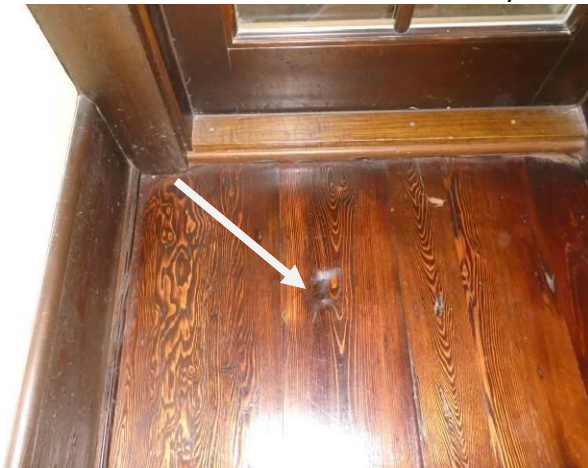
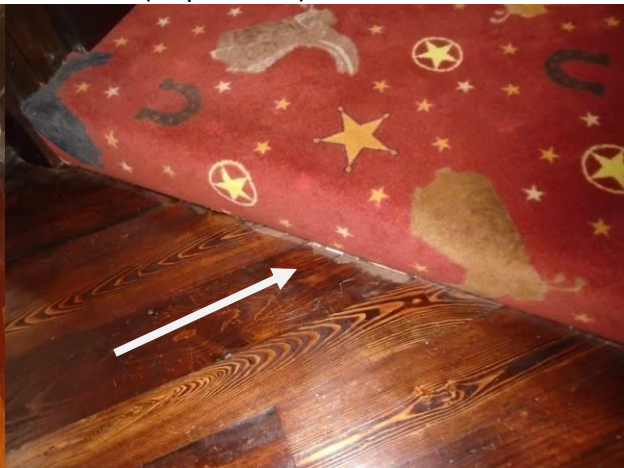
- Surface damage in several areas of the flooring throughout the house.

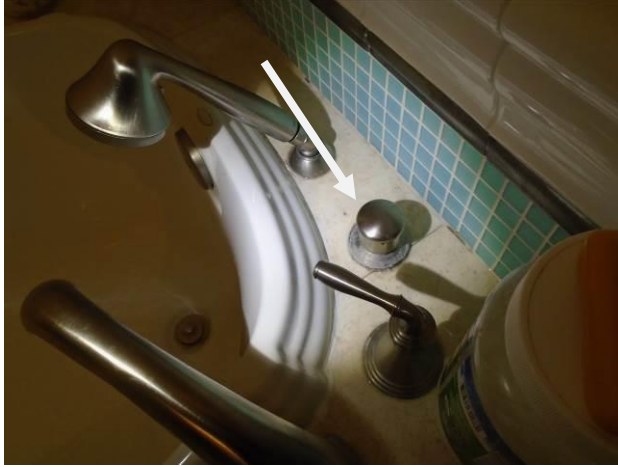
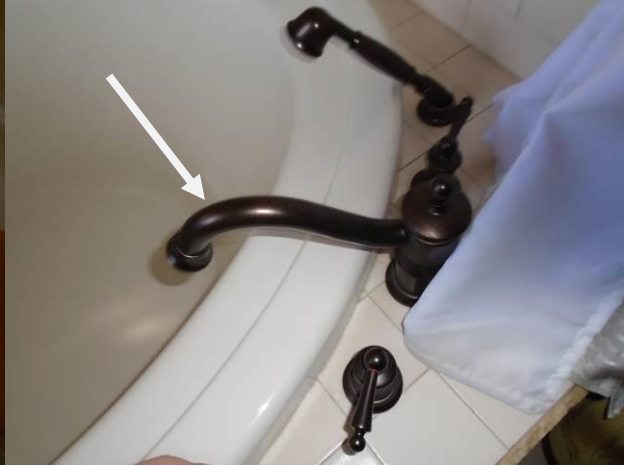
- The button that activates the spray nozzle for the upstairs left side bathroom tub leaks when operated.
- The tub faucet in the downstairs right corner bathroom is loose.

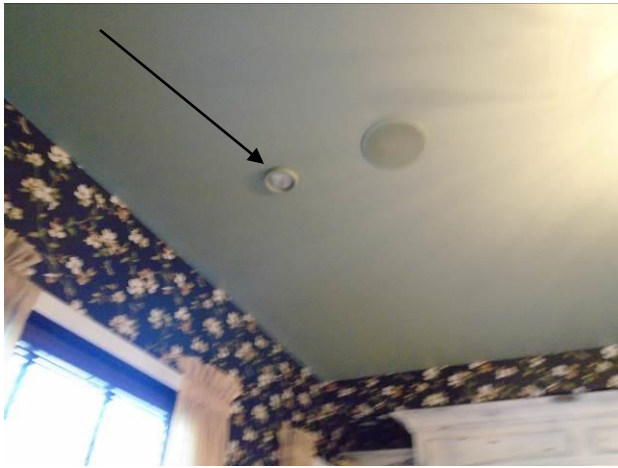
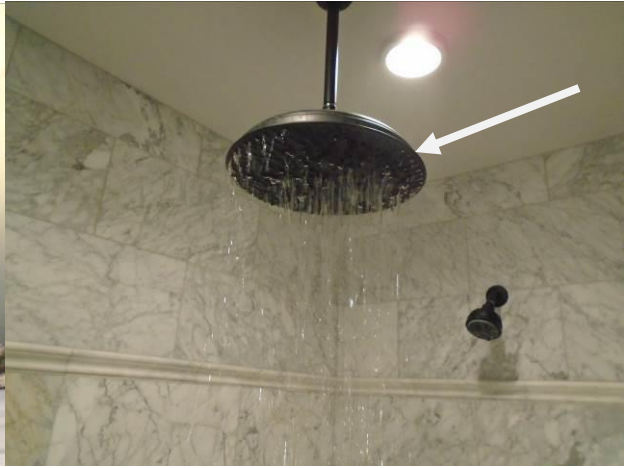
- Some of the light bulbs throughout the house do not operate.
- The water pressure from the overhead master bathroom shower faucet is not adequate.

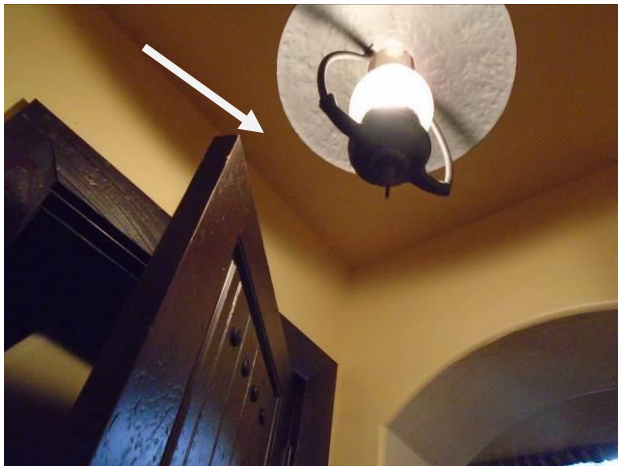
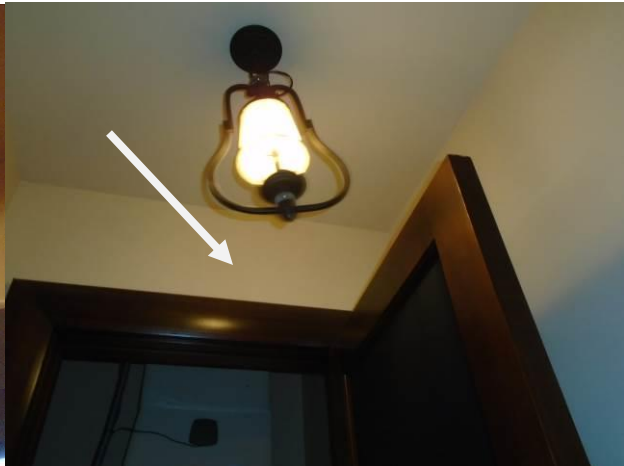
- One upstairs and one downstairs closet door contacts the light fixture above when opened. (Safety hazard)

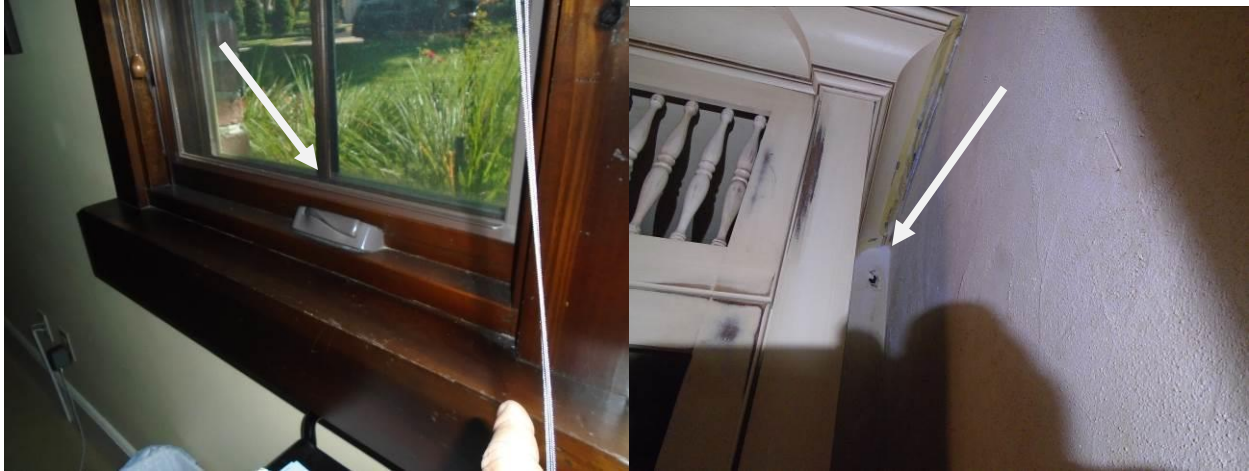
- One of the windows in the downstairs garage office does not open.
- Drywall hole on the right wall of the sitting area off of the kitchen.

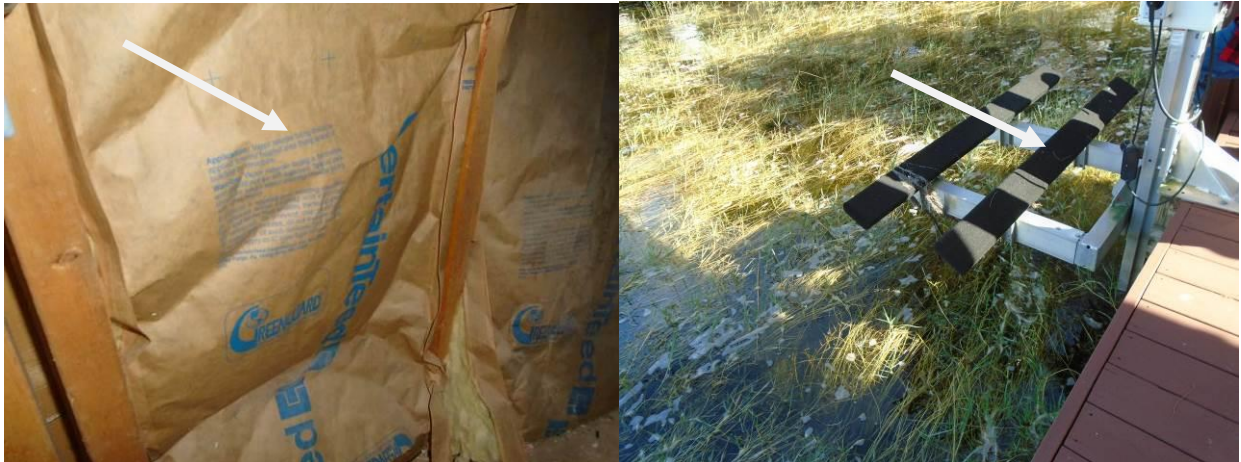
- The insulation inside the small closet that houses the elevator motor is installed backwards. The paper is flammable and should either be covered with drywall or installed with the paper side in.
- One of the Jet Ski lifts does not operate.

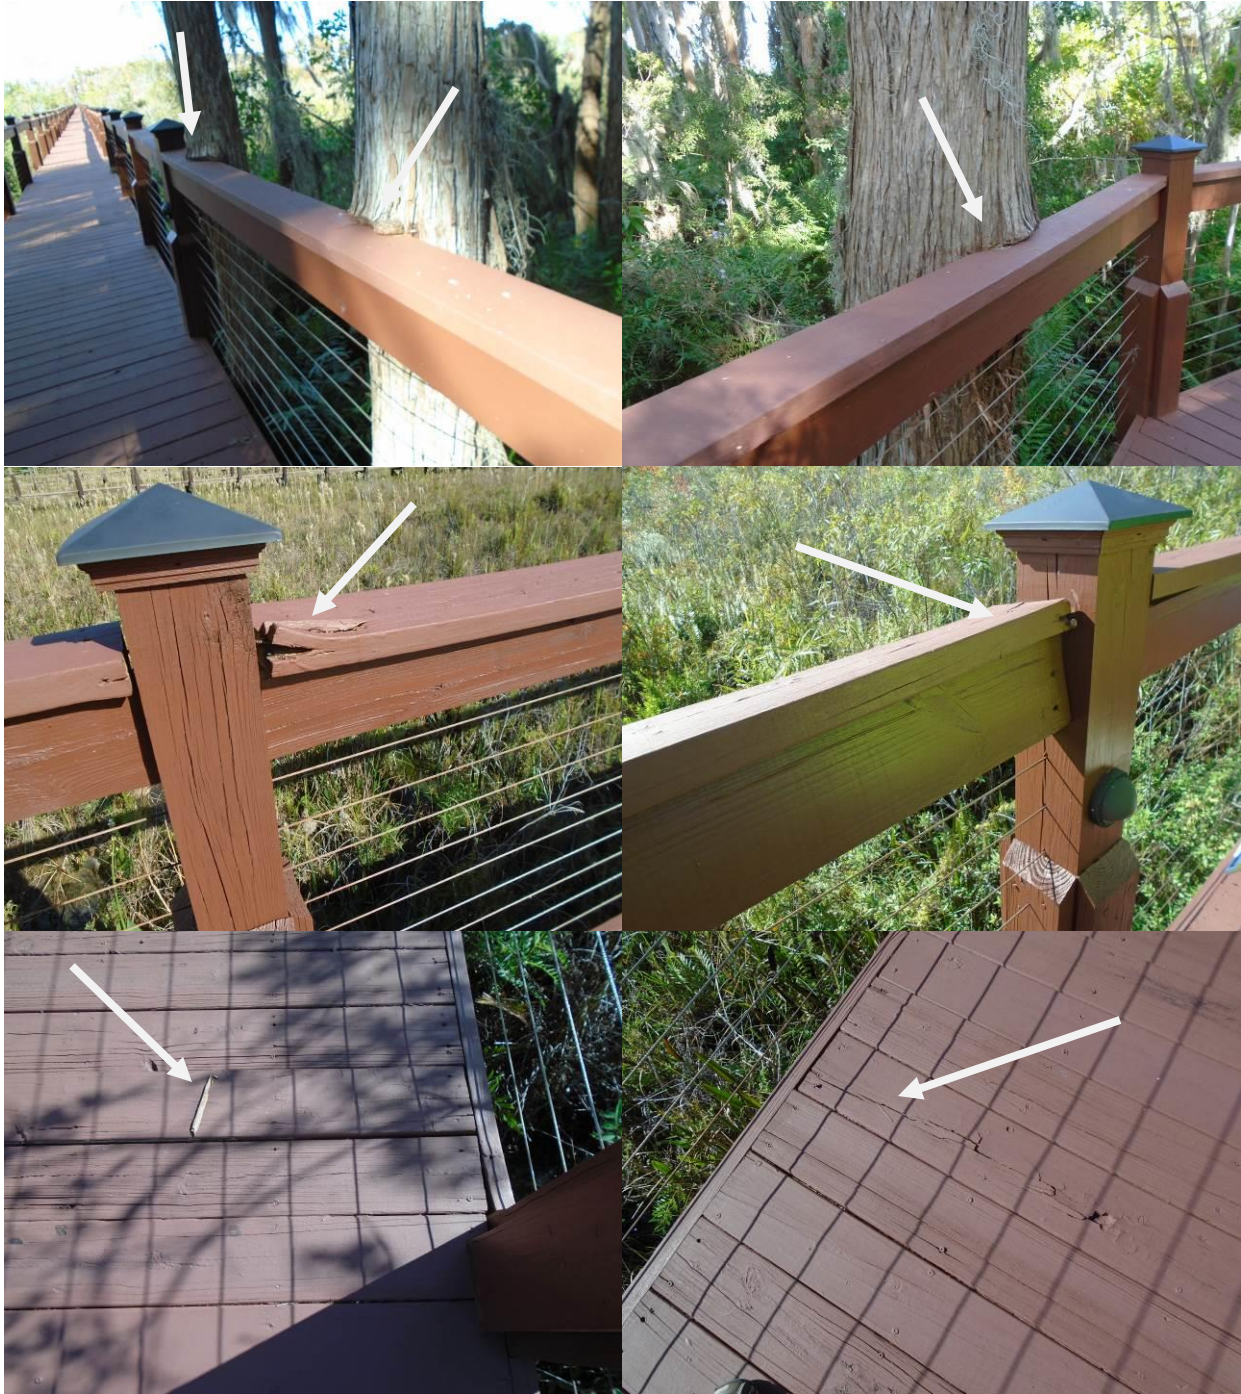
- Several floor boards and hand rail boards for the boat dock and boat dock walkway are damaged.
- Several screws have backed out of the boards.
- The stairs on the left side of the deck leading up to the walkway behind the pool have settled and are not level.
- Tree trunks are in contact with the walkway.
- Possible hidden damage on the underside of the deck boards. The condition of the under sides of the deck boards is not visible. Only the visible part of the walkway and dock were inspected. The undercarriage and framing below the water line were not inspected. Recommend further evaluation by a qualified contractor.

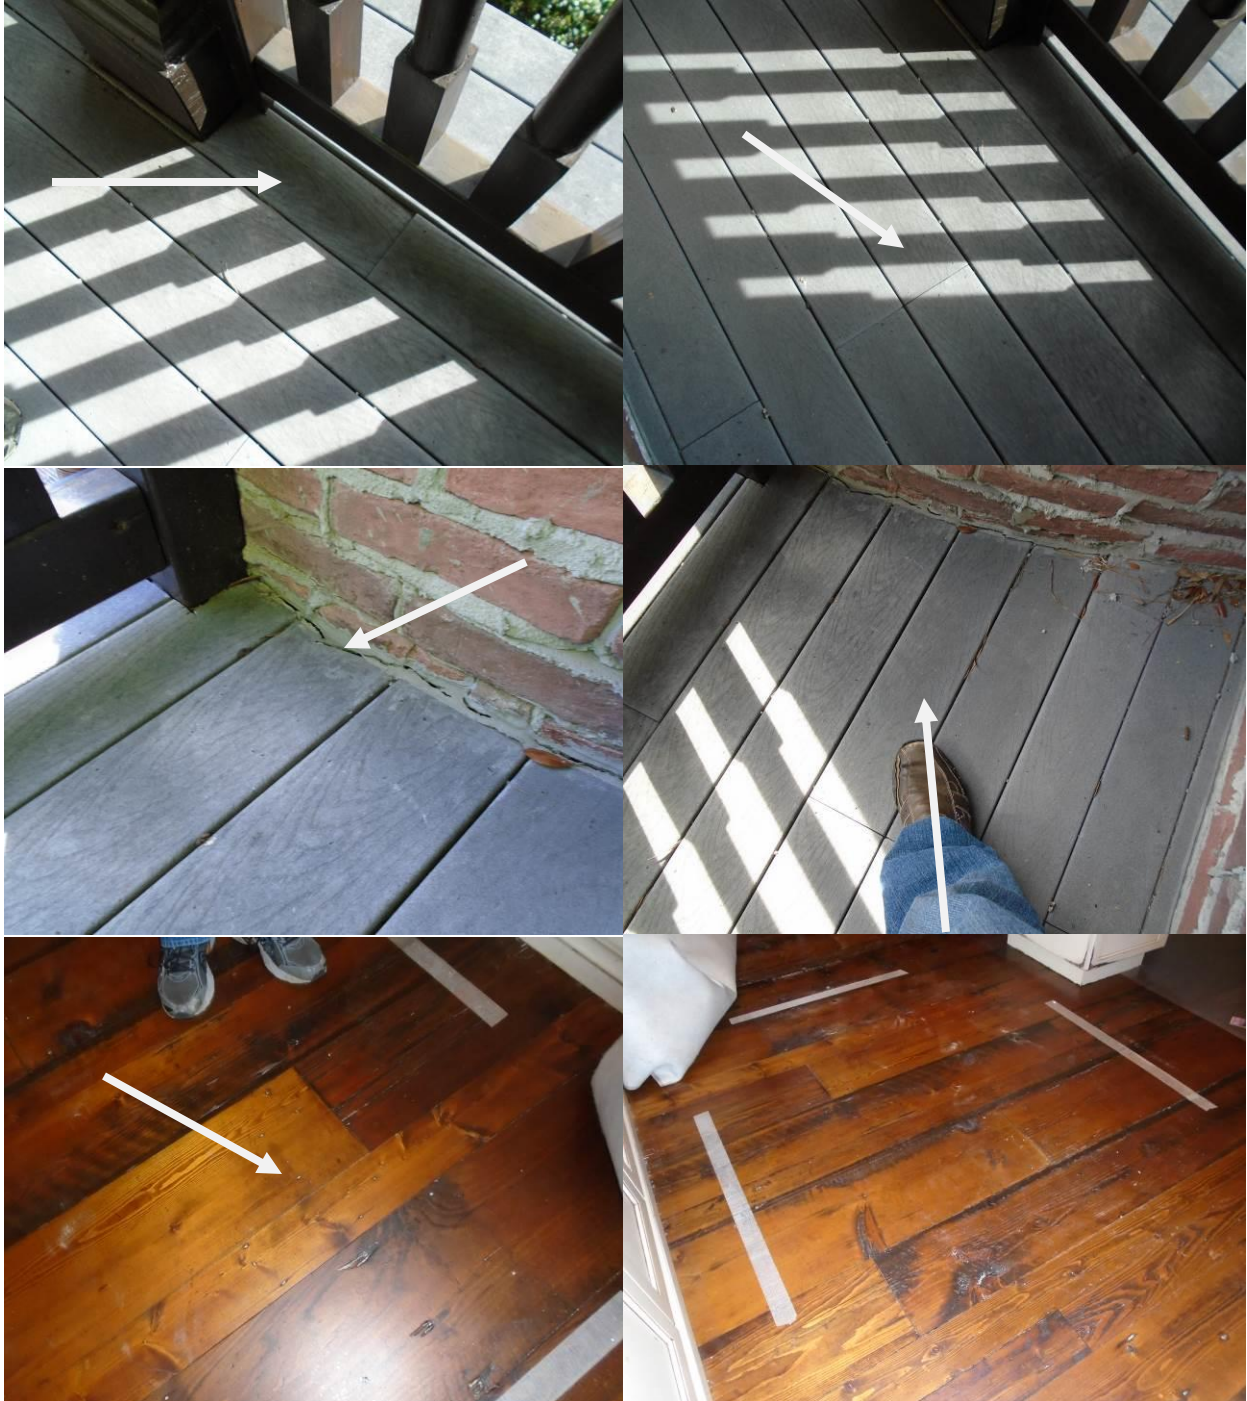
- Several of the front balcony framing pieces are cracked/damaged. It appears the balcony is stressed causing damage to the framing on and below the front balcony. Large cracks in all of the cantilever supports under the floor. Wood rot and evidence of previous repairs in several areas. One of the balcony floor boards is loose and some of the boards creak when walked on. One of the floor boards on the interior floor opposite of the balcony floor inside the doors may have been replaced. *There is possible significant hidden damage throughout the balcony structure and areas of the structure surrounding the balcony. Recommend further evaluation by a structural engineer.*

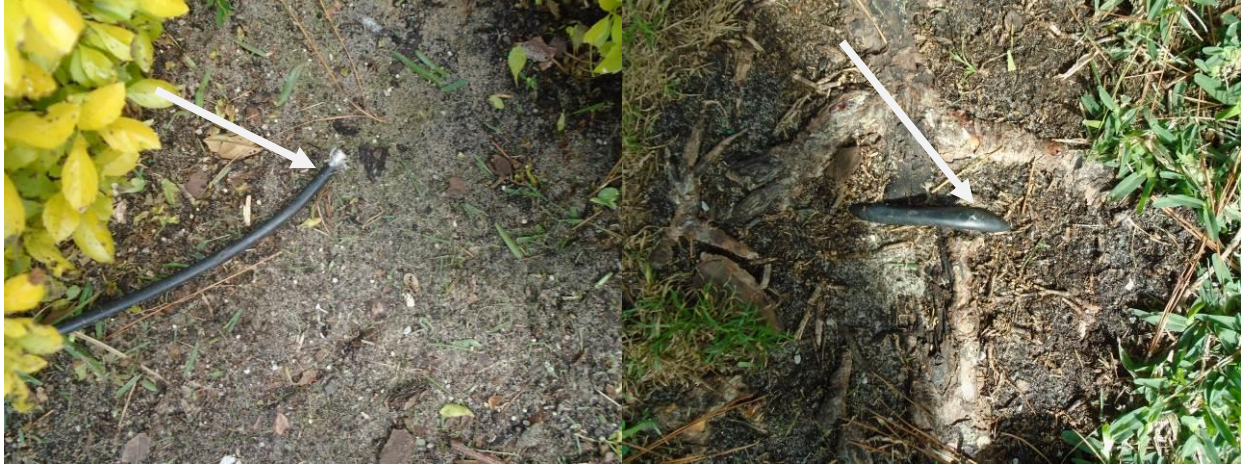
- Large cut electrical line buried on the right side of the front yard. At the time of inspection the line was not live. (Safety hazard).

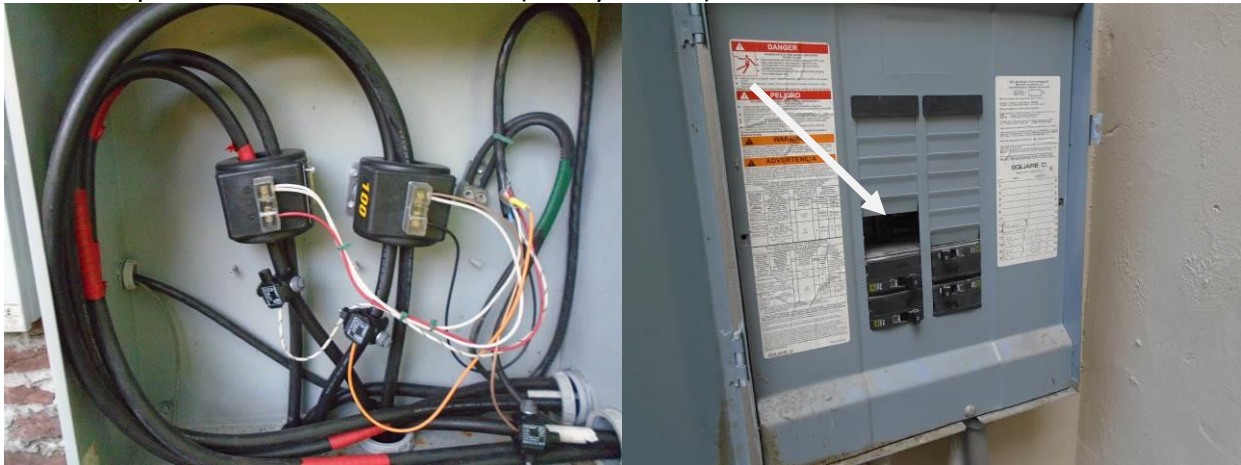
- One of the electrical boxes on the right side of the house does not have a dead front panel installed.
- Knock out missing in one of the exterior panels.

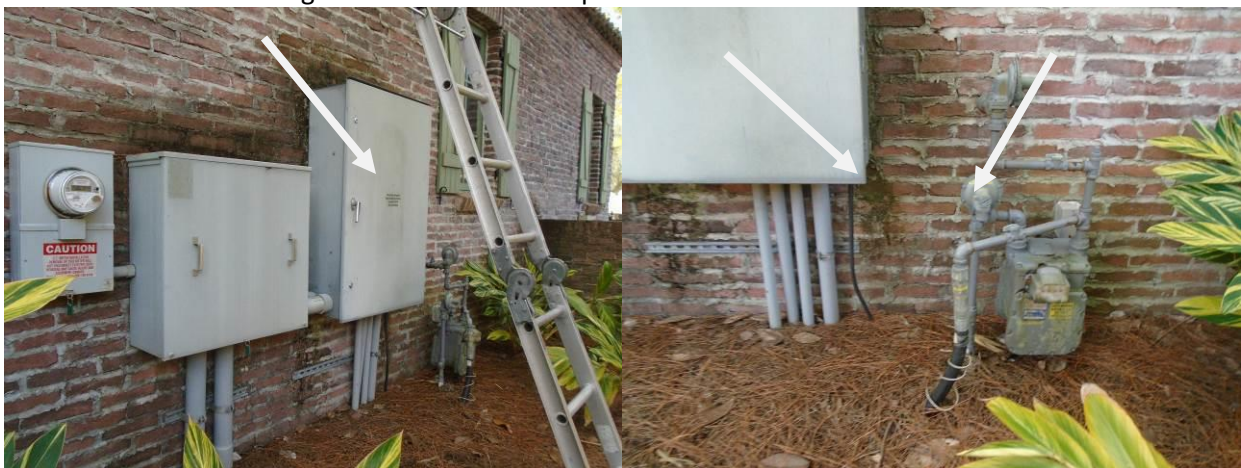
- One of the electrical boxes on the right side of the house does not open. The interior components of that panel were not inspected.
- There is not adequate clearance between the electrical box and the gas meter on the right side of the house.

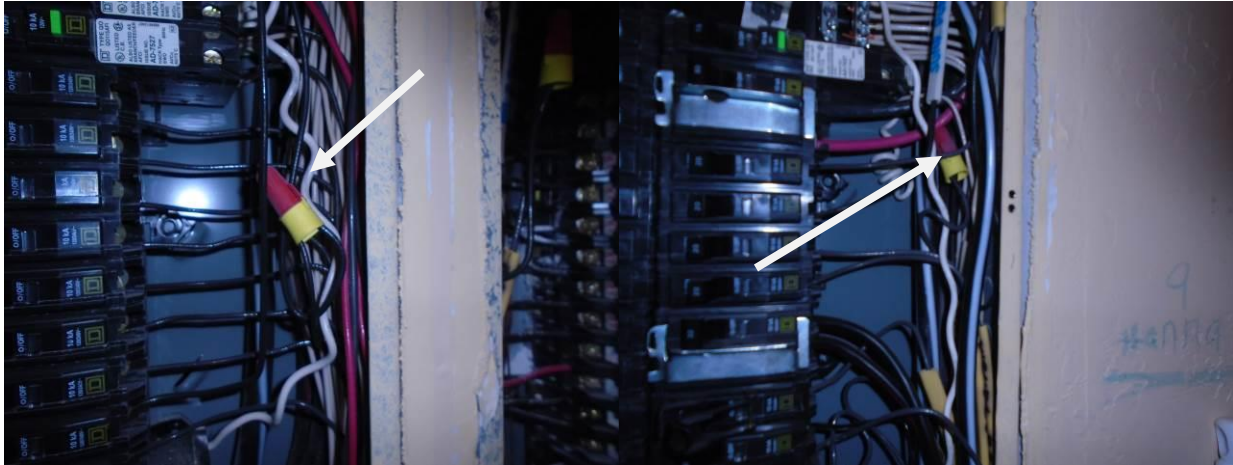
- Several wire nut connections in the sub panels.

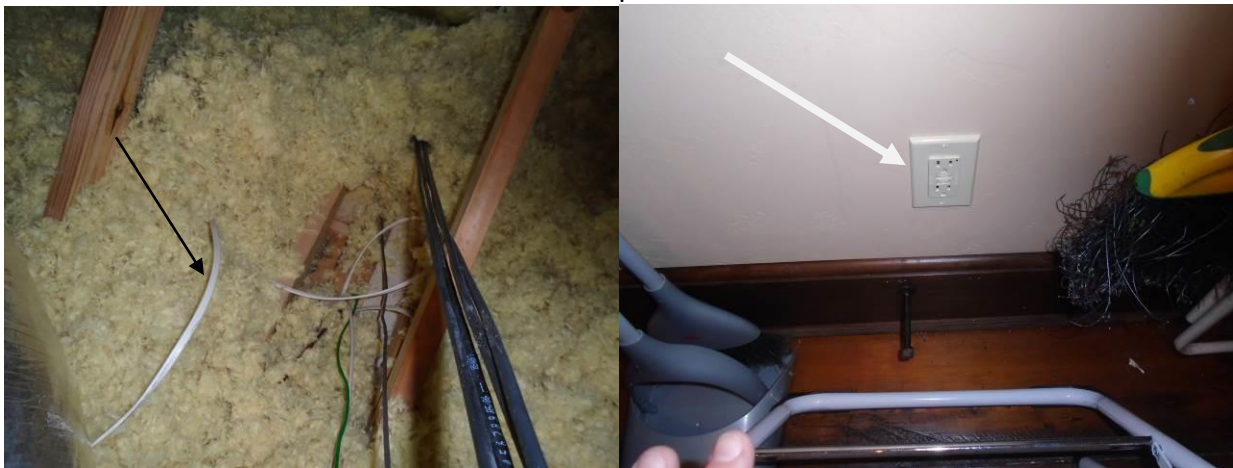
- There appears to be several electrical lines run through the attic after the house was constructed.
- The tripping mechanism for the GFCI outlet in the laundry room does not operate.
- There are two 200 amp shut offs on the left side of the house. There are four sub panels in the upstairs laundry room. There was no access to the locked panel on the right side of the house, we could not determine if there are additional main shut offs and if the amperage capacity for this home is adequate.
- Due to the number of electrical issues we recommend that a licensed electrician evaluate the entire electrical system in this home.

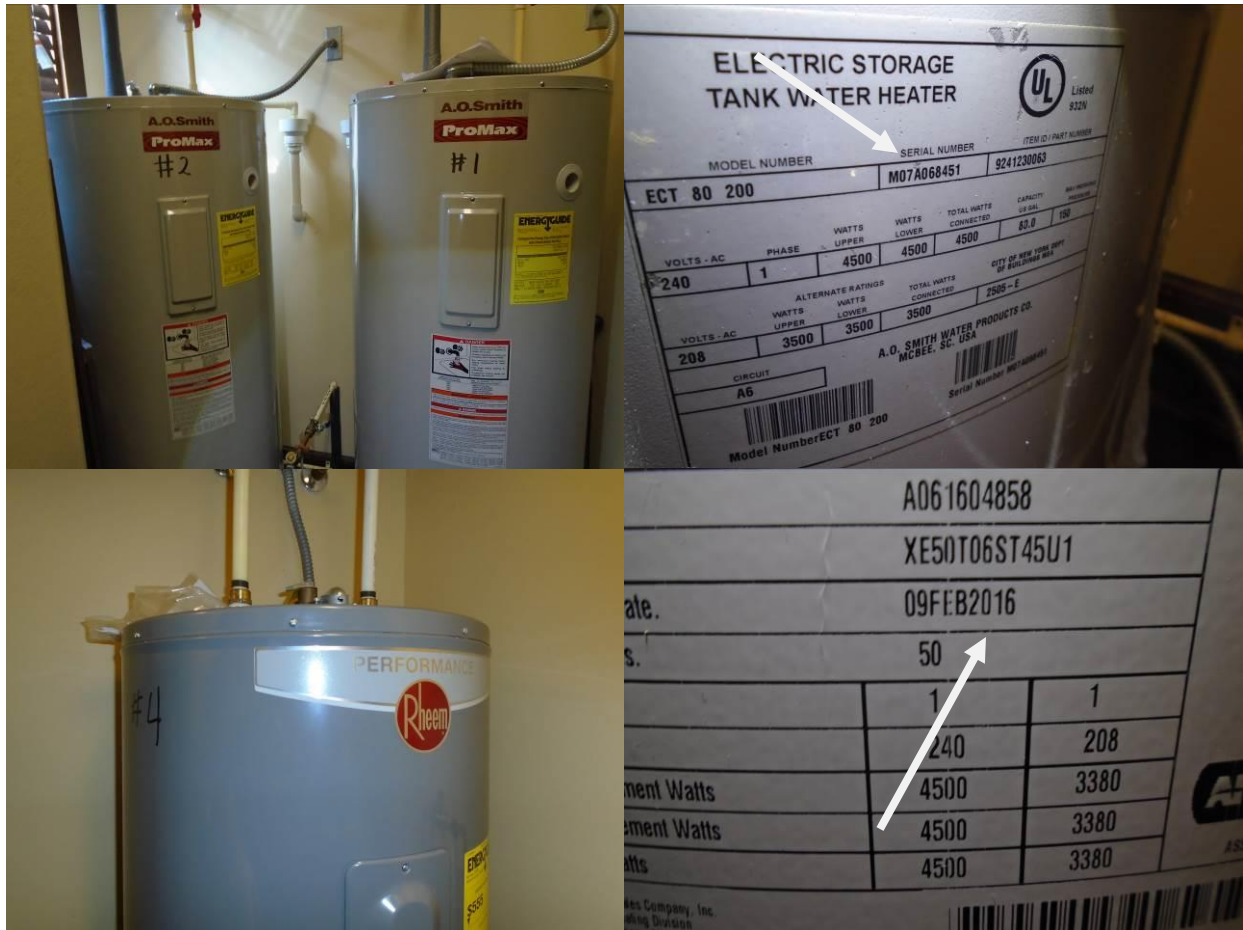
- This home is equipped with 4 electric powered A.O. Smith/Rheem hot water heaters three manufactured in 2007 one in 2016. The heaters are in satisfactory physical and operating condition.

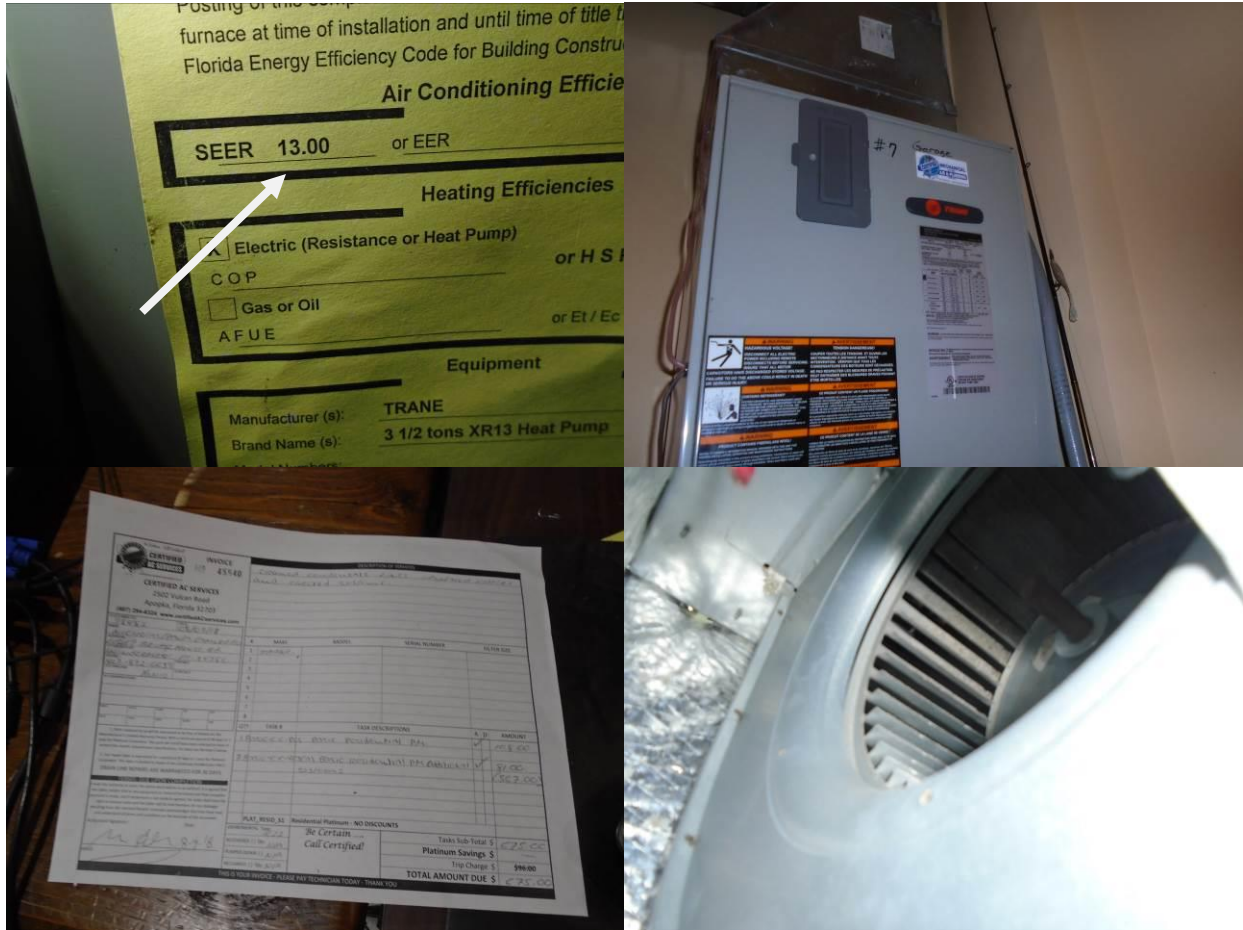
- This home is equipped with eight 13 seer (seasonal energy efficiency rating) Trane air conditioning systems manufactured in 2007/2008. There is some typical dissimilar metal corrosion on the evaporator coils in all air handlers. Due to the exterior temperature at the time of inspection all eight of the systems were operated in heat mode only. The temperature splits in air conditioning mode were not taken. *In heat mode the systems are in satisfactory physical and operating condition. According to documentation provided by the homeowner all systems were serviced in August 2018. Recommend having all systems serviced annually.*
