Home Inspection Report

Property: 11019 Bridge House Road Windermere Florida 34786

Inspection Date: 11/28/18

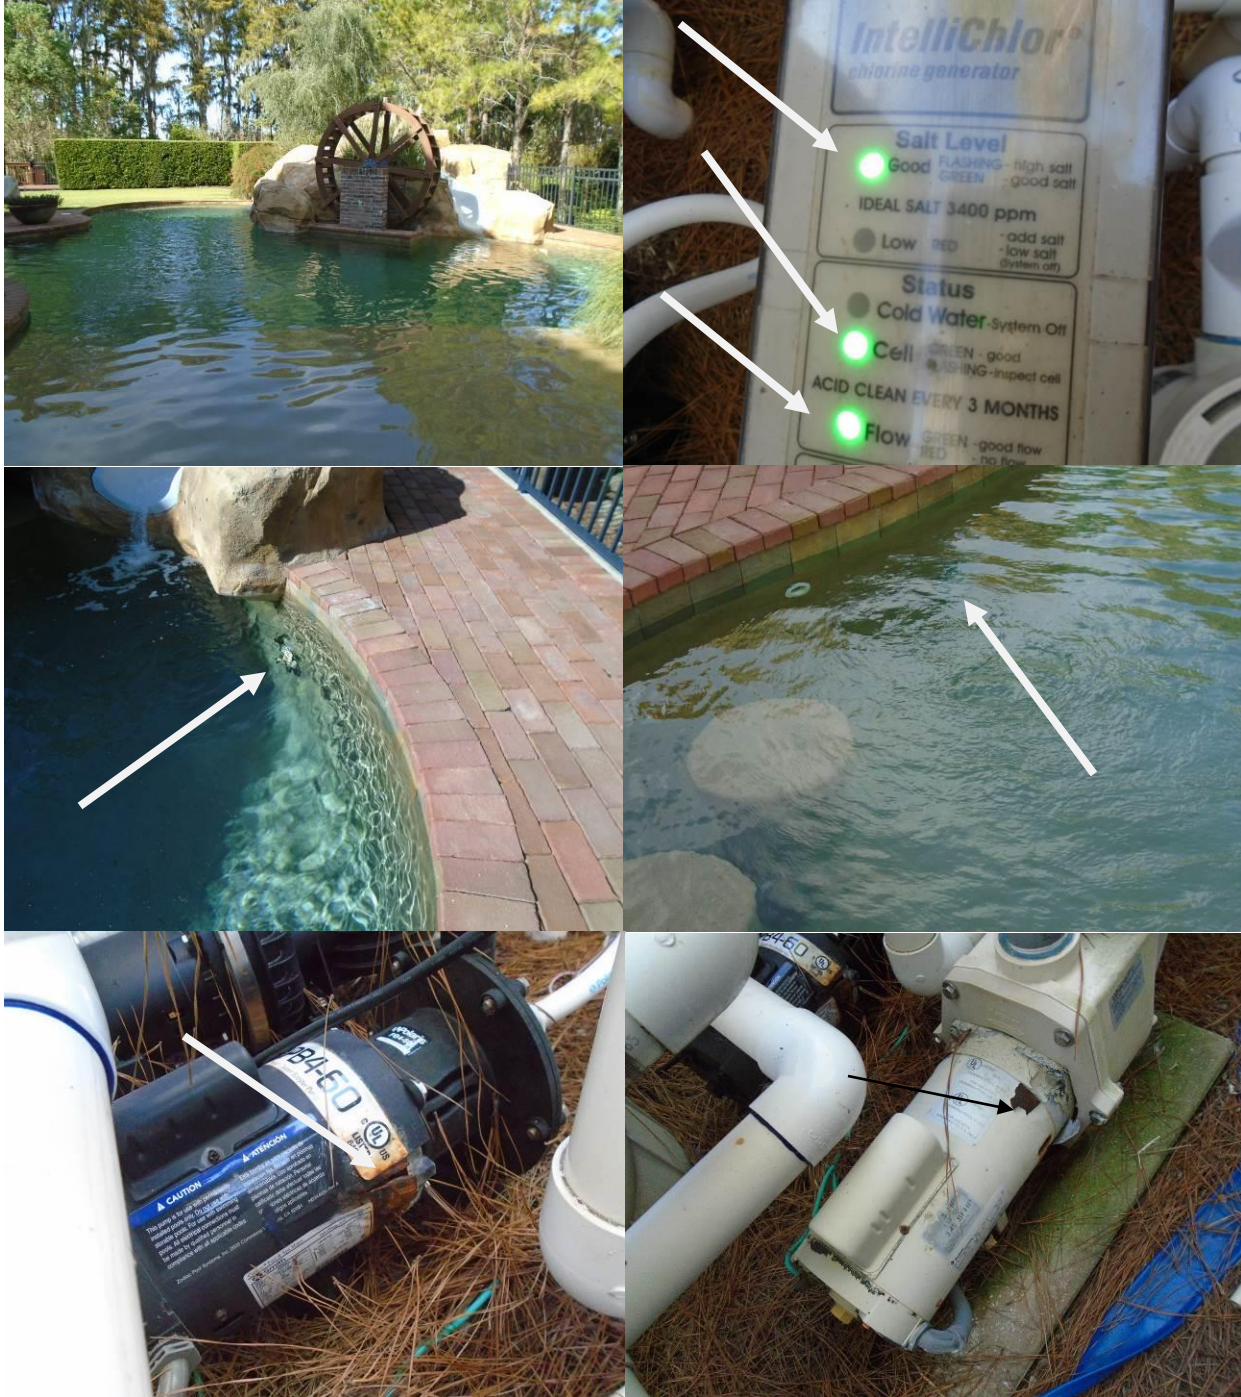
- One pool pump, filter, plumbing, salt cell, interior control panel, tile, interior surface, and one light are in satisfactory physical and operating condition. Pool was operating at the time of inspection.
- One pool light does not operate.
- Two of the pumps are operating but in poor physical condition.
- There is not a pool heater installed.
- Pool door alarms do not operate.
- **There is not a child protective fence installed around the pool.**
