Home Inspection Report

2965 Deer Run Trail
Orono, MN 55356

Inspection Solutions

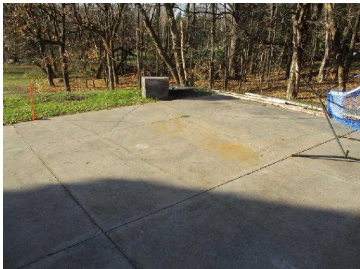
1. Driveway: Asphalt and Concrete - Re seal the asphalt as well as cracks in the concrete

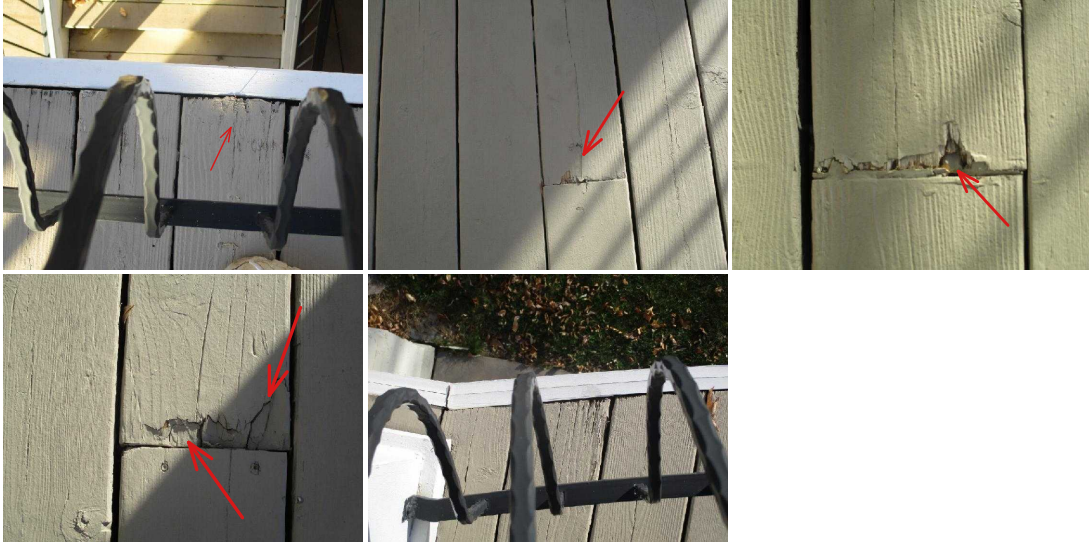
5. Deck: Painted wood - Moisture damage to isolated boards as well as areas that have been patched and now have failing paint are beginning to deteriorate.

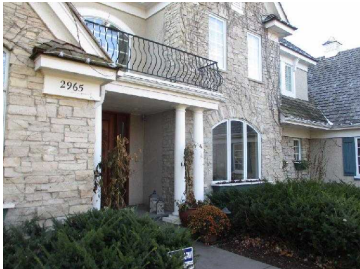
6. Balcony: Painted wood - Older board in place with peeling paint

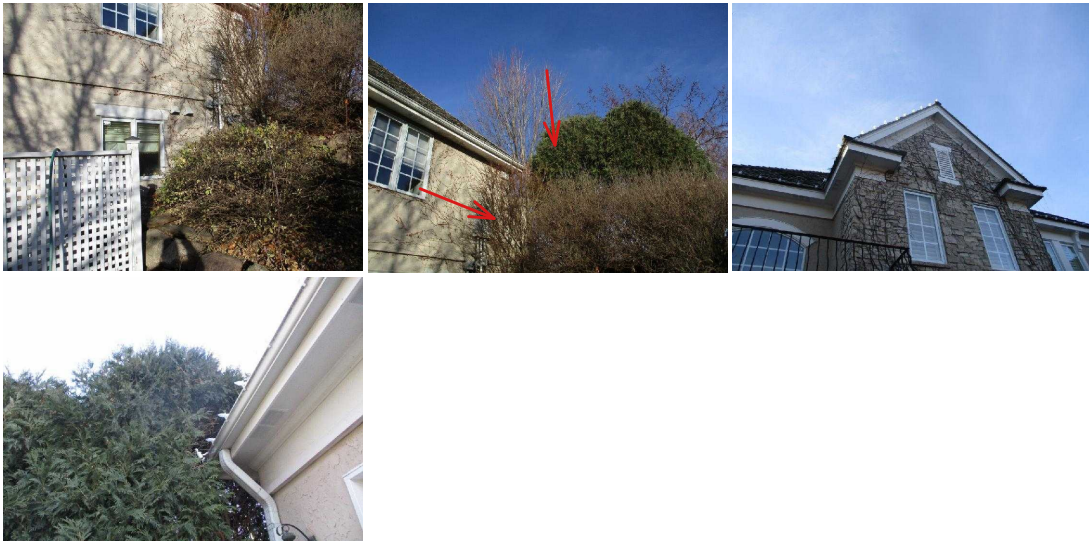
8. Vegetation: Trees grass and shrubs - Tree limbs over hang the roof and should be cut back

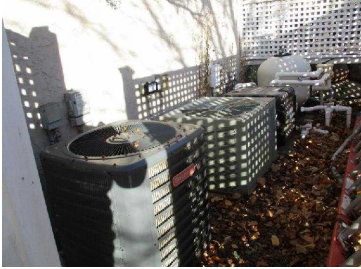
10. Fences: Wood - Gate will need repairs

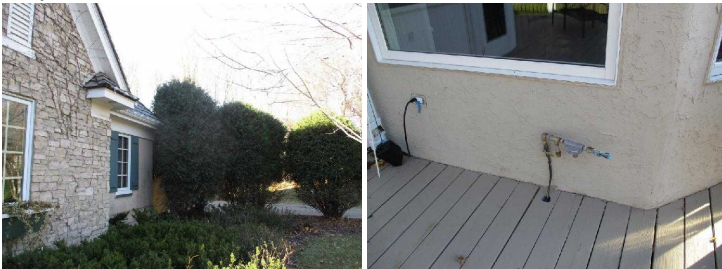
1. Type: Stucco and stone - Moisture stains as well as stucco installed below grade without weeps screeds in place. Isolated stucco cracks noted. The stucco was not tested during the home inspection

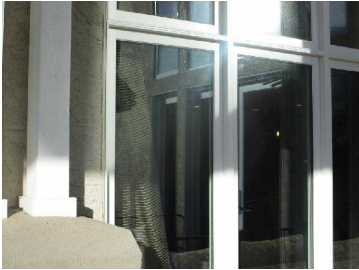
8. Windows: Casement - Window seal broken or damaged. See interior notes.

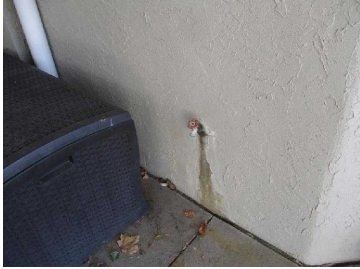
13. Hose Bibs: Rotary - **Not tested but appears to have leaked at the lower patio area.**

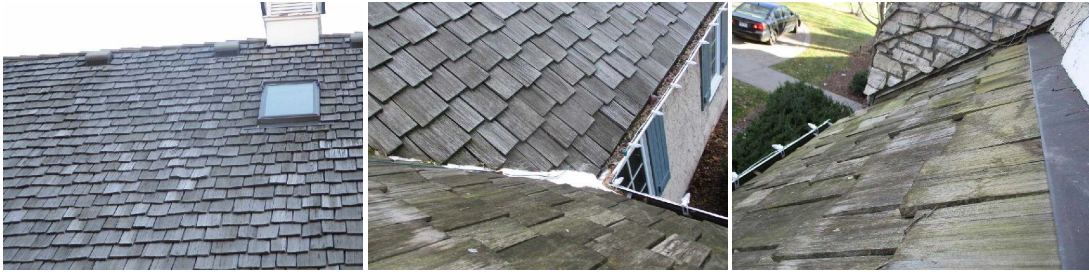
1. Method of Inspection: On roof
2. Material: Wood shake - Shingles appear to be in good condition with Minimal cracking and moss growth noted. A restoration in the future is recommended to extend the life of the shakes. Moss and algae growth noted

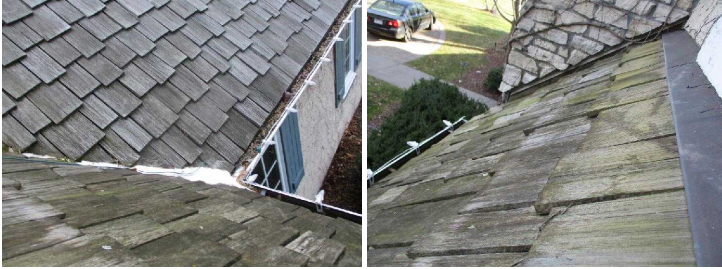
6. Valleys: Preformed metal - Past ice dames noted at the kitchen and porch roof line

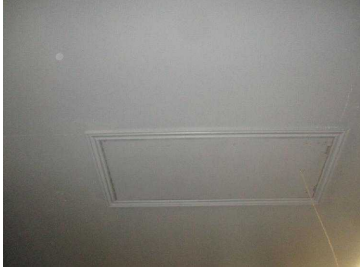
8. Ceiling: Paint - Scuff marks noted

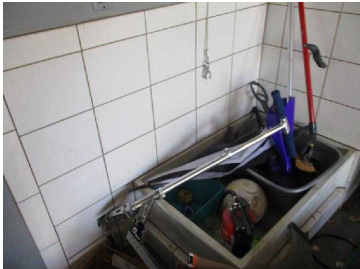
11. Hose Bibs: Dog Wash - Full of debris at the time of inspection

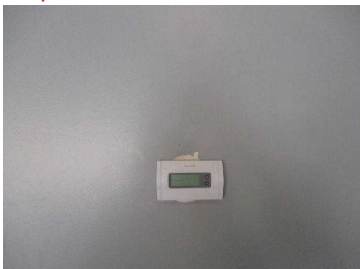
13. Heating: Not working - Missing a batteries at the cover as well as boiler not working at the time of inspection

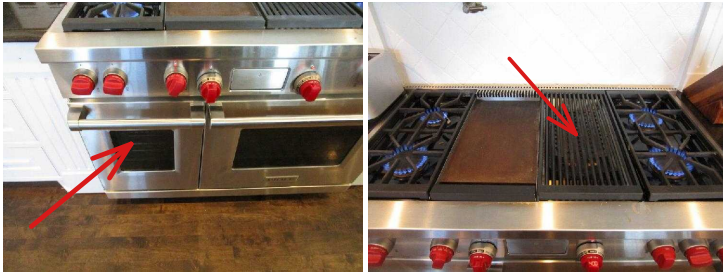
1. Cooking Appliances: Wolf - **Small oven was not working at the time of inspection. The cook top grill does not work properly. Repairs needed.**

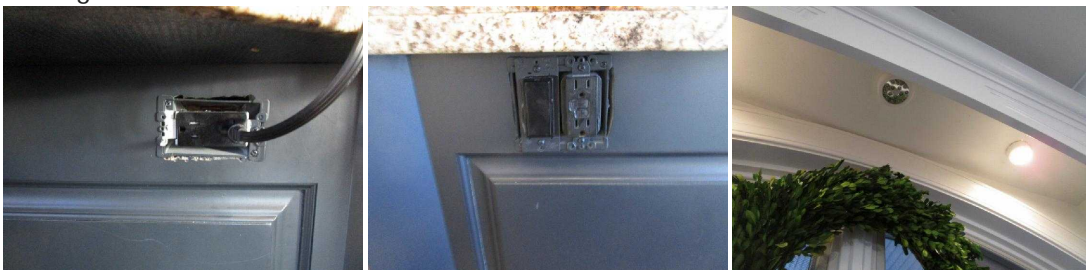
10. Electrical: 110 VAC GFIC Protected and Lighting Circuits - Missing outlet and switch cover plates. One light over the sink does not work.

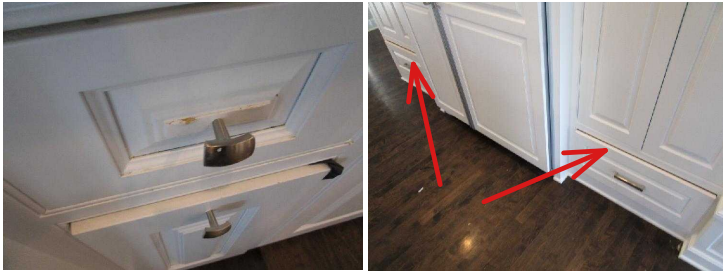
11. Plumbing/Fixtures: Kohler
12. Counter Tops: Granite
13. Cabinets: Wood - Wear noted at the floor finish. Missing pull knobs at the pull outs on each side of the oven. Lower cabinet drawers do not shut tightly.

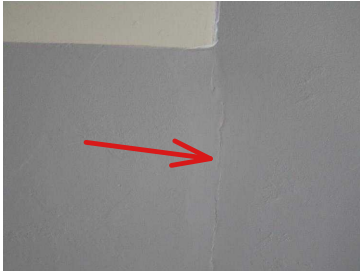
14. Ceiling: Texture paint - Cracked tape joint noted at the ceiling.

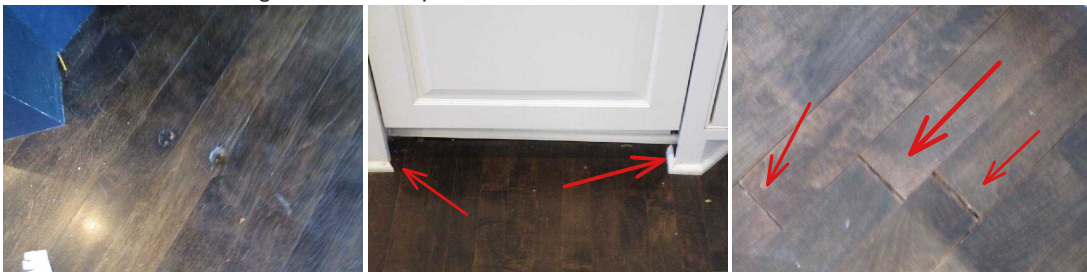
15. Walls: Paint and Tile
16. Floor: Hardwood - Water damage noted to the floor near the beverage refrigerator to the patio door to the three season porch door area. Wear/scratches noted at the floor finish. Dents noted in the floor surface. Missing and loose quarter round trim at the dishwasher.

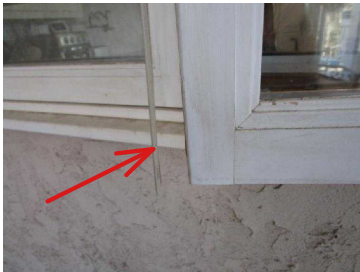
17. Windows: Casement - Loose weather stripping noted at the left hand window unit.

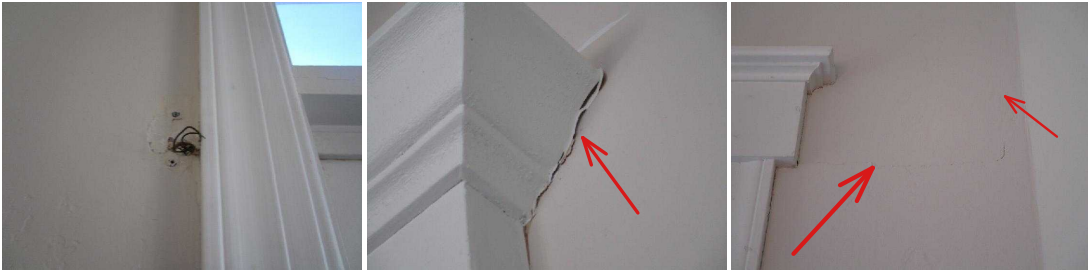
2. Walls: Paint - Hole noted in the wall with old security wire. Cracked tape joint noted adjacent to the three season porch door. Separation noted at the trim and wall.

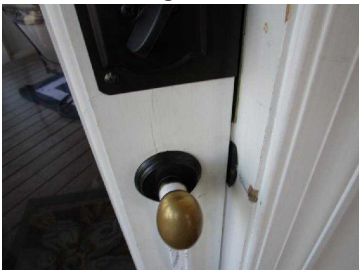
4. Doors: Sliding Patio Door and Patio Door with Glass - Chipped paint noted at the patio doors.

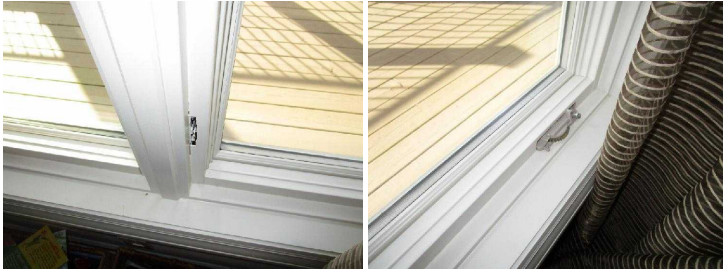
15. Sink: Metal
16. Plumbing/Fixtures: Rubbed Bronze
17. Windows: Casement and Fixed - The right hand south window unit is missing the lock handle and both south windows are missing the window crank handle trim. South right hand window unit could not be opened.

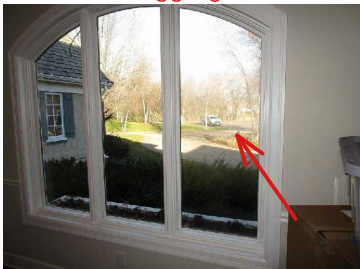
35. Ceiling: Texture paint
36. Walls: Paint
37. Floor: Hardwood
38. Windows: Fixed - Broken thermo seal at the right hand fixed window unit, resulting is moisture/fogging between the window glazing.

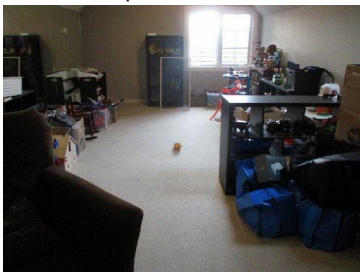
60. Floor: Carpet - Stained and soiled

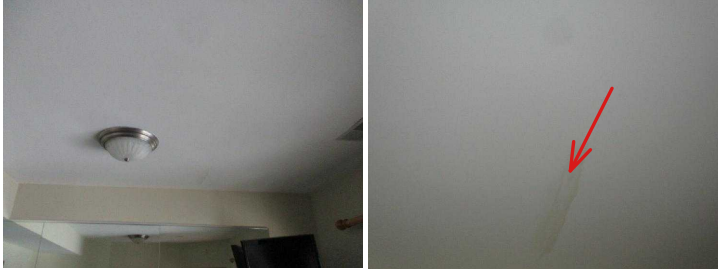
- 81. Ceiling: paint - Past staining noted from above ice dam

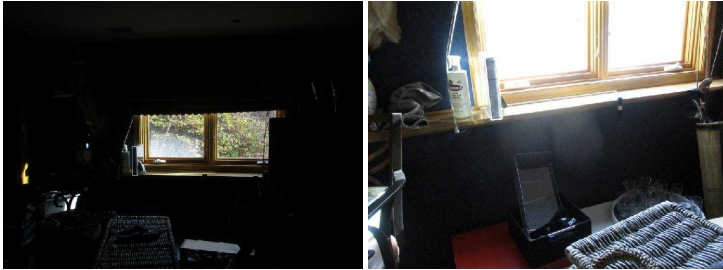
93. Windows: Casement - Broken seal at the window unit, resulting is moisture/fogging between the window glazing.

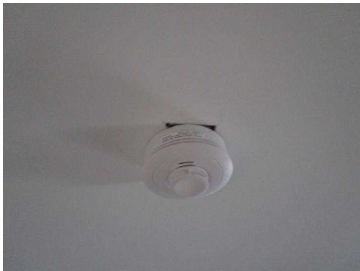
19. Closet: Reach-in
20. Ceiling: Texture paint - Gaps noted around the ceiling of the smoke detector.

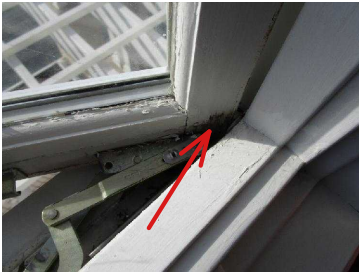
32. Windows: Casement - Peeling paint noted at the window sashes.

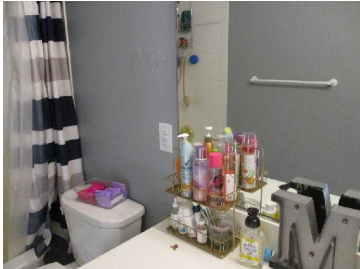
1. Closet: Reach-in
2. Ceiling: Texture paint
3. Walls: Paint
4. Floor: Tile and Carpet - Staining noted at the carpet
5. Doors: Six Panel - Pocket door rubs at the frame
6. Windows: Casement
7. Electrical: 110 VAC - **Faulty GFCI outlet-replace**

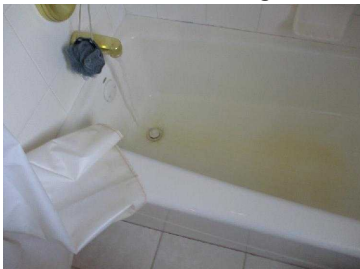
10. Faucets/Traps: Brass - **Small drip noted at the time of inspection**
11. Tub/Surround: Fiberglass tub and tile surround - Needs cleaning

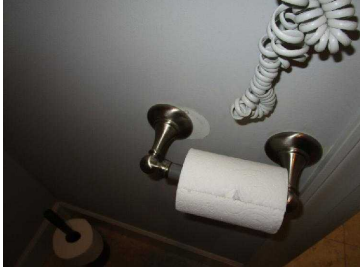
17. Walls: Paint - Small unpainted section.

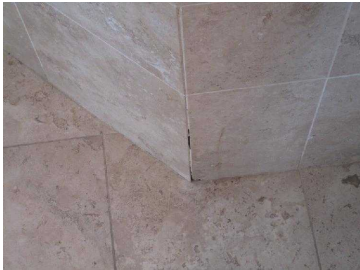
18. Floor: Tile - Chipped grout noted at the tile in isolated areas.

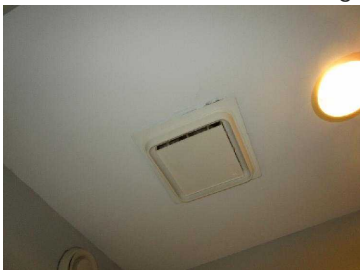
29. Ventilation: Air to Air Register, Electric ventilation fan and window - Bathroom vent in the water closet is loose at the ceiling and loud operation.

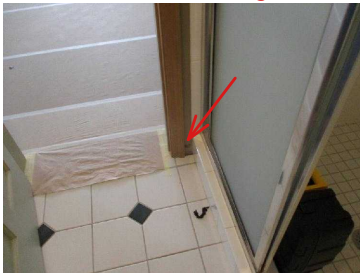
- 43. Ceiling: Paint - Under painting contractor at the time of inspection
- 44. Walls: Paint - **Mold growth noted behind the wall.**

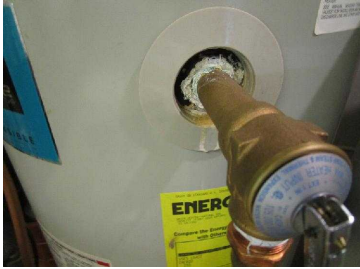
17. Model Number: PRV 40 NORSO Serial Number: C96670937
18. Type: Natural gas Capacity: 40 Gal.
19. Approximate Age: 1996 Area Served: Whole building
20. Flue Pipe: Double wall
21. TPRV and Drain Tube: Copper - Corrosion noted at the TPR valve where it meets the water tank/heater.

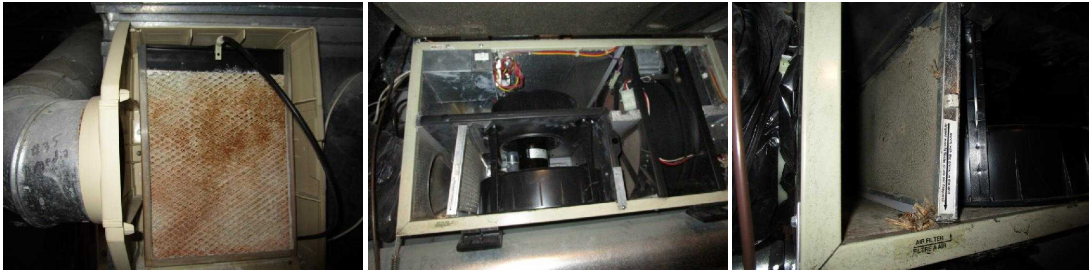
36. Humidifier: April-Aire - **Not functioning at the time of inspection. Replace water pad filter.**

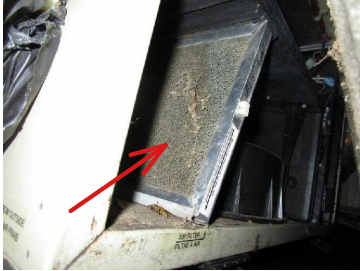
47. Devices: Air to Air exchanger - Clean the two reusable filters every three months and the core on a yearly basis. Filters are in need of cleaning.

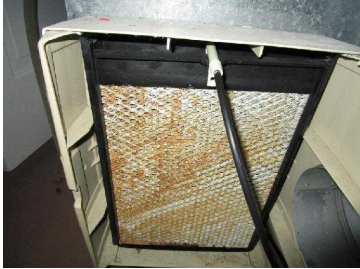
48. Humidifier: April-Aire - **Not functioning at the time of inspection. Replace water pad filter.**

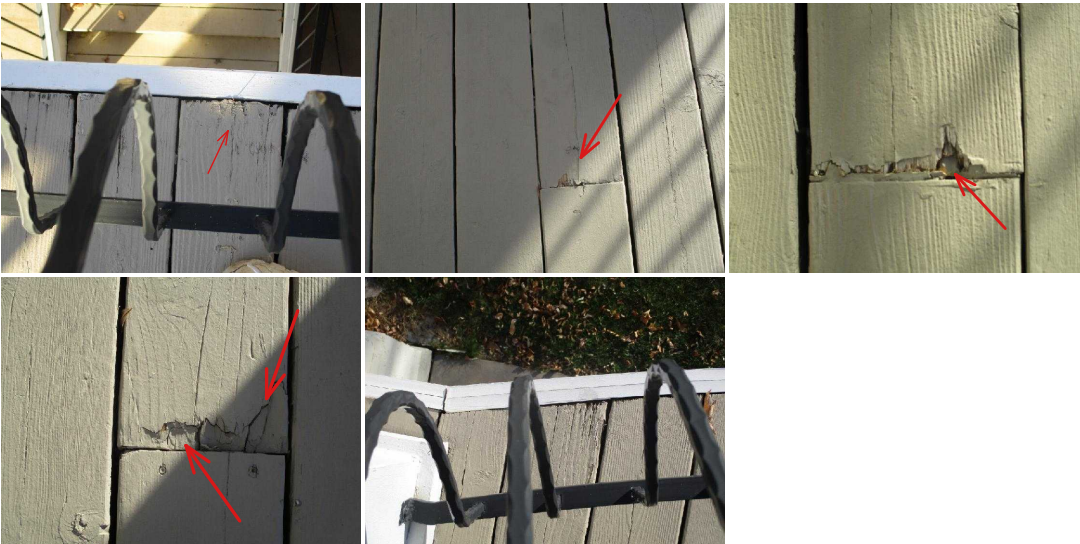
2. Walks: Concrete - Cracked
3. Steps/Stoops: Concrete - re seal at the front walk
4. Deck: Painted wood - Moisture damage to isolated boards as well as areas that have been patched and now have failing paint are beginning to deteriorate.

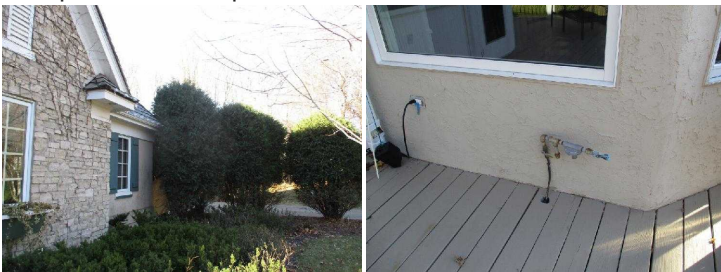
7. Main Exterior Surface Type: Stucco and stone - Moisture stains as well as stucco installed below grade without weeps screeds in place. Isolated stucco cracks noted. The stucco was not tested during the home inspection

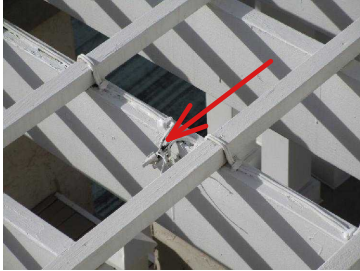
10. Exterior Lighting: Surface mounted lamps front and rear - Spliced wires noted outside of a junction box. Missing lights at isolated locations

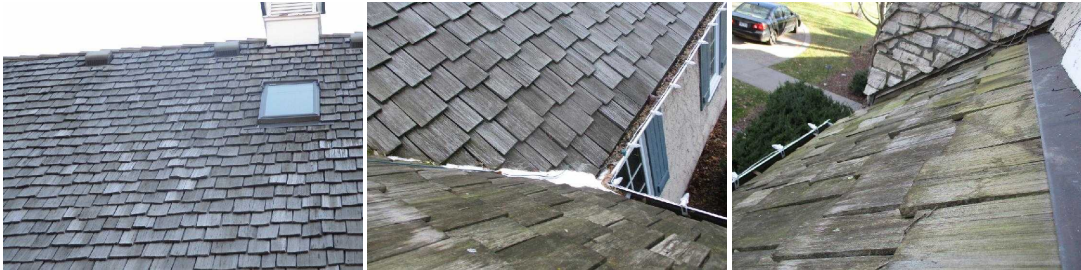
11. Main Roof Roof Surface Material: Wood shake - Shingles appear to be in good condition with Minimal cracking and moss growth noted. A restoration in the future is recommended to extend the life of the shakes. Moss and algae growth noted

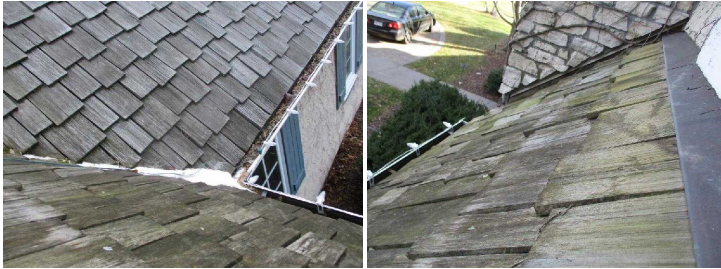
12. Valleys: Preformed metal - Past ice dams noted at the kitchen and porch roof line

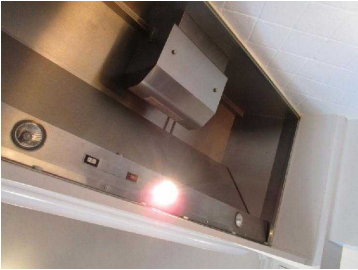
21. Main Kitchen Ventilator: Vent A Hood - Only one of the three vent hood lights work.

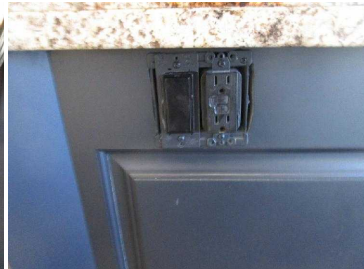
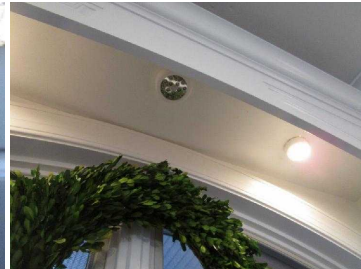
22. Main Kitchen Electrical: 110 VAC GFCI Protected and Lighting Circuits - Missing outlet and switch cover plates. One light over the sink does not work.

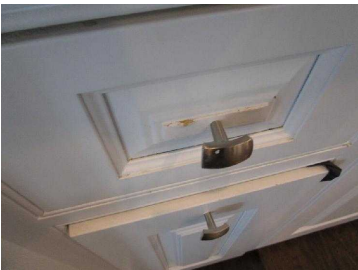
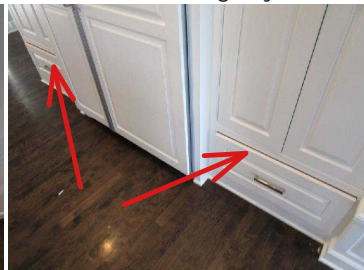
23. Main Kitchen Cabinets: Wood - Wear noted at the floor finish. Missing pull knobs at the pull outs on each side of the oven. Lower cabinet drawers do not shut tightly.

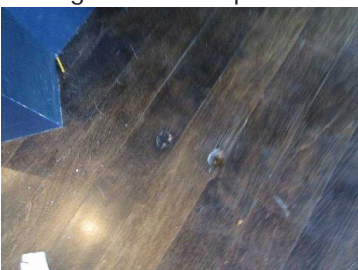
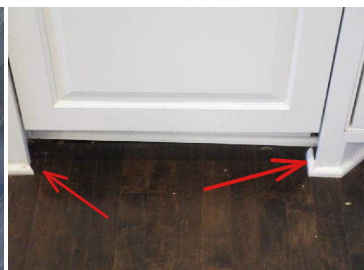
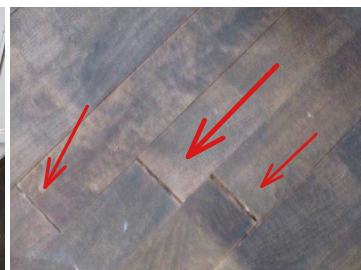
24. Main Kitchen Floor: Hardwood - Water damage noted to the floor near the beverage refrigerator to the patio door to the three season porch door area. Wear/scratches noted at the floor finish. Dents noted in the floor surface. Missing and loose quarter round trim at the dishwasher.

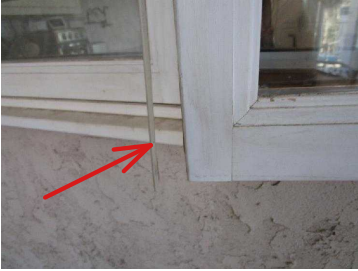
25. Main Kitchen Windows: Casement - Loose weather stripping noted at the left hand window unit.

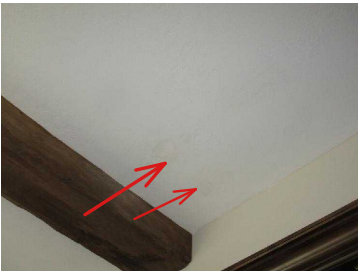
26. Family Room Living Space Ceiling: Texture paint - Stain/discoloring noted at the ceiling above the wet bar location.

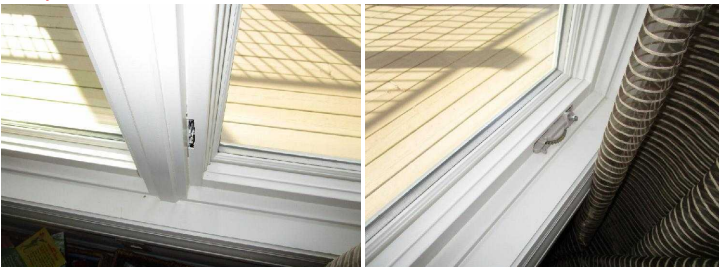
28. Family Room Living Space Windows: Casement and Fixed - The right hand south window unit is missing the lock handle and both south windows are missing the window crank handle trim. South right hand window unit could not be opened.

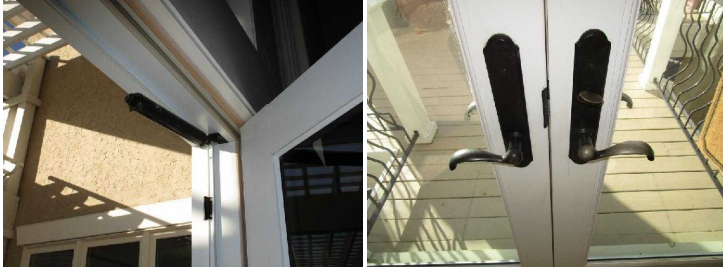
29. Great Room Living Space Doors: French Patio Doors with Glass - Door dead bolt does not align. Storm doors at the exterior are no longer in place.

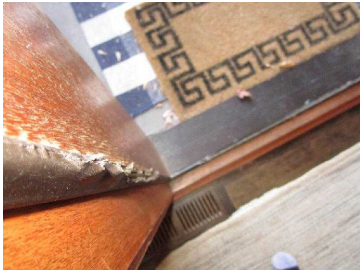
30. Foyer Living Space Doors: Entry Door - Weather striping is damaged at the door. Door dead bolt is loose and does not align properly.

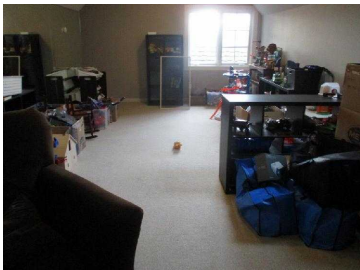
31. 2nd Floor Bonus Room Living Space Floor: Carpet - Stained and soiled

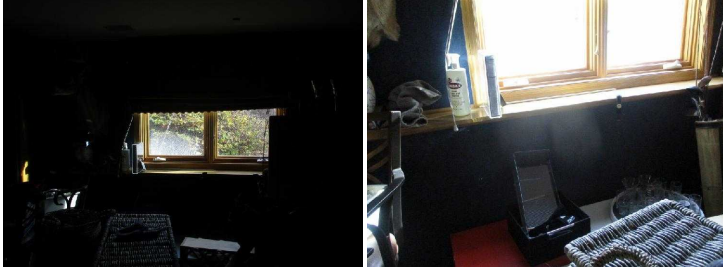
36. Lower Level Office Living Space Windows: Casement - Broken seal at the window unit, resulting in moisture/fogging between the window glazing.

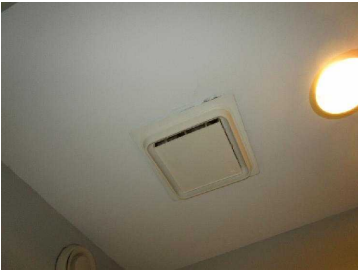
48. Owners Suite Bathroom Ventilation: Air to Air Register, Electric ventilation fan and window - Bathroom vent in the water closet is loose at the ceiling and loud operation.

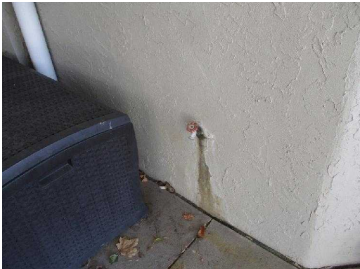
5. Hose Bibs: Rotary - Not tested but appears to have leaked at the lower patio area.

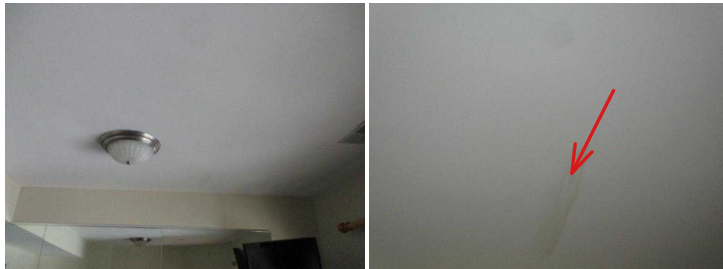
10. Lower Level Gym Living Space Ceiling: paint - Past staining noted from above ice dam
