SERVICE • BULLETIN

BULLETIN NUMBER 1943

SUBJECT: BODY AND SHEET METAL
SUJET: DOOR GLASS SCRATCHING

MODELS: 1970/71 BARRACUDA AND
MODELES: CHALLENGER

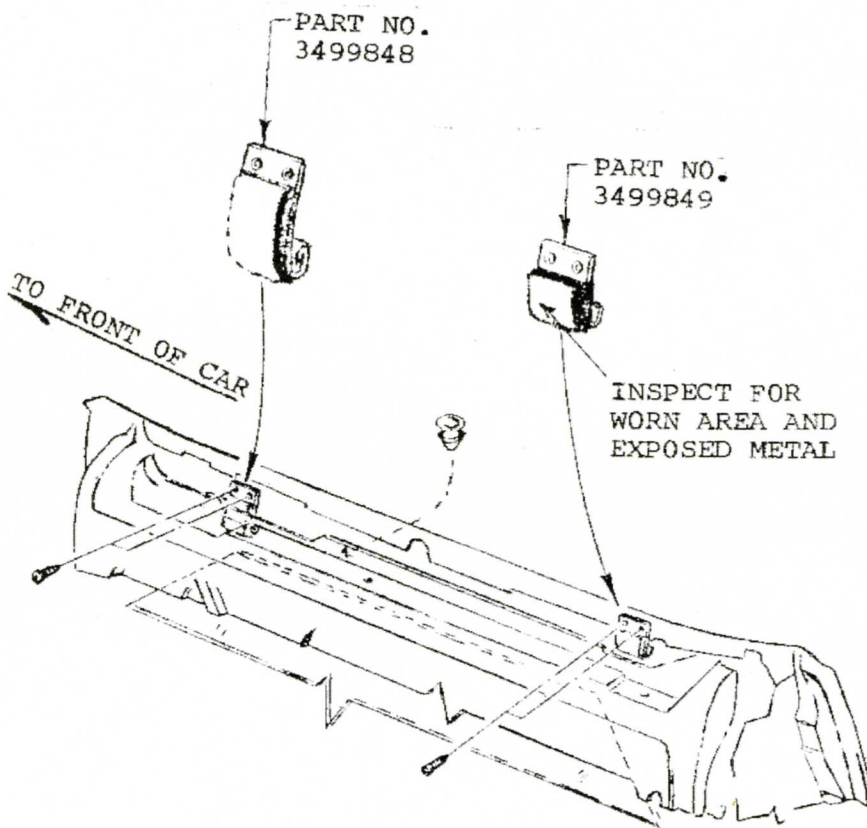
The following information will assist in the correction of a scratching condition which may occur on the outside rear surface of the front door glass.

Should this condition be brought to your attention, inspect the rear outboard glass anti-rattle stabilizer for loose screws or worn insulator tip, causing metal to glass contact. (See illustration).

If worn, obtain a new stabilizer, Part No. 3499849. Wrap the stabilizer in a shop cloth to protect the knap on the insulator tip. Place the tip end in a vise and crush the stabilizer approximately 1/8 inch.

Install the stabilizer and inspect the other stabilizers for loose screws. Check window for correct operation.
