Drainage Report

Matt Bartlett
Football Ground Land
Upper Solva

Land at Solva Pembrokeshire - CCTV Survey Report : 07/07/22

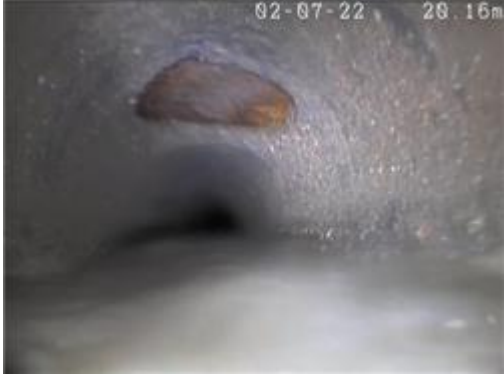
Pos	Video Ref	Code	Description	Image
00.00m		MH	Start node type, manhole MH3	
00.00m	0:00:00	WL	Water level: 0% Height/Diameter	
20.20m	0:00:58	CN	Connection other than junction: 100mm Diameter	<p>Image Provided - Ref: 1_2</p>

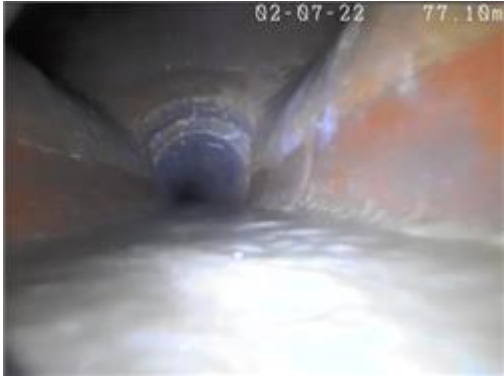
77.10m		MHF	Finish node type, manhole MH4	<p>Image Provided - Ref: 1_9999</p>
