**1979 Morgan 415 Ketch Rigged Sailing Vessel**

***SailAway***

# **Report of Marine Survey**

August 06, 2017

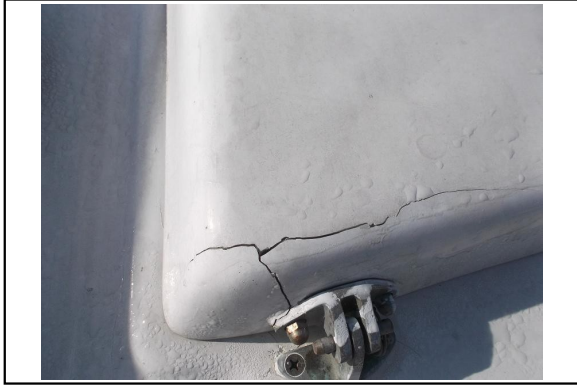
**Forward Deck Hatch**

- \* **HATCHES: [C1, C2]** Three opening deck hatches of FRP and aluminum construction were sighted on cabin top. Aluminum hatches. Good condition. Forward FRP hatch is cracked at hinge. Teak hatch track for sliding aft cabin hatch is split.

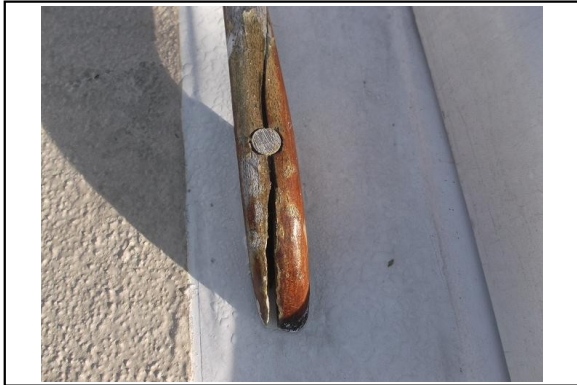
**Handrail**

- \* **GRAB RAIL: [B2]** Teak grab rails on cabin house. Starboard teak handrail on main cabintop is split and not secure.

Starboard teak handrail on main cabin top is split and not secure.	Repair or replace handrail and secure handrail to deck.
--	---

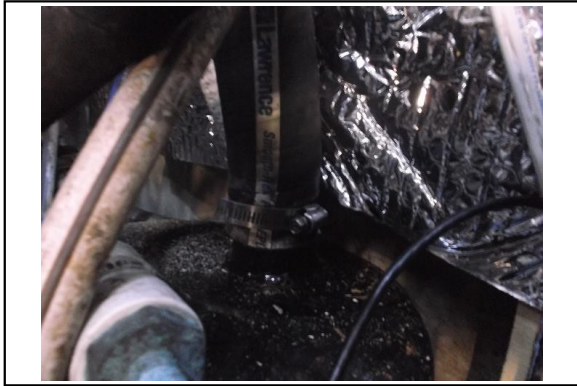
\* **EXHAUST SYSTEM:[A1]** Wet exhaust type system with water lift muffler with flexible exhaust hose. A siphon break was sighted in cooling water piping. Flexible exhaust hose is not double clamped and cooling water leak sighted at muffler leaking onto engine mount.

Single Clamped Exhaust Hose

FINDINGS	RECOMMENDATIONS
<b>A.1 (PAGE 5) EXHAUST SYSTEM:</b>	
Flexible exhaust hose is not double clamped and cooling water leak sighted near muffler leaking onto engine mount.	<i>Clamp Exhaust as per ABYC P-1. Flexible Exhaust Hose Connections: P-1.7.1.10.1 Every <b>exhaust hose connection shall be secured with at least two non-overlapping clamps</b> at each end to produce a secure, liquid and vapor-tight joint. Further investigate exhaust cooling water leak and repair as necessary.</i>
<b>A.2 (PAGE 6) FUEL FILL PIPE/TANK GROUNDED:</b>	
No grounding connections detected with meter.	<i>Provide fuel tank and fuel fill fitting grounding as per ABYC H-33. Diesel fuel systems, 33.15 FUEL SYSTEM GROUNDING. H-33.15.1; <b>Each metal or metallic plated component of the fuel fill system that is in contact with the fuel and the fuel tank shall be grounded</b> so that its resistance to the boat's ground is less than one ohm. NOTES: 1. <b>The deck fill is considered to be in contact with the fuel.</b></i>

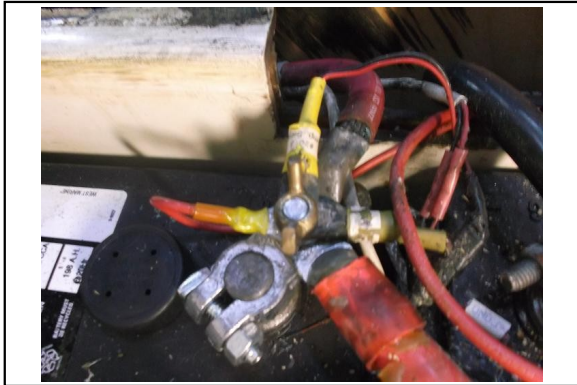
- \* **DC OVERCURRENT PROTECTION:**[A4, A5] All ABYC standards recommended overcurrent protection **is not** in place. Wires were sighted connected directly to the battery positive terminals without overcurrent protection. High amperage fuse sighted installed in negative battery cable.

**No Overcurrent Protection**

<p>All ABYC standards recommended overcurrent protection is not in place.</p>	<p><i>Further investigate and provide overcurrent to comply with ABYC E-11. 11.10 OVERCURRENT PROTECTION</i></p> <p><i>11.10.1 LOCATION OF OVERCURRENT PROTECTION - DC CIRCUITS</i></p> <p><i>11.10.1.1 General Requirements</i></p> <p><i>11.10.1.1.1 Overcurrent Protection Device Location</i></p> <p><i>Ungrounded conductors shall be provided with overcurrent protection within a distance of seven inches of the point at which the conductor is connected to the source of power measured along the conductor.</i></p> <p><b>EXCEPTIONS:</b></p> <ol style="list-style-type: none"> <li><i>1. Cranking motor conductors.</i></li> <li><i>2. If the conductor is connected directly to the battery terminal and is contained throughout its entire distance in a sheath or enclosure such as a conduit, junction box, control box or enclosed panel, the overcurrent protection shall be placed as close as practicable to the battery, but not to exceed 72 inches.</i></li> <li><i>3. If the conductor is connected to a source of power other than a battery terminal and is contained throughout its entire distance in a sheath or enclosure such as a conduit, junction box, control box or enclosed panel, the overcurrent protection shall be placed as close as practicable to the point of connection to the source of power, but not to exceed 40 inches.</i></li> </ol>

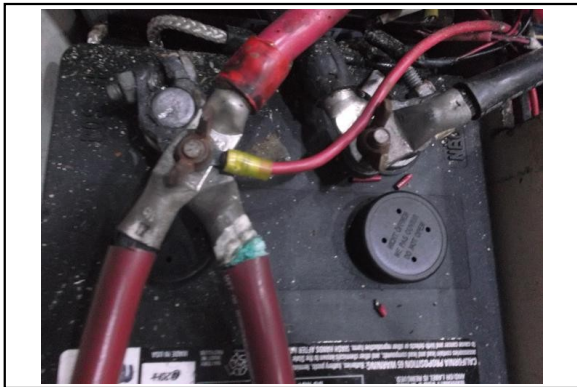
- \* **DC WIRING CONNECTORS:** [A6] Wing nuts were sighted connecting large gauge battery cable to batteries.

**Wing Nuts**

<p>Wing nuts were sighted connecting large gauge battery cable to batteries.</p>	<p><i>Replace wing nuts with standard nuts to comply with ABYC E-10.8.3 Battery cables and other conductors size 6 AWG and larger shall not be connected to the battery with wing nuts.</i></p>
--	---

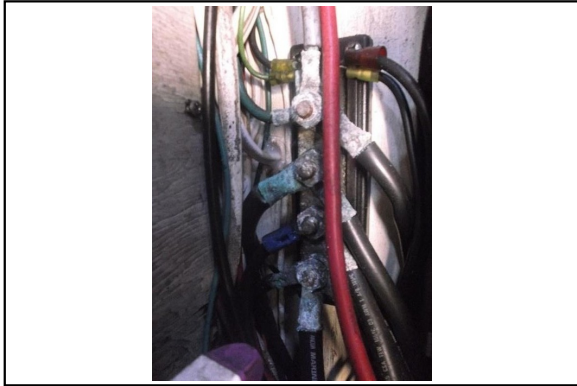
- \* **NOTE:** [C3] There are many electrical connections in the engine room with corrosion.

Terminal Corrosion

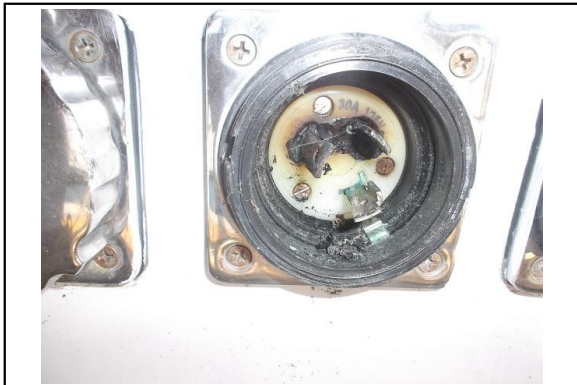
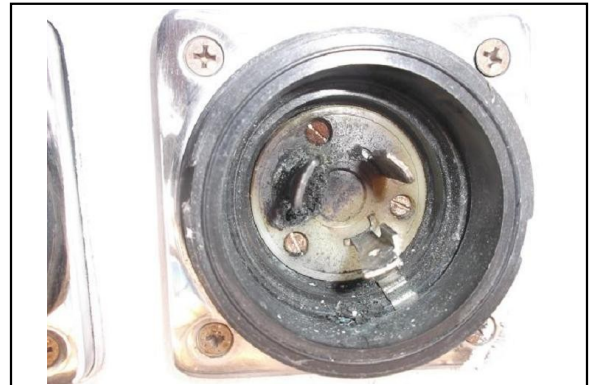
\* **SHORE POWER INLET: [A7]** Two 30 amp, 120 volt shore power inlets were sighted. Both shore power inlets and cords had burned terminals and pins and were not connected to shore power at time of survey.

Shore Power Inlet 1

Shore Power Inlet 2

<p>Both shore power inlets and cords had burned terminals and pins.</p>	<p><i>Replace shore power inlets and cords.</i></p>
---	---

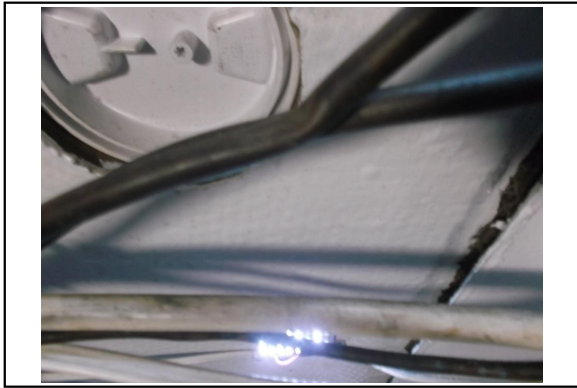
- \* **LINES AND FITTINGS: [C5]** Copper hydraulic fluid steering line damaged/kinked in engine room.

Steering Hydraulic Line

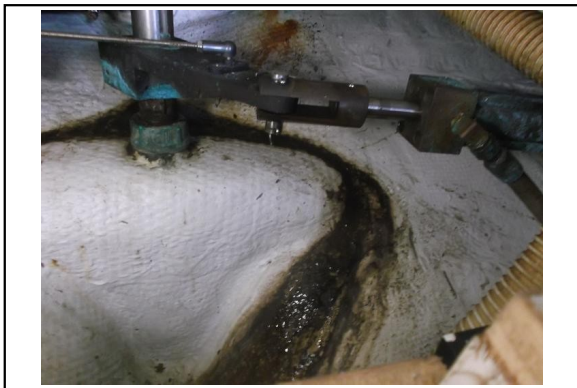
- \* **RUDDER SHAFT PACKING GLAND: [C6]** Rudder shaft seal is a traditional type bronze packing gland. The seal was leaking at time of inspection.

Leaking Rudder Post

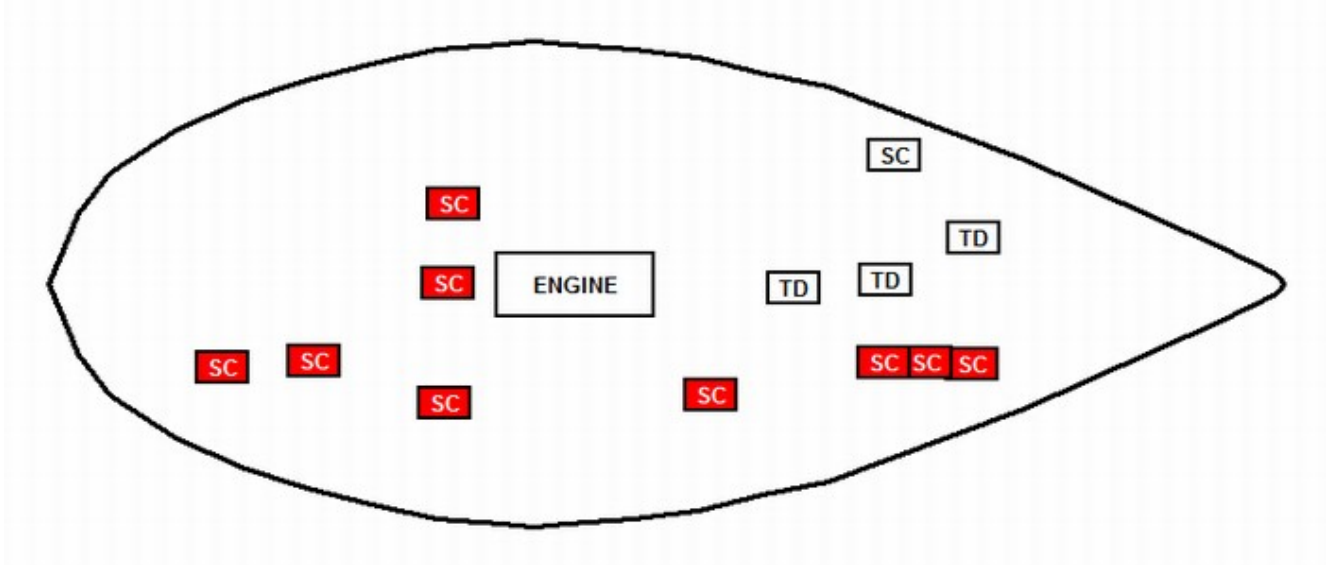
THRU-HULLS BELOW WATER LINE (DIAGRAM):

\* **THRU-HULL VALVE OPERATION: [A9]** No thru-hull valve operated with normal force with the exception of the forward air conditioning unit intake valve.

<p>No thru-hull valve operated with normal force with the exception of the forward air conditioning unit intake valve.</p>	<p><i>It is the surveyors recommendation that all seacocks be serviced. I would also like to add that wooden plugs of the appropriate size be readily accessible for emergency use at each seacock location.</i></p>
--	--

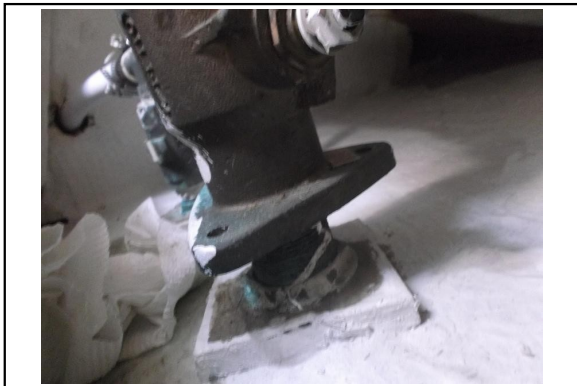
\* **MATERIAL/TYPE/INSTALLATION: [A10]** Flanged bronze ball valve seacocks. The seacocks are installed on thru-hull fittings that are too long to allow the seacock flanges to be secured to the hull.

Seacock Installation

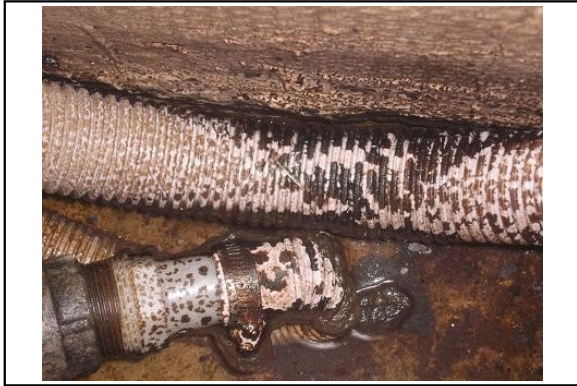
Aft Bilge Pump Discharge Hose

<p>The aft bilge pump discharge hose is kinked due to the weight of a bronze in-line check valve.</p>	<p><i>Replace and support aft bilge pump hose to avoid kinks.</i></p>
---	---

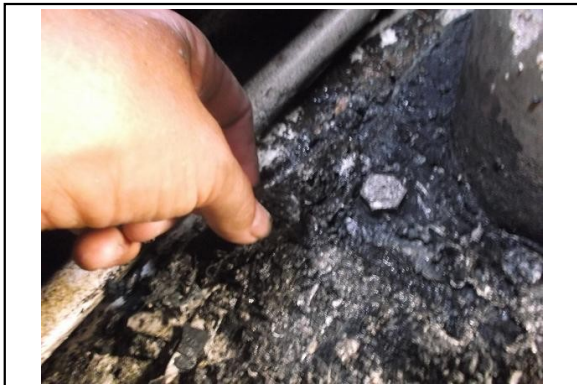
**Main Mast Step**

- \* **MAST STEP: [A18]**
- 1 - Main mast stepped on keel. A mild steel (magnetic) plate used to distribute the load has deteriorated due to corrosion (rust).
  - 2 - Mizzen mast stepped on the sole of the head in aft cabin is supported by bulkhead glassed in hull in bilge. Good condition. (Access for inspection is limited and was done with a mirror and light on one side only)

A mild steel (magnetic) plate used to distribute the main mast load on the keel has deteriorated due to corrosion.	Further investigate and repair as needed. Un-stepping the mast will likely be needed to complete this repair.
--	---

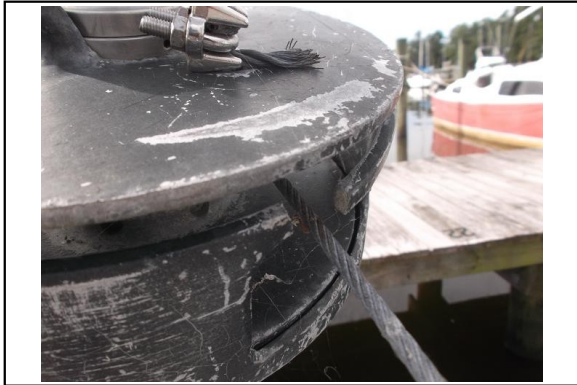
**Furling Drum**

- \* **RUNNING RIGGING:** [B12] All running rigging is worn and UV/weather degraded.
- \* **ROLLER FURLING GEAR:** [A19] Roller furling gear is of unknown manufacturer. The aluminum drum on furling gear is damaged in two places. The electric wire reel winch mounted below decks to operate the furling gear is inoperable.

Roller furling gear damaged and inoperable.	Further investigate and repair or replace as needed.
---	--
