1996 Fishing Machine 67

FISH ON

Report of Marine Survey

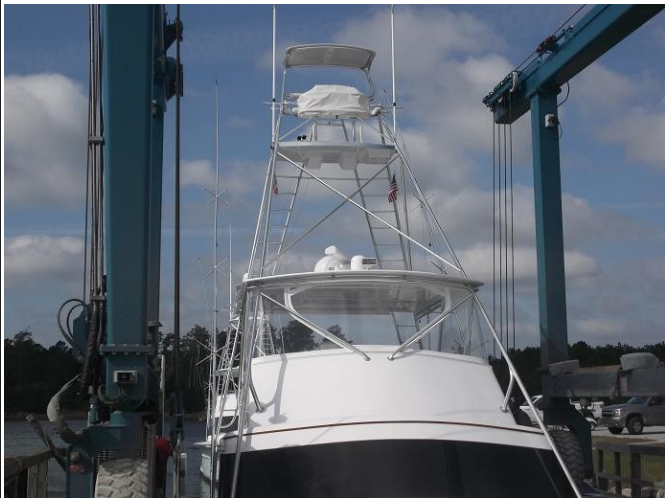
Custom designed and installed tower including an upper station. Constructed with welded pipe joints.

Good condition.

Tower

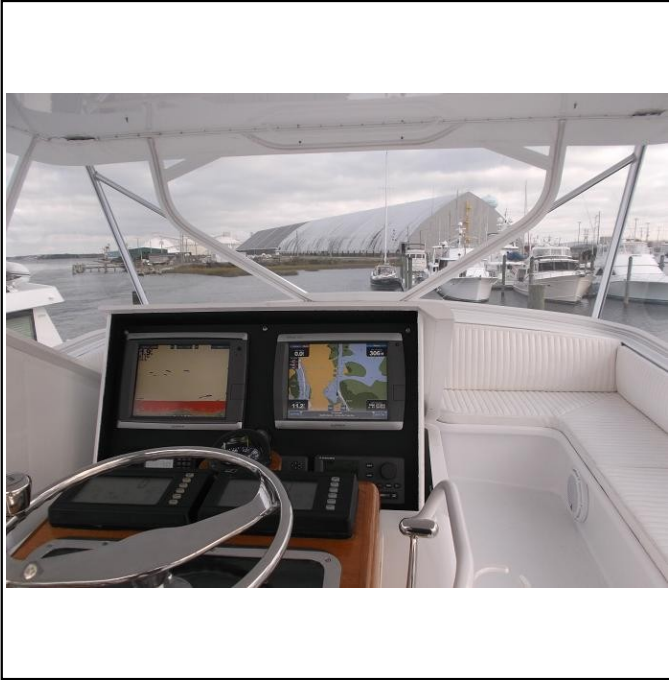
Flybridge with helm station and additional seating.

Good condition.

Flybridge

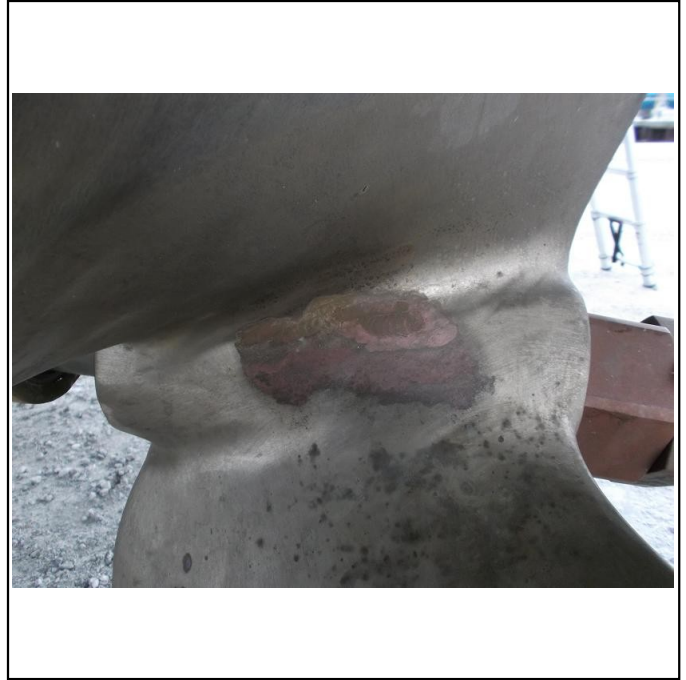
Note; Minor corrosion was sighted on each propeller.

FINDINGS	RECOMMENDATIONS
Minor corrosion was sighted on each propeller.	<i>A full corrosion survey may be needed if corrosion has increased at next haul-out.</i>

Propeller Corrosion

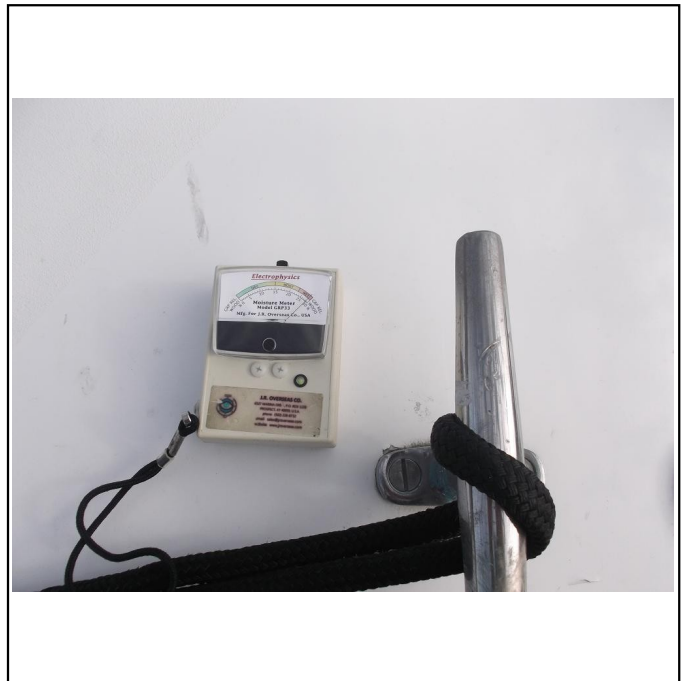
Elevated moisture meter readings were detected on foredeck in area near mooring clats and windlass.

Moisture Meter At Foredeck

Note; Consideration should be given to including re-bedding of foredeck hardware in a maintenance schedule.

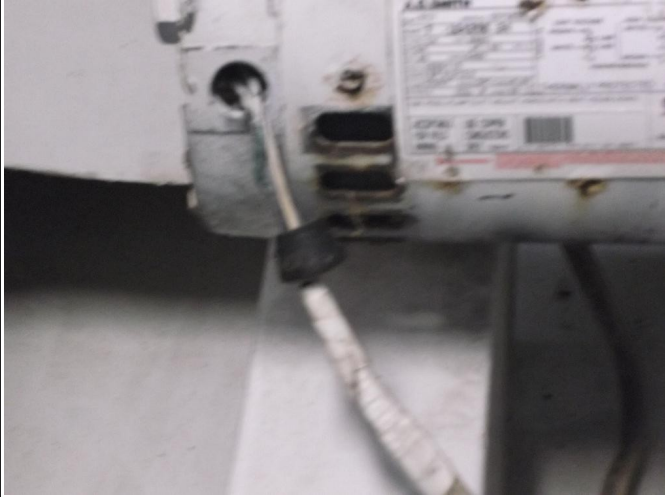
FINDINGS	RECOMMENDATIONS
Pump wiring not protected against chafe at pump motor.	Provide chafe protection at wire entry point to motor.

A/C Pump Wiring
