**Environmental Hazardous
Materials Survey**

Hancock Memorial Hospital

**622 Linton Road
Sparta, GA 31087**

February 25, 2022

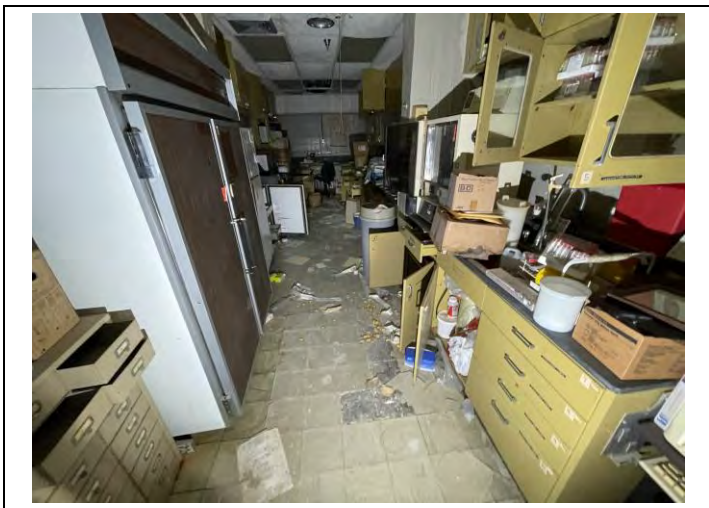
1. Black Mastic under Various Sizes of Floor Tile

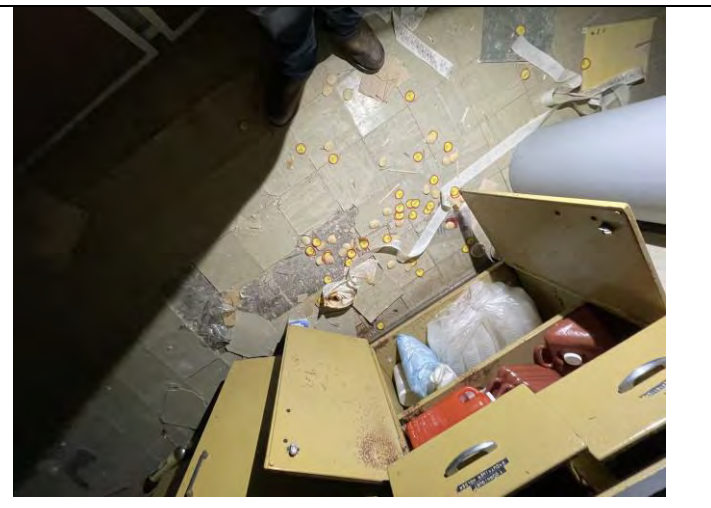
2. Black Mastic under Various Sizes of Floor Tile

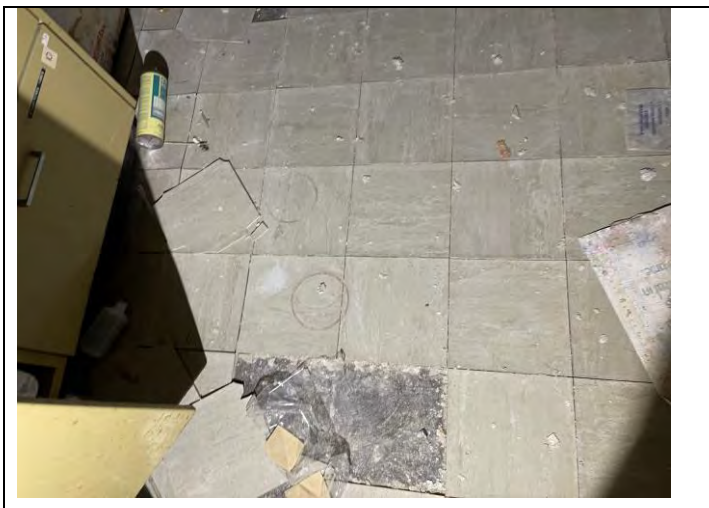
3. Black Mastic under Various Sizes of Floor Tile

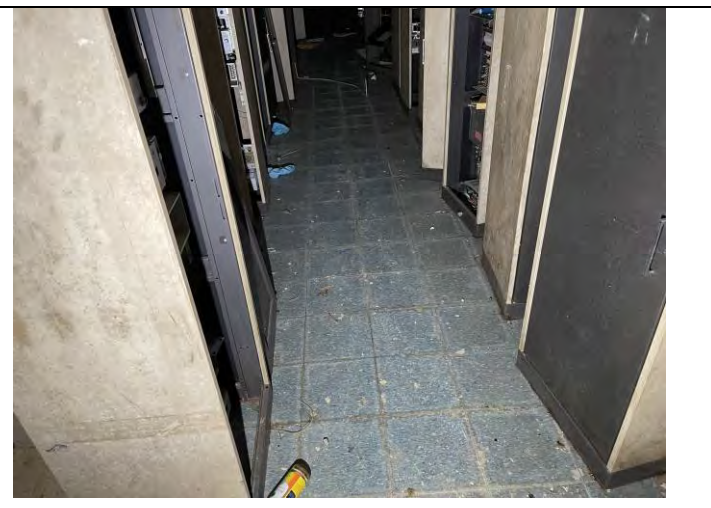
4. Black Mastic under Various Sizes of Floor Tile

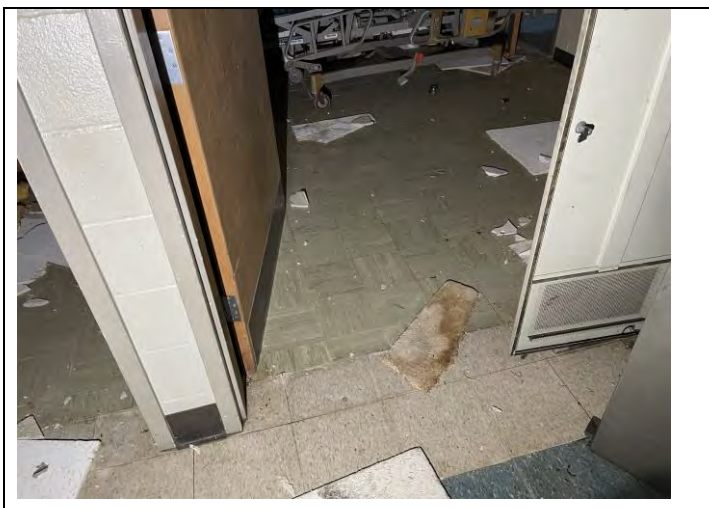
5. Black Mastic under Various Sizes of Floor Tile

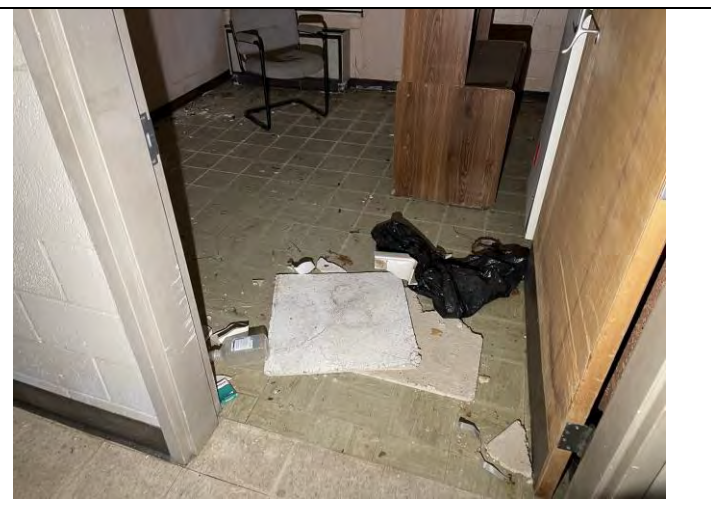
6. Black Mastic under Various Sizes of Floor Tile

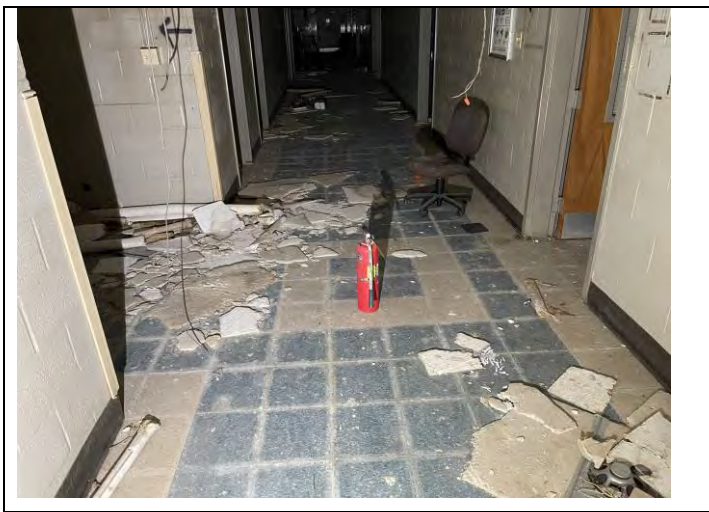
7. Black Mastic under Various Sizes of Floor Tile

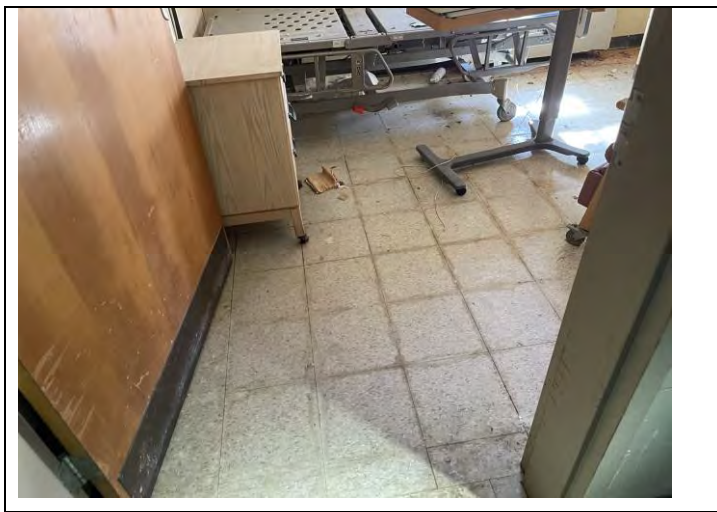
8. Black Mastic under Various Sizes of Floor Tile

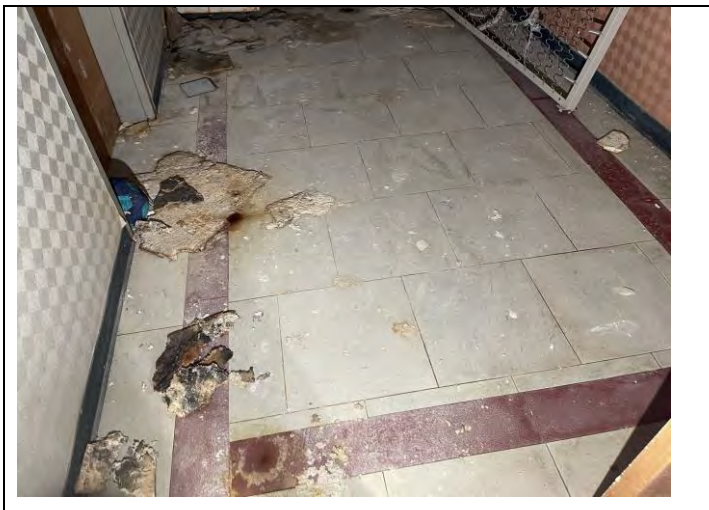
9. Black Mastic under Various Sizes of Floor Tile

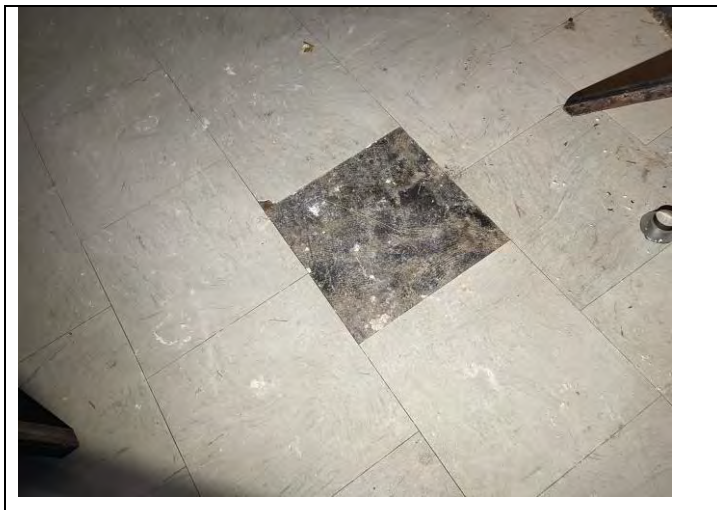
10. Black Mastic under Various Sizes of Floor Tile

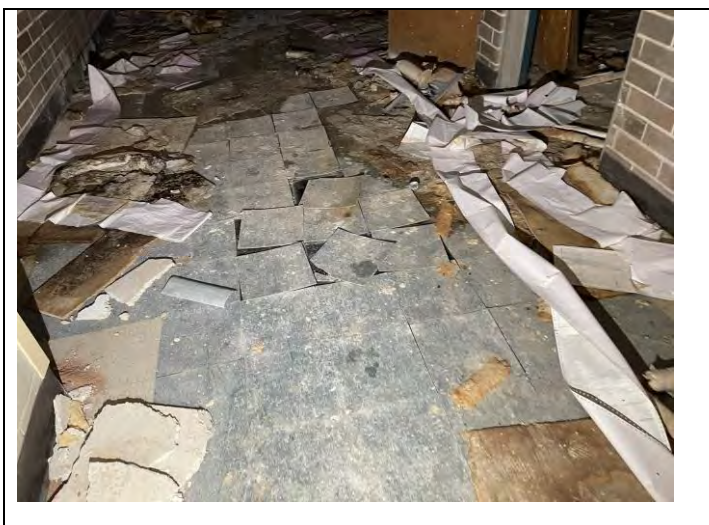
11. Black Mastic under Various Sizes of Floor Tile

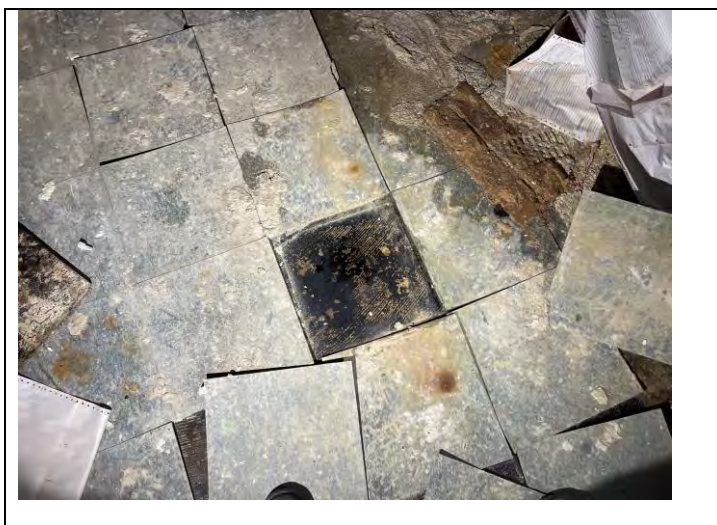
12. Black Mastic under Various Sizes of Floor Tile

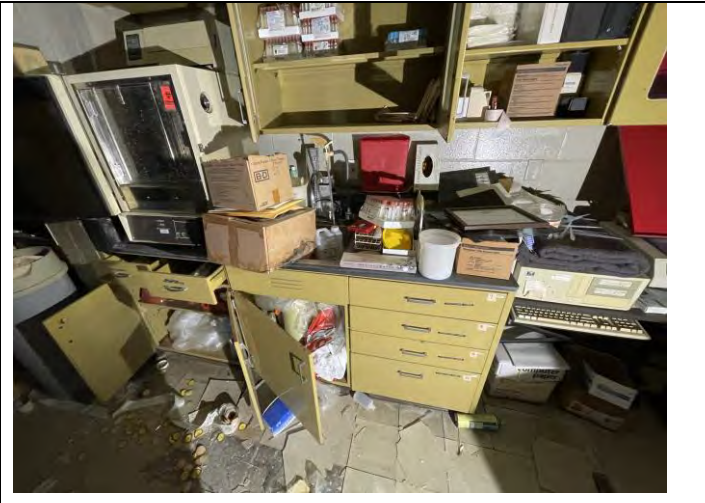
13. Laboratory Countertops

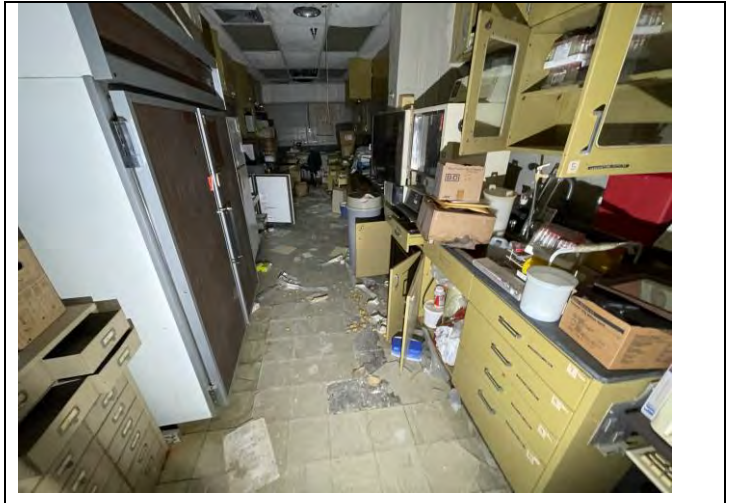
14. Laboratory Countertops

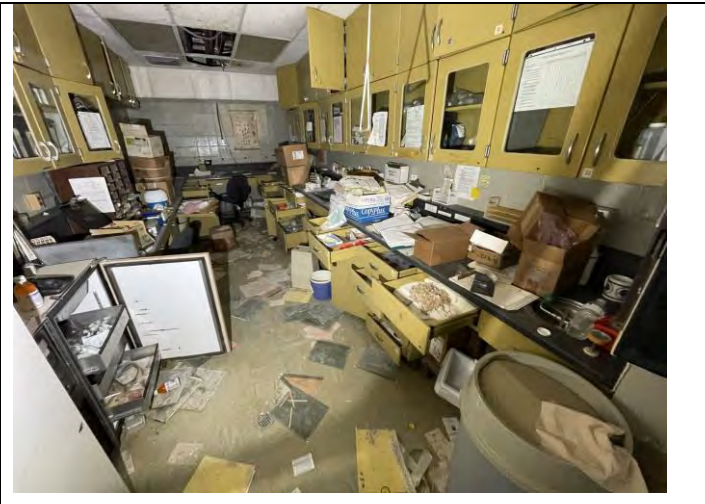
15. Laboratory Countertops

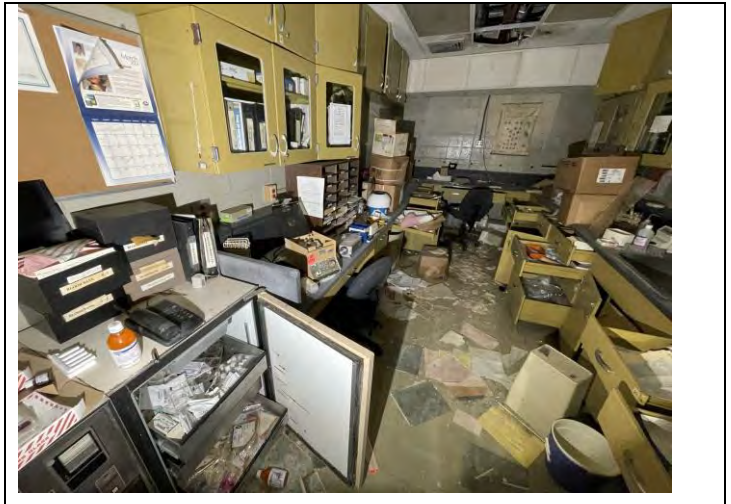
16. Laboratory Countertops

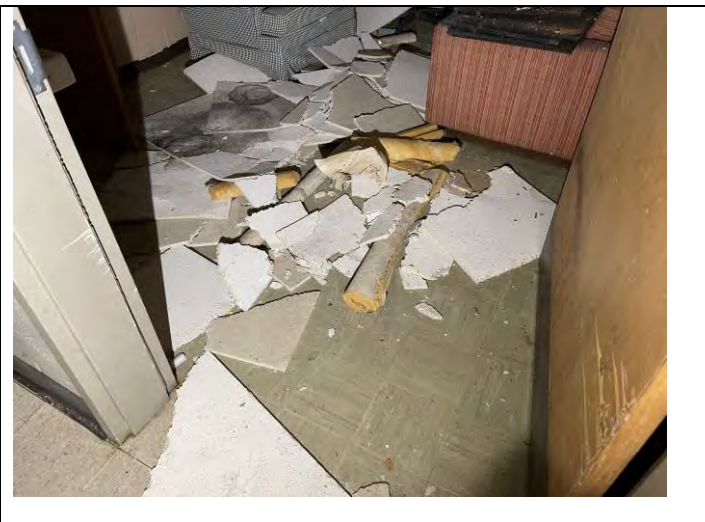
17. Pipe Fitting Insulation (Intact and debris on floor)

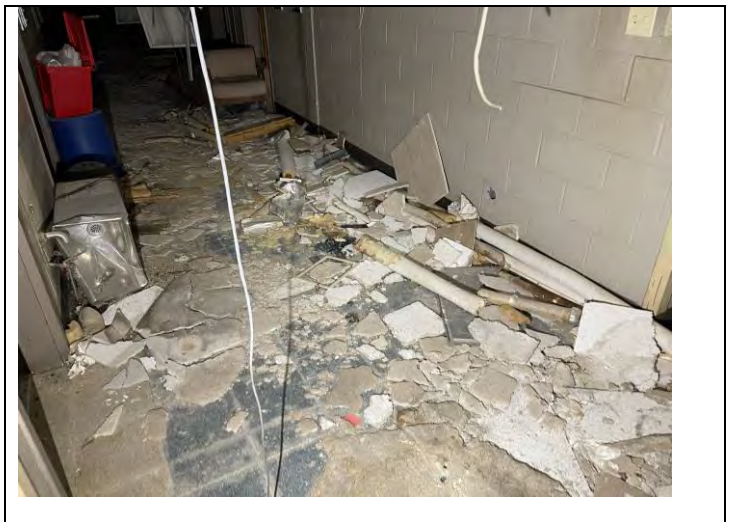
18. Pipe Fitting Insulation (Intact and debris on floor)

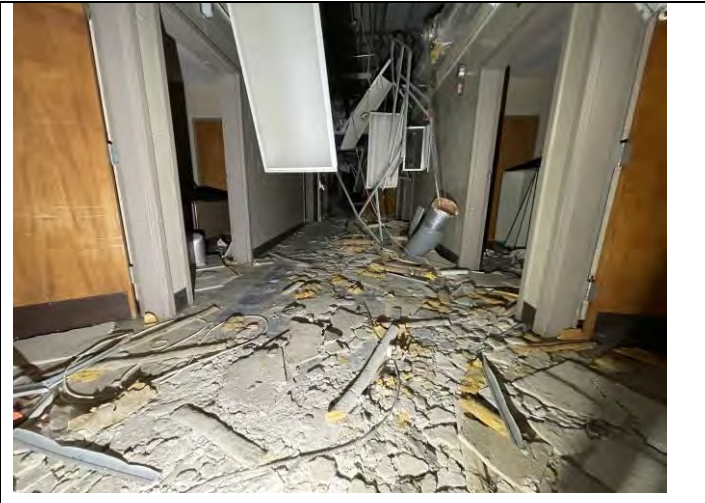
19. Pipe Fitting Insulation (Intact and debris on floor)

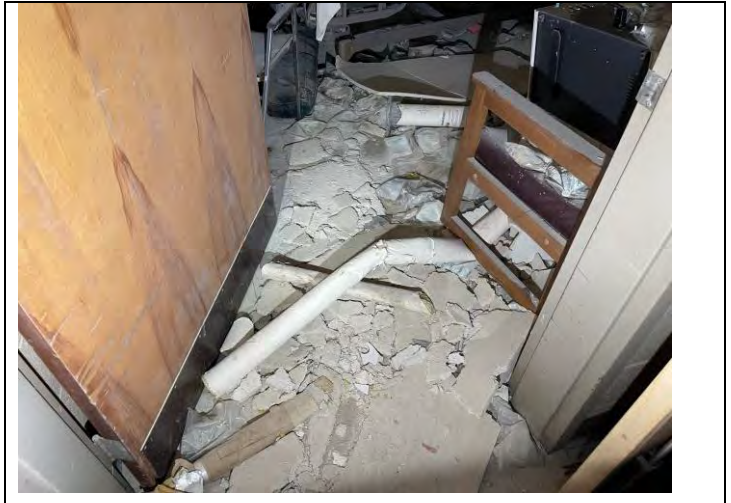
20. Pipe Fitting Insulation (Intact and debris on floor)

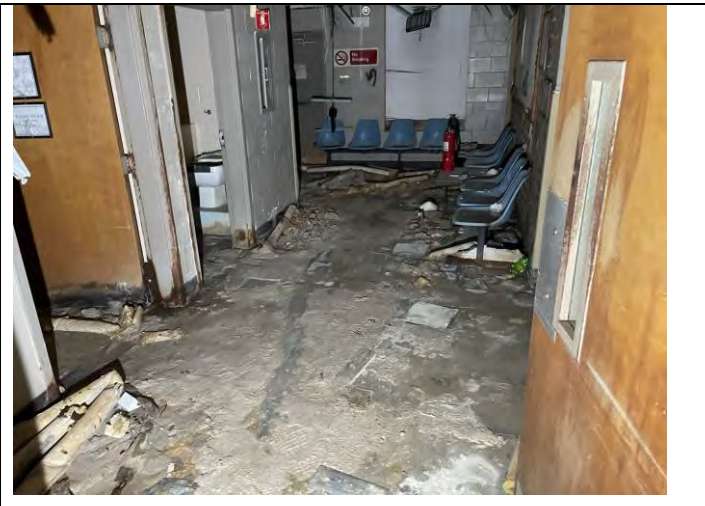
21. Pipe Fitting Insulation (Intact and debris on floor)

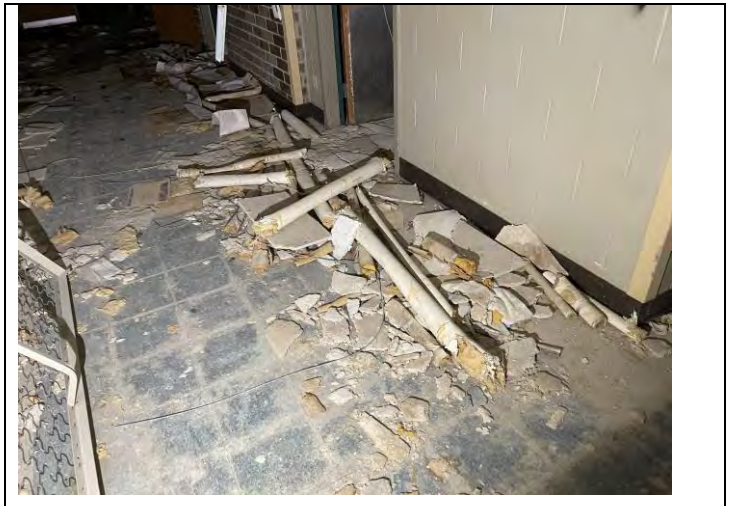
22. Pipe Fitting Insulation (Intact and debris on floor)

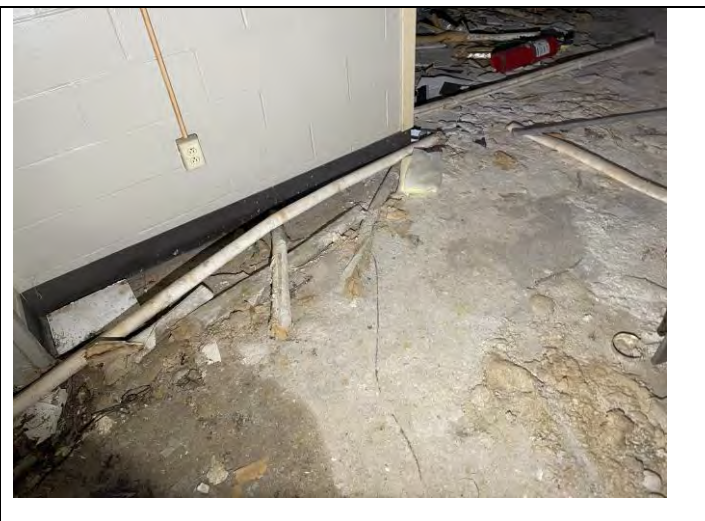
23. Pipe Fitting Insulation (Intact and debris on floor)

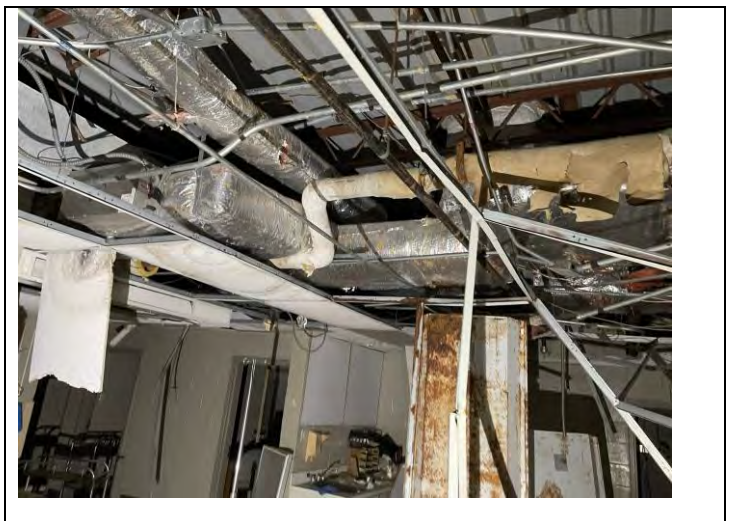
24. Pipe Fitting Insulation (Intact and debris on floor)

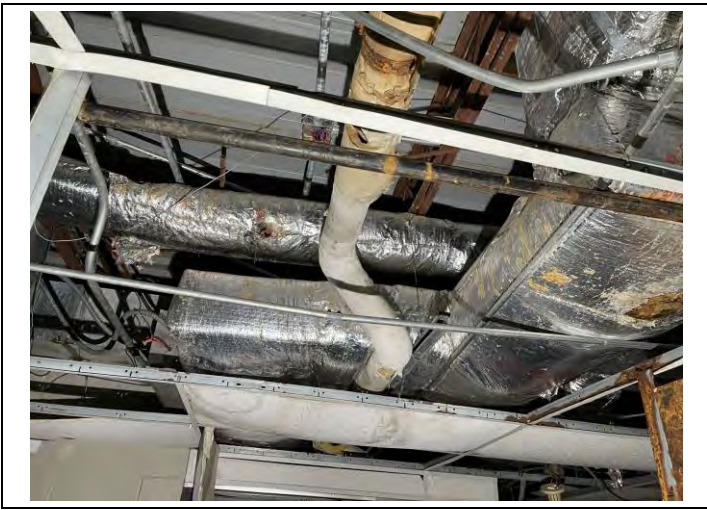
25. Pipe Fitting Insulation (Intact and debris on floor)

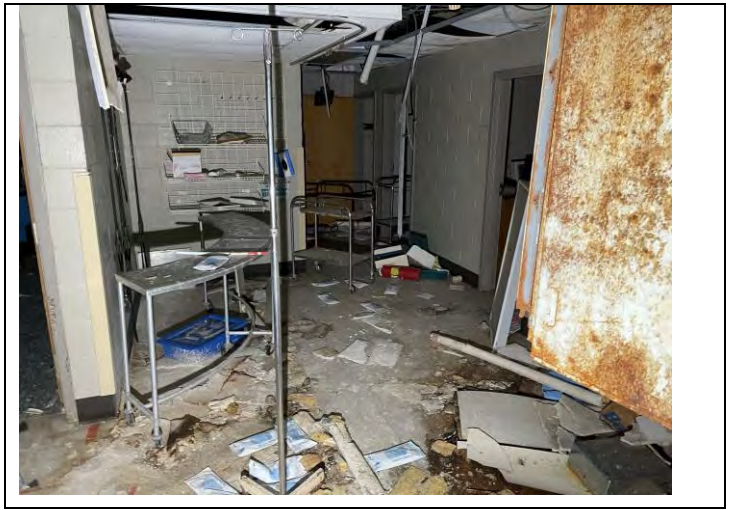
26. Pipe Fitting Insulation (Intact and debris on floor)

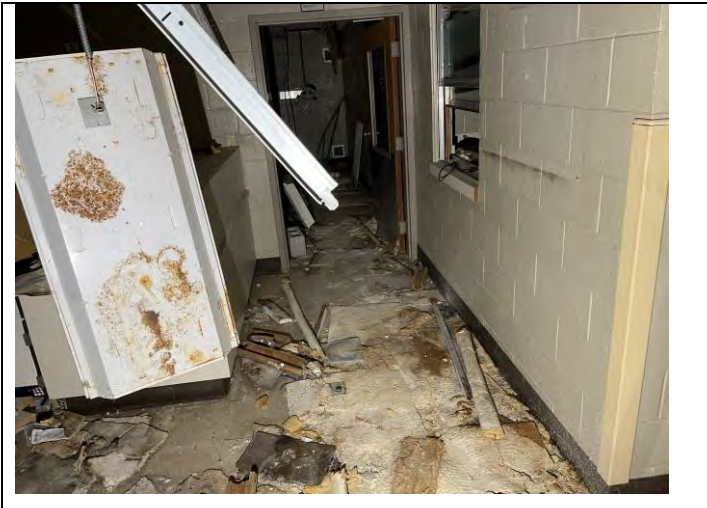
27. Pipe Fitting Insulation (Intact and debris on floor)

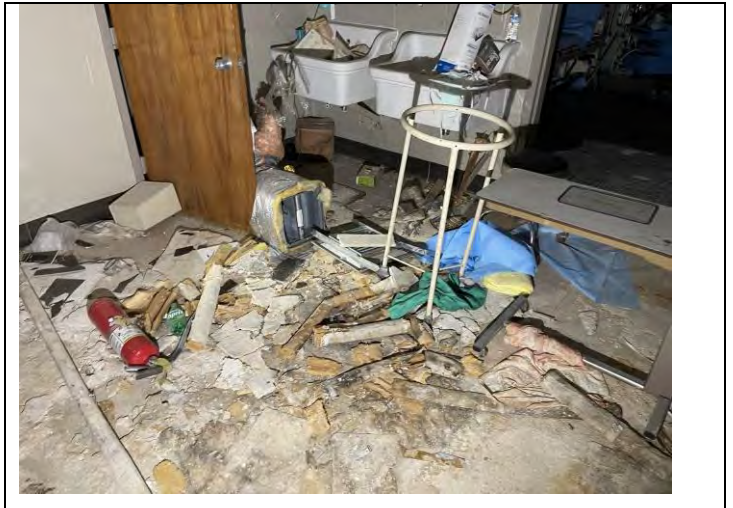
28. Pipe Fitting Insulation (Intact and debris on floor)

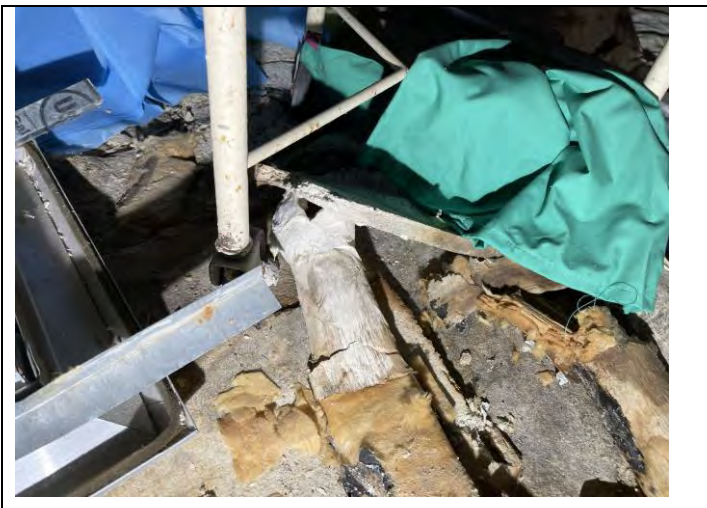
29. Pipe Fitting Insulation (Intact and debris on floor)

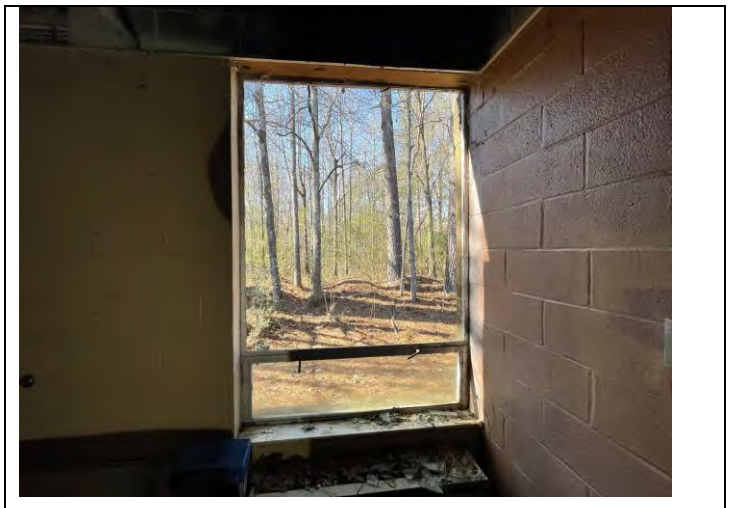
30. Window Frame Caulking and Windowpane Glazing

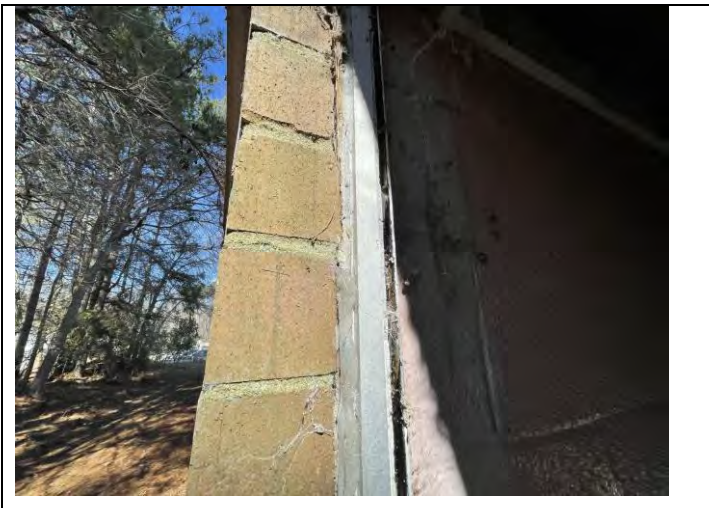
31. Window Frame Caulking and Windowpane Glazing

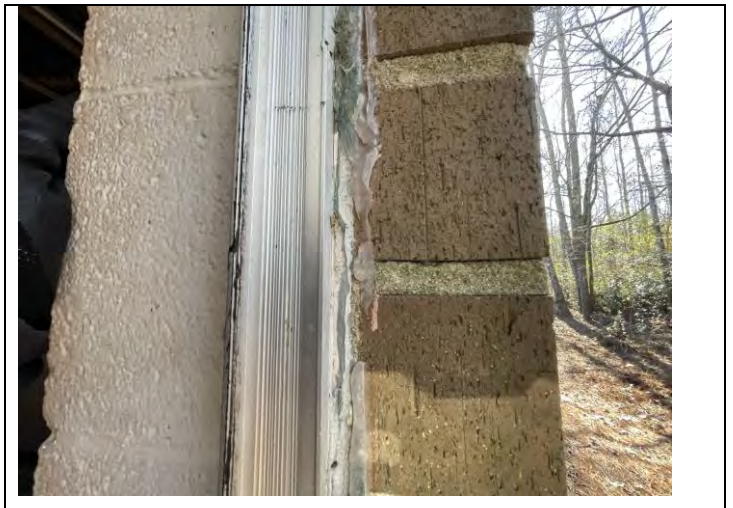
32. Window Frame Caulking and Windowpane Glazing

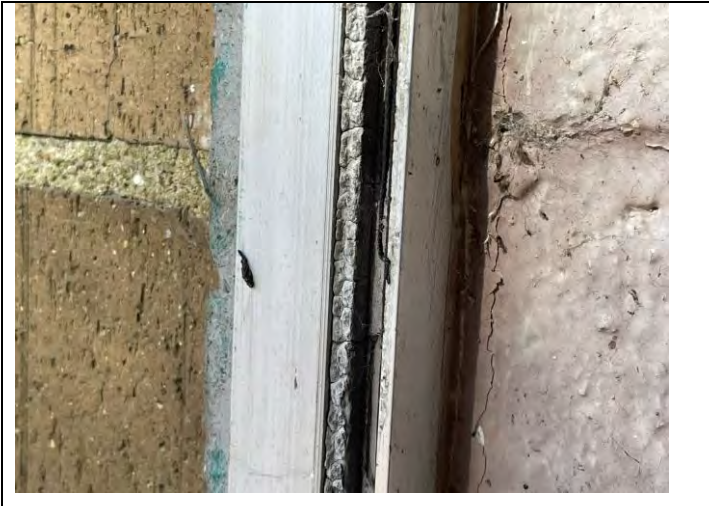
33. Window Frame Caulking and Windowpane Glazing

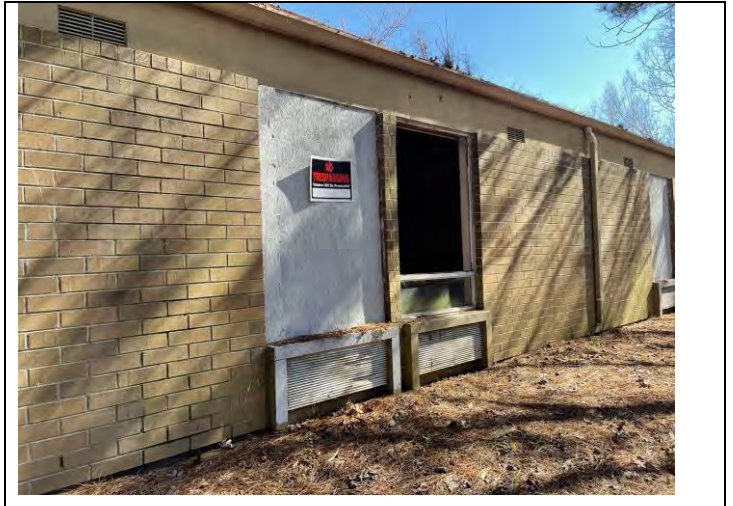
34. Window Frame Caulking and Windowpane Glazing

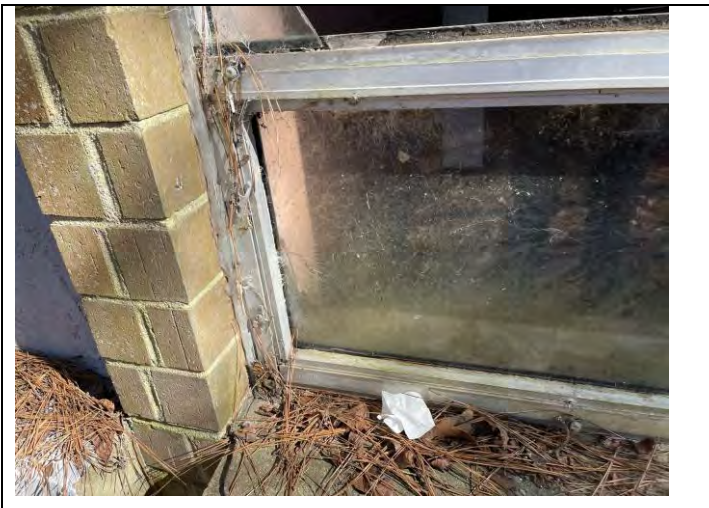
35. Window Frame Caulking and Windowpane Glazing

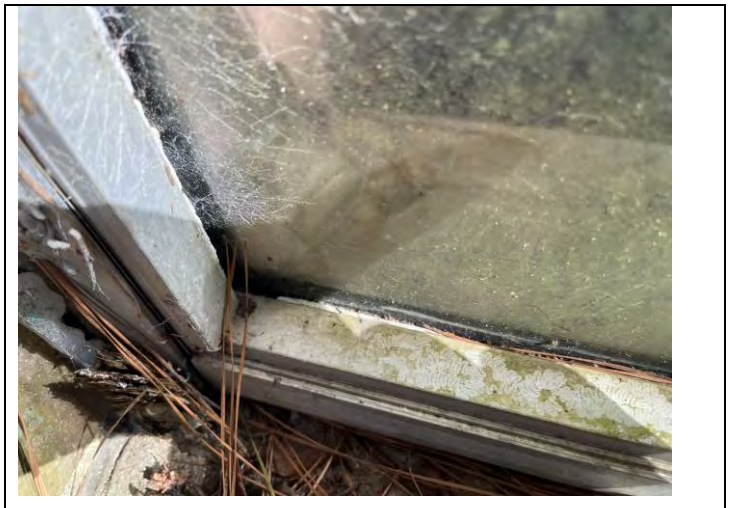
36. Window Frame Caulking and Windowpane Glazing

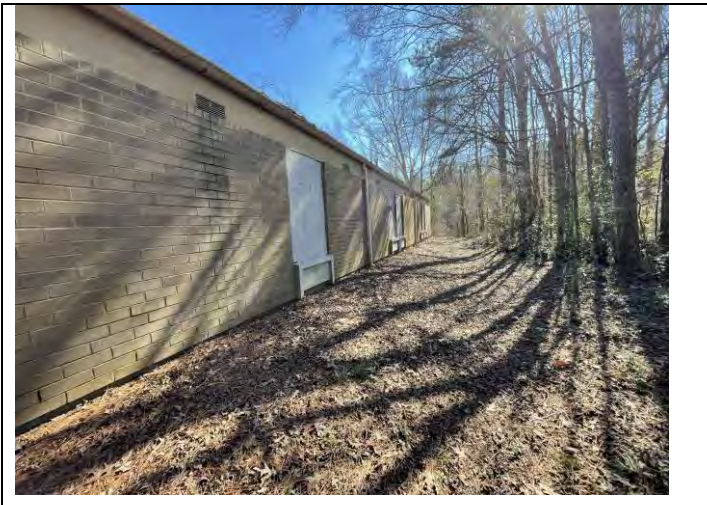
37. Window Frame Caulking and Windowpane Glazing

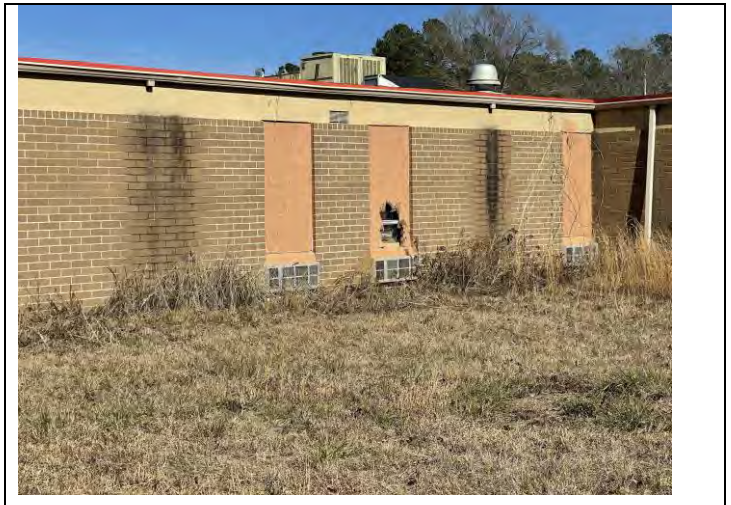
38. Window Frame Caulking and Windowpane Glazing

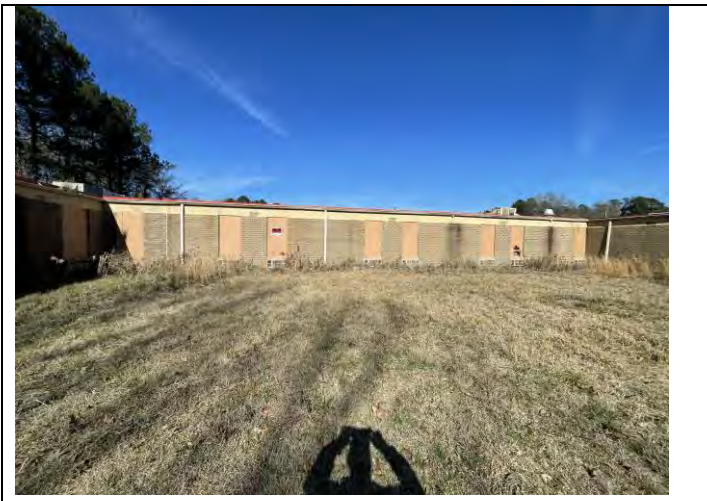
39. Window Frame Caulking and Windowpane Glazing

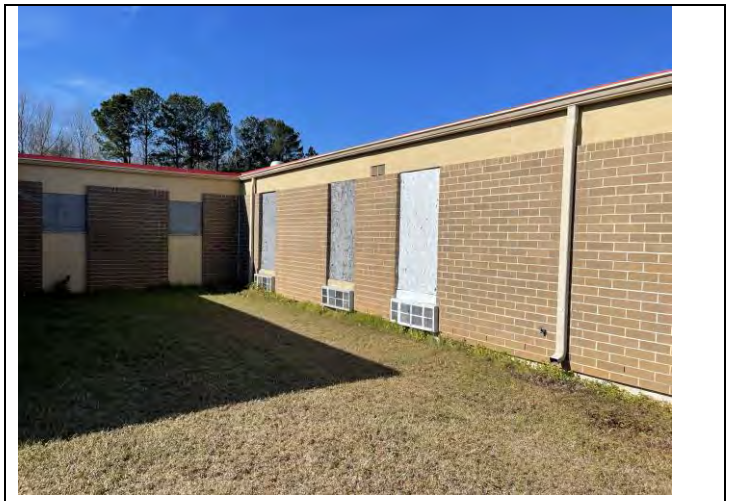
40. Window Frame Caulking and Windowpane Glazing

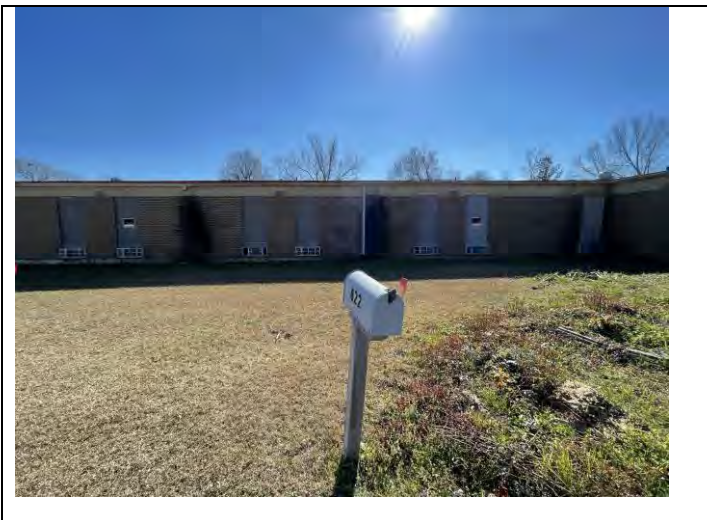
41. Window Frame Caulking and Windowpane Glazing

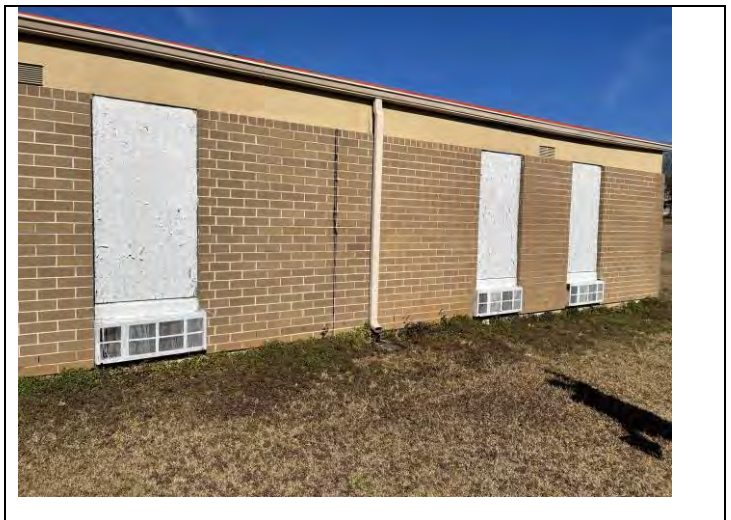
42. Window Frame Caulking and Windowpane Glazing
