ROADWAY CONDITION ASSESSMENT VILLAGE OF OLD BENNINGTON

Bennington, Vermont
September 2019

Village of Old Bennington
Bennington, VT 05201

Project No. 1007-004

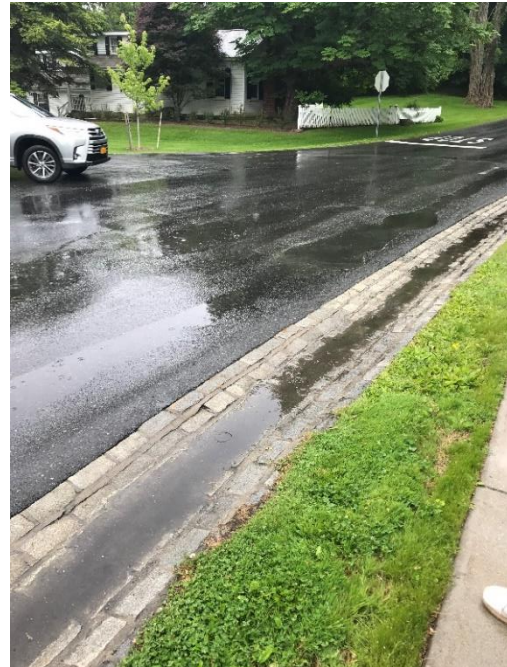
The pavement condition at Monument Avenue in the vicinity of Elm Street is very good. Proceeding north from the Village boundary the pavement is generally in good condition. There is a granite cobble paved drainage swale along the west side of the roadway and while the swale itself is in very good condition, there is little longitudinal pitch on the swale so standing water was observed. In many instances the edge of swale is higher than the adjacent pavement such that runoff from the roadway is not being effectively intercepted by the swale. Runoff is conveyed via wheel ruts in the roadway indicating a degree of potential base failure.

This roadway may be reclaimed in the vicinity of Elm Street as a way to improve the structural integrity of the road base given the rutting and shoving observed. While pulverized material would need to be removed for new paving to match existing grades at the roadside swale, reclaiming the roadway would provide the opportunity to reshape the cross section. It is recommended that the cross slopes generally be increased in order to ensure conveyance of runoff to the gutters and the granite cobble paved swale.

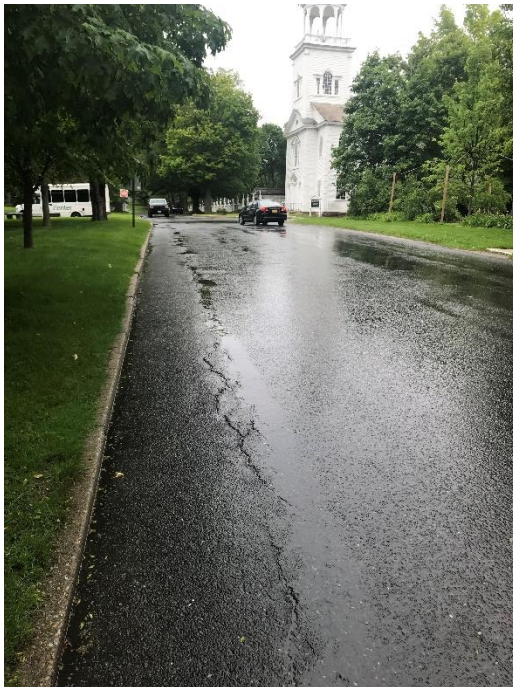
Shoving of the pavement can also be observed on approach to the "Stop" sign in the southbound direction on Monument Street at Elm Street.

Shoving is rutting in connection with braking on the incline and also indicates a degree of base failure. Similar to the condition described above, this rutting actually prevents runoff from the pavement from being conveyed to the granite cobble paved swale.

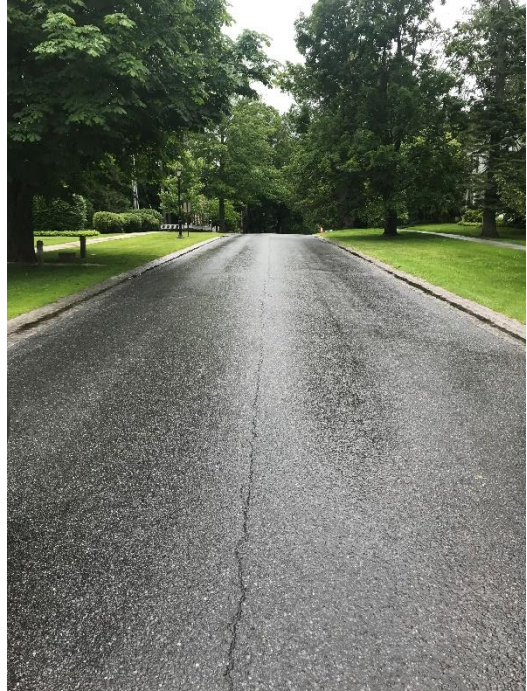
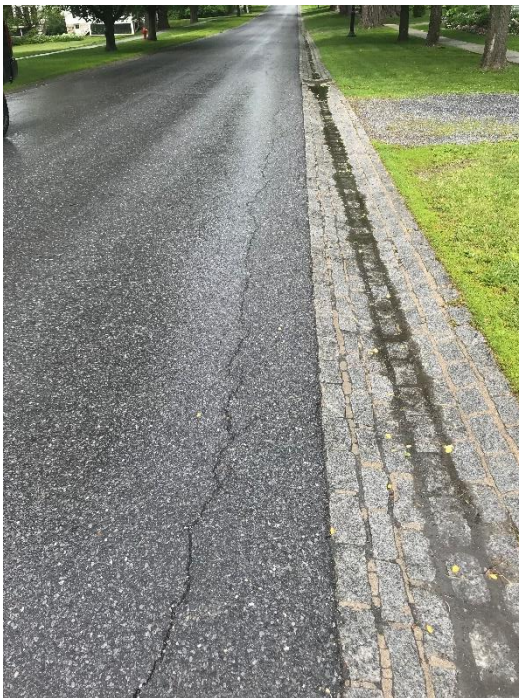
At the north end of the green near West Main Street, cracking along this segment of roadway parallels the edge of pavement a consistent ± 4 ft. Based on the consistent offset, the cracking may indicate the edge of an underlying concrete road base. Hairline cracks have formed in the gutters at the south end near Church Lane. Roadway cores would answer some questions regarding roadway composition.

For Monument Avenue north of the green and on approach to Monument Circle, the pavement is generally in very good condition. The primary issue with this roadway segment is longitudinal cracking along the roadway centerline and edges paralleling the granite cobble drainage swale. It is assumed the centerline cracking is caused by an underlying paving seam or joint. It is typical, over time, for such cracking to occur. The reason for the edge cracking isn't as clear from the surface indicators, however it may be caused by runoff infiltrating the granite cobble drainage swale, saturating and weakening the road base. The cracking is fairly consistent for the length of the roadway segment, however, in some areas the edge cracking has progressed to pavement failure. The roadway shape is consistent and the pavement smooth.

North of the green the longitudinal cracks should be sealed along both the center line and the gutters. This preventive maintenance will help prevent surface water runoff infiltration and associated weakening of the road base.

Where the edge cracking has progressed to pavement failure, saw-cutting, pavement removal and patching may be required. The construction detail for patching along the granite cobble drainage swale might include a revamped interface between the granite cobbles and pavement and/or a haunched or thickened pavement section at the gutter for added strength.

Long-term, the service life for this roadway segment can be extended by performing a mill and overlay. The cobble stone drainage swales will require periodic maintenance to replace cracked or missing mortar in order to protect the integrity of the system.

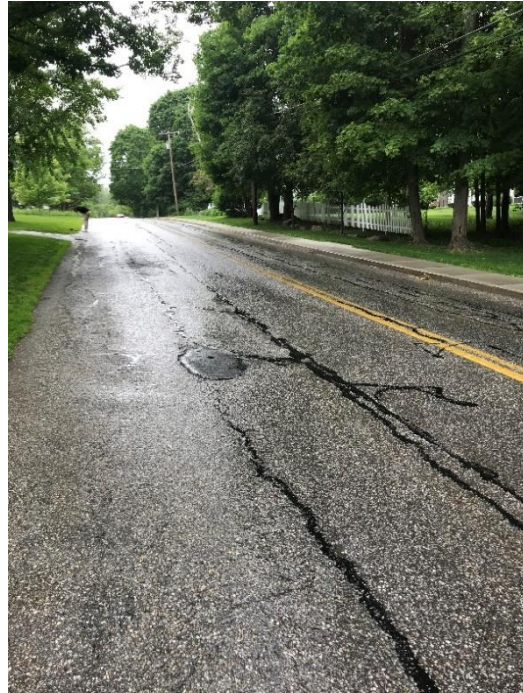
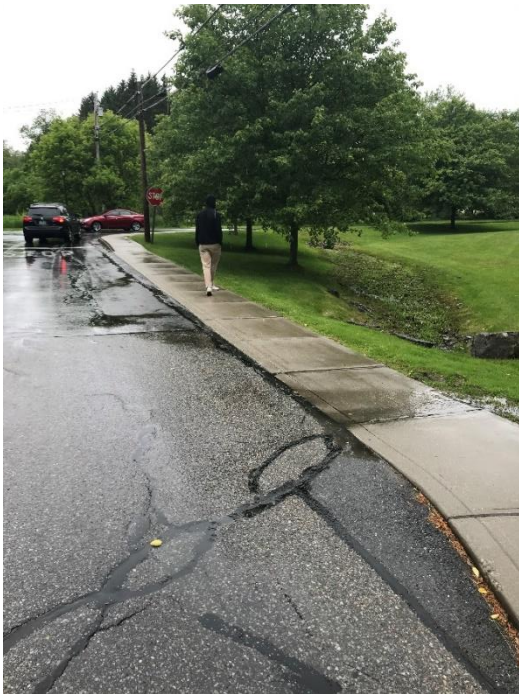
The condition of the pavement on this segment of roadway is generally fair. Crack sealing has been performed on the roadway which is a good sign the Village has attempted to preserve the facility service life. It appears the roadway was previously overlaid but due to the severity and extent of longitudinal cracking, the paved section has probably begun to exceed its useful service life. It is presumed that much of longitudinal cracking occurs along the paving seam where surface water intrusion may have occurred over time. A concrete sidewalk and curb running along the north side of the road is in very good condition.

The overall plane of the roadway on approach to the Village boundary is generally smooth, however the roadway lacks sufficient crown. Some minor rutting has formed along wheel paths such that during normal rainfall events runoff is conveyed along these ruts rather than the gutter. On approach to Monument Avenue the roadway has several surface drainage issues that should be resolved. The roadway is sloped to the north encouraging sheet flow over the sidewalk and discharge to a wet area on private property. Due to differential settlement between the pavement and concrete sidewalk edge, sheet flow runoff from normal rainfall events doesn't occur across the sidewalk. Runoff tends to pool on the pavement and sidewalk leading to icing in cold weather directly affecting longevity of the pavement along the edge.

The paved width on Elm Street narrows between the Village boundary and Monument Avenue. At the easterly limit of the Village there is a catch basin on the north side of the roadway which aligns with the wider roadway segment such that bypass gutter flow from the west bypasses the inlet during normal rainfall events.

Because of the prominent drainage issues observed, the pavement should be warped at the Village limit line for the catch basin to more effectively intercept gutter flow.

Regrading of the roadway approach to Monument Avenue with a normal crown and replacement of the sidewalk with a six-inch curb is recommended. The curb will require installing a traditional catch basin inlet with new discharge to private property via a drainage easement, unless the new pipe can be connected to a downgradient catch basin. This can be expected to better shed runoff from the roadway and reduce the potential for icing across the roadway and sidewalk.

The catch basin inlet in the yard at 120 Elm Street is low in comparison to adjacent grade and should be raised in connection with any roadway rehabilitation efforts.

Elm Street may be reclaimed. Pulverizing and incorporating ground asphalt layers into the granular road base would enhance the strength of the road base. Upon reclamation, pulverized/blended material will have to be removed in order to maintain existing elevations at the edges of roadway upon final paving. Reclamation is preferred over mill and overlay as the procedure allows for both shaping and regrading of the road base to remove rutting, achieve desired crown and permits compaction of the reclaimed road base which is important in order to restore integrity of the pavement section.

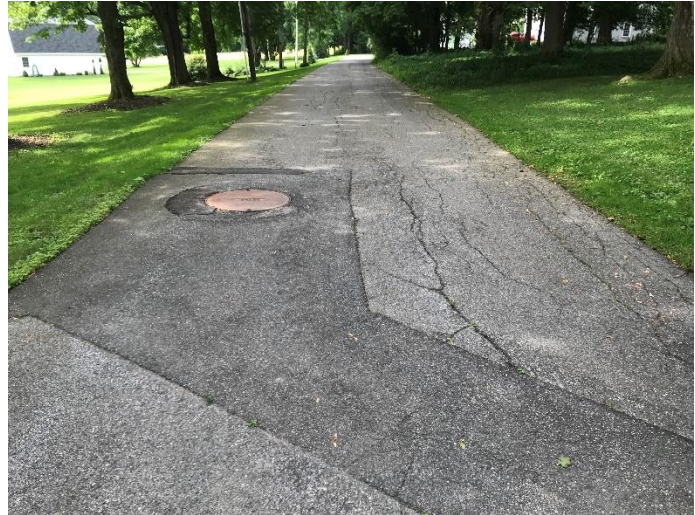
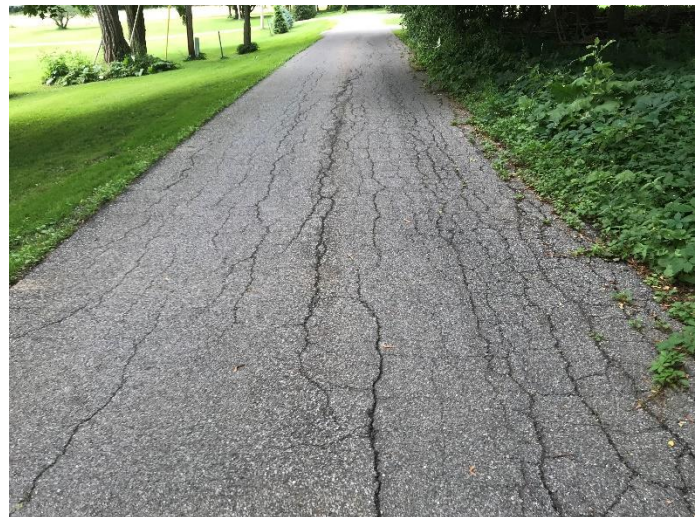
The road is narrow and the roadside edges generally well-maintained along private properties. The roadway is not curbed and does not have a formal drainage system. For much of the road length a narrow gravel shoulder parallels the paved edges. In other areas lawn abuts the edge of roadway. The pavement is in poor condition with a lot of distress and the surface exhibiting longitudinal and edge cracking throughout. The roadway was cut for a sewer installation and the trench repair is evident.

Based on the widespread and nearly complete pavement failure, this road may have to be reconstructed. Pavement coring should be performed to determine subbase and subgrade conditions. If ground water is affecting the longevity of the pavement, then a free draining subbase layer may be required but should daylight on the fill side in order to allow for evacuation of water from the pavement section.

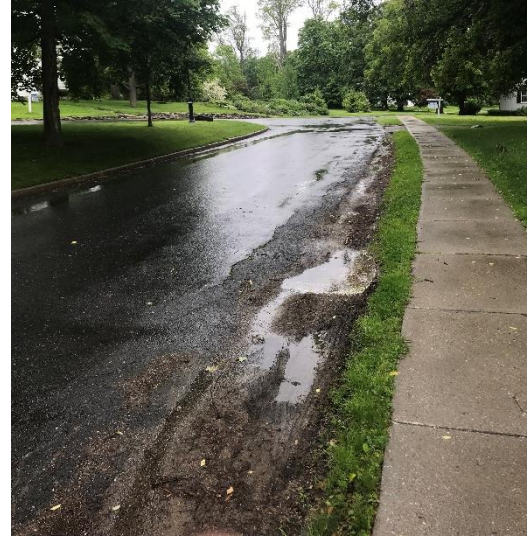
Park Way is a short, northbound one-way connection between Monument Avenue and West Main Street. In general, the pavement is in good condition. The roadway is curbed along the green on the east side but there is no curbing along the west edge of the roadway. The concrete curb along the green is in varying levels of disrepair with deterioration of the concrete in several places. A concrete sidewalk parallels the westerly edge of the roadway with a narrow strip of grass/earth between the sidewalk and pavement.

The roadway does not have any catch basin inlets along the westerly edge, and it appears the narrow strip between the sidewalk and the curb is routinely subject to parked vehicles. Much of the grass that can be seen in online imagery dating back to 2012 no longer thrives and has become bare earth. Given there are no drainage inlets, this area tends to collect runoff and can get quite muddy when subject to wheel loading. There is some edge cracking of the pavement where this condition persists. There is a catch basin inlet at the southern end of this short roadway segment near the terminus of the green and intersection of Monument Avenue.

The exposed earth/muddy condition along the west side of the roadway should be addressed. One option is to install an asphalt curb on the pavement and topsoil and seed the area between sidewalk and curb. Given the narrow width of the roadway, this may preclude on-street parking. If the loss of parking is an issue for the Village, then the area may be infilled with granite cobbles mortared in place on a compacted gravel or concrete base. This would match the aesthetics of the drainage swales along Monument Avenue. Both solutions would require the area to be pitched toward the roadway in order to drain effectively. It may be prudent to install a catch basin inlet in the flat section and pipe the discharge to the existing catch basin near Monument Avenue.

The concrete curb at the green should be replaced. Reinforcing bars are exposed in some places and the concrete is deteriorating at the curb joints.

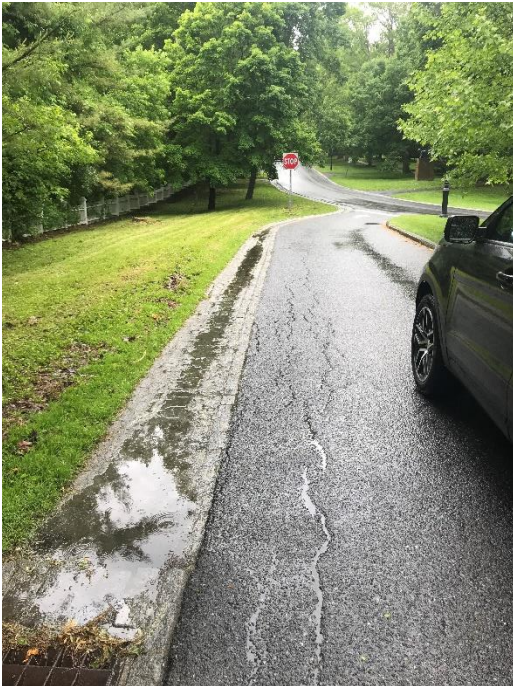
This segment of roadway provides access to one residence and serves as a short bypass for northbound traffic to avoid the West Main Street/Monument Avenue intersection. The roadway frames a small amount of green. There is concrete curbing along the east side of the roadway along the green and a granite cobble drainage swale borders the west edge of the roadway. While the pavement is generally in good condition, there is progressive edge cracking along the western side adjacent to the granite cobble drainage swale.

Where the edge cracking has progressed to pavement failure, saw-cutting may be required for pavement removal and patching. The construction detail for patching along the granite cobble drainage swale might include a revamped interface between the granite

cobbles and pavement and/or a haunched or thickened pavement section at the gutter for added strength.

Long-term, the service life for this roadway segment can be extended by performing a mill and overlay. The cobble stone drainage swales will require periodic maintenance to replace cracked or missing mortar in order to protect the integrity of the system.

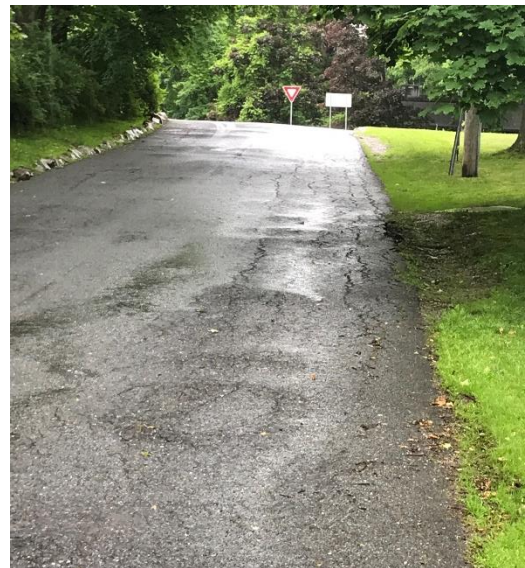
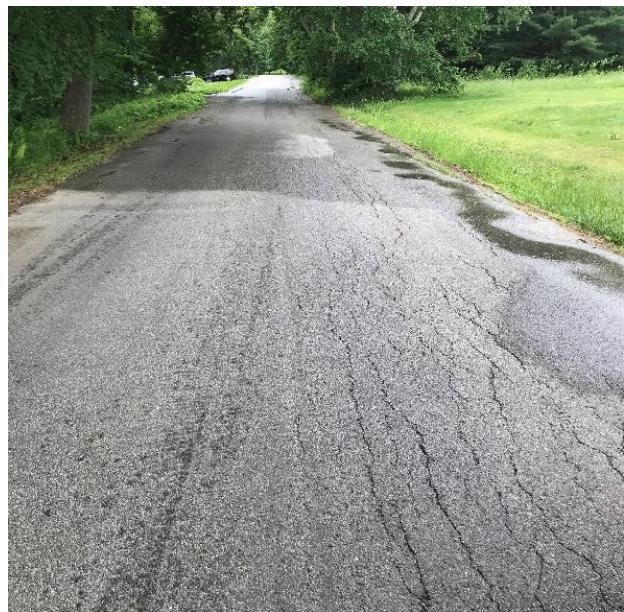
Providing access to the cemetery and to residential properties, Church Lane is narrow and somewhat steep. The roadway does not have traditional curbing and there is no drainage infrastructure, so runoff is generally uncontrolled. Small rocks line the southern edge of pavement and appear to function as a means for containing gutter flow but there is no curb on the north side of the road. The pavement exhibits edge cracking along the north side and moderate, random longitudinal cracking in various locations. Where the northern edge of pavement meets lawn, the exposed pavement channels the runoff. It is likely the edge cracking is caused by surface water infiltration along the gutter which typically results in a weakened road base. While the pavement shows distress, there is limited evidence of base failure throughout.

Overlaying the roadway is not a viable option due to the severity of many of the cracks. We would expect those cracks to reflect through to the new pavement. Given the roadway gradient, the town should consider curbing the roadway to protect the paved edges from erosion and surface runoff intrusion into the road base.

The road should be milled to remove all existing asphalt layers as this would give the opportunity to compact the road base prior to repaving. While the roadway may be reclaimed, it is not clear there would be tremendous benefit given the lack of evidence regarding base failure. In the short-term, the town should seal and fill cracks. It is possible the town may have to do a spot repair to address pavement on the north side where edge cracking is significant prior to addressing the full roadway.

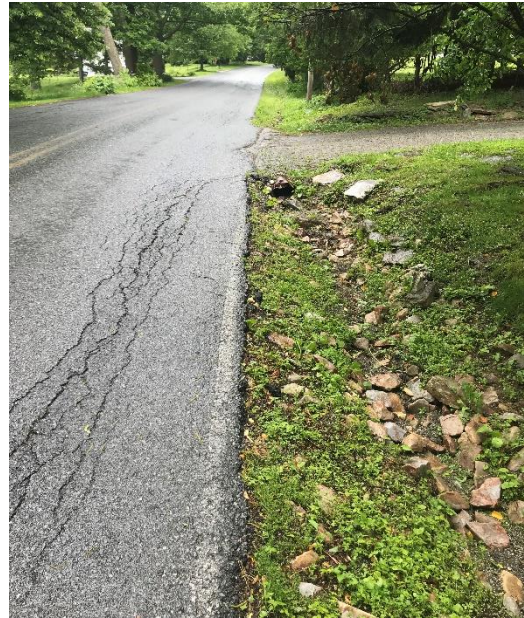
The pavement exhibits signs of failure throughout, including edge cracking and longitudinal cracking. In some places cracking is severe. The surface and shape of the roadway, however, remains consistent, so widespread base failure is not suspect. While there is a ditch along the west side of the roadway adjacent to an open field at the northerly end of Catamount Lane, runoff isn't effectively conveyed to the ditch. Severe edge cracking along the west side leads us to believe runoff infiltrating from the field may be affecting the longevity of the pavement. There is no formal drainage system in the roadway.

The paved edge along the east side where the roadway is in a fill section is not well supported and the paved edge has failed in places.

There is edge cracking along the roadway from Bank Street to West Main Street.

Coring should be conducted to confirm road base conditions. While the pavement has failed throughout, the roadway may be a candidate for reclamation if sufficient road base material is found. Long-term, roadway reclamation should be considered. Should the existing road base be deficient in coarse aggregate, it is possible that the road can be reclaimed with a crushed stone layer then added on top and reclaimed a second time to incorporate the stone into the overall road cross section. This can be a cost-effective method to strengthen the reclaimed road base.

The roadway should be properly crowned, and the western edge of pavement sloped to improve sheet flow to the drainage swale. Wherever possible, roadside ditching should be considered to convey runoff while preserving the integrity of the pavement. This will require identifying suitable discharge points. Wherever pavement is in a fill section, the roadway should be properly backfilled with topsoil and seeded to turf for support of the paved edge.

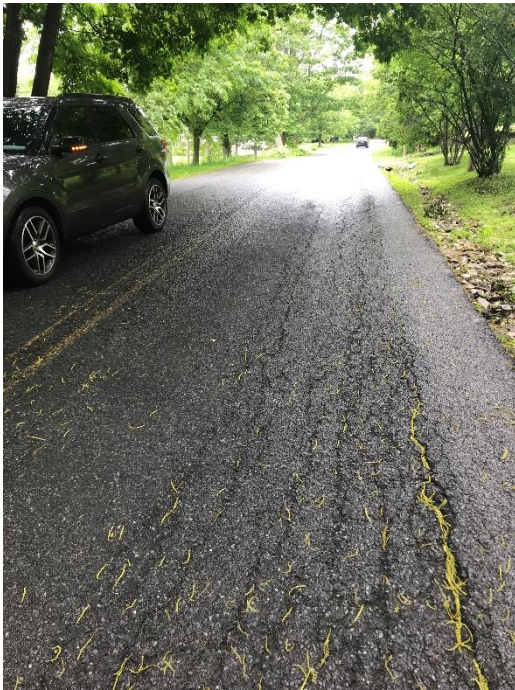
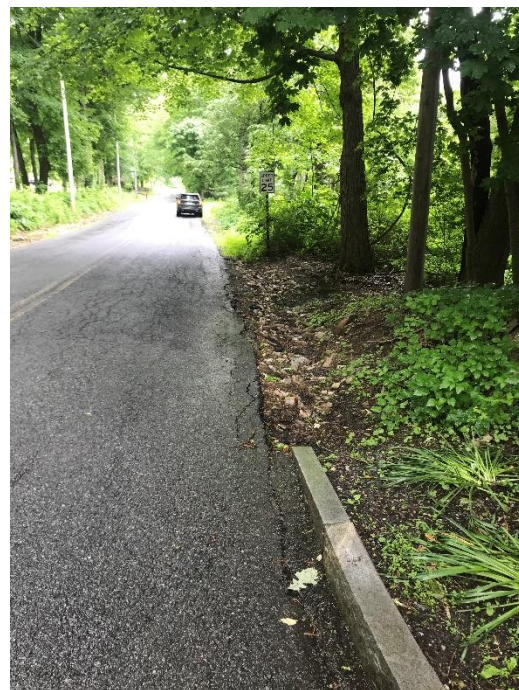
In general, Bank Street is in poor condition overall. This roadway may be considered the worst in the Village judging by pavement condition, traffic volume, and level of work necessary to improve the roadway to an acceptable level. The roadway gradient descends fairly sharply departing from its intersection with Monument Avenue. There is widespread pavement failure evidenced by visible cracking throughout. The northern edge of the roadway is protected by a cobble drainage swale or roadside treatment which appears to have accumulated sediment over time. While the edge is protected by stone, the shape of the swale provides limited conveyance. Cross slope on the travel lanes is generally limited. The roadway is not curbed and there is no formal storm drain system.

East of Catamount Lane, it appears the roadway has a thin overlay which may vary from ½-inch to one inch in thickness. The overlay exhibits widespread cracking. It appears the overlay was not “cut-in” at the intersection of Catamount Lane, rather, it may have been “feathered” to match. In this area, delamination of the overlay has occurred. Granite stone curbing at the intersection of Catamount Lane directs runoff, uncontrolled, to a drainage ditch.

A catch basin near the driveway at #32 Bank Street doesn’t appear to be located effectively and runoff appears to bypass the inlet and run down the driveway.

Given the condition of the roadway, Bank Street should be fully rehabilitated or reconstructed. While the pavement has deteriorated or failed throughout, the roadway does not exhibit extensive potholes or rutting so base failure may not be present. Pavement coring should be performed to determine whether the road base is suitable for reclamation, a process which could provide savings over full-depth reconstruction. Should the existing road base be deficient in coarse aggregate, it is possible that the road can be reclaimed with a crushed stone layer then added on top and reclaimed a second time to incorporate the stone into the overall road cross section. This can be a cost-effective method to strengthen the reclaimed road base. The roadway should be properly crowned to effectively convey runoff.

Given the roadway's gradient, particularly along its western end, the Village should consider installing curbing and a formal piped storm drain system. This would require identifying and establishing a discharge point, which may require environmental permits and potentially a private property easement depending on the discharge location. If the Village prefers to convey runoff via roadside swales, then the swales should be properly armored, with periodic check dams incorporated to attenuate velocities and resist erosion. Discharge points will have to be identified along the swales. Any swales should be maintained, kept free from sediment and debris accumulation.

The driveway ramp at 32 Bank Street should be reconstructed with a paved lip and a rise in order to prevent road runoff from entering the driveway.

Curbing at the intersection of Catamount Lane should be extended to safe termini at all corners. The drainage ditch just east of the intersection should be properly protected with rounded stone or other form of stabilization.

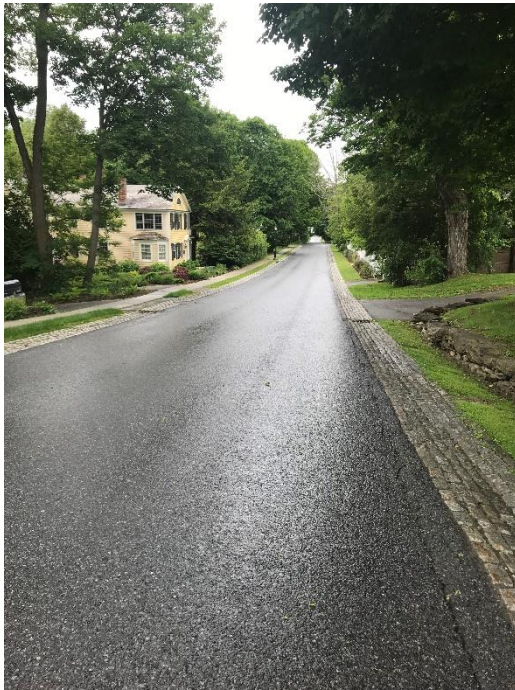
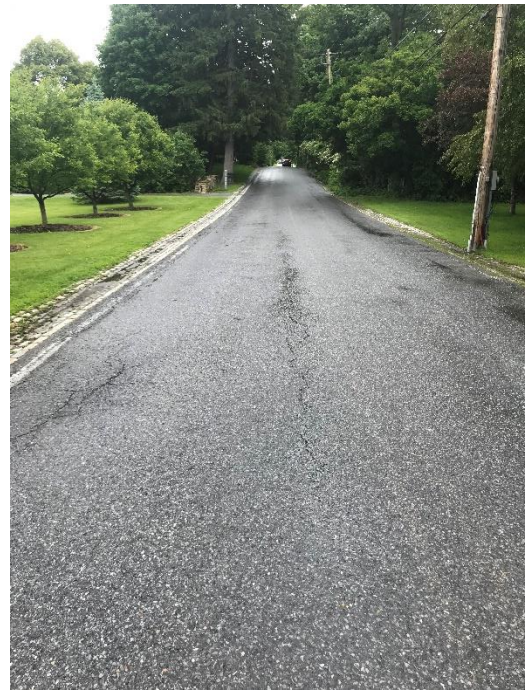
The pavement is generally in good or very good condition although cracks are starting to develop throughout. Cracking generally occurs at the center line, which is the presumed paving seam. The roadway is flanked on both sides with granite cobble drainage swales, and edge cracking parallels the cobble stone treatment similar to the condition occurring along Monument Avenue.

Longitudinal cracks should be sealed along both the center line and the gutters. This preventive maintenance will help prevent surface runoff infiltration weakening the road base.

Ultimately where edge cracking may progress prior to the roadway requiring rehabilitation, saw-cutting, pavement removal and patching will be required. The construction detail for patching along the granite cobble drainage swale might include a revamped interface between the granite cobbles and pavement and/or a haunched or thickened pavement section at the gutter for added strength.

Long-term, the service life for this roadway segment can be extended by performing a mill and overlay. The cobble stone drainage swales will require periodic maintenance to replace cracked or missing mortar in order to protect the integrity of the system.

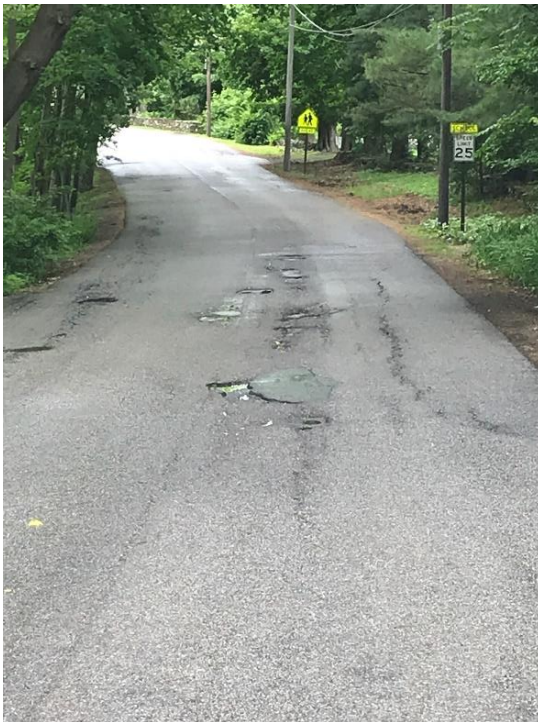
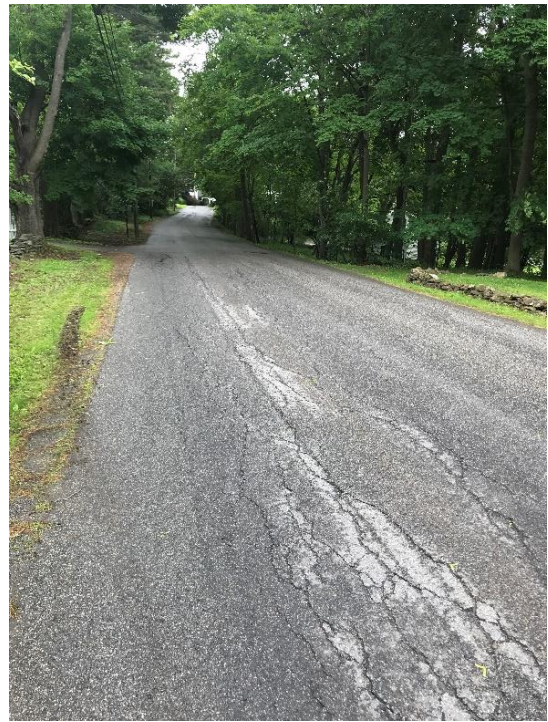
The granite cobble drainage swale from Walloomsac Avenue terminates on the easterly corner of Fairview Street and the pavement is in very good condition. The first 25 feet or so of Fairview Street were repaved in connection with work performed on Walloomsac Avenue. The pavement on Fairview Street exhibits cracking throughout, but in general widespread base failure is not suspect. The exception to this observation is at a low point on Fairview Street just north of the intersection with Walloomsac Avenue. At this location there are several potholes in the roadway and the pavement has failed over a roughly ± 100 -foot segment. The roadway is in a cut section on the east side and there does not appear to be any provision for drainage from east to west. Based on field observations runoff from the is infiltrating the road base and flowing west toward the lower elevation. It is believed that this section of road may be constantly wet with no provisions to evacuate water from the road base.

North of this area the remainder of the pavement exhibits distress throughout. In some locations multiple overlays are apparent.

Coring should be conducted to confirm road base conditions. While the pavement has failed throughout, the roadway may be a candidate for reclamation if sufficient road base material is found. Long-term, roadway reclamation should be considered. Should the existing road base be deficient in coarse aggregate, it is possible that the road can be reclaimed with a crushed stone layer then added on top and reclaimed a second time to incorporate the stone into the overall road cross section. This can be a cost-effective method to strengthen the reclaimed road base. While the roadway may be a good candidate for reclamation, the area where base failure has occurred may require full-depth reconstruction.

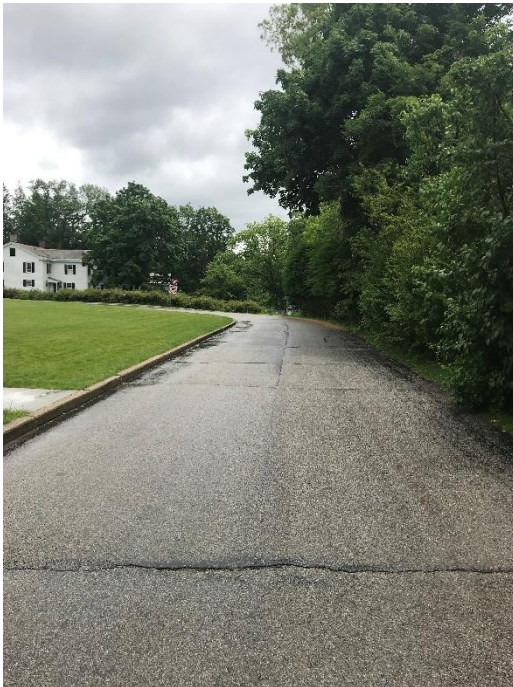
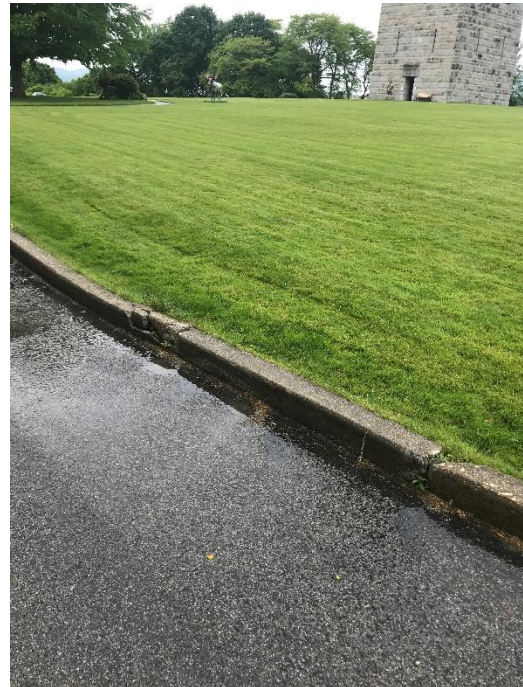
Monument Circle appears to have been meticulously maintained over the years. The pavement is smooth and generally in good or very good condition. Judging by the transverse and longitudinal crack patterns, it is believed this roadway has an underlying concrete base and anecdotally, we understand this is the case. Many of the larger cracks have been filled or sealed. The paved surface has been treated with a fine mix for a smooth and comfortable finish. Where sections have spalled, the thickness of the fine mix can be seen. Concrete curbing around the center island has deteriorated in numerous locations exposing reinforcing bars. The parking lot adjacent to the circle is in very good condition.

This pavement has not yet reached its useful service life. Typically, a roadway in this condition could be simply overlaid, however that would diminish curb reveal. It may be more cost-effective to simply mill the pavement and then overlay with bituminous concrete. The fine mix finish could then be re-applied.

An alternative approach would be to replace the concrete curbing, repair the sawcut edge, address any cracks in the asphalt, and then re-apply the fine mix finish for a uniform surface. The fine mix should be researched and studied to determine whether it will adhere to the weathered surface or whether any scarification or other preparatory measures would have to be taken, such

as a fine milling after all patching and repairs. Any cracks that may form in the parking lot should be addressed over time.
