Western Boat & Trawler Marine Survey

1987 58' Alacraft Purse Seiner/Tender

"Pacific Predator"

Report of Condition/Valuation of the Fishing Vessel

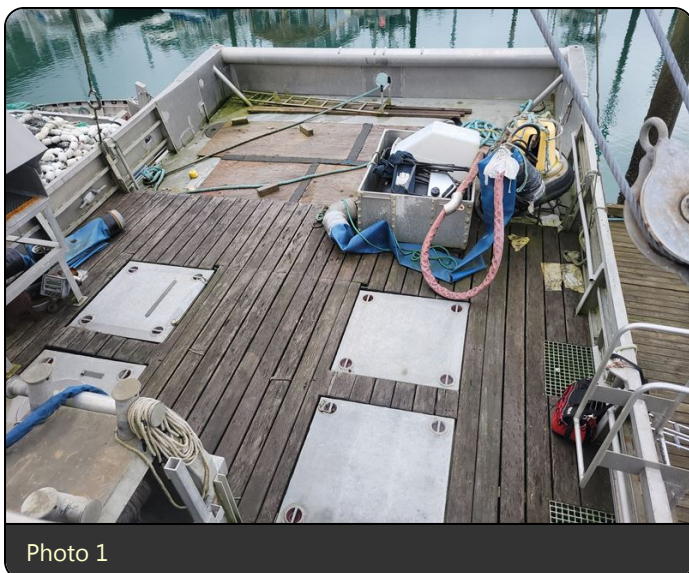
Photo 1

Raised wear deck, 2x6 Apitong high-density decking wood some exceptions

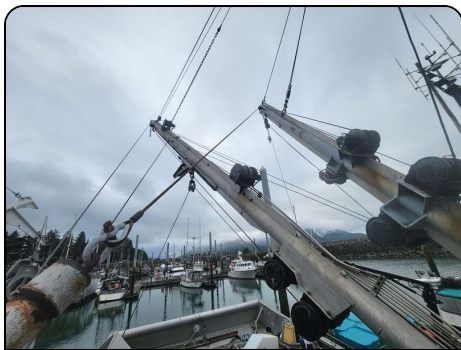
Photo 2: Twin main booms (tender vessel rig)

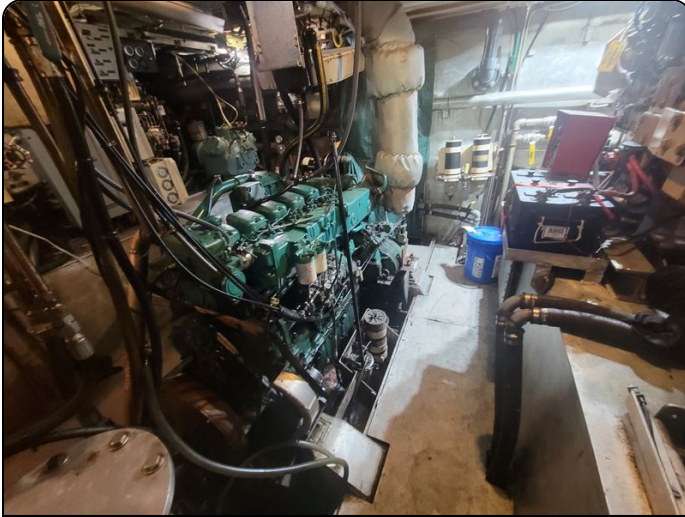
Photo 9

Volvo-Penta TAMD-121-C,. Turbocharged.

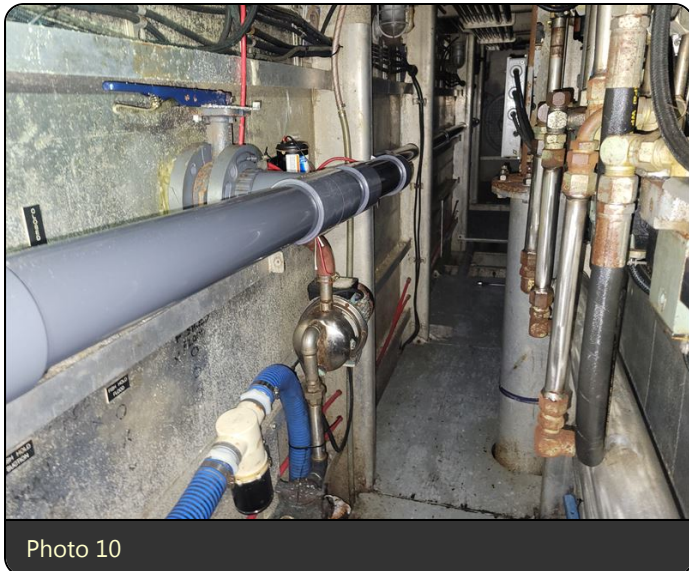
Photo 10

The shaft alley companionway leads aft between the crab tanks giving access to the aft lazarette. The Furuno Sonar Hull unit is mounted in the space. The storm windows are stored port side and the deck hose pump is mounted starboard in the space. The lazarette is entered through a watertight door in the bulkhead. The door handle and dogs are seized closed. Must be water pressure tested or opened and chalk test the seals to prove that it is still watertight. See notes.

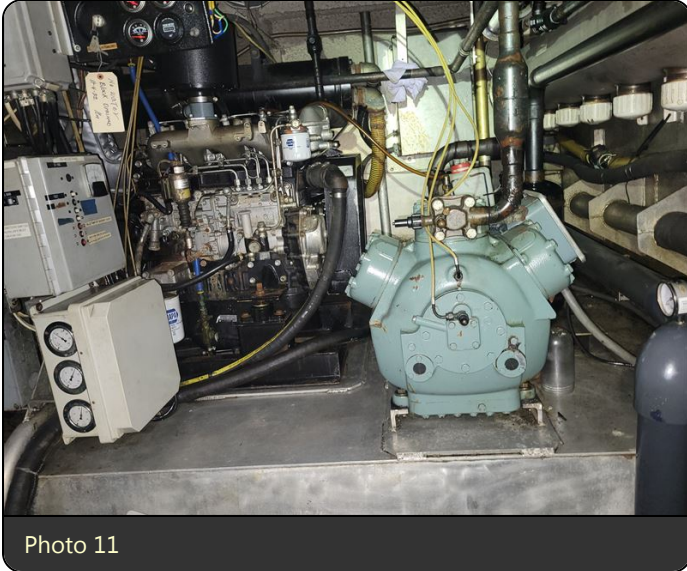
Photo 11

Appears to be a custom fitted 30-ton system with a titanium Sirsa Refrigeration Industrial chiller

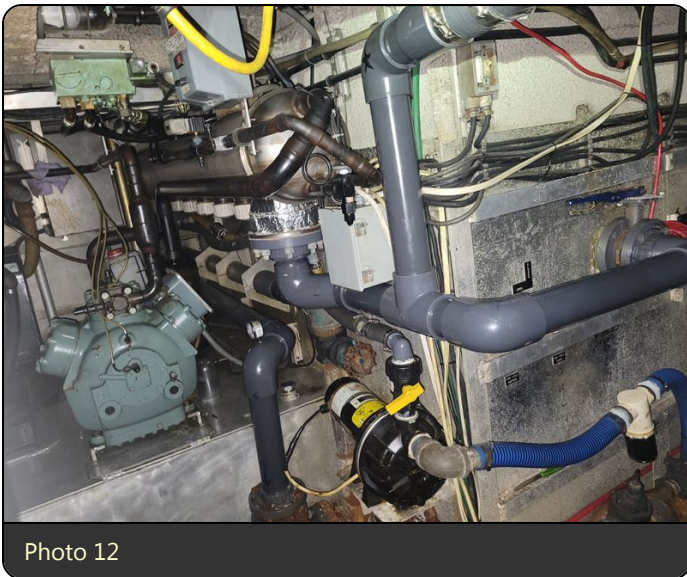
Photo 12

The RSW manifold is 4" PVC crab tank plumbing. 2" PVC pipe for the condenser plumbing with a blue TigerFlex intake line. All the PVC seen is schedule 80 pipes.

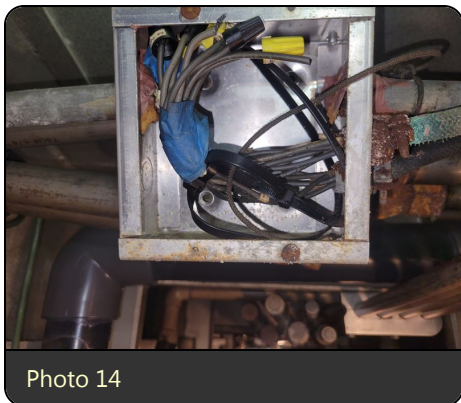
Photo 14

Finding A-1

The backside of an AC switch box in the below deck lazarette/engine room companionway did not have a protective insulation terminal cover installed. Wire nuts were utilized to terminate wiring. In the above photo, a wire has apparently pulled loose from a wire nut labeled '2' in the photo.

Recommendation

Install protective insulating terminal covers, where appropriate. Replace wire nut connections with Marine Grade insulated butt connections (wire nuts are approved for solid household-type wiring only).

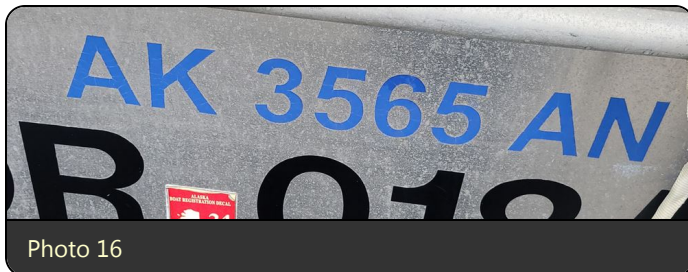
All state (registration numbers and decals) are displayed. No registration paperwork was found. see notes
