INSPECTION REPORT

For the Property at:
1000 FARM RD
FORNEY, TX 75126

Prepared for: JANE DO
Inspection Date: Thursday, February 8, 2024
Prepared by: Jeffrey Knight, 25885

Knight Home Inspection
10121 Bantry Lane
Forney, TX 75126
214-566-5243

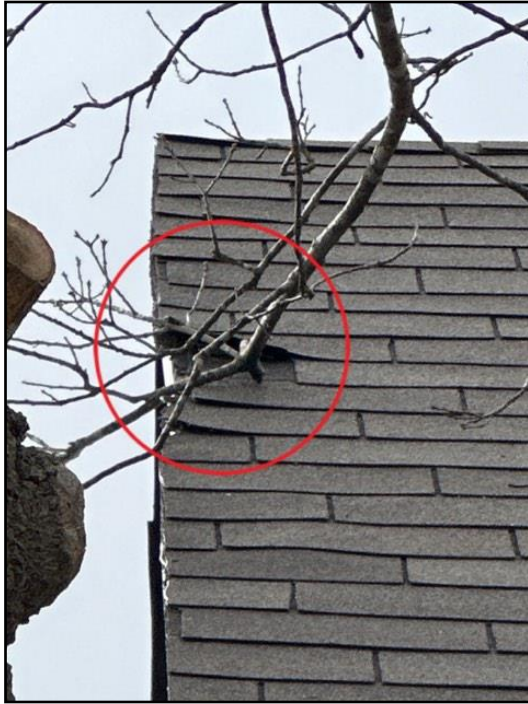
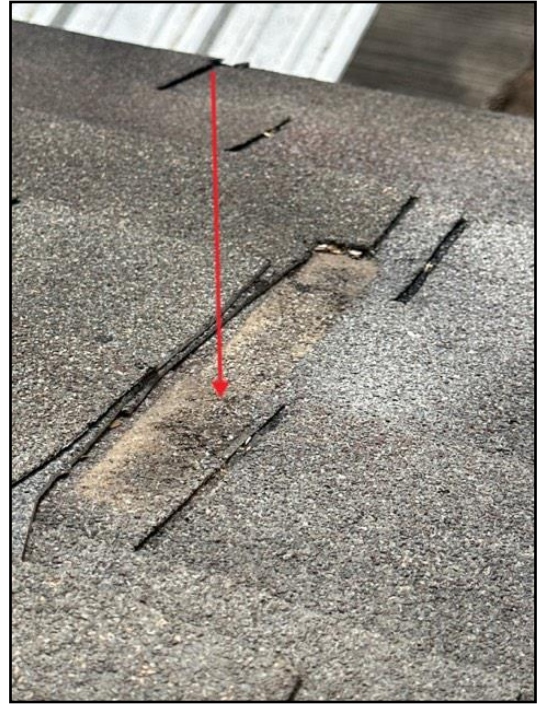
1. Condition: • [Damage](#)

Tree limb has caused damage to the asphalt shingles recommend a professional licensed roofing contractor and arborist make repairs

Implication(s): Chance of water damage to structure, finishes and contents

10. Damage

11. Damage

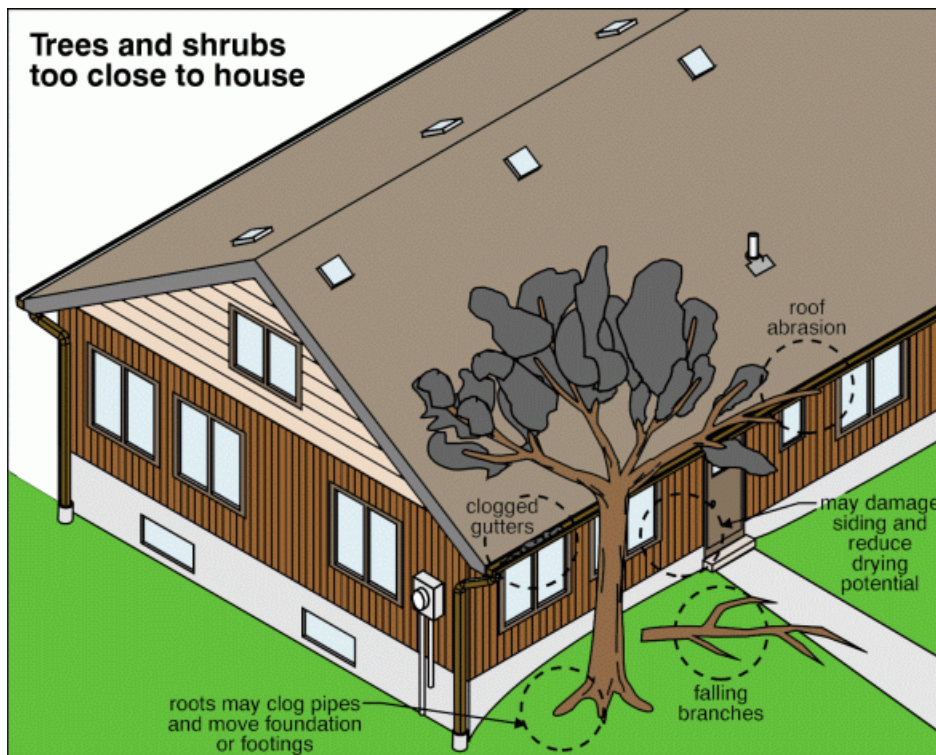
2. Condition: • Tree branches touching roof

12. Tree branches touching roof

13. Tree branches touching roof

Recommend a professional licensed tree arborist make repairs

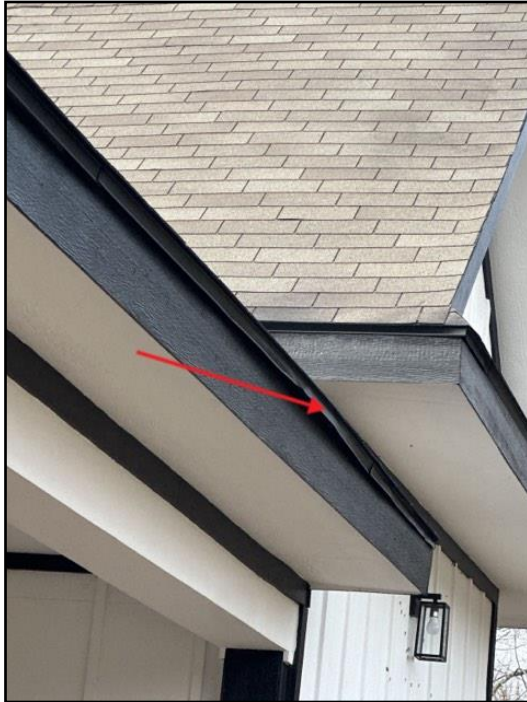
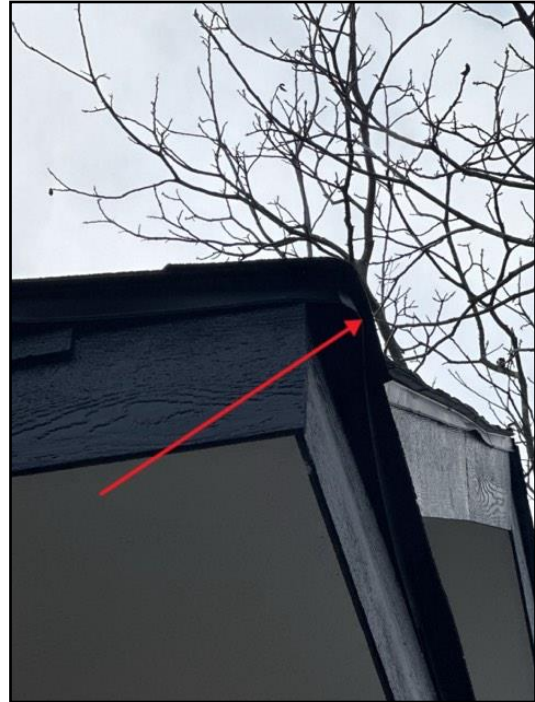
3. Condition: • [Loose](#)

Drip edge loose, recommend a professional licensed contractor make repairs

Implication(s): Chance of water damage to structure, finishes and contents

14. Loose

15. Loose

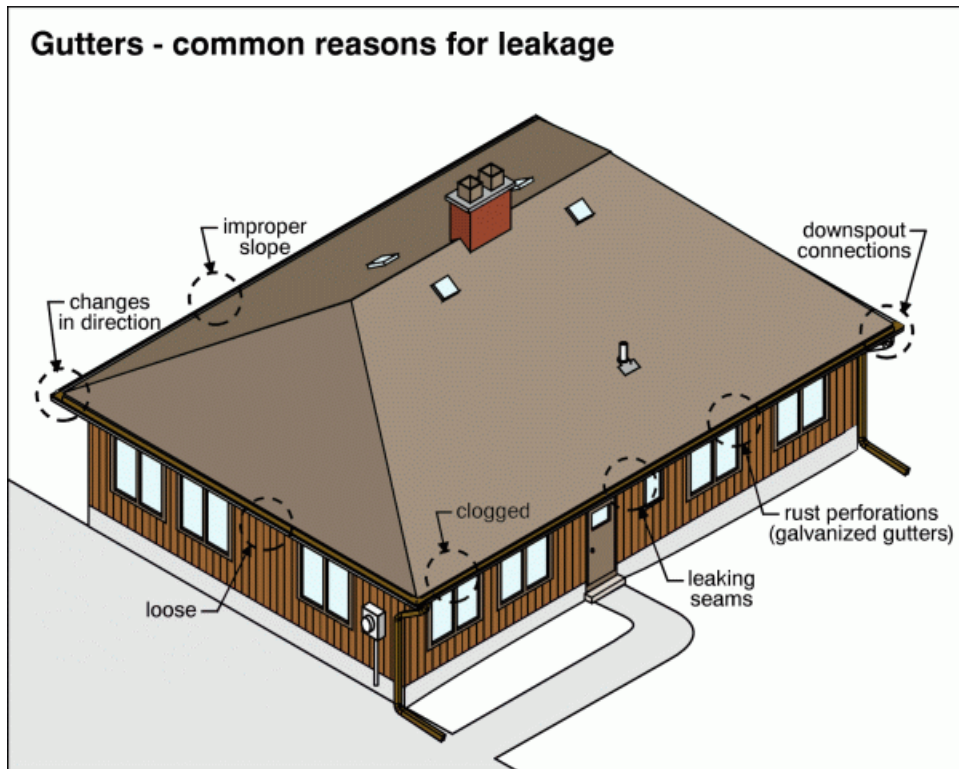
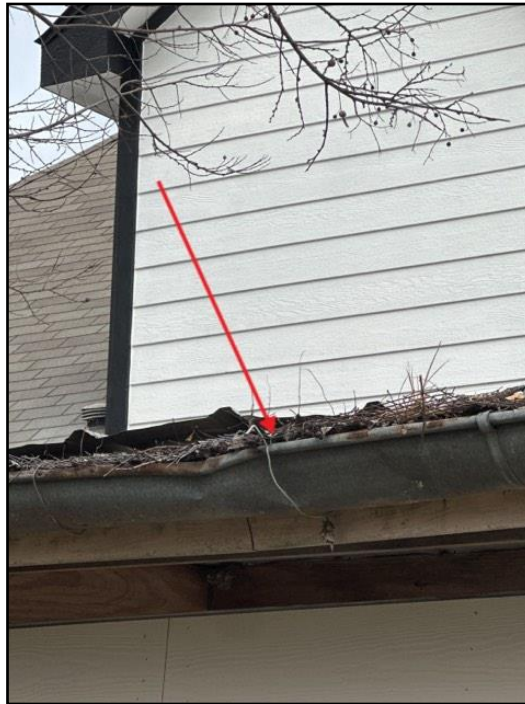
4. Condition: • [Clogged](#)

Gutters clogged recommend a professional, licensed contractor, clean the gutters

16. Clogged

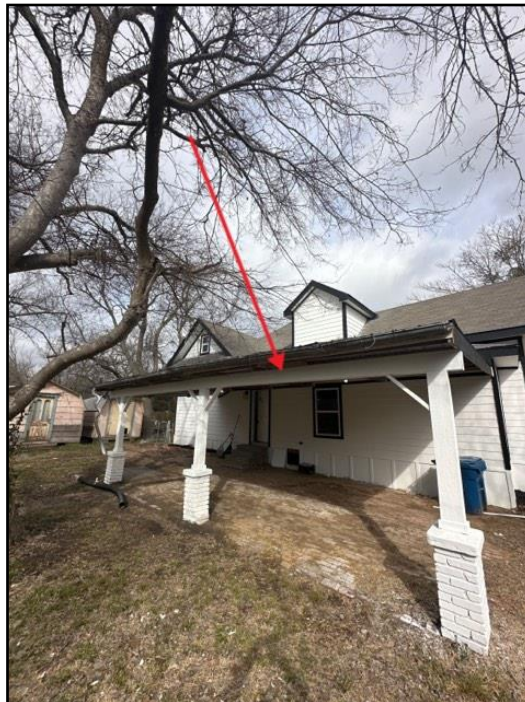
5. Condition: • Damage

17. Damage

Recommend a professional, licensed gutter contractor make repairs

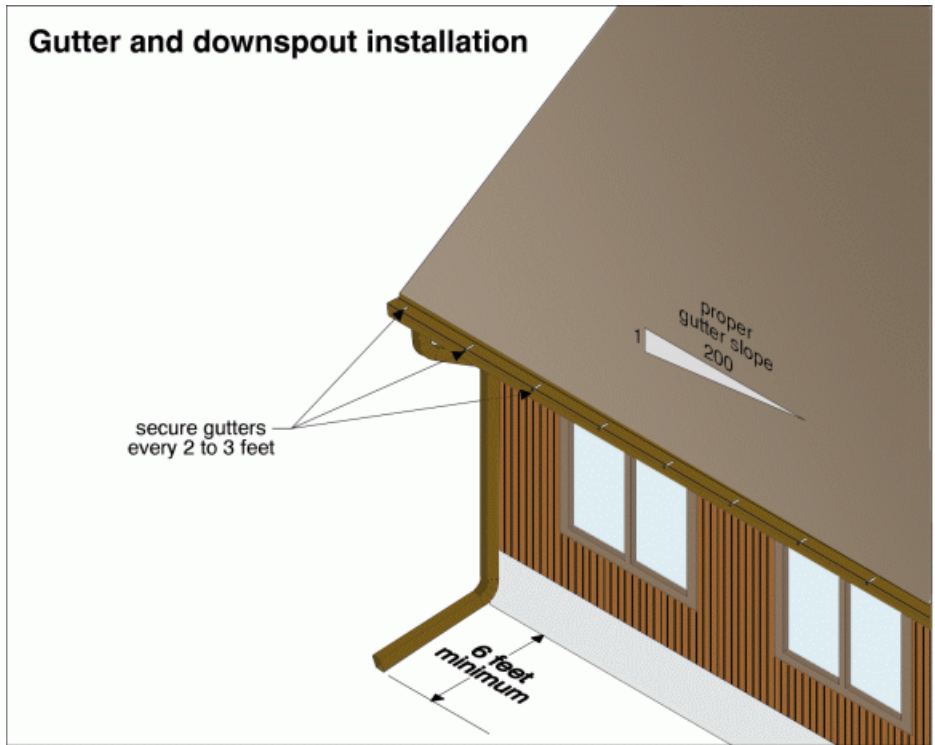
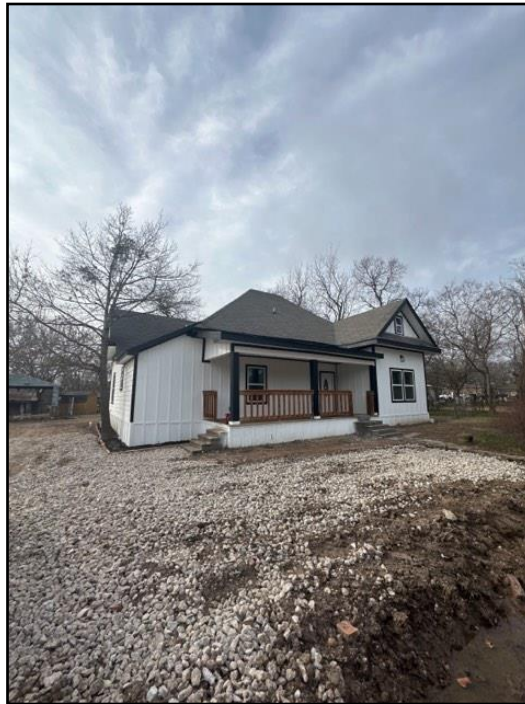
6. Condition: • [Missing](#)

Gutters missing throughout most of the home, gutters are only installed in the rear of the home but are damaged and clogged. Recommend a professional, licensed contractor install gutters and make repairs.

18. Missing

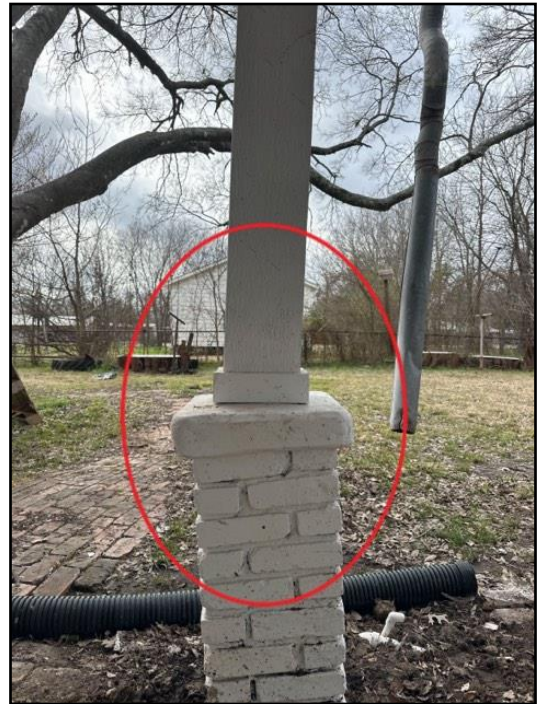
7. Condition: • Poorly built

Rear porch cover is not safely built and the post are leaning and not structurally sound. Additionally, the gutters are damaged and the electrical is unsafe. recommend a professional licensed contractor further evaluate make repairs

20. Poorly built

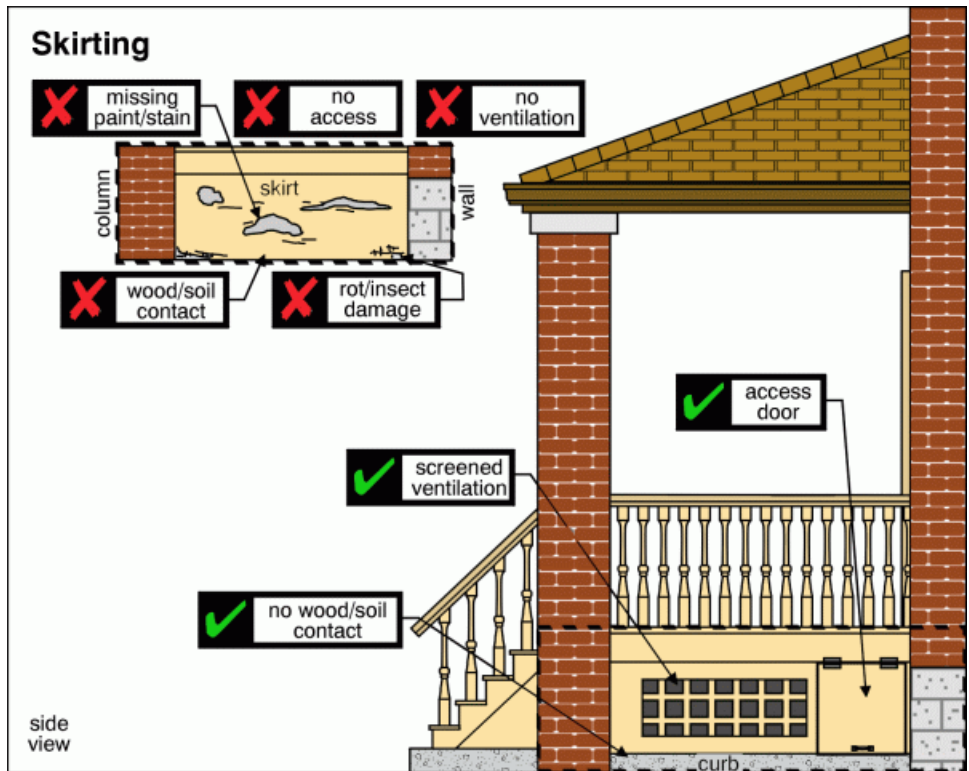
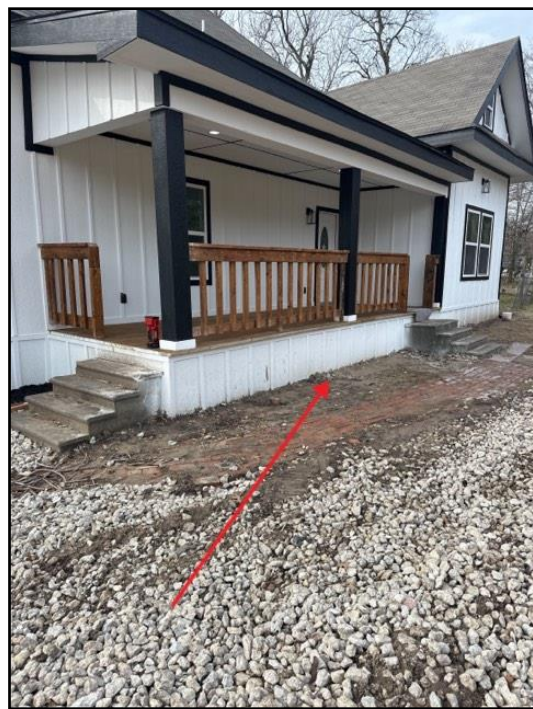
8. Condition: • [Wood/soil contact](#)

Implication(s): Rot | Insect damage

24. Wood/soil contact

Recommend a licensed professional contractor make repairs

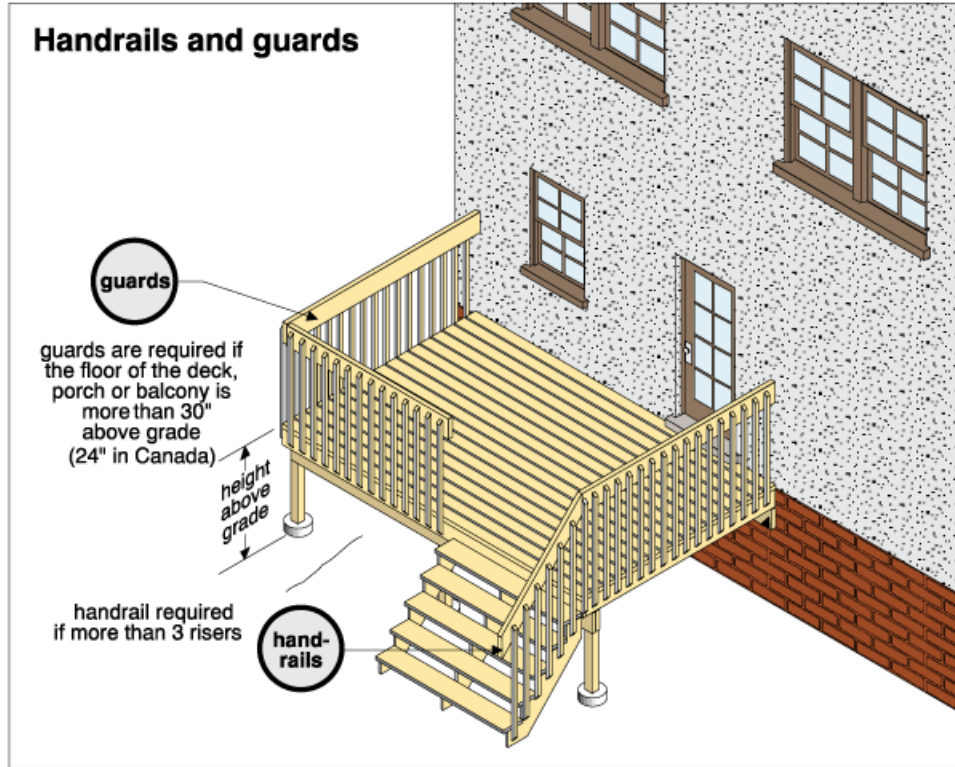
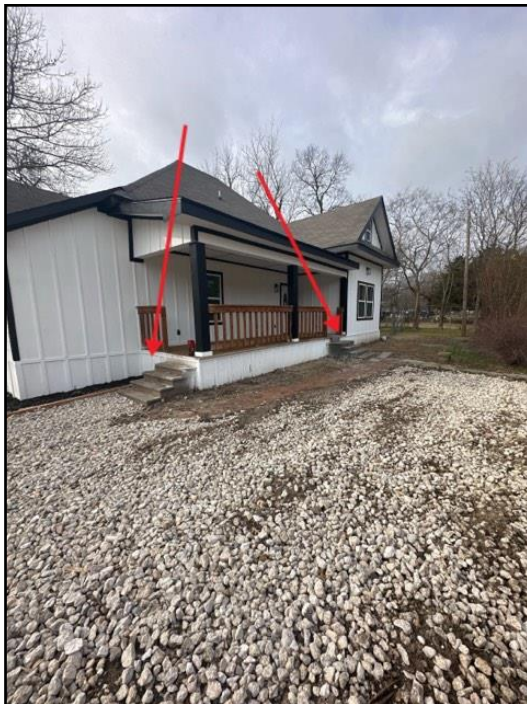
9. Condition: • [Missing](#)

Hand railings missing recommended, professional license, contractor, make repairs

25. Missing

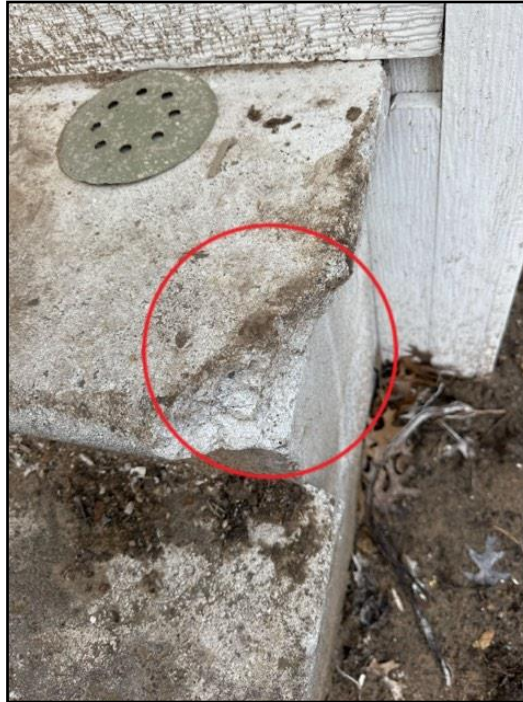
27.

10. Condition: • Stairs has slight damage recommend a professional licensed contractor, make repairs

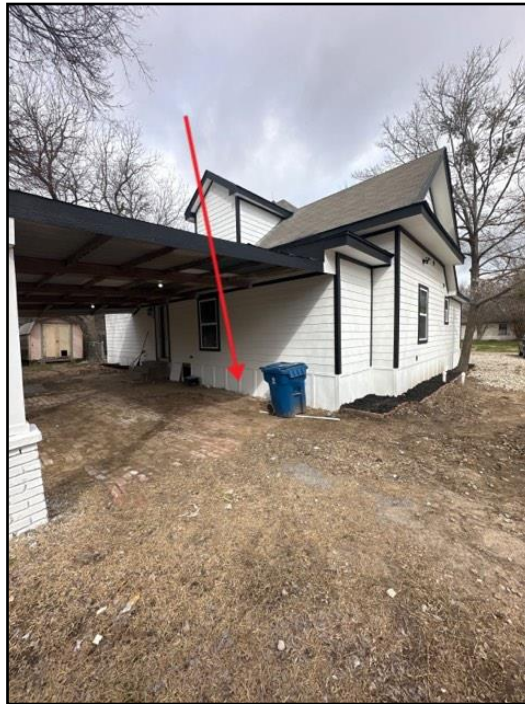
11. Condition: • [Improper slope or drainage](#)

Lot has a slight slope towards the home recommend a professional, licensed drainage, expert further evaluate and make required adjustments or repairs

28. *Improper slope or drainage*

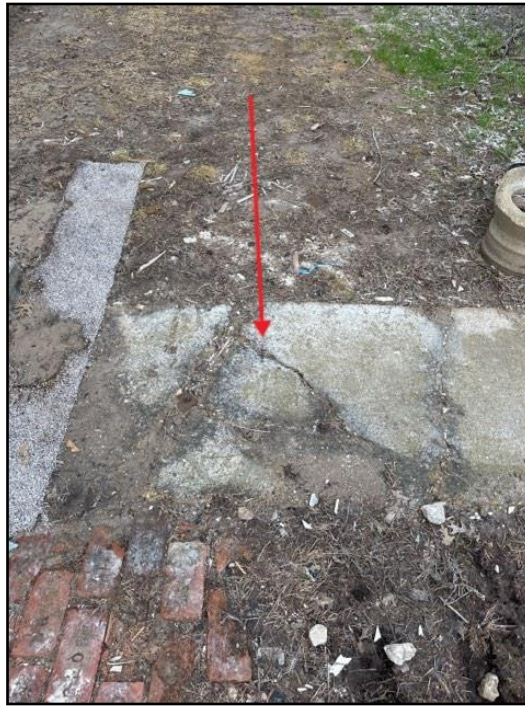
12. **Condition:** • [Cracked or damaged surfaces](#)

Front walk way has cracking recommend a professional licensed contractor make repairs

29. Cracked or damaged surfaces

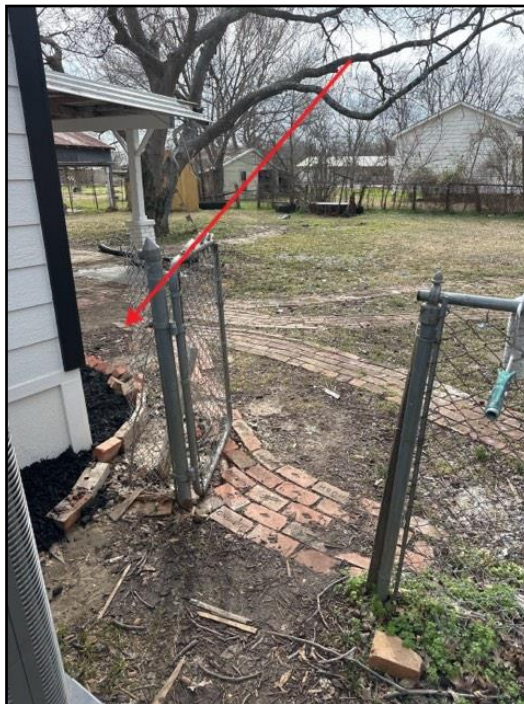
13. Condition: • Damage

Rear gate has several damaged areas that are open recommend a professional license contract and make repairs

30. Damage

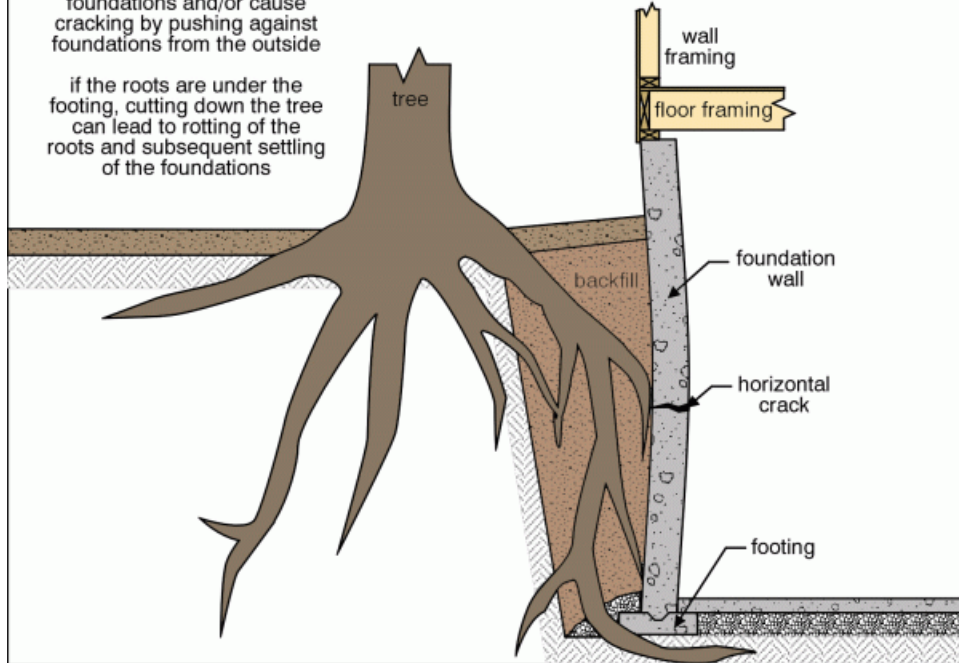
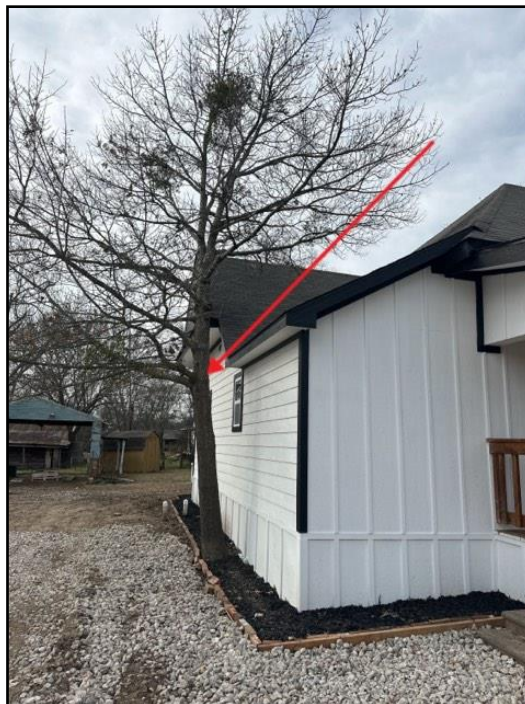
14. Condition: • [Large trees close to building](#)

Large tree close to home. This can present foundation issues as well as roof issues recommend a professional, licensed arborist further evaluate and make repairs.

31. Large trees close to building

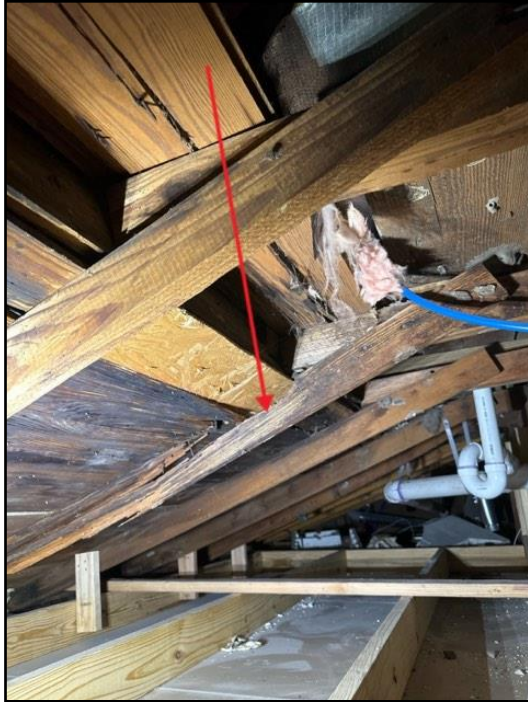
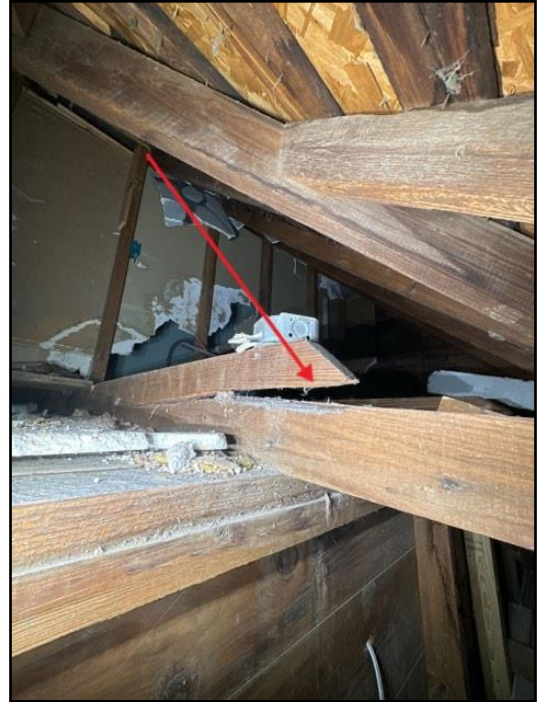
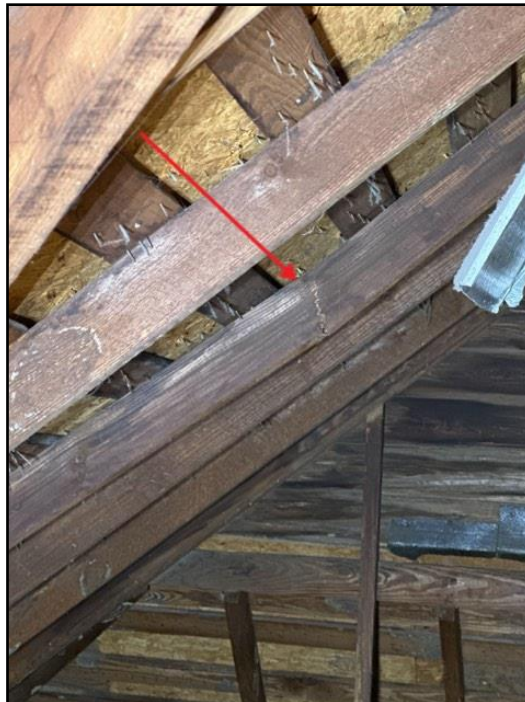
15. Condition: • [Rot, fire or insect damage](#)

Attic rafters and some structural components, have damage. Recommend a professional licensed structural contractor, further evaluate and make repairs

Implication(s): Weakened structure | Chance of structural movement

32. Rot, fire or insect damage

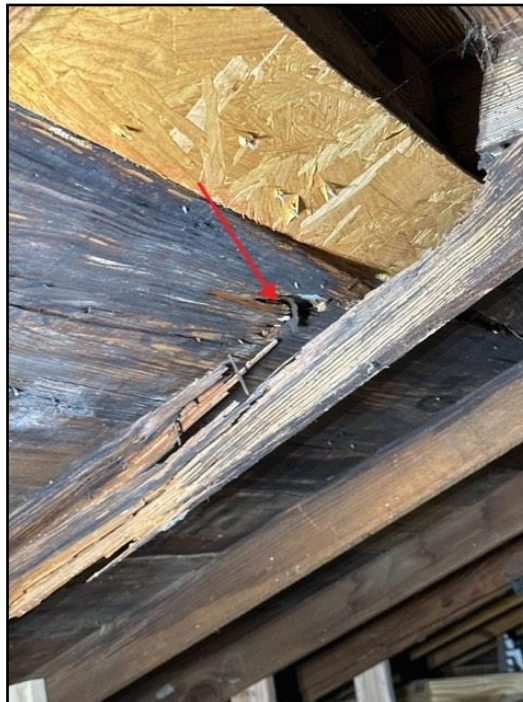
16. Condition: • Damage

Roof sheathing has areas that are damaged recommend a professional licensed structural contractor, further evaluate and make repairs

35. Damage

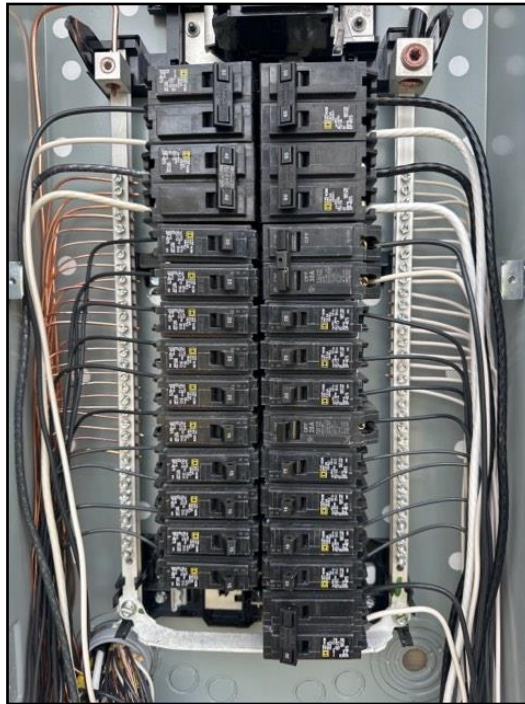
39. No AFCI

Recommend a professional, licensed electrician, install AFCI protection to avoid an electrical fire

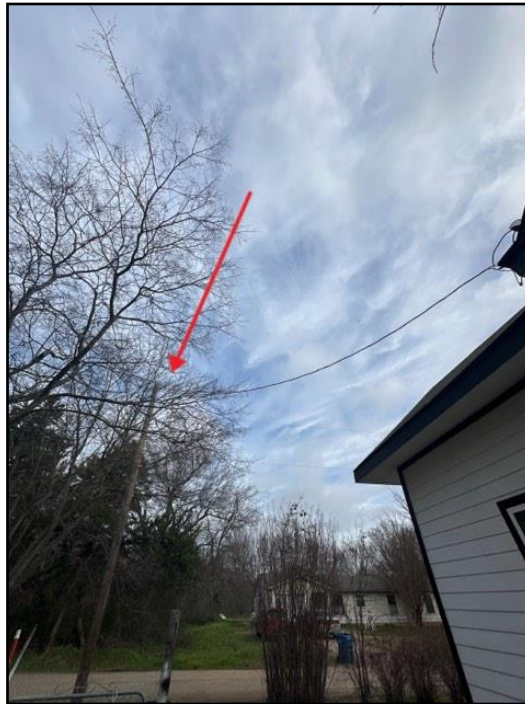
17. Condition: • [Branches / vines interfering with wires](#)

40. Branches / vines interfering with wires

Recommend a professional tree, arborist or utility make repairs

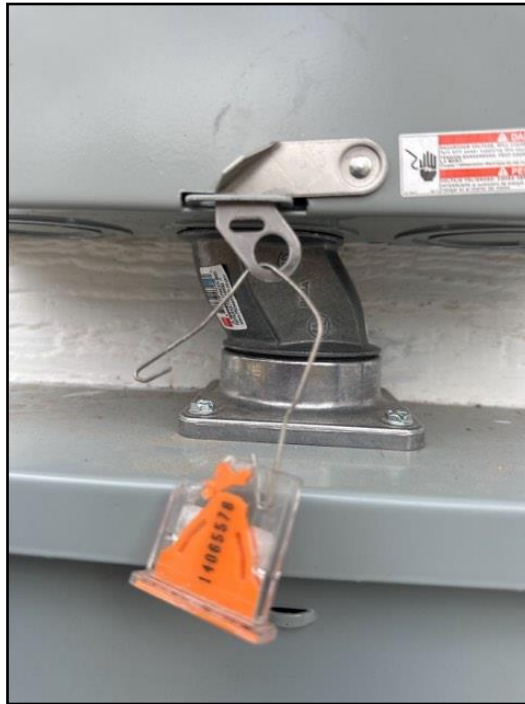
18. Condition: • [Damage](#)

Main electrical meter tamper lock is damaged recommend a professional, licensed utility electrician make repairs

41. Damage

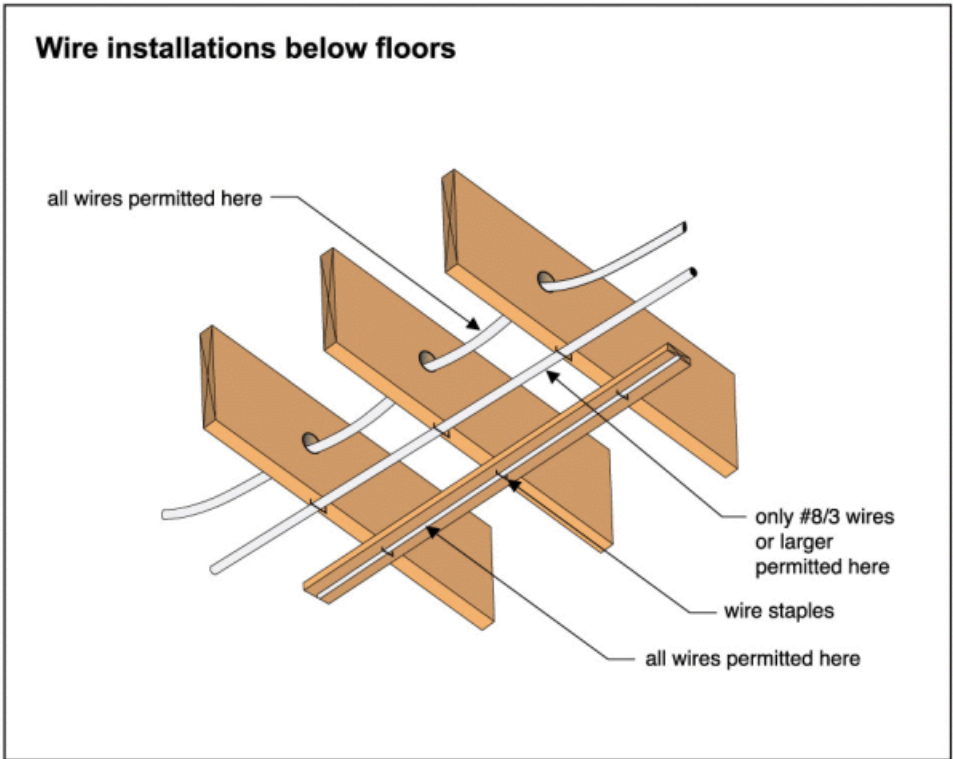
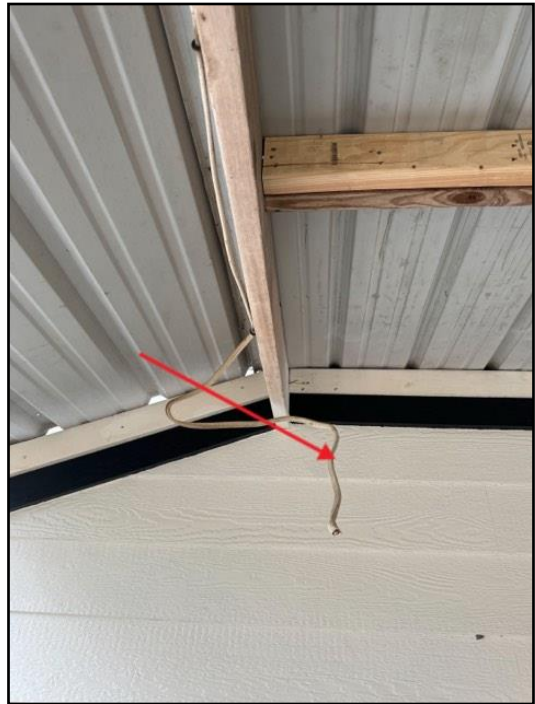
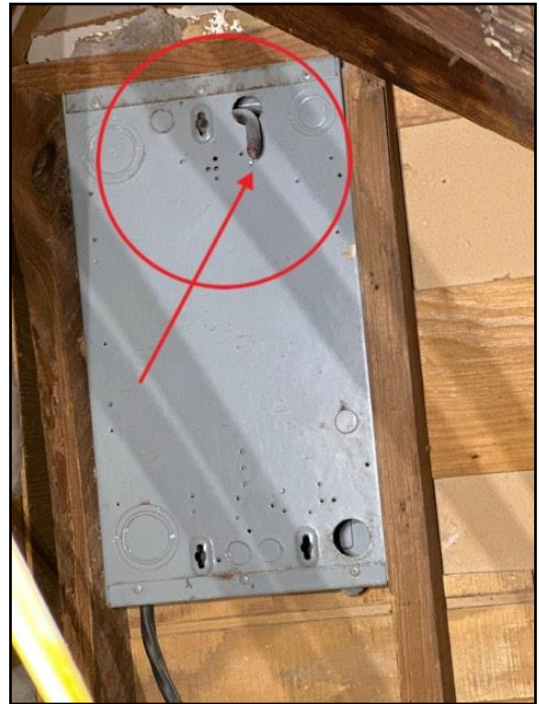
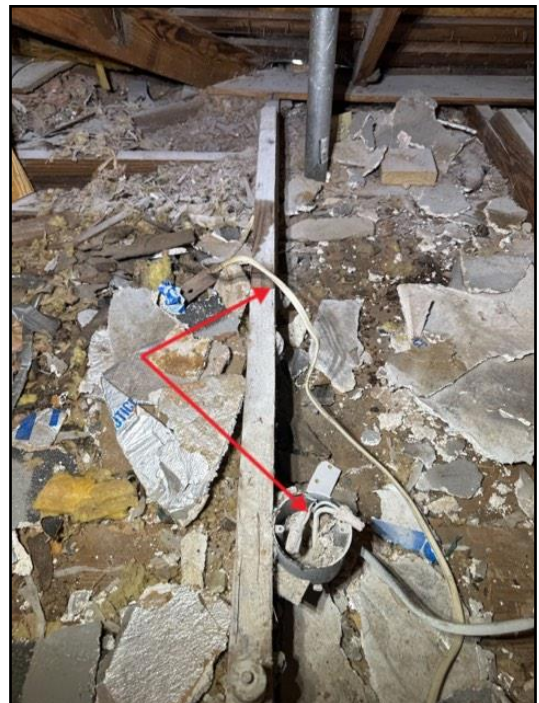
19. Condition: • [Exposed on walls or ceilings](#)

Exposed electrical Romax wiring recommend a professional, licensed electrician make repairs

42. Exposed on walls or ceilings

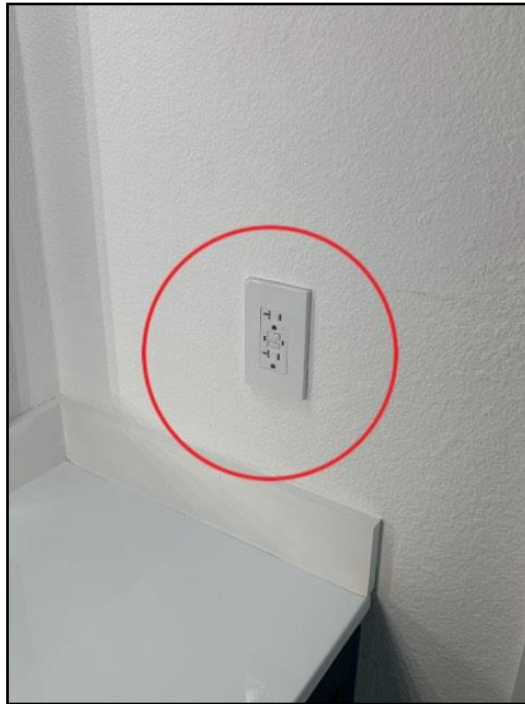
20. Condition: • [Inoperative](#)

GFCI outlet in the master bathroom not functional recommend a professional license electrician make repairs

50. Inoperative

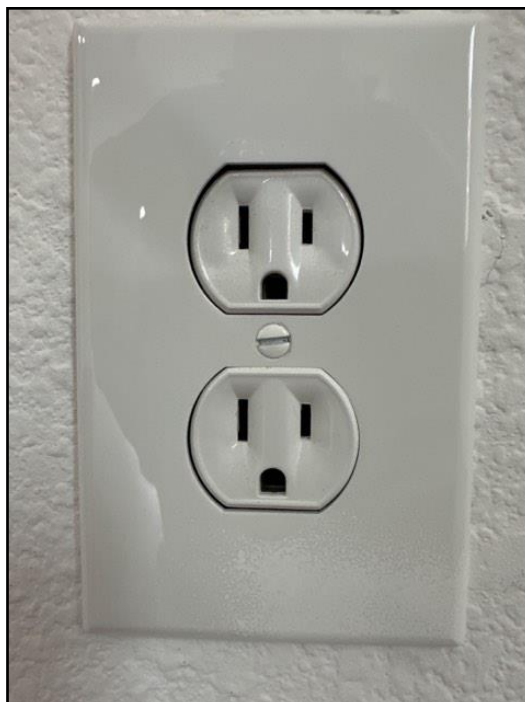
21. Condition: • Receptacle within 5 ½ feet of floor not tamper resistant

51. Receptacle within 5 ½ feet of floor not...

Recommend a professional, licensed electrician, update, plugs or install child safety covers, these type of plugs can present a hazard for children, sticking their fingers or objects into them

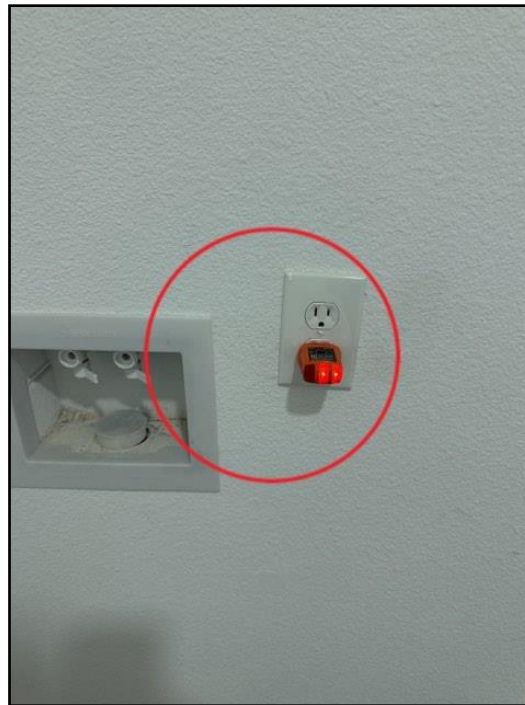
22. Condition: • Laundry area

No GFCI protection in the laundry area. It is recommended by the national electric code, and the Texas real estate commission standards of practice to have GFCI protection in the laundry area. Recommend a professional license electrician make repairs.

52. Laundry area

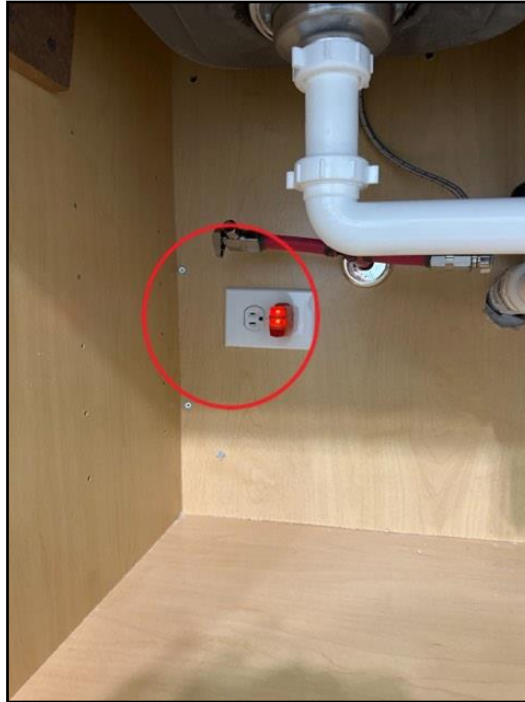
23. Condition: • Dishwasher

Although there is no dishwasher, installed the dishwasher outlet should be GFCI protected recommend a professional license electrician install GFCI protection to avoid electrical shock hazard

53. Dishwasher

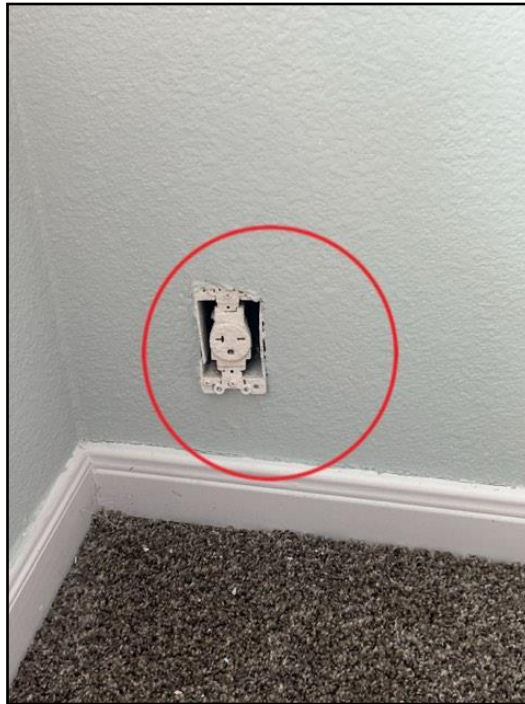
24. Condition: • [Missing](#)

54. Missing

Recommend a professional, licensed electrician, install a cover plate

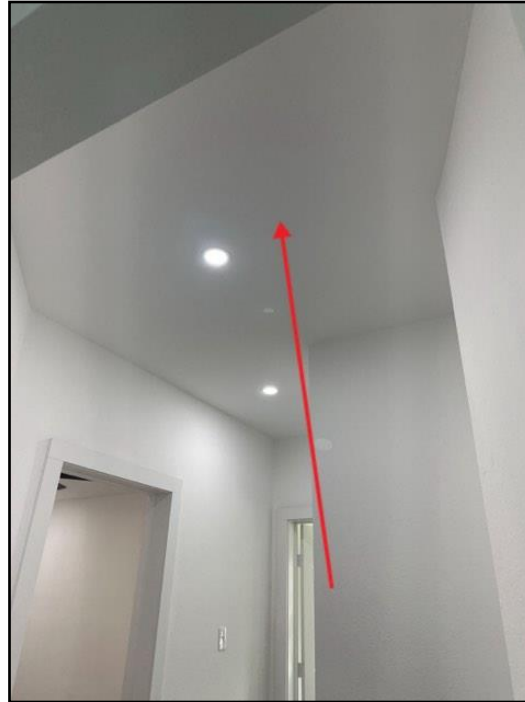
26. Condition: • Missing

No smoke alarm present outside sleeping areas it is recommended to have a smoke alarm outside all sleeping areas and

59. Missing

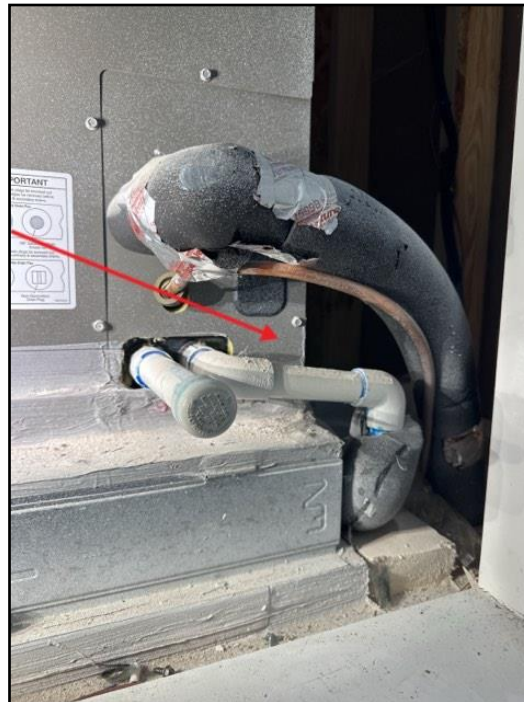
28. Condition: • [No float switch](#)

No condensation float switch for air-conditioning air handler. Recommend a professional licensed, HVAC technician install a float switch for added protection against water damage to your structure.

66. No float switch

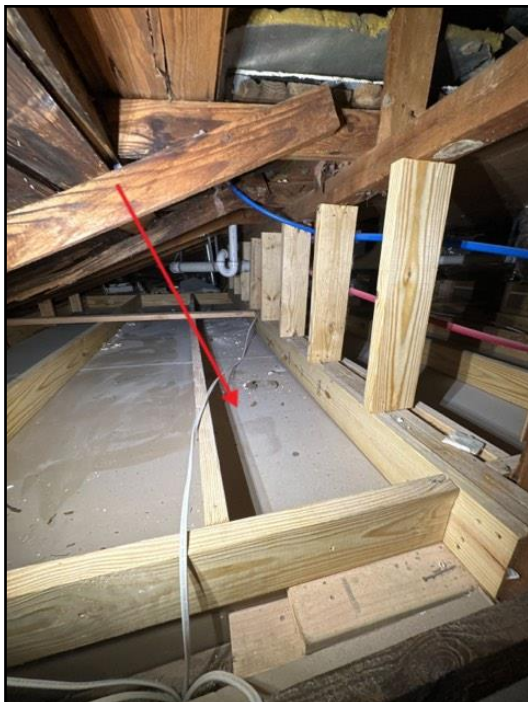
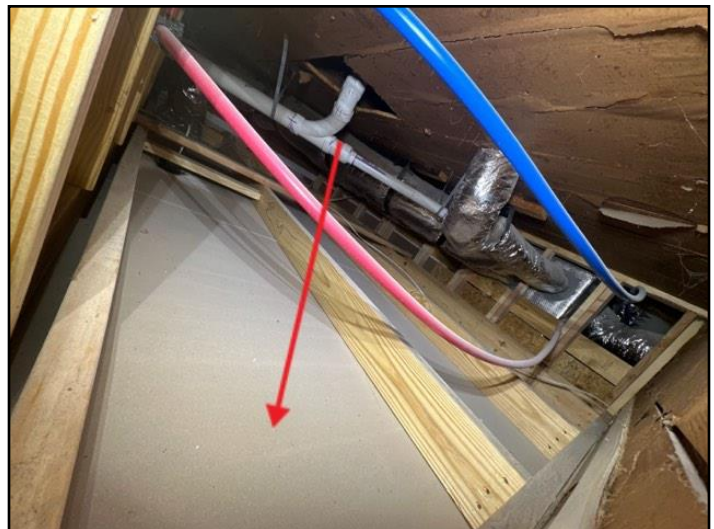
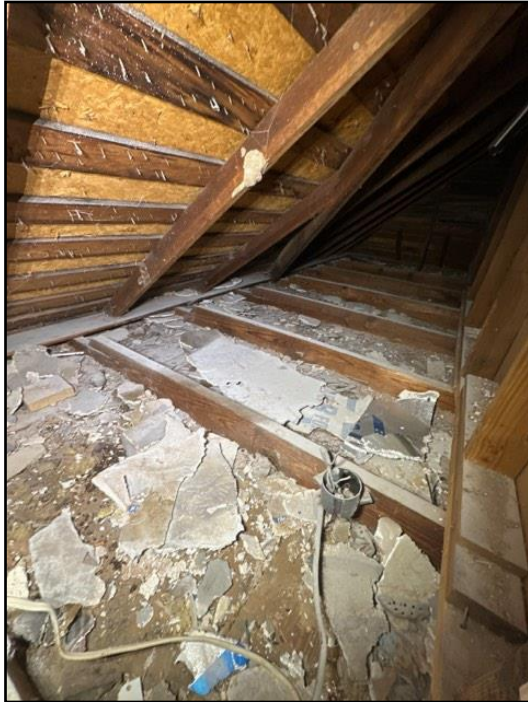
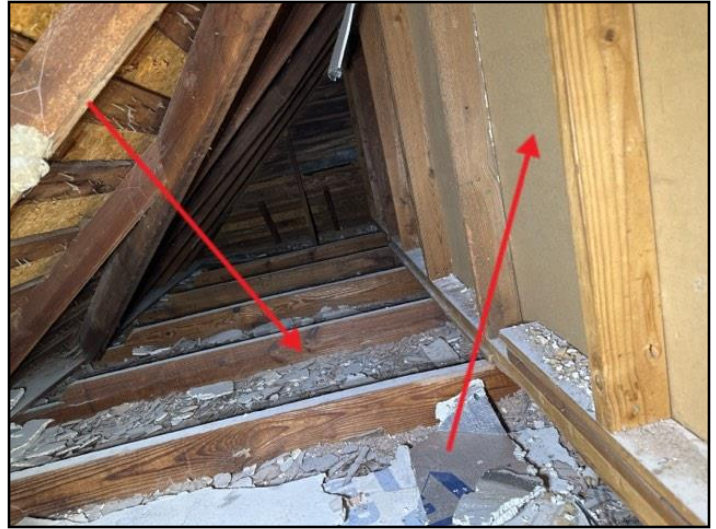
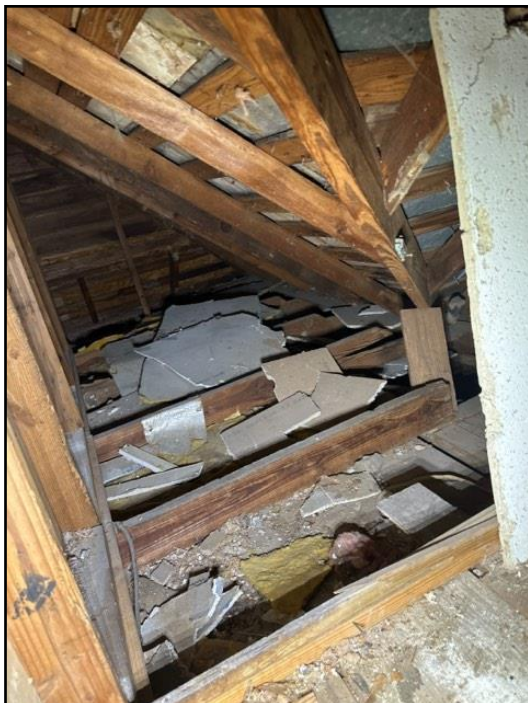
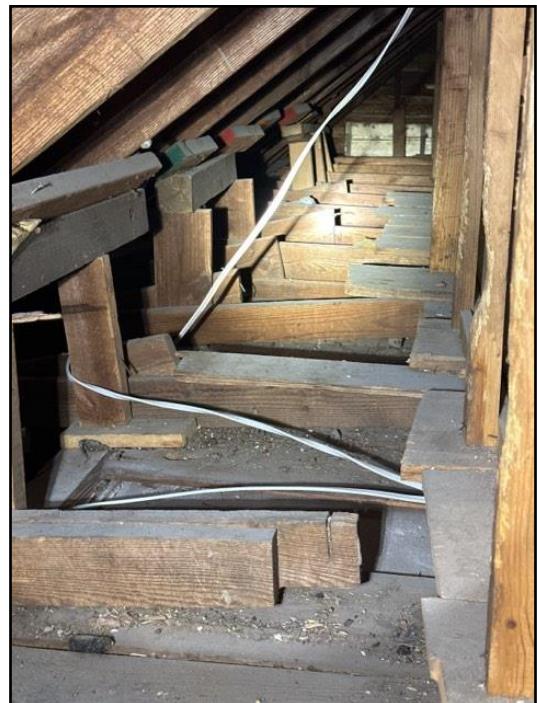
29. Condition: • [Amount inadequate](#)

Missing insulation, recommend a professional, licensed insulation expert make repairs and install the proper amount of insulation

67. Amount inadequate

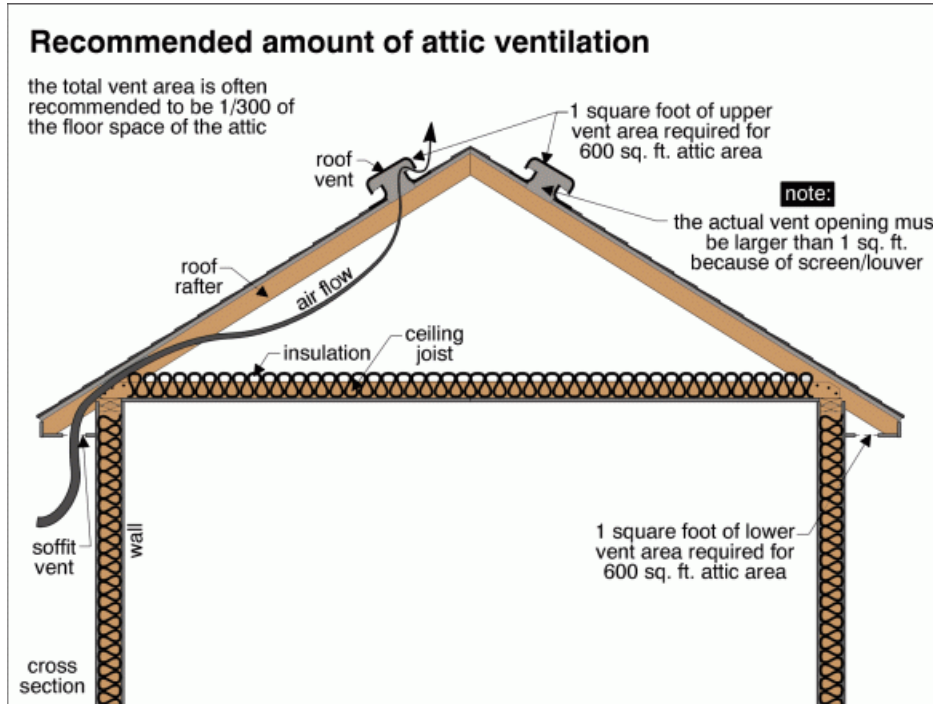
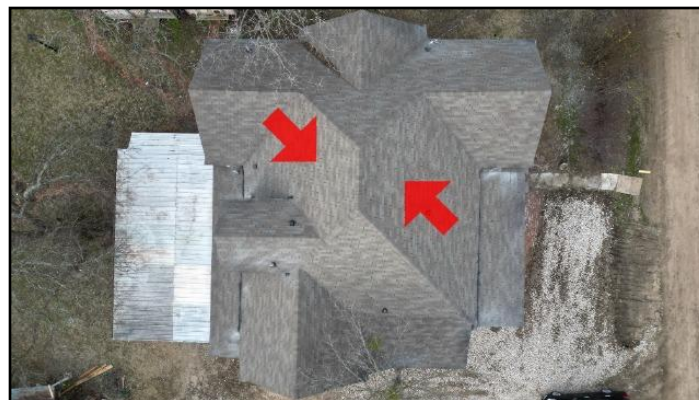
30. Condition: • [Missing](#)

Missing eave and attic ventilation, Recommend a professional licensed HVAC contractor further evaluate and make

73. Missing

required repairs.

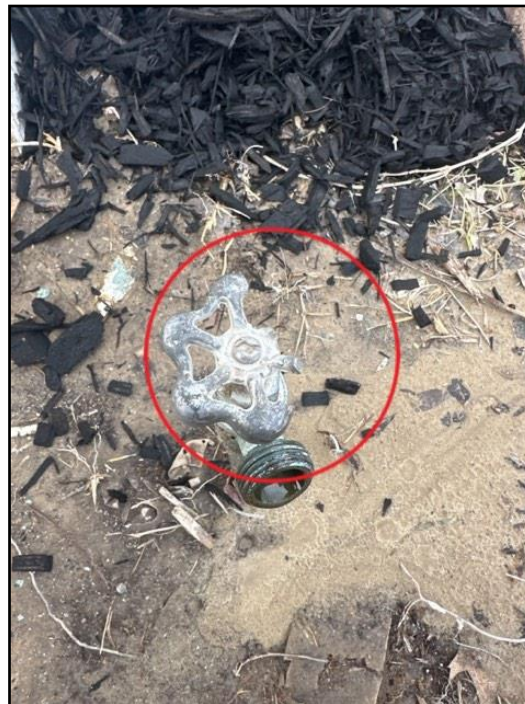
31. Condition: • [Damage](#)

77. Damage

Recommend a professional, licensed plumber make repairs

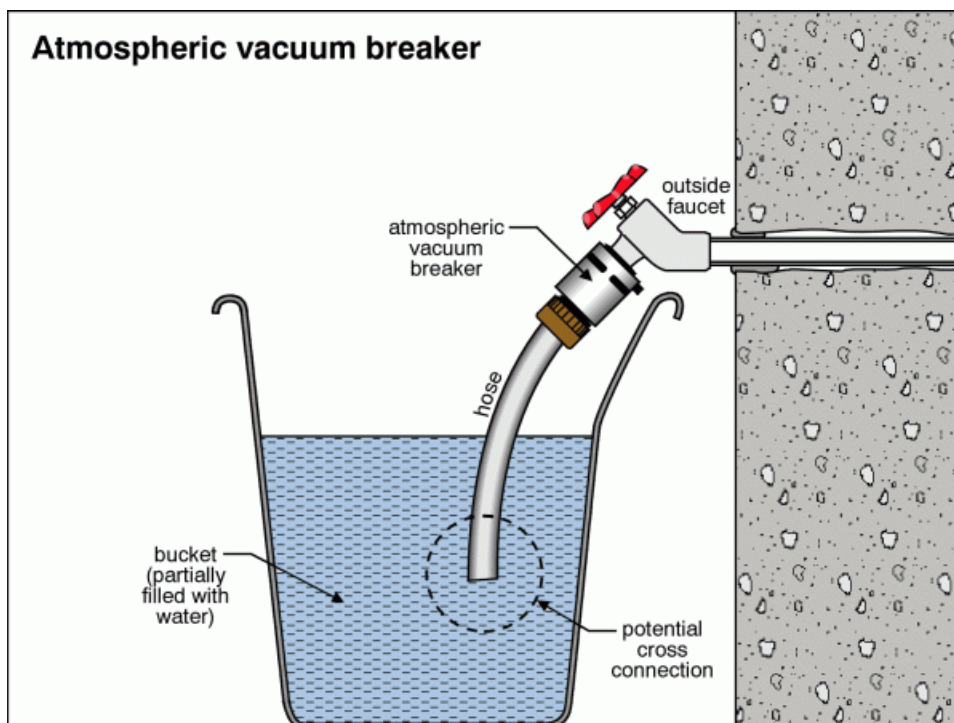
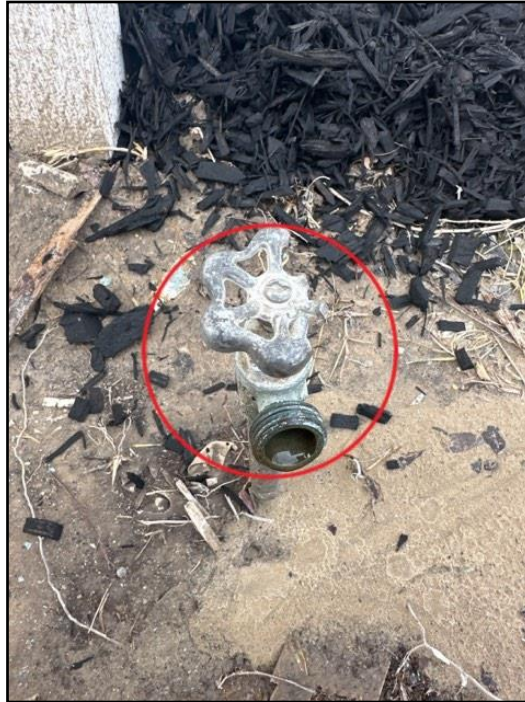
32. Condition: • [Backflow prevention missing](#)

78. Backflow prevention missing

Recommend a professional, licensed plumber, install a hose bib anti-siphon device
