INSPECTION REPORT

For the Property at:
1000 FARM RD
FORNEY, TX 75126

Prepared for: JANE DO
Inspection Date: Thursday, February 8, 2024
Prepared by: Jeffrey Knight, 25885

Knight Home Inspection
10121 Bantry Lane
Forney, TX 75126
214-566-5243

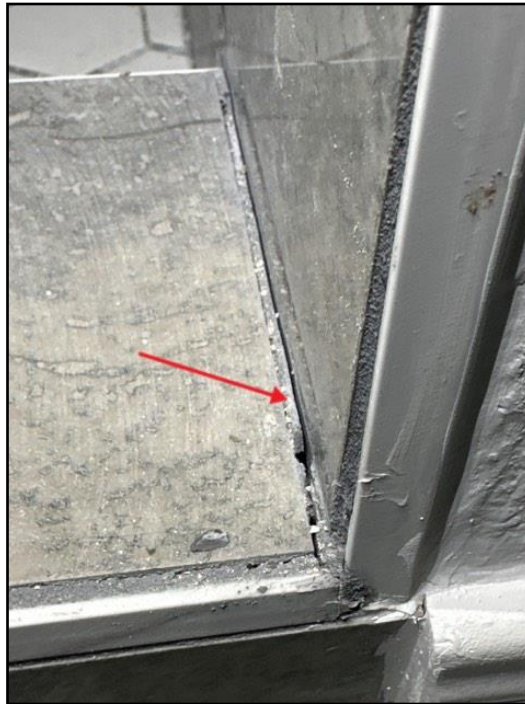
33. Condition: • [Grout loose, missing or deteriorated](#)

79. Grout loose, missing or deteriorated

Recommend a professional licensed contractor make repairs

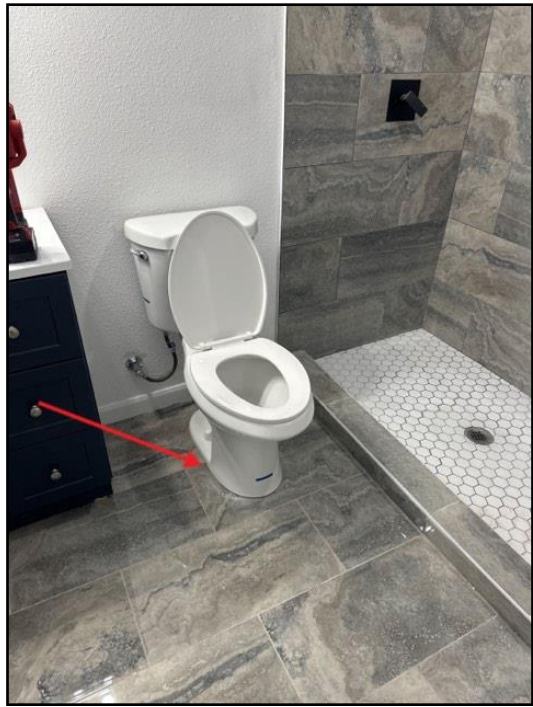
34. Condition: • [Loose](#)

Toilet loose at base, recommend a professional licensed plumber make repairs

80. Loose

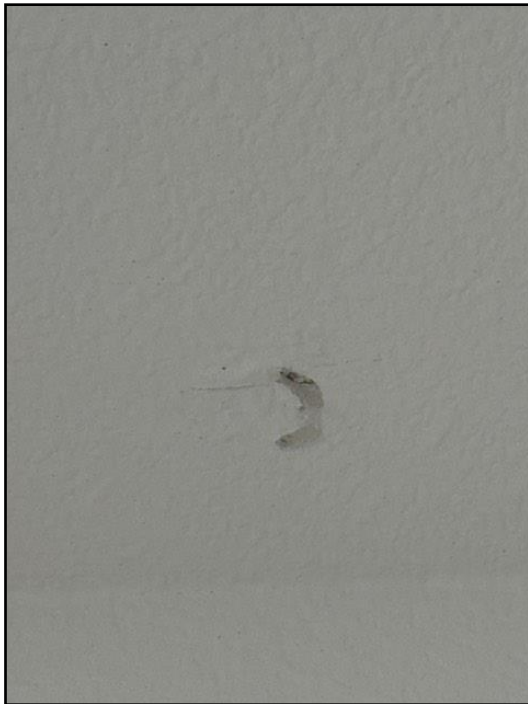
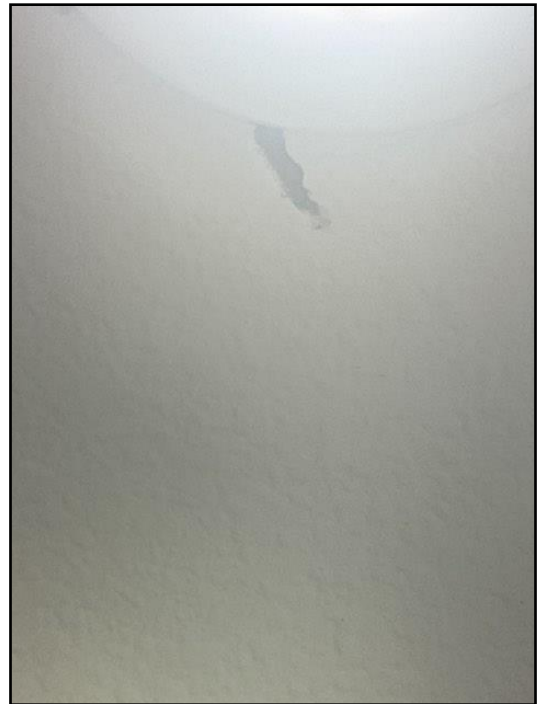
35. Condition: • Typical minor flaws

Some typical minor flaws located throughout the home, overall the interior looks clean and has a nice new paint job recommend touchup repairs

81. Typical minor flaws

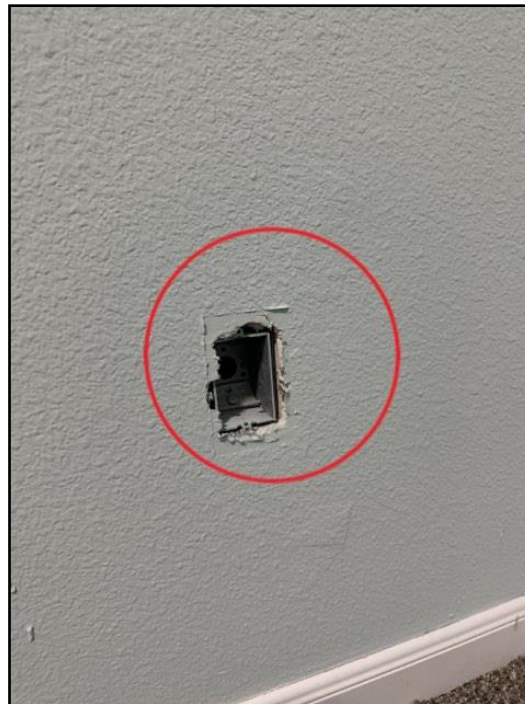
36. Condition: • Damage

84. Damage

Recommend a professional licensed contractor make repairs

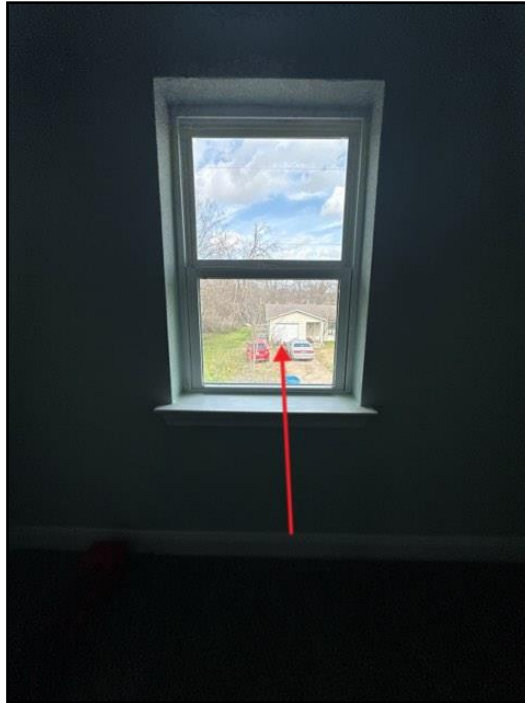
85.

38. **Condition:** • Recommend installing window safety locks due to a potential fall hazard with small children or people

Implication(s): Fall hazard, especially for small children

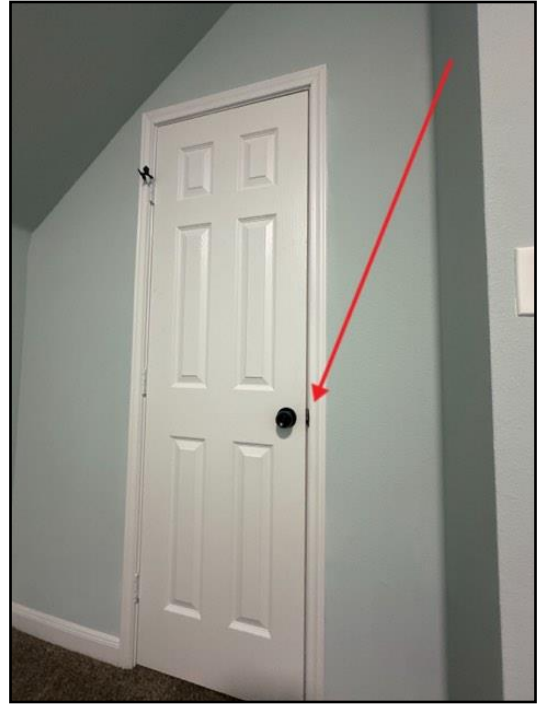
39. **Condition:** • [Inoperable](#)

Doorhandle does not latch recommend repair

87. Inoperable

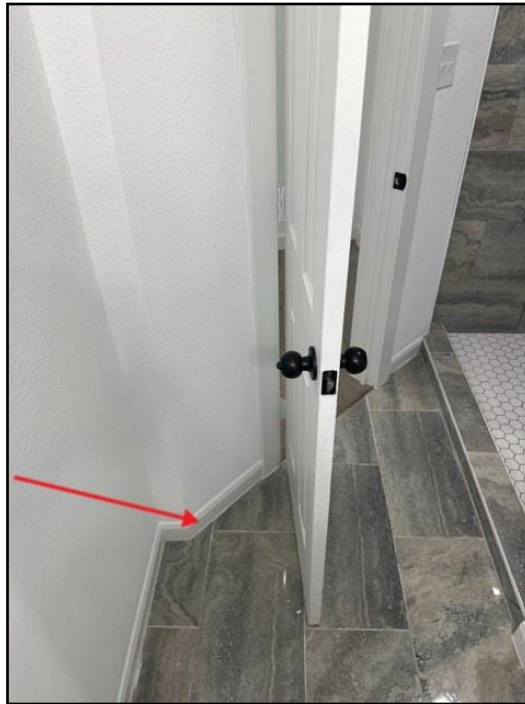
40. Condition: • [Doorstops missing or ineffective](#)

88. Doorstops missing or ineffective

Recommend installing doorstops

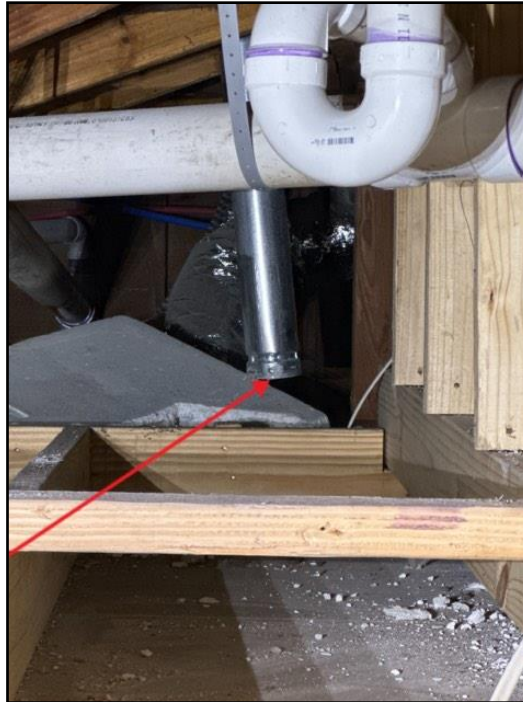
42. Condition: • [Not vented to exterior](#)

90. Not vented to exterior

Recommend a professional licensed contractor, make repairs on exhaust vent

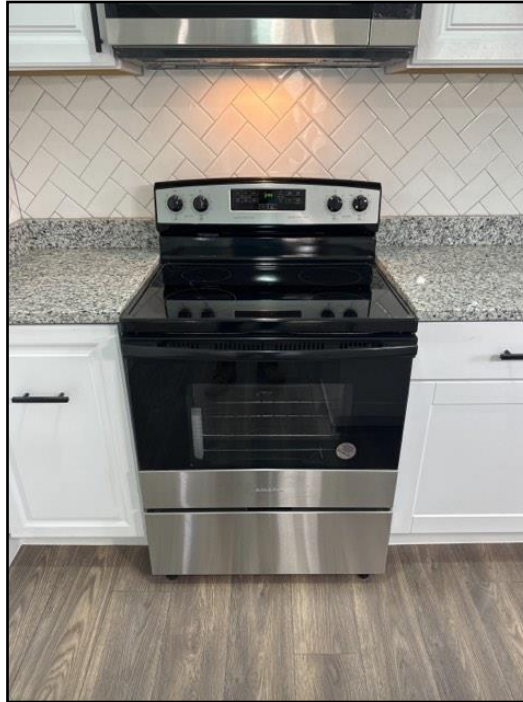
45. Condition: • Anti-tipping device missing

No oven anti-tipping device installed. This can present a hazard when children stand on the oven door and the oven flips over on them, recommend a professional licensed contract to make repairs.

91. *Anti-tipping device missing*
