08 February 2021
Job No. 9762
Serial No. D-3011

Ref: Spillway Area Inspection
Woodland Lake Dam
Eudora, Mississippi

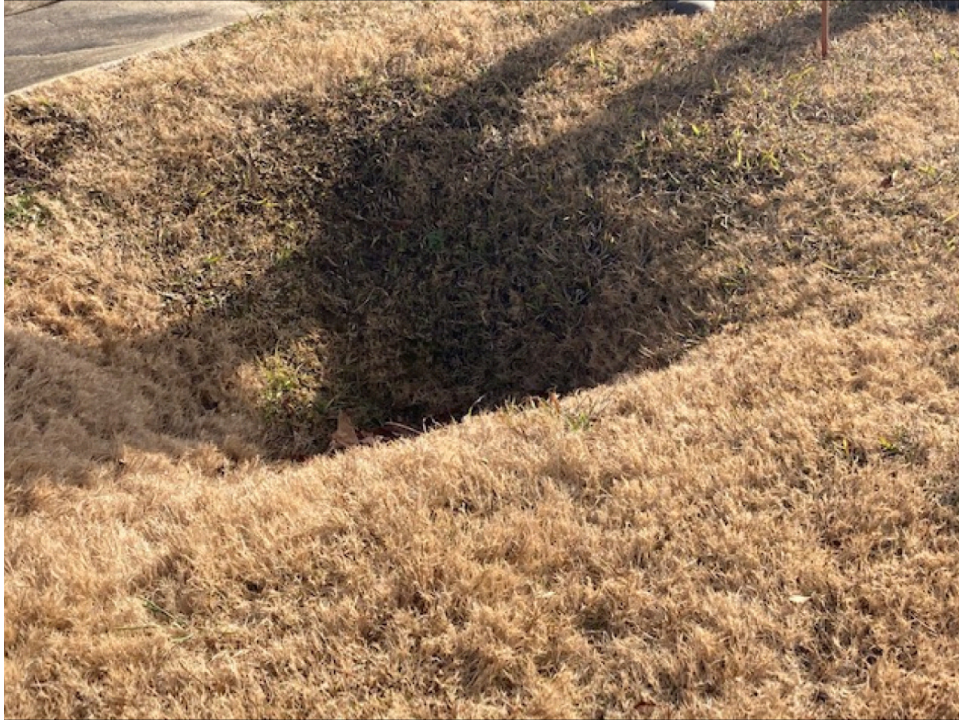
1. Inspection of the sink hole revealed that the sod that previously covered the area had fallen into the hole, indicating that sink hole formation was likely caused by subsurface erosion. In many cases, such erosion occurs over an extended period of time and is not noticed until the surface falls into the hole. See Photo #1.

Photo #1: Sink Hole South of Upper End of Spillway, 04 January 2021

At this time, it is recommended that the depressions/holes described in Items 1, 2, and 3 above, be filled with bentonite clay, in either granular or chip form, up to a depth of about six inches, after first removing any remaining remnants of sod or other organic materials that may be encountered. Tamped silty clay should be placed over the bentonite up to the previous surface levels, and new sod should be placed over the silty clay. This must be considered a temporary solution, unless the recommended inspection deems it otherwise.

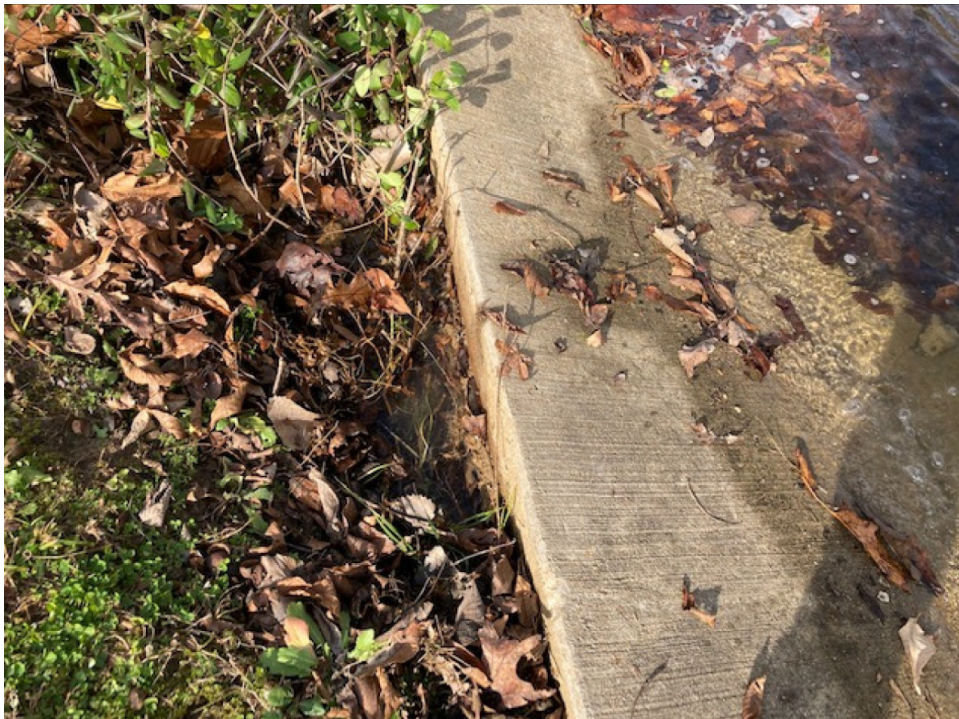
4. Another larger depression was noted near the lower (west) end of the spillway, just east of the downstream end sill. Moving water of unknown source was noted in this depression. See Photo #2, which shows a small portion of this depression.

Photo #2: Depression Near Lower End of Spillway, 04 January 2021

It is recommended that a more thorough inspection be performed during a dry season at a time during which flow over the spillway weir has not been noted for at least several days.
