# HomInspect - home inspection services

## \*\*\* Residential Inspection Report \*\*\*

December 23, 2019

1122 15th St  
Your Town, USA

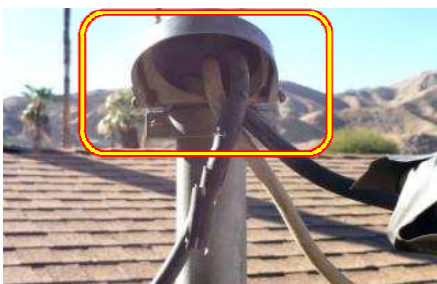
- The masthead insulator grommet was damaged/missing where the main overhead service entrance conductors (SEC) enter masthead. Recommend further evaluation by a qualified electrical contractor and corrective repair as necessary.
- There were neutral (white) wires doubled or bundled together under the same lug (screw), this condition could cause loose connections and overheating. Neutrals should always have a single connection (Unless the manufacturer states otherwise, bus bars are only designed for one current carrying conductor per terminating lug). Recommend further evaluation by a qualified electrical contractor and corrective repair in accordance with accepted practice is recommended.

Masthead insulator grommet was damaged/missing

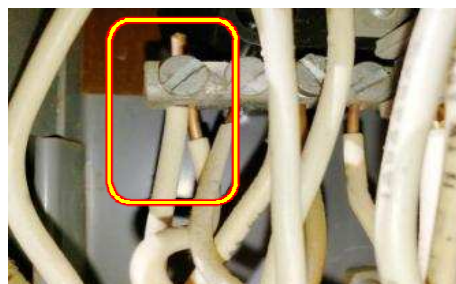
Neutral (white) wires were doubled or bundled together

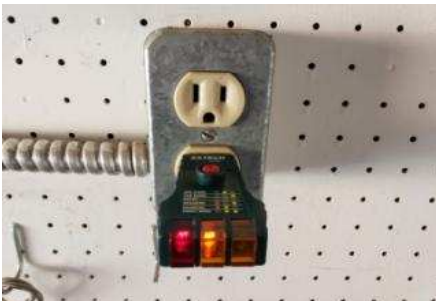
- There were outlets in garage next to the work bench that tested with reverse polarity. This happens when the hot live wire (black or red wire) and neutral wires (white wire) get flipped around at an outlet or switch. Reversed polarity creates a potential shock hazard. Recommend further evaluation and corrective repair in accordance with accepted practice.
- GFCI electrical outlet in the master bath did not respond correctly when tested and should be repaired or replaced as necessary for safe and proper function. A GFCI outlet also known as "Ground fault circuit interrupter device" is to add additional protection against electrical shock or electrocution. It's designed to detect very low levels of electrical current leaks (ground faults), and acts quickly to shut off power, preventing serious shock.

Reversed polarity outlet in garage

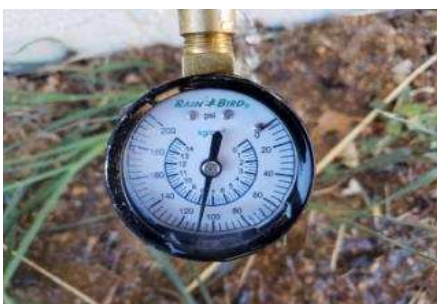
The home water supply pressure exceeded the 80 psi limit considered the maximum allowable by generally-accepted current standards (water pressure tested at 105-115 psi). Excessively high water pressure is likely to cause leaks if not corrected. Recommend a qualified plumbing contractor for corrective action.

Water pressure tested to high

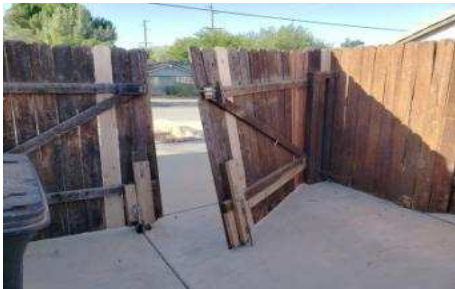
**Further Comments:** There was some weathering and damage to the wood fencing and gate that should be repaired as necessary as part of routine maintenance.

Weathered/damaged gate

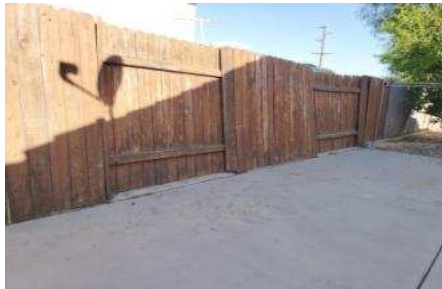
Loose/damaged fencing

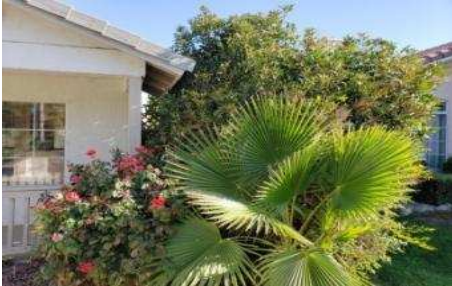
Clear away vegetation as needed

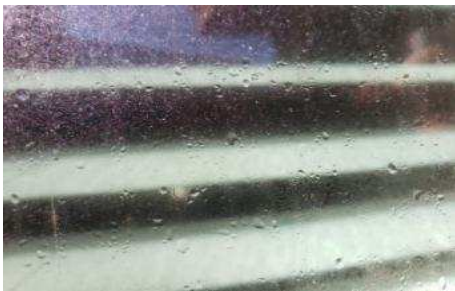
- At time of the inspection there were one or more windows observed with a staining and condensation between the window glass panes. This condition typically indicates a failed seal. Recommend further evaluation from a qualified window specialist and serviced according to their recommendations. Locations observed were family room and the master bedroom.
- There were hung type windows that will need service as the balancers have come out of the window assembly. Balancers are the spring type mechanisms that are a necessary component to assist in the operation of vertical or hung type windows. Locations observed were dining room and family room.

Moisture between glass panes

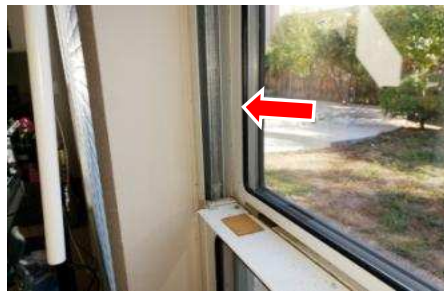
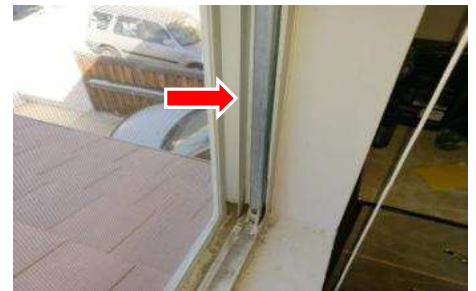
Window balancers were damaged

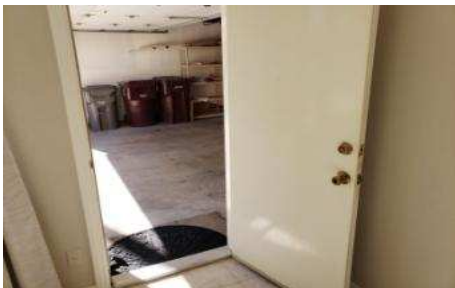
**Further Comments:** The garage service door entry to home was not operating as designed. It is a fire door that is designed to close and latch automatically from a fully open position to serve as a protective barrier in the event of a fire. Recommend corrective repair as necessary.

Fire door closure was inoperable

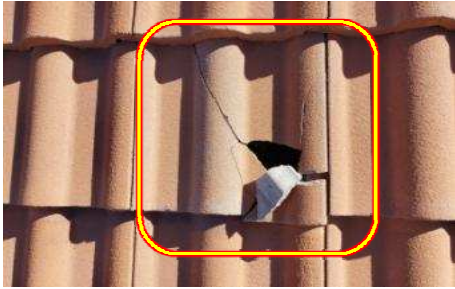
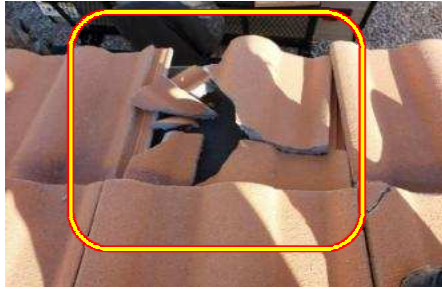
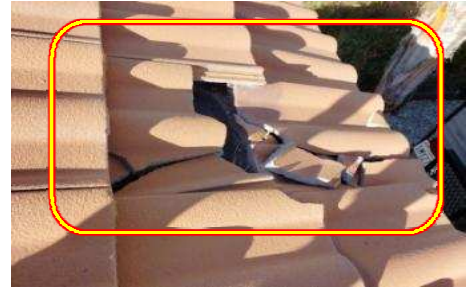
**Further Comments:** There were damaged and displaced roofing tiles observed on the roof structure at time of the inspection. Recommend further evaluation and corrective repair or replacement as necessary from a qualified roofing contractor.

Damaged/displaced roofing tiles

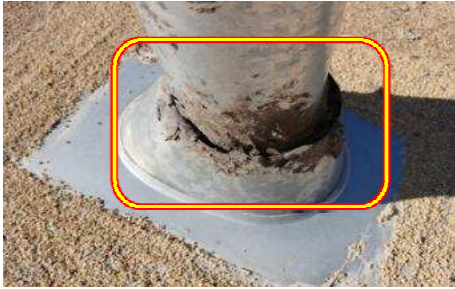
**Further Comments:** The sealant/caulking around flashing, vents and valley areas were showing signs of deterioration or was missing. Recommend further evaluation and corrective repair such as re-sealing/caulking as necessary.

Weathered/missing sealant

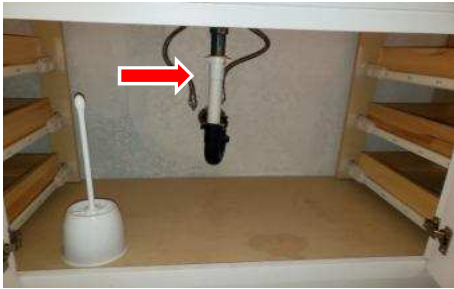
**Further Comments:** There was a water leak at the master bath sink drain line. Recommend corrective repair as necessary

Water leak at sink drain

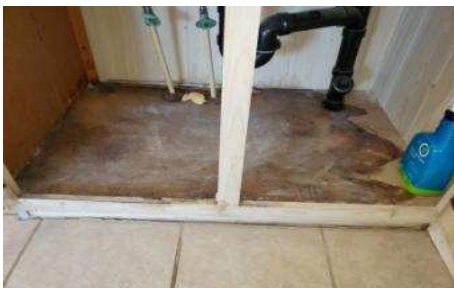
**Further Comments:** There were stained and discolored areas inside the kitchen cabinet. This condition typically indicates a moisture caused problem. The source of moisture should be identified and the condition corrected. Recommend further evaluation and corrective repair as necessary.

Stain and discoloration inside cabinet

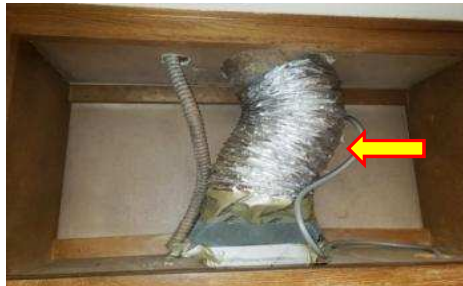
The exhaust vent ducting in the overhead cabinet was using a soft flex ducting. This type of ducting is improper for this type of application and should be a rigid ducting that is designed for this type of use. Recommend corrective repair as necessary in accordance with the manufactures installation instructions.

Improper exhaust vent ducting

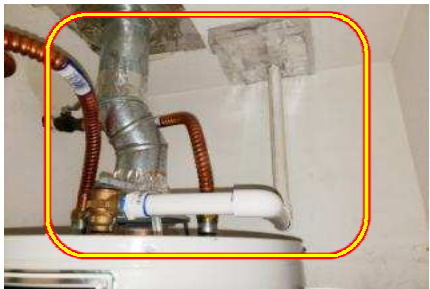
- The water heater TPR (temperature pressure relief valve) discharge pipe has a positive slope or runs uphill. This condition can cause water to be trapped in the discharge pipe and could cause the TPR valve to fail. This TPR valve is a very important safety device. Also noted the TPR piping material (PVC) used was improper. Recommend corrective repair as necessary to properly configure the discharge pipe that meets current standards.
- It is recommended in accordance with current standards to install a drain pan below the water heater to protect against potential water leakage and damage concerns.

TPR pipe improper/runs uphill

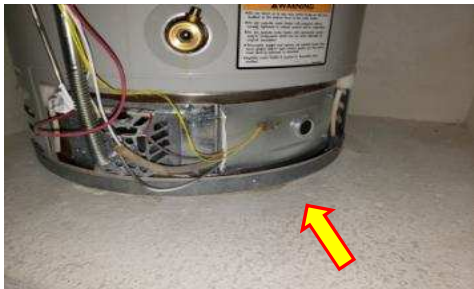
Missing drain pan

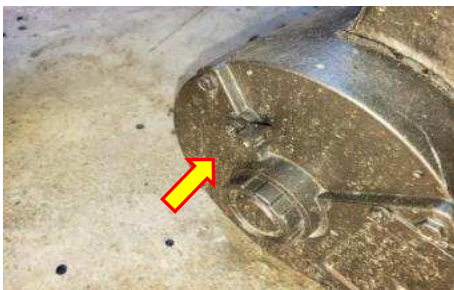
**Further Comments:** The pool equipment (pump) does not appear to be properly bonded. Metal parts of electrical equipment associated with the pool water circulating system should be properly bonded to the equipotential bonding grid in accordance with equipment instructions. Recommend a qualified pool contractor to evaluate and any corrective action that may be needed.

Bonding wire was missing
