# HomInspect - home inspection services

## \*\*\* Residential Inspection Report \*\*\*

December 23, 2019

1122 15th St  
Your Town, USA

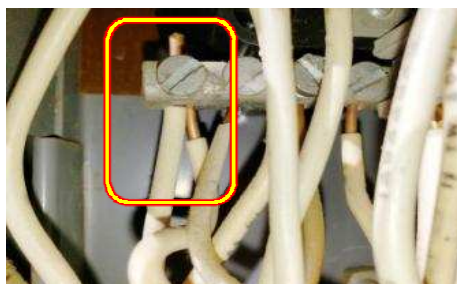
- The masthead insulator grommet was damaged/missing where the main overhead service entrance conductors (SEC) enter masthead. Recommend further evaluation by a qualified electrical contractor and corrective repair as necessary.
- There were neutral (white) wires doubled or bundled together under the same lug (screw), this condition could cause loose connections and overheating. Neutrals should always have a single connection (Unless the manufacturer states otherwise, bus bars are only designed for one current carrying conductor per terminating lug). Recommend further evaluation by a qualified electrical contractor and corrective repair in accordance with accepted practice is recommended.

Masthead insulator grommet was damaged/missing

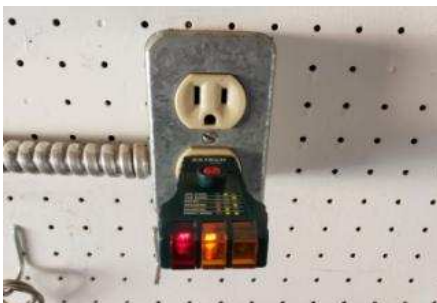
- There were outlets in garage next to the work bench that tested with reverse polarity. This happens when the hot live wire (black or red wire) and neutral wires (white wire) get flipped around at an outlet or switch. Reversed polarity creates a potential shock hazard. Recommend further evaluation and corrective repair in accordance with accepted practice.
- GFCI electrical outlet in the master bath did not respond correctly when tested and should be repaired or replaced as necessary for safe and proper function. A GFCI outlet also known as "Ground fault circuit interrupter device" is to add additional protection against electrical shock or electrocution. It's designed to detect very low levels of electrical current leaks (ground faults), and acts quickly to shut off power, preventing serious shock.

Reversed polarity outlet in garage

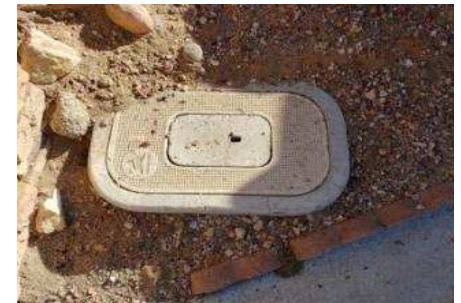
The home water supply pressure exceeded the 80 psi limit considered the maximum allowable by generally-accepted current standards (water pressure tested at 105-115 psi). Excessively high water pressure is likely to cause leaks if not corrected. Recommend a qualified plumbing contractor for corrective action.

Water pressure tested to high

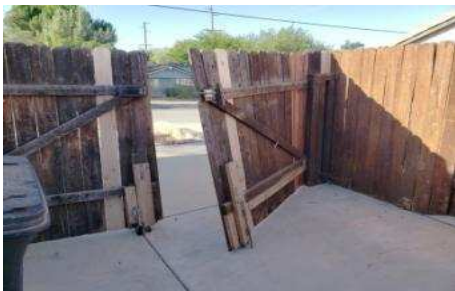
**Further Comments:** There was some weathering and damage to the wood fencing and gate that should be repaired as necessary as part of routine maintenance.

Weathered/damaged gate

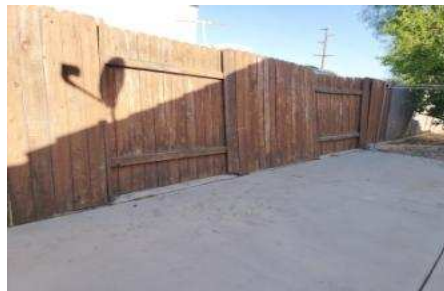
Loose/damaged fencing

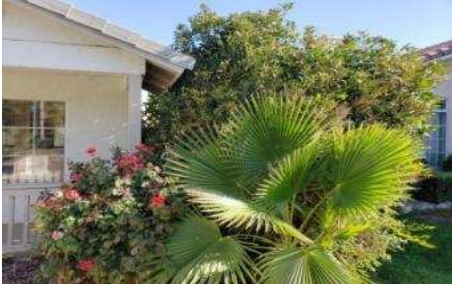
Clear away vegetation as needed

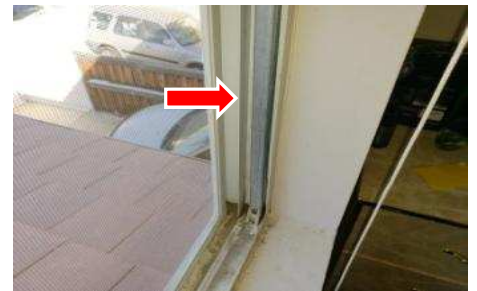
Window balancers were damaged

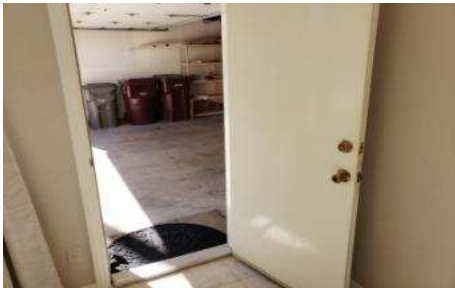
**Further Comments:** The garage service door entry to home was not operating as designed. It is a fire door that is designed to close and latch automatically from a fully open position to serve as a protective barrier in the event of a fire. Recommend corrective repair as necessary.

Fire door closure was inoperable

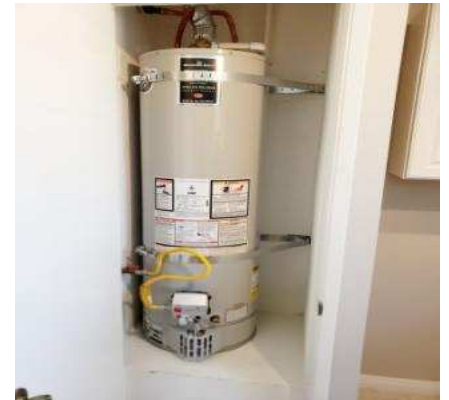
- The water heater TPR (temperature pressure relief valve) discharge pipe has a positive slope or runs uphill. This condition can cause water to be trapped in the discharge pipe and could cause the TPR valve to fail. This TPR valve is a very important safety device. Also noted the TPR piping material (PVC) used was improper. Recommend corrective repair as necessary to properly configure the discharge pipe that meets current standards.
- It is recommended in accordance with current standards to install a drain pan below the water heater to protect against potential water leakage and damage concerns.

TPR pipe improper/runs uphill

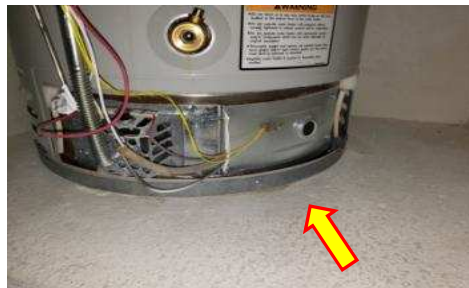
Missing drain pan

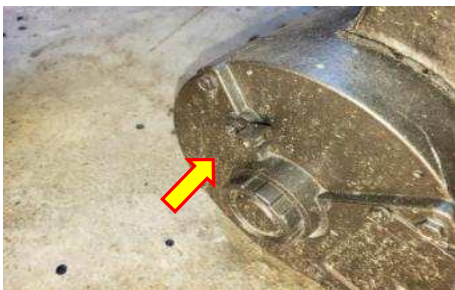
**Further Comments:** The pool equipment (pump) does not appear to be properly bonded. Metal parts of electrical equipment associated with the pool water circulating system should be properly bonded to the equipotential bonding grid in accordance with equipment instructions. Recommend a qualified pool contractor to evaluate and any corrective action that may be needed.

Bonding wire was missing

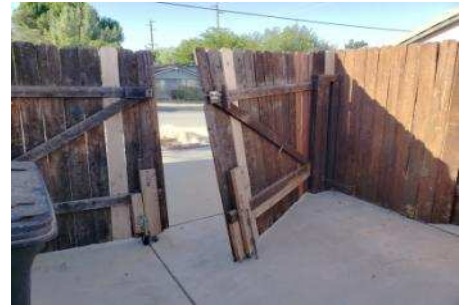
Damaged wood gate

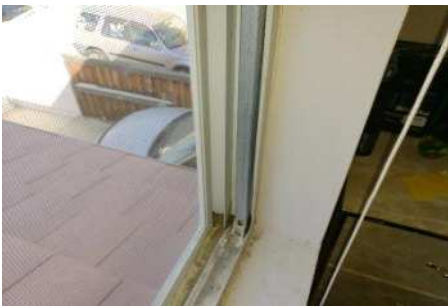
Damaged detached window balancers

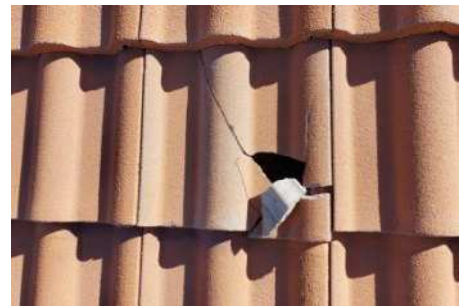
Damaged roofing tiles
