# Conditions Assessment for the Alexander Baker Building

900 5<sup>th</sup> Street  
International Falls, MN

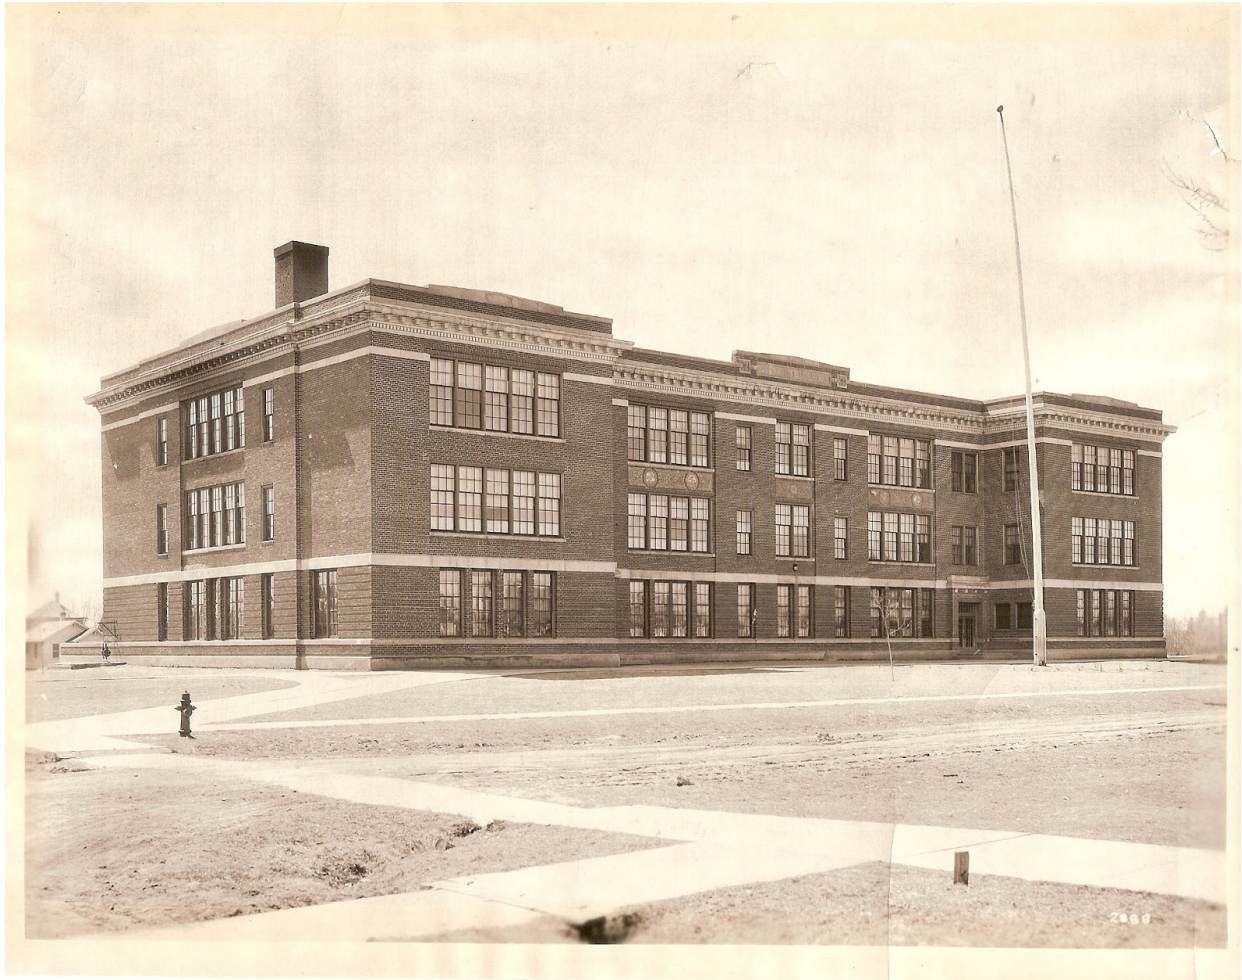
Photo courtesy of Citizens for Backus/AB

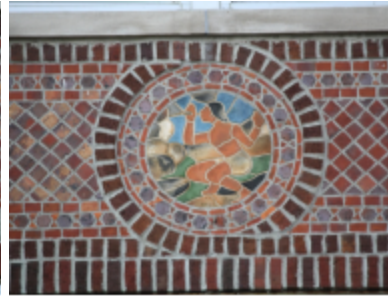
**Photo 2**  
**Location:** North Elevation  
**Description:** Mosaic detail on north facade. *Courtesy of Citizens for Backus/AB*

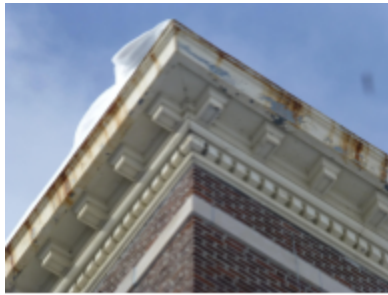
**Photo 3**  
**Location:** Southeast corner  
**Description:** Typical cornice detail.

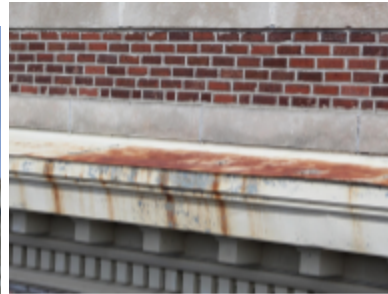
**Photo 119**  
**Location:** South cornice  
**Description:** Rusting and staining on top of sheet metal cornice, typical. *Courtesy of Bob Marquardt*

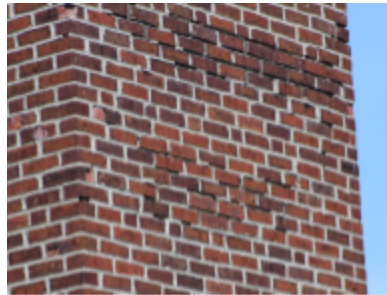
**Photo 120**  
**Location:** Southeast corner of chimney taken from Backus roof.  
**Description:** Spawling face brick and deteriorated mortar joints on east side of chimney. *Courtesy of Bob Marquardt.*

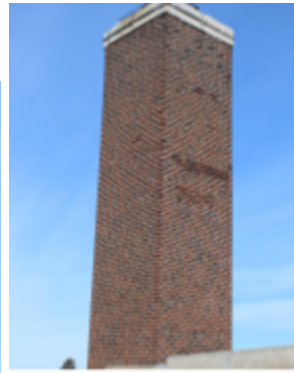
**Photo 121**  
**Location:** SE corner taken from roof of Backus building.  
**Description:** View of chimney showing location and extents of damage on south/east sides. *Courtesy of Bob Marquardt*

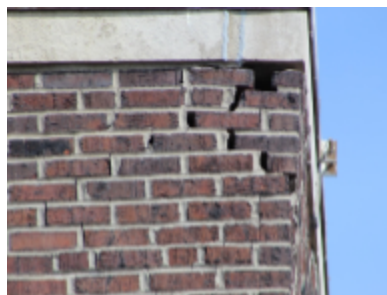
**Photo 122**  
**Location:** Southeast corner of chimney taken from Backus roof.  
**Description:** Failed mortar joints and shifting of brick near limestone cap. *Courtesy of Bob Marquardt.*

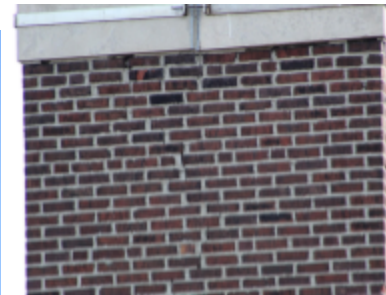
**Photo 123**  
**Location:** West side of chimney taken from Backus roof.  
**Description:** Hairline cracks in mortar joints leading down from joint at limestone cap. *Courtesy of Bob Marquardt.*

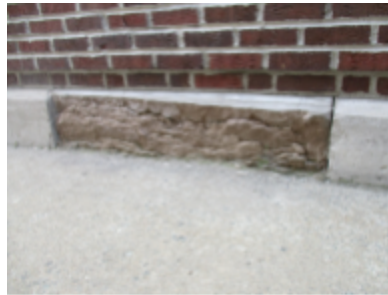
**Photo 124**  
**Location:** Foundation  
**Description:** Deteriorated limestone at water table course. *Courtesy of Bob Marquardt*

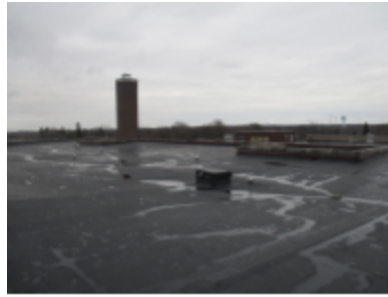
**Photo 126**  
**Location:** Roof looking east  
**Description:** Roof after replacement. Appears to drain properly. *Courtesy of Citizens for Backus/AB*

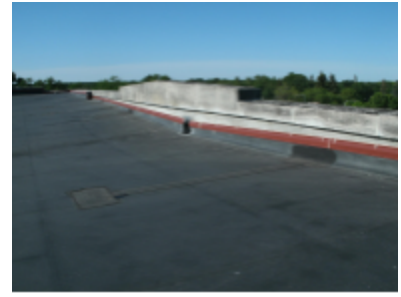
**Photo 127**  
**Location:** Roof  
**Description:** Parapet walls and flashings after roof replacement. *Courtesy of Bob Marquardt*

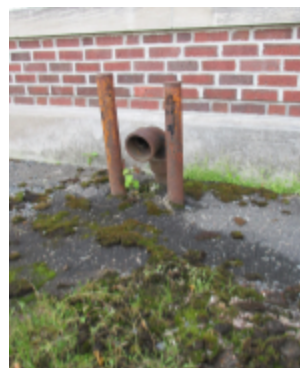
**Photo 128**  
**Location:** North Facade  
**Description:** P trap from roof drain discharging at north side. *Courtesy of Bob Marquardt*

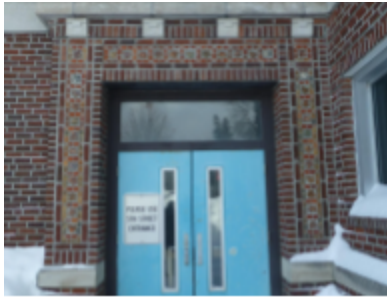
**Doors** - All exterior doors have been replaced with metal panel doors with single tall vertical lites offset to one side, painted blue with transoms. Nearly all original interior door frames, trim, and transoms remain. Some examples of original wood doors to ancillary spaces (closets, janitor rooms) remain and retain their original hardware. All classroom door panels and hardware were replaced with modern flush panel doors with a square centered lite and light-colored wood finish. The finish of original doors is a dark stained wood.

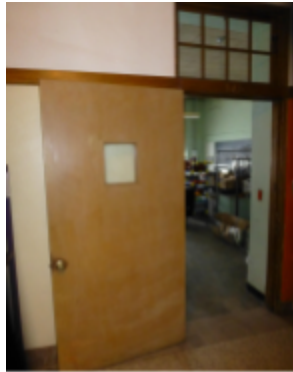
**Description:** Replacement metal exterior doors with transom.

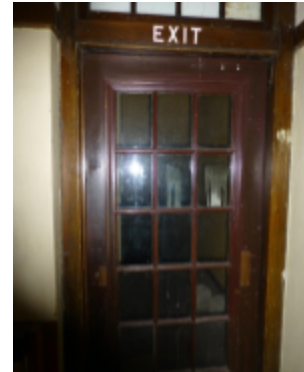
**Description:** Typical classroom replacement door with original transom above door.

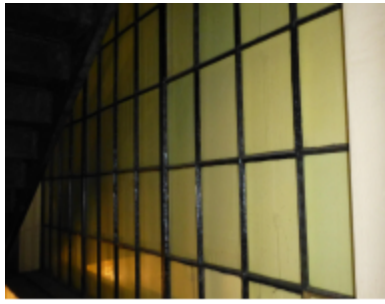
**Photo 7**  
**Location:** west stair, corridor 25  
**Description:** Original metal frame window at west stairwell as seen from inside.

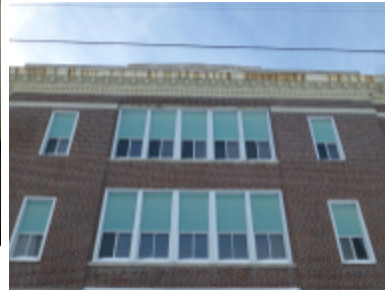
**Photo 9**  
**Location:** East Elevation  
**Description:** Typical existing 1978 aluminum/insulated panel replacement windows

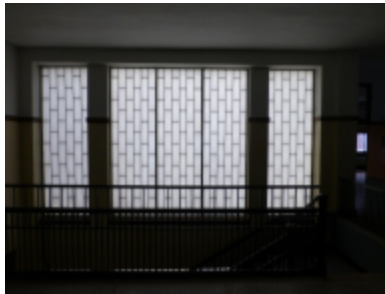
**Photo 10**  
**Location:** Room 222, west stair  
**Description:** Typical fiberglass insulated replacement windows at stairwells.

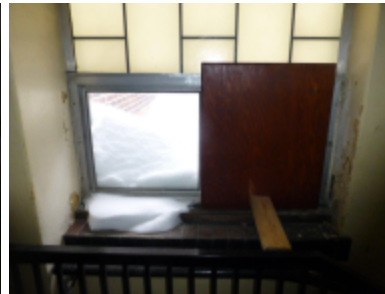
**Photo 11**  
**Location:** Room 126, east stair  
**Description:** Failure at fiberglass insulated replacement windows at east stairwell.

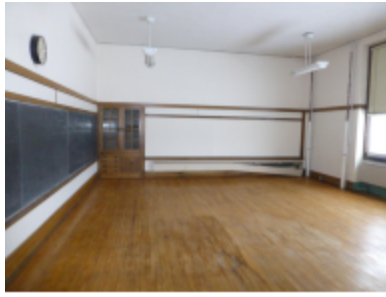
**Photo 12**  
**Location:** Room 116  
**Description:** Typical wood flooring in classroom.

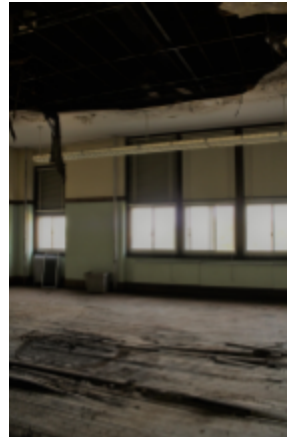
**Photo 14**  
**Location:** Room 218  
**Description:** Damage to wood floor in room 218.  
*Courtesy of Citizens for Backus/AB*

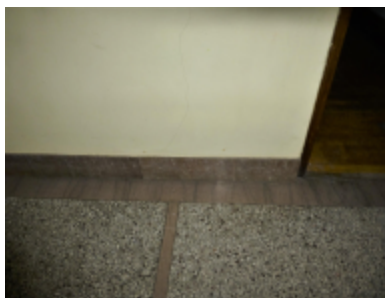
**Photo 16**  
**Location:** Room 126  
**Description:** Terrazzo corridor flooring with marble dividing strips and marble base.

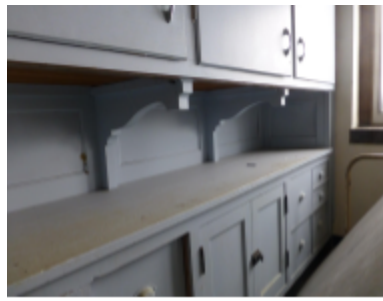
**Photo 18**  
**Location:** Room 8  
**Description:** Casework in room 8 on ground level. Original built-in casework with upper cabinet doors replaced.

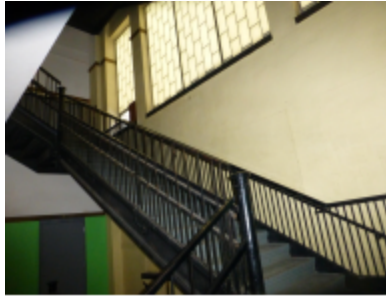
**Photo 19**  
**Location:** Room 25, east stair  
**Description:** View of east stair from ground level looking up. Handrail extensions were added.

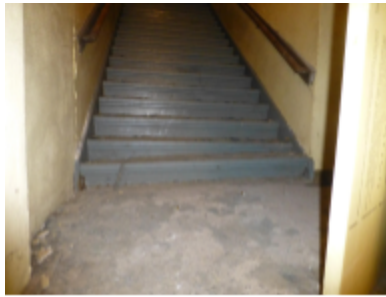
**Photo 21**  
**Location:** Room B14, west basement stair  
**Description:** Stair treads damaged due to heaving.

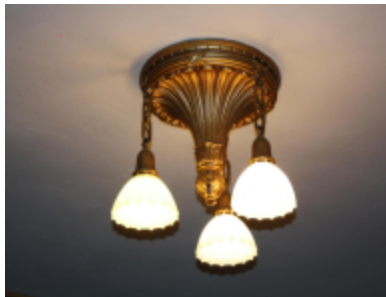
**Photo 23**  
**Location:** corridors, typical  
**Description:** Original ornate plaster light fixtures typical in corridors.  
*Credit: Citizens for Backus/AB*

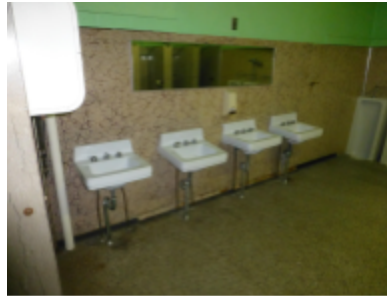
**Photo 25**  
**Location:** Room 27  
**Description:** Men's restroom at ground level showing replacement fixtures.

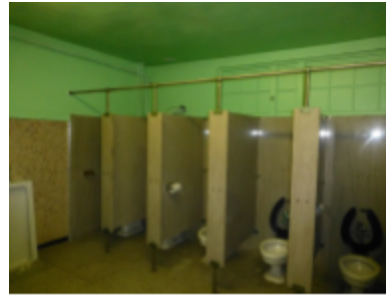
**Photo 26**  
**Location:** Room 27  
**Description:** Men's restroom on ground level original toilet partitions.

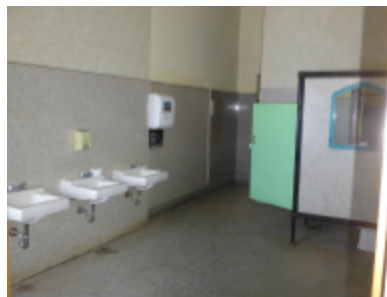
**Photo 28**  
**Location:** Room 213  
**Description:** Replacement fixtures in men's restroom on level 2. Replacement plywood door and laminate on partitions visible.

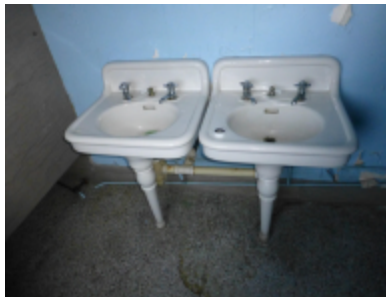
**Photo 29**  
**Location:** Room 202  
**Description:** Double pedestal sinks found in women's room 202 and 204 on level 2.

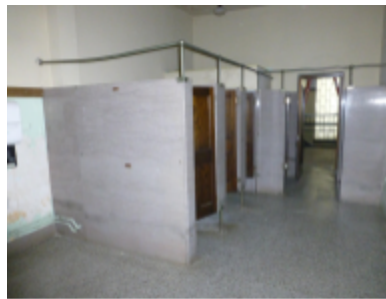
**Photo 30**  
**Location:** Room 204  
**Description:** Original marble stall partitions in women's restroom 204 shown with their original wood doors.

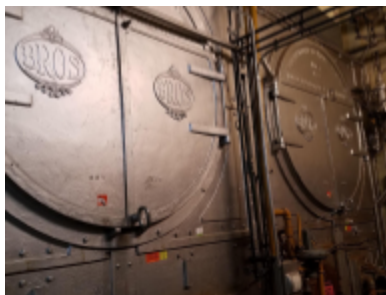
**Photo 31**  
**Location:** Room B03  
**Description:** The buildings two original steam boilers which have been recently rebuilt and currently serve to heat the Backus Building.

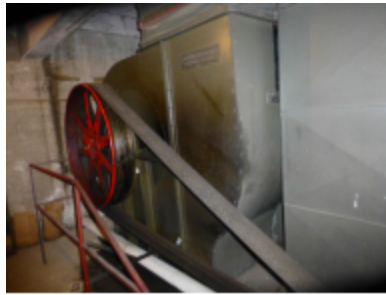
**Photo 33**  
**Location:** Room B11  
**Description:** Motor for large air handler unit.

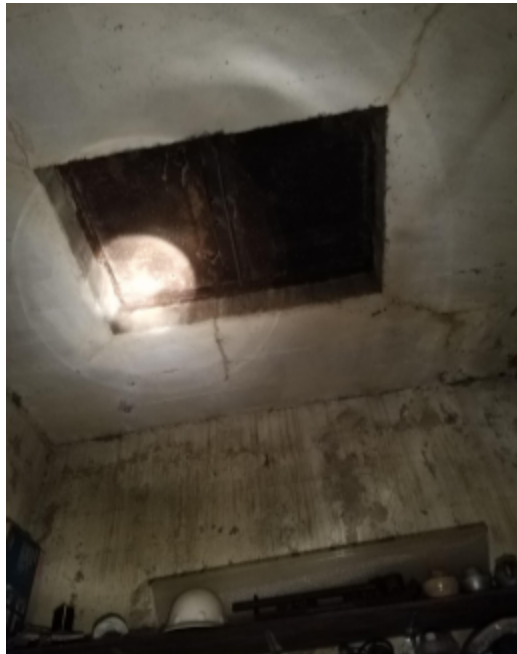
Photos of existing conditions and character defining features.

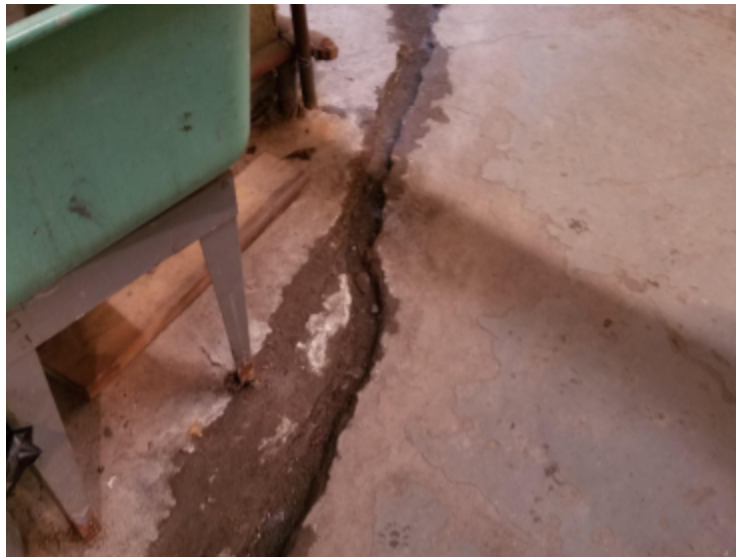
**Description:** manhole cover in ceiling where leaking around rim was observed.

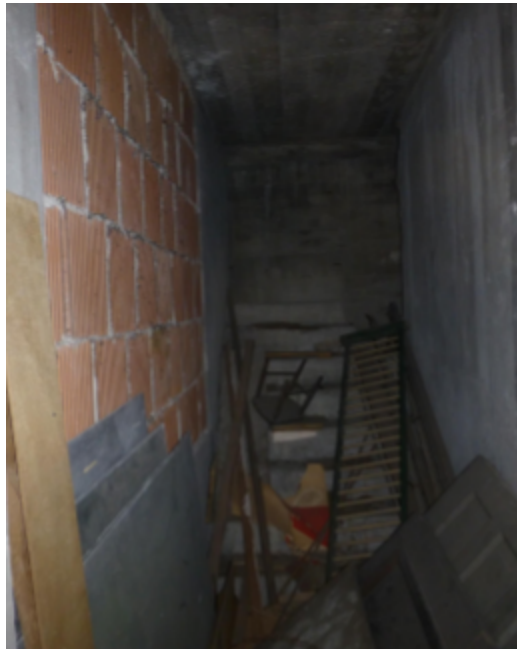
**Description:** Cracking and heaving of terrazzo flooring and metal and concrete stairs.

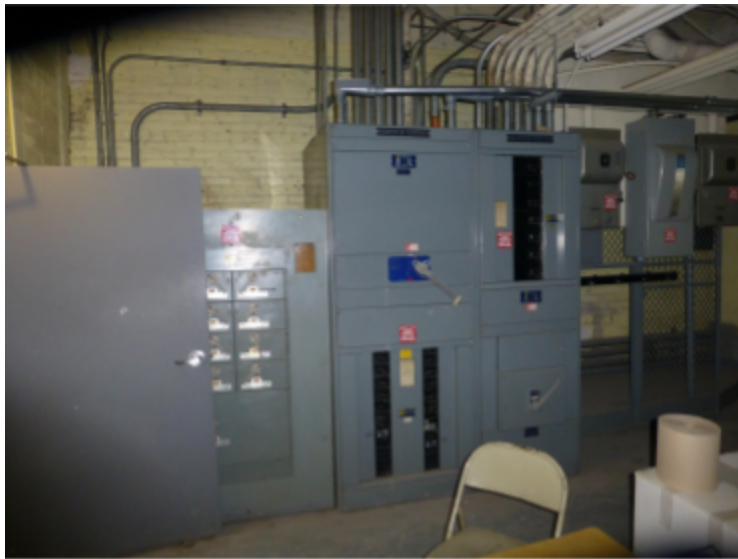
**Description:** Water from leaking plaza above addition to room B1 beneath east parking.

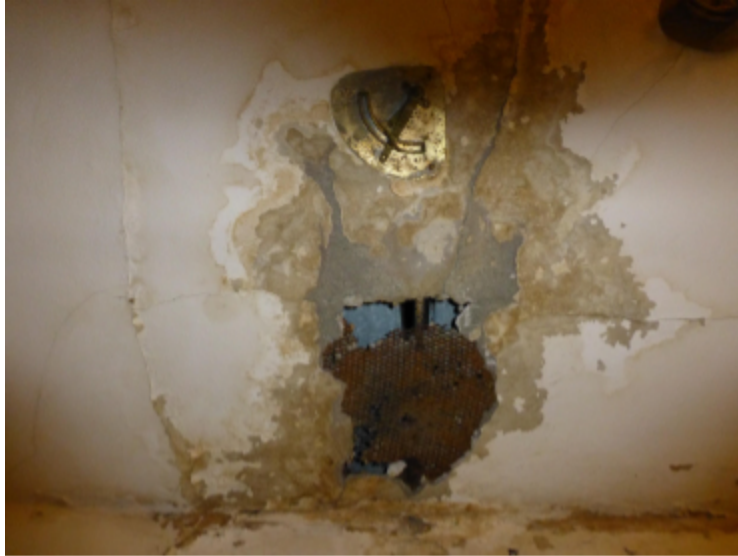
**Photo 50**  
**Location:** Room 25  
**Description:** Damage to corridor ceiling near damper valves.

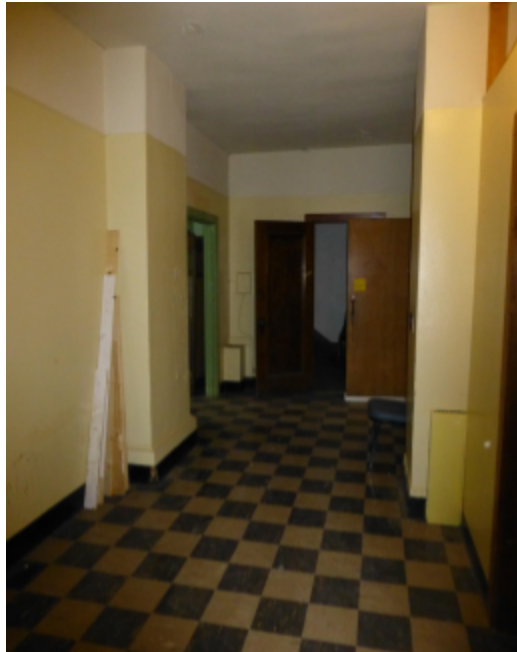
**Photo 51**  
**Location:** Room 28  
**Description:** Modifications to room 28. Non-historic door at right currently used to seal off these rooms from main corridor.

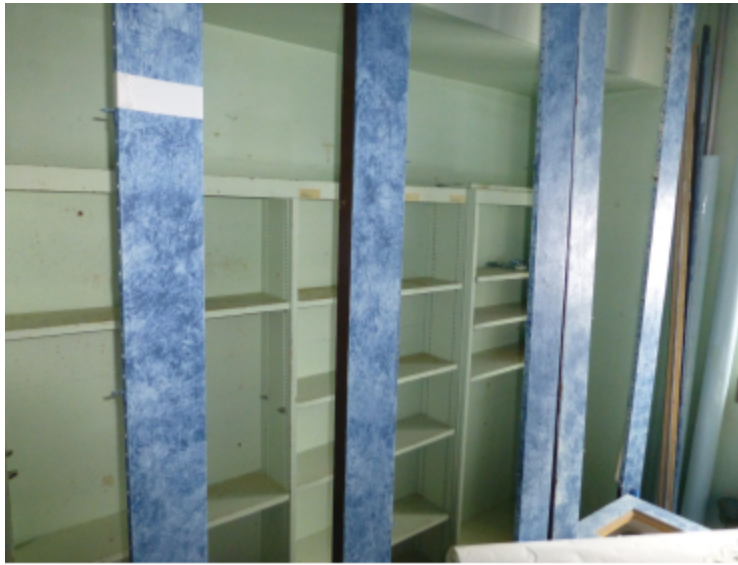
**Description:** Four light ornate plaster light fixture at vestibules, rooms 3 and 10. Missing glass shades.

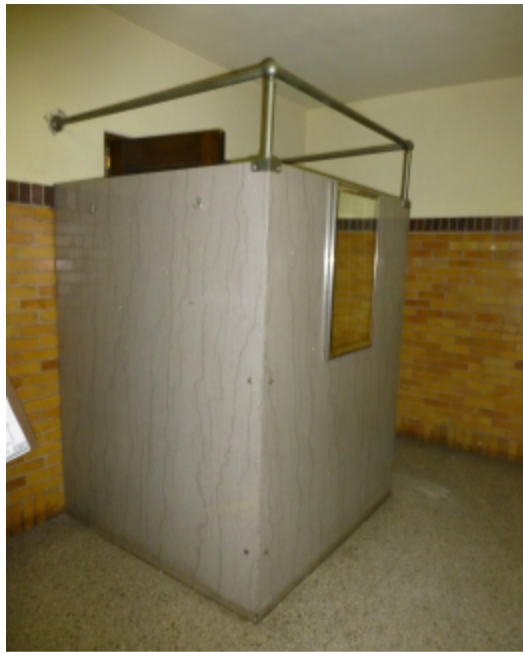
**Photo 68**  
**Location:** Room 23  
**Description:** Marble partition at entry to Women's restroom. Note Glazed brick wainscoting.

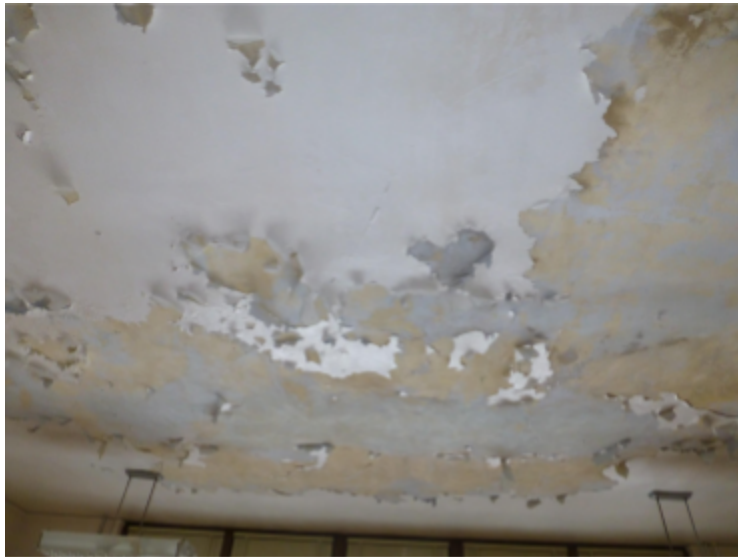
**Description:** Damage to wood flooring from previous roof leaking. Note gypsum wall tile can be seen where segment of slate chalkboard has been removed.

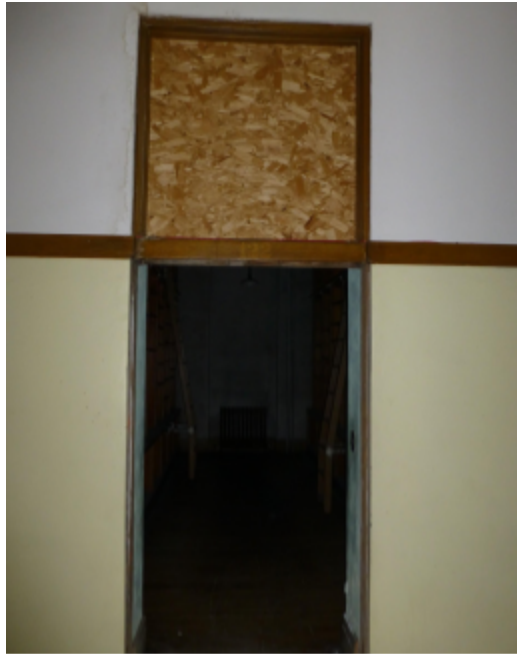
**Description:** Damage to ceiling from previous leaking roof.

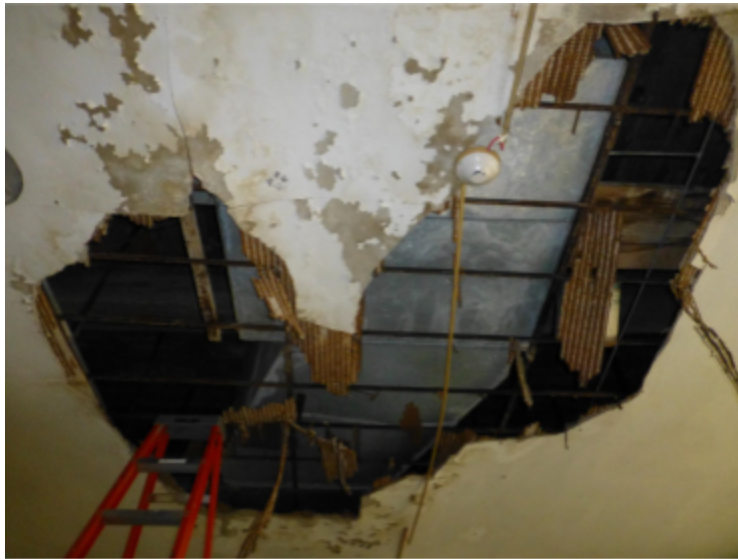
**Description:** Damaged wall and ceiling west end of corridor. Rain leader from roof visible with spliced PVC section connecting to cast iron pipe.

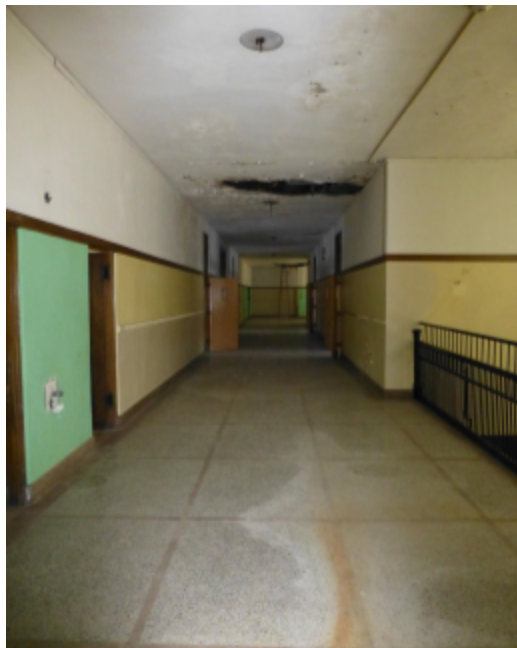
**Description:** Damage to suspended metal frame, lath, and plaster ceiling above east stair in corridor. Support members visibly rusted.

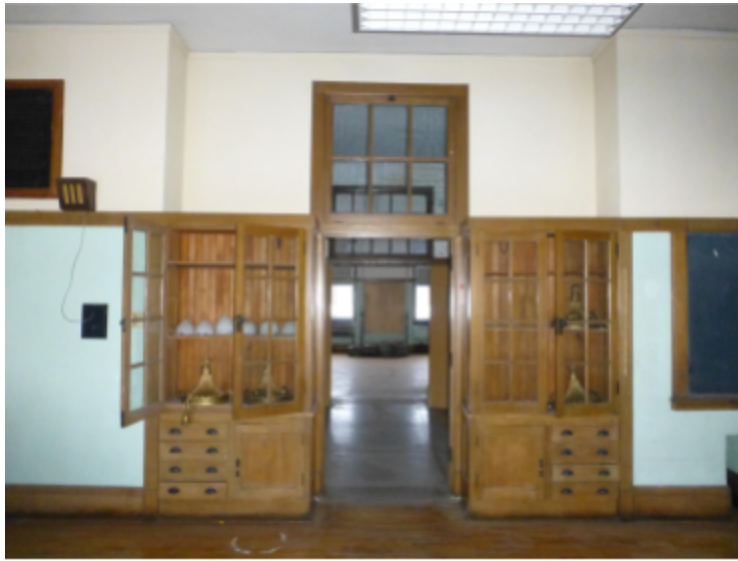
**Description:** Corridor looking east. Damage to ceiling in center and original lighting fixtures removed due to previous roof leaking.

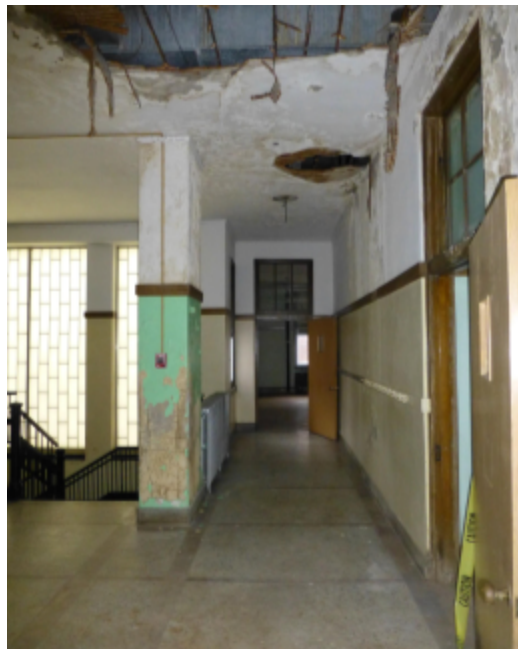
**Description:** Damaged wood flooring, buckling, and concrete patch repair.

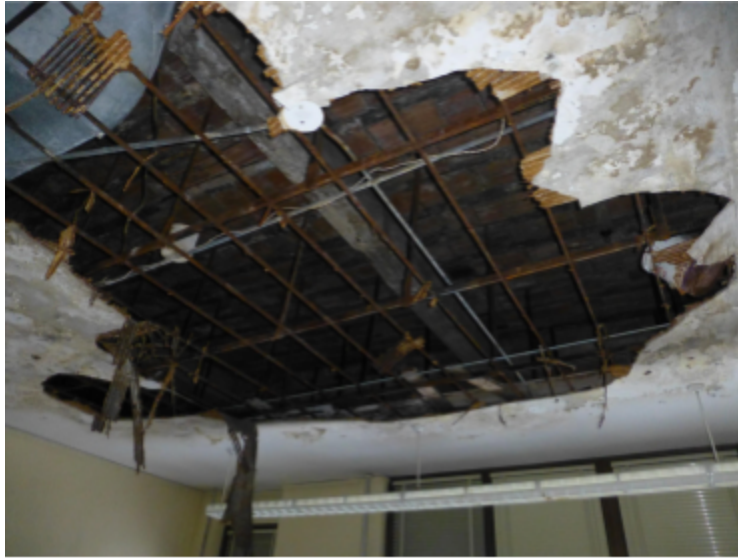
**Description:** Corridor looking south. Damage to ceiling and peeling paint.

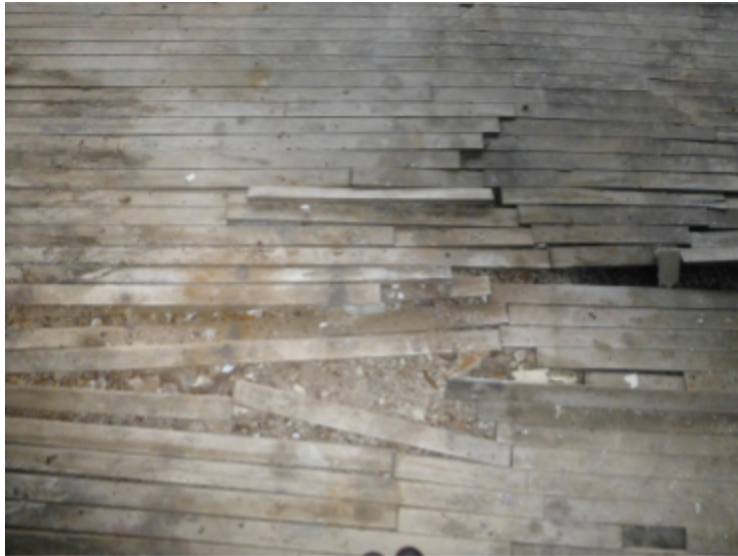
**Description:** Extensive area of ceiling damage, small areas of spalled concrete beams with some visible structural rebar exposed.

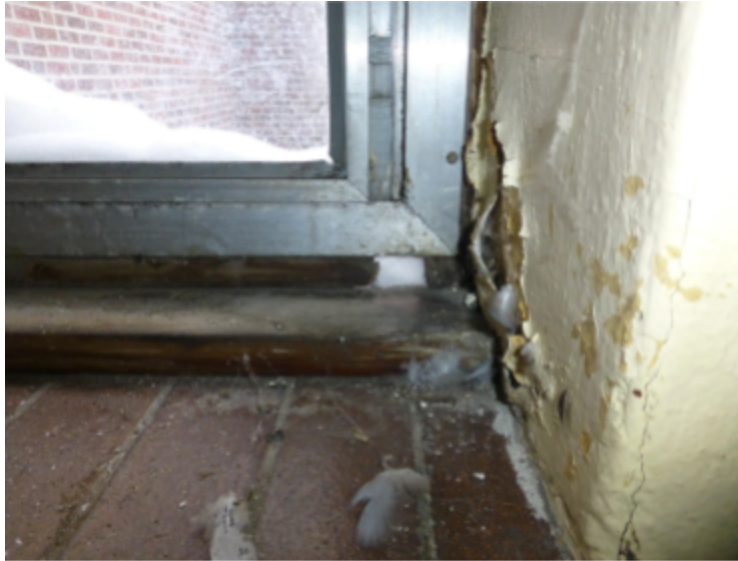
**Description:** Damage to wood floor extends throughout room.

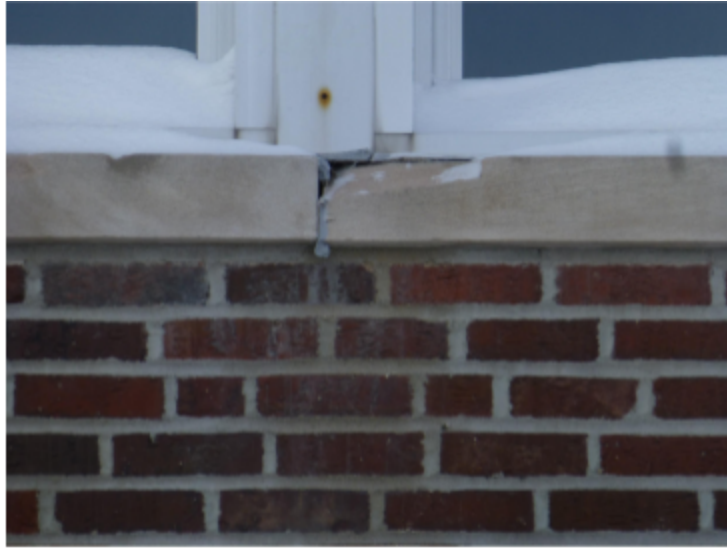
**Photo 102**  
**Location:** east elevation  
**Description:** Damaged stone sill at level 1 window.

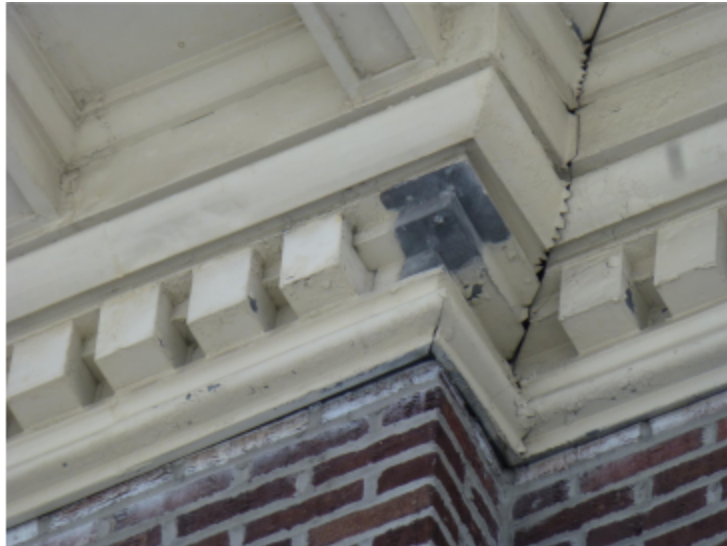
**Photo 103**  
**Location:** east elevation  
**Description:** Missing dentil at corner of cornice. Slight efflorescence below cornice at multiple locations.

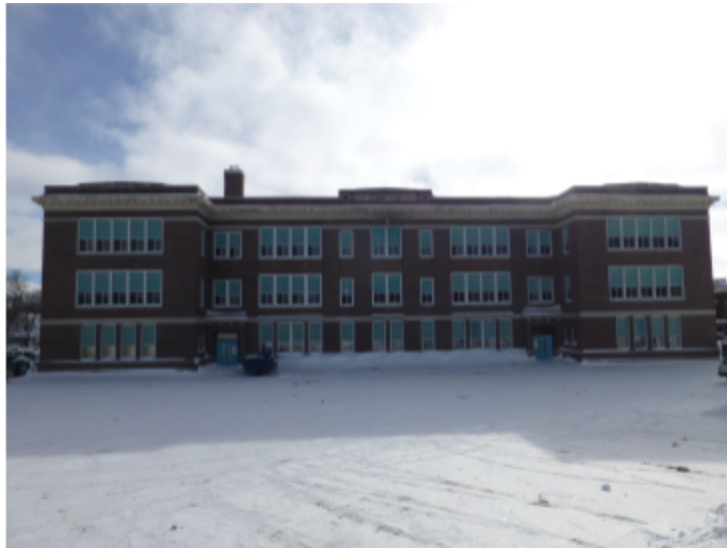
**Photo 106**  
**Location:** north elevation  
**Description:** north elevation, significant snow cover on site at time of visit. Pavement extends to face of building.

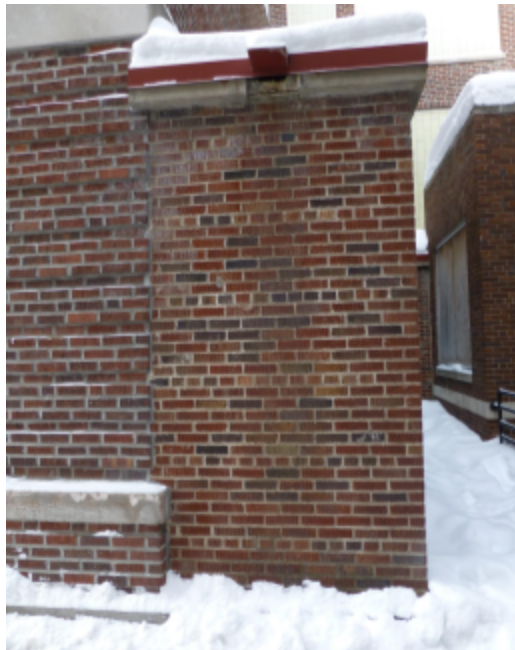
**Photo 111**  
**Location:** southwest elevation  
**Description:** hole beneath replacement scupper on addition to building over tunnel stairs.

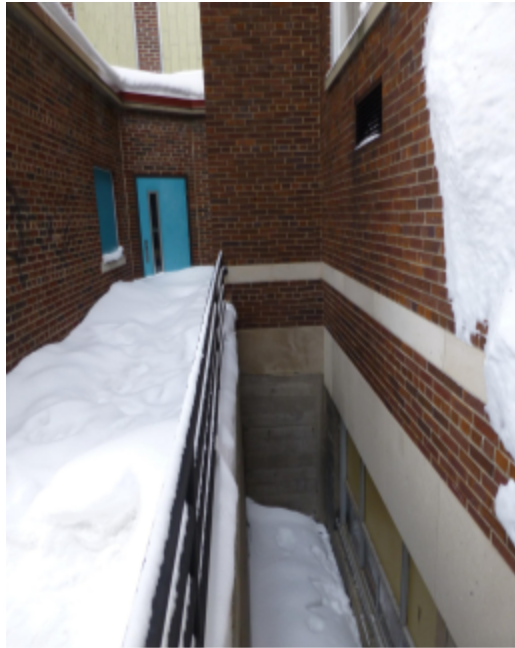
**Photo 112**  
**Location:** southwest elevation  
**Description:** door to added vestibule space near west stair.
