July 7, 2003
File No. 1003.04

Re: Construction Quality Assurance
Repairs to the leachate force main between the
Leachate Consolidation Building and Valve Box 301
North Country Environmental Services, Inc.
Bethlehem, New Hampshire

REPAIRS TO THE LEACHATE FORCE MAIN BETWEEN
THE LEACHATE CONSOLIDATION BUILDING &
VALVE BOX 301
NORTH COUNTRY ENVIRONMENTAL SERVICES, INC.

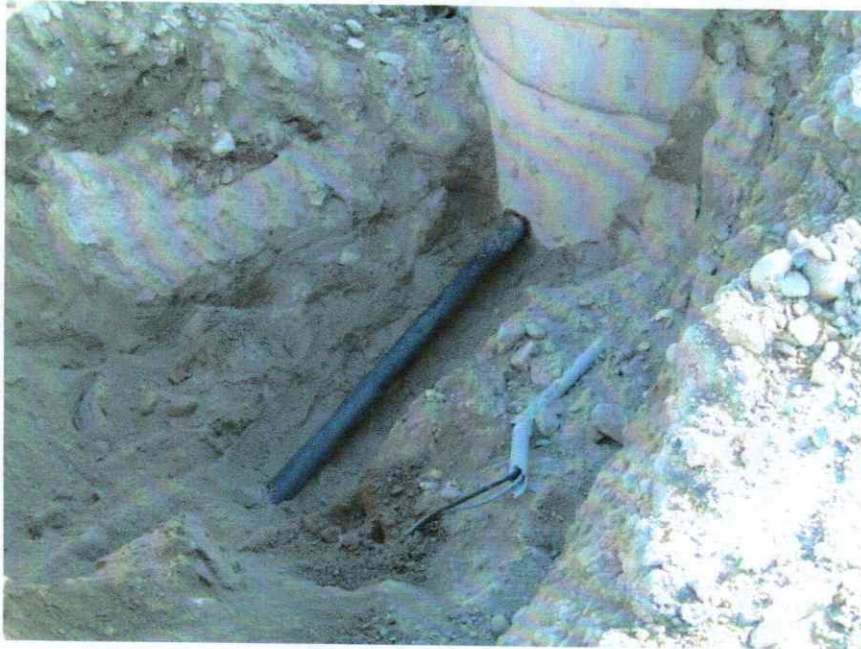
PHOTO #1 – Excavation around Leak Detection Manhole #1

The first carrier pipe leak was located approximately 8 feet east of Leak Detection Manhole No. 1, (LMH-1). The dual-walled pipe was cut, an 8-foot section of 2-inch diameter carrier pipe was installed from the cut location back to LMH-1. Both the carrier and containment pipes were butt-fusion welded. Representative photos of this pipe repair are included in Appendix B as Photo Nos. 1, 3 and 4. Refer to Figure Number 2 for the locations of forcemain repairs.

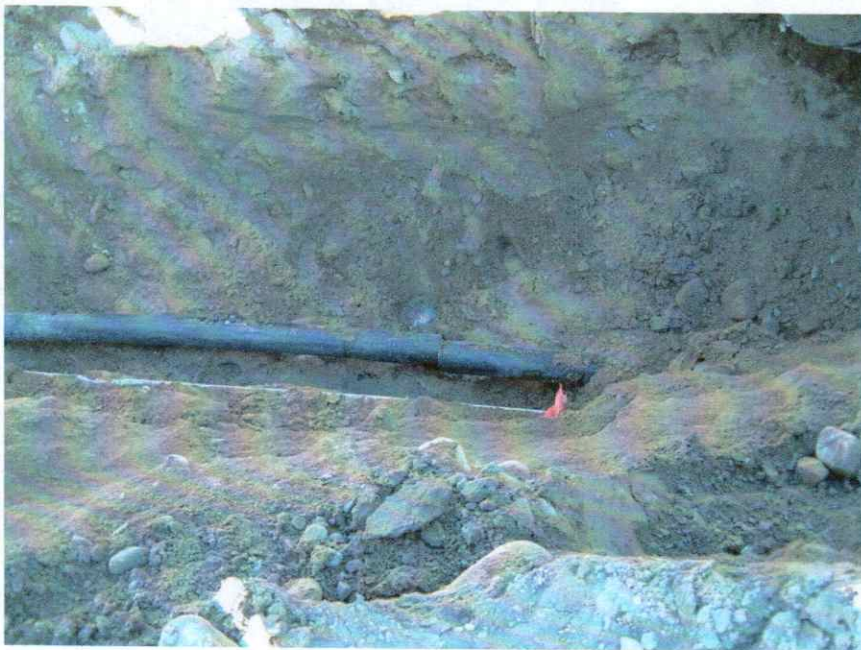
PHOTO #2 – Forcemain repair #2, located approximately 14' west of LMH-1

The second pipe repair was performed approximately 14 feet west of LMH-1. The video display from the pipe camera showed a cracked pipe weld at this location. The pipe was cut at the cracked weld, both sides of the cut pipe were re-faced, and a simultaneous butt-fusion weld made to join the carrier and containment pipes. Refer to Photo Nos. 2 and 6.

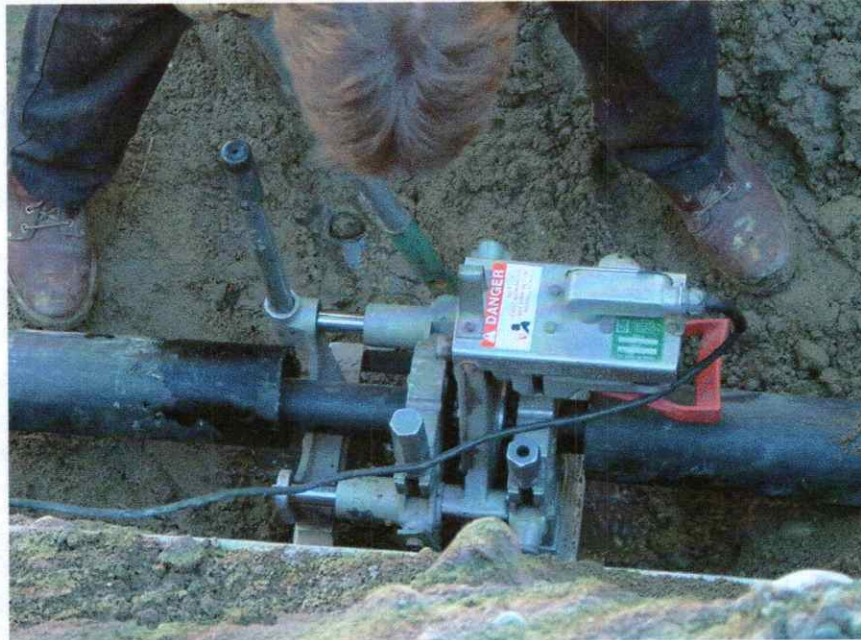
PHOTO #3 – Butt-fusion welding of 2" carrier pipe at Forcemain repair #1 location

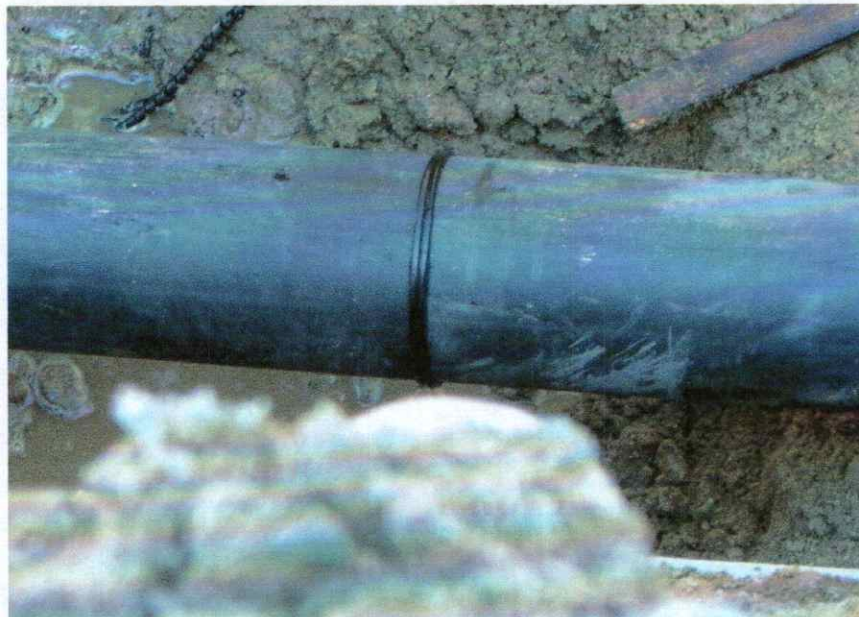
PHOTO #4 – Completed 4" containment pipe butt-fusion weld at Forcemain repair #1 location

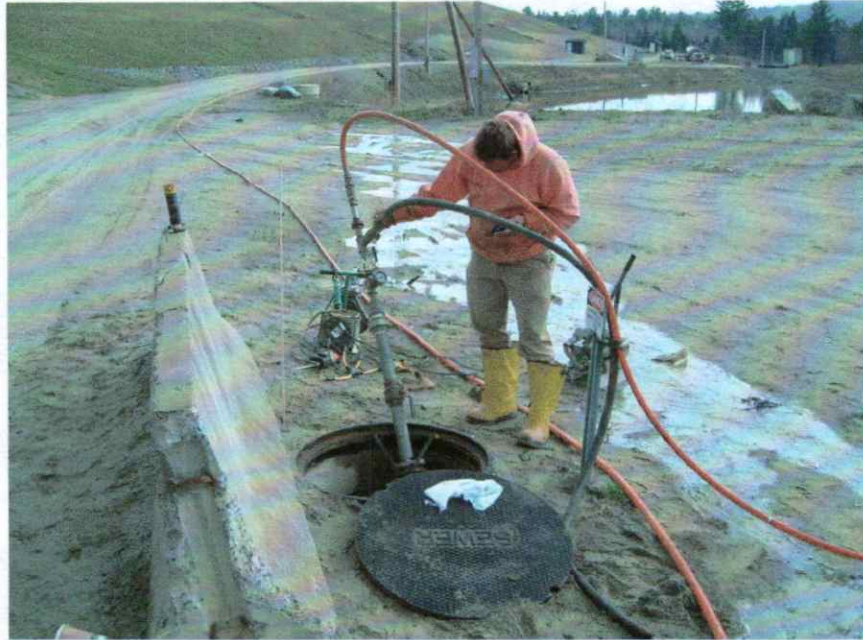
PHOTO #5 – Pneumatic testing of 4” carrier pipe at LMH-2

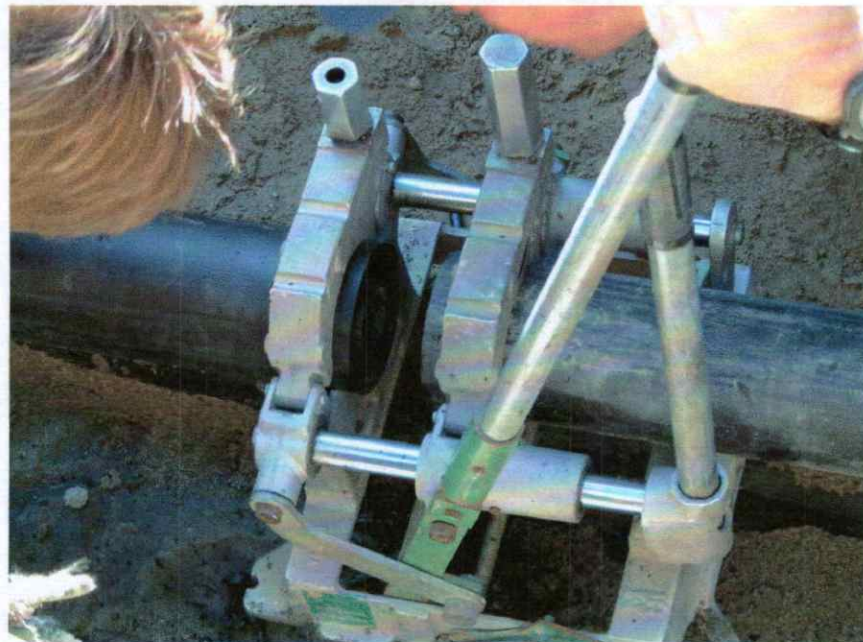
PHOTO #6 – Simulations butt-fusion welding of forcemain

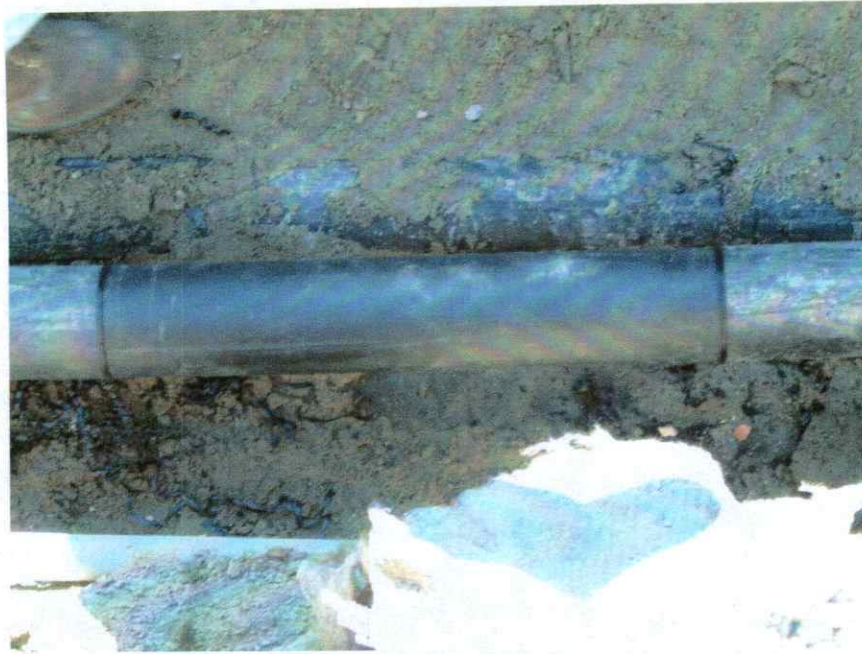
PHOTO #7 – Completed simultaneous butt-fusion weld

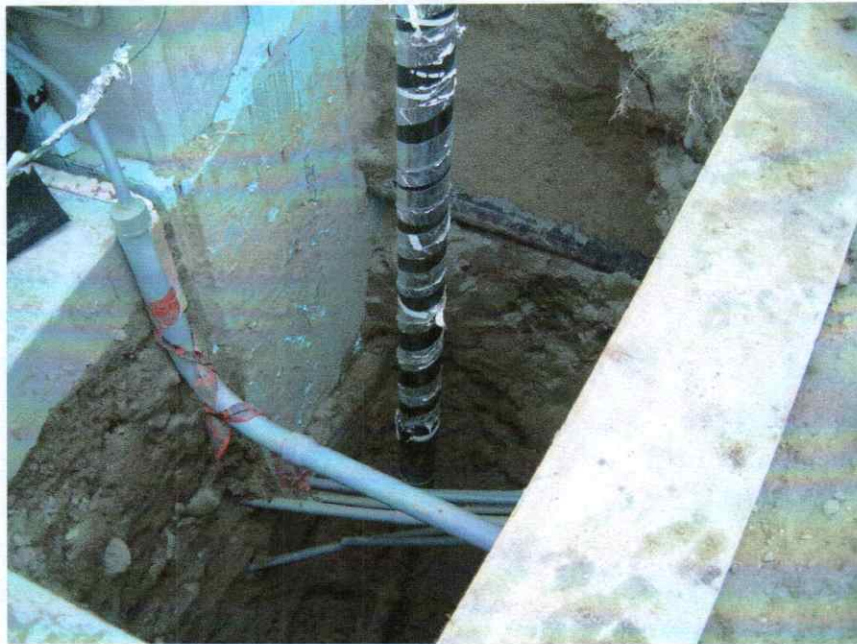
PHOTO #8 – Vertical forcemain excavation at consolidation building

The pipe camera showed a crack in the vertical section of carrier pipe located just outside the Leachate Consolidation Building. The vertical section of carrier pipe was removed and replaced. Simultaneous butt-fusion welds of the carrier and containment pipes were completed at both ends of the vertical section of the forcemain. Refer to Photo Nos. 8 and 10.

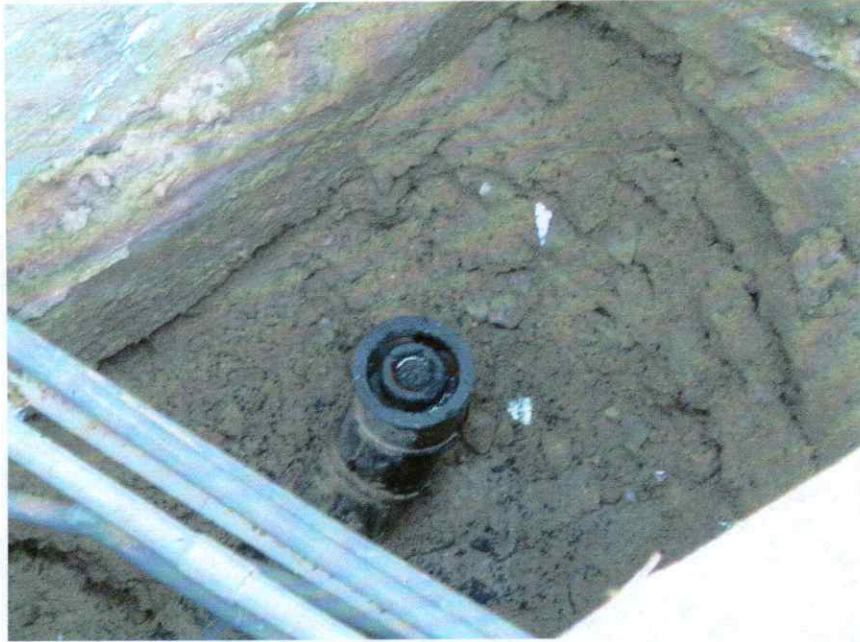
PHOTO #9 – 90° Elbow at bottom of vertical section of forcemain

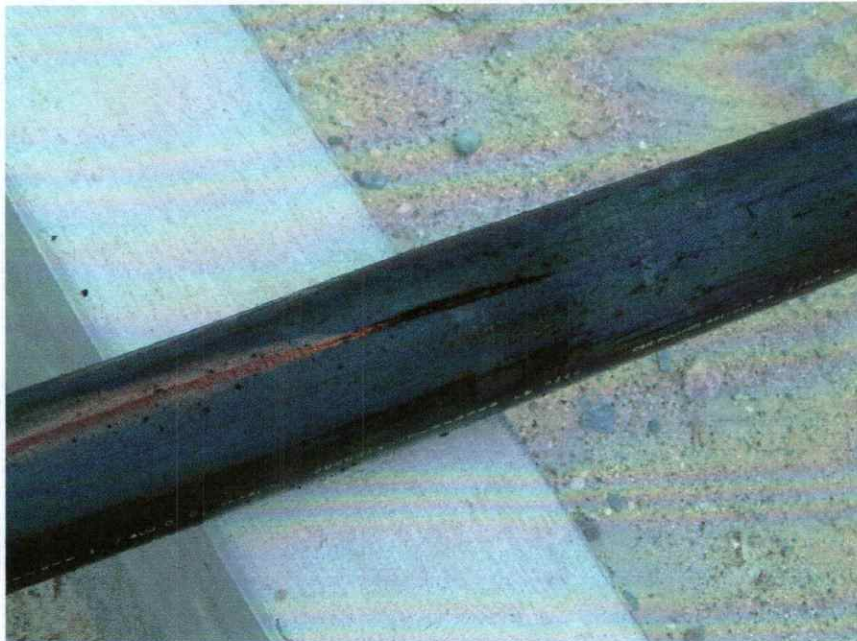
PHOTO #10 – Crack in vertical section of 2" containment pipe

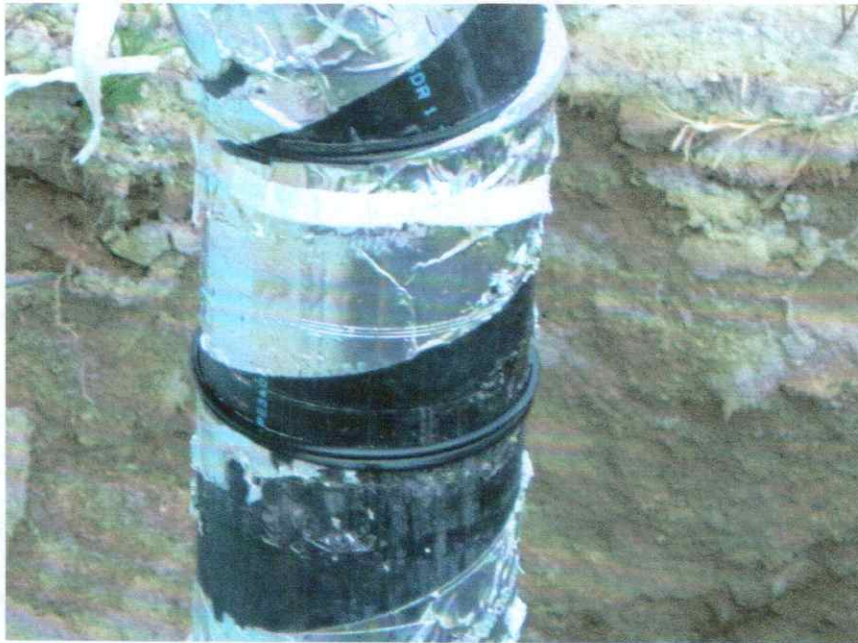
PHOTO #11 – Completed simultaneous weld in vertical section of force main
