LETTER OF DEFICIENCY
No. WMD LOD 19-132

SUBJECT: North Country Environmental Services, Inc. Landfill
581 Trudeau Road, Bethlehem, NH
Solid Waste Permit No. DES-SW-SP-03-002

Inadequate Daily Cover

SOLID WASTE FACILITY INSPECTION REPORT	New Hampshire Department of Environmental Services Waste Management Division P.O. Box 95, 29 Hazen Drive Concord, NH 03302-0095 Phone: 603-271-2925 Fax: 603-271-2456
---	---	--

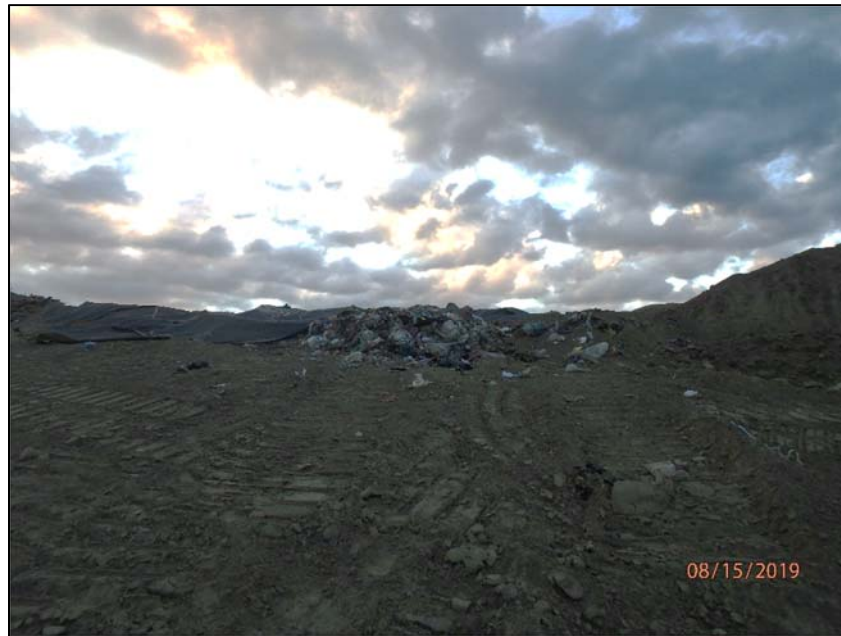
P8150008: Working face in the southern portion of Stage IV/Phase II, prior to the working face being uncovered, as viewed from the west and looking upslope in an easterly direction. Pile of soil cover mixed with debris present in the center of the photograph; pile of soil cover present on the right of the photograph.

Assessment: NHDES personnel observed exposed waste during inspection of the working face located in the southern portion of Stage IV/Phase II (see Photographs P8150001 through P8150008), as well as the working face located in the southern portion of Stage V/Phase II (see Photographs P8150021 through P8150025).
