All-Star Inspections

All-Star Home Inspection Report

**123 Easy Street
Cleveland, OH 44102**

Inspected on Wed, Apr 10 2019 at 1:00 PM

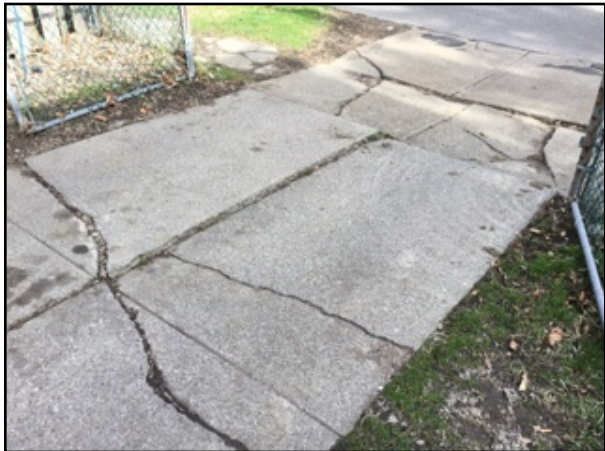
Figure 2-1

**Comment 2:**
Large settling cracks and settling present at driveway creating potential trip hazards. Safety Hazard. Recommend repairs.

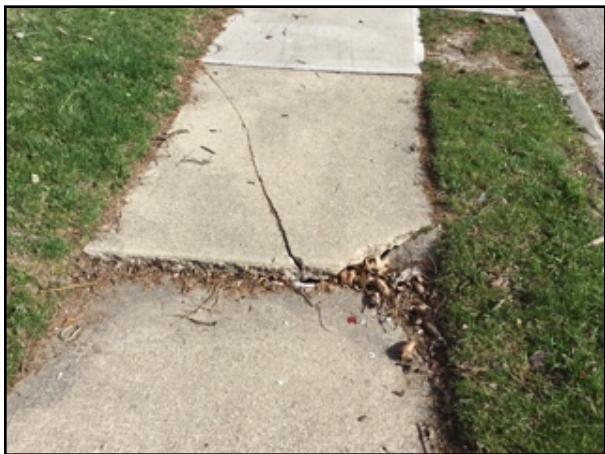
Figure 3-1

**Comment 3:**
Settled section of front sidewalk creating a potential trip hazard. Safety Hazard. Recommend contacting the city to see if they will repair this.

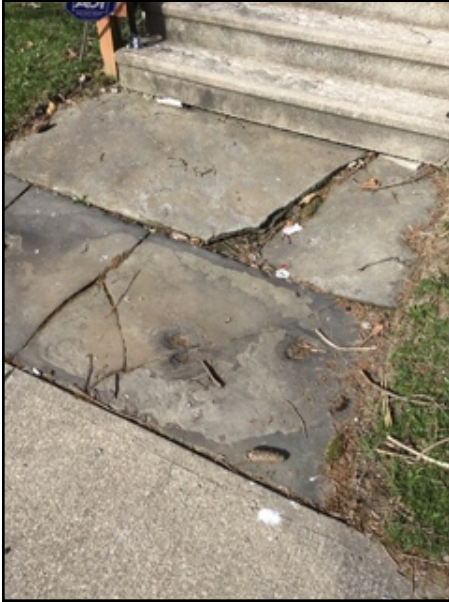
Figure 4-1

Cracking and settling at service walks around house creating potential trip hazards. Safety Hazard. Recommend repairs.

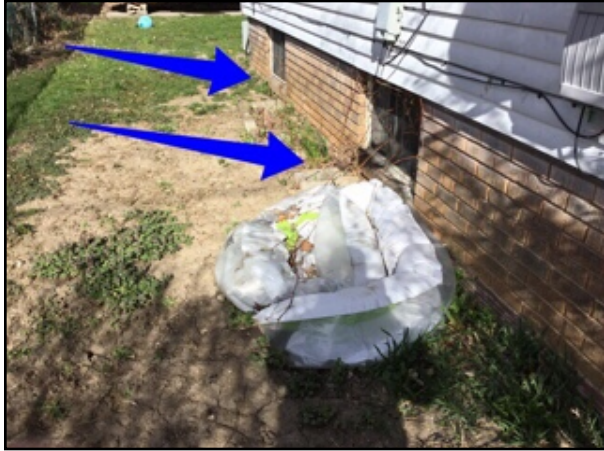
Figure 5-1

Negative soil grades present at several areas around house. Recommend adding additional hard-packed topsoil around the foundation to prevent moisture intrusion along foundation walls.

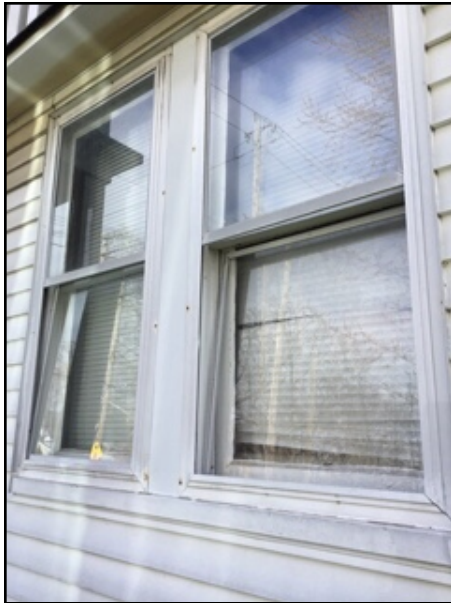
Figure 6-1

Storm window panes out of place or missing at several of the storm windows. Recommend repairs.

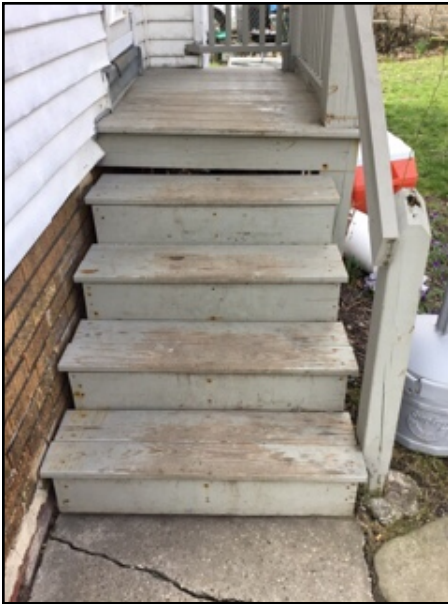
Figure 7-1

Rear porch wood is weathered. Recommend painting or staining to prevent further deterioration.

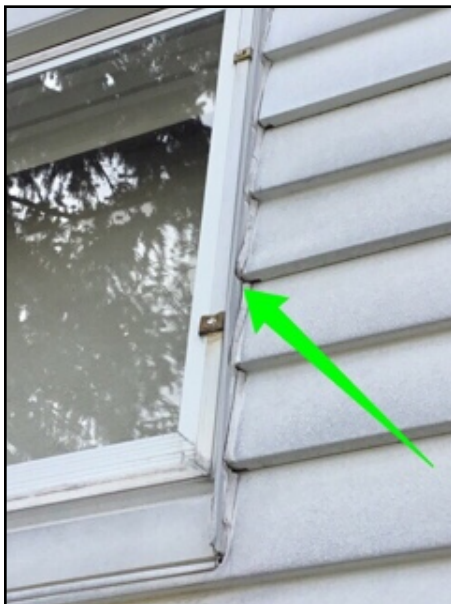
Figure 8-1

Typical caulking maintenance needed around windows and trim. Recommend sealing areas as needed.

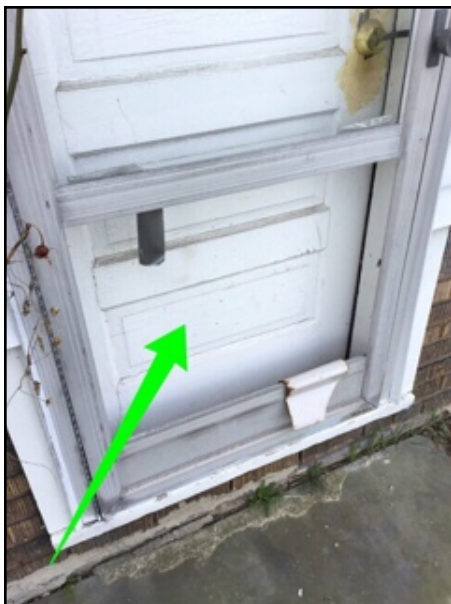
Figure 9-1

Side storm door is missing lower glass pane. Recommend repairs as needed.

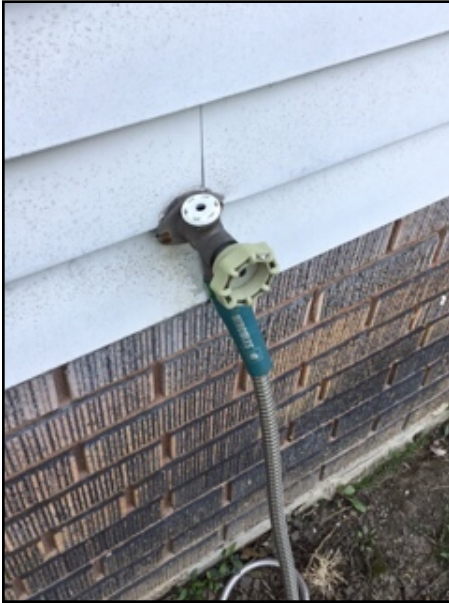
Figure 10-1

Hose bib at side of house is not securely fastened. Recommend fastening securely.

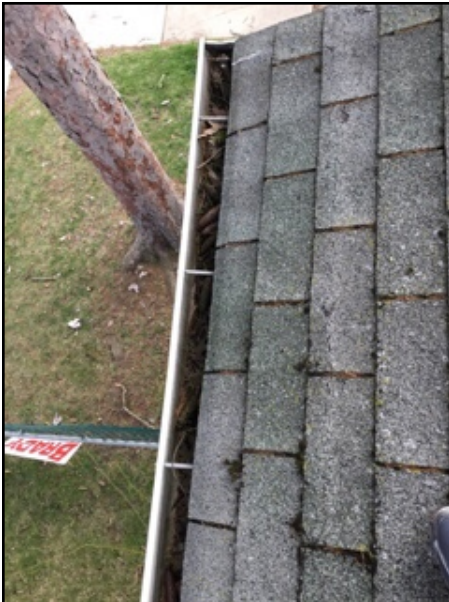
Figure 11-1

Gutters need cleaned out. Recommend cleaning out gutters to ensure proper water drainage.

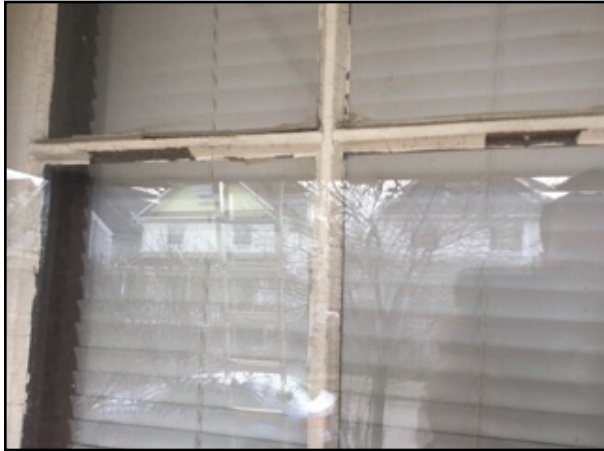
Figure 12-1

Cracked and missing window glazing present at several windows. Recommend monitoring and repair or replace as needed.

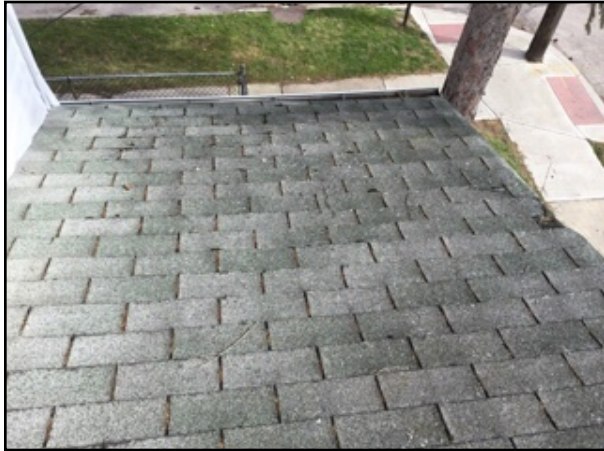
Figure 15-1

**Comment 15:**
Moss, algae, and lichen developing at front porch roof. Recommend treating affected areas to prevent premature deterioration of roofing shingles.

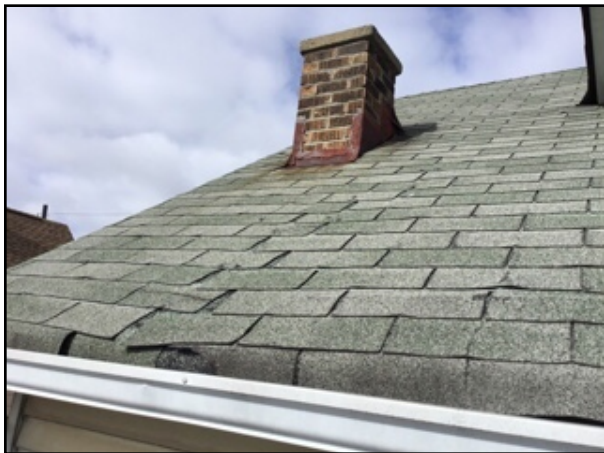
Figure 16-1

**Comment 16:**
Shingle spreading present at front of roof. No structural evidence of the roof spreading. This may have been done during installation. Recommend monitoring and repair or replace as needed.

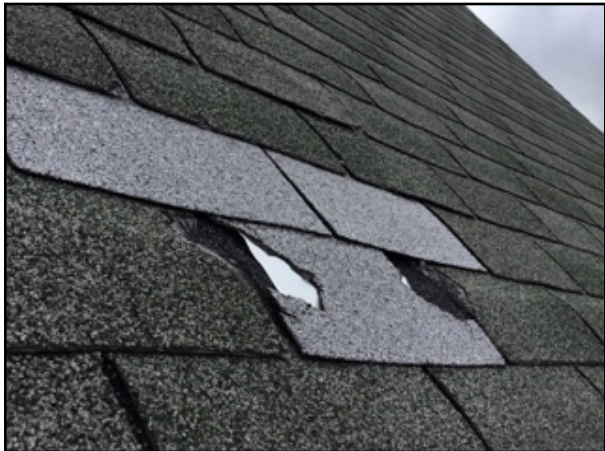
Figure 17-1

Previous repair present with damage to shingles at rear roof. Does not appear to be leaking at the moment, but this damaged area should be repaired.

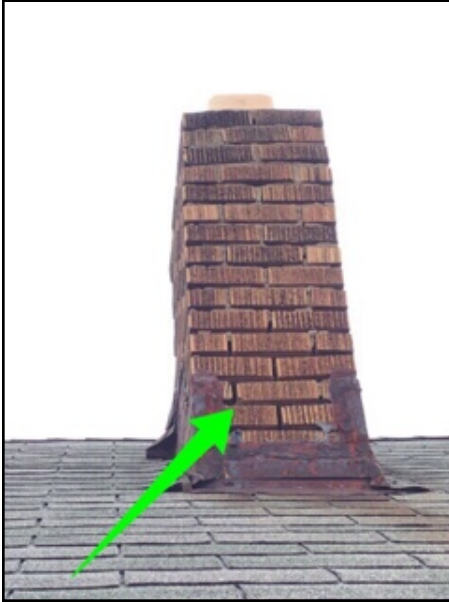
Figure 20-1

Chase:	Brick, Deteriorated and/or missing mortar joints at rear chimney. Recommend tuck pointing repairs Condition: Marginal
Flue:	Tile, Not visible at front chimney, Missing weather caps, Recommend adding a weather caps
Inspected From:	Roof, Ladder at eaves

**Comment 20:**
Deteriorated and/or missing mortar joints at rear chimney. Recommend tuck pointing repairs.

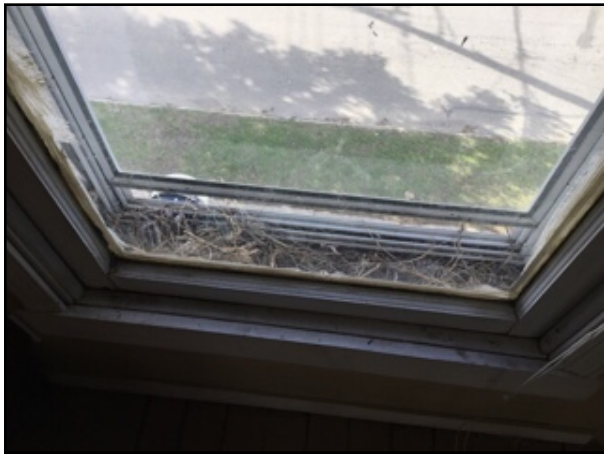
Figure 22-1

Nesting materials present in 3rd floor window sill due to storm window not being fully closed. Recommend cleaning out nesting material and properly closing storm window.

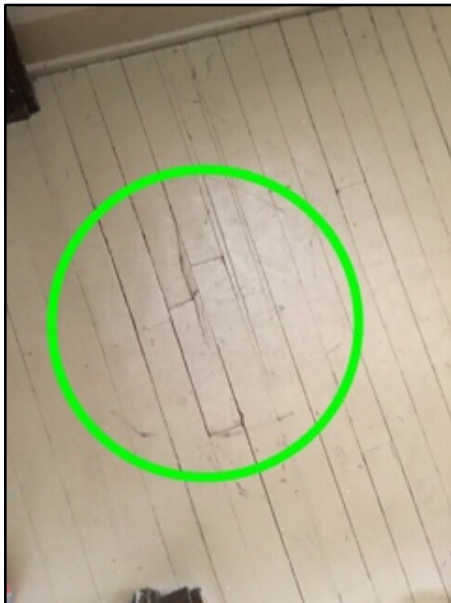
Figure 23-1

Spongy section of flooring present at 2nd floor hallway near entrance to bathroom. Recommend repairs as needed.

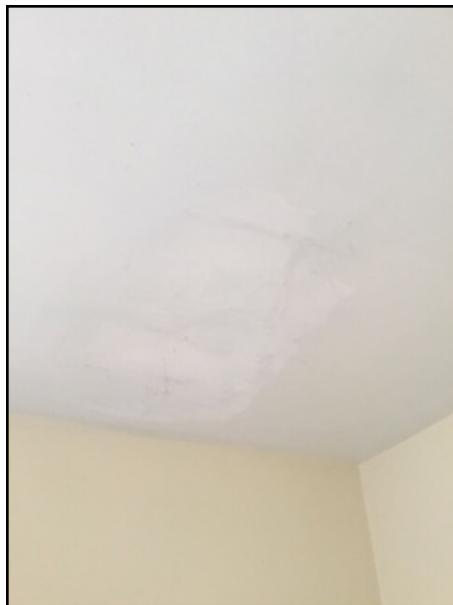
Figure 26-1

Comment 26:
Previous repair made to bedroom ceiling. Recommend monitoring and repair further as needed.

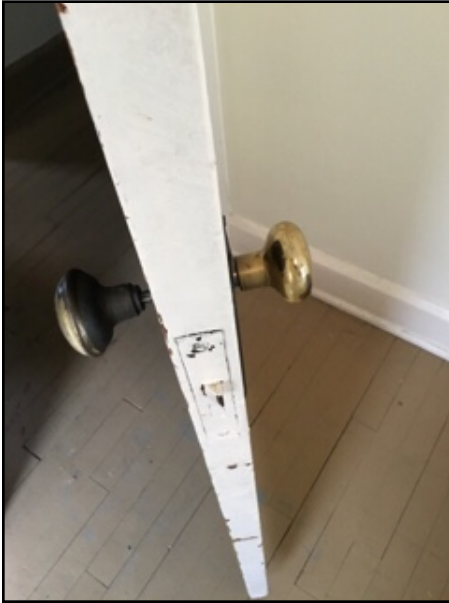
Figure 27-1

Damaged/loose door knob. Recommend replacing.

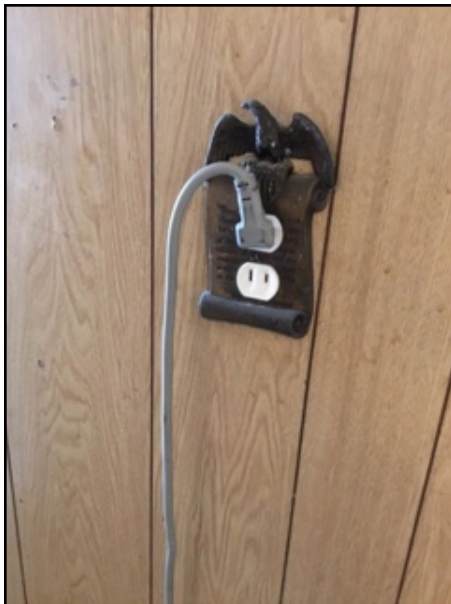
Figure 32-1

Comment 32:
Ungrounded appliance outlet. Safety Hazard. Recommend repair.

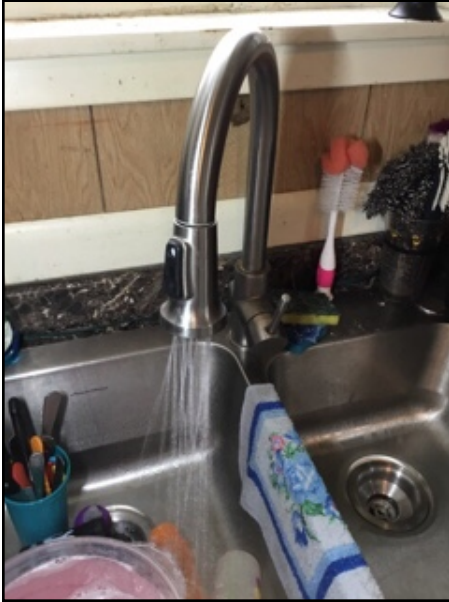
Figure 33-1

Kitchen sink faucet no longer alternates from stream to spray mode. Stuck in spray mode. Recommend replacing faucet as needed.

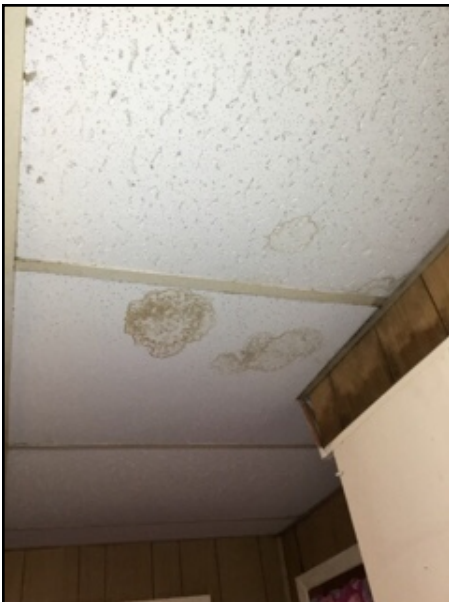
Figure 34-1

Moisture stains present at kitchen drop ceiling panels. No active moisture present at time of inspection. Recommend monitoring and repair as needed.

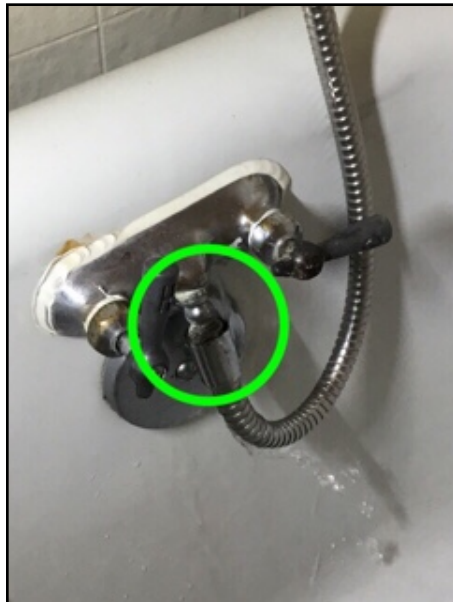
Figure 37-1

No tub faucet present. Shower hose connection leaks. Recommend repairing or replacing.

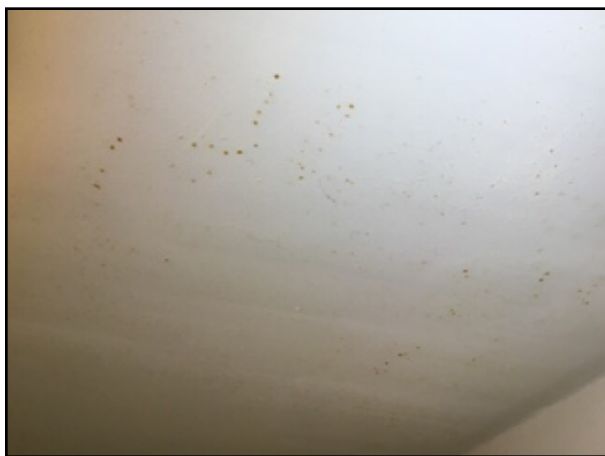
Figure 38-1

Moisture stains present at bathroom ceiling. Recommend adding an exhaust fan to minimize moisture.

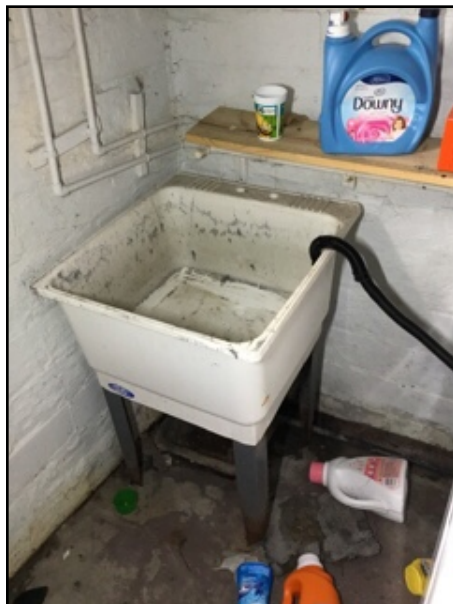
Figure 40-1

Utility sink is not properly secured and is missing a faucet. Recommend repairs as needed.

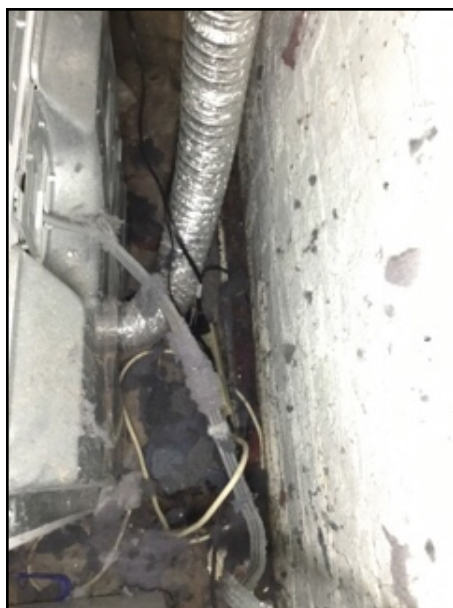
Figure 41-1

Excessive amount of laundry lint behind dryer. Dryer vent ducting was secure at time of inspection. Recommend monitoring and repair as needed, as well as cleaning up the lint behind the dryer to prevent a fire hazard.

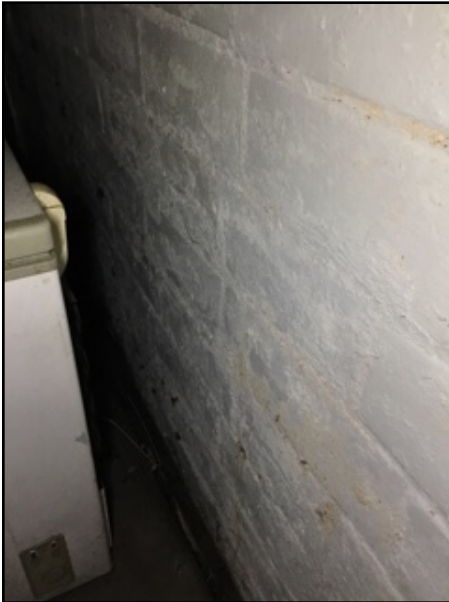
Figure 45-1

Typical efflorescence and moisture staining present at interior foundation walls. Recommend monitoring and repair as needed, as well as any exterior water control measures as needed, such as ensuring the gutters and downspouts are draining properly and the soil grading around the house is sloping away from the foundation walls.

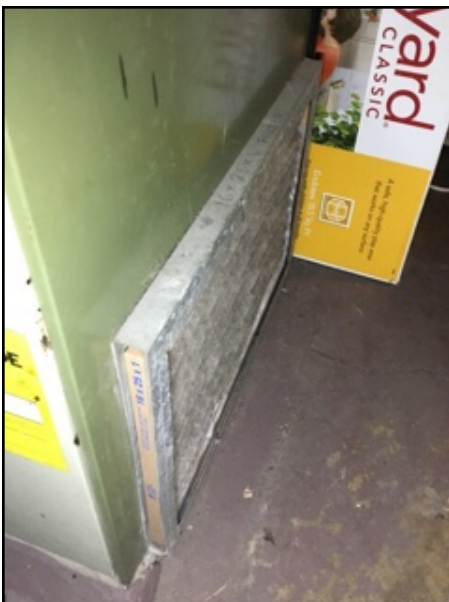
Figure 47-1

Air filter needs replaced. Recommend replacing with a new air filter.

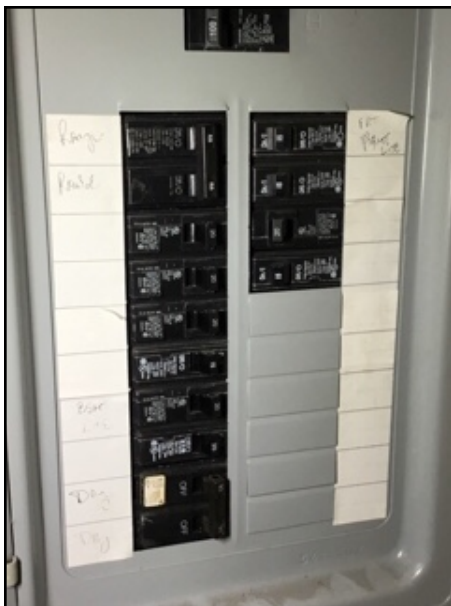
Figure 53-1

Comment 53:
Electrical panel is not properly labeled. Recommend properly labeling panel.

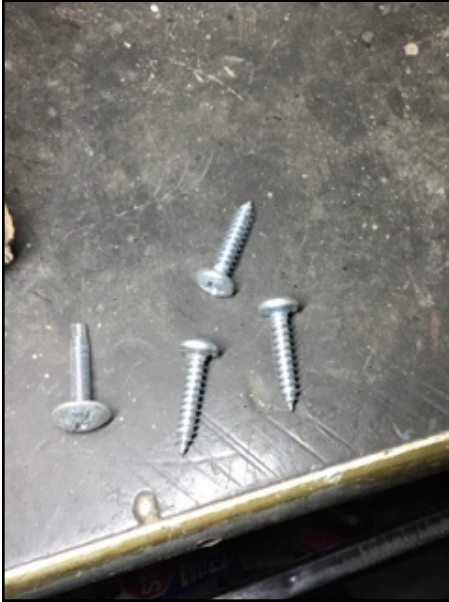
Figure 54-1

**Comment 54:**
Improper screws used at electrical panel cover. Safety Hazard. Recommend replacing with the proper flat-tipped panel screws.

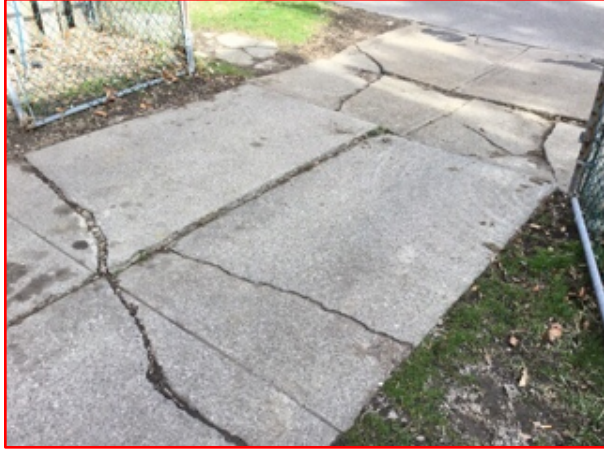
Figure 2-1

1) Large settling cracks and settling present at driveway creating potential trip hazards. Safety Hazard. Recommend repairs.

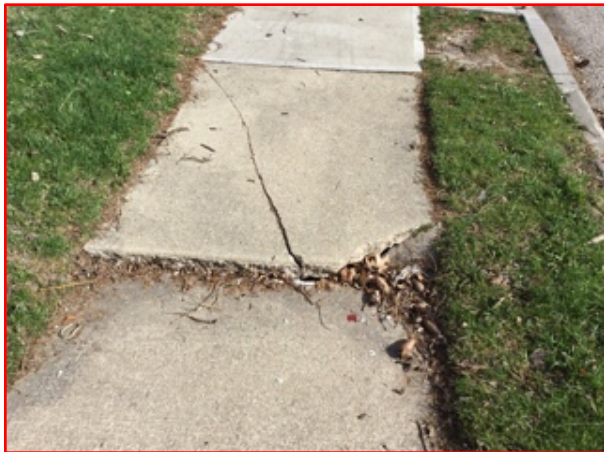
Figure 3-1

2) Settled section of front sidewalk creating a potential trip hazard. Safety Hazard. Recommend contacting the city to see if they will repair this.

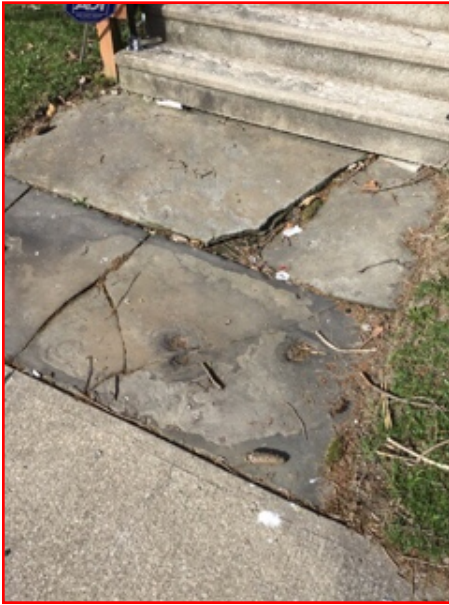
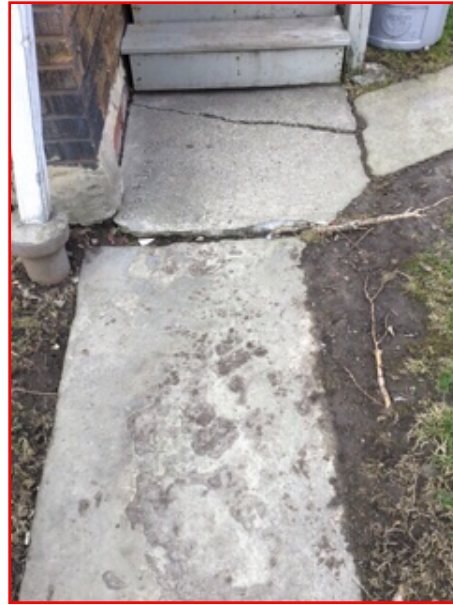
3) Cracking and settling at service walks around house creating potential trip hazards. Safety Hazard. Recommend repairs.

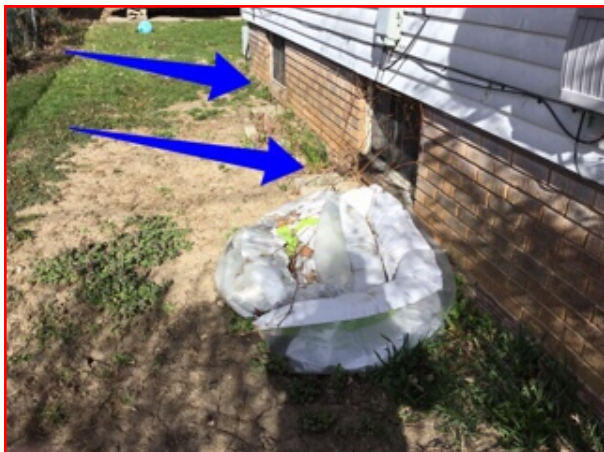
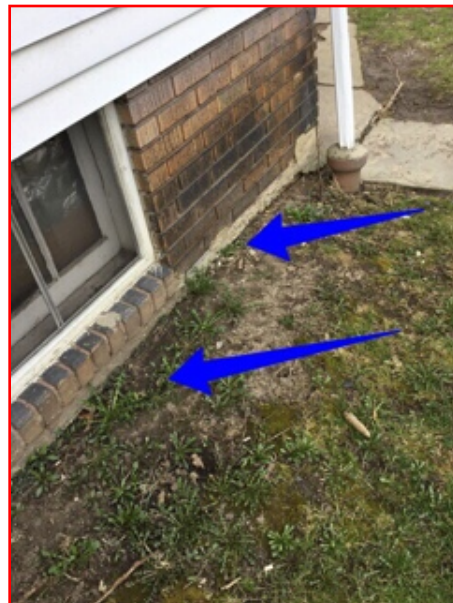
4) Negative soil grades present at several areas around house. Recommend adding additional hard-packed topsoil around the foundation to prevent moisture intrusion along foundation walls.

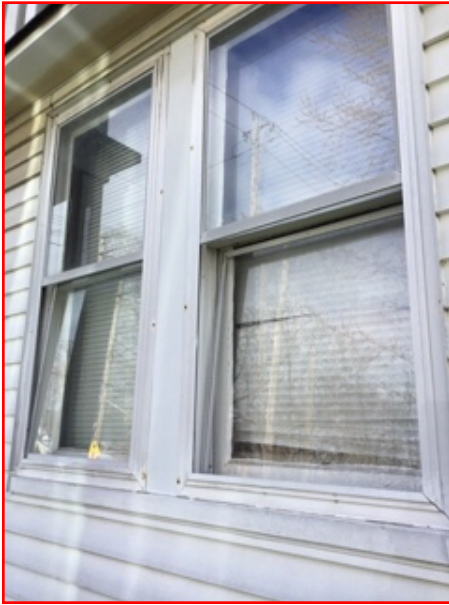
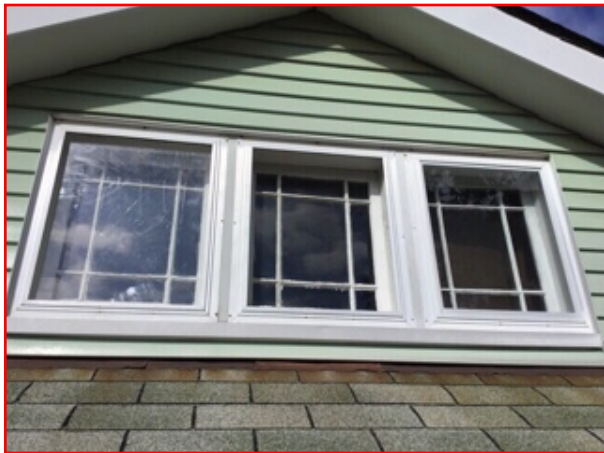
5) Storm window panes out of place or missing at several of the storm windows. Recommend repairs.

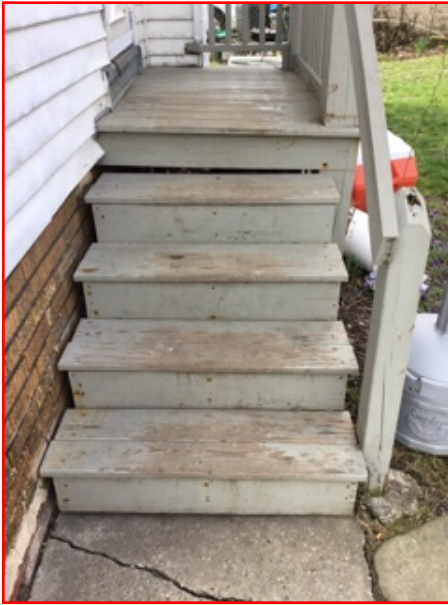
Figure 7-1

6) Rear porch wood is weathered. Recommend painting or staining to prevent further deterioration.

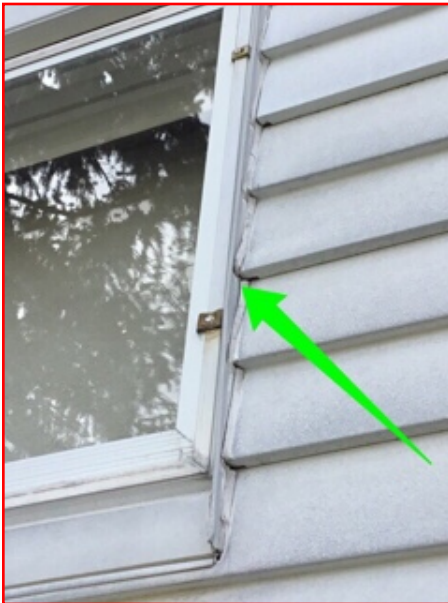
Figure 8-1

7) Typical caulking maintenance needed around windows and trim. Recommend sealing areas as needed.

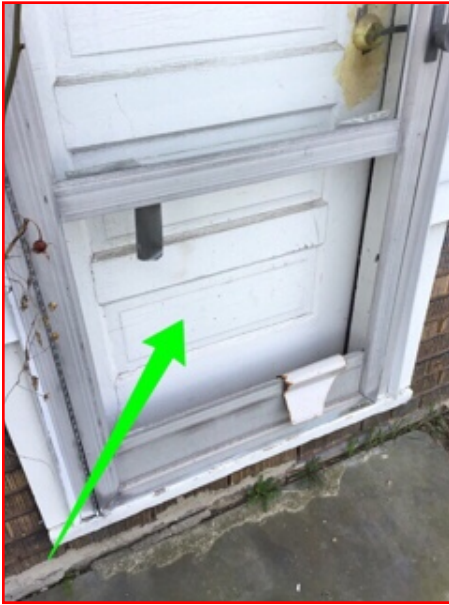
Figure 9-1

8) Side storm door is missing lower glass pane. Recommend repairs as needed.

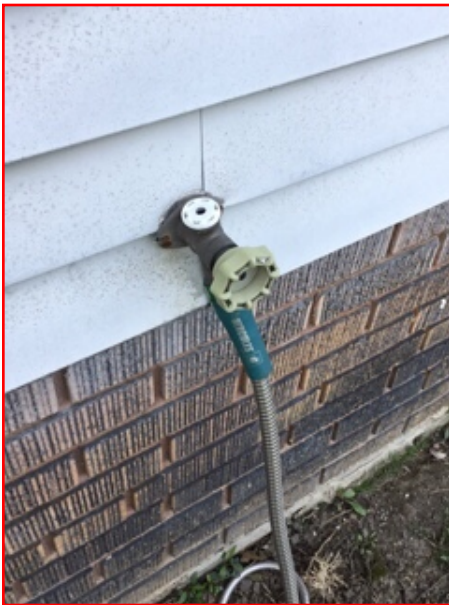
Figure 10-1

9) Hose bib at side of house is not securely fastened. Recommend fastening securely.

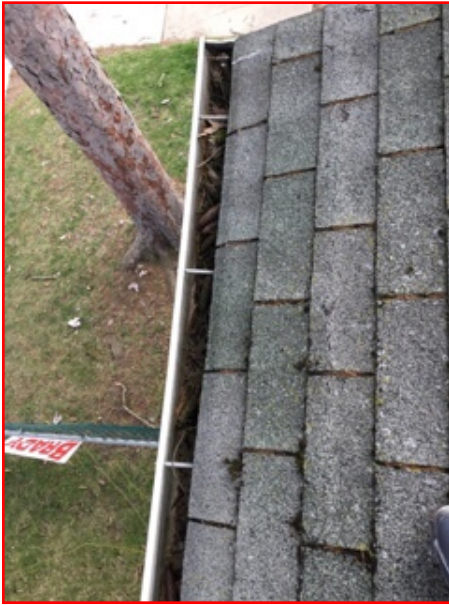
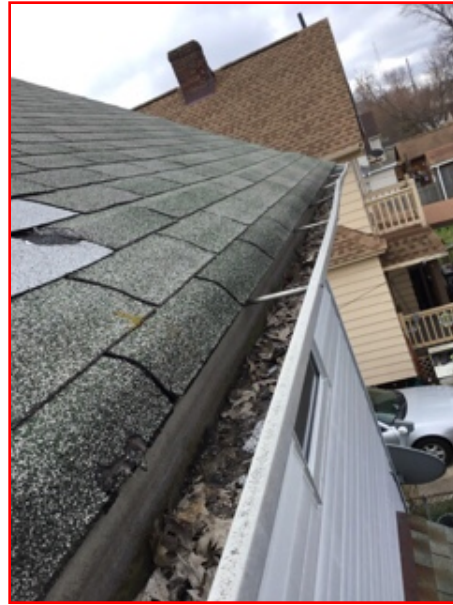
10) Gutters need cleaned out. Recommend cleaning out gutters to ensure proper water drainage.

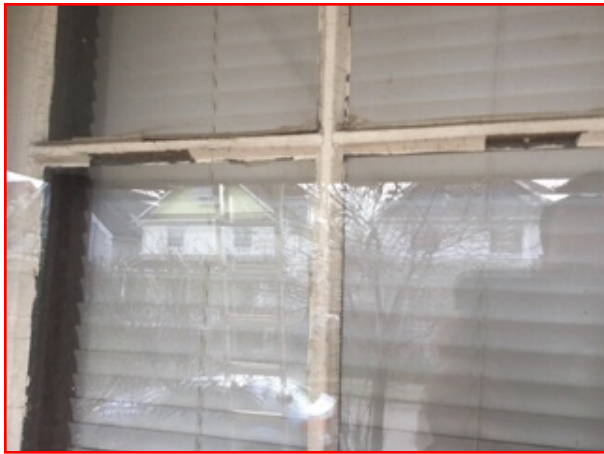
Figure 12-1

11) Cracked and missing window glazing present at several windows. Recommend monitoring and repair or replace as needed.

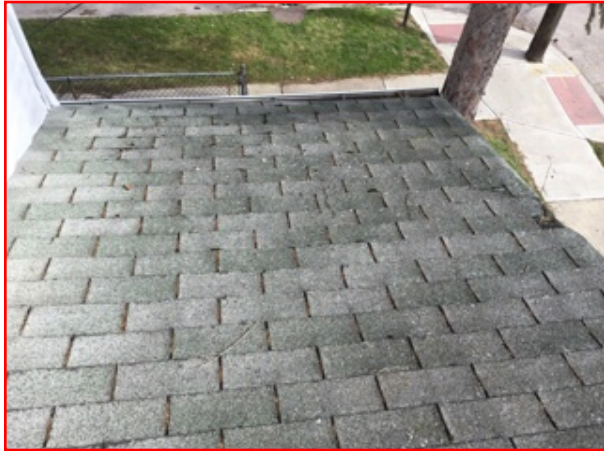
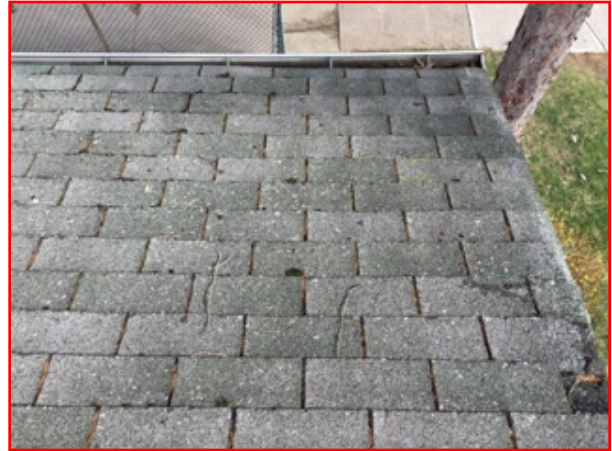
12) Moss, algae, and lichen developing at front porch roof. Recommend treating affected areas to prevent premature deterioration of roofing shingles.

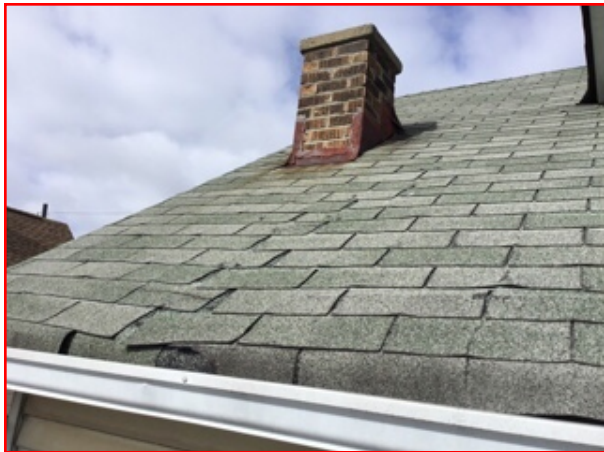
Figure 16-1

13) Shingle spreading present at front of roof. No structural evidence of the roof spreading. This may have been done during installation. Recommend monitoring and repair or replace as needed.

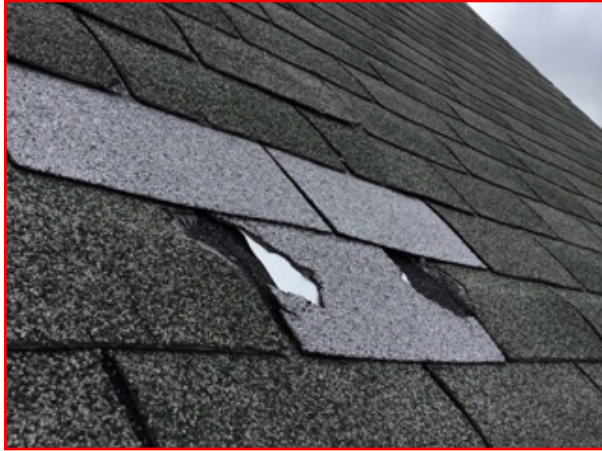
Figure 17-1

14) Previous repair present with damage to shingles at rear roof. Does not appear to be leaking at the moment, but this damaged area should be repaired.

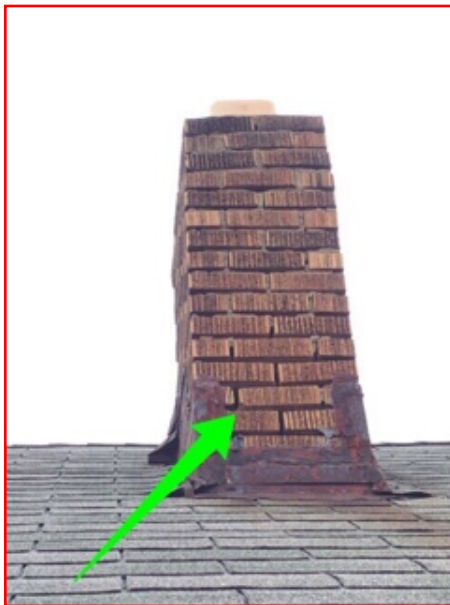
Figure 20-1

15) Deteriorated and/or missing mortar joints at rear chimney. Recommend tuck pointing repairs.

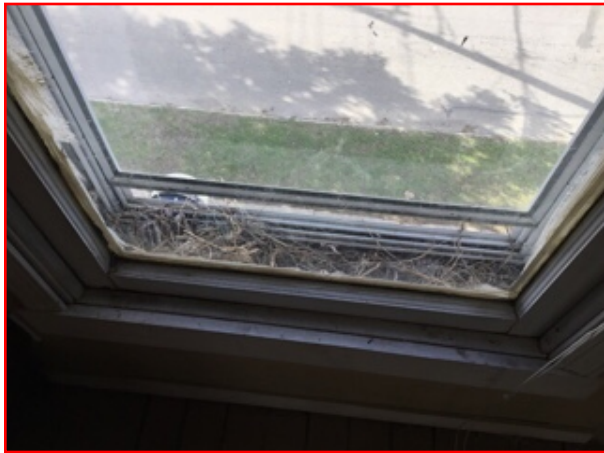
Figure 22-1

16) Nesting materials present in 3rd floor window sill due to storm window not being fully closed. Recommend cleaning out nesting material and properly closing storm window.

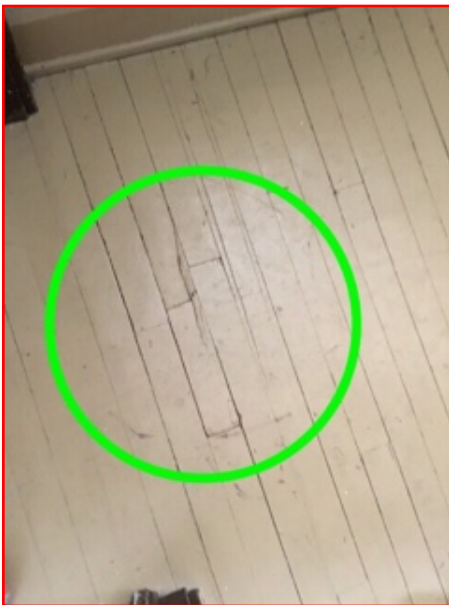
Figure 23-1

17) Spongy section of flooring present at 2nd floor hallway near entrance to bathroom. Recommend repairs as needed.

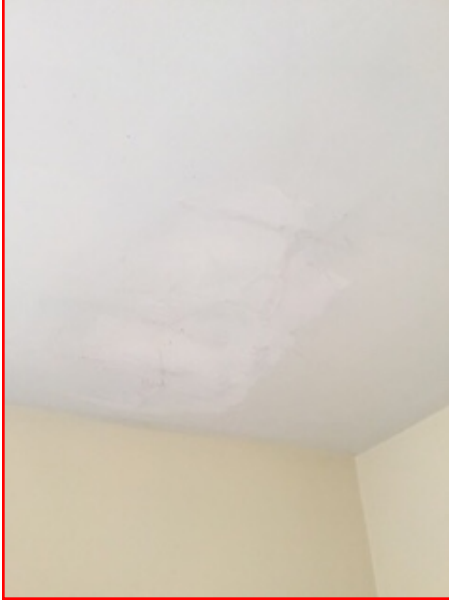
Figure 26-1

18) Previous repair made to bedroom ceiling. Recommend monitoring and repair further as needed.

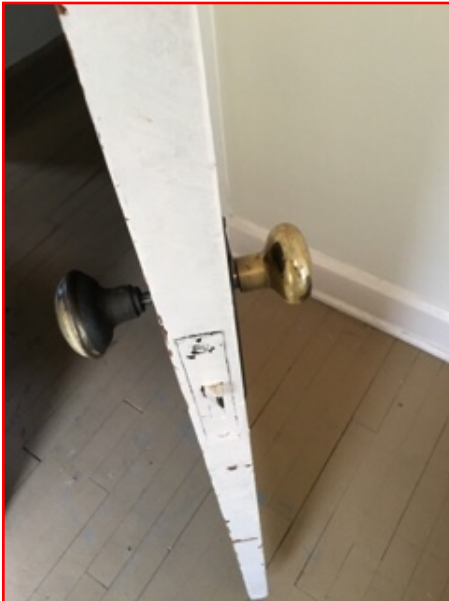
Figure 27-1

19) Damaged/loose door knob. Recommend replacing.

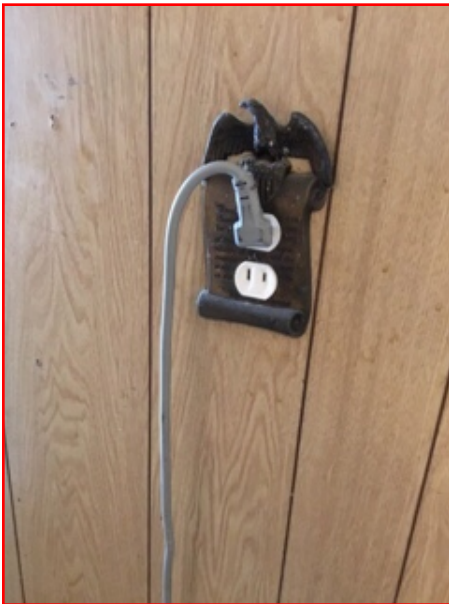
Figure 32-1

20) Ungrounded appliance outlet. Safety Hazard. Recommend repair.

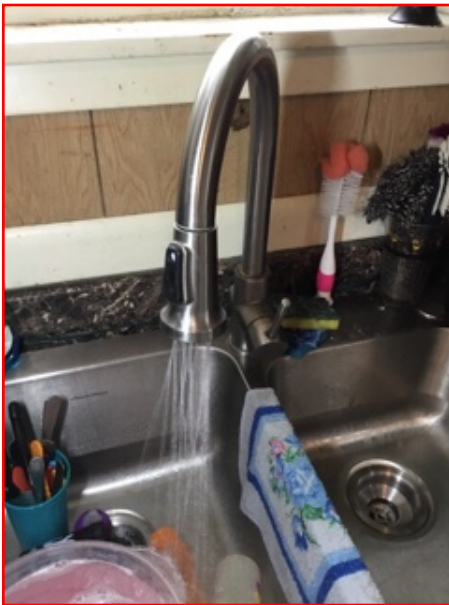
Figure 33-1

21) Kitchen sink faucet no longer alternates from stream to spray mode. Stuck in spray mode. Recommend replacing faucet as needed.

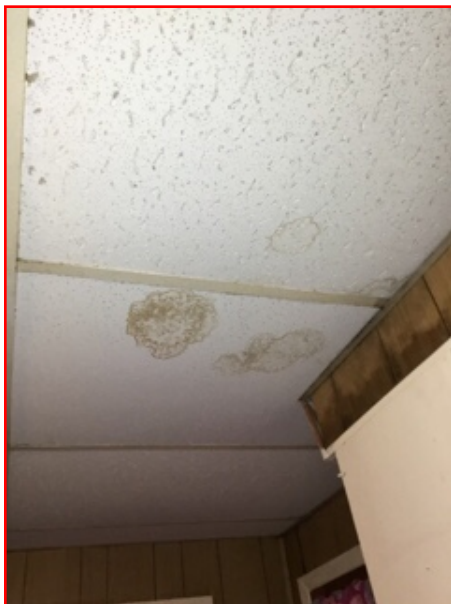
Figure 34-1

22) Moisture stains present at kitchen drop ceiling panels. No active moisture present at time of inspection. Recommend monitoring and repair as needed.

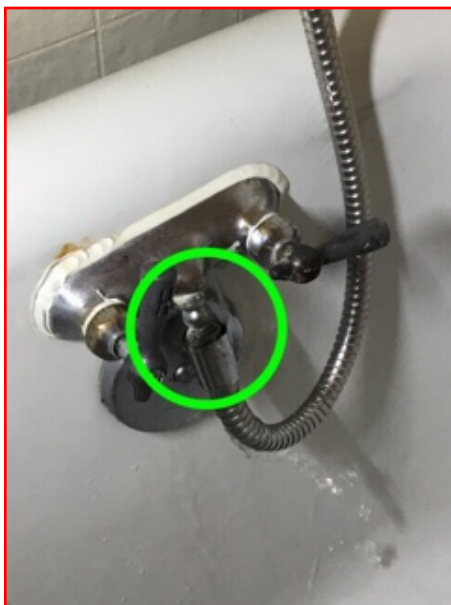
Figure 37-1

23) No tub faucet present. Shower hose connection leaks. Recommend repairing or replacing.

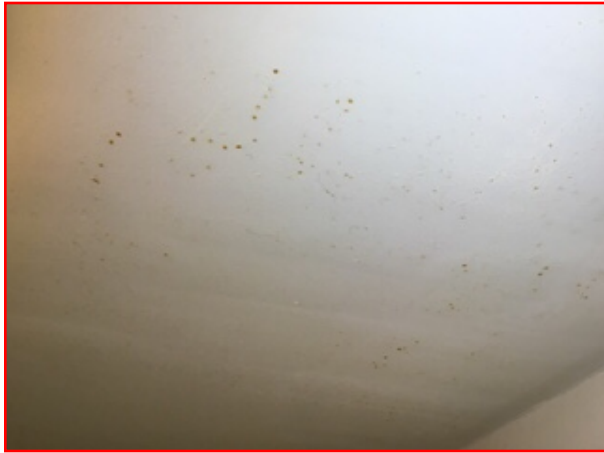
Figure 38-1

24) Moisture stains present at bathroom ceiling. Recommend adding an exhaust fan to minimize moisture.

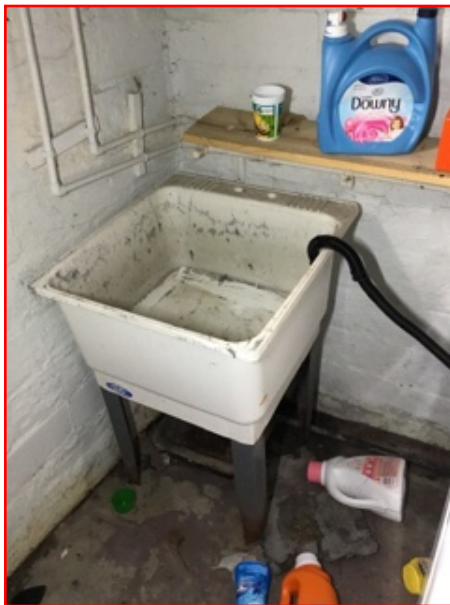
Figure 40-1

25) Utility sink is not properly secured and is missing a faucet. Recommend repairs as needed.

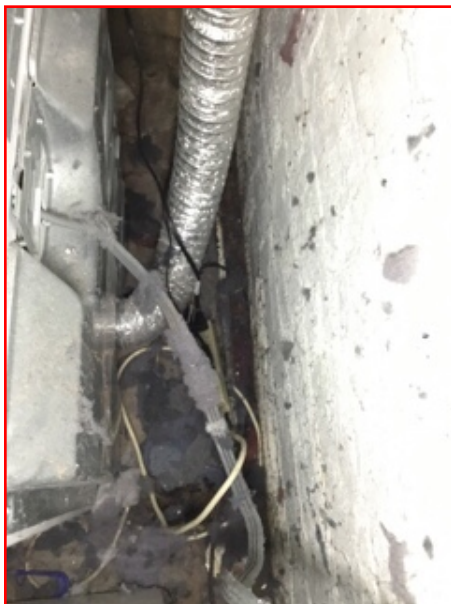
Figure 41-1

26) Excessive amount of laundry lint behind dryer. Dryer vent ducting was secure at time of inspection. Recommend monitoring and repair as needed, as well as cleaning up the lint behind the dryer to prevent a fire hazard.

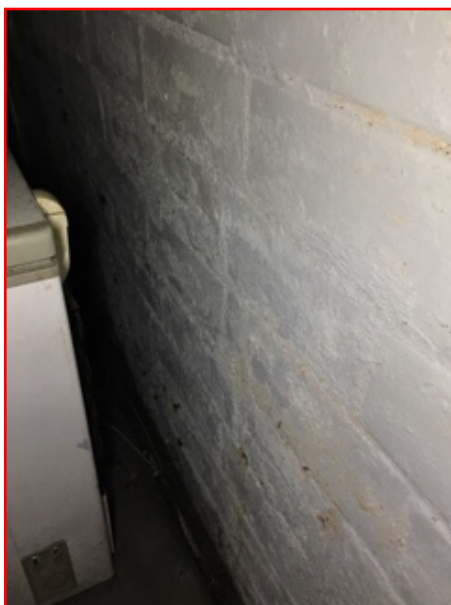
Figure 45-1

27) Typical efflorescence and moisture staining present at interior foundation walls. Recommend monitoring and repair as needed, as well as any exterior water control measures as needed, such as ensuring the gutters and downspouts are draining properly and the soil grading around the house is sloping away from the foundation walls.

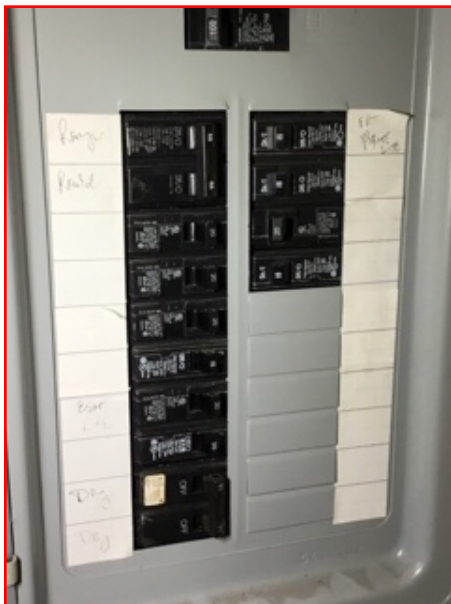
Figure 53-1

28) Electrical panel is not properly labeled. Recommend properly labeling panel.

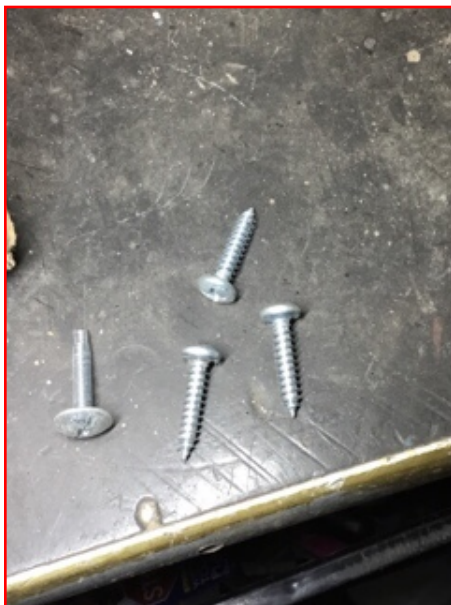
Figure 54-1

29) Improper screws used at electrical panel cover. Safety Hazard. Recommend replacing with the proper flat-tipped panel screws.
