Home Inspection Report

Alabama Home InspeXions, LLC

12:16 September 29, 2020

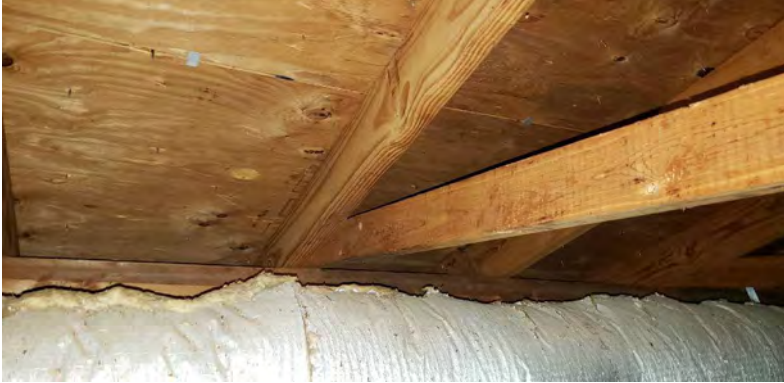
Ventilation: Soffit vents - Recommend additional ventilation be installed. The ridge vent was not properly opened during installation. Recommend properly venting the ridge cap.

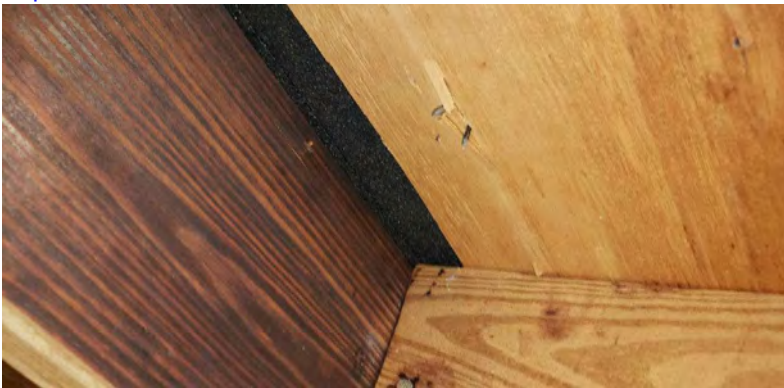
Satisfactory, Marginal Insulation: Fiber fill - Insulation compressed. Recommend installing an insulated access door. This with help with energy efficiency.

Missing insulation over the laundry room area where past repairs were made. Recommend installing..

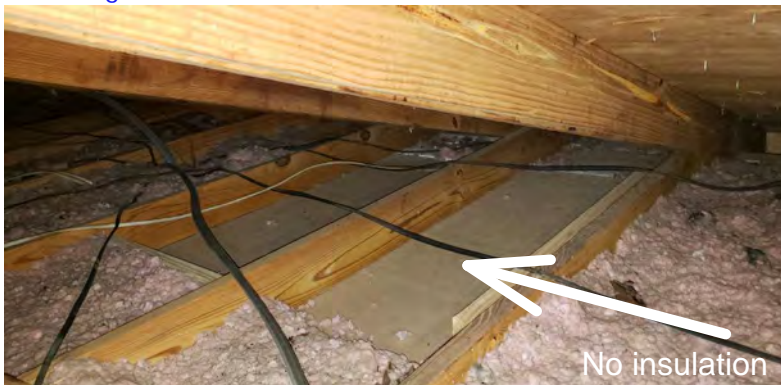
Insulation Depth: 1"-3" - Insulation compressed. Recommend redistributing the insulation evenly. Recommend additional insulation be installed.

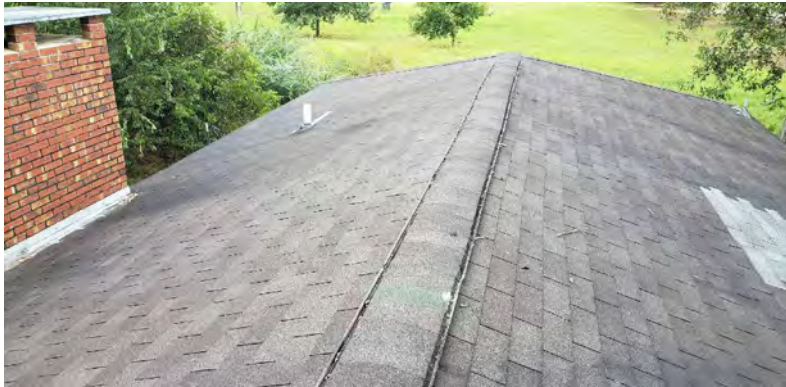
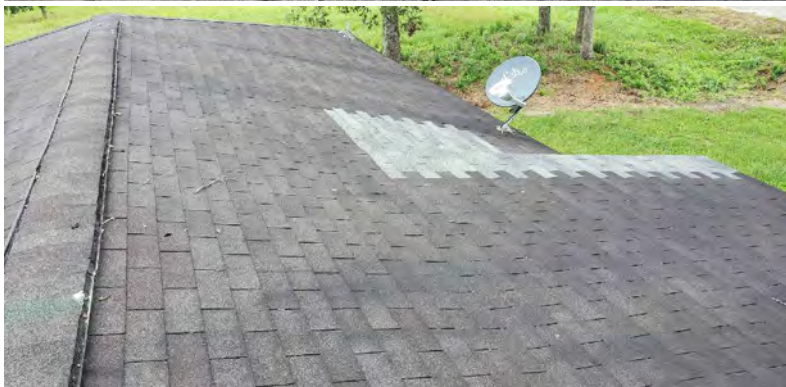
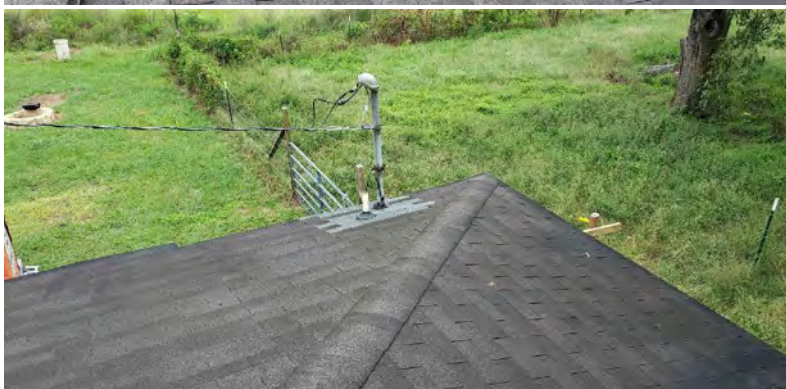
Material: Asphalt shingle - It appears that recent roof maintenance has been completed and appears satisfactory. Recommend requesting a copy of the repair invoice for future reference and possible warranty information.

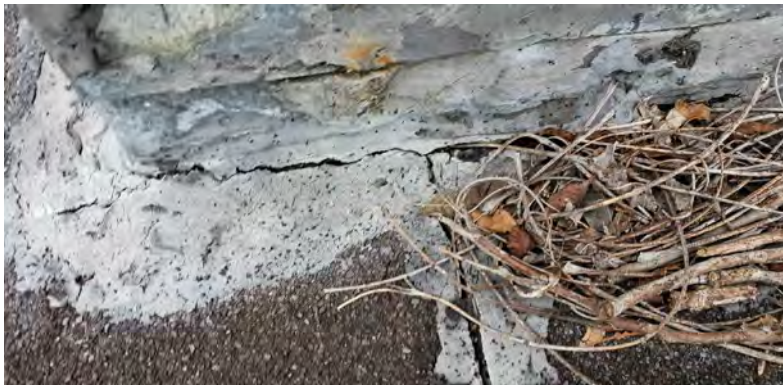
Satisfactory, Marginal Flue/Flue Cap: Metal - [Recommend installing a screen to prevent animals from entering the chimney.](#)

Satisfactory, Marginal Chimney Flashing: Metal - [Dry rot and loose sealant. Recommend sealing flashing. No active leak detected.](#)

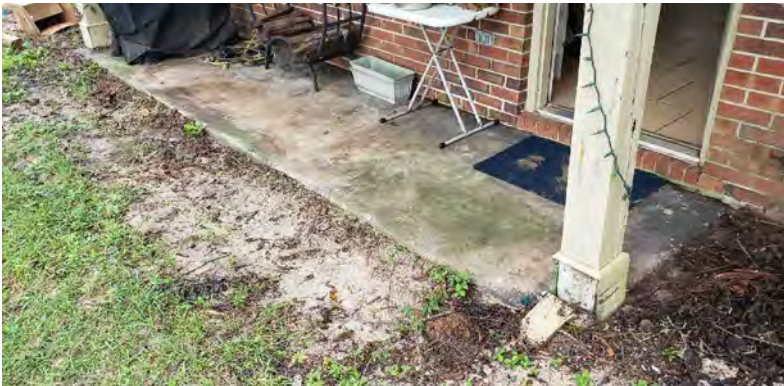
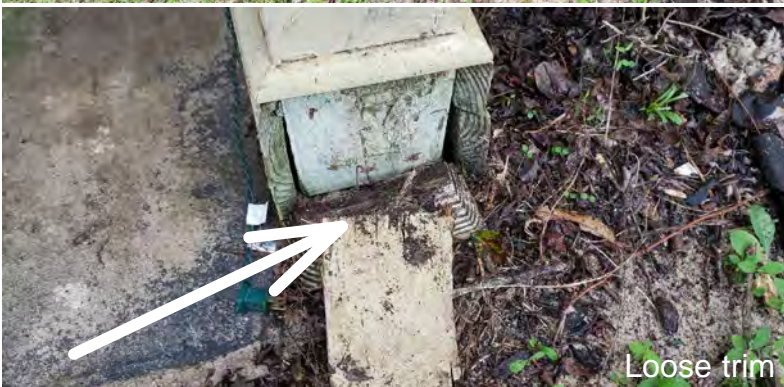
Satisfactory, Marginal Fences: Wire - [Trees and shrubbery have grown into the fence. Recommend removing.](#)

Satisfactory Porch: Concrete - [Recommend re attaching the loose trim.](#)

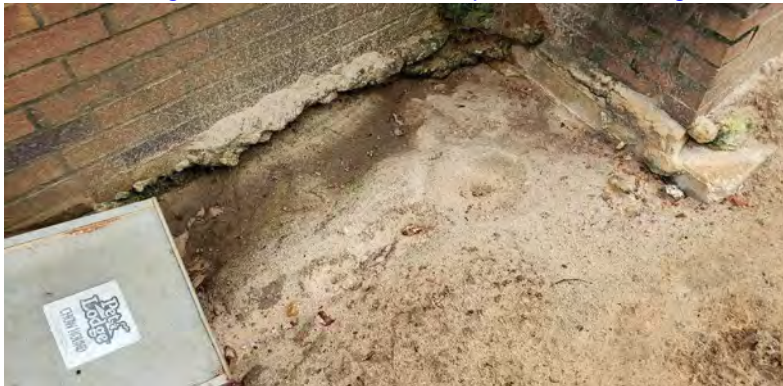
Satisfactory, Marginal Grading: Flat, Minor slope - Grading has negative slope and water is pooling against the foundation. We recommend evaluation by a licensed contractor to determine your best course of action.

Many dig holes from pets. Recommend filling the holes and planting grass.

Gutters would help control the rain water run off from the roof. This will help prevent water from standing at the foundation and possible entering the structure.

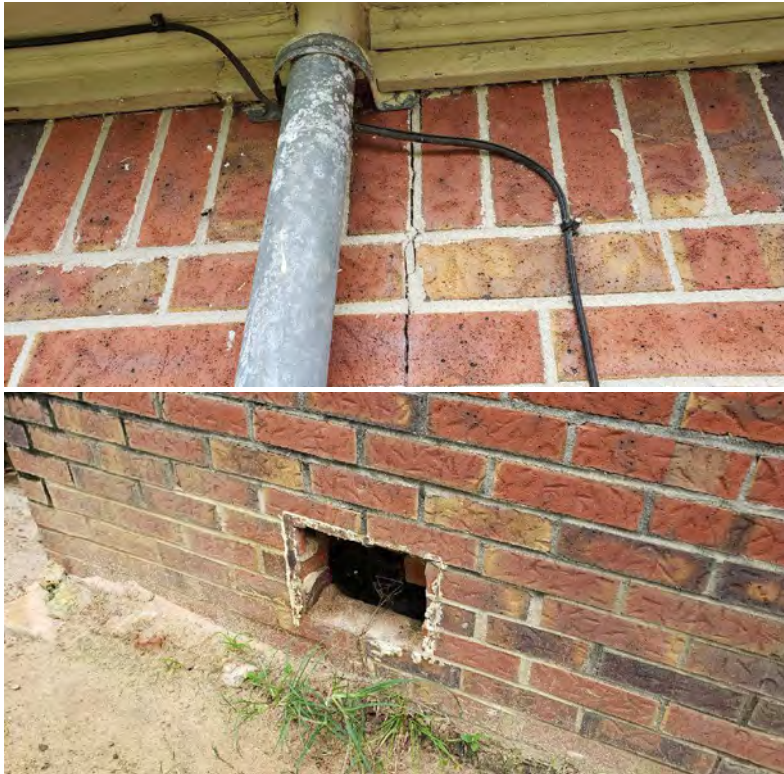
Satisfactory, Marginal Exterior Surface Brick [Typical step cracks noted. Recommend tuck point masonry repairs. See photos.](#)

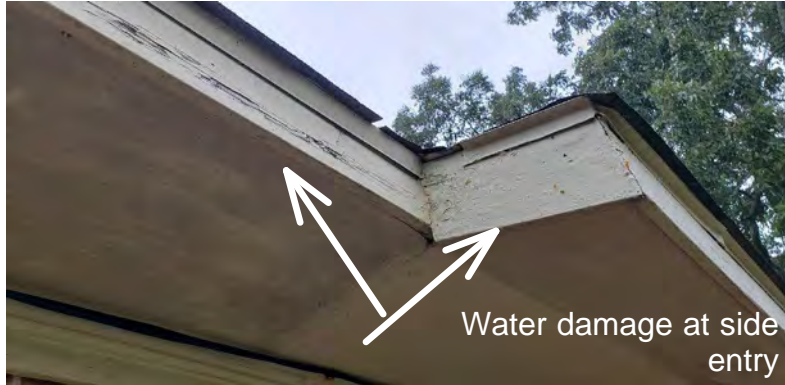
Satisfactory, Marginal Fascia: Wood - [Wood rot. Recommend repair to the water damaged wood.](#)

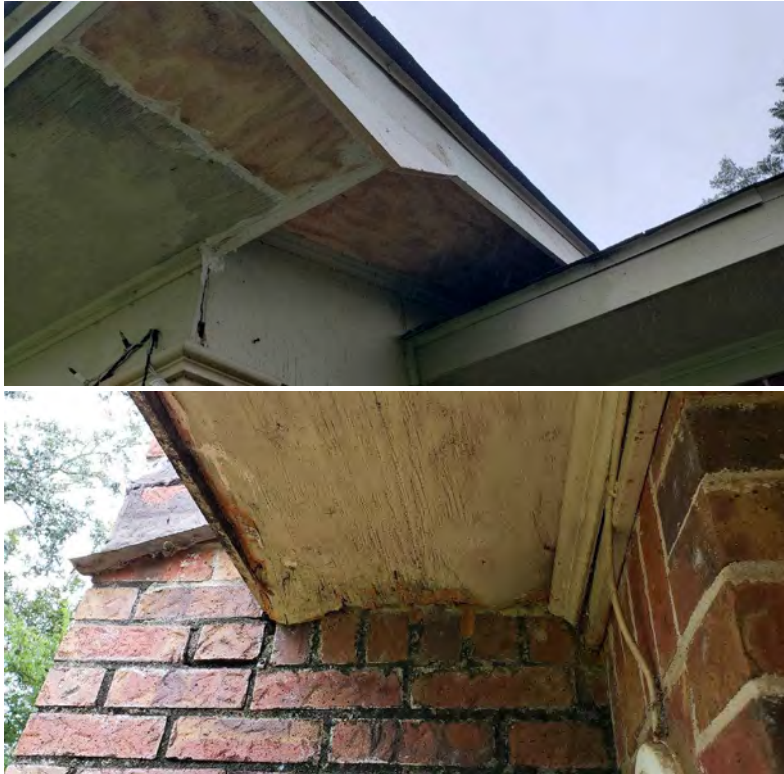
Satisfactory, Marginal Soffits: Wood - [Recommend painting all exposed wood.](#)

[Wood rot and water damage at the chimney chase area. Recommend repair and painting.](#)

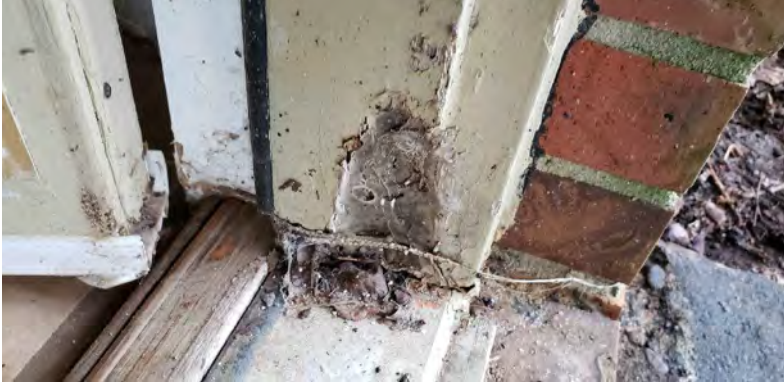
Entry Doors: Metal - Wood rot present at the door jamb. Recommend repair or replacement of the damaged wood.

The door rubs when operated. Recommend adjusting the door for a smooth closure.

Recommend installing a peep hole for safety.

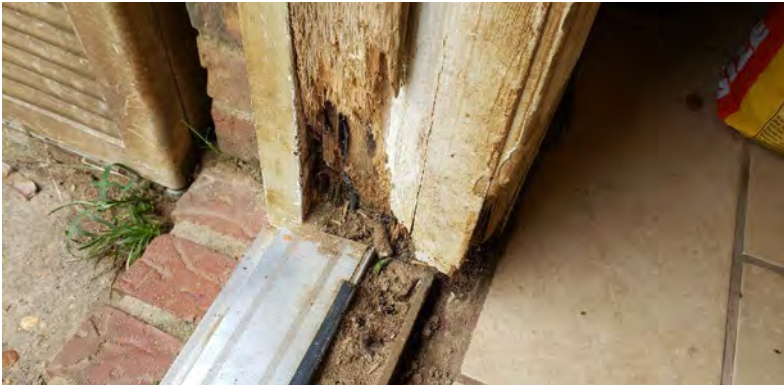
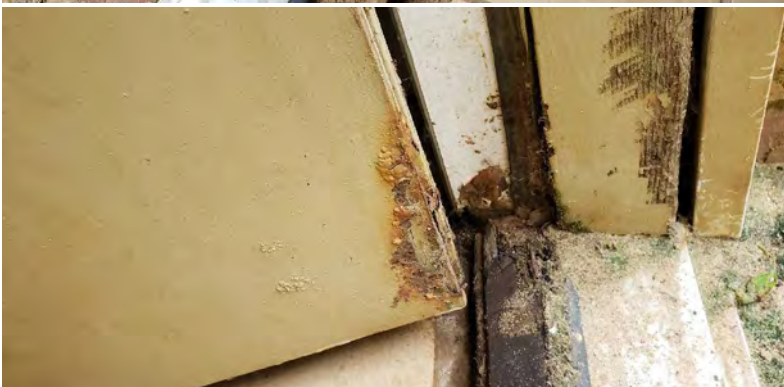
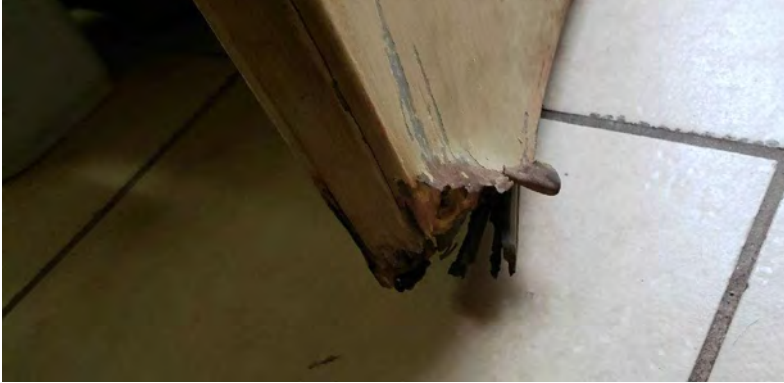
Poor Patio Door: Metal and glass entry door - Gaps in the weatherstripping. Recommend repair.

Lower door seal is loose/damaged. Recommend repair.

Metal is rusting. Recommend sanding and painting.

Wood rot at the door and jamb area. Recommend repair or replacement.

Pet damage on the framing. Recommend repair and painting.

May require replacement.

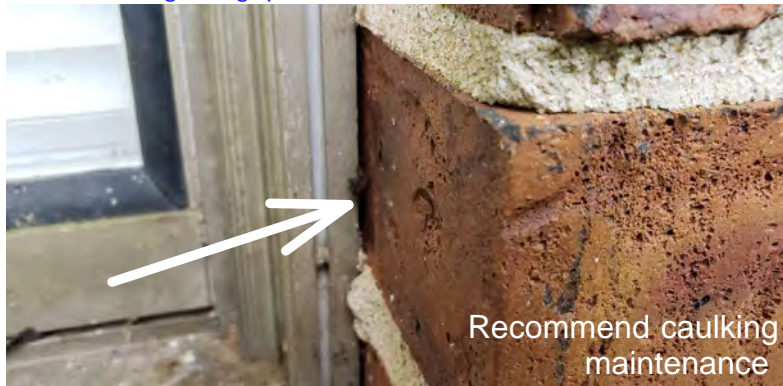
Satisfactory, Marginal Side Entry Door: Metal and glass entry door - Metal is rusting. Recommend sanding and painting.

Gaps in the weatherstripping. Recommend repair.

Satisfactory, Marginal Windows: Metal - Recommend re-caulking and including caulking as part of regular maintenance around all windows and doors. This will help prevent moisture, insects and spiders from entering the gaps.

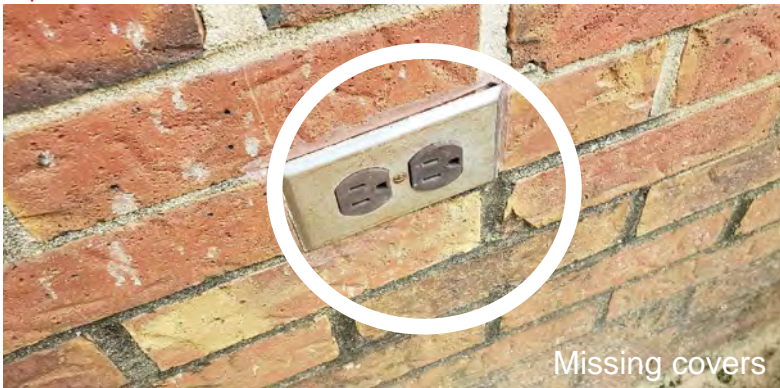
Satisfactory, Marginal Exterior Lighting: Surface mount - Bulbs missing or burned out at time of inspection, recommend replacing the bulbs and retesting. If the light still does not function repair or replacement may be necessary.

Missing cover. Recommend installing.

Satisfactory, Safety Hazard Exterior Electric Outlets: 110 VAC - **Non-GFCI receptacles.** GFCI protection was required when the home was built. Recommend a licensed electrical contractor evaluate and repair.

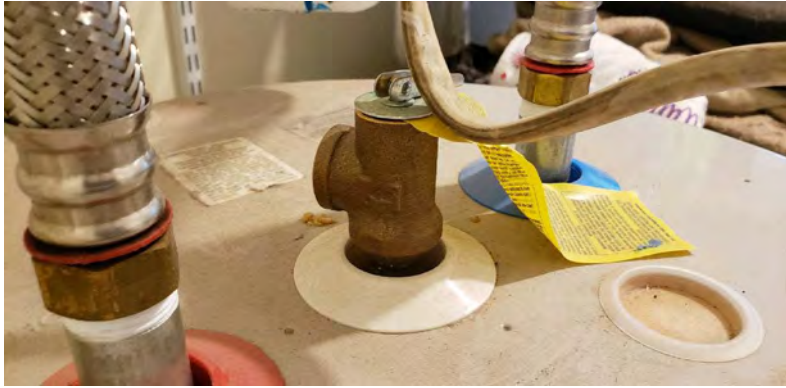
Safety Hazard TPRV and Drain Tube: Not installed. Drain tube opening is not within six inches of the floor, this is a burn hazard. Recommend a licensed plumber repair.

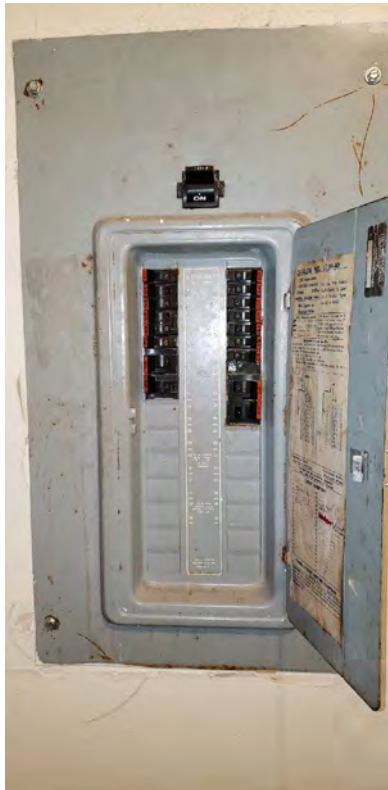
Satisfactory, Major Concerns Manufacturer: Federal Pacific - Federal Pacific panel breakers have had a history of not tripping when circuit overloading exists. Recommend the electrical panel and circuit breakers be evaluated by a licensed electrical contractor and any recommendations be followed.

The panel is not properly labeled. Recommend labeling the panel. Unable to determine proper breaker size, compatibility and independent circuits for installed electrical appliances and HVAC systems.

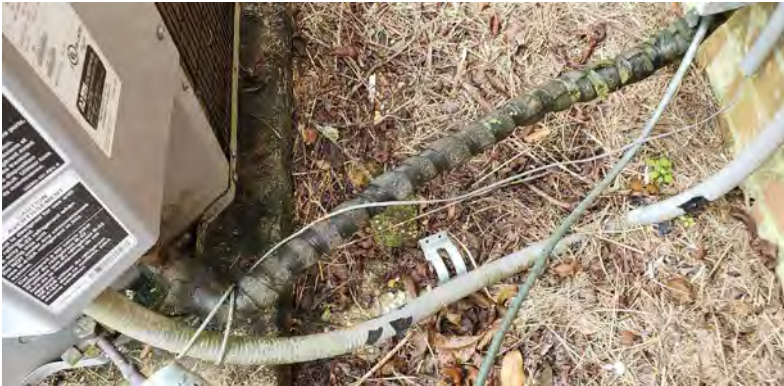
Satisfactory, Marginal Visible Coil: Copper core with aluminum fins - [Recommend cleaning the coil.](#)

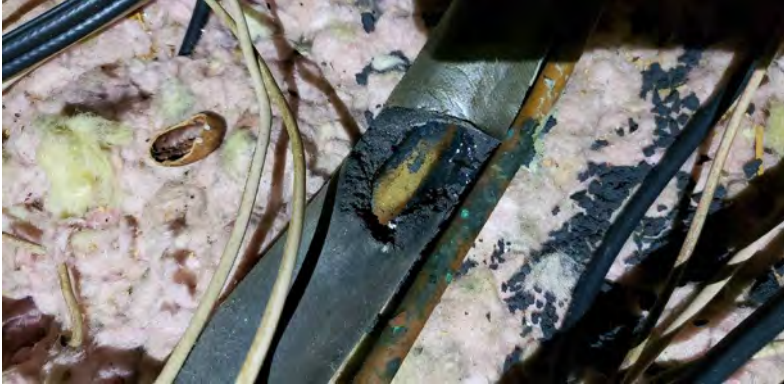
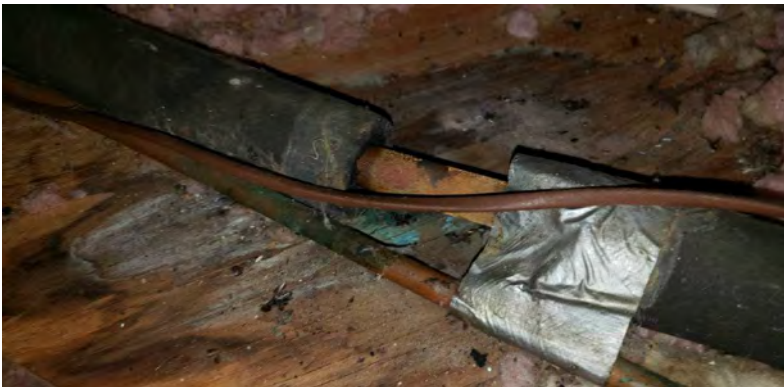
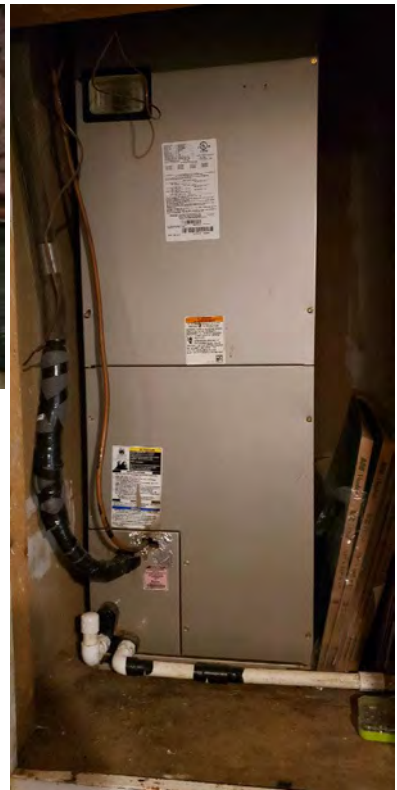
HVAC System Operation: Appears serviceable, functioned as designed. [Missing insulation on the cold lines in the attic. Recommend repair.](#)

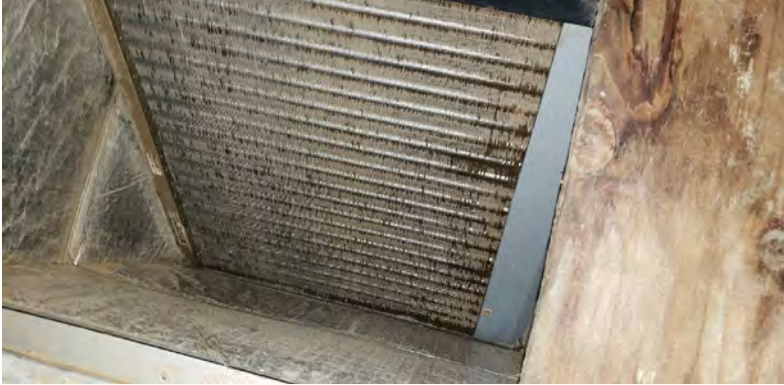
Marginal Visible Coil: Copper core with aluminum fins - [Recommend cleaning the coil.](#)

Satisfactory, Marginal Refrigerant Lines: Appear in serviceable condition. [Torn insulation in the attic, recommend repair.](#)

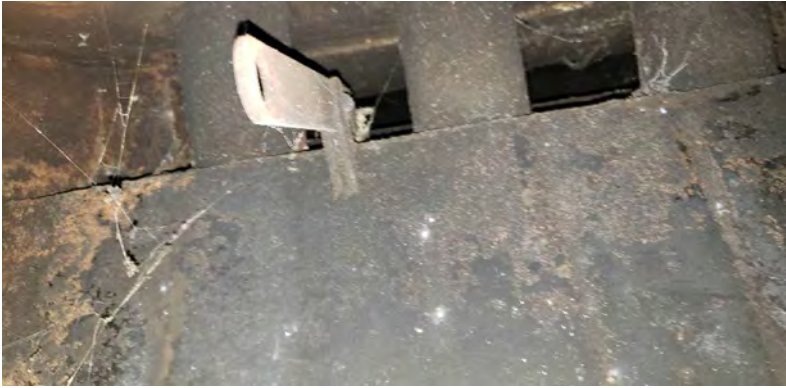
Marginal Flue: Tile - [Recommend qualified chimney sweep clean before use.](#)

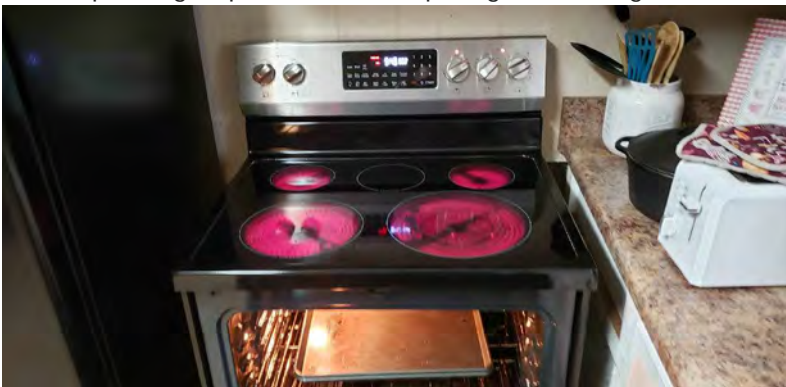
Satisfactory, Marginal Ventilator: Operational - [Recommend replacing light bulb.](#)

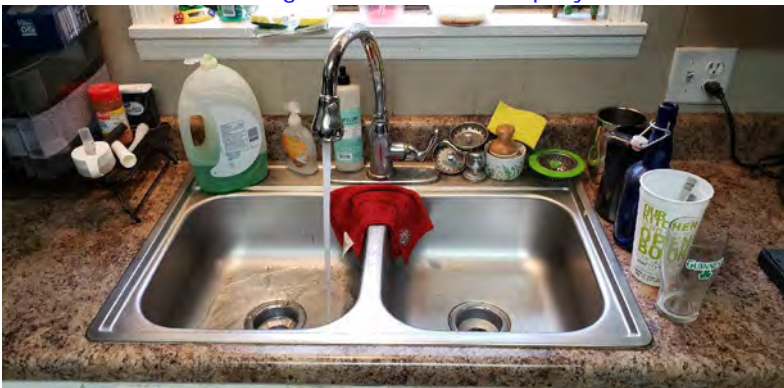
Sink & Fixtures: Stainless Steel, Single handle faucet with spray nozzle , Soap Dispenser - [Spray nozzle would not change from stream to spray.](#)

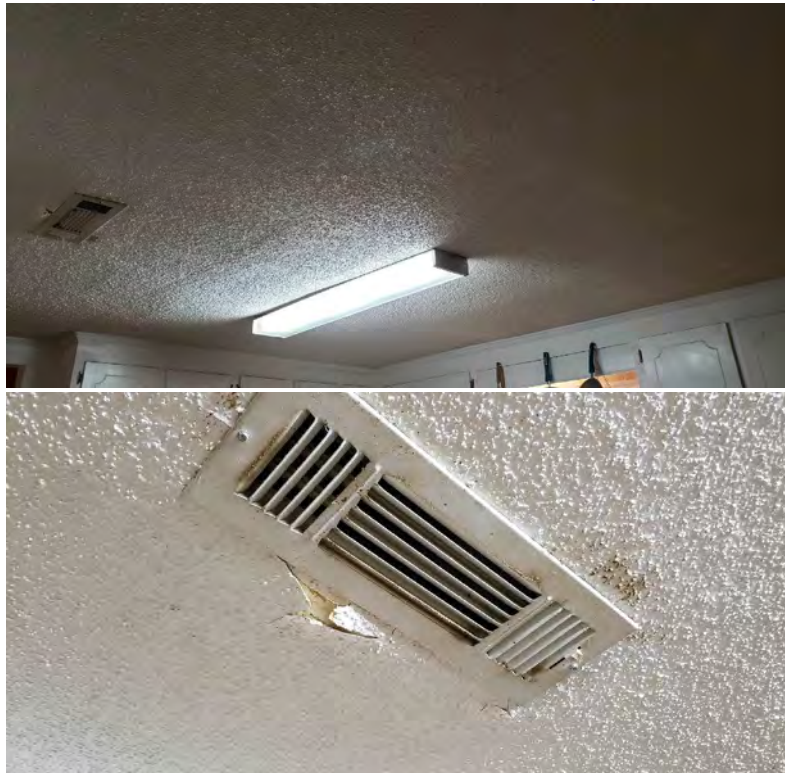
Satisfactory, Marginal Ceiling: Drywall - [Loose or peeling paint](#). [Recommend painting](#).

[Evidence of past water staining. Moisture testing was conducted in multiple locations and no active leak was detected at the time of the inspection.](#)

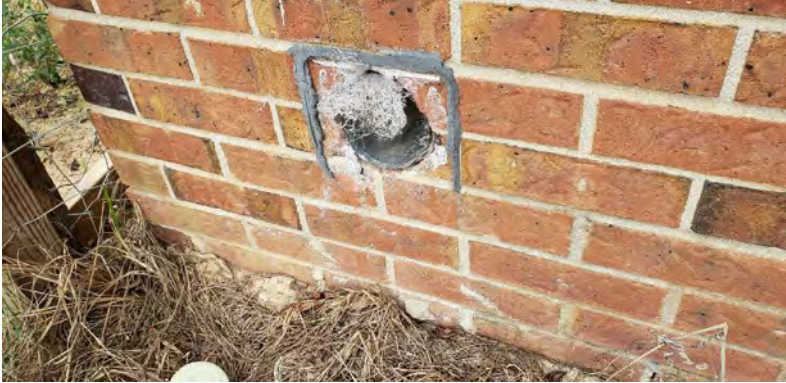
Dryer Vent: Not visible - [Missing small animal cover, recommend installing.](#)

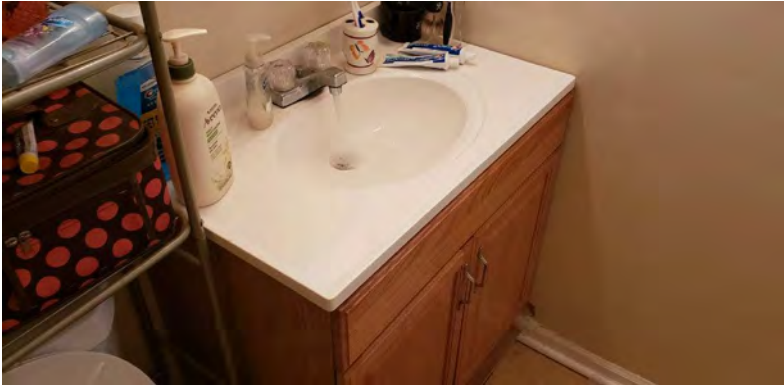
Satisfactory, Marginal Sink / Basin Molded dual bowl - Slow draining. Recommend cleaning the drain and retesting. Stopper not holding water.

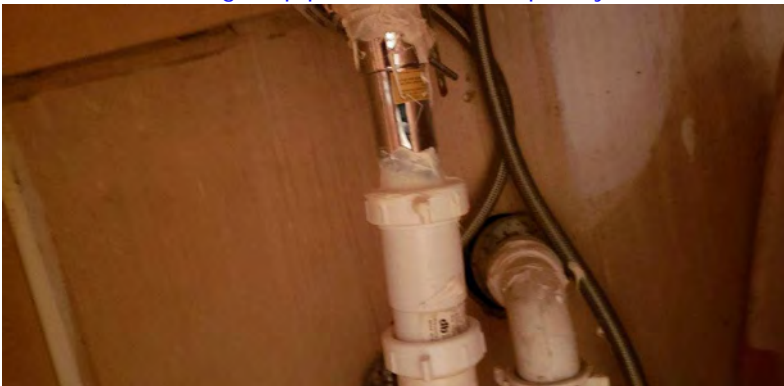
Marginal Faucets / Trap / Plumbing Dual handled Faucet. Hardware is loose. Recommend securing. Excessive caulking on pipes. This is a temporary solution. Recommend proper repair.

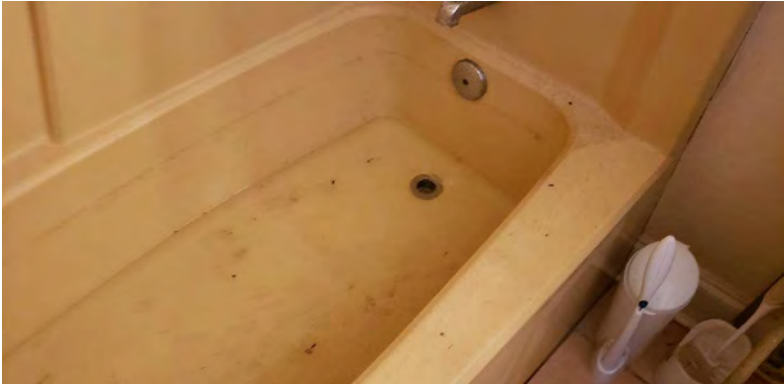
Tub Plumbing Dual Handled Faucet - [Slow draining. Recommend cleaning the drain and retesting.](#)

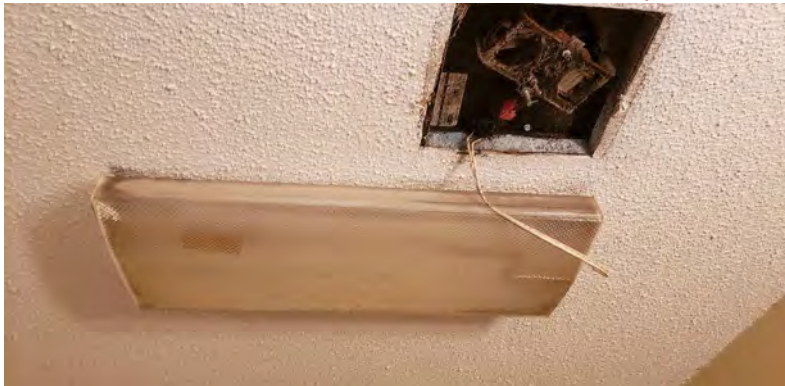
Toilets: Floor Mount - **The toilet is loose at the floor, recommend resealing.**

Ventilation: Electric ventilation fan. **Missing covers.**

Unsafe electrical wiring.

Recommend a licensed contractor evaluate and repair.

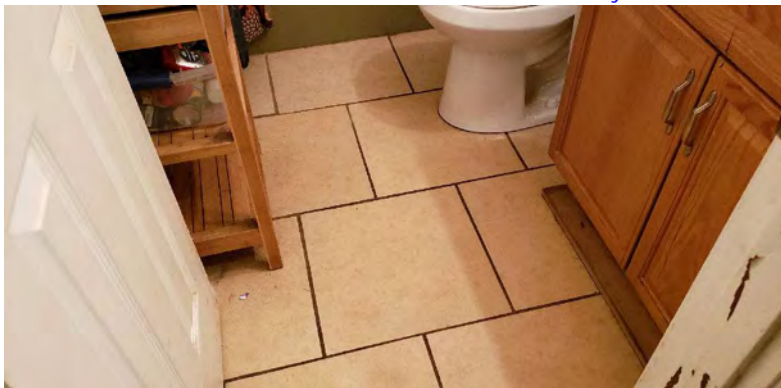
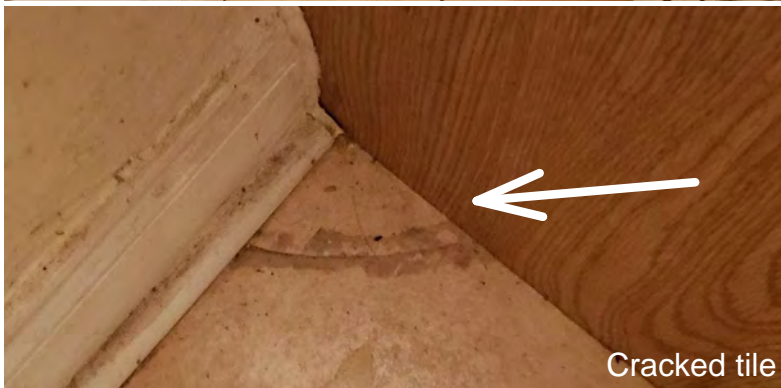
Satisfactory, Marginal Floor: Tile - [Cracked tile on the side of the vanity.](#) [Recommend repair.](#)

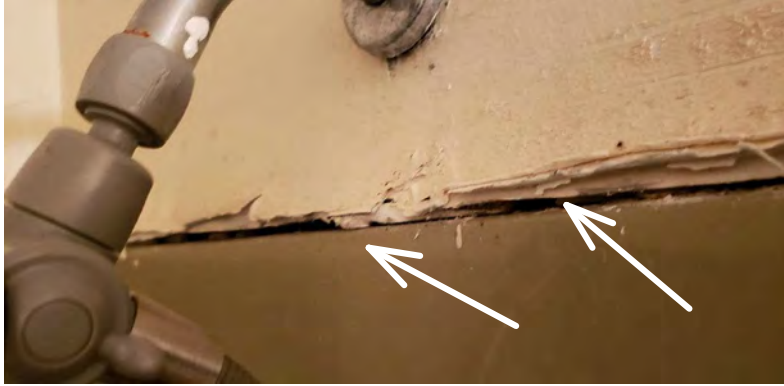
Satisfactory, Marginal Tub/Shower Combo Fiberglass/Acrylic Tub and Surround - [Recommend repair to drywall at the upper seam and caulking maintenance.](#)

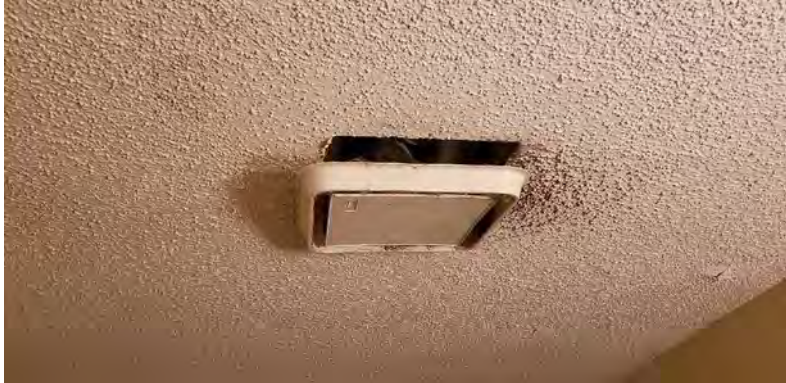
Toilets: Floor Mount - [The toilet is loose at the floor, recommend resealing.](#)

Ventilation: Electric ventilation fan. [Loose in the ceiling.](#) [Recommend repair.](#)

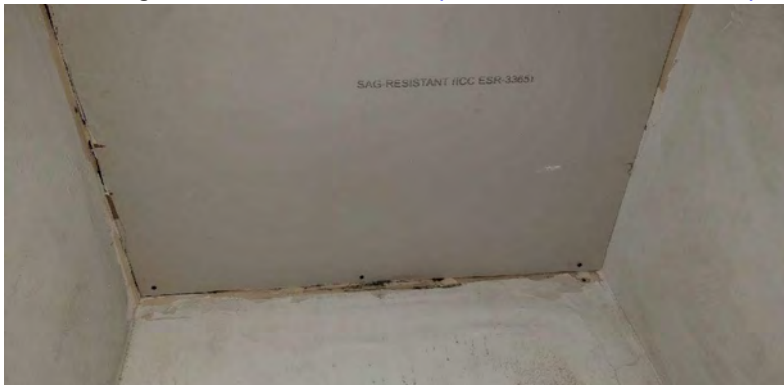
Satisfactory, Marginal Closet: Single Door - [Unfinished repairs.](#) [Recommend completing.](#)

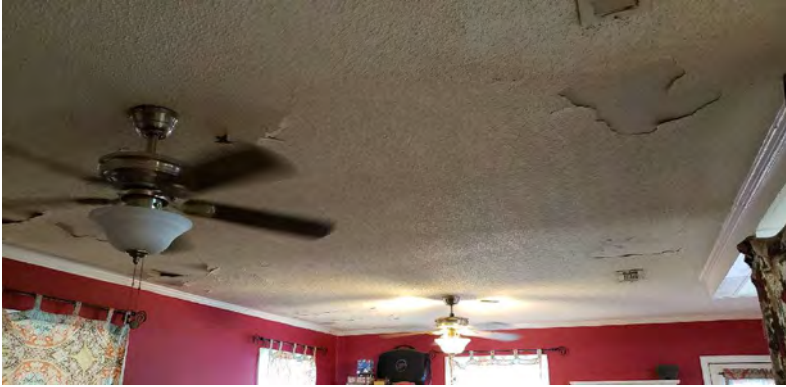
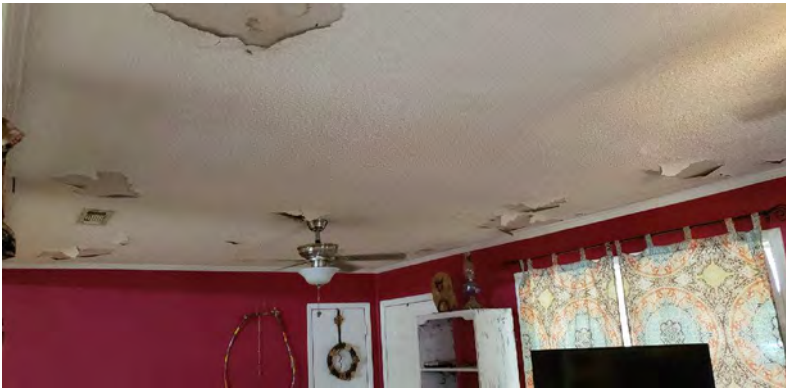
Ceiling: Drywall - Evidence of past water staining. Moisture testing was conducted in multiple locations and no active leak was detected at the time of the inspection.
Loose or peeling paint. Recommend painting.

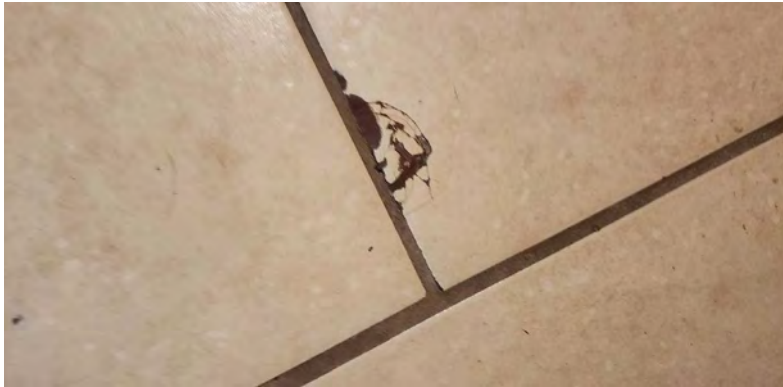
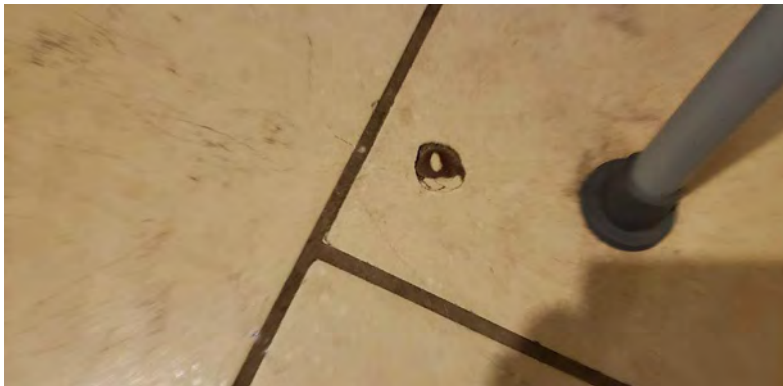
Satisfactory, Marginal Floor: Tile - [Chipped tiles](#). [Recommend repair](#)

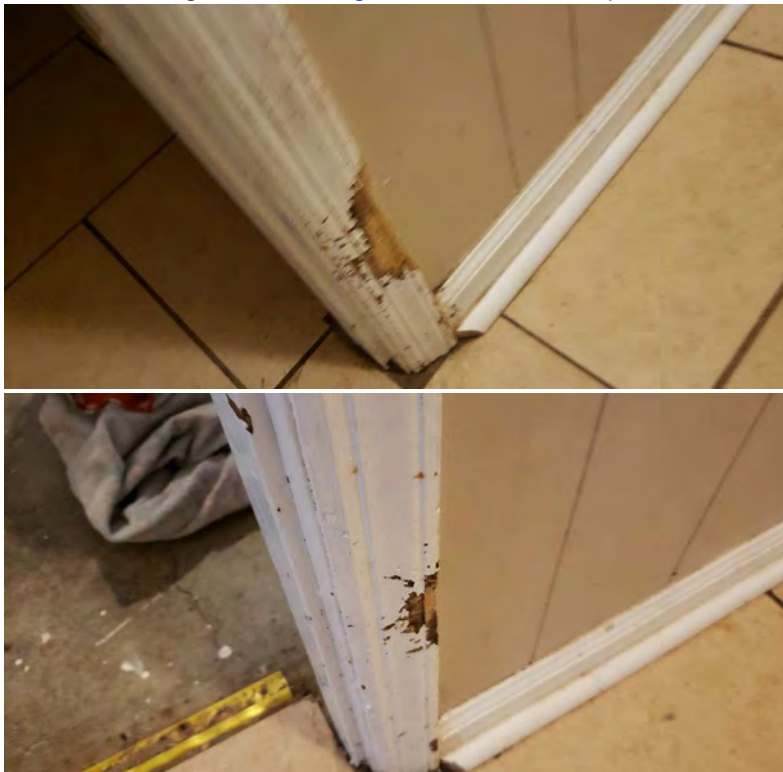
Satisfactory, Marginal Walls: Paneling - [Pet damage.](#) [Recommend repair.](#)

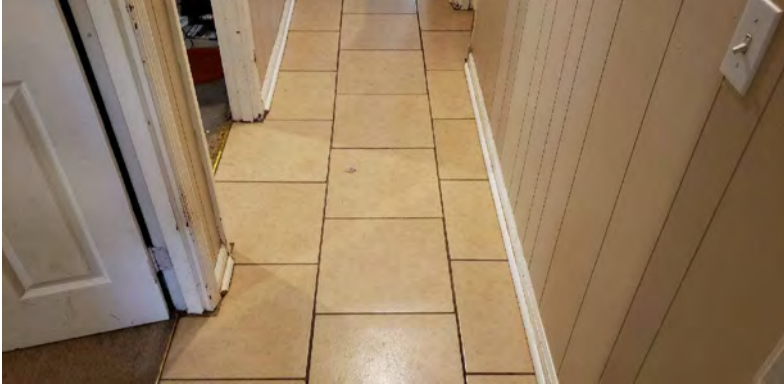
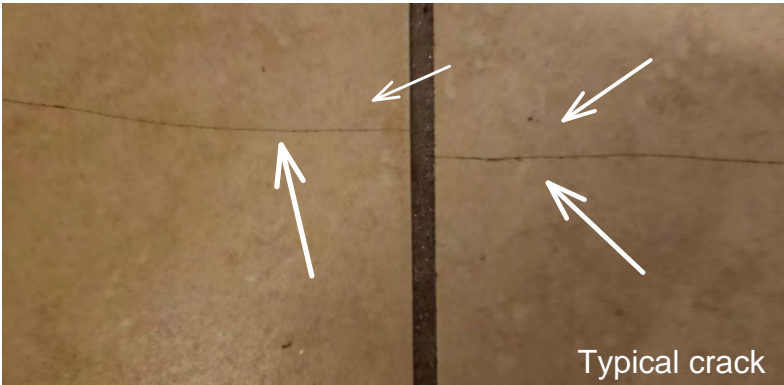
Satisfactory Floor: Tile - Typical cracks noted. Less than 3/8" with no displacement. Recommend sealing before installing flooring.
