Review Committee Report on the
Fatal Accident Involving *Imedi*
During the 2018 Chicago Yacht Club Race to Mackinac
on July 21, 2018
Published: February 25, 2019

Committee Members: Christopher Thomas, chair, Nick Berberian, Sally Lindsay
Honey, Jay Kehoe, Matt Knighton, Shawn O’Neill, Sarah Renz, and Ronald White

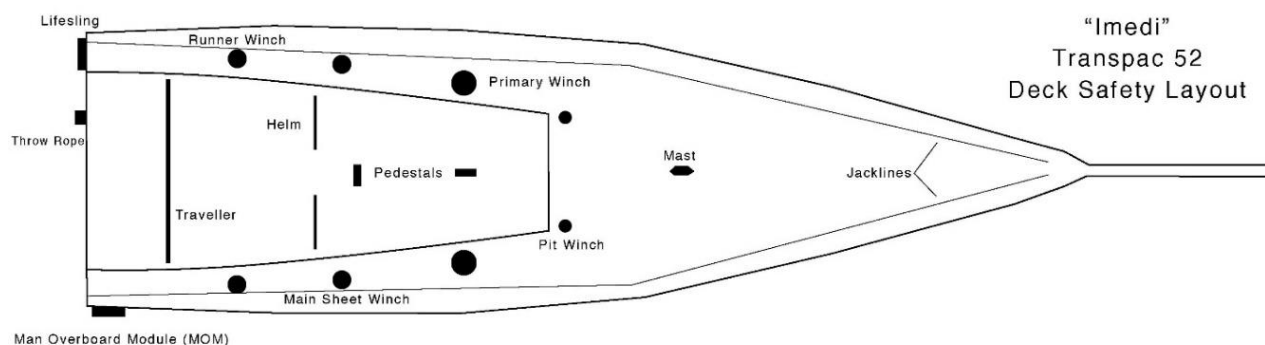
3.2. The TP 52 has a large open cockpit, with the vang control located far aft (behind the steering wheels in the center of the deck) and remote from likely handholds and jacklines.

Figure 2: *Imedi* Jacklines- Hydraulic vang controls were on centerline between the wheels

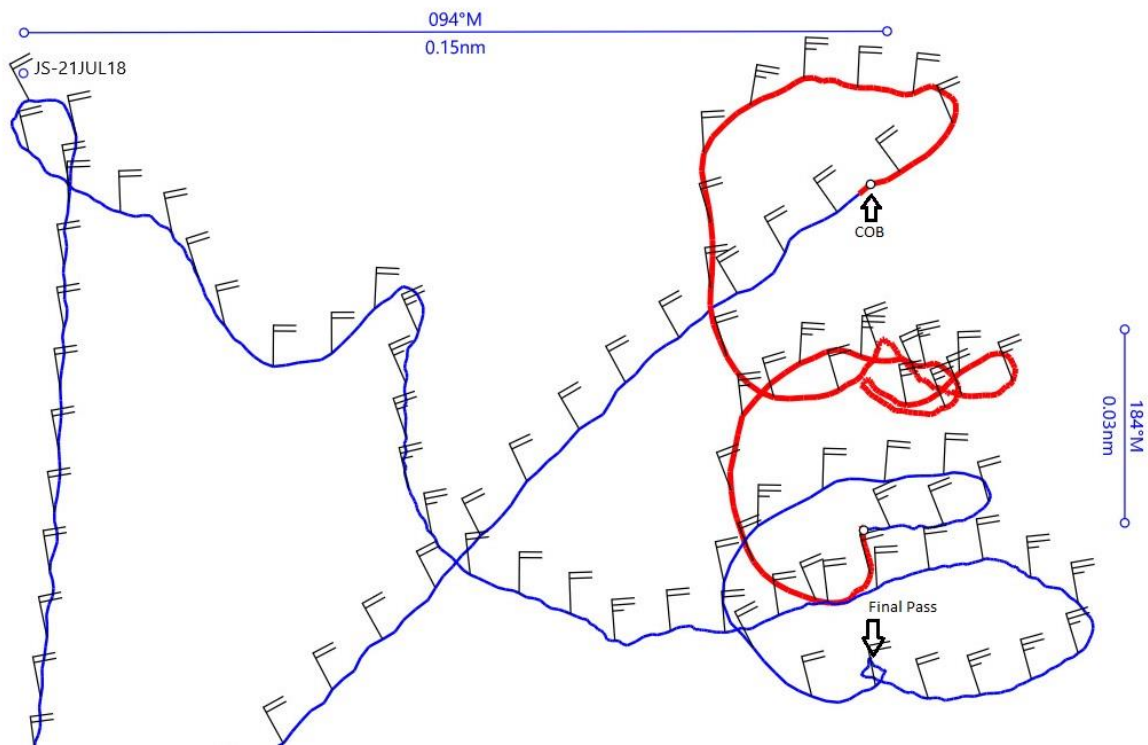
Figure 4: MOB recovery attempt track from approximately 14:24:45 to 14:41:52

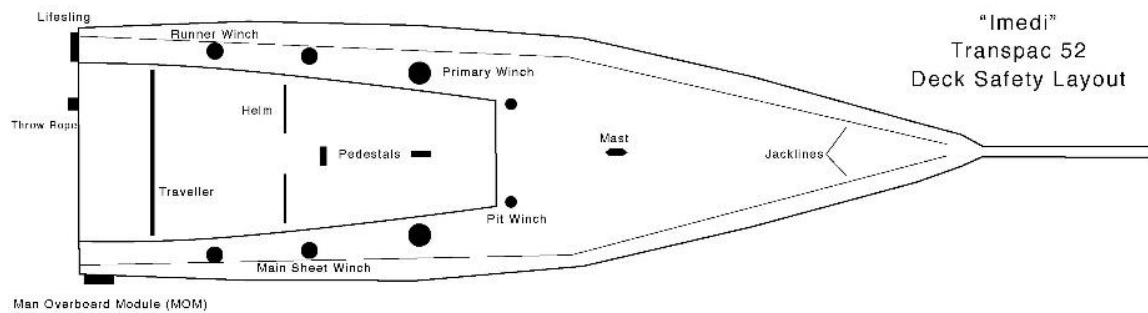
The TP 52 has a large open cockpit, with the vang control located far aft and remote from likely handholds and jacklines.

Figure 5- Imedi Deck Layout: Hydraulic vang controls were on centerline between the wheels

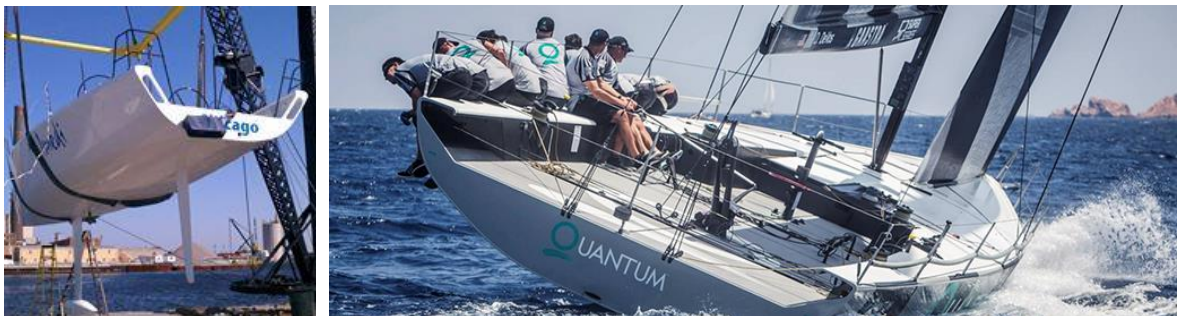
Figure 6 Underwater fins subject to stalling and Open afterdeck with minimal handholds

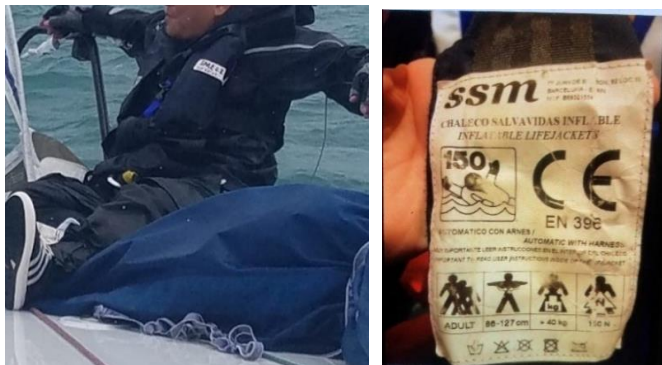
All reports are consistent that Santarelli was wearing an inflatable life jacket at the time he went overboard, and it did not inflate. Nor is there any indication that the manual pull or the oral inflator was attempted to be utilized by him. Had the life jacket inflated, there would have been considerable additional time to effectuate a retrieval of him once he went overboard.

The Hammar MA1 inflator is a hydrostatic type inflator that is utilized in a number of different brands of inflatable life jackets. Based upon interviews with the crew, the life jackets came with the boat, and thus could be as much as 12-13 years old. Whether the inflator mechanism in the jacket Santarelli was wearing had ever been replaced is unknown.

Figure 7 Boat-issued life Jacket and life jacket label

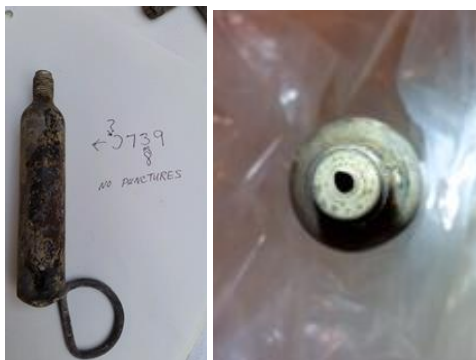
Figure 8 CO₂ Inflation cylinder from Jon's life jacket showing it had not been pierced prior to the incineration
