**456 Sample Report Ln
Houston, TX 77095**

PROPERTY INSPECTION REPORT FORM

Jane Smith <i>Name of Client</i>	07/04/2022 <i>Date of Inspection</i>
456 Sample Report Ln, Houston, TX 77095 <i>Address of Inspected Property</i>	
John Tatum <i>Name of Inspector</i>	Professional Inspector # 9459 <i>TREC License #</i>
 <i>Name of Sponsor (if applicable)</i>	 <i>TREC License #</i>

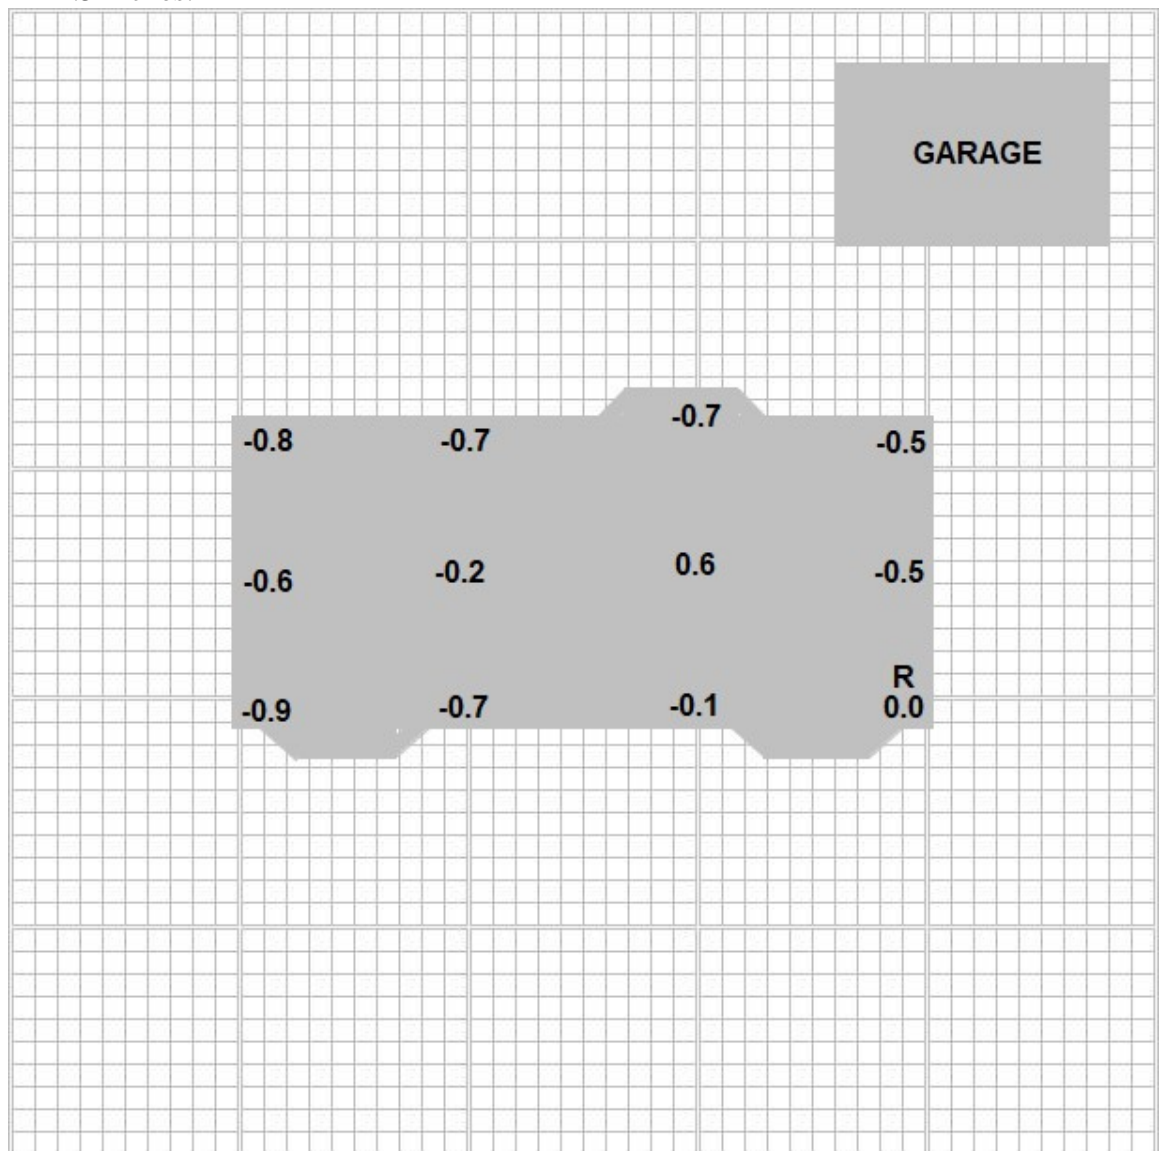
A foundation elevation survey was conducted during the inspection. The table below represents data gathered using a Zip Level or similar instrument and adjusting for floor covering height differences. i.e. differences between tile, carpet and wood flooring. Measurements are listed to the nearest .1". Measurements were taken along the respective walls listed below-North, East South, West, etc. Greatest variance was 1.5 inches.

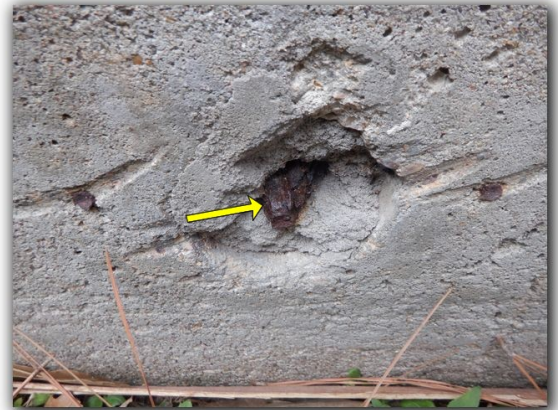
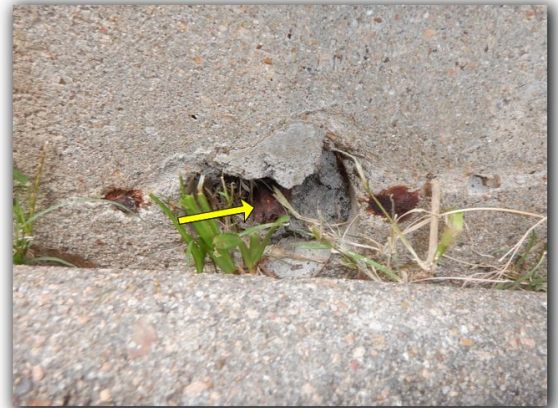
Post tension cable live ends are exposed, should be covered with non-shrink grout. Recommend repair before more extensive repairs become needed.

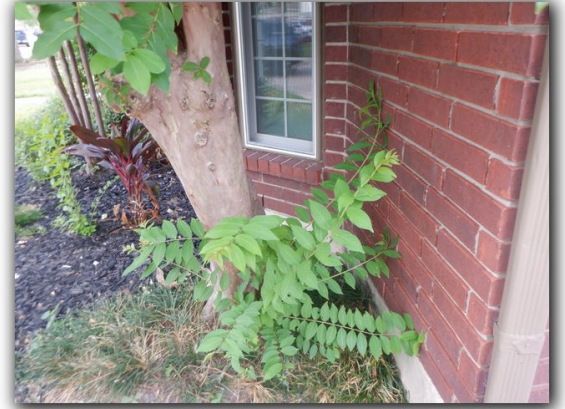
Large tree(s) near house foundation. Client should consider removal of tree(s) or the installation of root barrier to reduce possibility of damage to house foundation from tree roots and moisture removal.

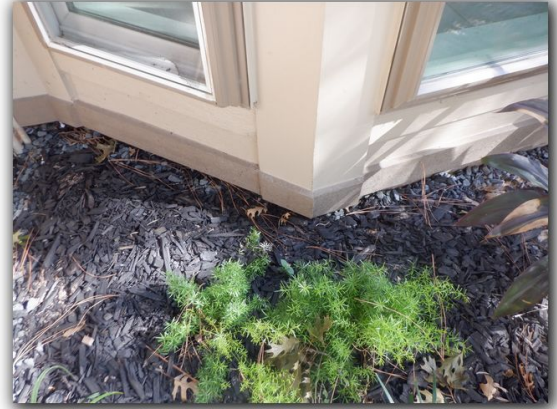
Soil level too high around areas with wood siding. Code and common industry practice requires a clearance of 6-8 inches from bottom of wood veneer to soil. High soil level near wood siding promotes water/termite penetration and wood rot.

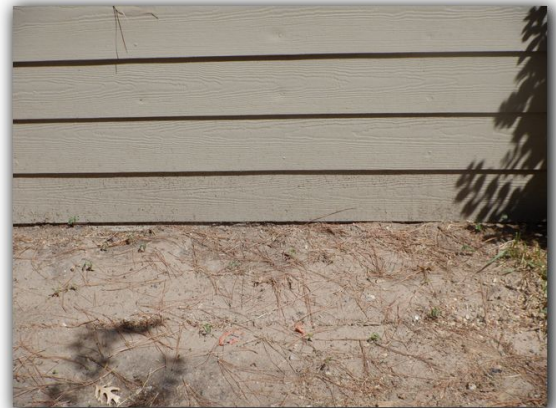
Soil level too high, or close to Hardi plank siding, promotes wood rot and is considered a conducive condition to termite activity at one or more locations around house/garage.

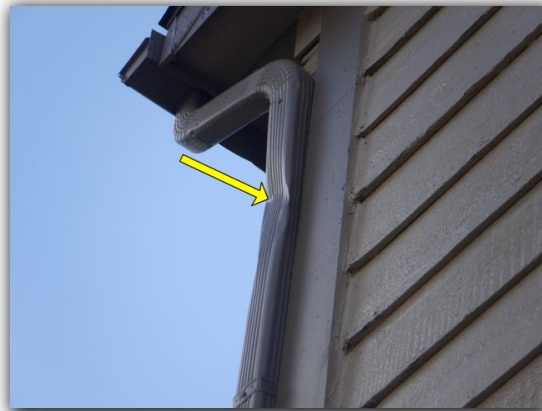
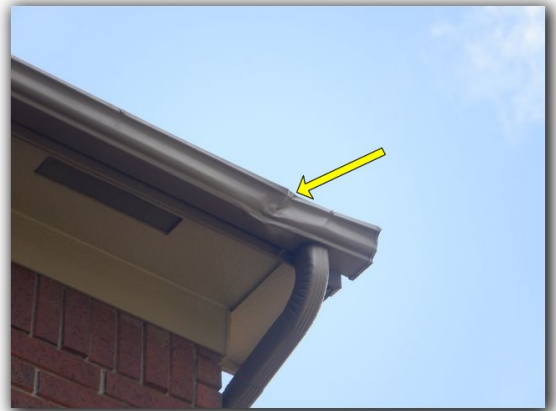
Multiple areas of damaged and / or dented gutter / downspouts were observed.

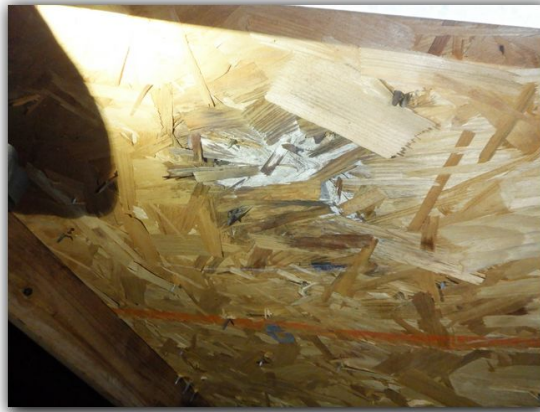
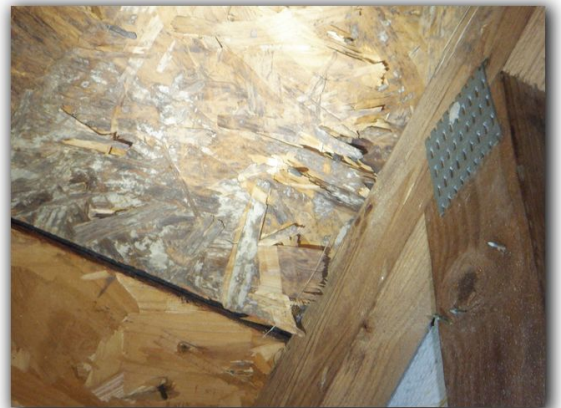
Water stain(s) observed in attic at numerous areas in the garage and house.

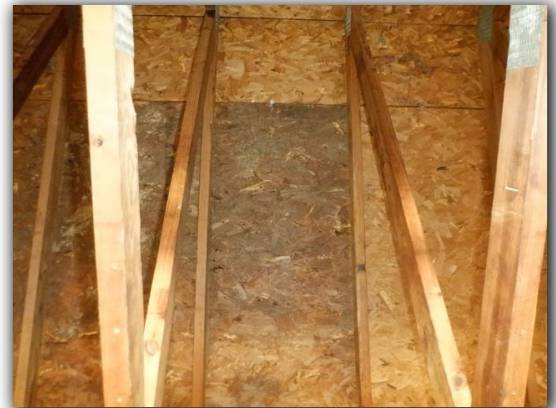
Evidence of previous (possibly current) rodent activity in attic.

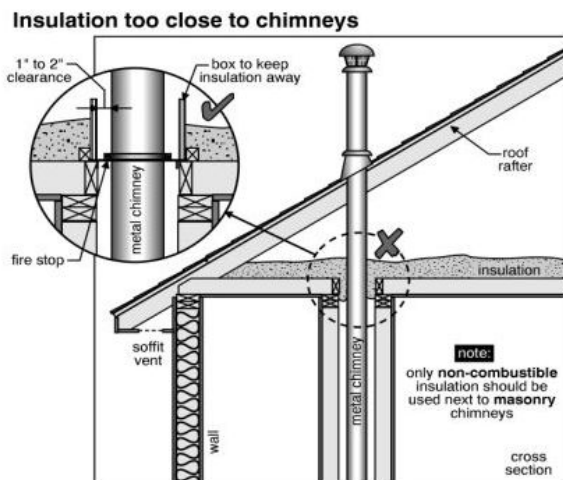
Ensure insulation is maintained a minimum of 2 inches and wood a minimum of 1 inch from around fireplace vent to reduce possible fire hazard.

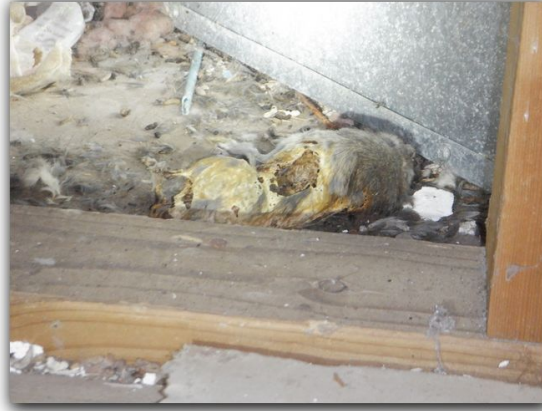
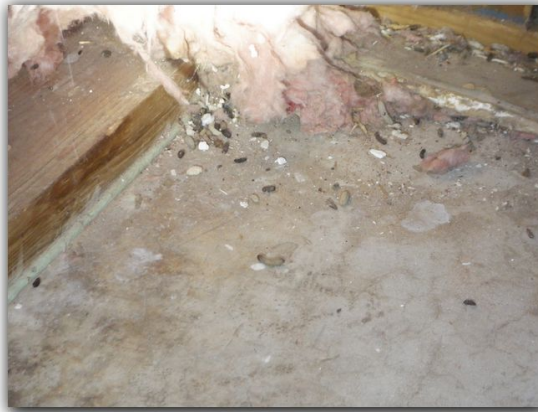
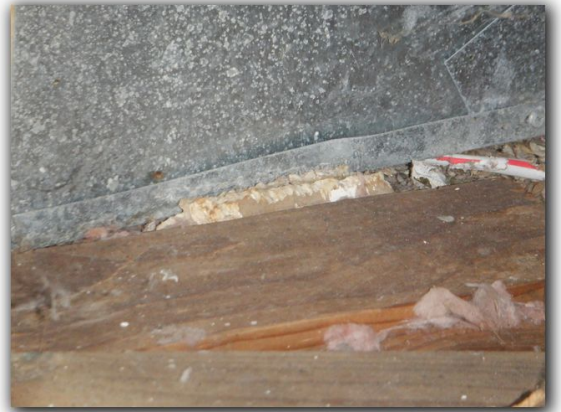
Evidence of previous (possibly current) rodent activity in the water heater closet.
Recommend considering a rodent exclusion.

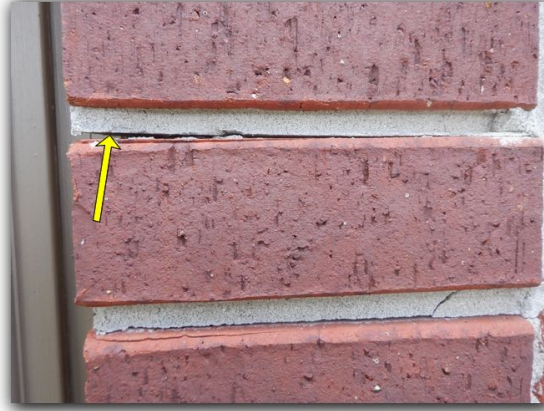
Mortar gapping / separation was observed at brick between windows at the northeast corner.

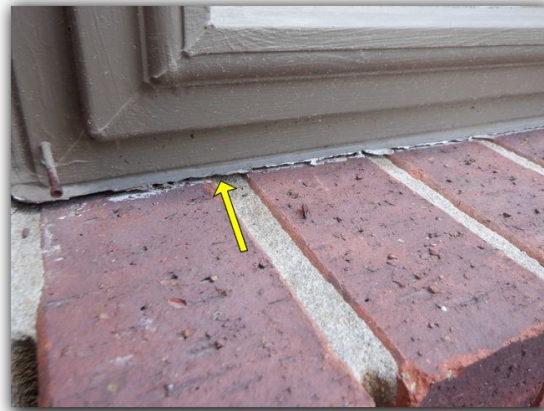
Caulking deficient around one or more windows, will allow water penetration during heavy / wind driven rains.

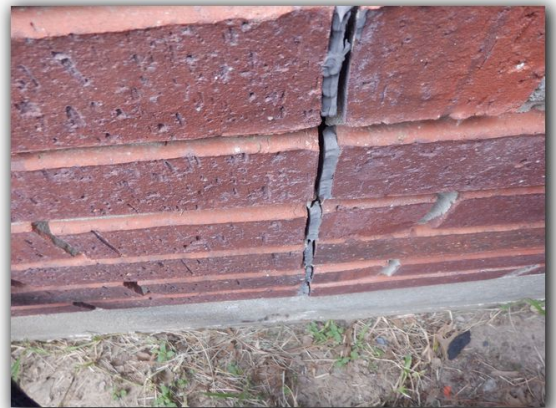
Uneven separation of expansion joint was noted between the upper and lower wall at the east exterior.

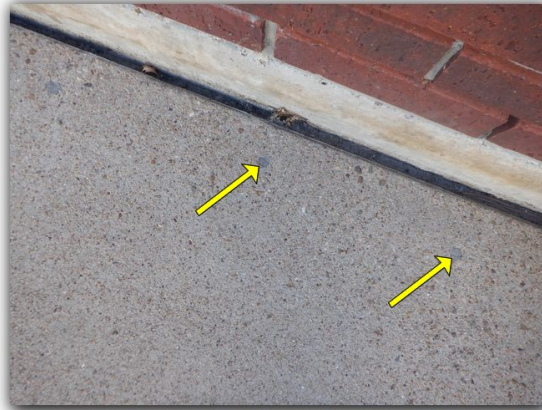
Evidence house and/or garage has been treated for wood destroying insects in the past. Final determination of structurally significant damage to wood members (if any) cannot be determined without removal of wall coverings. Recommend client obtain additional information from seller regarding extent and location of previous infestation, chemical & company used, warranty if applicable, etc.. Sentinel Inspection Group specifically excludes hidden / latent damage if present (we cannot see thru walls!). (Drill marks)

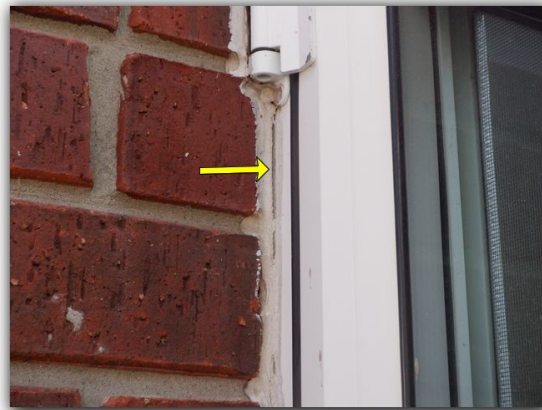
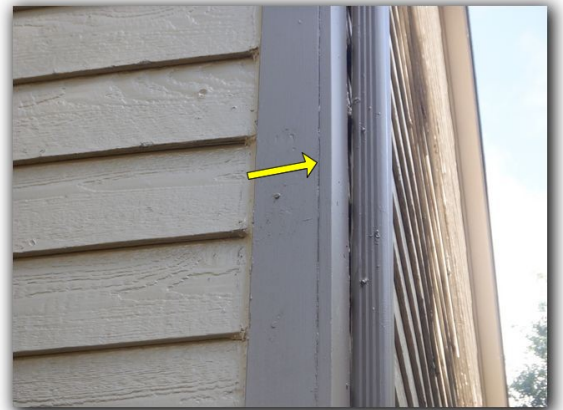
Caulking missing and/or deficient around vertical trim boards may allow wind driven rain entry.

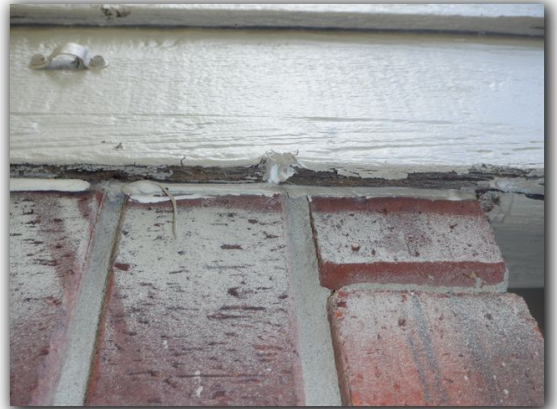
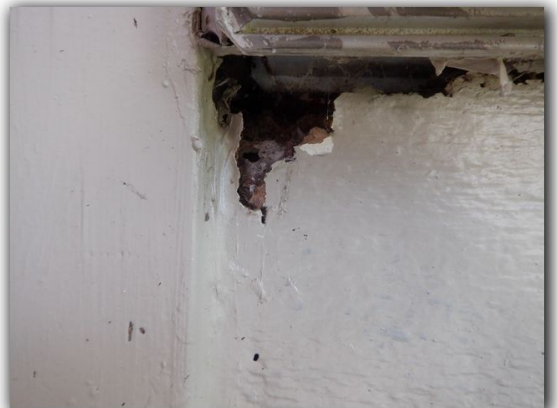
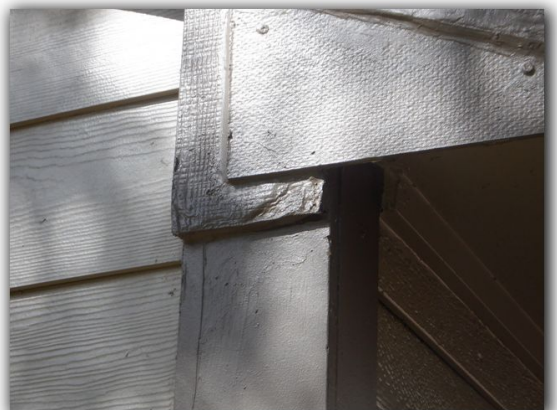
Wood rot observed on areas of house / garage.

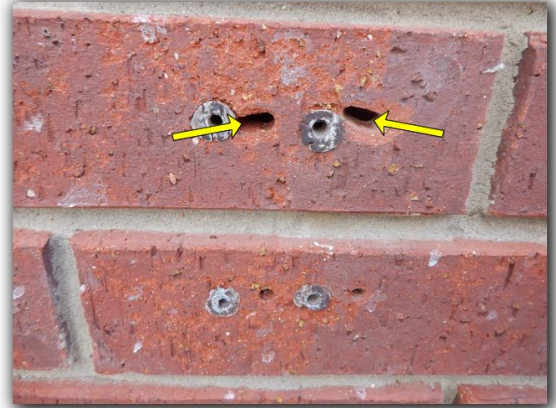
Recommend filling holes in brick to protect against bee infestation.

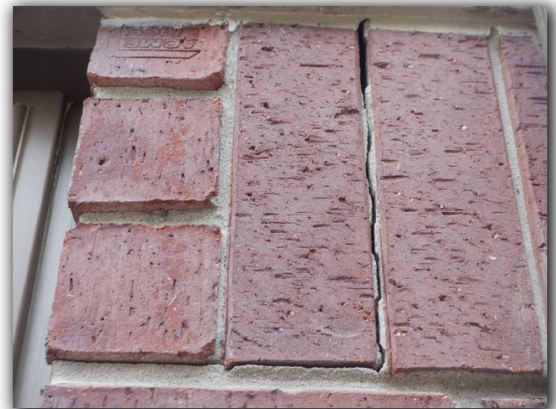
Loose bricks were present at the upper corner of a window at the west exterior.

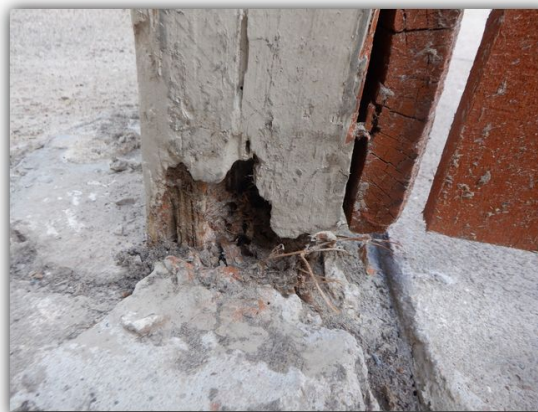
Wood rot / damage observed bottom/base of one or more wood columns.

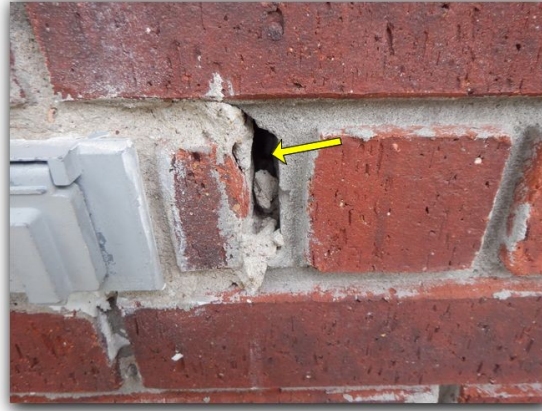
Mortar joints between brick ends is deficient in areas, indication the brick layer might not have properly "struck" the bricks (used enough mortar), recommend re-pointing areas where voids in mortar are present.

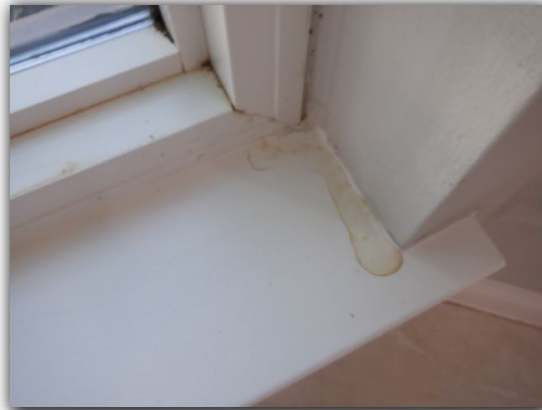
Water stains / damage on interior of one or more window jambs.

Possible from exterior window frames not properly caulked / sealed.

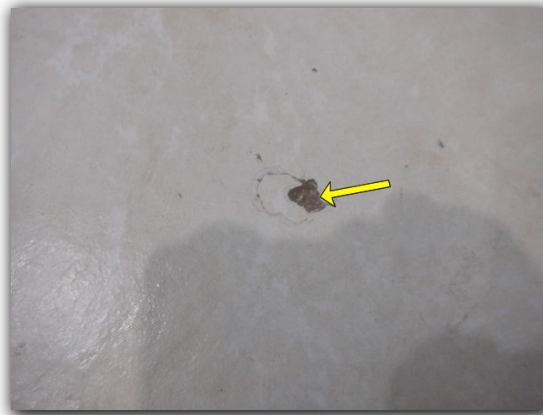
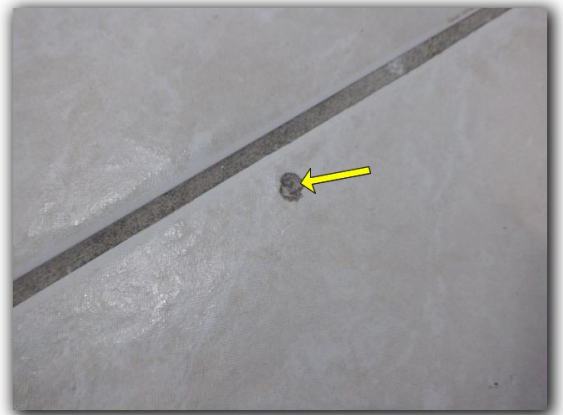
Damaged / Chipped tile was observed in the kitchen.

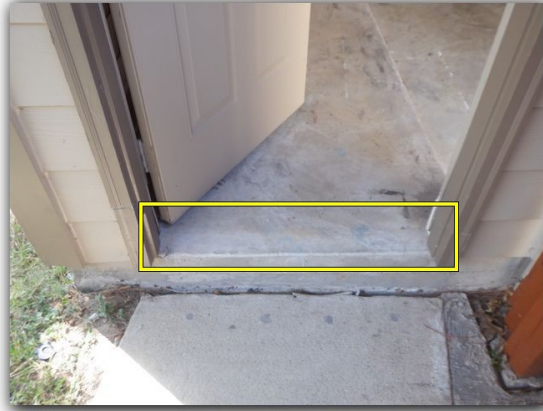
The pedestrian door to the garage was missing the lower threshold.

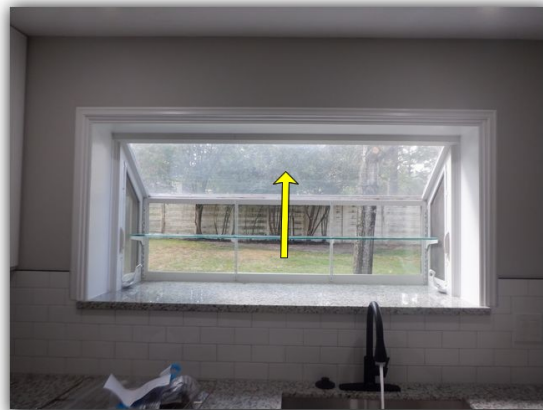
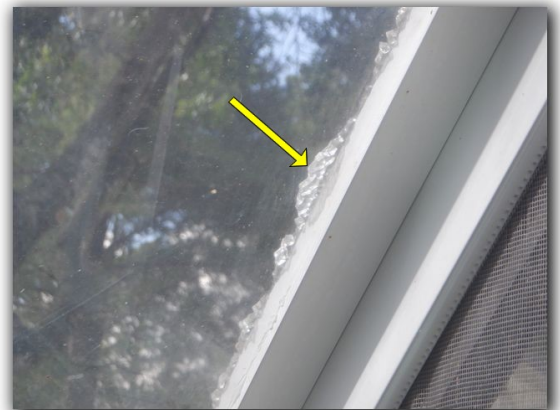
The outer pane of the kitchen window was observed to be broken with only glass shards present around the edges.

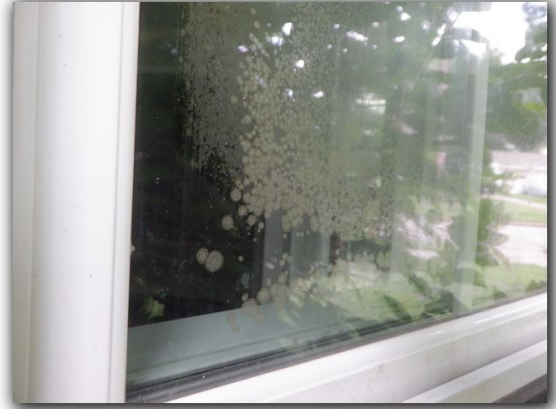
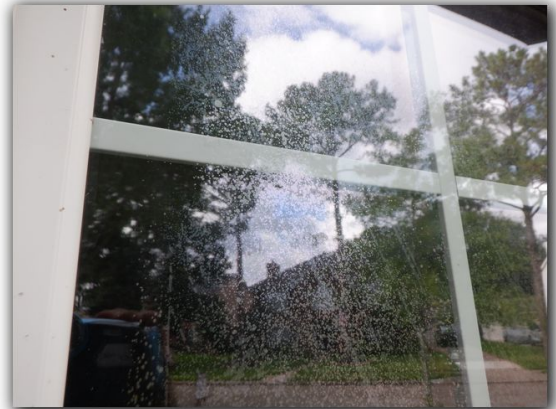
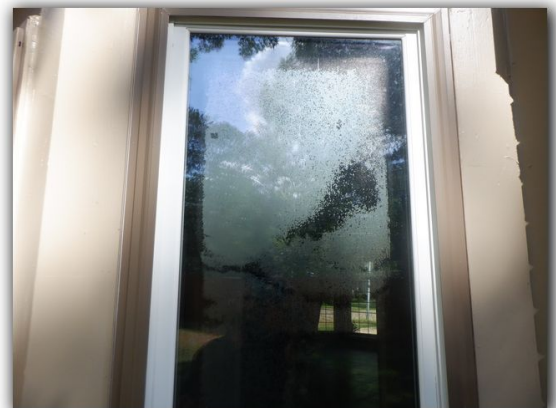
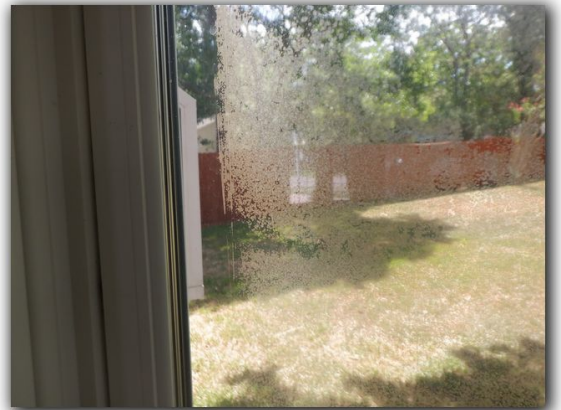
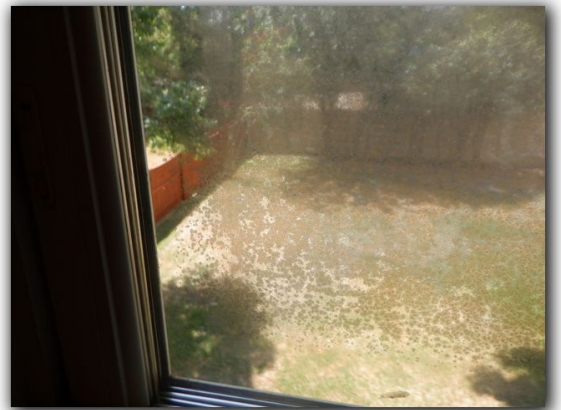
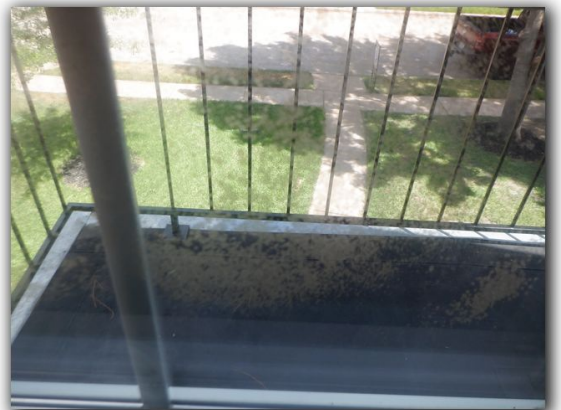
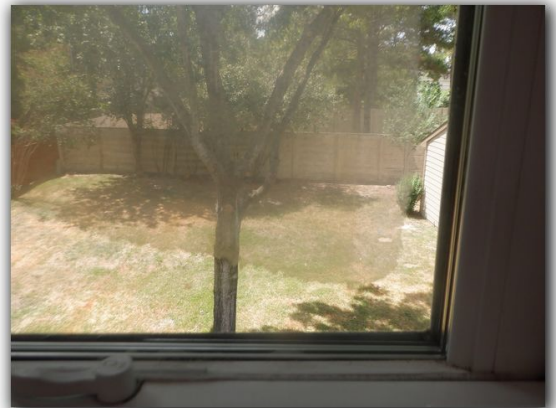
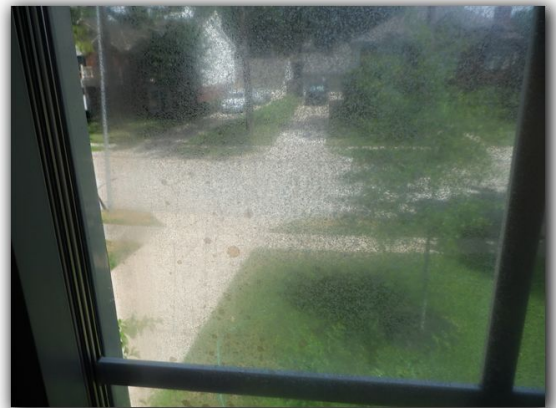
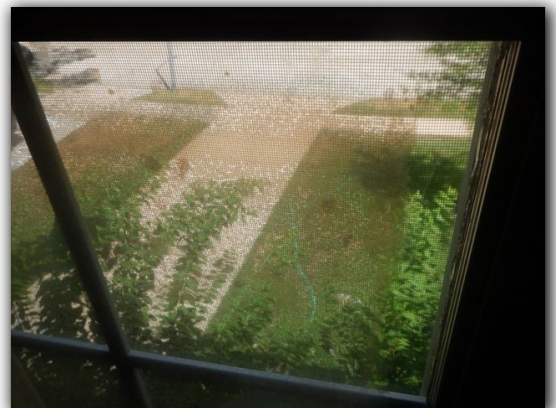
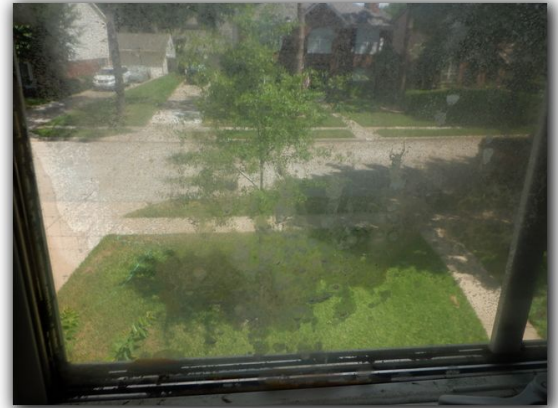
Double pane window vapor seals appear broken, including but not limited to, (Kitchen, Living Room, Formal Living Room, Dining Room, Breakfast Room, All Bedrooms, 2nd Floor Hall Bathroom)

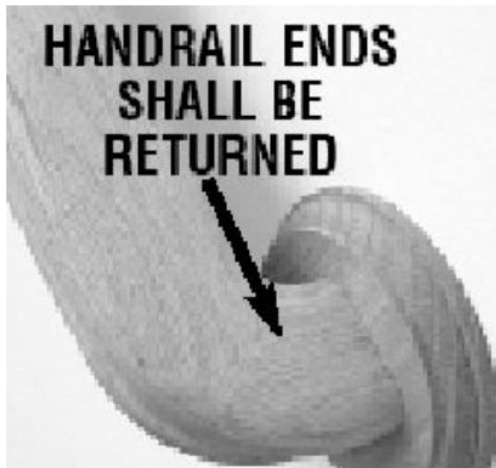
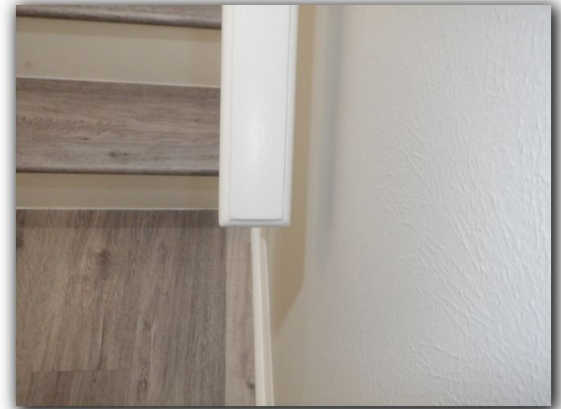
Ends of handrail do not return to wall. This condition may allow loose articles of clothing to catch on ends of handrail while using stairs and result in a trip / fall mishap.

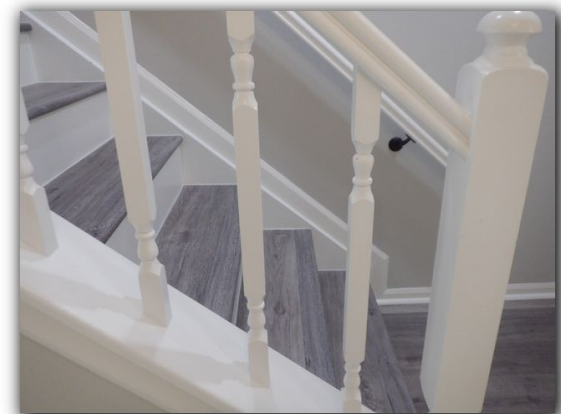
Space between railings does not comply with current industry standard, (code) UBC 421.1.1 & CABO D105.2.1. Requires spacing between intermediate rails do not allow passage of an object four inches in diameter. Recommend covering large openings in stair rails with temporary type nylon netting if small children are present in house to prevent injury.

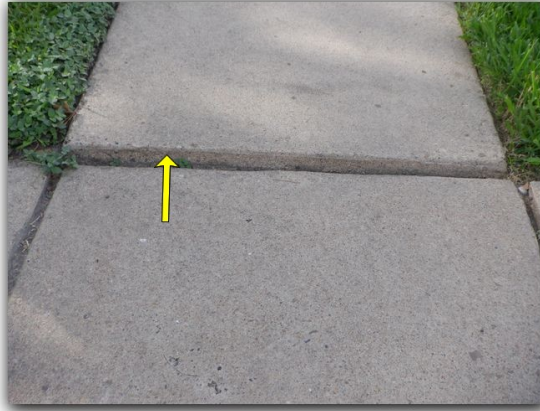
Tripping Hazard(s), walks and/or driveways are uneven.

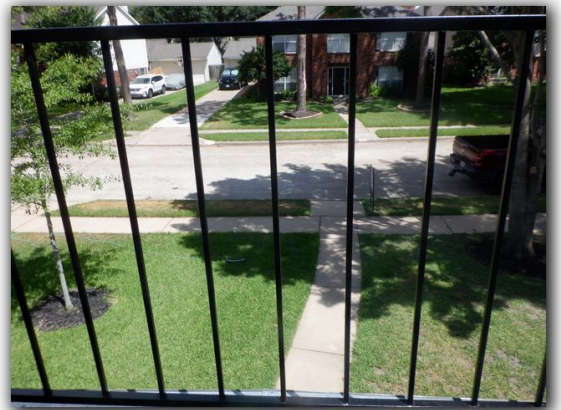
Space between railings does not comply with current industry standard, (code) UBC 421.1.1 & CABO D105.2.1. Requires spacing between intermediate rails do not allow passage of an object four inches in diameter. Recommend covering large openings in stair rails with temporary type nylon netting if small children are present in house to prevent injury.

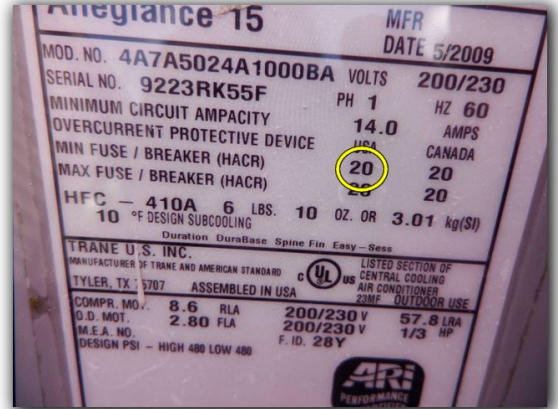
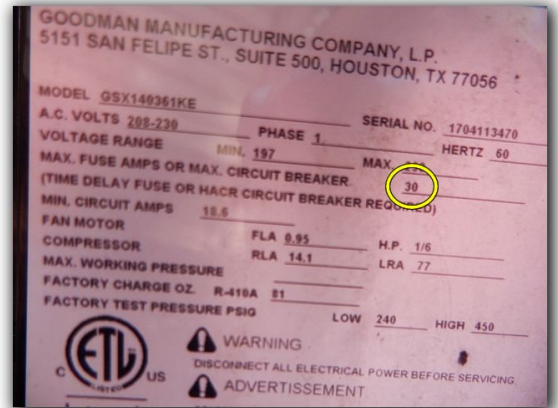
Breakers are oversized per data plates on sides of A/C units.

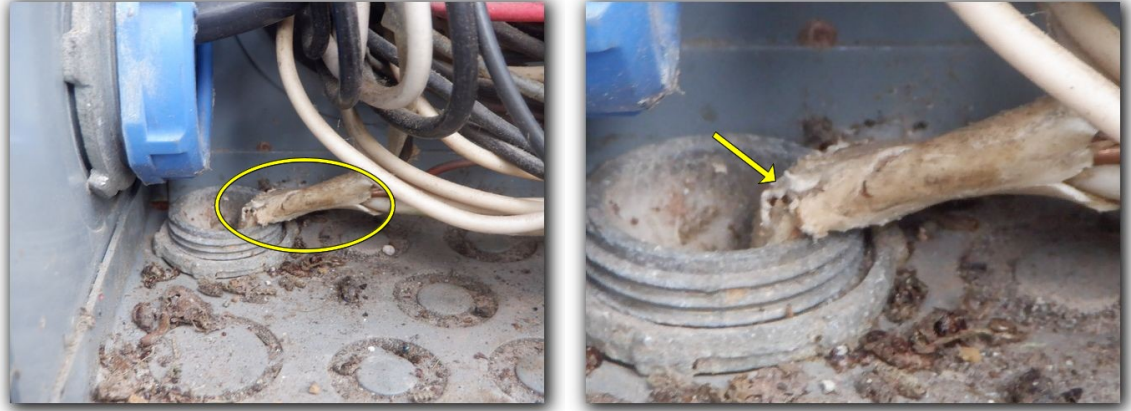
Wire insulation damaged at it passes through the metal box of the panel. This could potentially charge the panel / safety hazard exists.

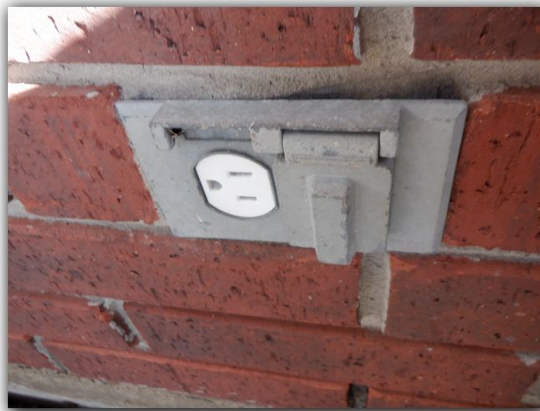
Exterior outlet damaged, missing weather proof cover, (Southern exterior)

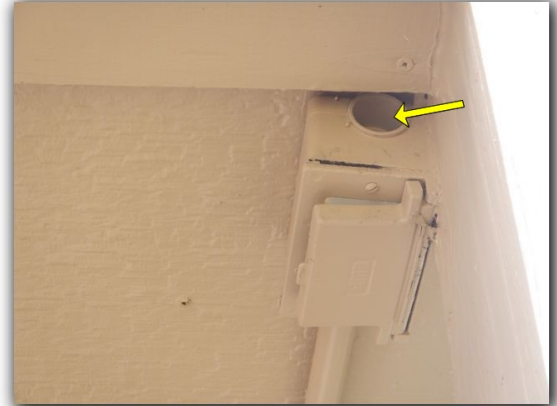
Southern soffit outlet exterior circular knock out(s) need to be sealed to prevent wasp / bee infestation.

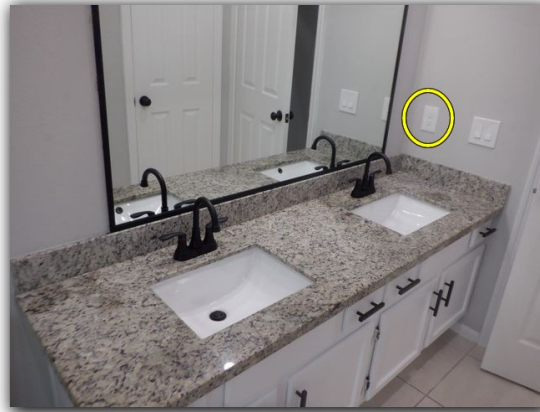
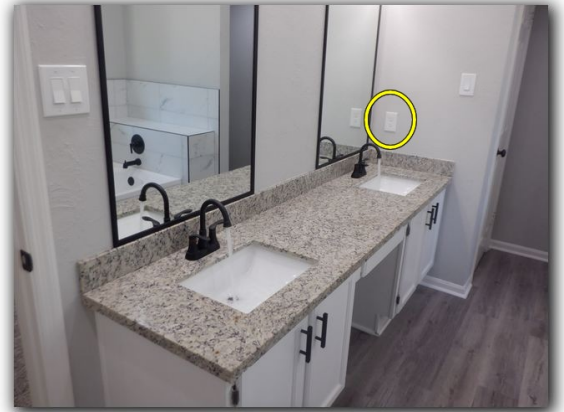
Double bath vanity sink(s) with only 1 electrical outlet on far side does not comply with current electrical code / minimum standards of the National Electric Code (NEC) which states; " At least one wall receptacle outlet shall be installed in the bathroom adjacent to each lavatory location. A wall receptacle outlet located between two adjacent lavatories shall satisfy the requirements of this section. IE: you can place a dual receptacle between the sinks or 1 on both sides.

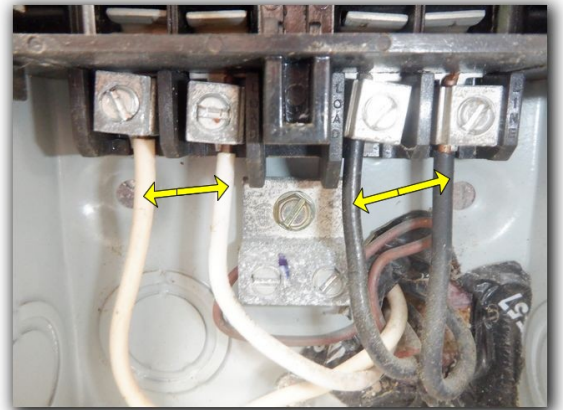
A/C unit electrical disconnect wiring reversed, line / load connections are backwards.
Live electrical wiring to wrong side of electrical disconnect when power turned off at disconnect will result in shock hazard, repair. (Northern disconnect)

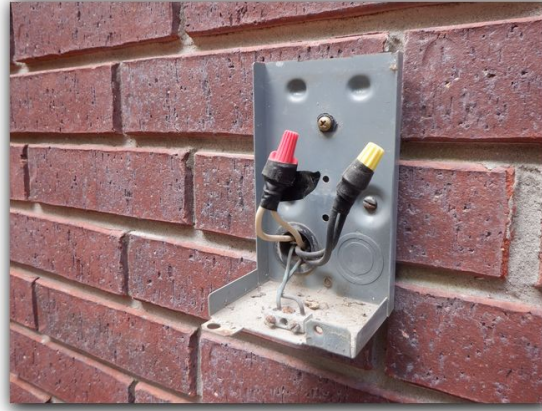
Electrical disconnect in sight of A/C unit for protection of personnel servicing unit. has been disabled, NEC code violation, repair by installing operational electrical disconnect. (Southern disconnect / first floor)

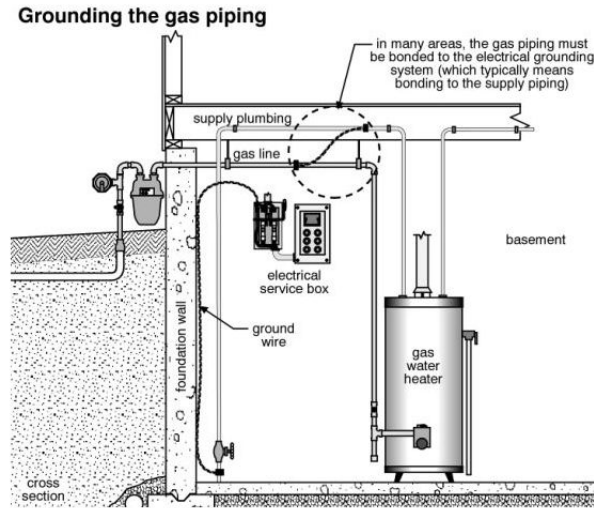
Gas and hot / cold water lines are not properly bonded near water heater. Does not comply with most recent electrical code. NEC 250-80b.

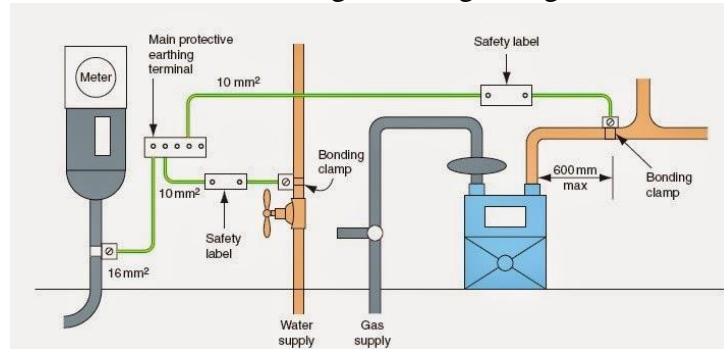
Ground rod / wire missing or damaged at gas meter.

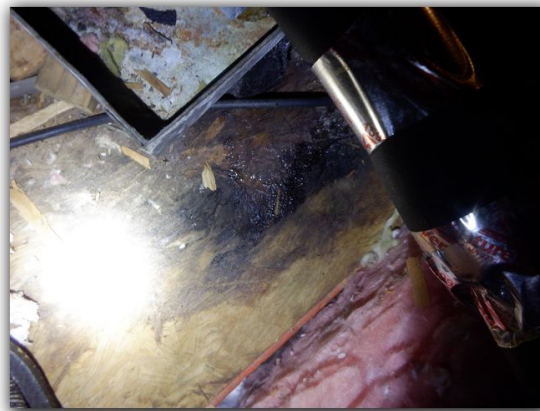
Water was dripping to the decking below the 1st floor evaporator coil.

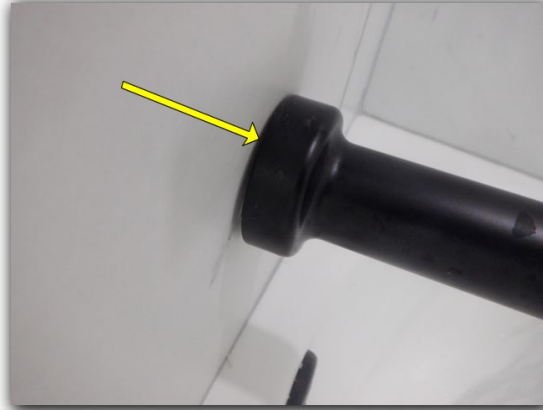
Recommend caulking around all tub/shower faucets and spouts to prevent water entry behind wall.

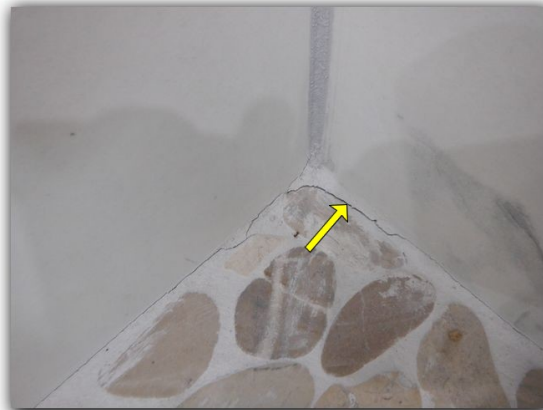
Grout / caulking needed at vertical tile corners, cracks in tile and/or mortar between tiles, to prevent water entry behind wall.

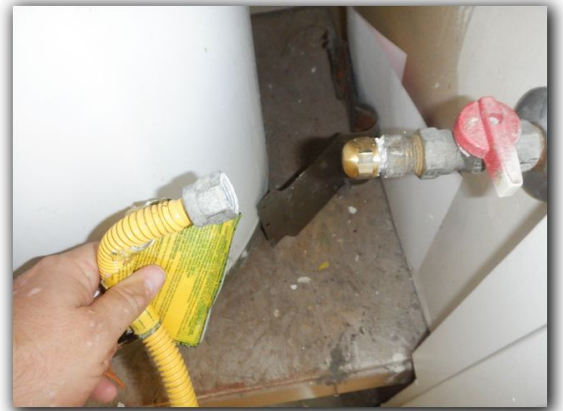
Not checked/inspected; no gas connected to the water heater at the time of inspection. The water heater was Red Tagged and disconnected at the time of inspection.

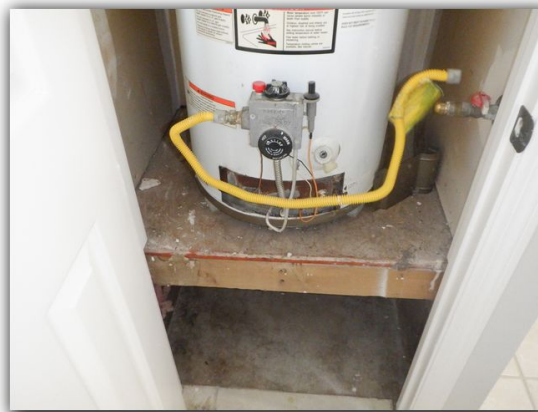
Located in house without benefit of a drain pan. Should water heater leak interior flooring can be damaged REF.: 1991 Standard Plumbing Code 1213.7.1 IRC 2801.5.

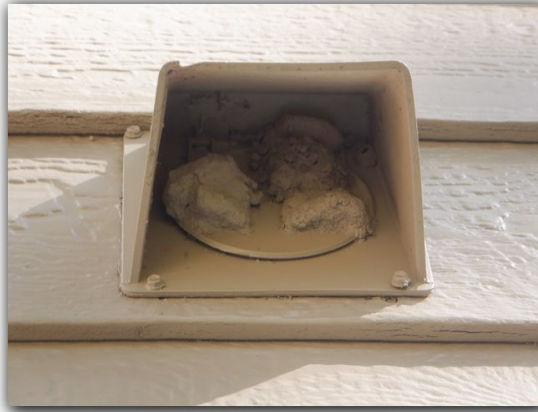
Recommend cleaning insect nesting from the flapper door of southern vent penetration. Nesting may prevent proper opening of the flapper door.

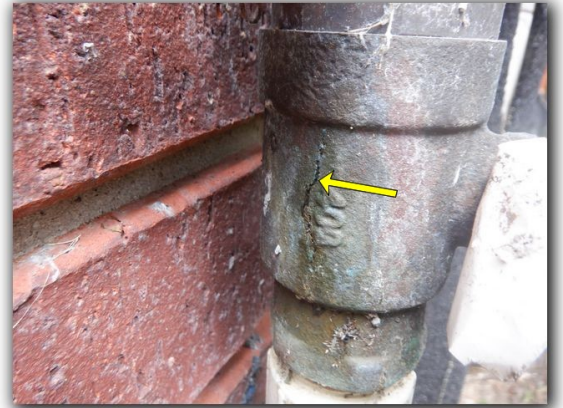
The sprinkler back flow preventer was damaged / could not be turned on. Sprinkler system could not be operated / inspected.
