**123 Sample Report St
Houston, TX 77005**

PROPERTY INSPECTION REPORT FORM

John Smith <i>Name of Client</i>	08/02/2022 <i>Date of Inspection</i>
123 Sample Report St, Houston, TX 77005 <i>Address of Inspected Property</i>	
John Tatum <i>Name of Inspector</i>	Professional Inspector # 9459 <i>TREC License #</i>
 <i>Name of Sponsor (if applicable)</i>	 <i>TREC License #</i>

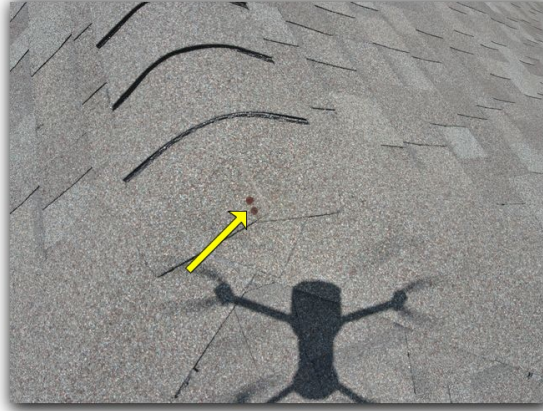
Exposed staples / nail heads / fasteners observed on roof, all exposed fasteners should be sealed to prevent water entry.

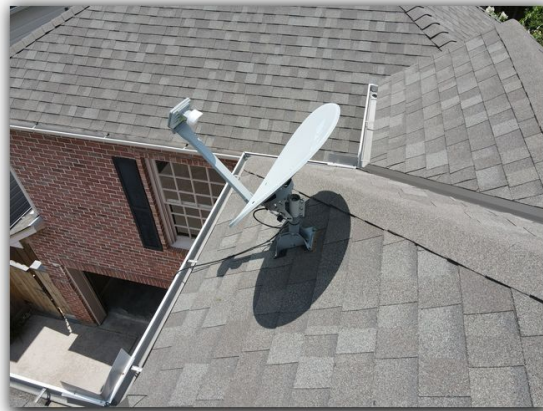
Buyer's note: Satellite dish bracket attachments can be more susceptible to water penetration.

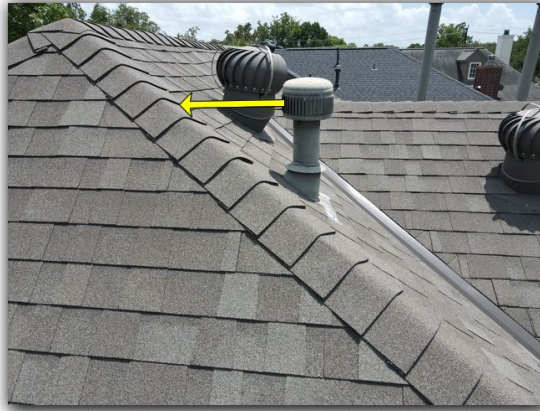
Improperly vented, Does not comply with the 1992 CABO One and Two Family Dwelling Code section M-1604.2.3 which states: "Such vents shall terminate not less than 1-foot above the roof, and not less than 4-feet from any portion of the building that extends at an angle of more than 45 degrees upward from the horizontal."

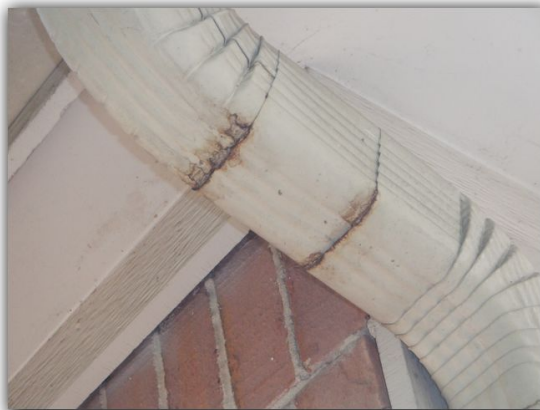
Need general maintenance, Clean out debris / resecure to fascia board / tilt toward drains, seal leaks, etc.

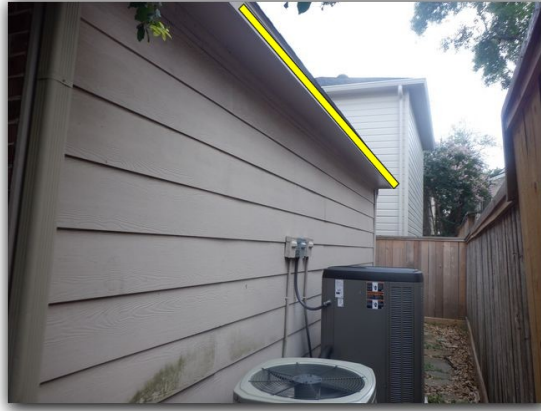
Recommend addition of rain gutters to help improve drainage and/or prevent wood rot at following locations; (West side of the garage above the A/C units) Roof rain water runoff will currently dump into the A/C units.

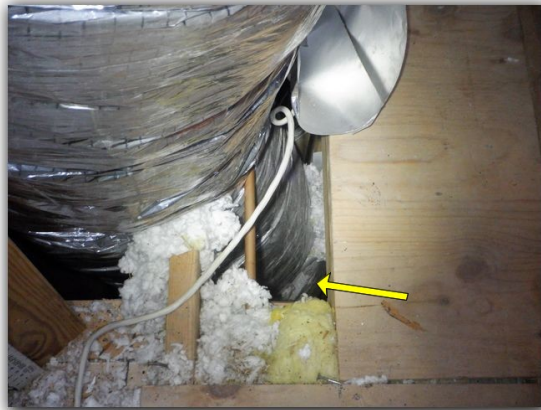
Recommend sealing/fire stopping all open chases in attic down to living area below, To comply with current industry standards, Code. (CABO 602.7 IRC 602.8).

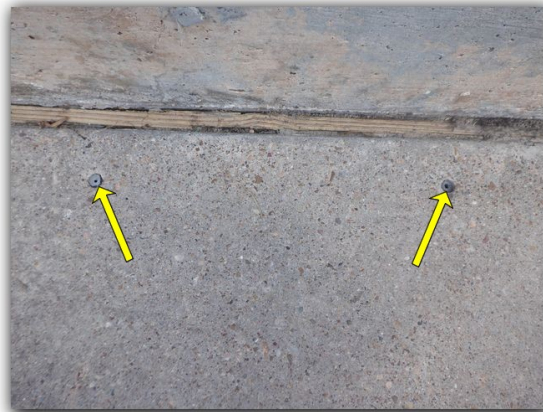
Evidence house and/or garage has been treated for wood destroying insects in the past. Final determination of structurally significant damage to wood members (if any) cannot be determined without removal of wall coverings. Recommend client obtain additional information from seller regarding extent and location of previous infestation, chemical & company used, warranty if applicable, etc.. Sentinel Inspection Group specifically excludes hidden / latent damage if present (we cannot see thru walls!).

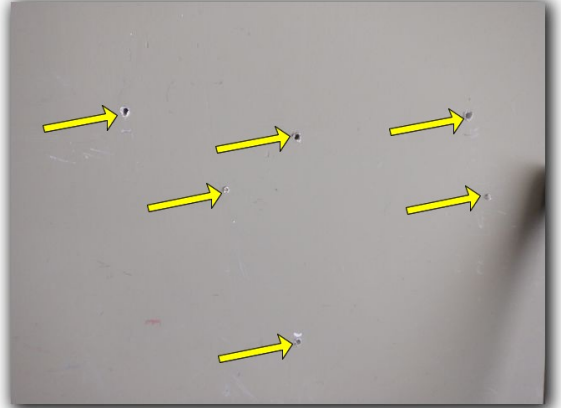
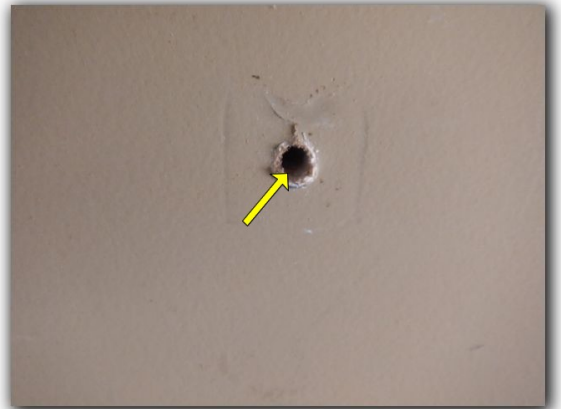
Recommend repairing holes / openings in garage walls and / or ceiling to serve as fire stopping to comply with current code and help protect house.

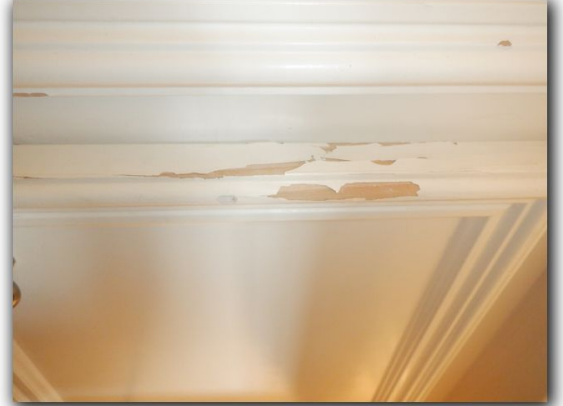
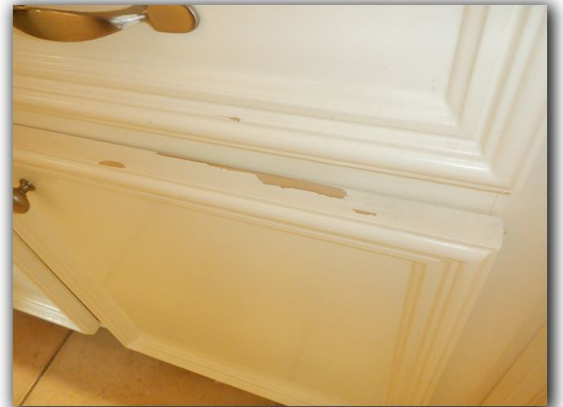
Peeling paint was observed to the cabinetry in multiple bathrooms.

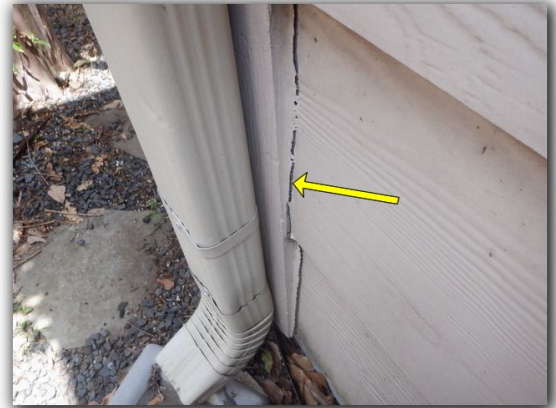
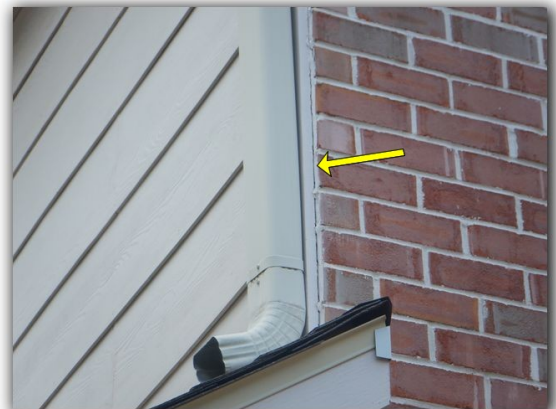
Caulking missing and/or deficient around vertical trim boards may allow wind driven rain entry.

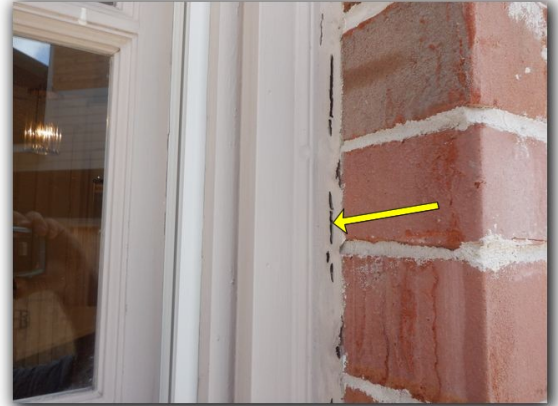
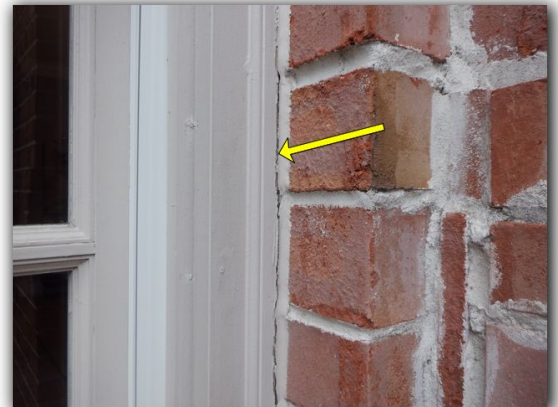
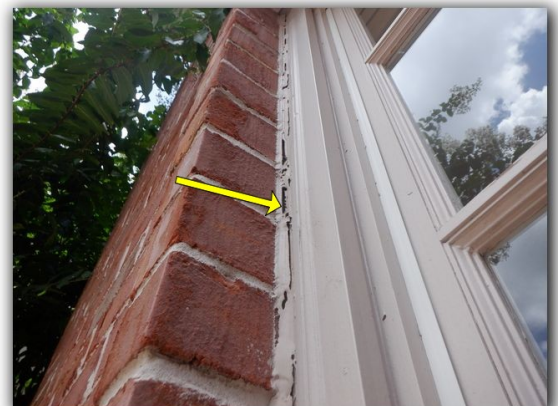
Caulking deficient around one or more windows, will allow water penetration during heavy / wind driven rains.

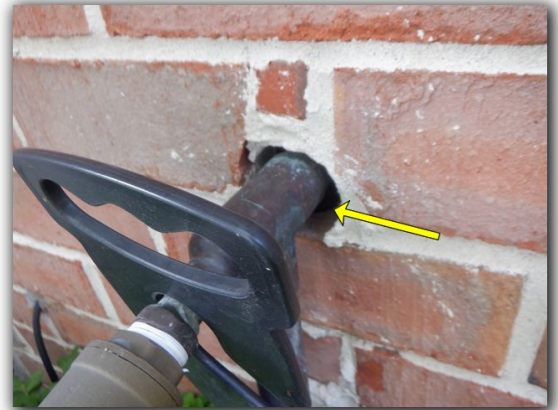
Need sealing / caulking around all holes and exterior siding penetrations on top and both sides, (leave bottom open) to prevent water entry. Including but not limited to dryer, bath and range top vents, light fixtures, etc. Need sealing / caulking around all holes and exterior siding penetrations on top and both sides, (leave bottom open) to prevent water entry. Including but not limited to dryer, bath and range top vents, light fixtures, etc.

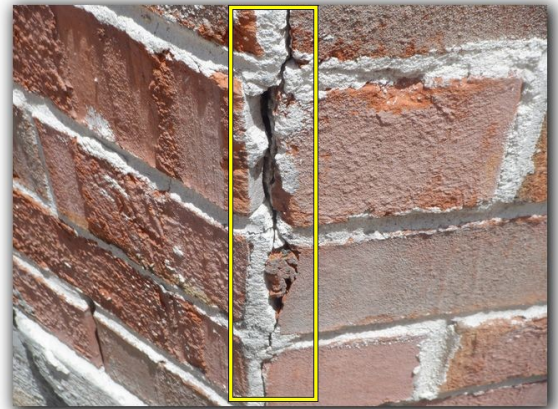
Mortar deficiencies were present in the exterior corner in brick at the southern exterior.

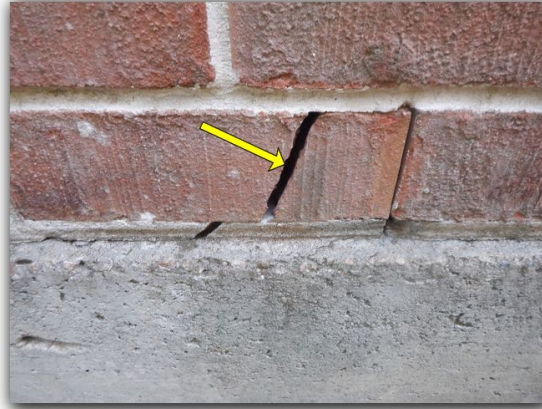
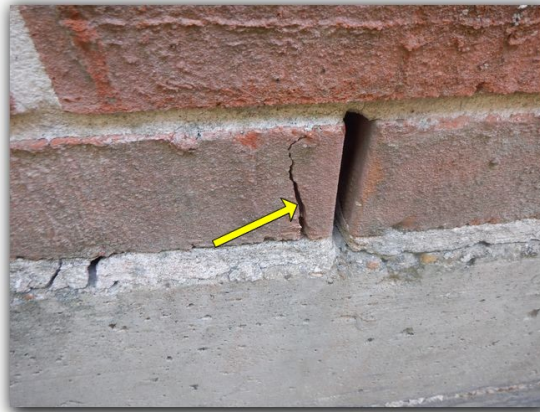
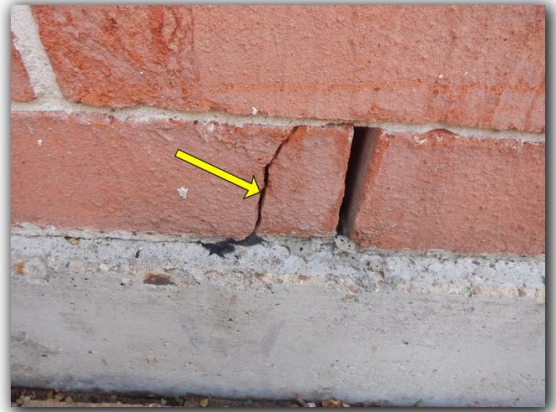
Multiple brick cracks were observed at the base of the wall adjacent to weep holes at the north and west exteriors.

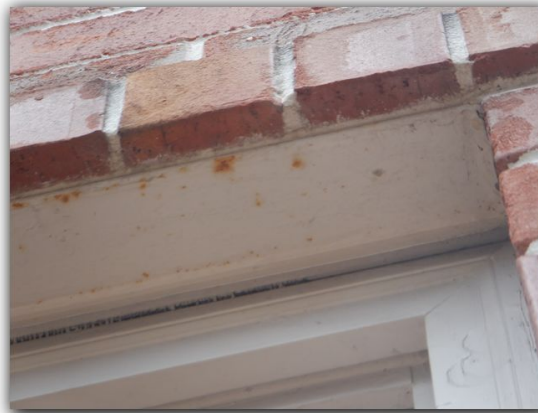
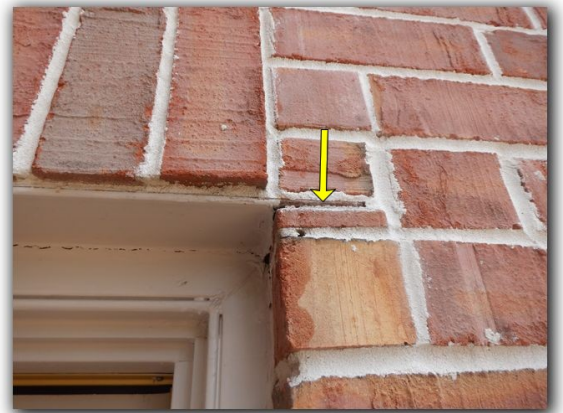
Metal lintel(s) over window/door openings are not well painted / are beginning to rust and / or ends are improperly left exposed.

Rusting lintels

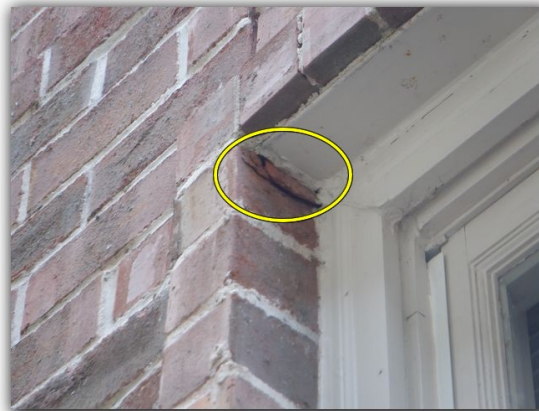
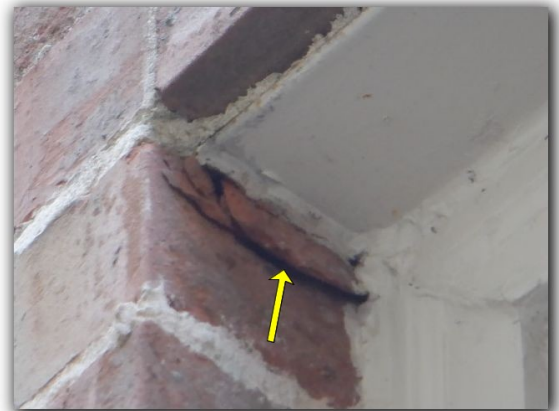
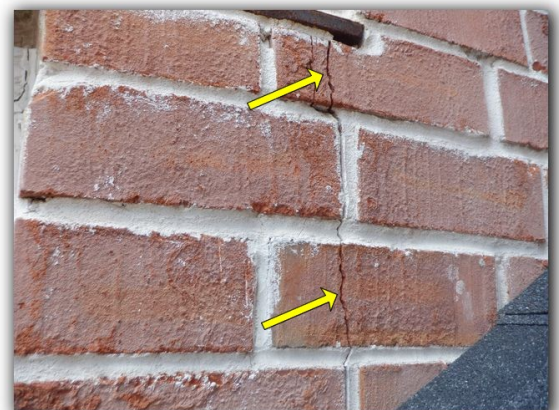
Cracks at upper corners of windows is typical due to not enough space left at ends of steel lintel at time of construction to allow for expansion of metal.

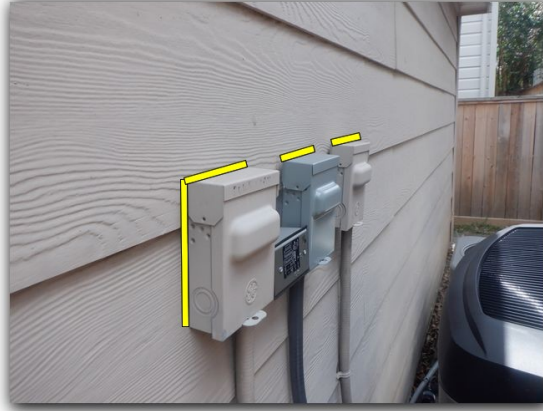
Recommend caulking around electrical disconnect box(s) of A/C unit(s) to prevent water entry behind disconnect(s).

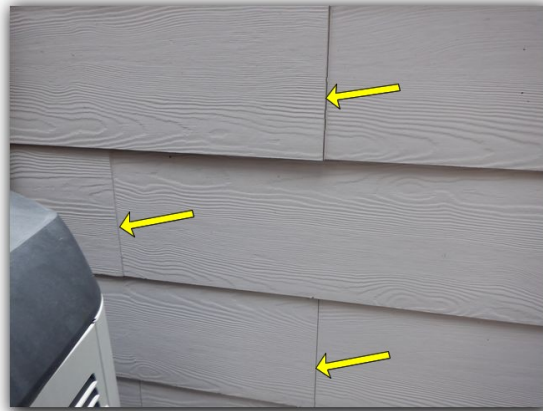
Caulking missing and/or deficient at vertical joints in siding; may allow wind driven rain entry.

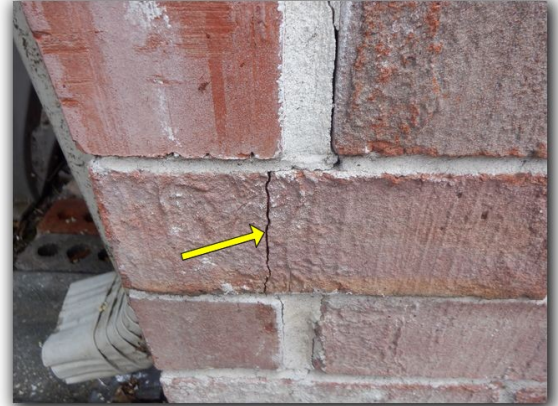
Cracks in brick veneer and/or repairs, one or more locations, Recommend buyer take photographs of cracks, their location, and width [ruler across the crack] with a high resolution camera that has a date stamp for future reference. Including but not limited to the following location(s): (Northwest corner)

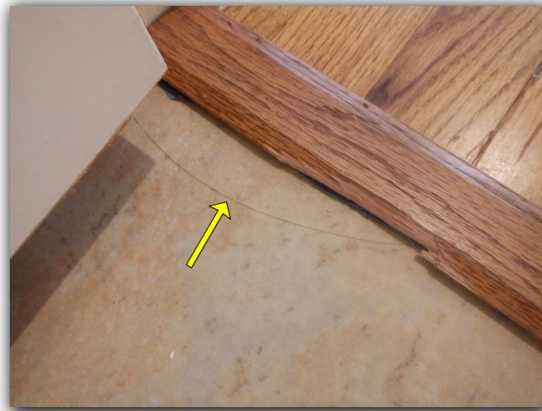
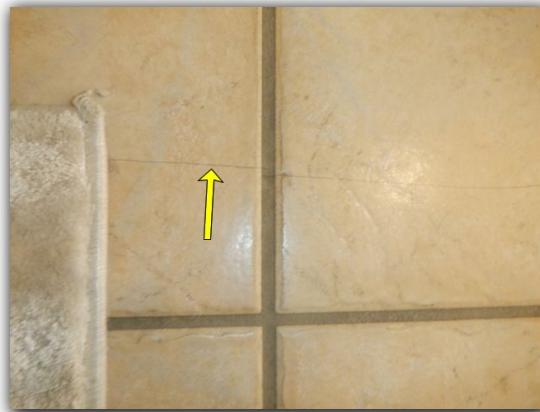
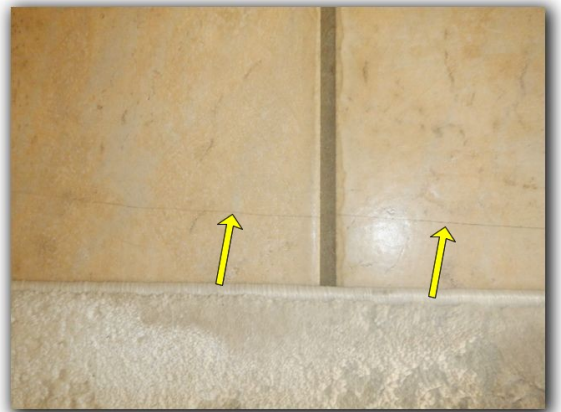
Cracks and/or loose floor tile observed in, (Laundry room and dining room)

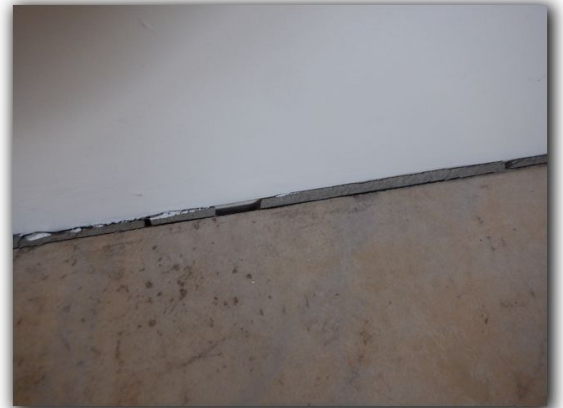
Multiple grout deficiencies were observed in the dining room.

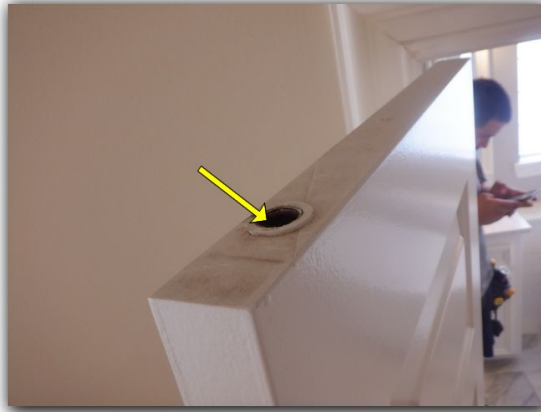
The upper ball latch was missing on one of the doors to the master bathroom.

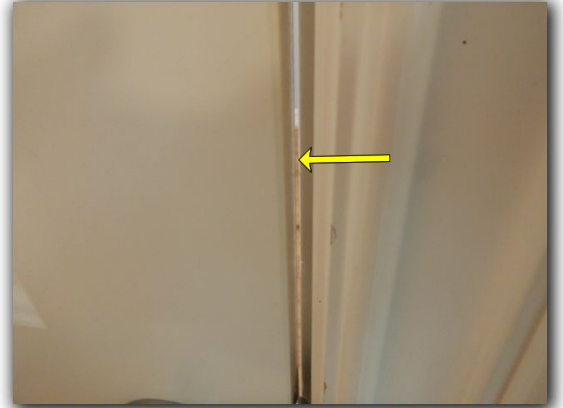
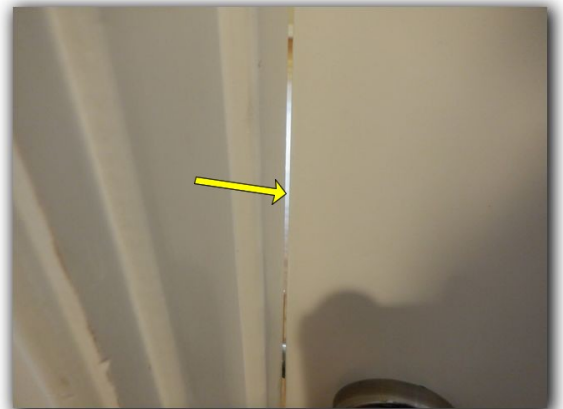
Gapping was present between the door and frame to the Northeast bedroom.

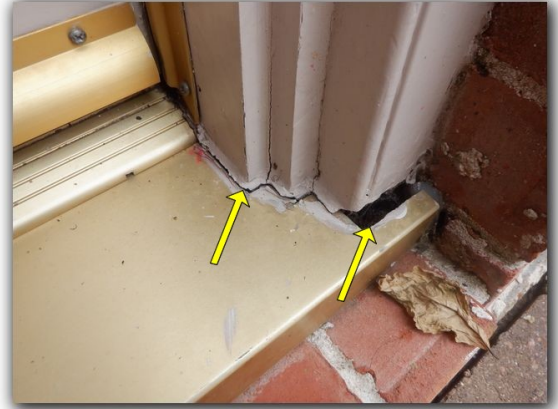
The northwest exterior door threshold was loose and very poorly sealed / will allow water entry.

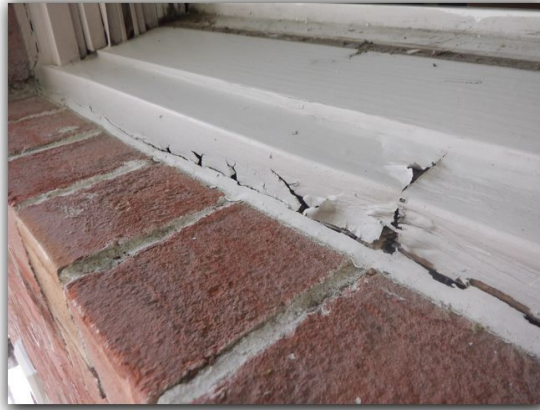
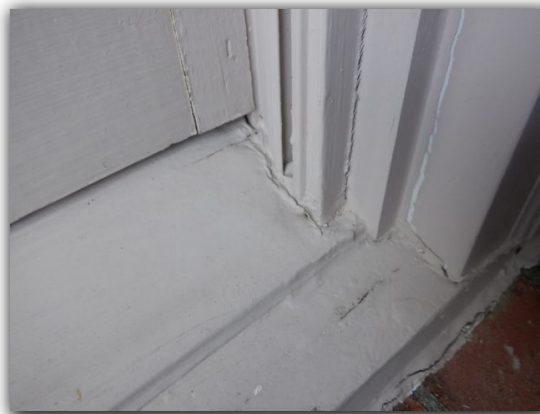
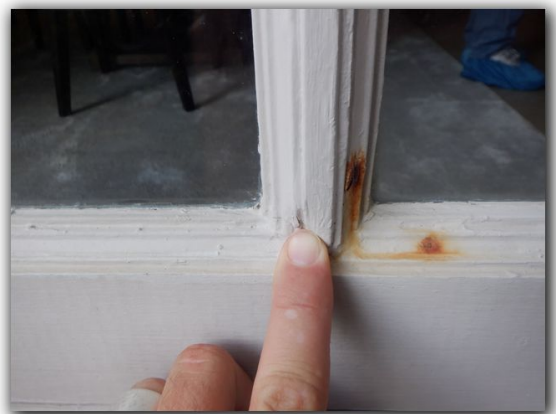
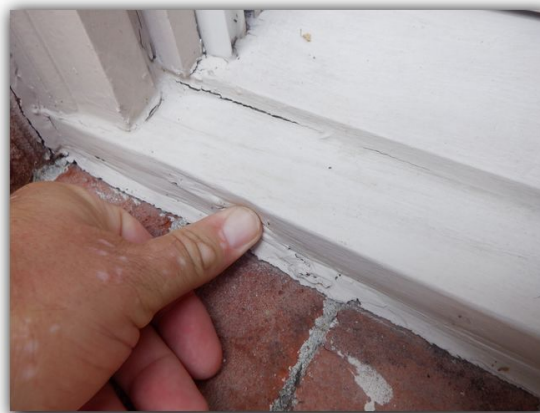
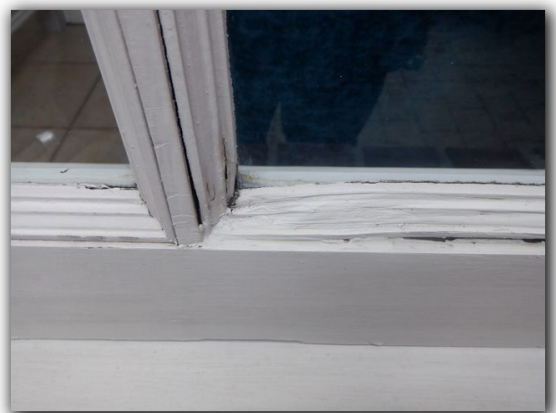
Wood rot of window frame/jambs observed at numerous locations.

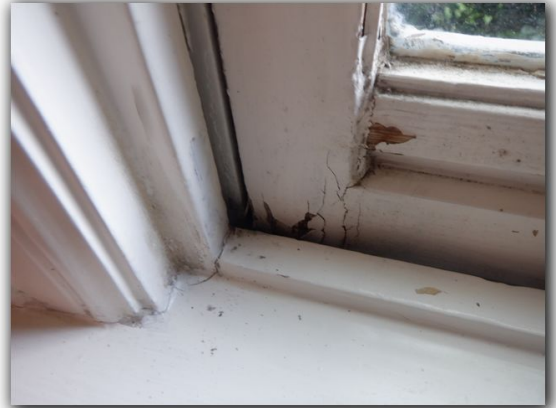
The paint was observed to be peeling heavily at the dining room windows.

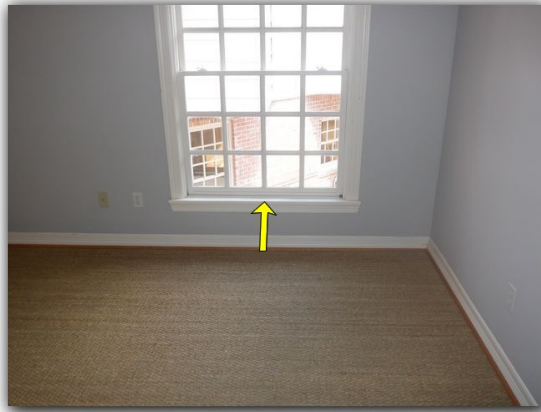
Windows at one or more 2nd floor rooms were a potential fall hazard for small children due to their low height above the floor; did not observe fall protection outside the window. Ref IRC R613.2 Window Sills: In dwelling units, where the opening of an operable window is located more than 72 inches above finished grade or surface below, the lowest part of the clear opening of the window shall be a minimum of 24 inches above the finished floor of the room in which the window is located. Glazing between the floor and 24 inches shall be fixed or have openings through which a 4-inch diameter sphere cannot pass.

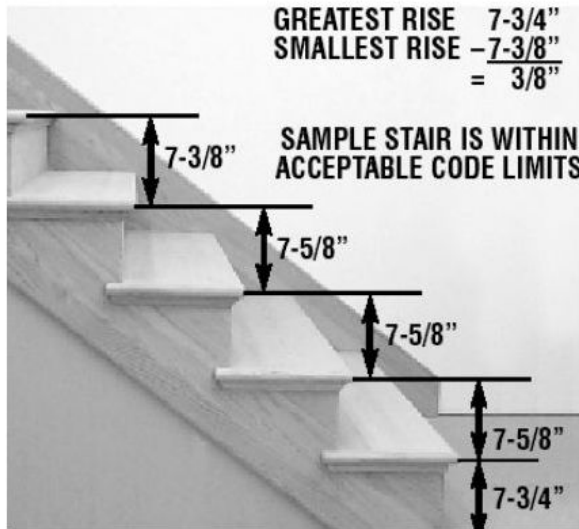
Stairway has tripping hazard, Risers are not same height along the entire height of steps. Stairway does not comply with current industry standard, (code). CABO 314.2 & UBC 1006.3 requires "The greatest riser height within any flight of stairs shall not exceed the smallest by more than 3/8 inch." (Room over the garage to the master suite)

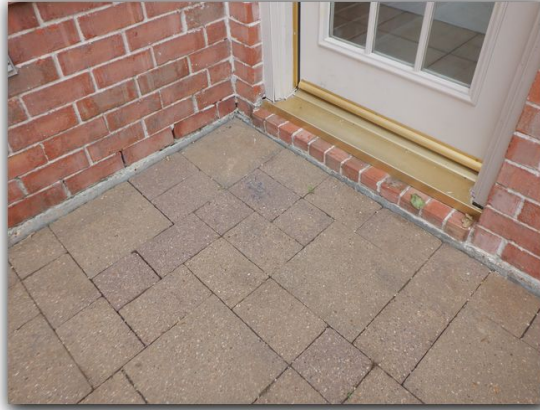
High soil and patio obscures view of foundation and prevents visual inspection for termite and/or water penetration.

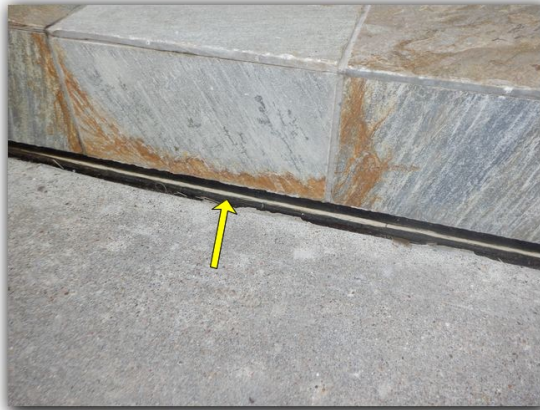
Wood expansion board(s) at the front porch should be removed to reduce chance of wood destroying insect activity.

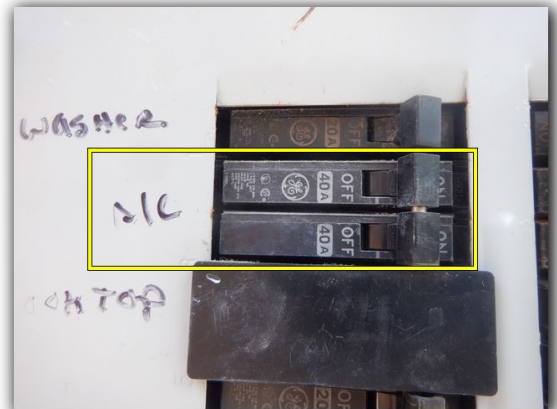
Breaker is oversized per data plate on side of A/C unit. (2nd Floor main unit)

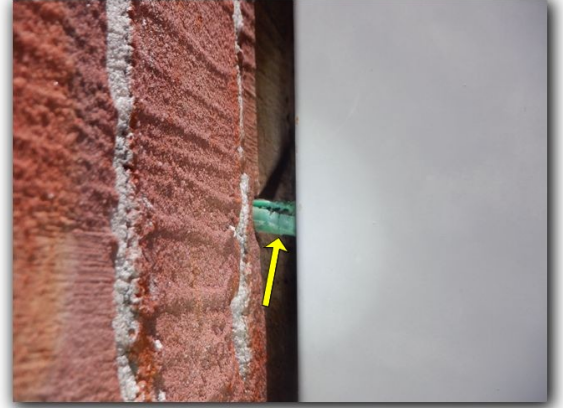
The electric panel was pulling away from / is not adequately secured to the wall.

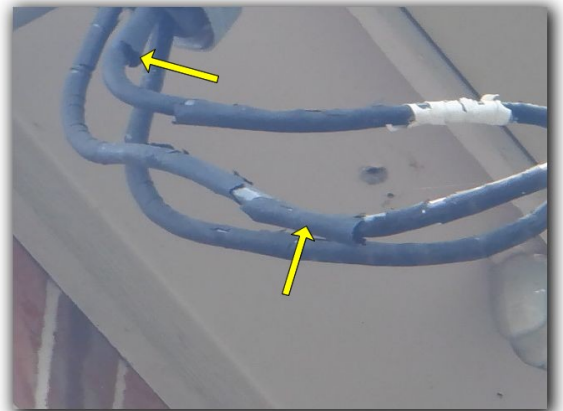
Electrical wiring insulation is damaged on service drop. Recommend evaluation by Center Point.

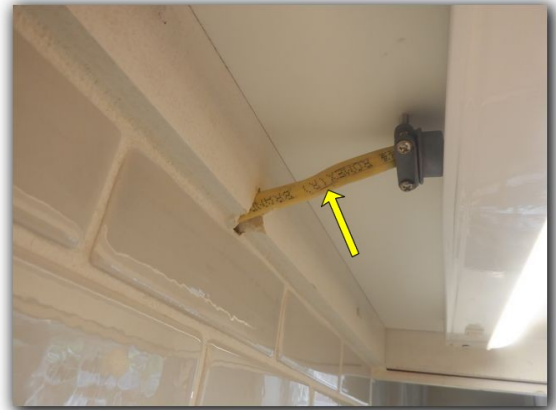
Electrical wiring not in protective conduit; (To under cabinet lighting in the kitchen)

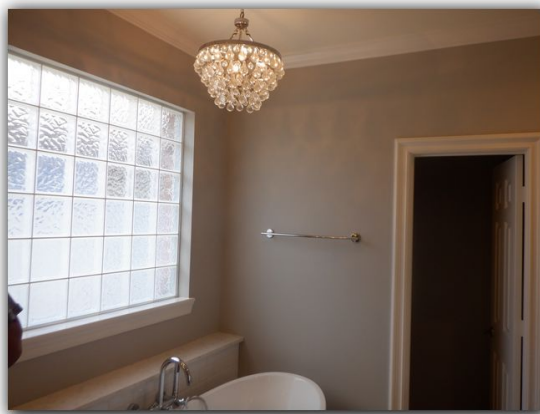
Light fixture over bath not rated for wet/damp locations. Ref. IRC E3908.8: "All fixtures installed in wet/damp shall be marked SUITABLE FOR WET/DAMP LOCATIONS." Bare light bulbs are not to be installed over a bath /shower location.

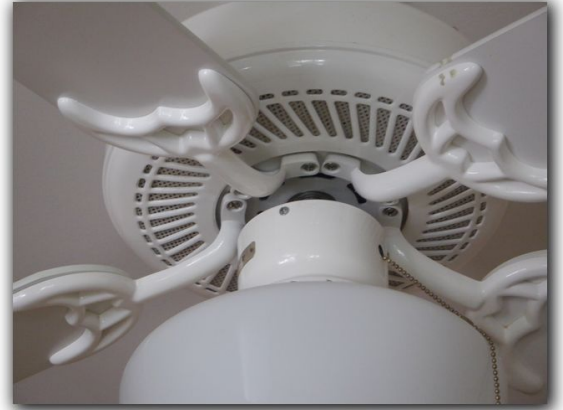
The fan blades were loose in the northeast bedroom and in the living room.

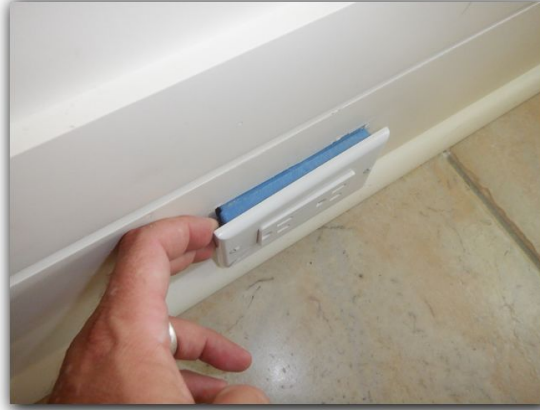
One or more outlets are not secured well in wall. (Formal living room)

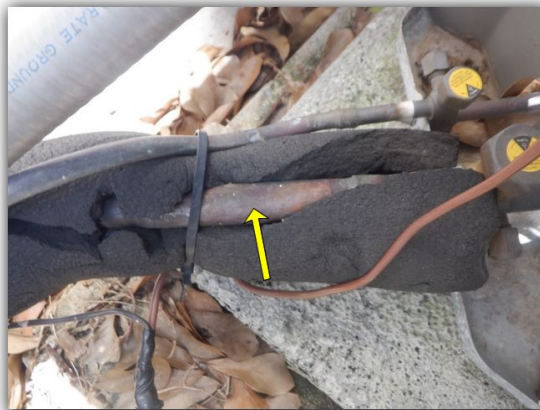
Section of suction line insulation missing or deteriorated near condenser.

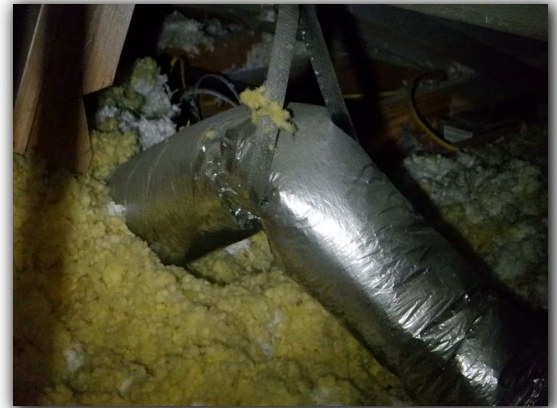
Observed several / multiple areas in attic where flex duct touch and are missing required 1" clearance from other ducts to prevent condensation between ducts that touch. Recommend general maintenance to flex ducts in attic, Re-support where needed, seal/tape minor air leaks, repair torn/damaged vapor seal, etc.

Some flex duct observed to be improperly routed with sharp bends and / or excess material in bends. Improper routing increases frictional loss in the duct and reduces heating and cooling efficiency. Radius at centerline of the bend should be no less than the diameter of the duct.

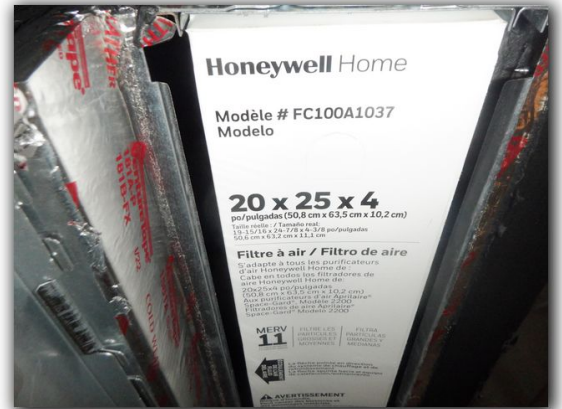
Media air filter(s) located in attic that requires changing/cleaning every 6 months, recommend checking guide for proper maintenance information.

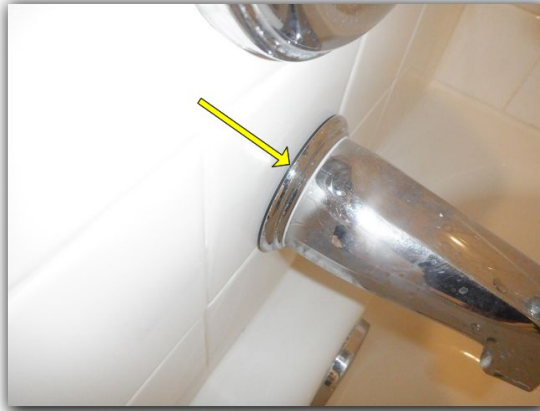
Recommend caulking around all tub/shower faucets and spouts to prevent water entry behind wall.

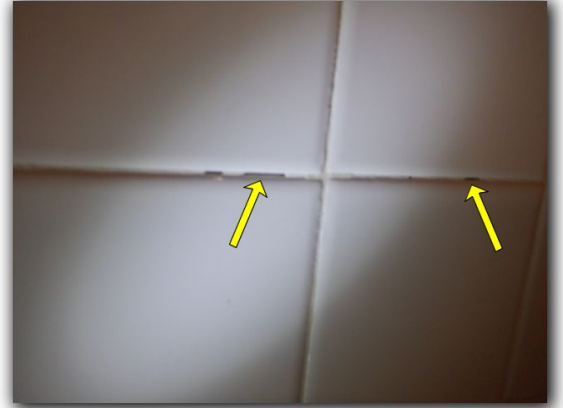
Minor grout deficiencies were present in the tub of the room over the garage.

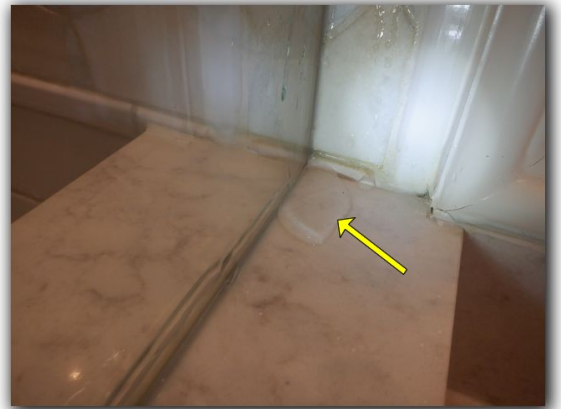
The master shower enclosure needs to be re-sealed / currently leaks.

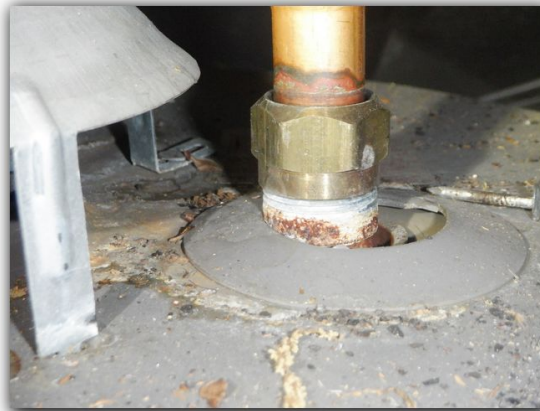
Corrosion observed at shut off valve and/or connections on top of water heater.

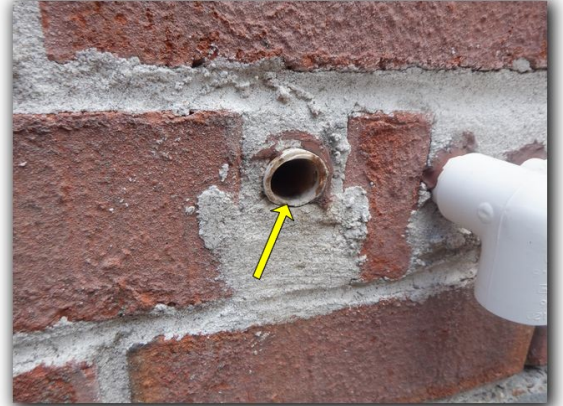
The drain line termination for the water heater drain pan drain line or temperature and pressure relief valve drain line was damaged at the southern exterior.

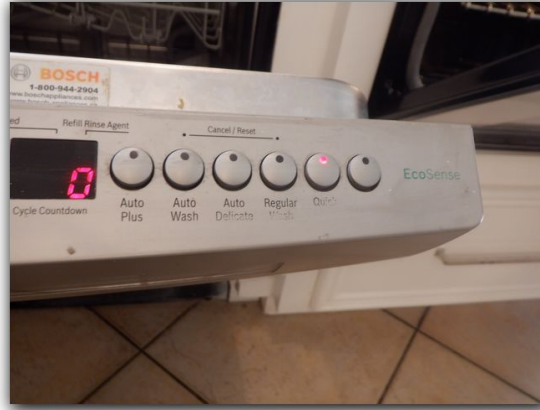
The labeling was worn on the dishwasher door.

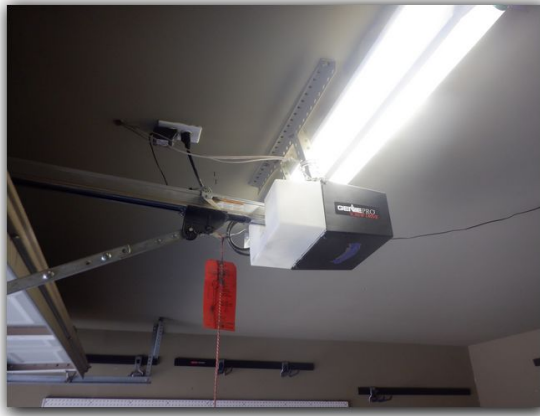
The garage door opener moves during operation / is not adequately mounted / secured.

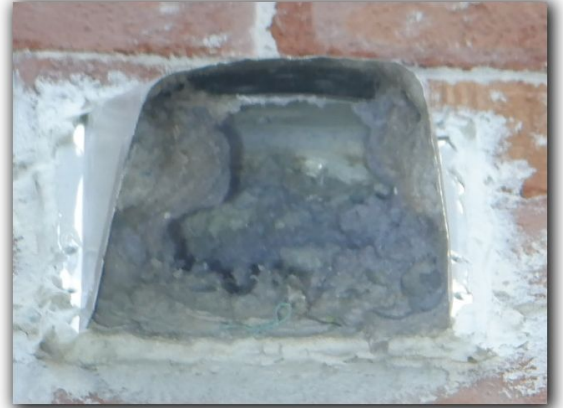
Dryer vent contains lint buildup. Recommend cleaning dryer vent to reduce drying time and risk of fire hazard.

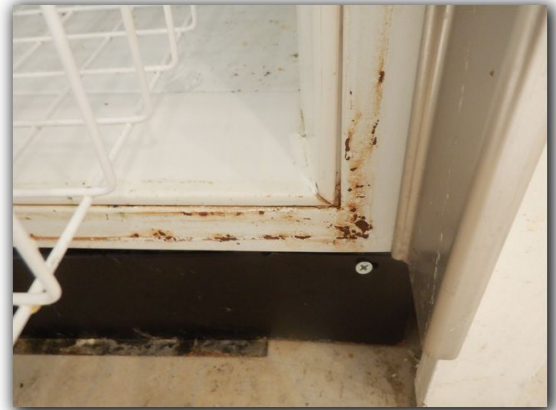
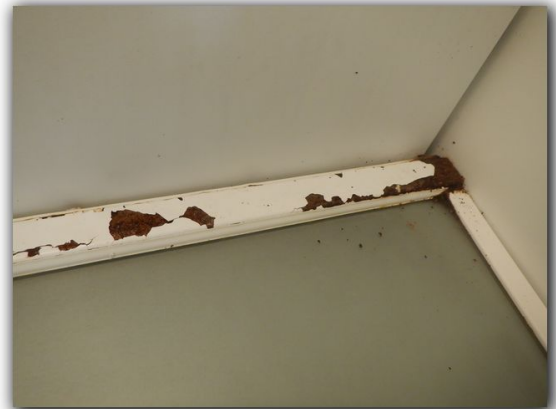
Heavy corrosive damage is present on the interior of the refrigerator / freezer.
