SENTINEL
INSPECTION GROUP

Houston 77008

Foundation:

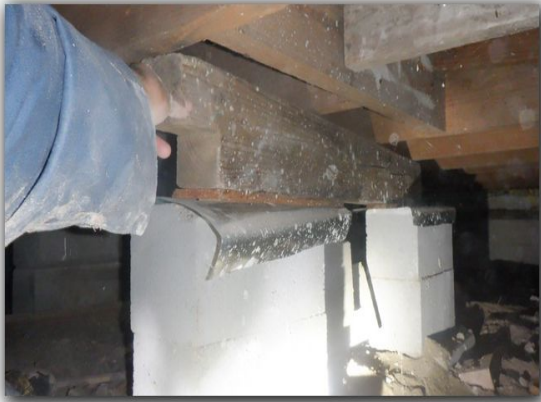
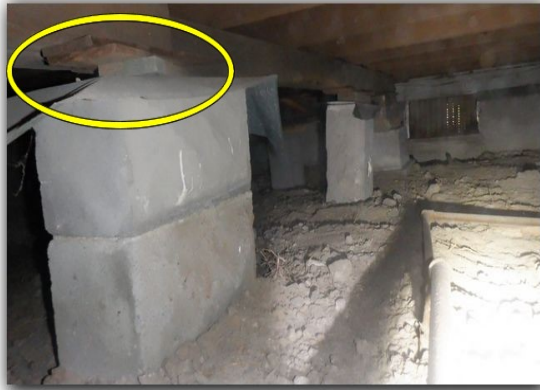
Multiple areas where stations are not properly supporting beams, are leaning, and/or are not stable. Recommend repair. (under the living room area)

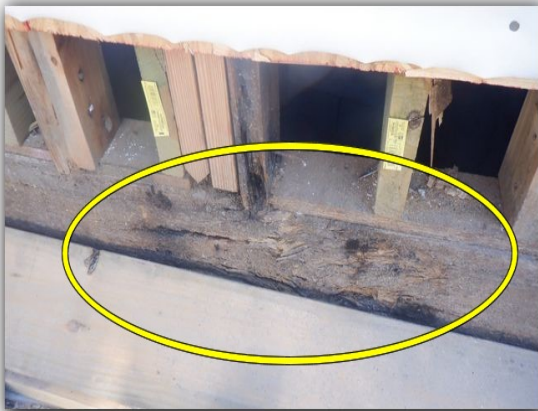
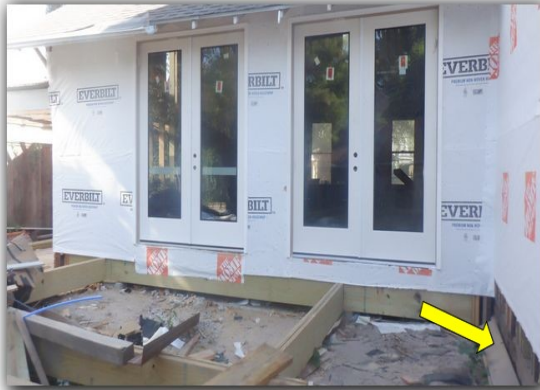
Wood deterioration to a foundation perimeter beam can be observed at the back yard, recommend having the beam replaced if possible for structural integrity.

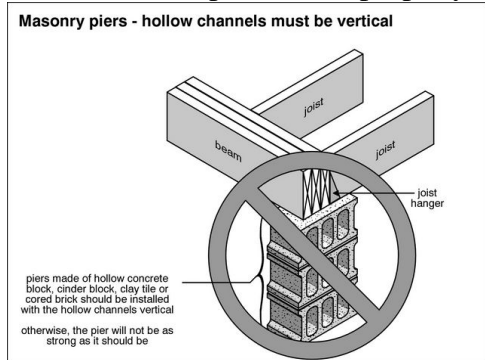
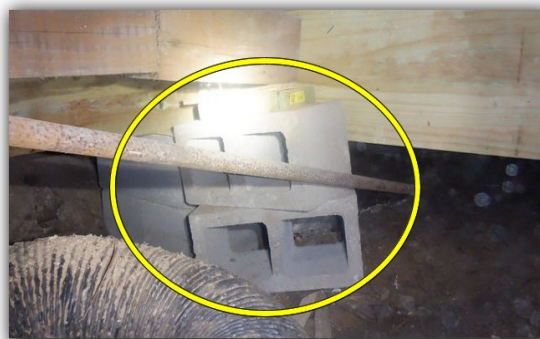
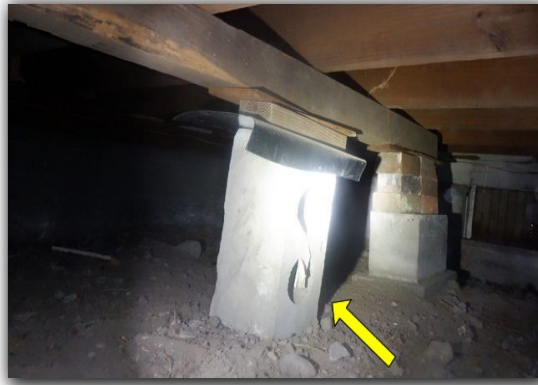
Concrete block piers are improperly installed. Not installed on strength axis with cavities oriented vertically.

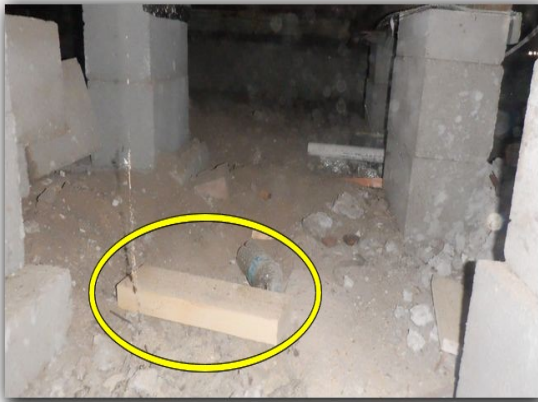
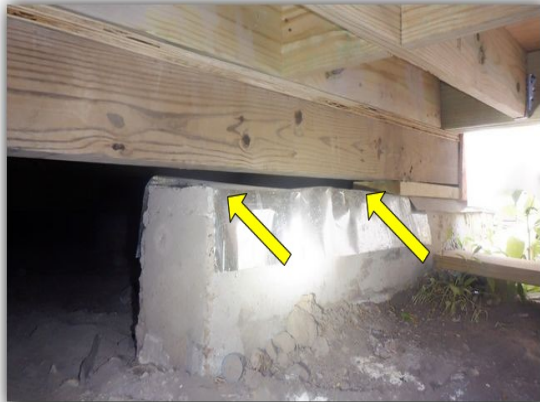
Scrap wood below house is considered a conducive condition for wood destroying insects. A beam at the east/central location is not properly supported or chimmed.

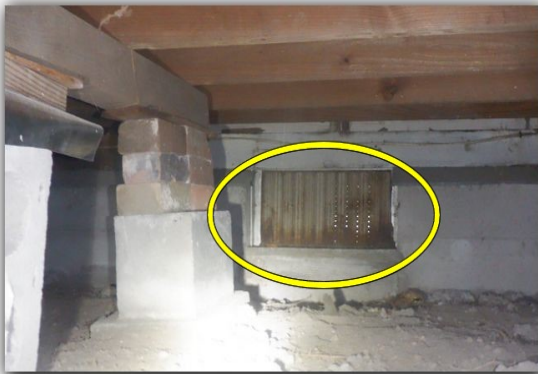
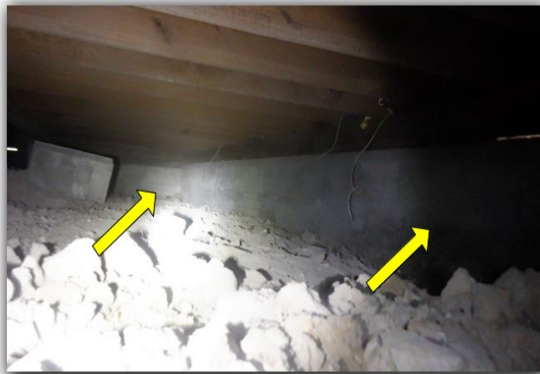
Crawlspace ventilation is limited. Conducive condition for wood rot and mold if not corrected. Only 1 foundation vent observed on the front part of the house and none on the east side of the structure. Cross ventilation throughout the structure should be present.

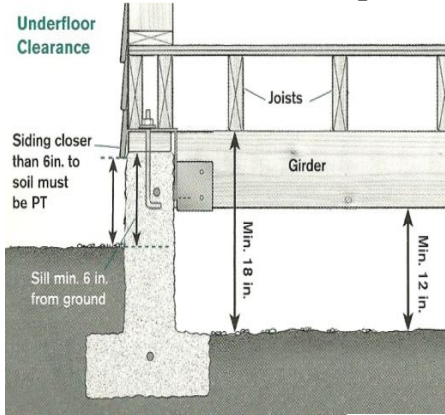
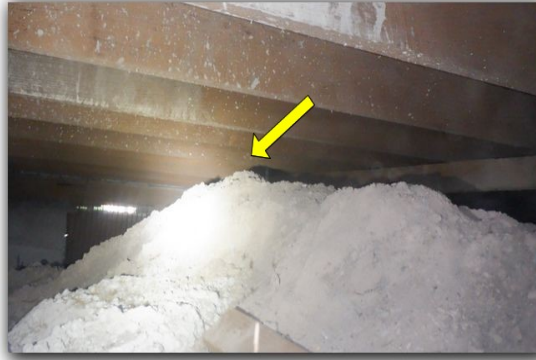
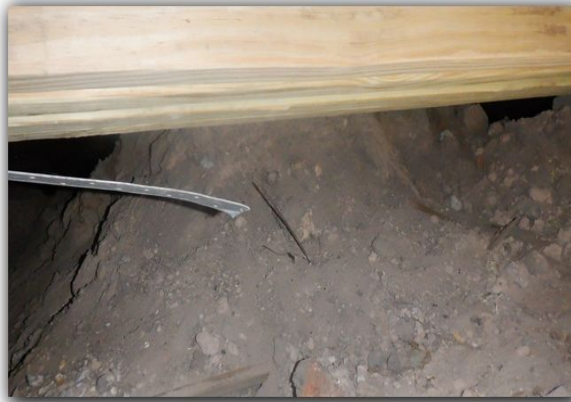
Observed wood framing under house has inadequate clearance from soil to prevent wood rot according to code.
Minimum soil clearance to untreated wood joists is 18". Minimum soil clearance to untreated wood beams is 12". IRC R317.1 (multiple locations)

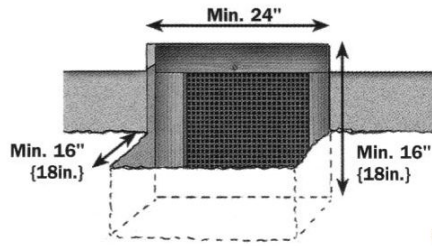
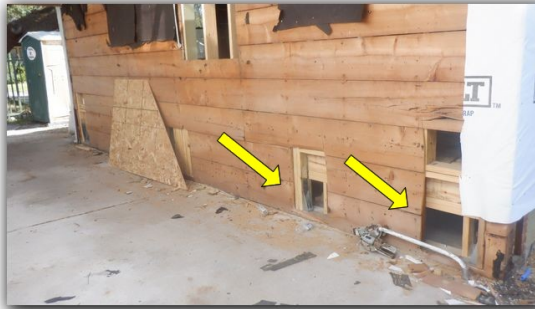
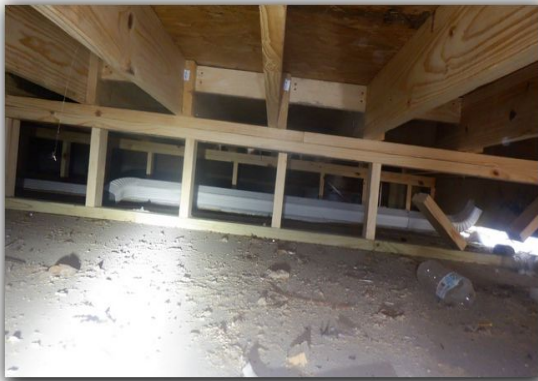
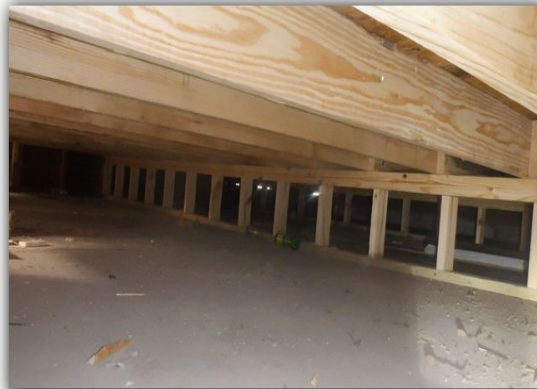
Could not access below most of home due to inadequate access and clearance of framing from ground. Code (IRC Section R408.4) requires that access be provided to all under floor spaces. Access openings through floors shall be a minimum of 18x24 inches, while openings through a perimeter wall shall be at least 16x24 inches. Recommend installation of proper access opening and subsequent inspection under house. (addition or northwest corner) The area was only viewed by small scuttle holes and could not be accessed.

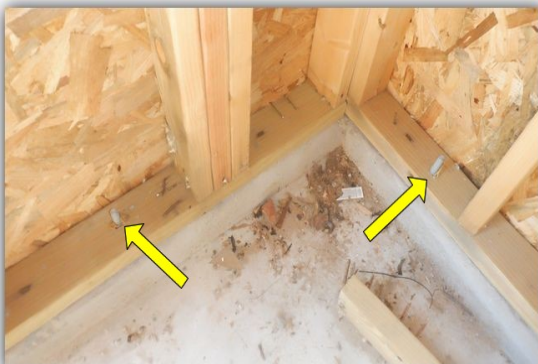
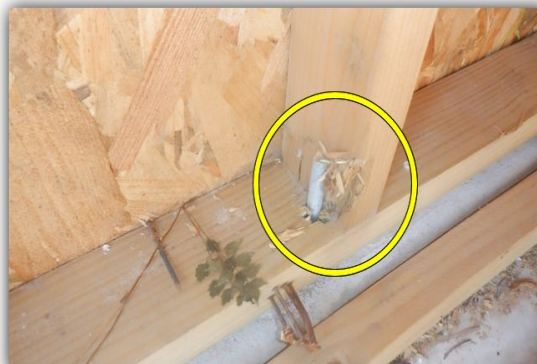
The garage anchor bolts were not fastened at the time of this inspection. Recommend installing the required nuts at all location. One the bolts on the south edge of the garage may not be able to be fastened. A wall stud was installed to close to the bolt.

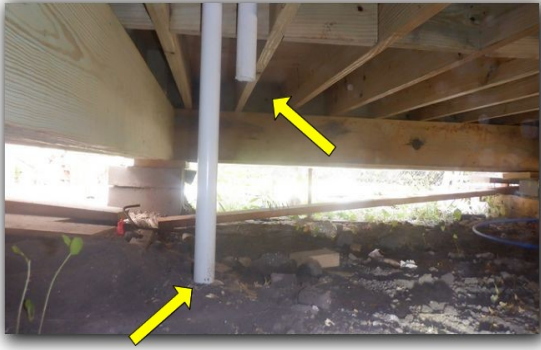
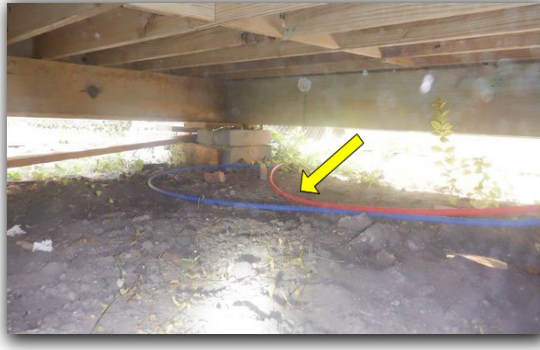
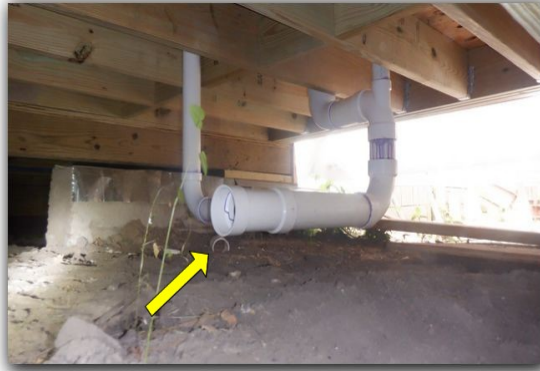
Note: areas of unfinished plumbing can be observed under the structure on the southeast/south side of the crawl space.

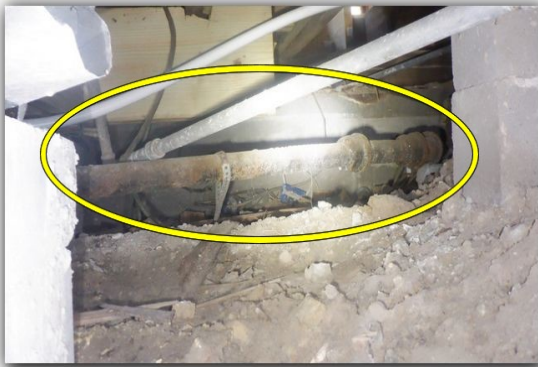
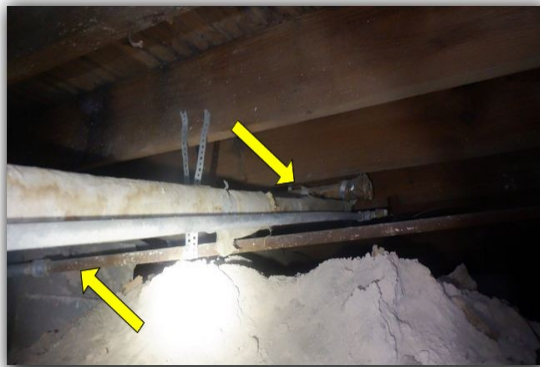
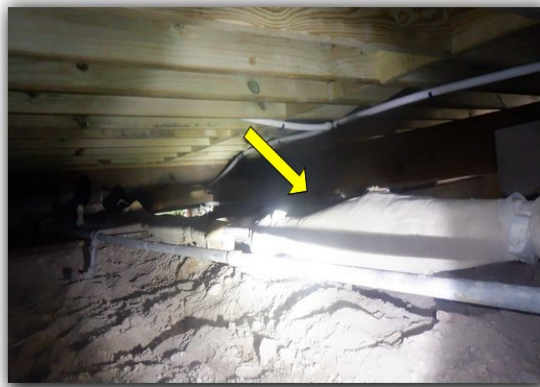
Note: old cast iron drains and galvanized plumbing observed, recommend removal of all unused antiquated plumbing to prevent giving the perception that the plumbing is still active should be future inspection occur.

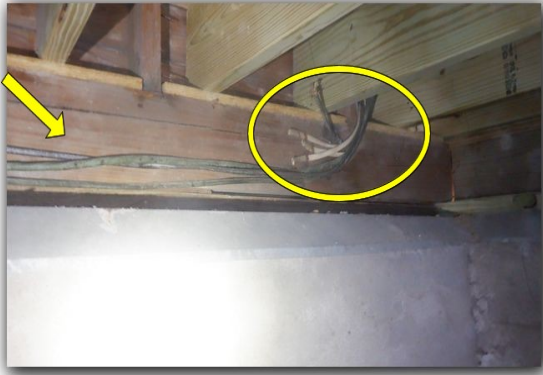
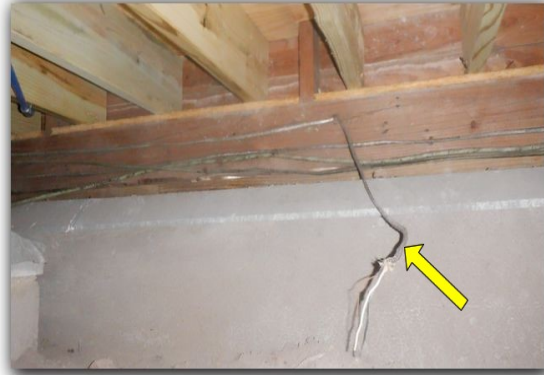
Note: old electrical wiring observed, recommend removal of all unused antiquated wiring to prevent giving the perception that the wiring is still active should be future inspection occur.

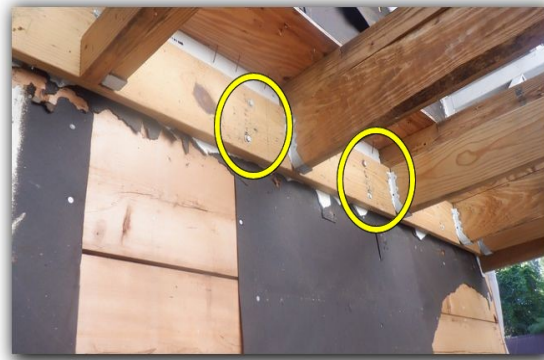
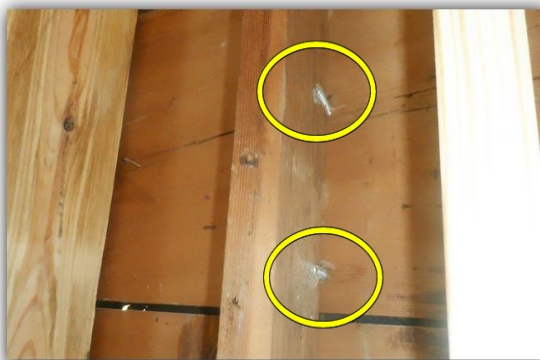
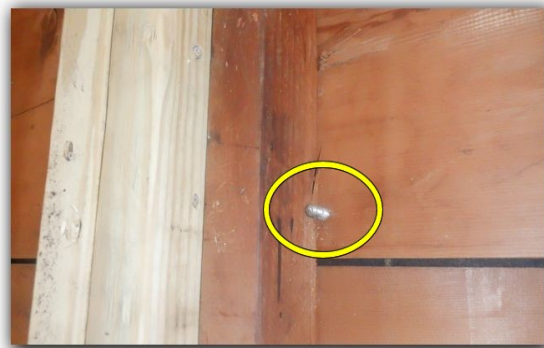
Carport supporting bolts were not anchored to the wall studs on the southwest corner of the addition. The bolts are only being anchored to the outside veneer. Recommend repairs to this condition for safety reasons.

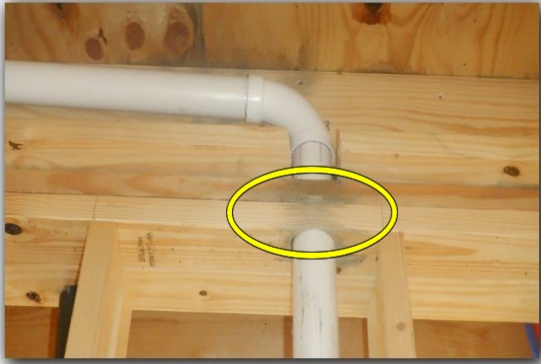
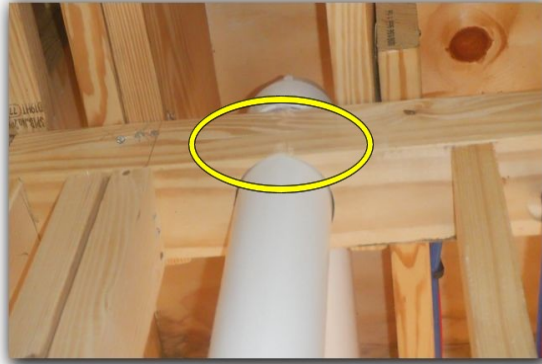
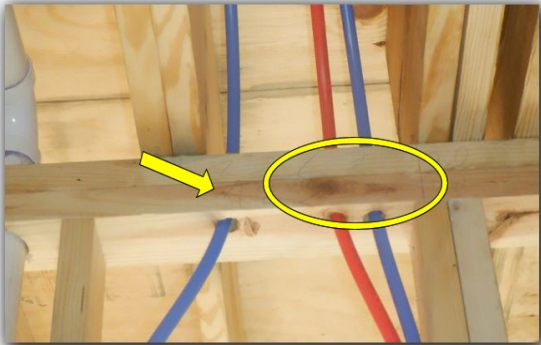
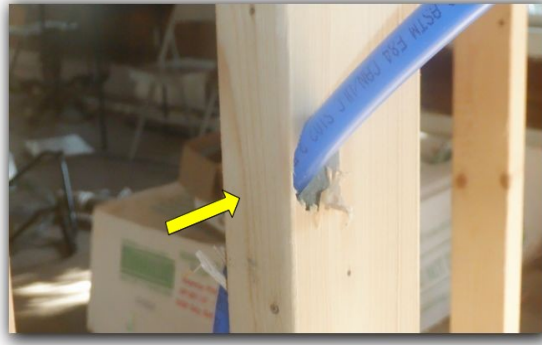
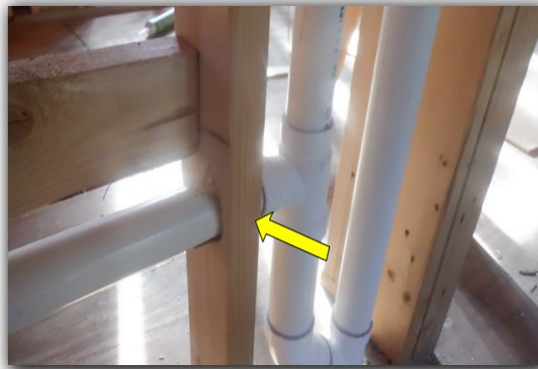
Numerous areas of striker plates that were missing to protect plumbing from being damaged by sheetrock nails. Recommend installing striker plates at all areas to prevent leaks within the wall voids.

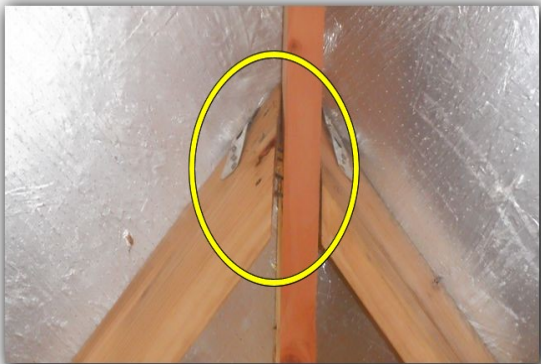
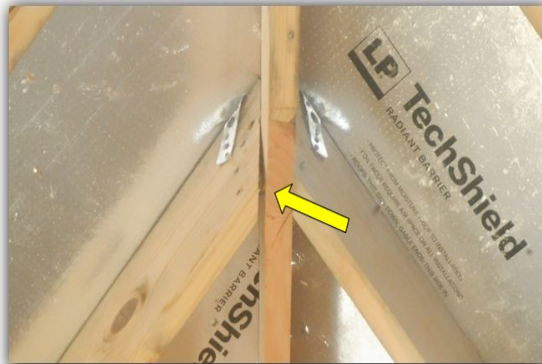
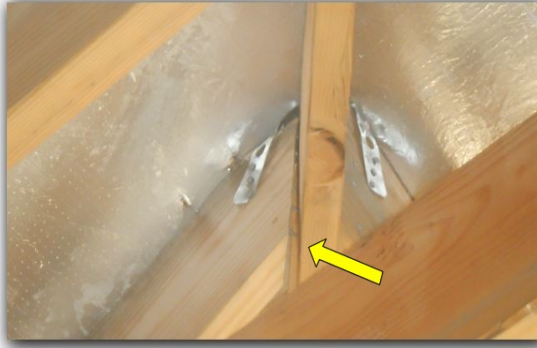
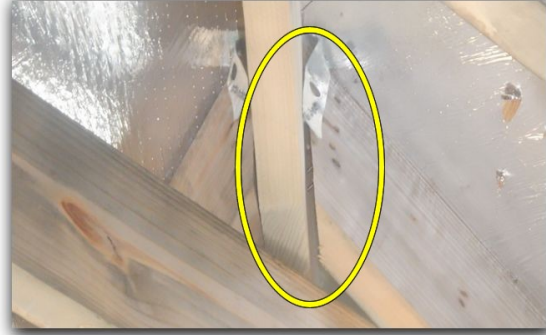
Several ends of rafters were observed to be not cut flush with corresponding components, some degree of misfit was observed, average/mediocre framing. Recommend repair .(garage and 1 location on the upstairs south addition area)

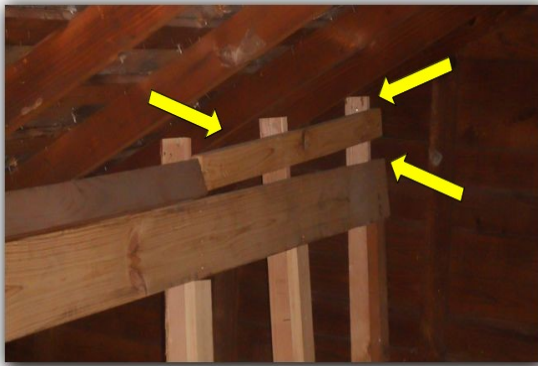
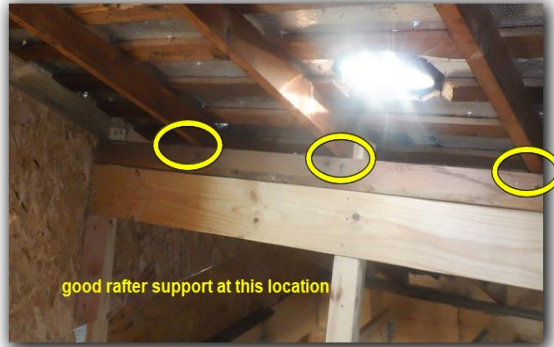
Some disconnection of the purlin and rafter observed on the north side of the older attic section. This is the older attic and appears to have some expected sagging or out of square framing. The new purlins due to this condition were somewhat disconnected.

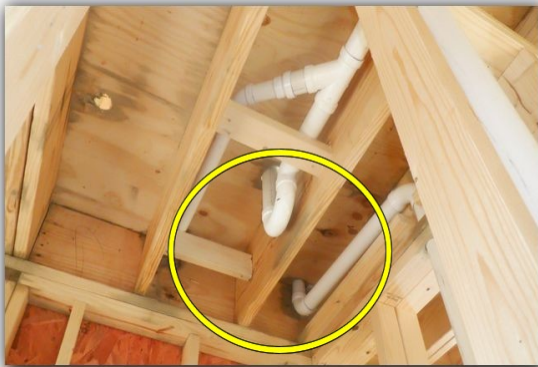
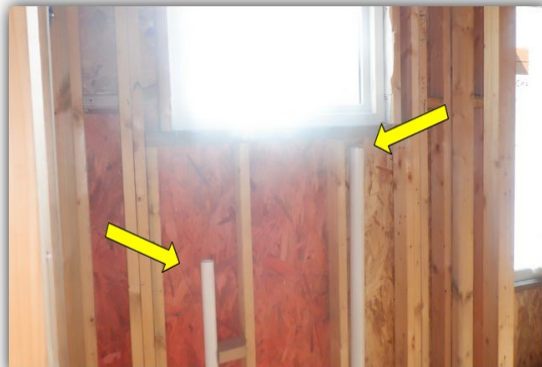
There appears to be either laundry drains or plumbing vent stacks to vent sewer gases to the exterior on a location at the upstairs east area. If these are plumbing vent stacks the plumbing should extend to the exterior past the roof for proper venting and are being blocked by framing of a window. The remedy should be investigated and corrected as necessary.
