SENTINEL
INSPECTION GROUP

West University

PROPERTY INSPECTION REPORT FORM

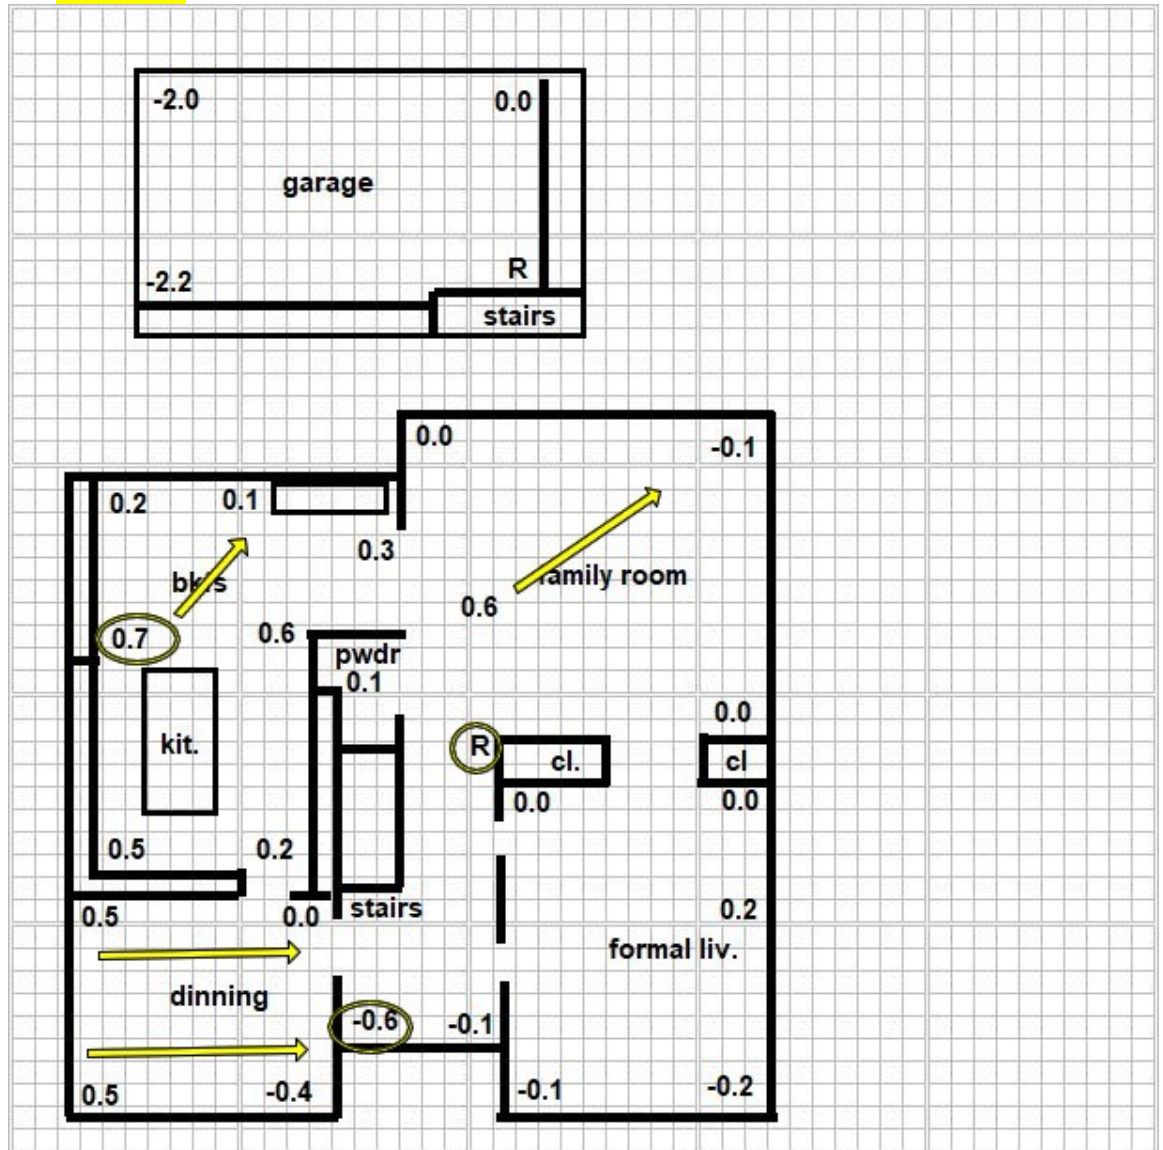
A foundation elevation survey was conducted during the inspection. The table below represents data gathered using a Zip Level or similar instrument and adjusting for floor covering height differences. i.e. differences between tile, carpet and wood flooring. Measurements are listed to the nearest .1". Measurements were taken along the respective walls listed below-North, East South, West, etc. Greatest variance was 1.3 inches

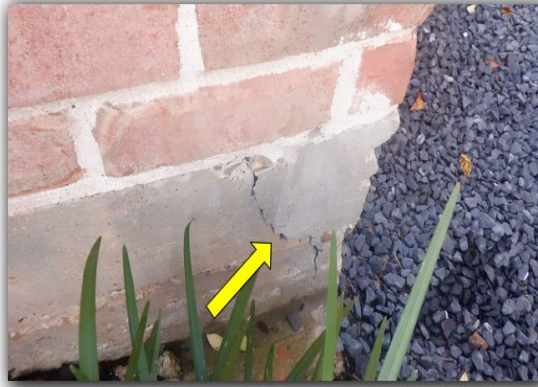
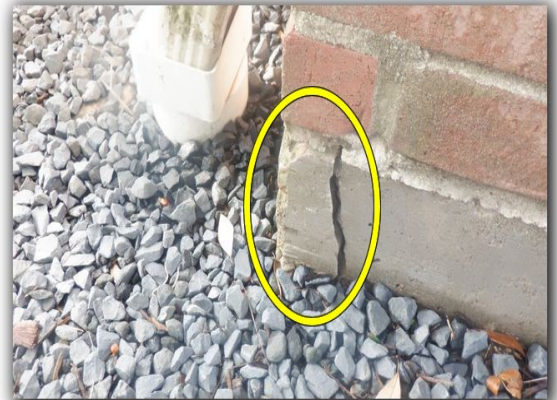
Differential movement / settlement observed; indicated by one or more of the following observed conditions; Cracks in brick veneer and/or foundation, Cracks in sheetrock over doors and windows, doors that are not square in jamb, etc. In my opinion the distress patterns observed at the time of inspection are/were not severe enough to recommend repair. Acceptance of present and future condition / performance / maintenance rests solely with the buyer / client.

Spalling (i.e., corner pops) at one or more corner(s), Corner spalling is common to slab foundations and does not affect the structural integrity of the foundation.

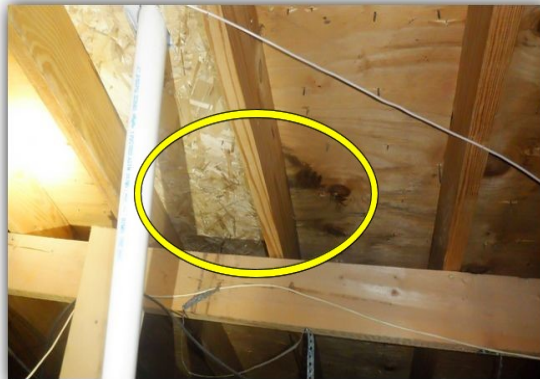
Roof water penetration observed at the following location(s): Low moisture meter readings were taken in the attic at the location of the evidence.

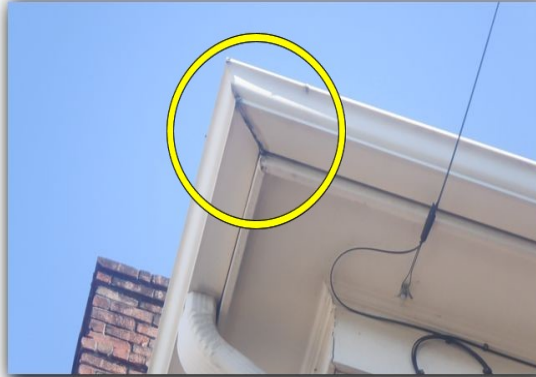
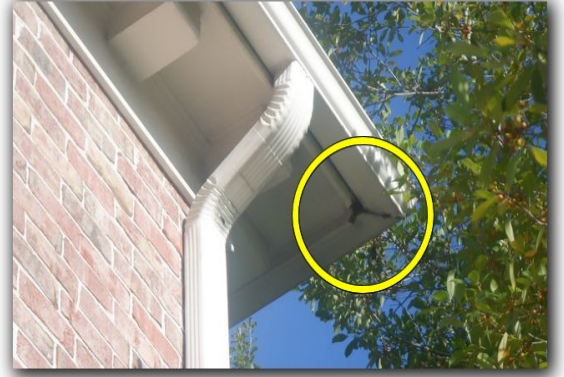
Need general maintenance, Clean out debris / resecure to fascia board / tilt toward drains, seal leaks, etc.

Observed water stains or wood rot on fascia board on back side of rain gutters; indication water is running down back side of rain gutter which leads to wood rot.

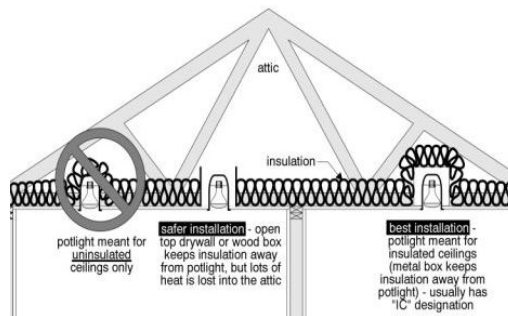
Potlights in insulated ceilings

Ensure insulation is maintained a minimum of 3 inches and wood a minimum of 1 inch from around all recessed lights to reduce possible fire hazard.

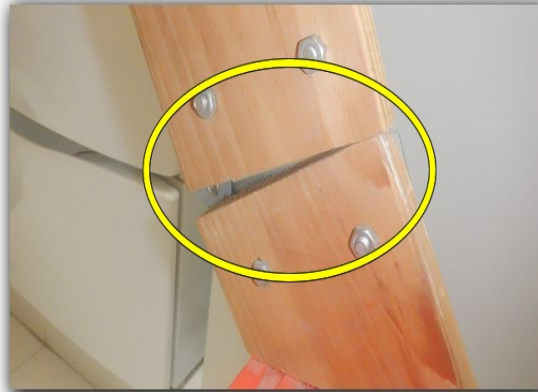
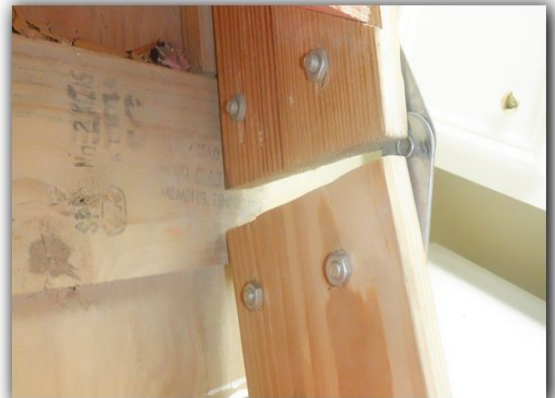
Stairway to attic is not sealed with weather stripping to seal gaps and prevent loss of conditioned air to attic or is missing insulation on stairway.

Attic ladder not cut to fit properly, which puts undue stress on ladder; there should be no gaps at section ends.

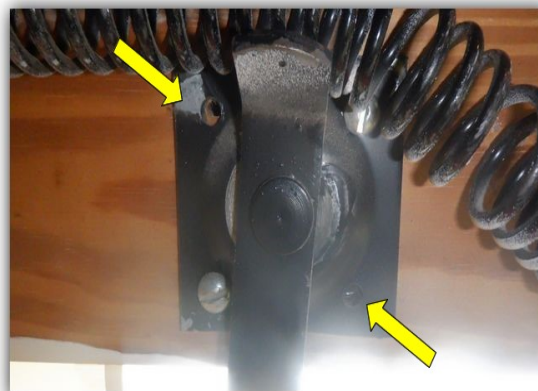
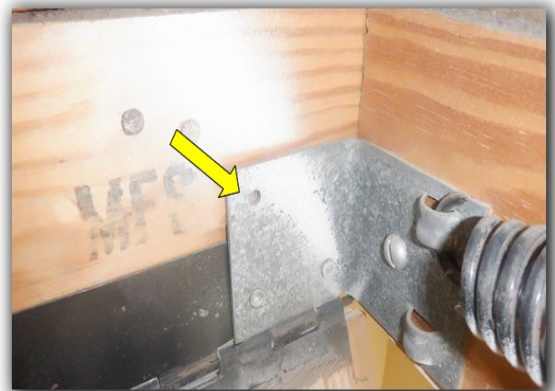
Not installed per manufacturer's installation instructions. Missing securing nails / lag bolts in holes of metal pivot points and corner braces.

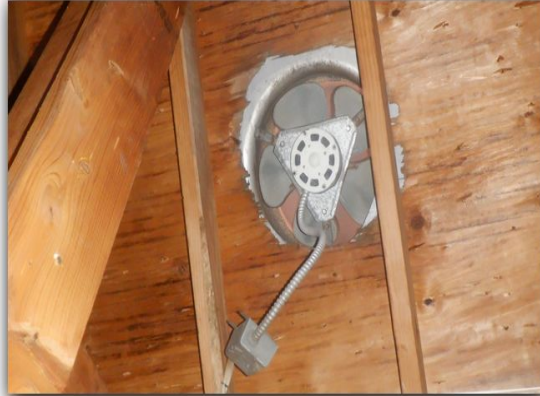
Attic power fan control box is not accessible, was unable to verify operation.

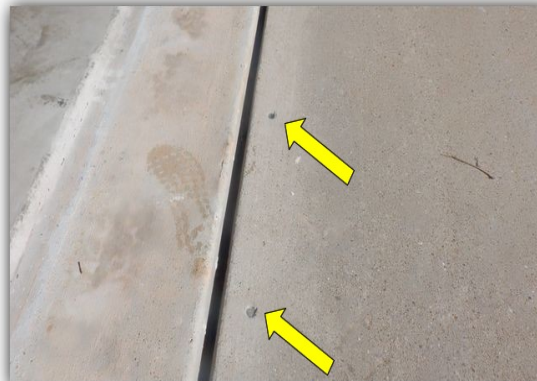
Evidence house and/or garage has been treated for wood destroying insects in the past. Final determination of structurally significant damage to wood members (if any) cannot be determined without removal of wall coverings. Recommend client obtain additional information from seller regarding extent and location of previous infestation, chemical & company used, warranty if applicable, etc.. Sentinel Inspections specifically excludes hidden / latent damage if present (we cannot see thru walls!).

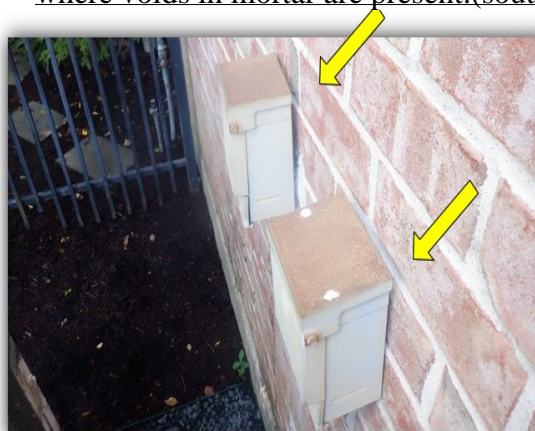
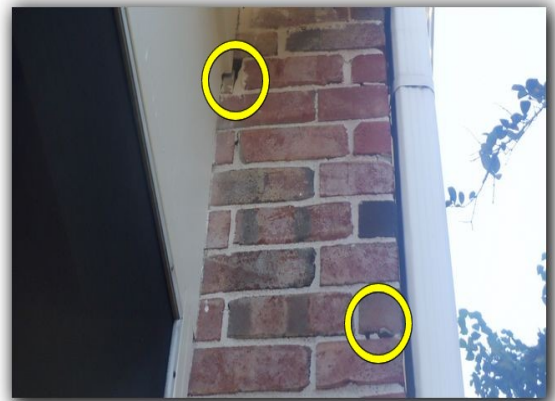
Recommend caulking around electrical disconnect box(s) of A/C unit(s) to prevent water entry behind disconnect(s).

Mortar joints between brick ends is deficient in areas, indication the brick layer might not have properly "struck" the bricks (used enough mortar), recommend re-pointing areas where voids in mortar are present.(southeast corner of the house)

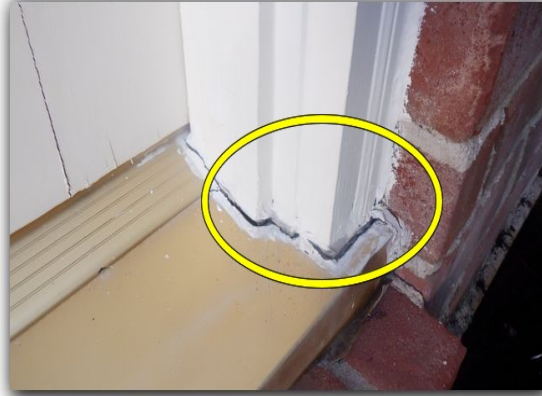
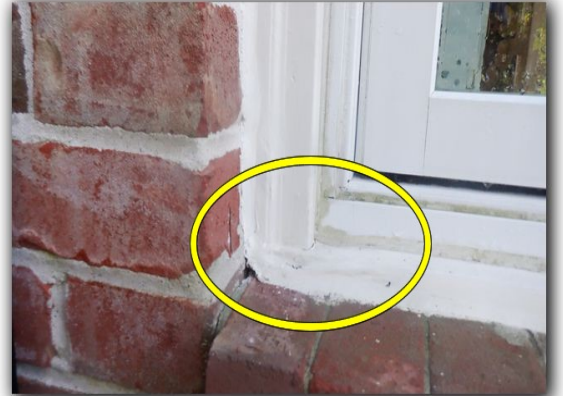
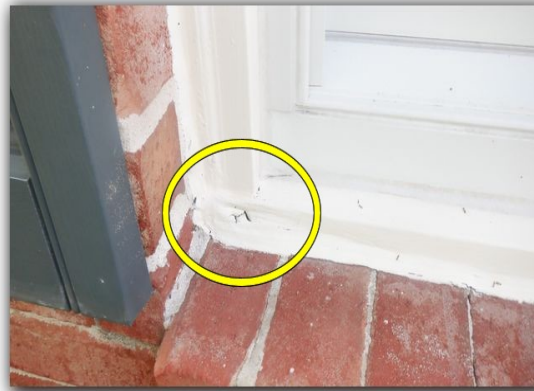
Wood rot observed on areas of house / garage.(back door trim and multiple window frames.

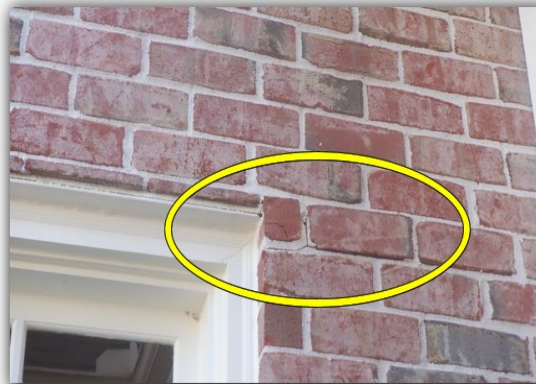
Cracks at upper corners of windows is typical due to not enough space left at ends of steel lintel at time of construction to allow for expansion of metal.

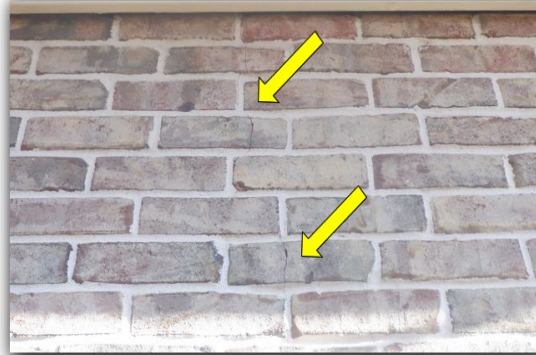
Cracks in brick veneer and/or repairs, one or more locations, Recommend buyer take photographs of cracks, their location, and width [ruler across the crack] with a high resolution camera that has a date stamp for future reference. (south side of garage)

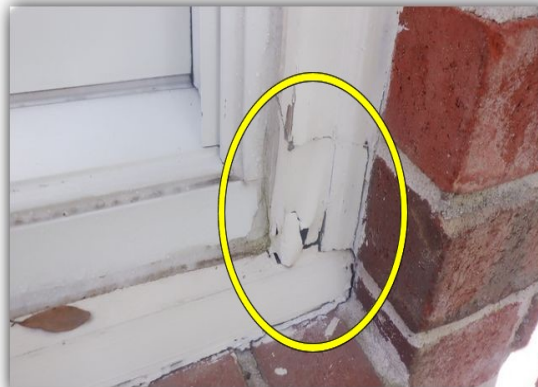
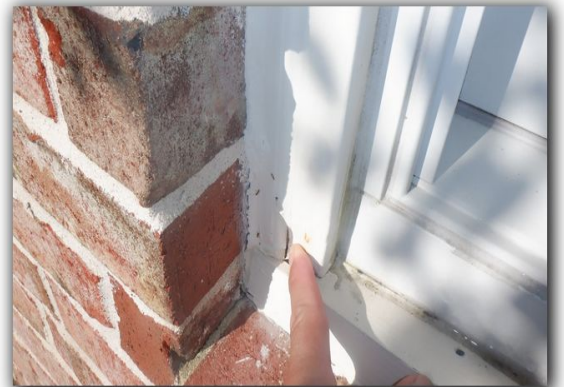
Wood rot of window frame/jamb observed at one or more locations.

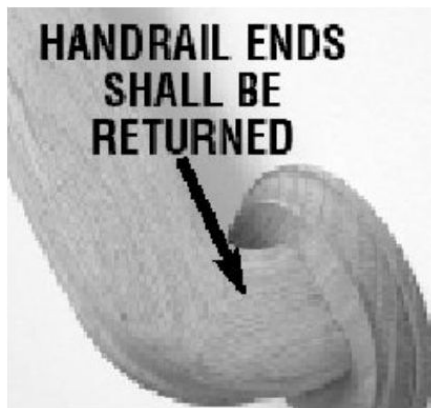
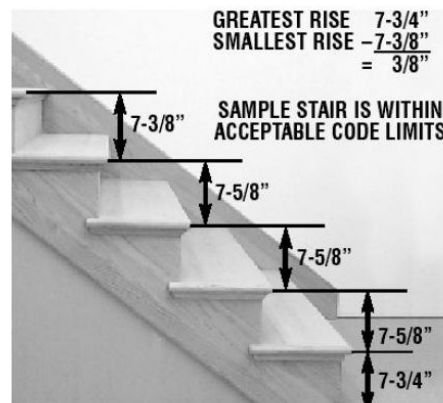
Ends of handrail do not return to wall. This condition may allow loose articles of clothing to catch on ends of handrail while using stairs and result in a trip / fall mishap.(garage storage)

Stairway has tripping hazard, Risers are not same height along the entire height of steps. Stairway does not comply with current industry standard, (code). CABO 314.2 & UBC 1006.3 requires "The greatest riser height within any flight of stairs shall not exceed the smallest by more than 3/8 inch."(garage storage)

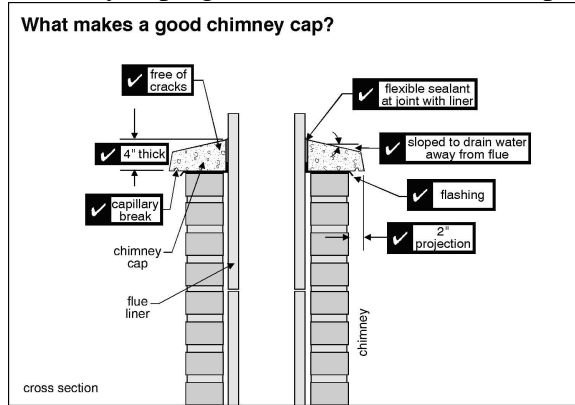
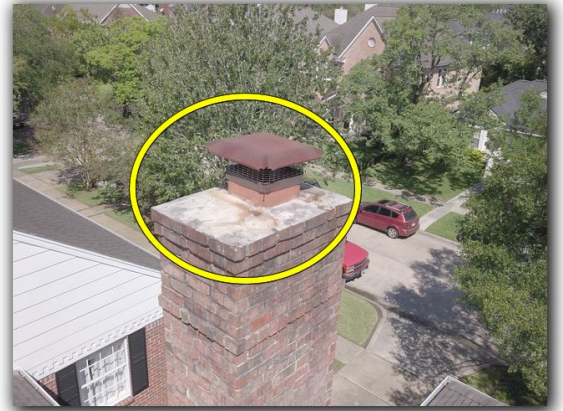
Masonry coping cracked, or in need of improvements on top of chimney.

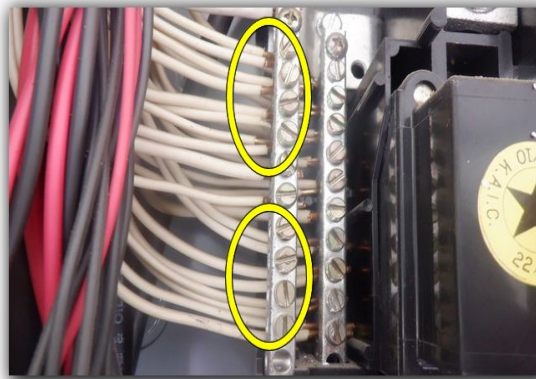
Observed two or more neutral conductors under one screw lug on the neutral bus.
Current industry standards and National Electric Code permit one neutral conductor per screw lug.

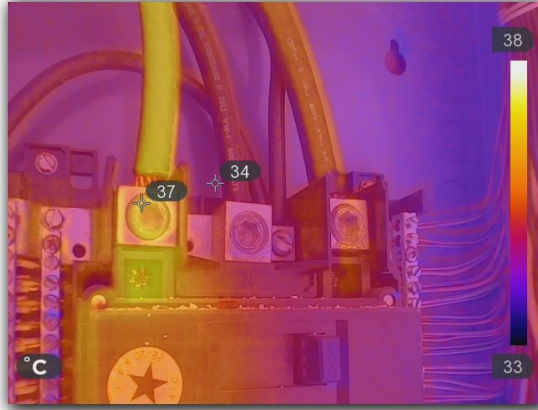
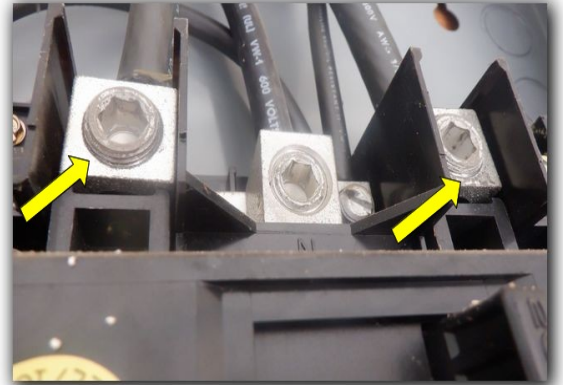
The left leg of the feeder wire appears to be running hotter than typical and the fastener appears to be in need of being torqued. compared to the fastener on the right.

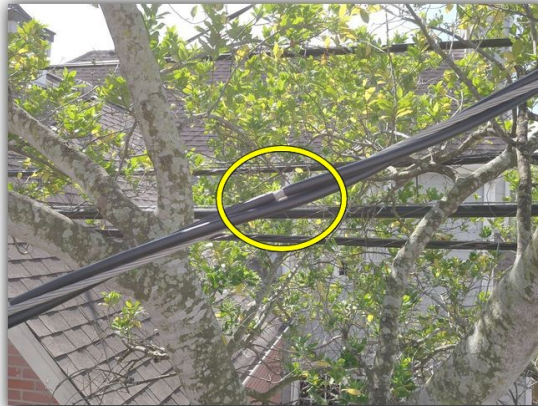
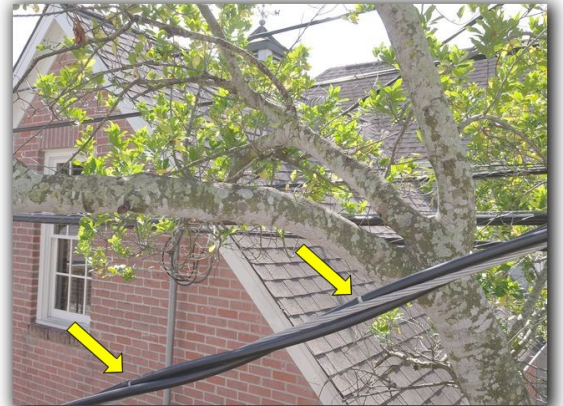
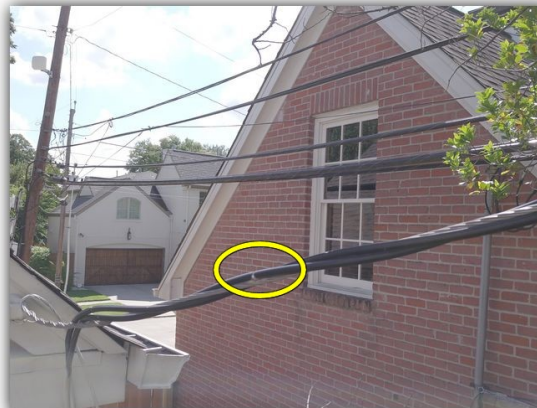
Electrical wiring insulation damaged on service drop, shock hazard, in need of repair.

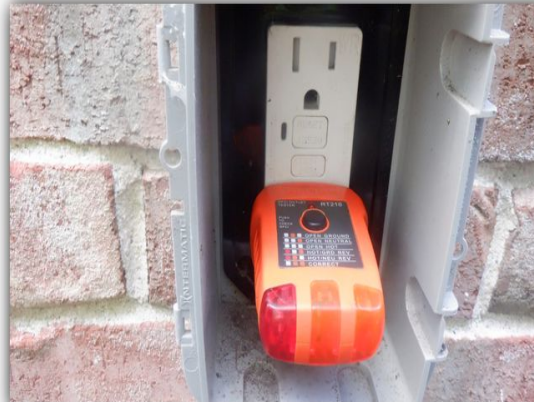
No power to outlet(s); front exterior. The GFCI outlet is not resetting.

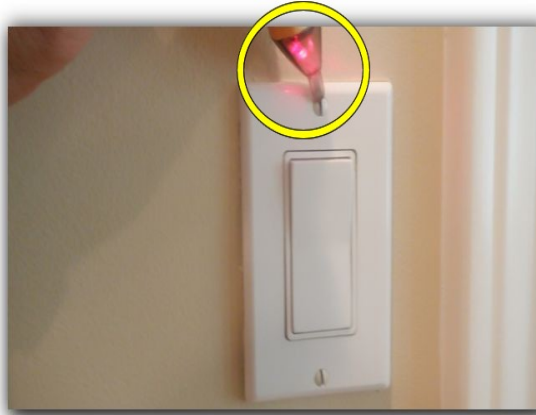
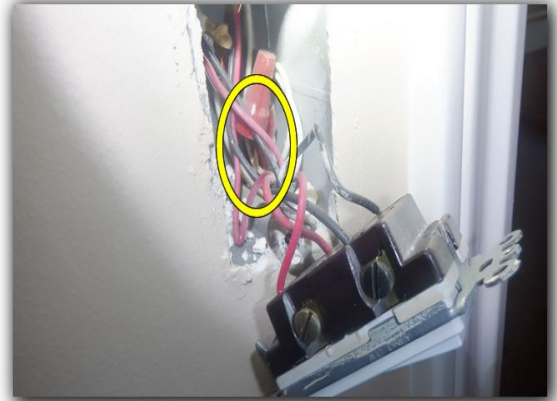
Voltage detector indicated switch(s) are not grounded as required by current industry standards (code) to reduce risk of electrical shock. Prior to 1999, grounding of switches was not required. Recommend grounding all non-grounded switches or replace all metal face plates and screws with non-conductive plastic face plates and screws.

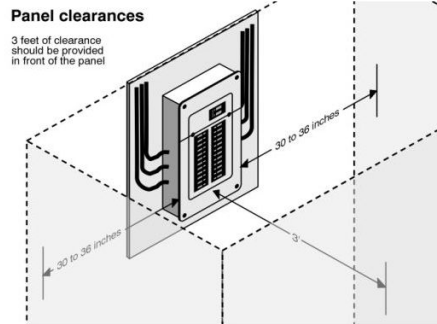
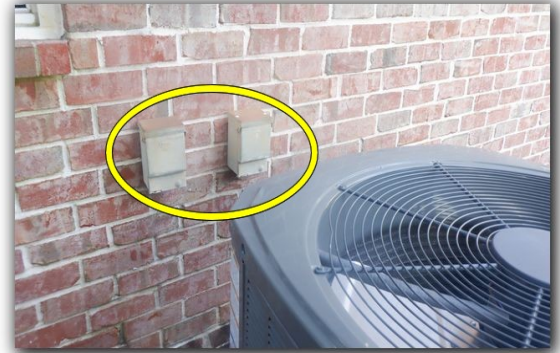
Code requires minimum clearance to electrical service panels (including A/C disconnects) to be 36" in front of and 30" from side to side.

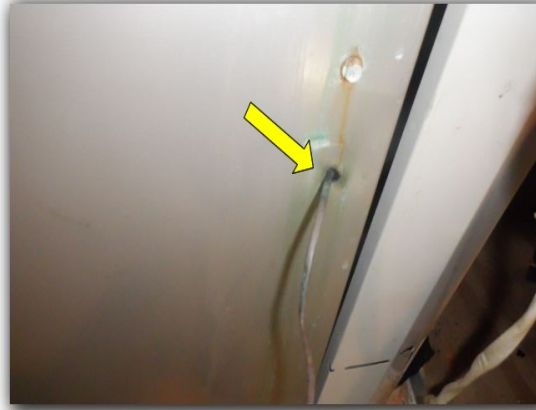
Thermostat wiring not secured to attic unit(s), missing small fitting that secures wiring to cabinet to prevent pulling loose by service personnel or homeowner.

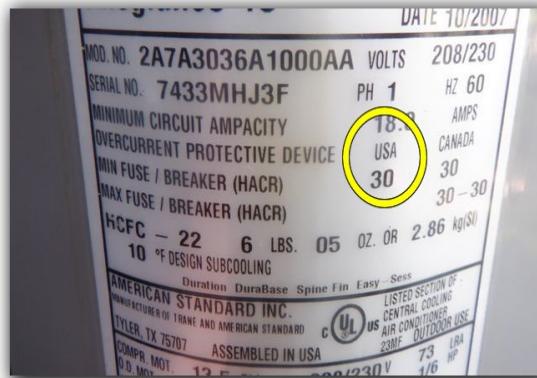
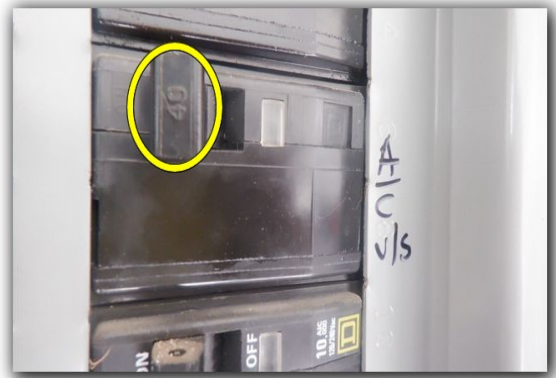
Improper sizing of breaker to unit may void manufacture's warranty. Data plate on unit states maximum breaker size to be 30 amps, observed size in service panel is 40 amps.

**Recommend qualified/licensed HVAC technician service/repair/replace as needed.
Not cooling well.**

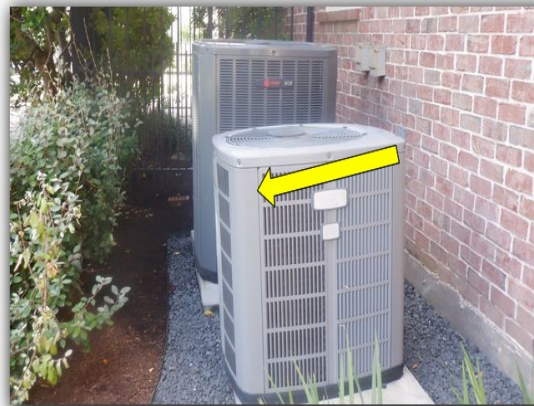
Older unit, limited service life remaining.
Unit not level, needs to be level for proper operation.

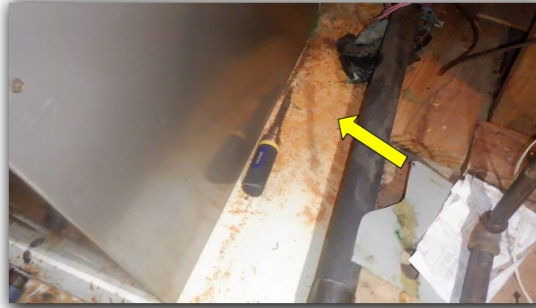
Secondary drain pan is rusted; indication coil (or previous coil) has history of leaking/dripping condensation into pan.

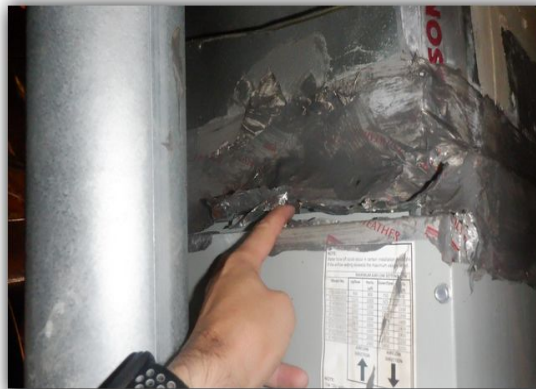
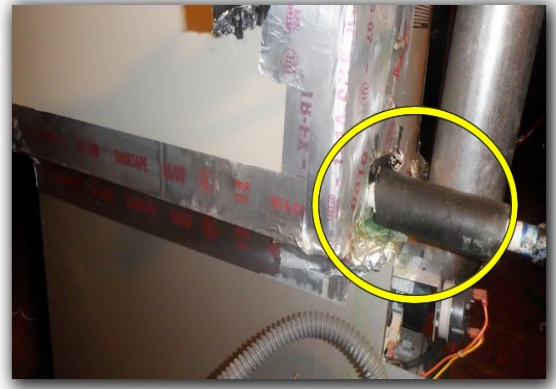
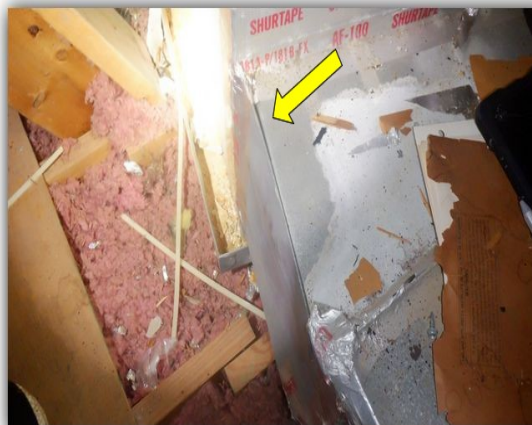
Excessive air loss at defective manufacture construction joint / seam of heaters and coils. (both units)

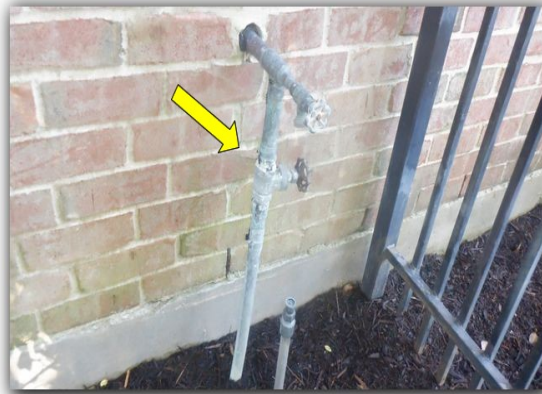
Water softener, treatment and filtration type of equipment was not checked/inspected. Recommend insulating exterior water line(s) to prevent freeze damage.

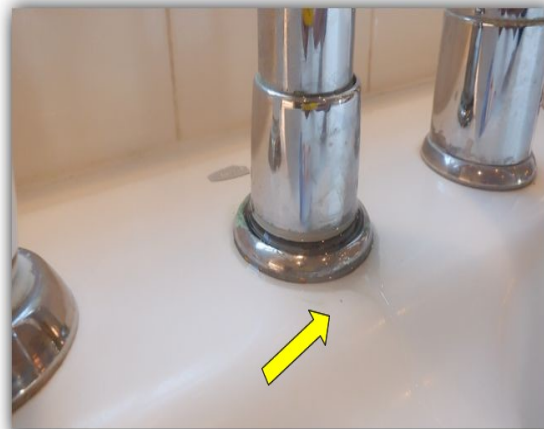
Leaks at base "O" rings, and/or stem washers; kitchen sink.

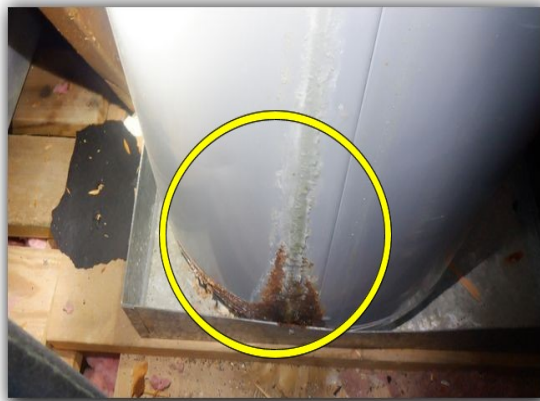
Unit has exceeded its normal serviceable life; budget for repair or replacement.

One of the water heaters was excessively corroded, recommend replacing to prevent damage if the unit corrodes thru.

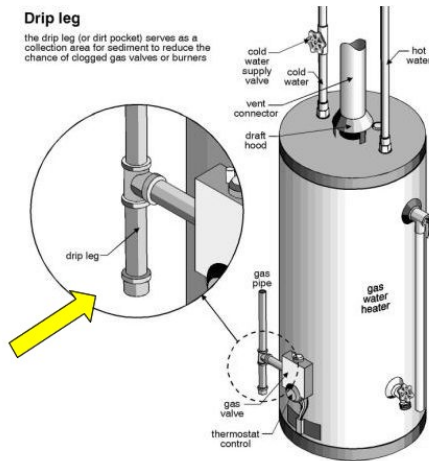
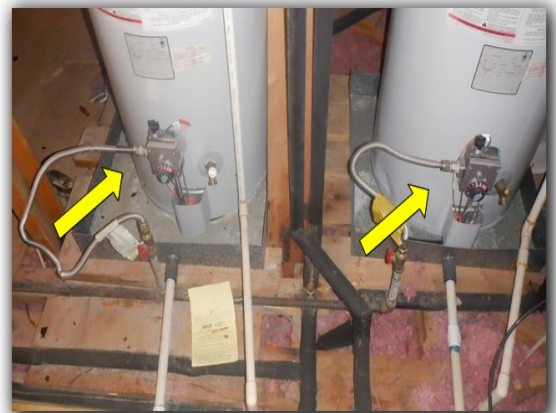
Did not observe gas line drip leg(s) on gas house heater and/or gas water heaters which is called for in the manufactures installation instructions.

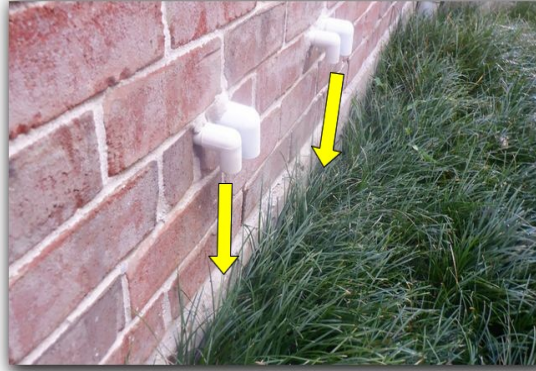
Drain line terminates improperly, current industry standards (Code) require drain line terminate within 6 inches from grade. Recognized safety hazard, repair IRC 2803.6.1.

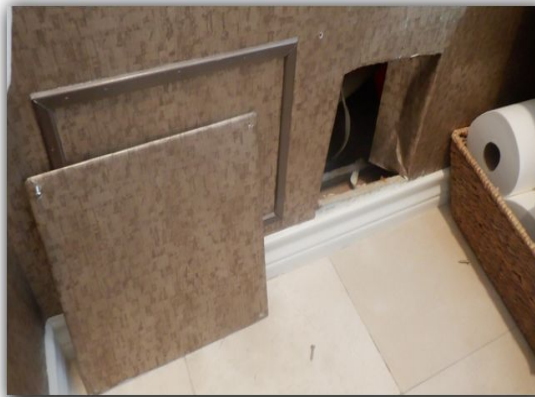
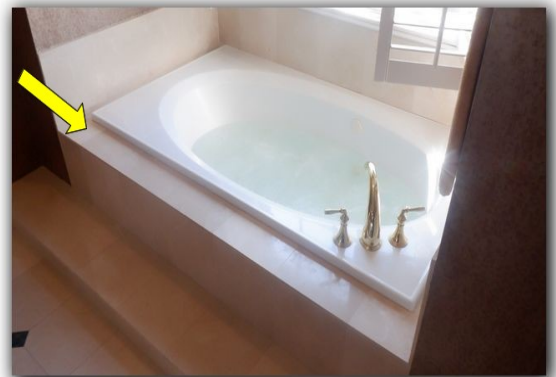
Was not able to access motor for visual inspection. Does not fully comply with National Electric Code (Reference NEC 680-72. Accessibility. “hydromassage bathtub electrical equipment shall be accessible for repair / replacement without damaging the building structure or building finish”.) Should have access panel installed for servicing / access to pump motor IRC 4109.3.

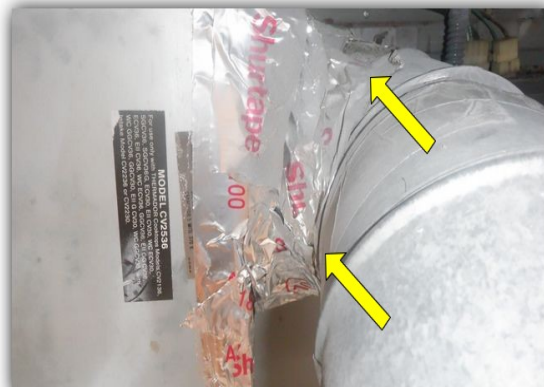
Excessive air loss from vent ducting, needs to be sealed. (cabinet under the range)

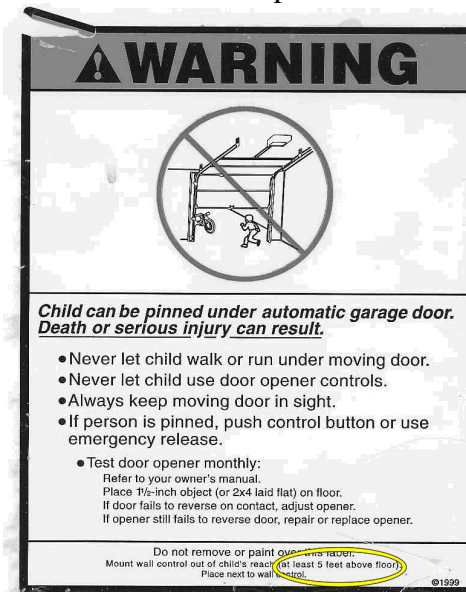
Garage door operator control button is improperly located. Federal safety standard for automatic residential garage door openers states "Locate control button: (a) within sight of door, (b) at a minimum height of 5 feet so small children cannot reach it, and (c) away from all moving parts of the door."

Missing required safety sticker / decal next to operator button.

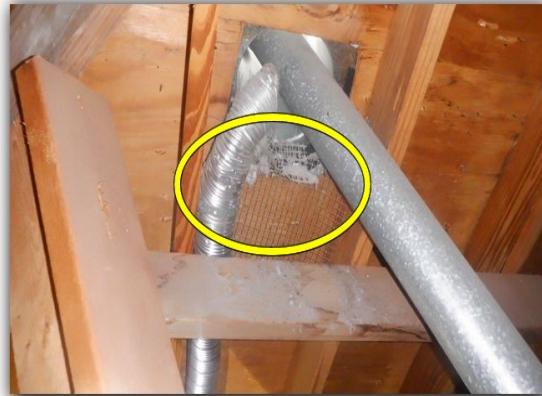
The dryer vent does not appear to be venting properly, lint observed to be falling back into the attic, recommend a roof termination with a damper.

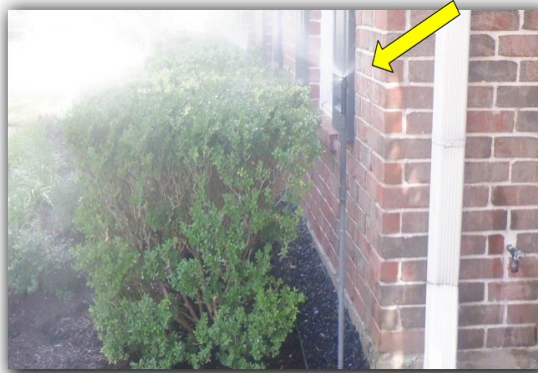
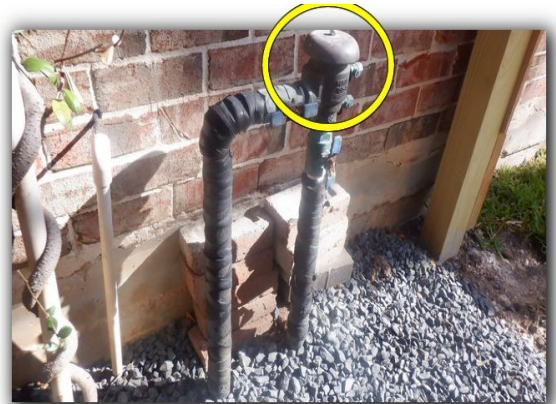
Code required back flow prevention device on sprinkler system is not installed at proper height; a minimum of 6” above highest head IRC 2902.2.2.

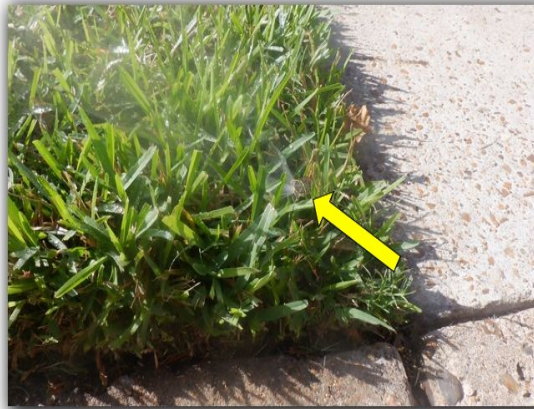
One of the rotating heads in station 3 was damage or not rotating.

One of the heads in station 5 was not popping up high enough to dispense water properly.
