**Pier & Beam Sample report
Houston, TX 77008**

PROPERTY INSPECTION REPORT FORM

John Doe <i>Name of Client</i>	10/13/2022 <i>Date of Inspection</i>
Pier & Beam Sample report, Houston, TX 77008 <i>Address of Inspected Property</i>	
John Tatum <i>Name of Inspector</i>	Professional Inspector # 9459 <i>TREC License #</i>
 <i>Name of Sponsor (if applicable)</i>	 <i>TREC License #</i>

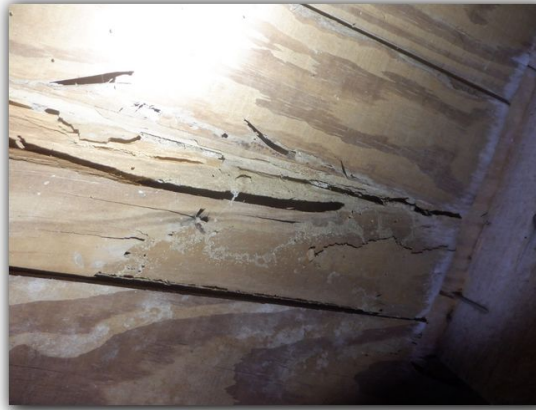
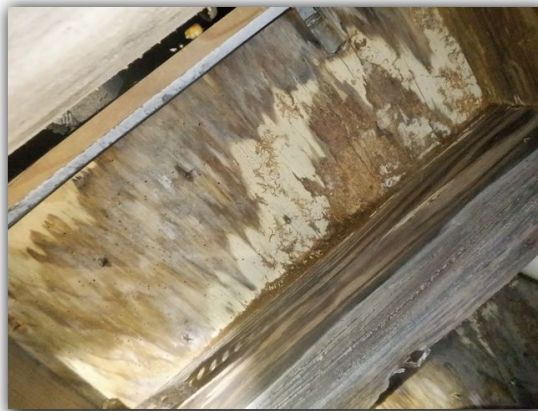
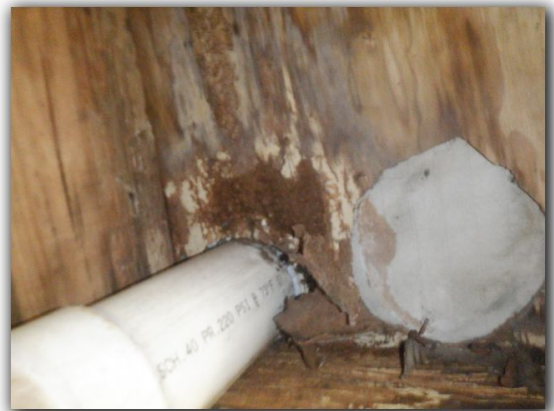
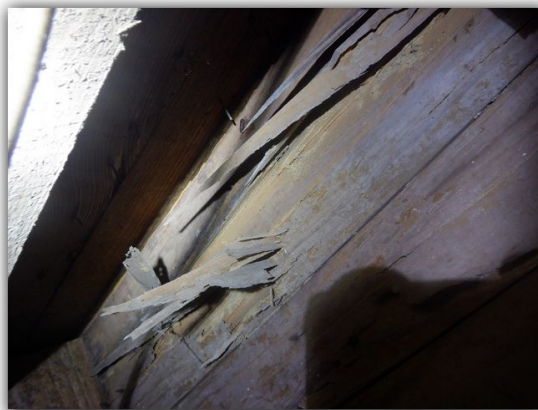
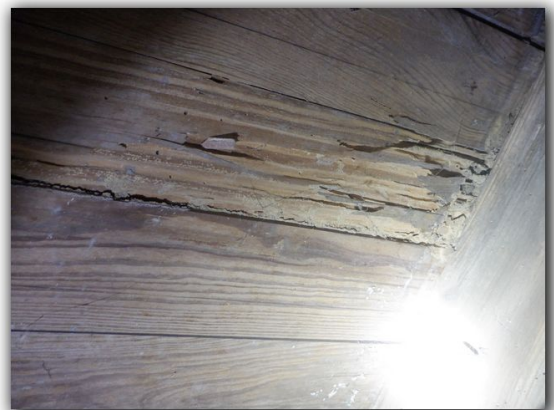
Multiple areas observed below house with various degrees of damage from water and/or wood destroying insects. **Damage found to be in my opinion as in need of repair was observed below the vicinity of both bathrooms. The area below the hall bathroom appears to be a combination of water and wood destroying insect damage.** Recommend qualified contractor be retained/consulted regarding scope of all repairs needed/required and deemed necessary to effect a proper repair that the contractor deems adequate and is willing to warrant.

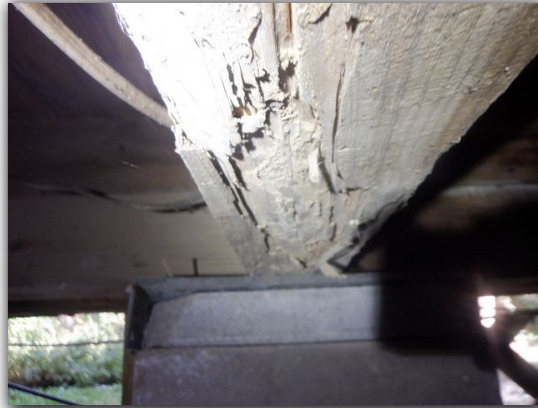
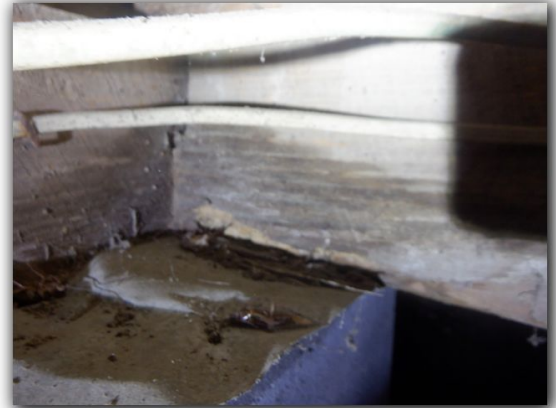
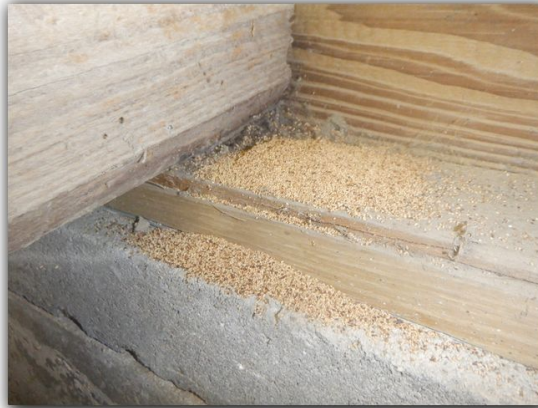
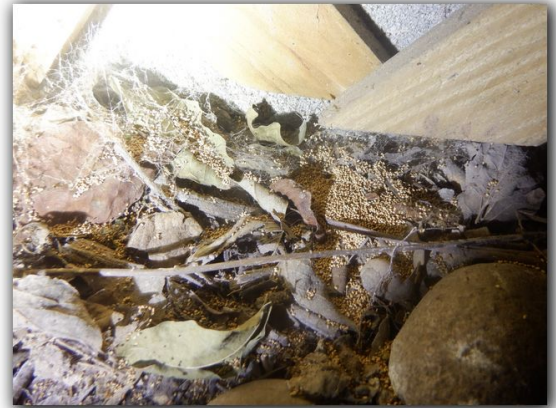
What appears to be active wood destroying insect activity observed below the house; Final determination of structurally significant damage to wood members cannot be determined without removal of wall covering {interior sheetrock or exterior siding}.

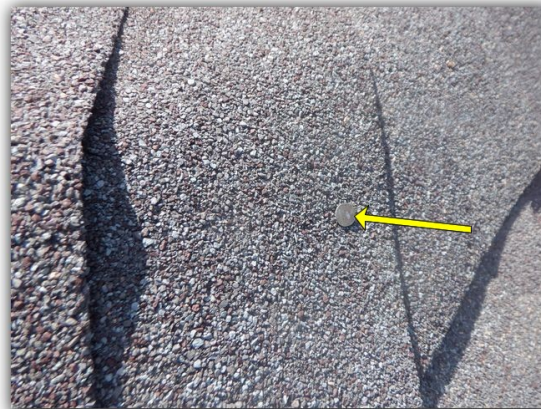
The roll roofing over the back patio appears to have been nailed and caulked around the perimeter. This style of roofing should not be penetrated by nails.

Exposed staples / nail heads / fasteners observed on roof, all exposed fasteners should be sealed to prevent water entry.

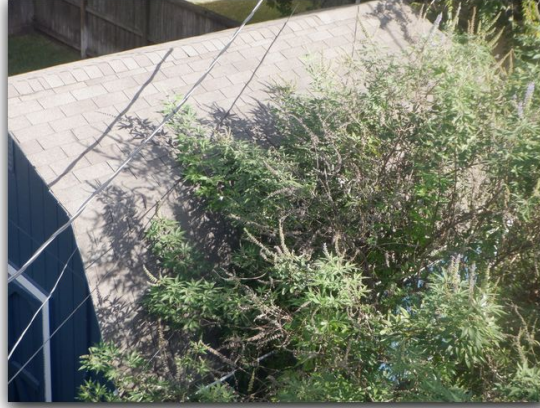
Tree limbs in contact with shed roof should be cut back.

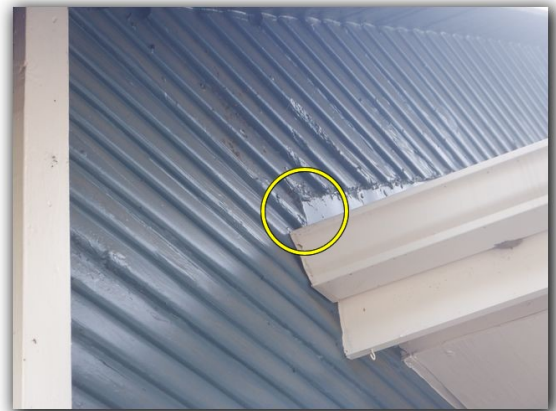
Recommend addition of “kick out” flashing wherever a roof or balcony terminates along a vertical wall to encourage rain water running down roof or balcony to be diverted / “kicked out” away from vertical wall and reduce water running down vertical wall.

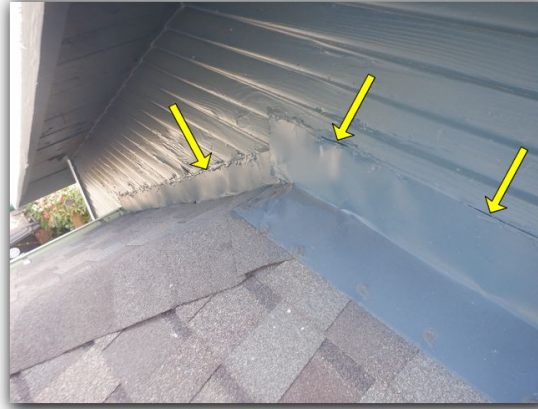
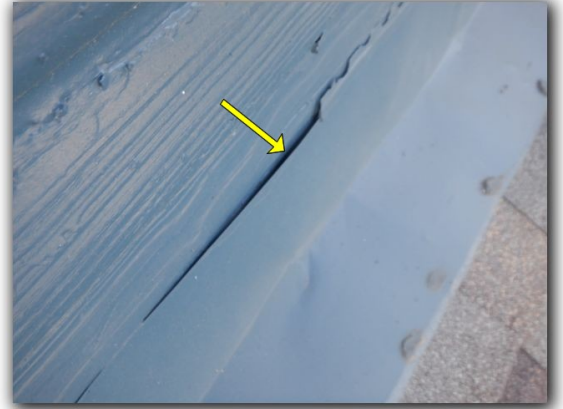
Flashing over the patios is improperly installed. The wood should overlap the flashing to act as a counter flashing. Gapping is already taking place between the flashing and siding, which can allow water penetration.

Possible from improper areas of flashing over patios.

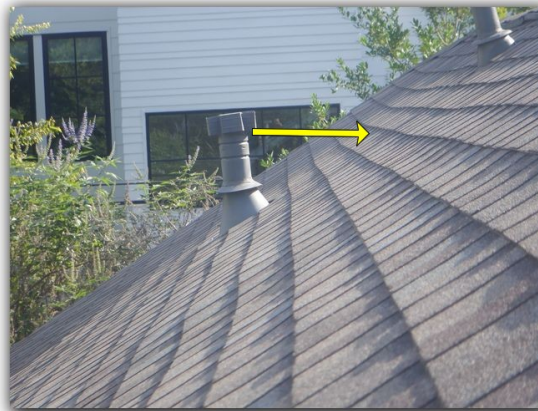
Improperly vented, Does not comply with the 1992 CABO One and Two Family Dwelling Code section M-1604.2.3 which states; "Such vents shall terminate not less than 1-foot above the roof, and not less than 4-feet from any portion of the building that extends at an angle of more than 45 degrees upward from the horizontal."

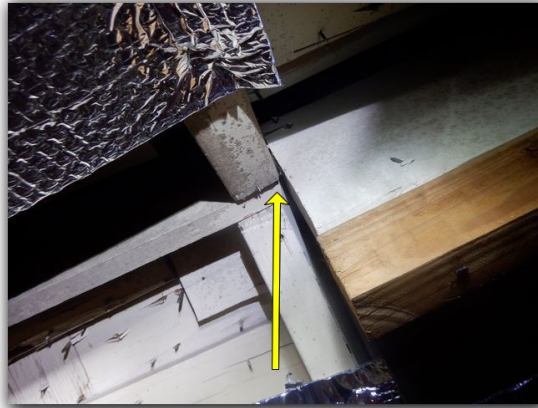
Ridge and/or valley board(s) not deep enough to support ends of rafters, recommend addition of 2x4 below bottom end of ridge/valley board to support end of rafters, Reference: 1989 CABO One & Two Family R-702.2 Ridge and/or valley board(s) not deep enough to support ends of rafters, recommend addition of 2x4 below bottom end of ridge/valley board to support end of rafters, Reference: 1989 CABO One & Two Family R-702.2

Observed ridge and/or valley rafter splice(s) not properly supported in attic. Recommend repair as splices are separating or may separate;

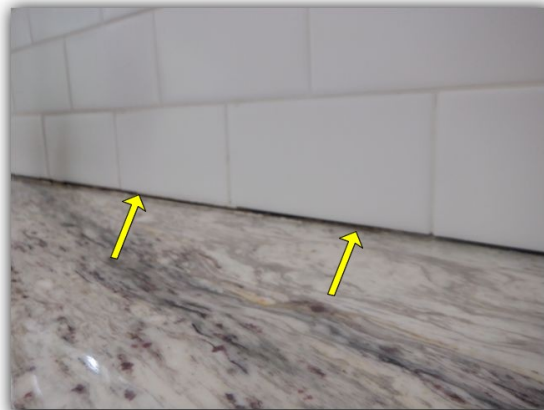
Recommend properly sealing the kitchen countertop at the backsplash.

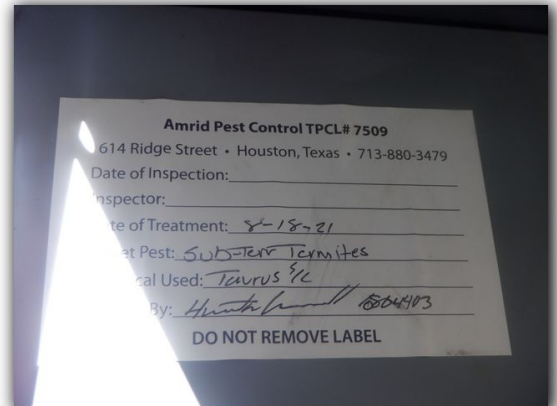
Evidence house and/or garage has been treated for wood destroying insects in the past. Final determination of structurally significant damage to wood members (if any) cannot be determined without removal of wall coverings. Recommend client obtain additional information from seller regarding extent and location of previous infestation, chemical & company used, warranty if applicable, etc.. Sentinel Inspection Group specifically excludes hidden / latent damage if present (we cannot see thru walls!).

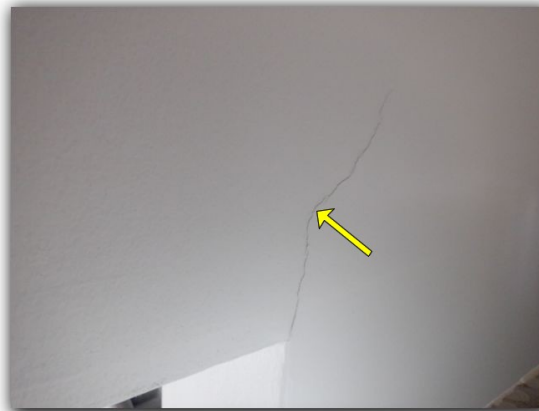
Cosmetic cracks and/or repaired cracks in sheetrock observed over some / many doors, windows, and/or corners.

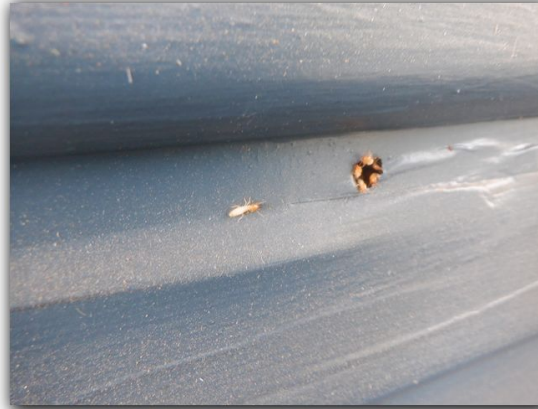
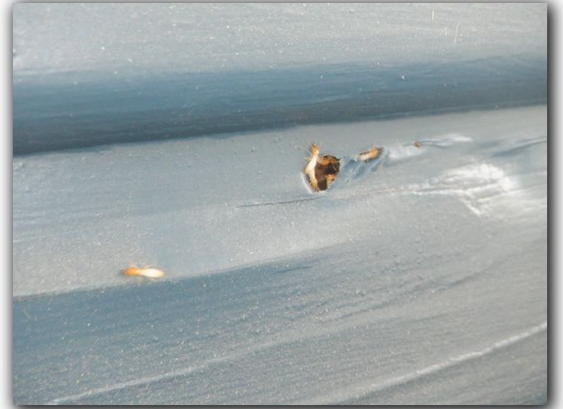
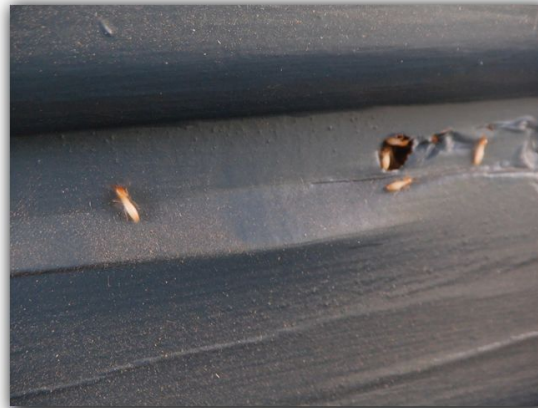
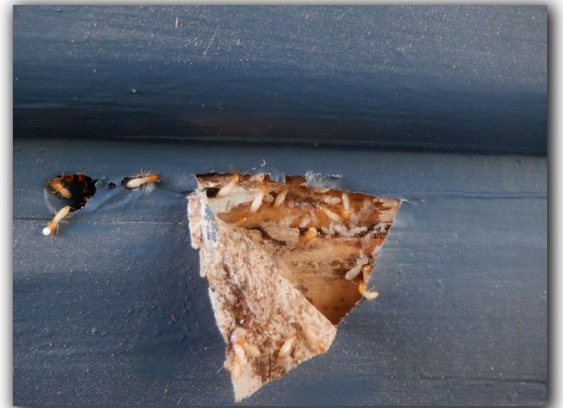
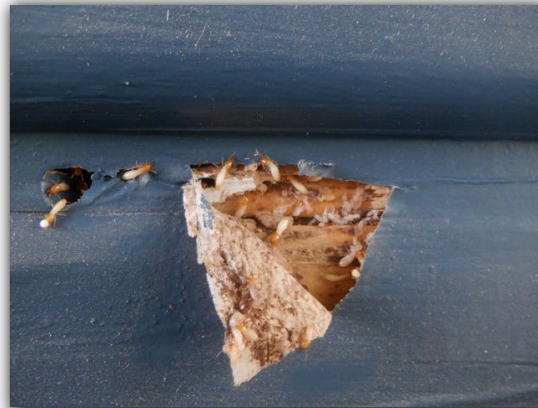
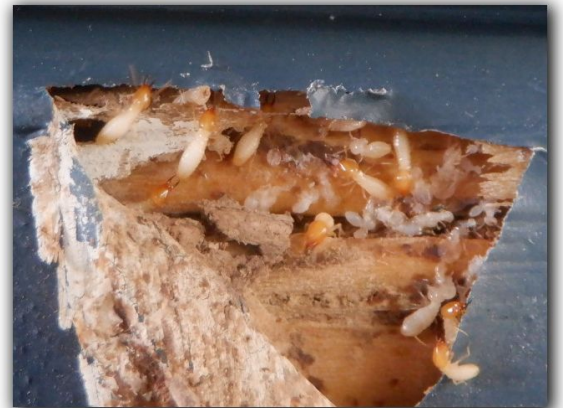
Wood destroying insect activity observed at the southern exterior; Final determination of structurally significant damage to wood members cannot be determined without removal of wall covering {interior sheetrock or exterior siding}.

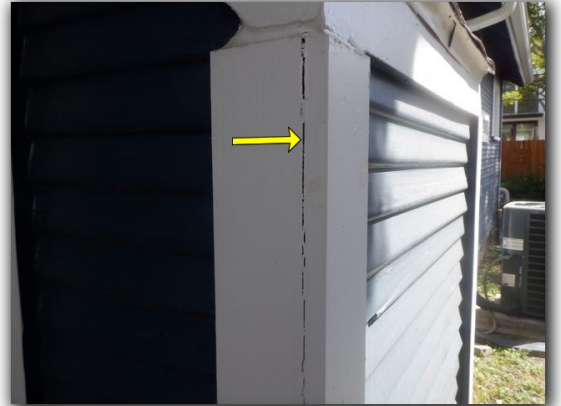
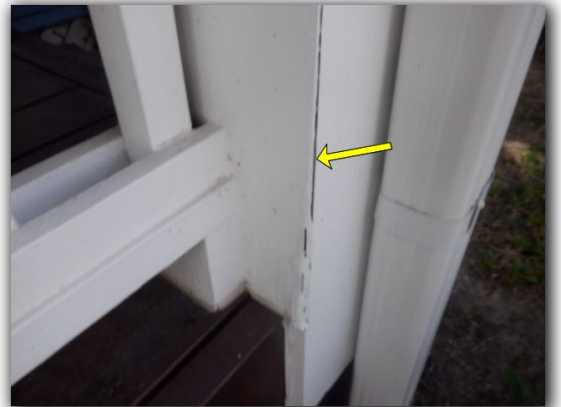
Caulking missing and/or deficient around vertical trim boards may allow wind driven rain entry.

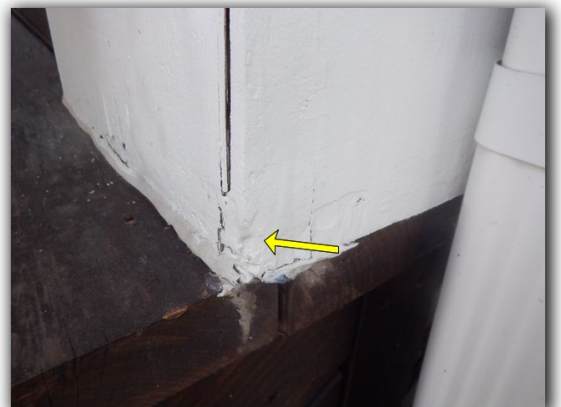
Wood rot / damage observed bottom/base of one or more wood columns.

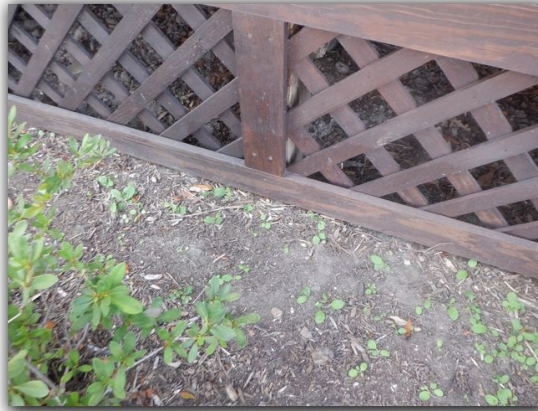
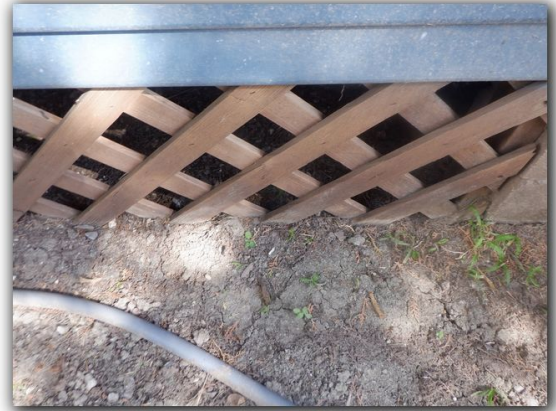
Earth wood contact in some areas, conducive condition to termite activity and wood rot.

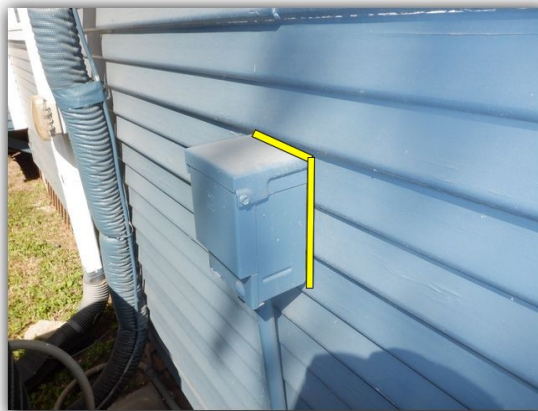
Recommend caulking around electrical disconnect box(s) of A/C unit(s) to prevent water entry behind disconnect(s).

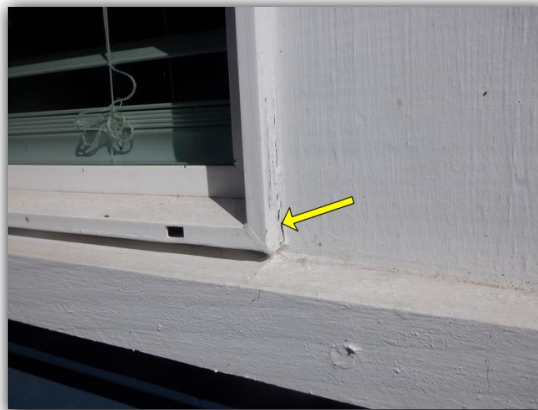
Caulking deficient around one or more windows, will allow water penetration during heavy / wind driven rains.

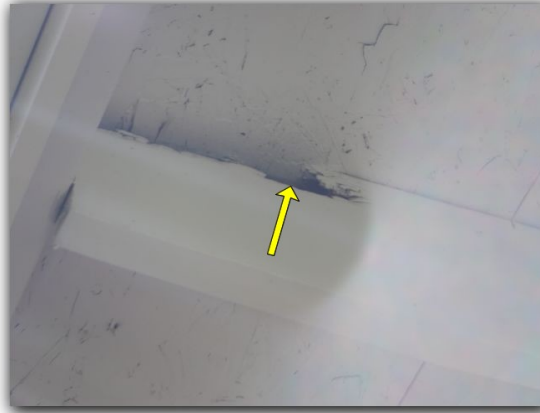
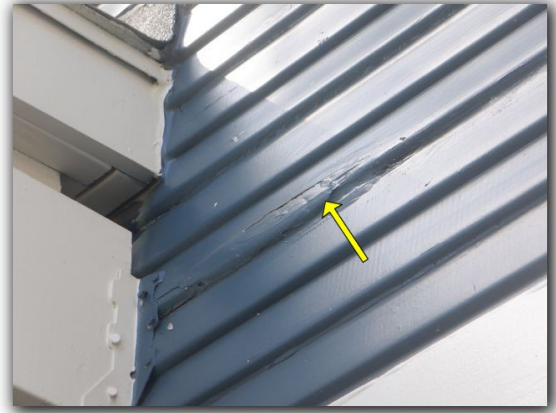
Wood rot observed on areas of house / garage.

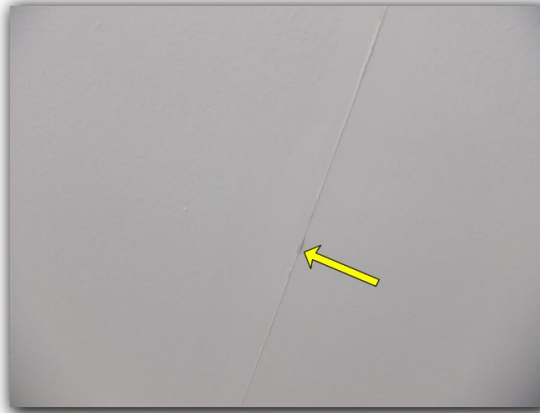
Observed cosmetic cracks and/or repaired cracks in sheetrock ceiling of several rooms.

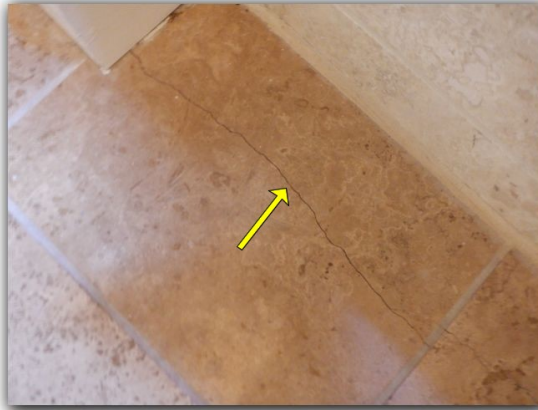
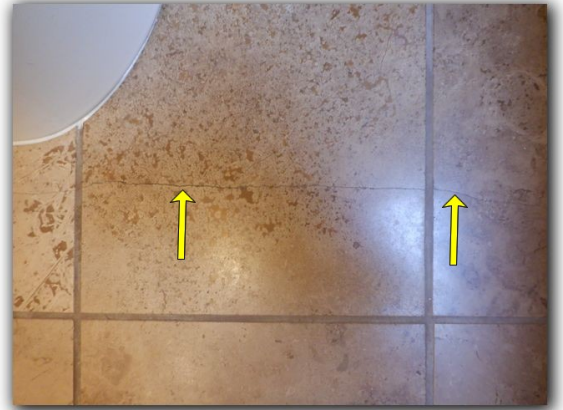
Cracks and/or loose floor tile observed in both bathrooms.

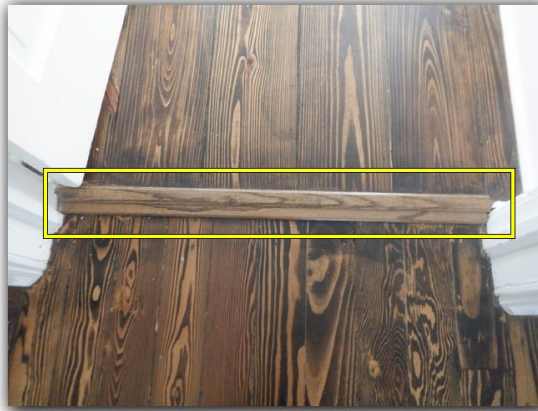
Tripping hazard, there is no contrasting color at raised section of flooring:

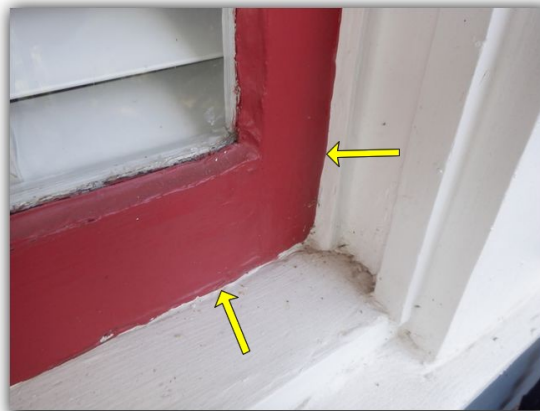
Buyer's note; Many original windows were not operational, painted shut, ropes broken, etc.. windows in a bedroom that do not open are a recognized fire/safety hazard.

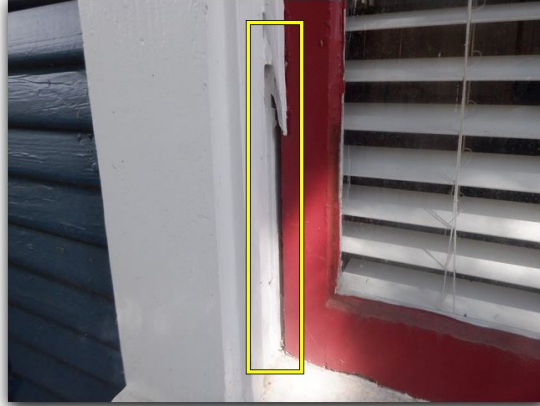
Damaged window trim was present at a northwest window, which leaves a gap between the window and frame that may allow water entry.

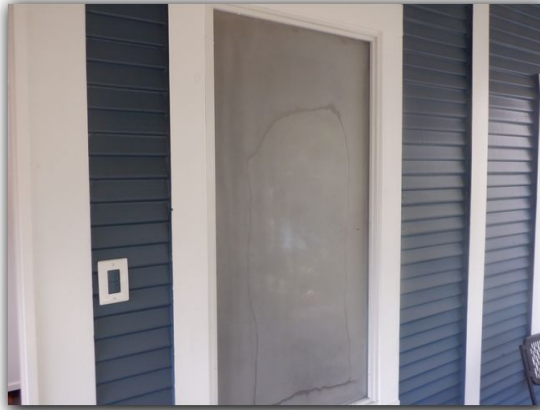
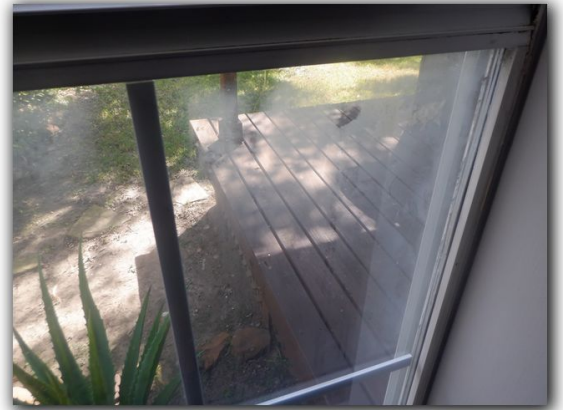
Double pane window vapor seals appear broken, including but not limited to, (Master bathroom & Master bedroom)

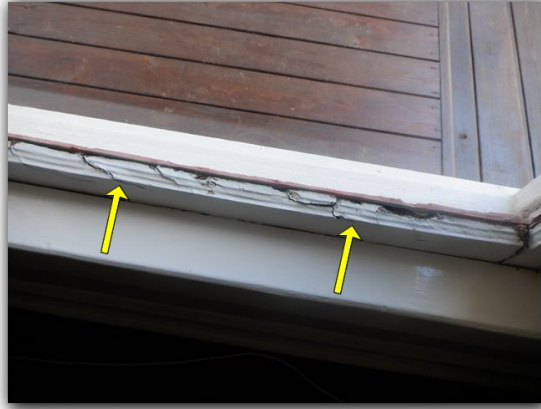
Wood rot of window frame/jambs observed at one or more locations. (Interior of the northern bedroom)

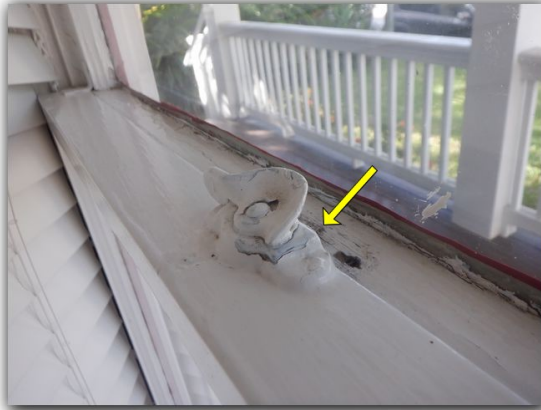
One or more window locking latches were broken and/or difficult to operate.

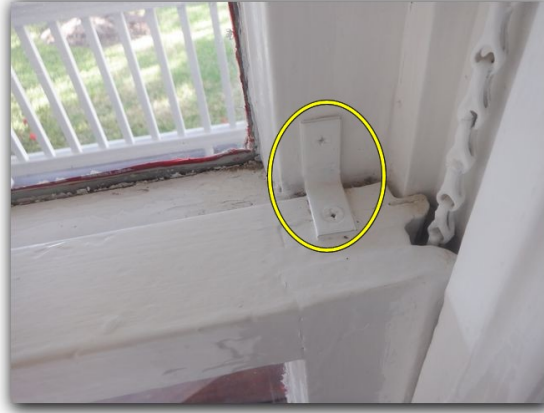
Several windows were observed to be screwed and/or locked shut, which is a safety hazard in bedrooms in the event of a fire.

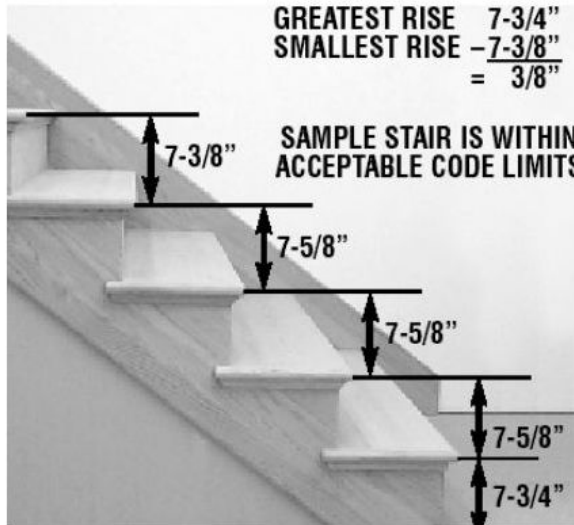
Stairway has tripping hazard, Risers are not same height along the entire height of steps. Stairway does not comply with current industry standard, (code). CABO 314.2 & UBC 1006.3 requires "The greatest riser height within any flight of stairs shall not exceed the smallest by more than 3/8 inch."

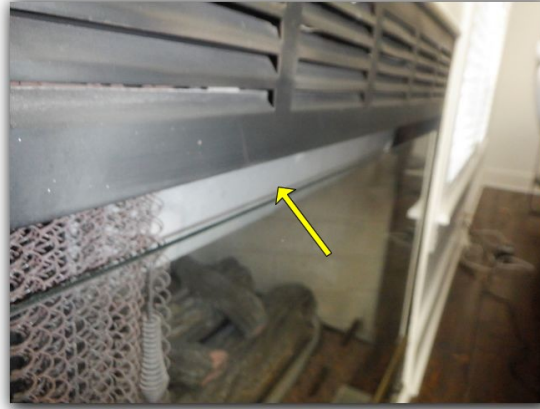
A gap was present between the glass and upper frame of the fireplace / is not properly fully enclosed.

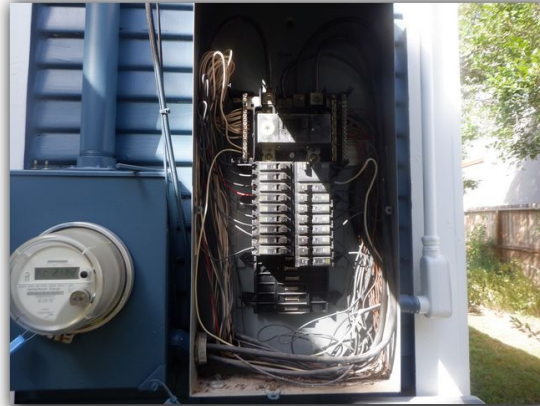
150 AMP ELECTRICAL SERVICE PANEL LOCATED AT THE SOUTHERN EXTERIOR:

Did not observe installed AFCI (Arc Fault Circuit Interrupt) device protection, as required by current building standards, for all: family rooms, dining rooms, living rooms, parlors, libraries, dens, bedrooms, sunrooms, recreations rooms, closets, hallways, or similar rooms or areas. AFCI devices are intended to protect against fires caused by electrical arcing faults in the home's wiring. Arc faults are a common cause of residential electrical fires. Arc faults can be created by damaged, deteriorated, or worn electrical plugs, cords, and/or branch circuit conductors. As of September 1, 2008, the State of Texas has adopted the 2005 NEC, which includes this requirement, as the "minimum standard" for all non-exempt electrical work. Homes built prior to 2002, generally were not required to have arc fault protection. However, the current TREC standard of practice requires inspectors to indicate that a hazardous or deficient condition exists if any home does not have this protection, regardless of date the home was constructed.

Not all breakers are properly identified.

Observed improper use of normal wire conductor colors. Observed white wire used for other than grounded / neutral conductors.

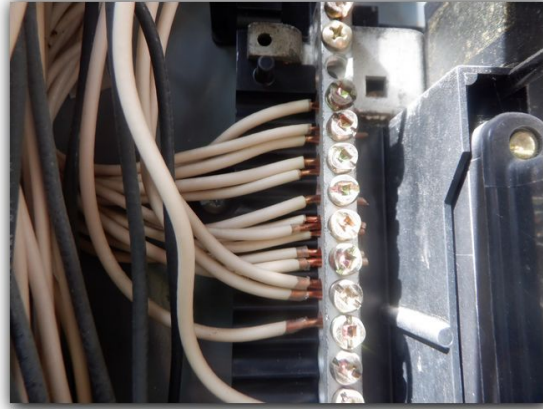
Observed two or more neutral conductors under one screw lug on the neutral bus.
Current industry standards and National Electric Code permit one neutral conductor per screw lug.

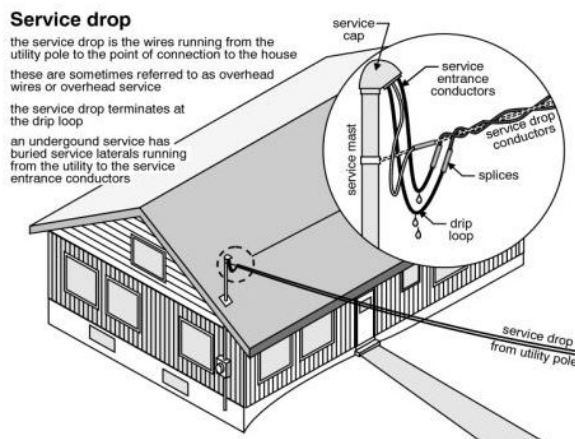
Drip loop of electrical service drop is not proper, rain water can run down conductors into weather head.

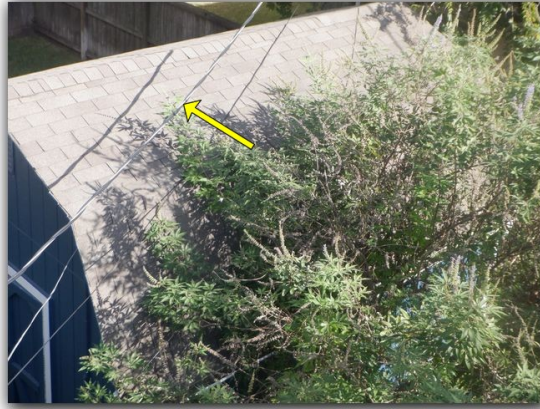
Low elevation of power lines over shed roof, electrocution hazard. Code requires a minimum clearance of 3 feet over roof with a pitch greater than 4 in 12.

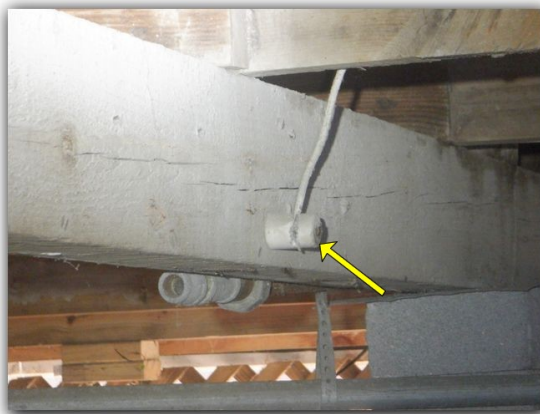
All knob & Tube wiring found during course of inspection was not active / live.
(Interpretation: While inspector did not find any active/live knob & tube wiring in house we cannot guarantee there is no active/live knob & tube in the house, only that what we visually observed during the inspection process was not active/live.)

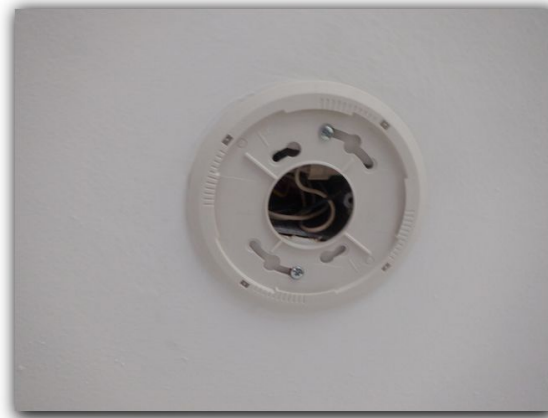
Inadequate number and/or improper location of smoke detectors in home. Smoke detectors should be located on each level of the home AND inside AND outside of all sleeping rooms. Consult the smoke detector manufacturer's instructions regarding specific placement of detectors.

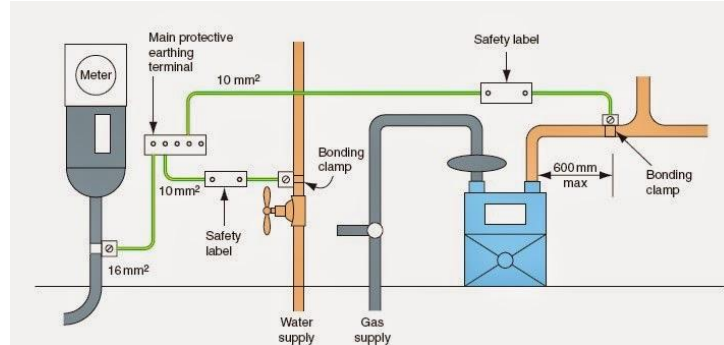
Ground rod / wire missing or damaged at gas meter.

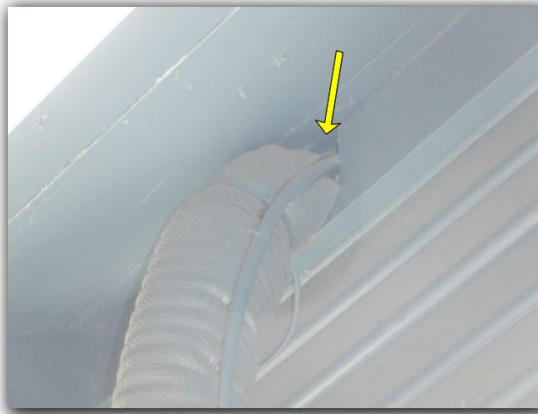
Recommend sealing exterior where AC lines enter house.

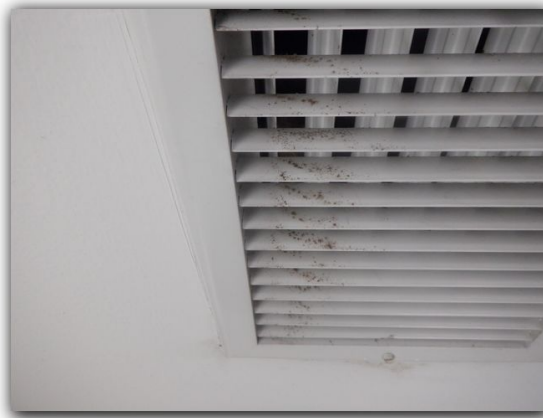
Observed possible micro-organism growth on air supply grills / vents which may be a concern due to increased awareness of environmental issues associated with molds. This company does not inspect for and is not qualified to render opinions on any type of environmental or other bio-hazards. If this is a concern or potential concern, Sentinel Inspection Group recommends contacting a qualified professional of your choice for further information / investigation. (Northern bedroom)

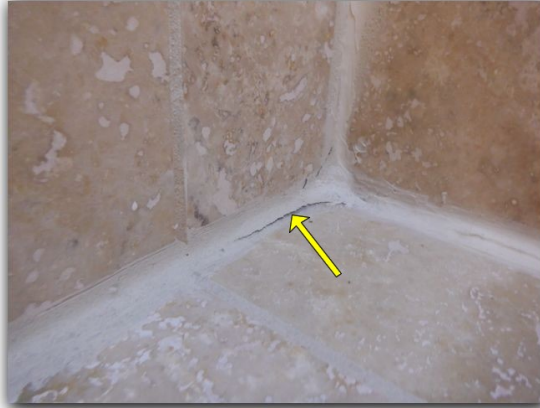
Grout / caulking needed at vertical tile corners, cracks in tile and/or mortar between tiles, and where tile meets tub to prevent water entry behind wall.

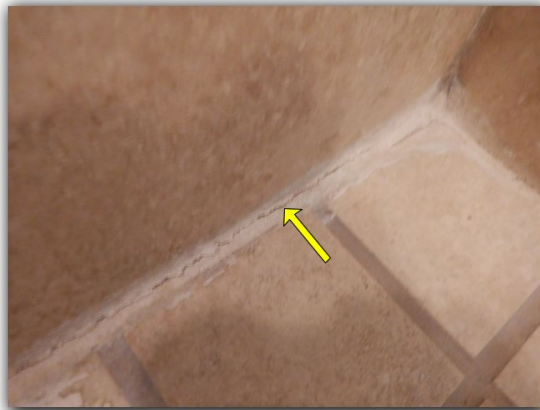
Grout / caulking needed at vertical tile corners, cracks in tile and/or mortar between tiles, to prevent water entry behind wall.

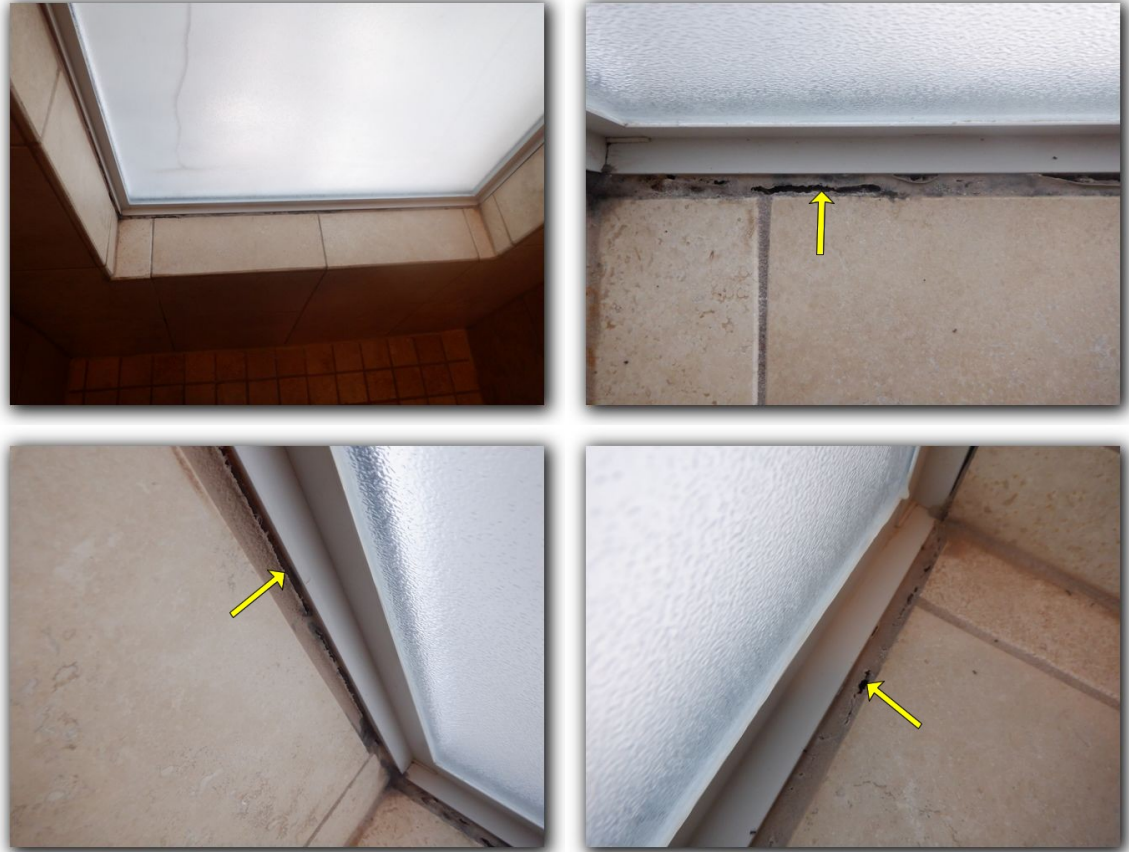
The master shower window is poorly sealed / appears to allow water penetration. Wood destroying insect activity was observed to the exterior side below this window. The moisture can make it possible for these insects to stay in the structure rather than having to go back and forth to the earth for moisture.

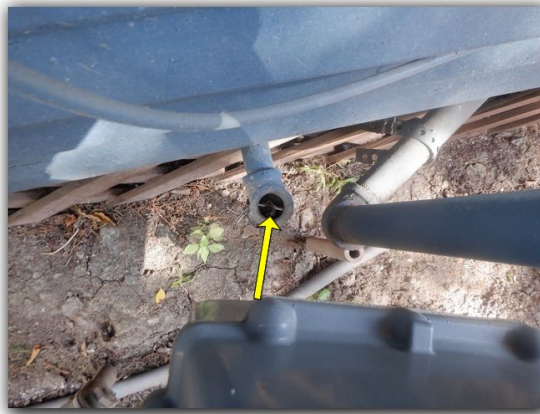
An open / abandoned gas line was present adjacent to the meter to an unknown location. Recommend inquiry of the seller.

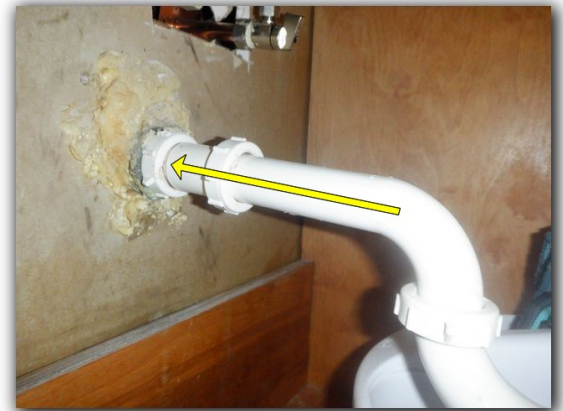
Reverse slope of drain line, does not tilt towards downhill for proper drainage, (Hall bathroom)

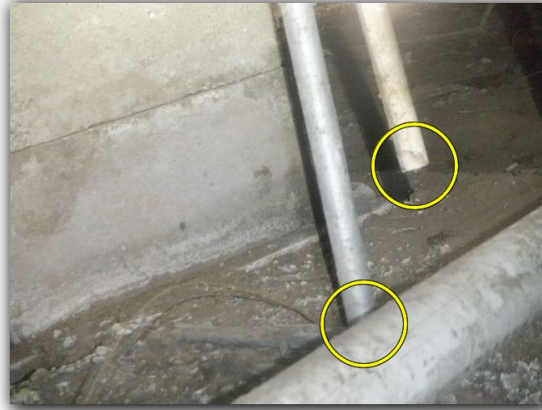
Drain line for T&P valve and drain pan terminate improperly below house, *should extend to exterior, cause no property damage or personal injury, and be readily observed by the building occupants; REF.: 1991 Standard Plumbing Code 1213.7.4 IRC 2803.6.1.*

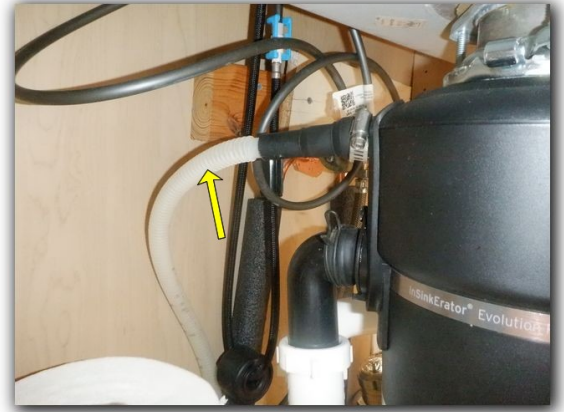
Drain line needs to be elevated above side inlet of disposal to underside of countertop to prevent debris and gray water from draining down line from disposal and back into dishwasher.

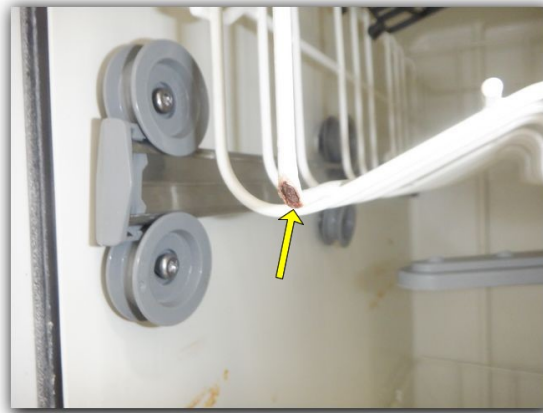
Rusting / corrosive damage was observed to the dishwasher racks.

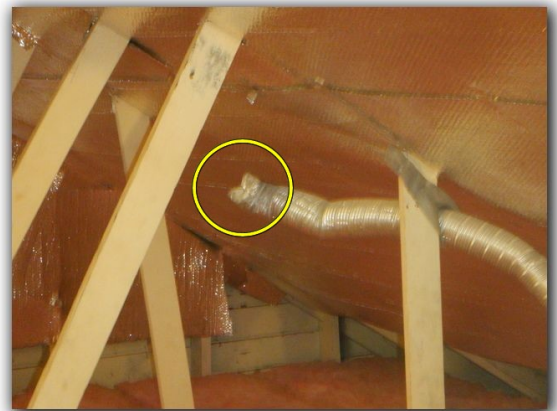
Exhaust system components

Improperly vents into attic. Should vent to exterior.

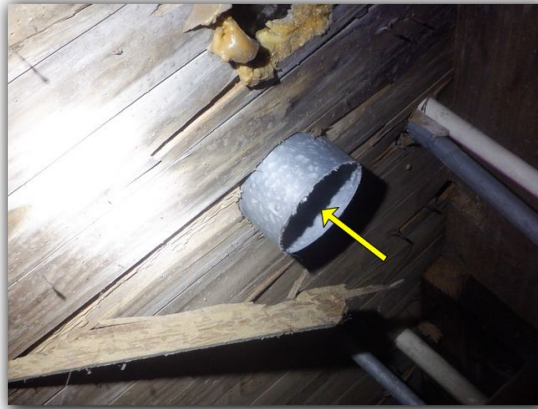
Dryer vents improperly below house / needs to be properly routed to the exterior and have a proper vent cover installed with a back draft damper.

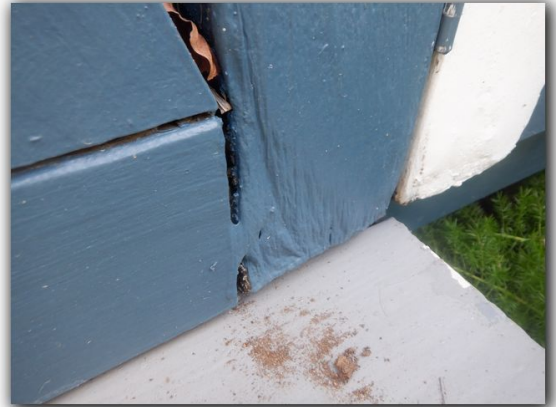
Wood rot was observed around the perimeter of the backyard shed.
