SENTINEL
INSPECTION GROUP

**456 Your Street
Houston, TX 77084**

PROPERTY INSPECTION REPORT FORM

Jane Smith <i>Name of Client</i>	10/29/2022 <i>Date of Inspection</i>
456 Your Street, Houston, TX 77084 <i>Address of Inspected Property</i>	
John Tatum <i>Name of Inspector</i>	Professional Inspector # 9459 <i>TREC License #</i>
 <i>Name of Sponsor (if applicable)</i>	 <i>TREC License #</i>

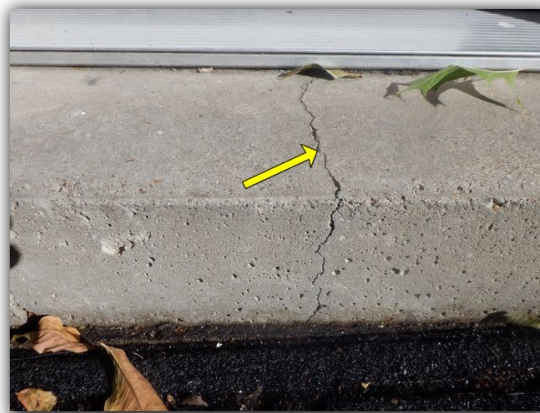
One or more cracks found in perimeter grade beam of house.

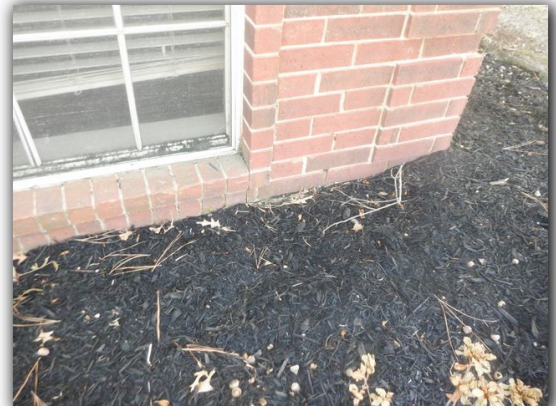
Soil level too high around areas with brick siding at multiple areas around house .
Common industry practice requires a clearance of at least 4 inches from bottom of brick veneer to soil. High soil level near brick siding promotes wood rot and is considered a conducive condition to termite activity and water penetration.

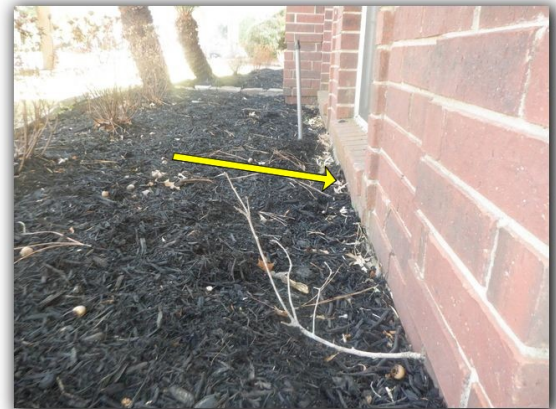
Soil grade and drainage patterns around some areas of house do not appear to properly direct water away from foundation to aid in controlling runoff water and could cause differential movement of the foundation or water penetration during heavy rains.

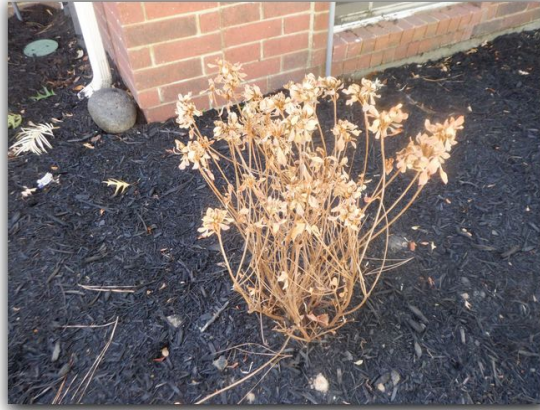
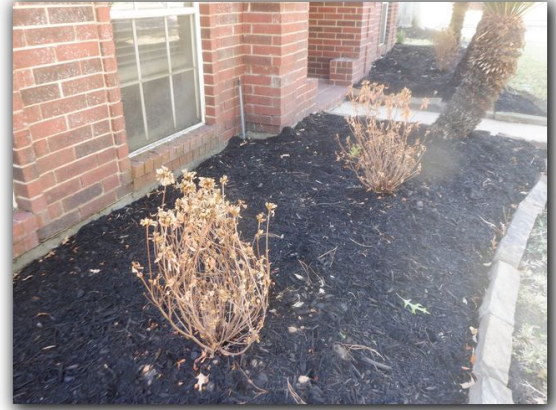
Multiple plants were observed to be dead in the front flower beds.

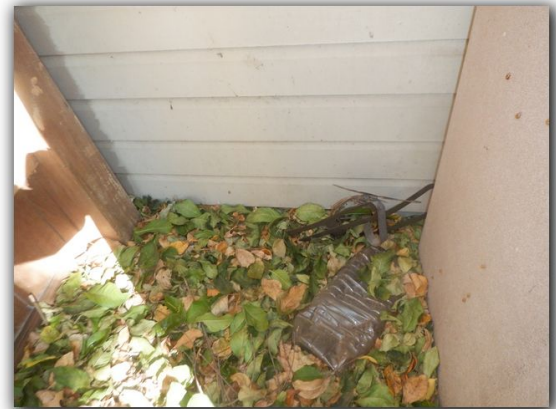
Soil level too high around areas with wood siding. Code and common industry practice requires a clearance of 6-8 inches from bottom of wood veneer to soil. High soil level near wood siding promotes water/termite penetration and wood rot.

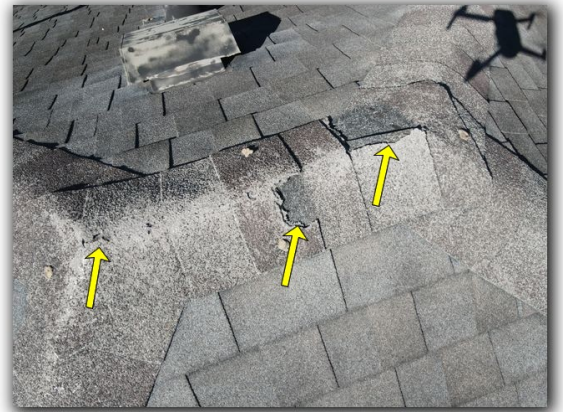
Areas that need immediate attention, including but not limited to; (e.g., torn/damaged shingles, etc.)

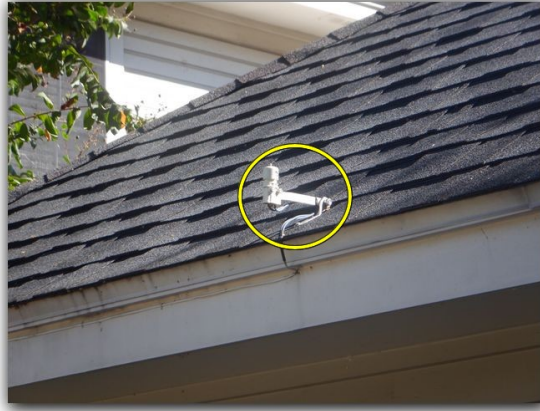
The sprinkler system rain sensor should not have been screwed to the roof surface / may cause leaking.

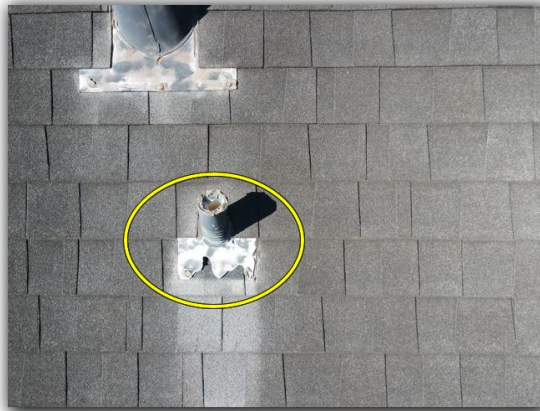
Not all lead flashing of drain waste vents are properly rolled down interior of plumbing vent pipes and/or are damaged by squirrels, may allow some rain water entry.

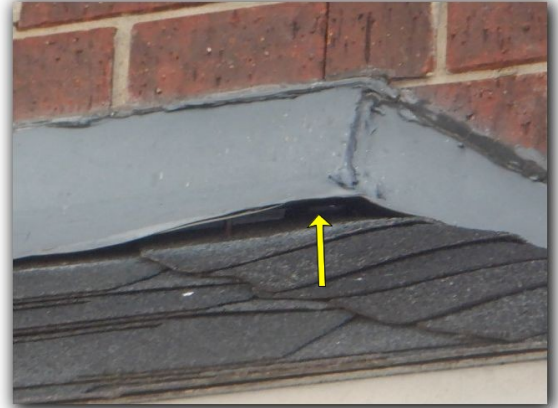
Lower side of flashing is not sealed down at one or more locations where roof meets vertical wall, wind driven rains will cause water penetration.

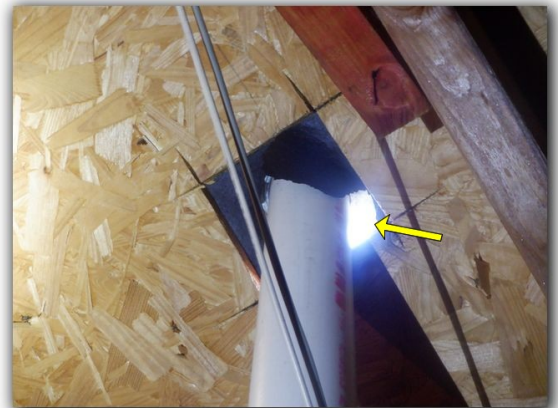
Roof water penetration observed at the following location(s): (Around multiple drain waste vents in the attic)

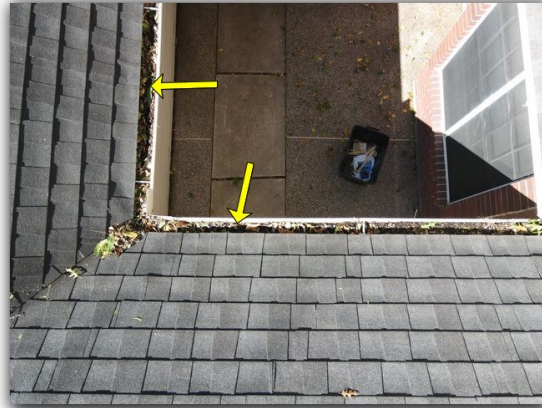
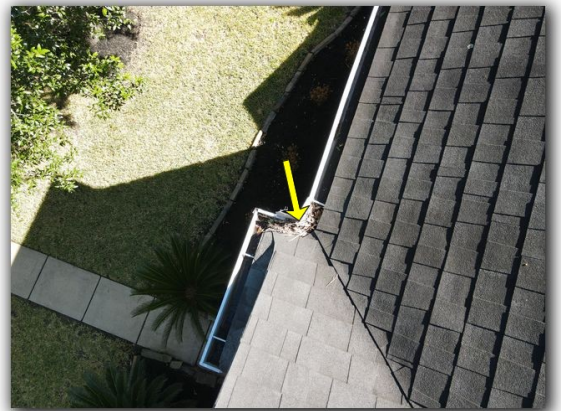
Full of debris and/or holds standing water.

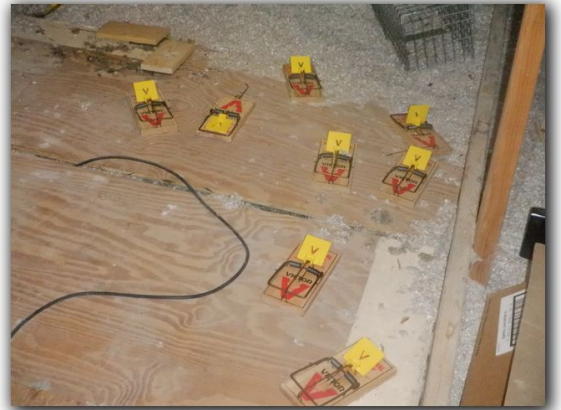
Evidence of previous (possibly current) rodent activity in attic.

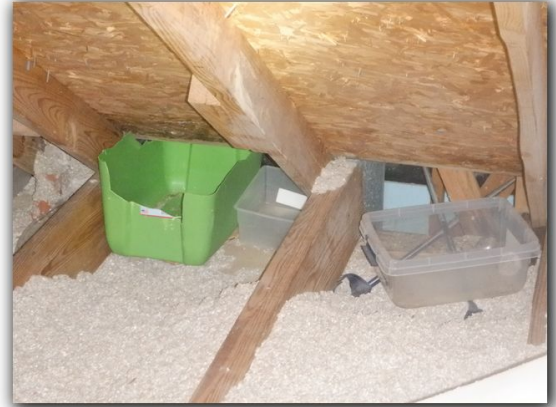
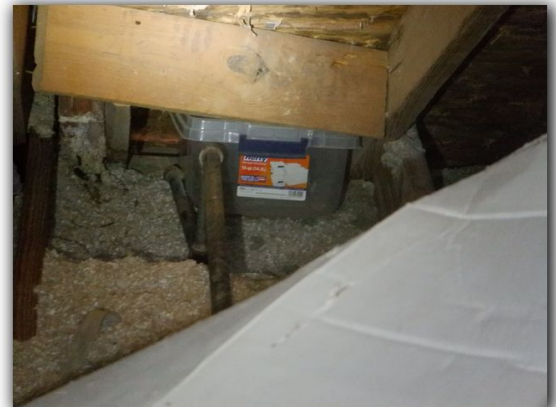
Observed bucket(s) in attic, possibly used for roof leak in the past or currently in use. Recommend inquiry of seller.

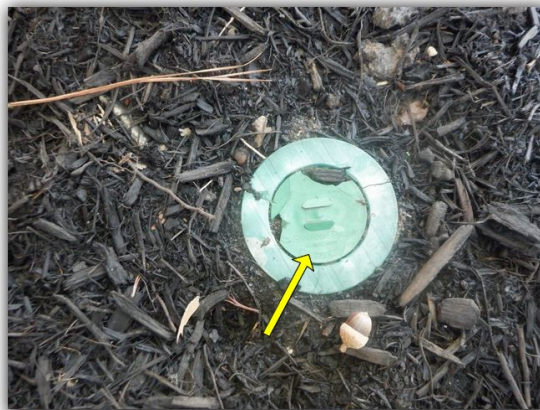
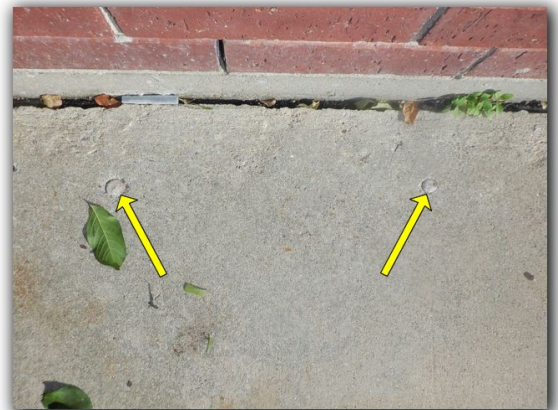
Evidence house and/or garage has been treated for wood destroying insects in the past. Final determination of structurally significant damage to wood members (if any) cannot be determined without removal of wall coverings. Recommend client obtain additional information from seller regarding extent and location of previous infestation, chemical & company used, warranty if applicable, etc.. Sentinel Inspection Group specifically excludes hidden / latent damage if present (we cannot see thru walls!).

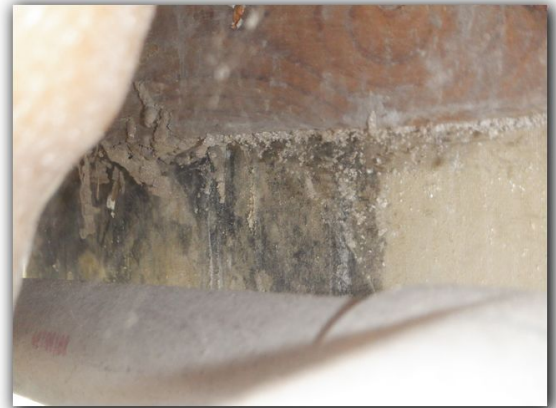
Observed possible micro-organism growth (Below the master bathtub) which may be a concern due to increased awareness of environmental issues associated with molds. Recommend removal of all sheetrock containing visible mold growth plus an additional 2 feet surrounding area. *This company does not inspect for and is not qualified to render opinions on any type on environmental or other bio-hazards. If this is a concern or potential concern, Sentinel Inspection Group recommends contacting a qualified professional of your choice for further information / investigation.*

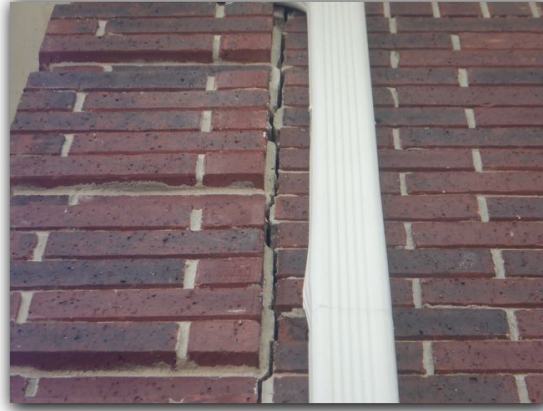
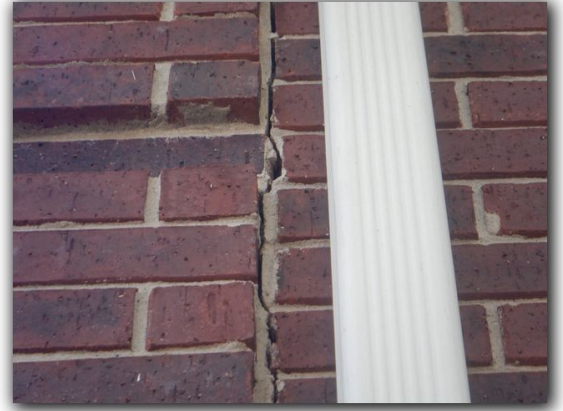
Numerous areas of mortar damage and brick separation were observed at the northern exterior.

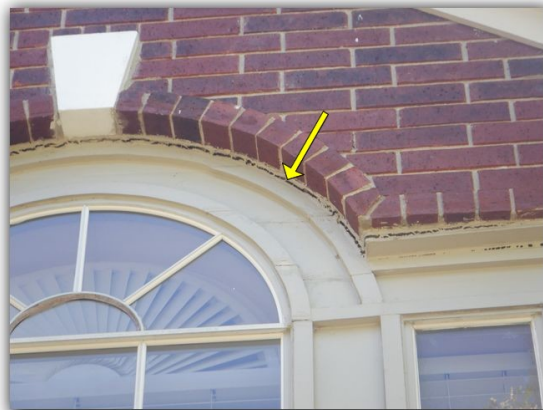
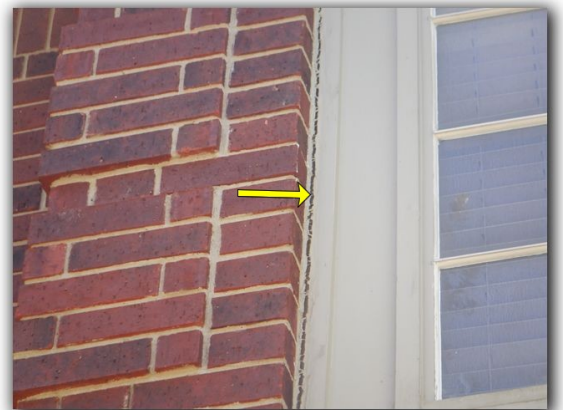
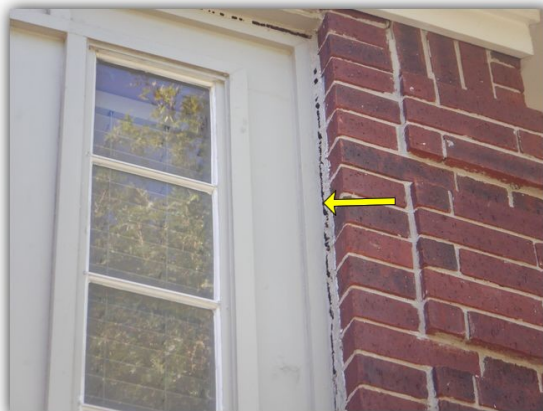
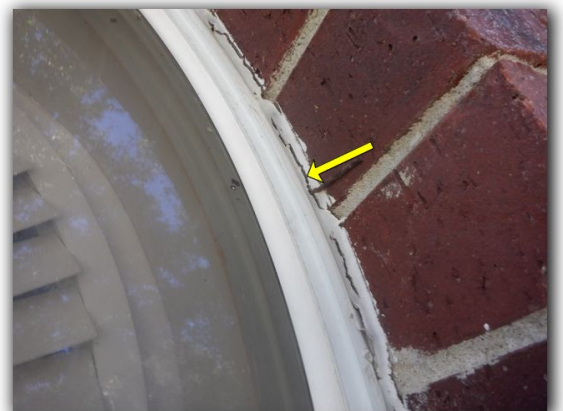
Caulking deficient around one or more windows, will allow water penetration during heavy / wind driven rains.

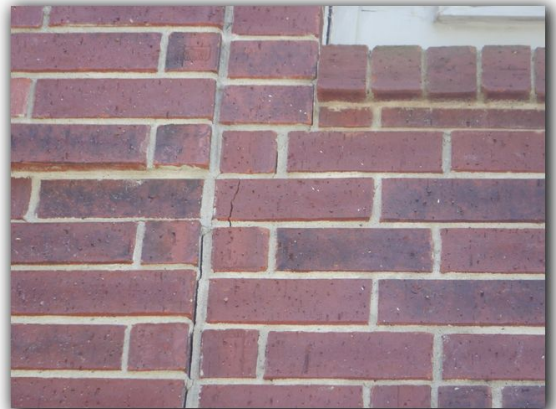
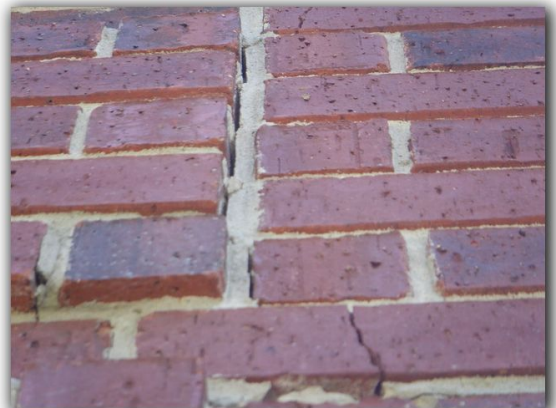
Cracks in brick veneer and/or repairs, one or more locations, Recommend buyer take photographs of cracks, their location, and width [ruler across the crack] with a high resolution camera that has a date stamp for future reference.

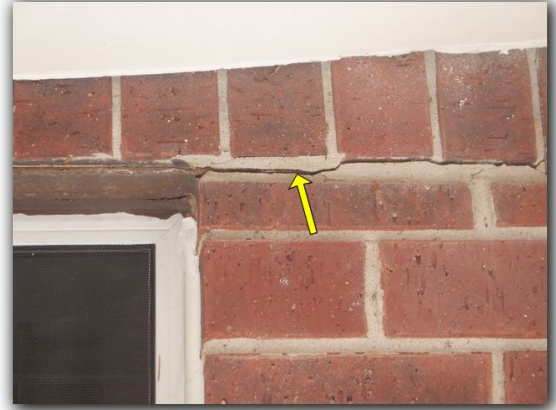
Cracks at upper corners of windows is typical due to not enough space left at ends of steel lintel at time of construction to allow for expansion of metal.

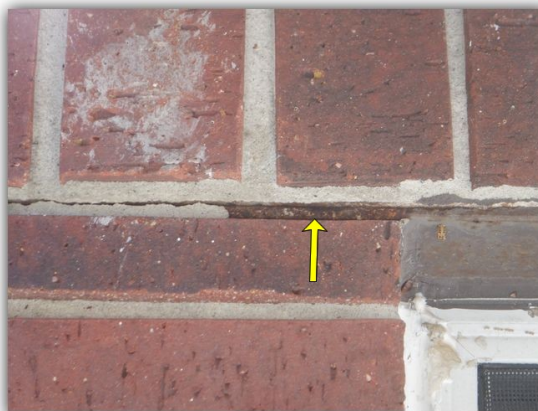
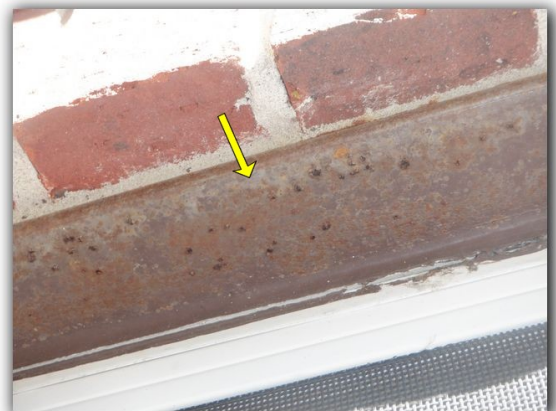
Rusting lintels

Metal lintel(s) over window/door openings are not well painted and are rusting.

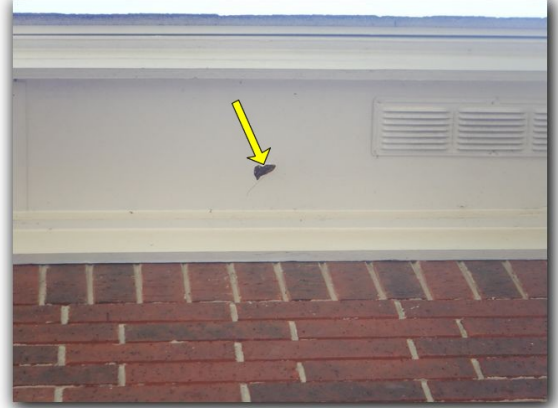
Soffit damage was observed at multiple locations of the west exterior.

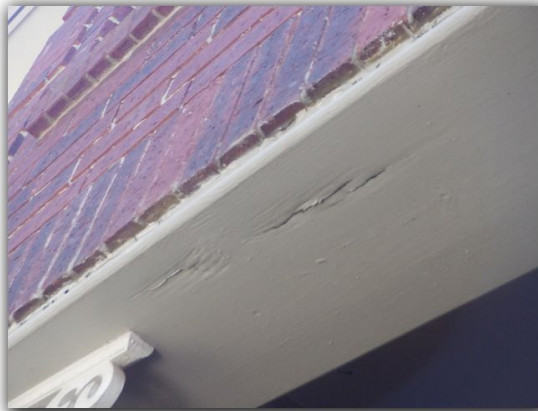
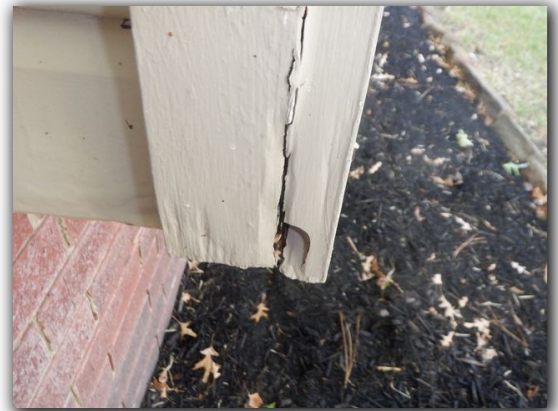
Wood rot observed on areas of house / garage.

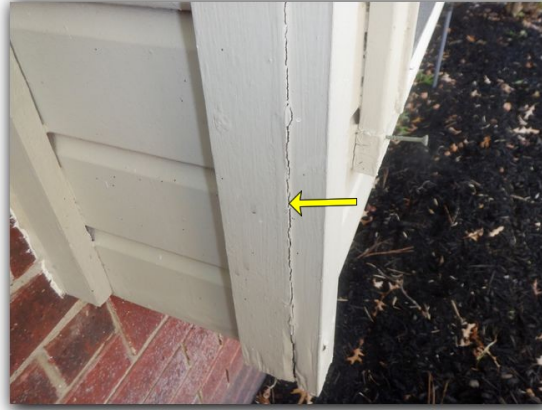
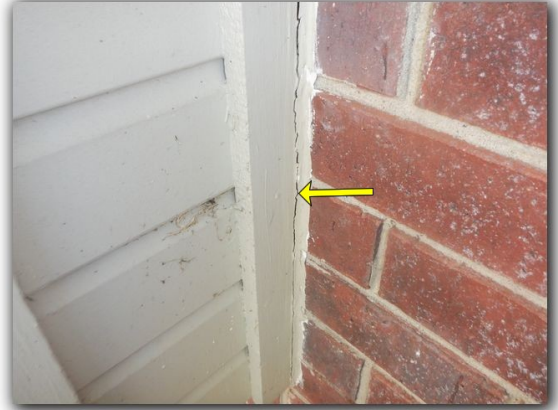
Caulking missing and/or deficient around vertical trim boards may allow wind driven rain entry.

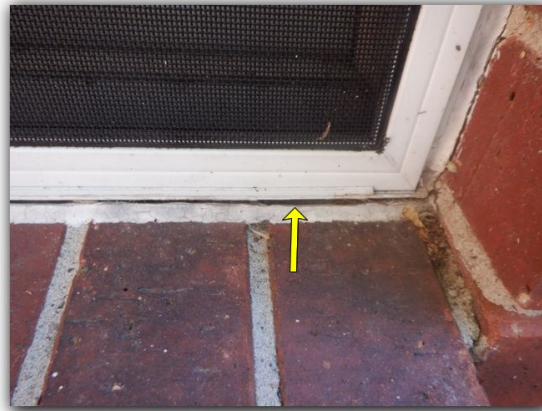
Caulking deficient around one or more windows, will allow water penetration during heavy / wind driven rains.

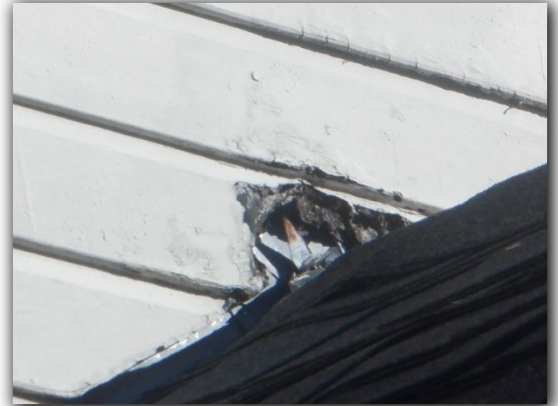
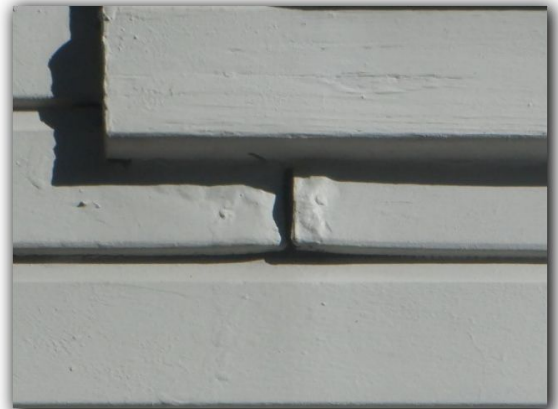
Synthetic wood siding observed on house, it is common industry knowledge that this siding has a tendency to rot easily if not kept well sealed / painted and that most manufactures of this type of product are / have been involved in some type of class action lawsuit.

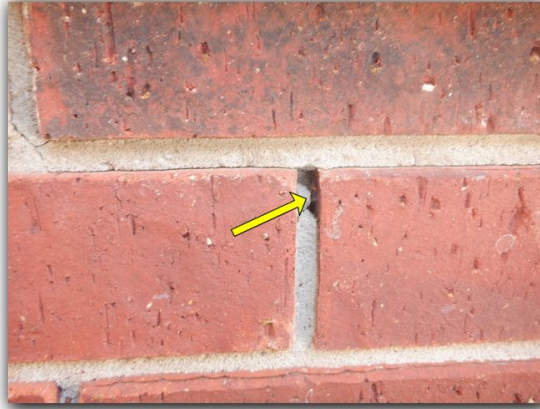
Mortar joints between brick ends is deficient in areas, indication the brick layer might not have properly "struck" the bricks (used enough mortar), recommend re-pointing areas where voids in mortar are present.

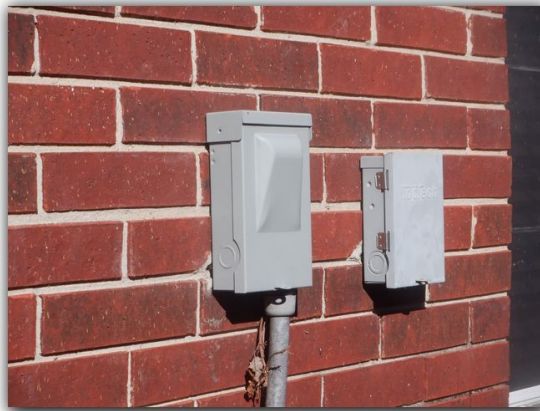
Recommend caulking around electrical disconnect box(s) of A/C unit(s) to prevent water entry behind disconnect(s).

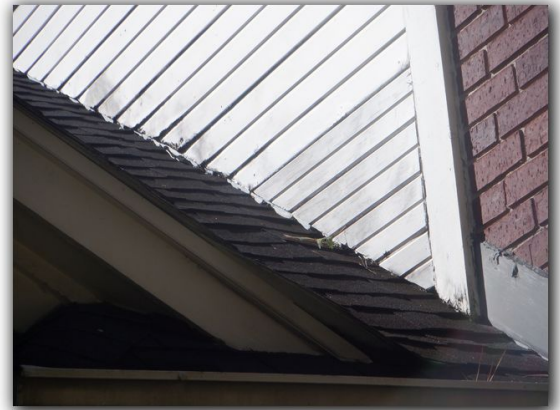
Most wood siding installation requirements specifically state “Leave a 2 inch clearance between roofing and bottom edge of siding to prevent wood rot.” Did not observe the normal 2” clearance from roof surface.

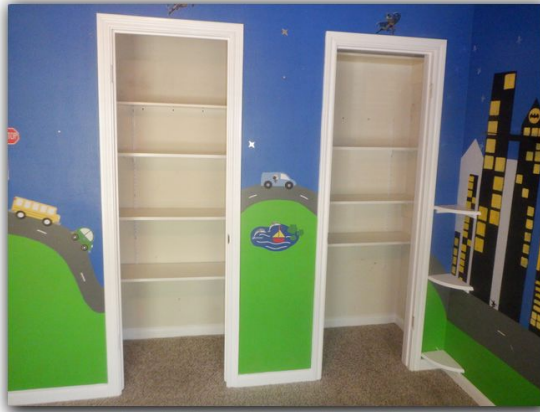
The closet doors were missing in the 2nd floor northwest bedroom.

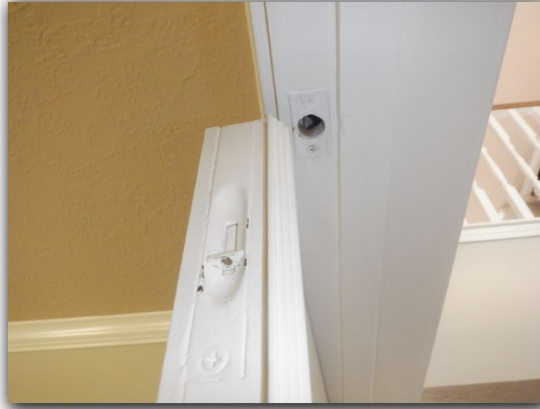
The upper latch for the stationary side of the double doors to the study is not properly aligned / does not latch.

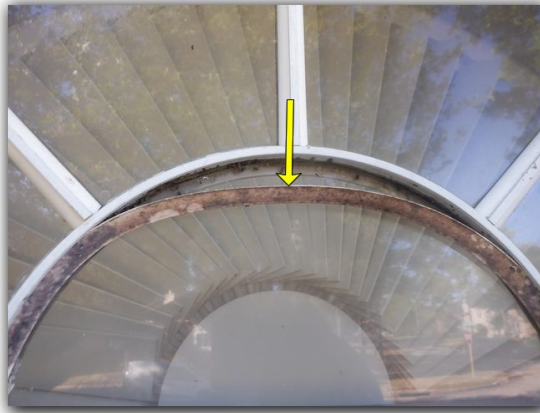
One or more windows had plastic exterior retaining strips loose or damaged.

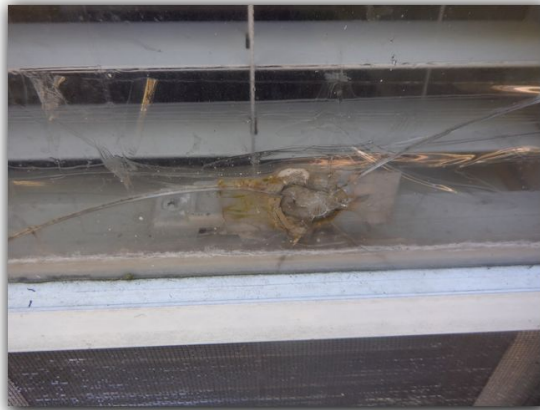
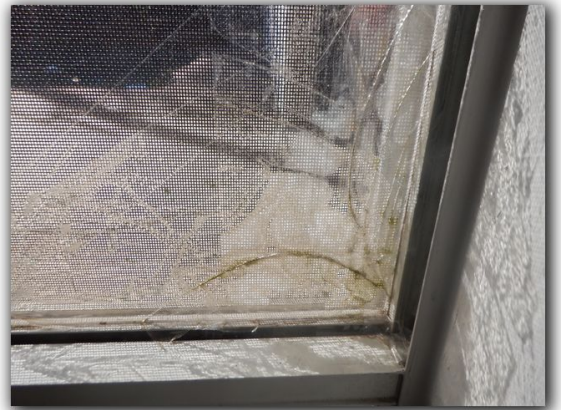
One or more windows had cracked / broken glass pane(s). (Dining room & Living room)

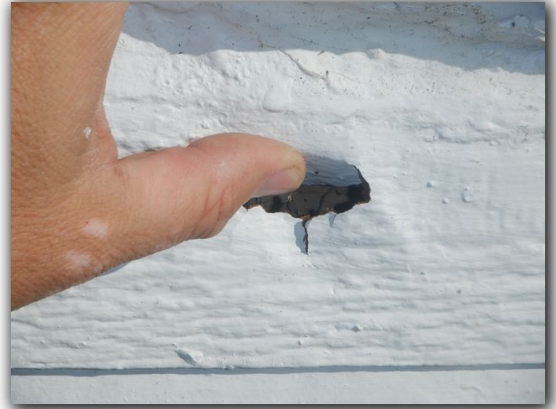
Wood rot of window frame/jambs observed at one or more locations.

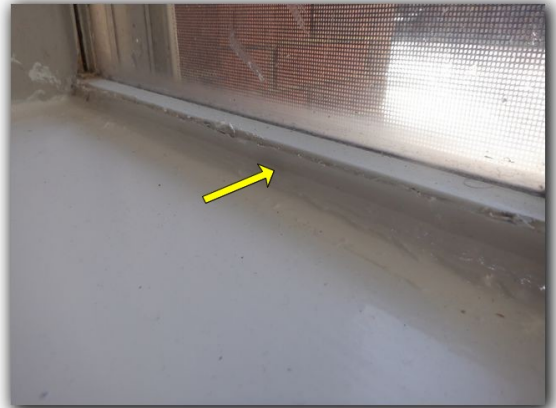
Many windows were observed to be improperly sealed shut. Buyer's note; bedroom(s) without operational / operable window and/or 2nd means of emergency egress is a RECOGNIZED FIRE/SAFETY HAZARD. Does not comply current life safety codes.

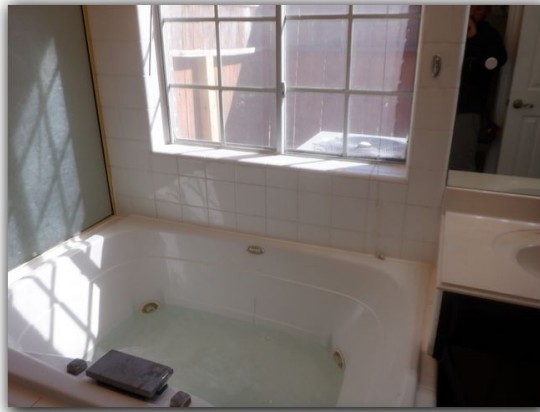
Could not find/observe markings on glass panel(s) of window near tub / shower to indicate the presence of required tempered / safety glass. Code reference ; UBC 2406.4.5 & CABO 308.4.5 IRC 308.4.

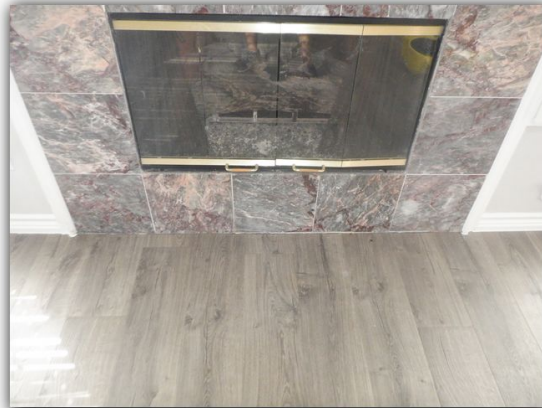
Inadequate sized non-combustible hearth extension at sides of fireplace. . *Where the fireplace opening is more than 6 square feet the hearth extension shall extend 20 inches in front and at least 12 inches beyond each side of the opening. Ref. IRC R1003.10.*

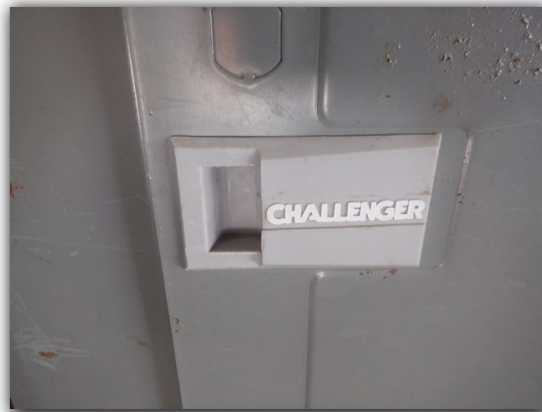
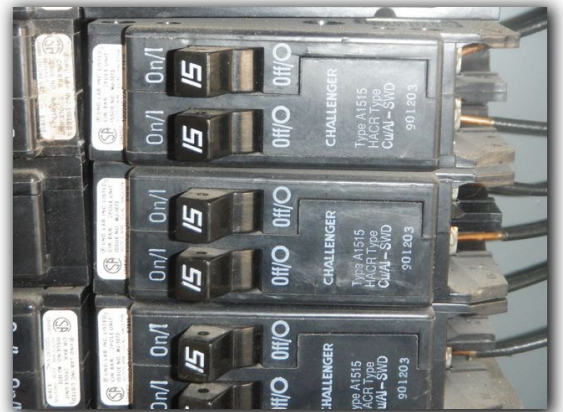
The panel was observed to be brand named Challenger. Challenger panels pose safety hazards very similar to that of Zinsco or Federal Pacific. The biggest concern for Challenger panels are their issues with overheating. In turn, that can cause many other issues, like fusing and / or melting, corrosion, or actual fires. Occasionally breakers don't trip at all or take too long to trip. Recommend replacement.

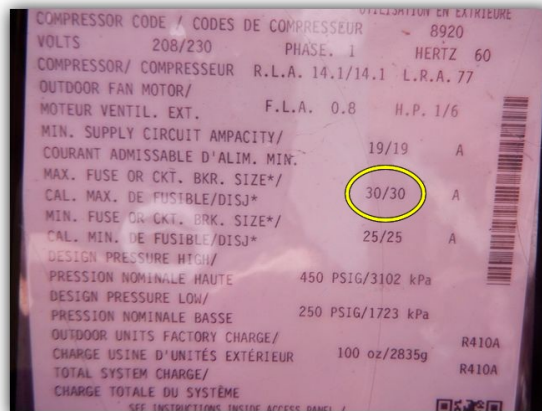
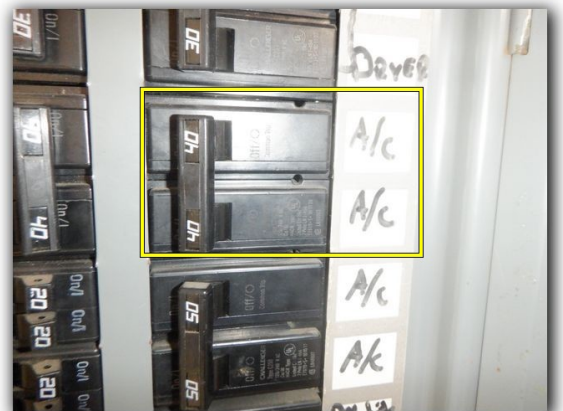
Breaker is oversized per data plate on side of A/C unit.

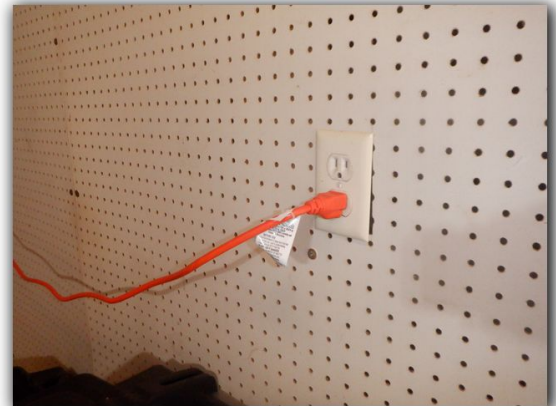
Extension cord wiring used improperly as permanent wiring; (To the sprinkler control panel)

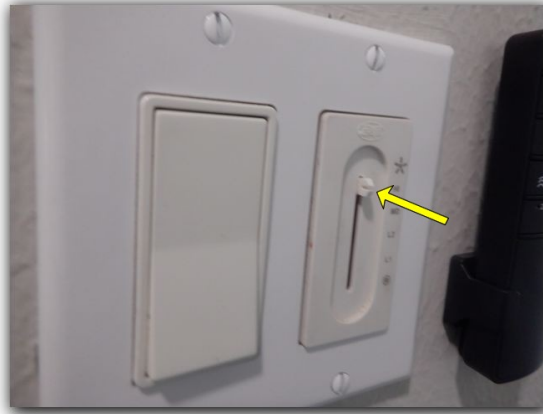
Multiple fan switches were missing the control knobs.

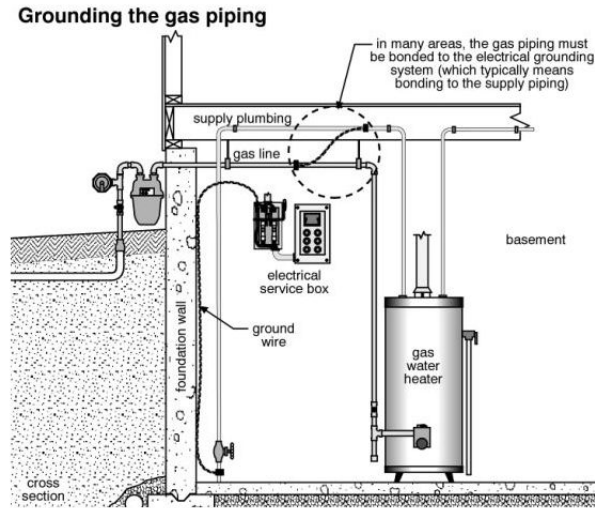
Gas and hot / cold water lines are not properly bonded near water heater. Does not comply with most recent electrical code. NEC 250-80b.

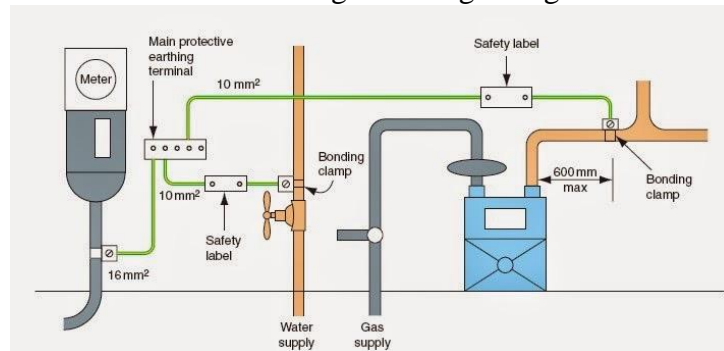
Ground rod / wire missing or damaged at gas meter.

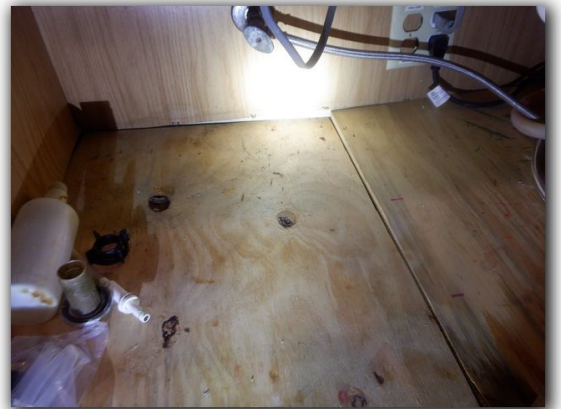
Water damage and loose decking were observed below the kitchen sink.

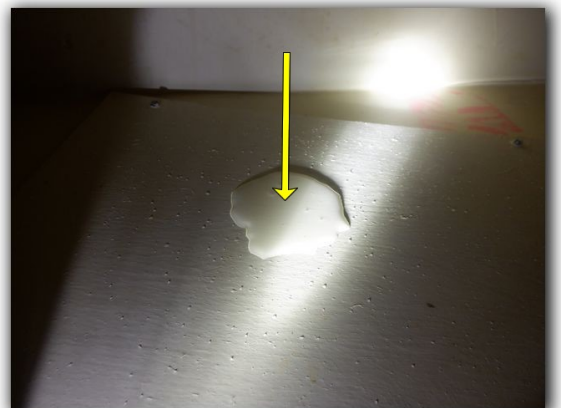
Large water leak below sink, (Left master bathroom sink)

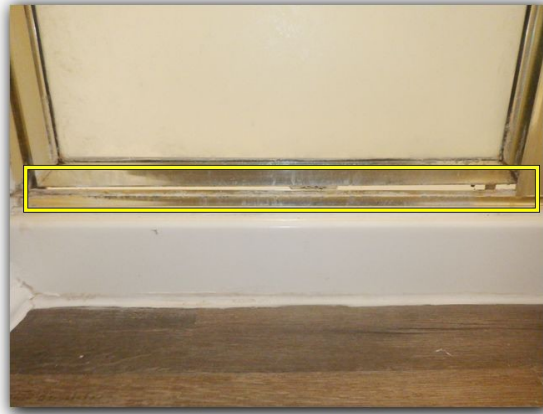
Shower door lower weather stripping loose and / or damaged, results in possible water leaking from base of door, needs repair / replacement.

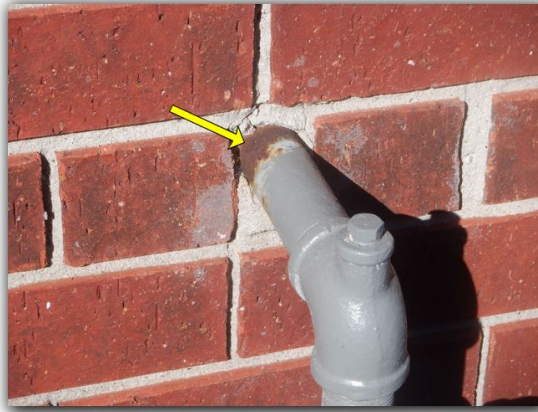
Gas piping not sleeved as it passes through masonry wall as required by Code [CABO 2608.3] IRC 2603.3.

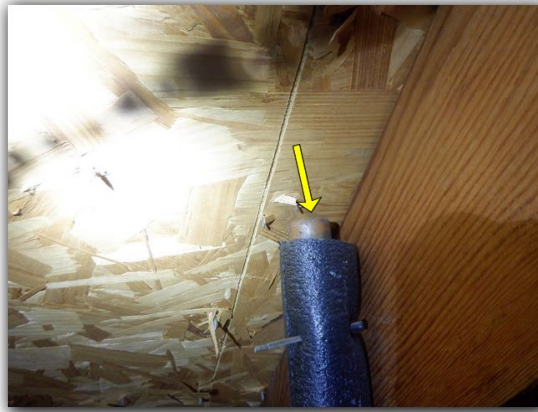
A water line above the water heater was improperly in contact with the underside of the decking, which may allow damage by a roofing nail when roof is replaced or repaired.

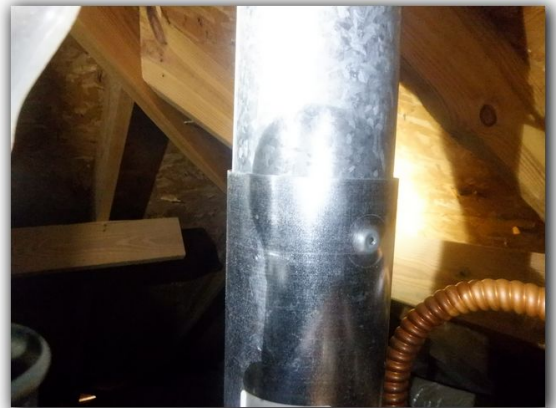
Vent pipe connection(s) improper, inside out / upside down, does not fully contain products of combustion in duct.

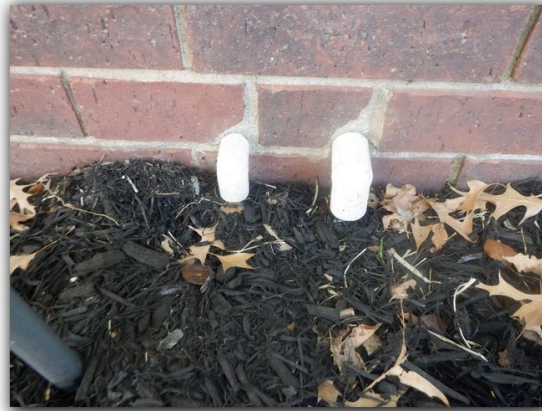
Drain line terminates improperly, current industry standards (Code) require drain line terminate within 24-6 inches from grade. Recognized safety hazard, repair IRC 2803.6.1.

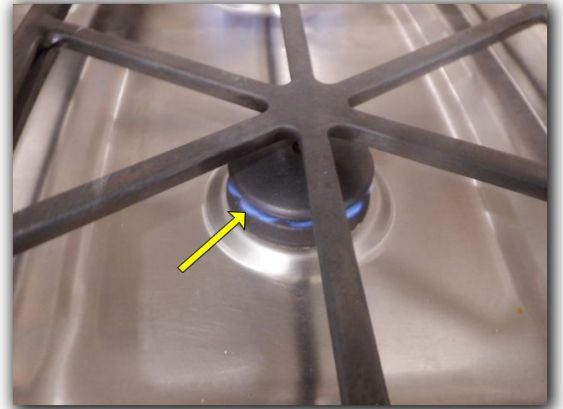
The flame was very low for the front right burner, even when set at high.

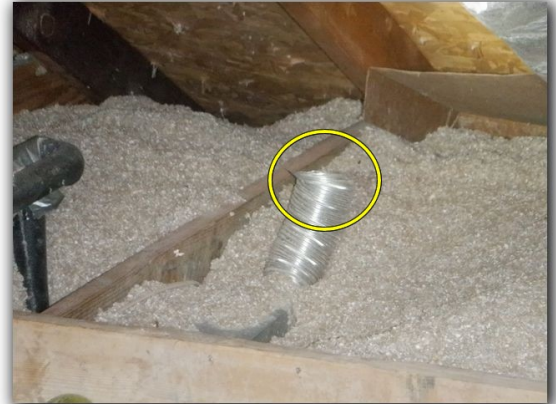
Improperly vents into attic. Should vent to exterior.

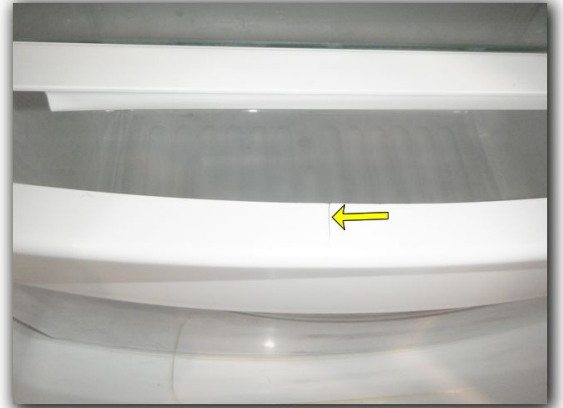
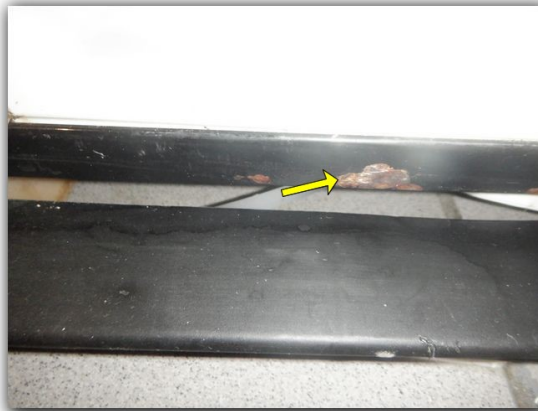
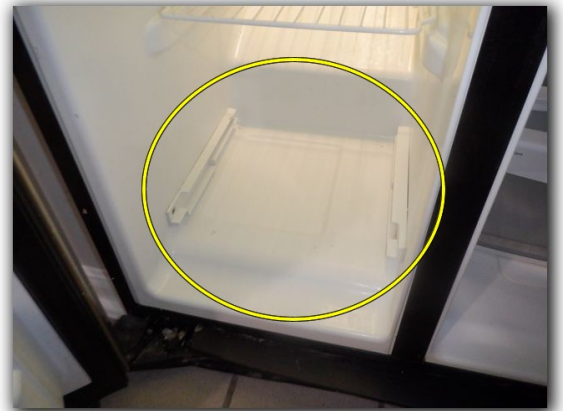
Multiple areas of minor damage and missing components were observed in the refrigerator / freezer.
