PROPERTY INSPECTION REPORT FORM

John Doe <i>Name of Client</i>	10/30/2022 <i>Date of Inspection</i>
123 Your Street, Houston, TX 77030 <i>Address of Inspected Property</i>	
John Tatum <i>Name of Inspector</i>	Professional Inspector # 9459 <i>TREC License #</i>
 <i>Name of Sponsor (if applicable)</i>	 <i>TREC License #</i>

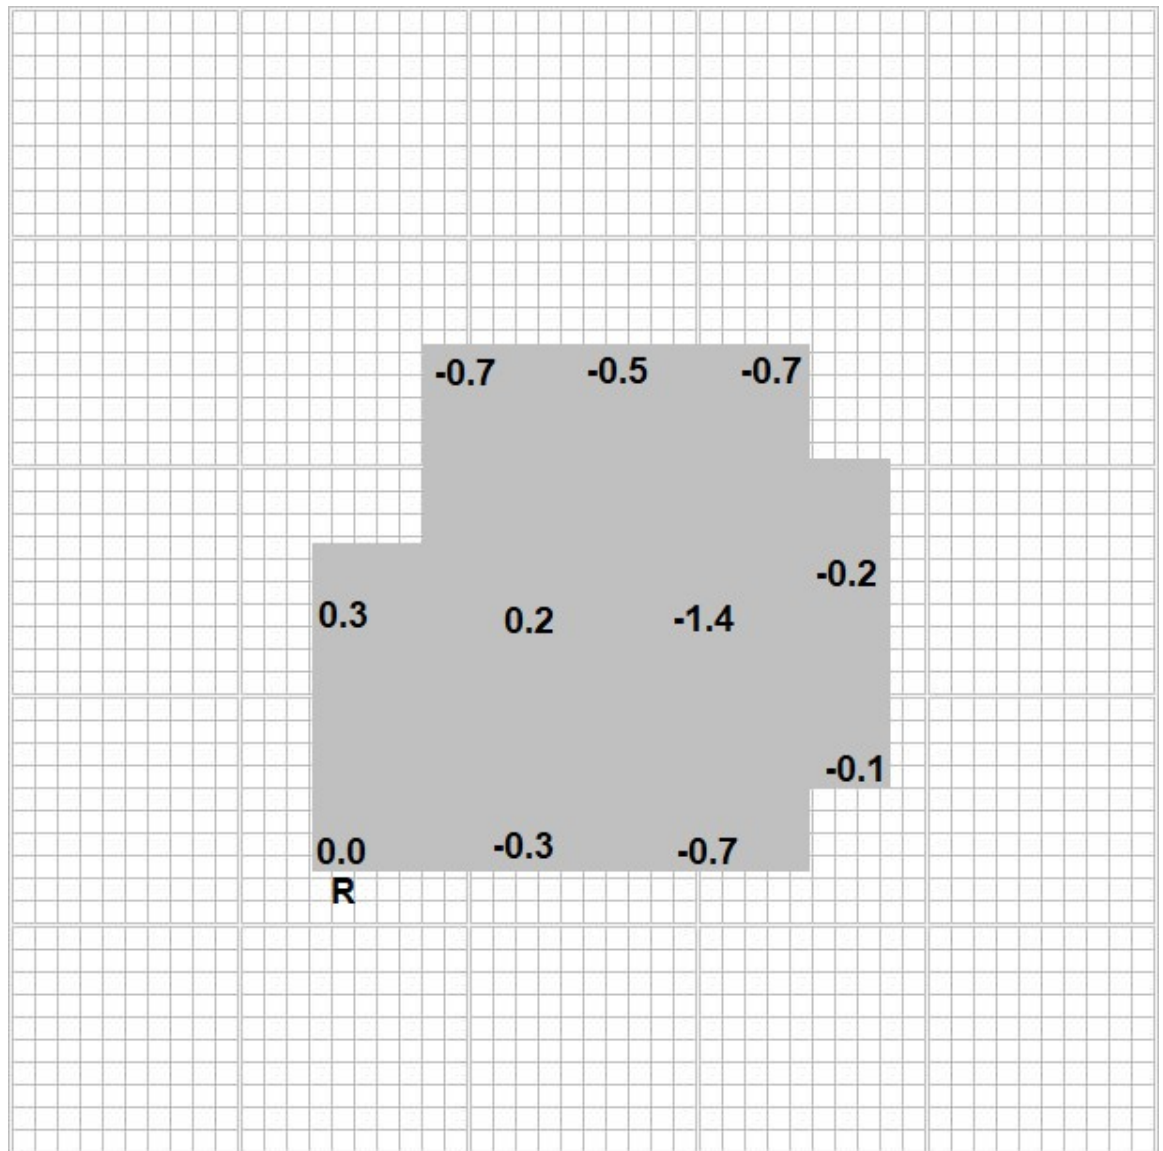
A foundation elevation survey was conducted during the inspection. The table below represents data gathered using a Zip Level or similar instrument and adjusting for floor covering height differences. i.e. differences between tile, carpet and wood flooring. Measurements are listed to the nearest .1". Measurements were taken along the respective walls listed below-North, East South, West, etc. Greatest variance was 1.6 inches.

Though the elevations are not outside of standard for this age and type of foundation, a full determination of foundation performance can not be made without proper access to the crawl space to inspect the framing.

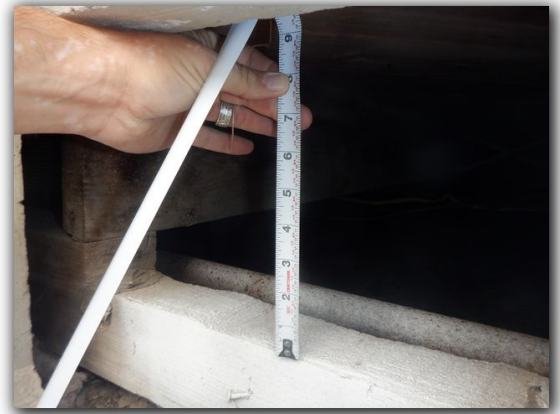
Could not access below most of home due to inadequate access and clearance of framing from ground. Code (IRC Section R408.3) requires that access be provided to all under floor spaces. Access openings through floors shall be a minimum of 18x24 inches, while openings through a perimeter wall shall be at least 16x24 inches. Recommend installation of proper access opening and subsequent inspection under house.

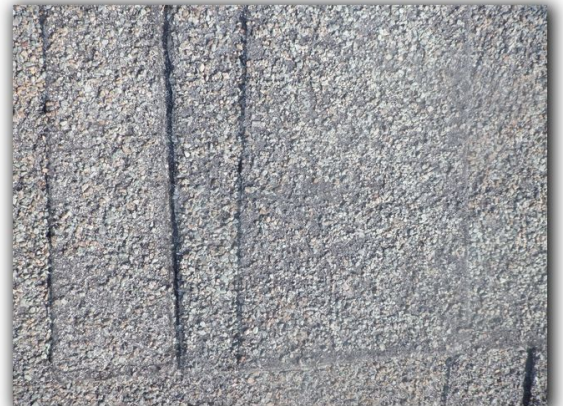
Older roof, nearing end of serviceable life. Observed Brittle, cracked, curled ends, and/or excessive granular loss of shingles.

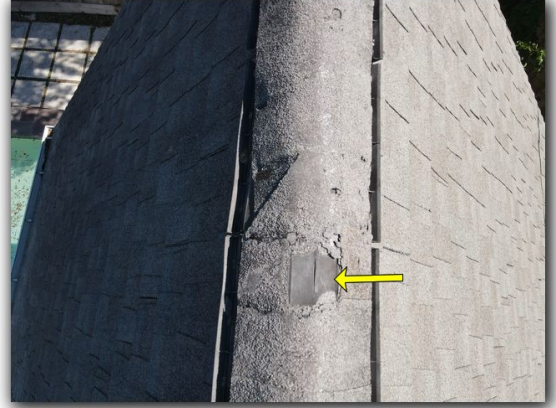
Substantial roof damage was present at the ridge of the pool house.

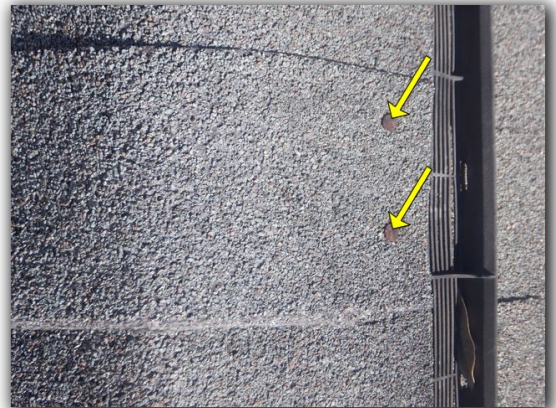
Exposed staples / nail heads / fasteners observed on roof, all exposed fasteners should be sealed to prevent water entry.

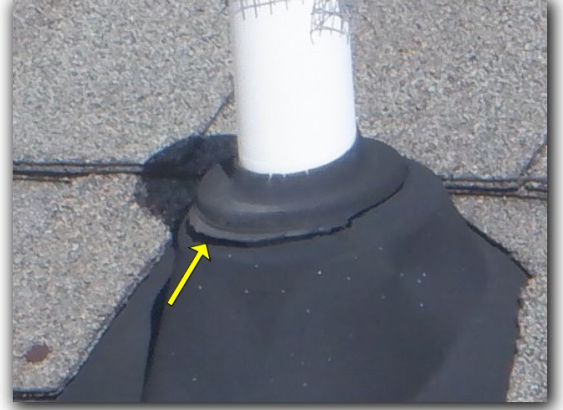
Rubber gasket of drain waste vents has deteriorated, allows water entry. Recommend caulking / sealing around vent pipes.

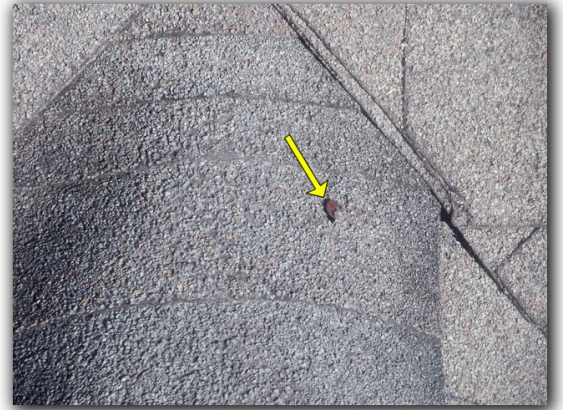
Areas that need immediate attention, including but not limited to; (e.g., torn/damaged shingles, nail/staples popping through roofing, etc.)

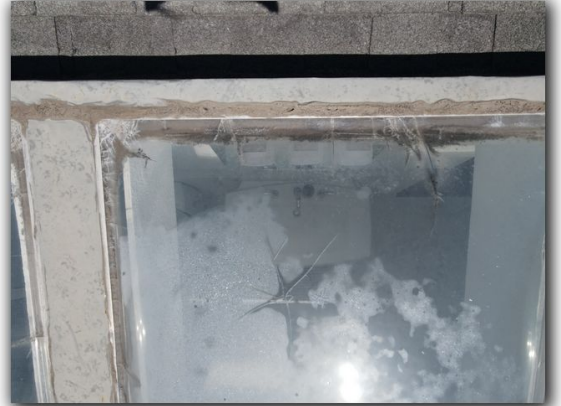
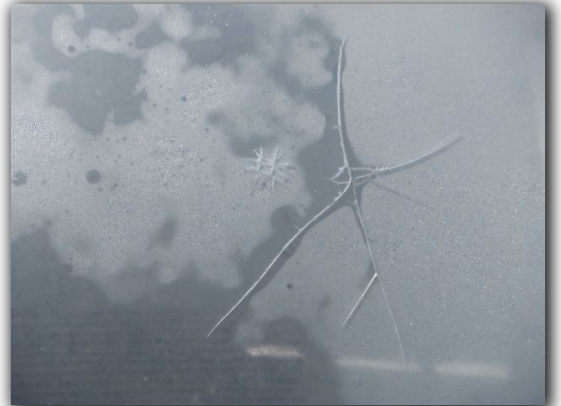
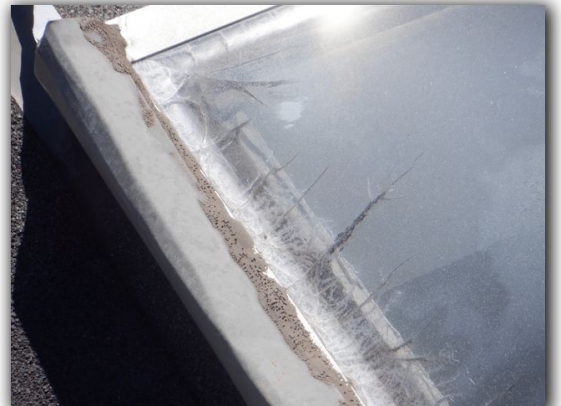
Cracking and fogging was observed in all of the sky lights over the 1st floor master bathroom.

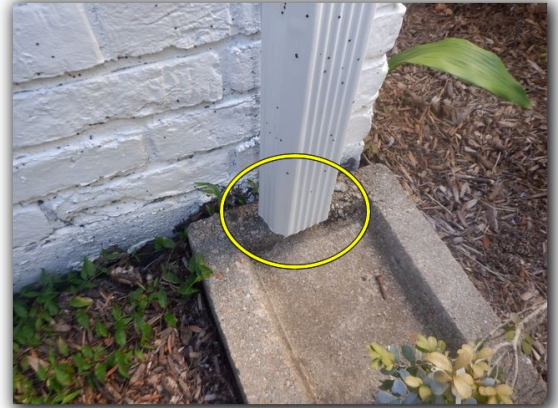
Multiple gutter downspouts were observed to be dented / damaged.

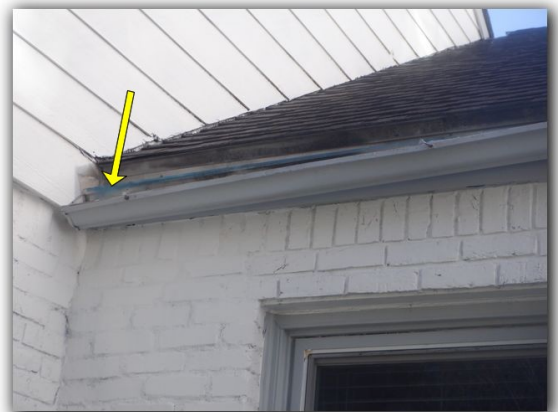
Damaged / Loose gutters were present at the north and west exteriors.

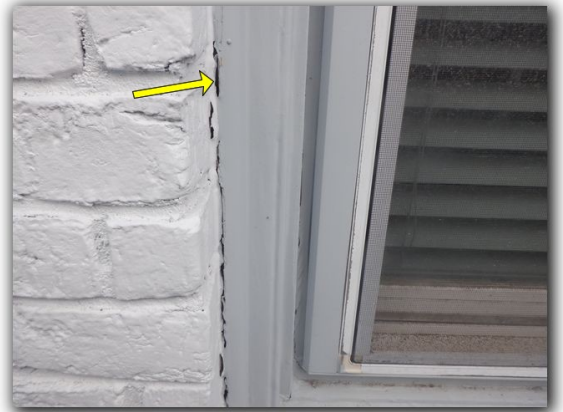
Caulking deficient around one or more windows, will allow water penetration during heavy / wind driven rains.

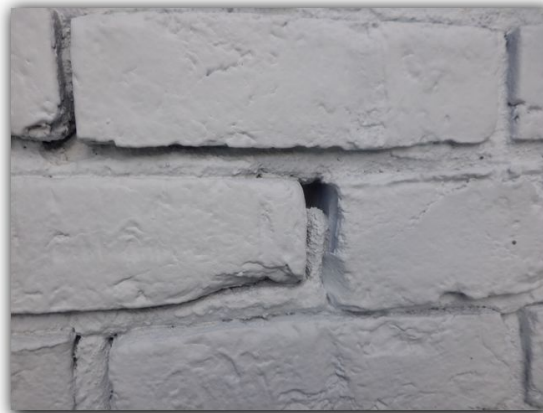
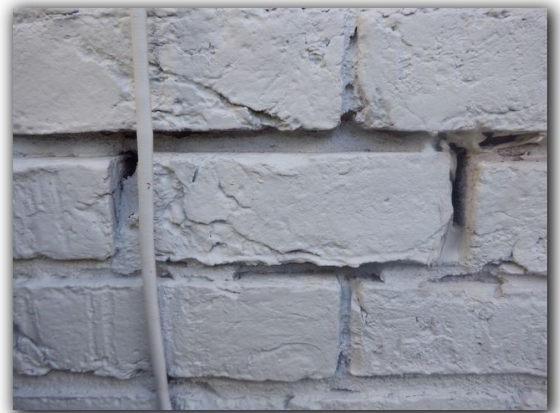
Mortar joints between brick ends is deficient in areas, indication the brick layer might not have properly "struck" the bricks (used enough mortar), recommend re-pointing areas where voids in mortar are present.

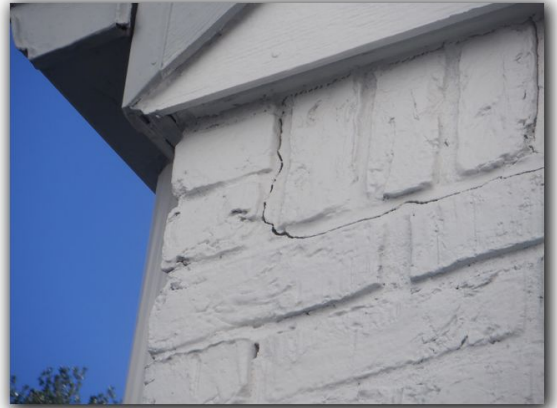
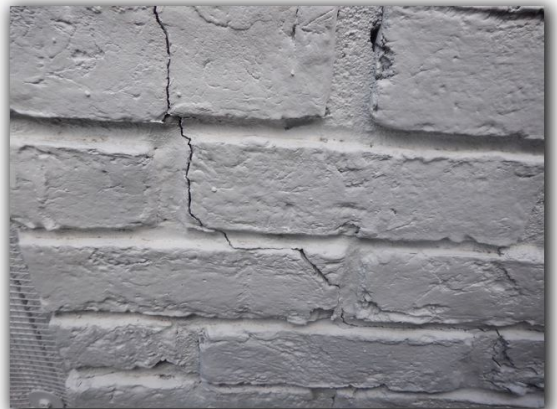
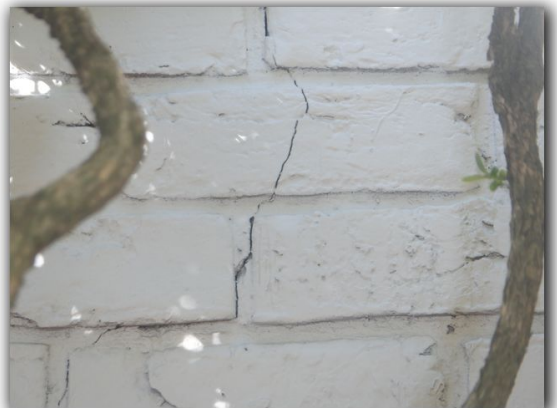
Cracks in brick veneer and/or repairs, one or more locations, Recommend buyer take photographs of cracks, their location, and width [ruler across the crack] with a high resolution camera that has a date stamp for future reference.

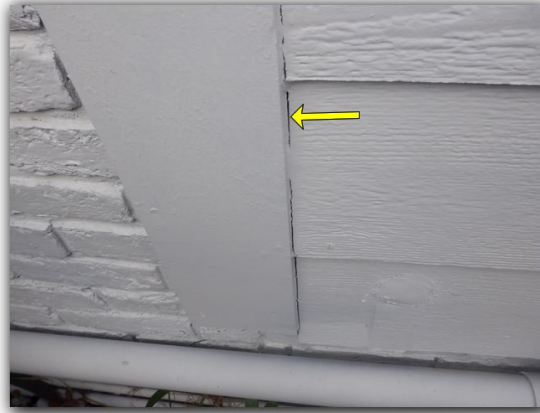
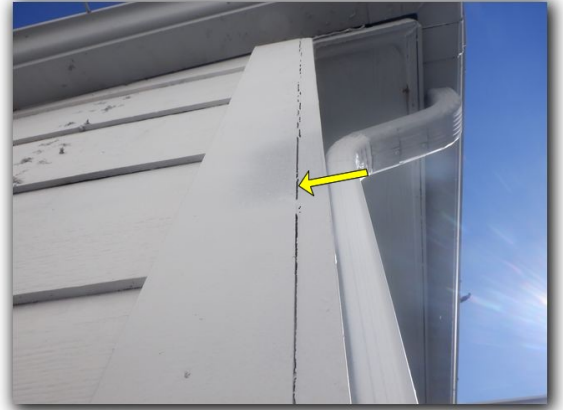
Caulking missing and/or deficient around vertical trim boards may allow wind driven rain entry.

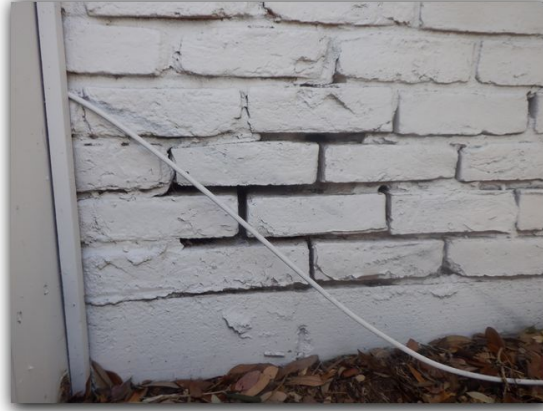
Multiple areas of brick were observed to have significant voids in mortar and should be re-pointed.

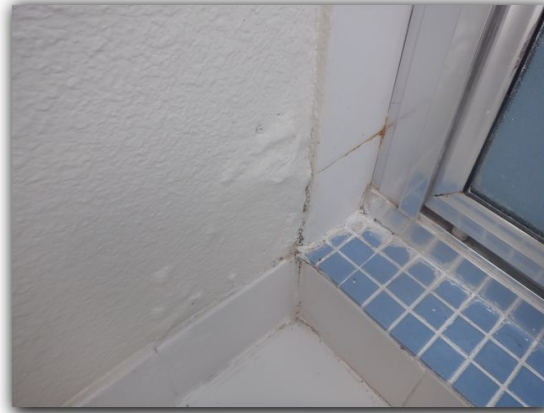
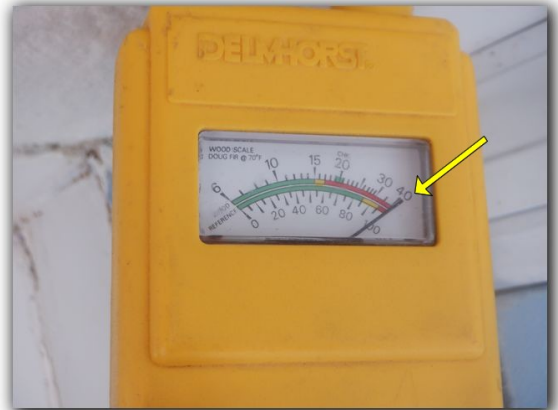
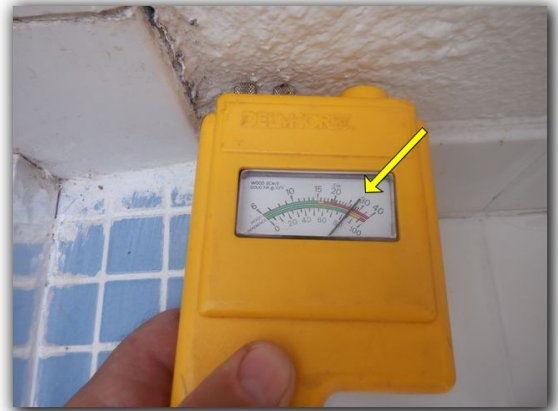
Water penetration observed at the following location(s): (Both sides of the 1st floor master bathroom shower enclosure.)

Possible from exterior window frames not properly caulked / sealed.

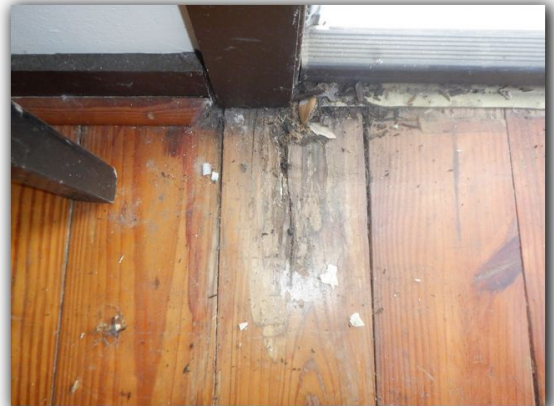
Water damage was present on the wood flooring in the pool house near the HVAC closet and at the west exterior door.

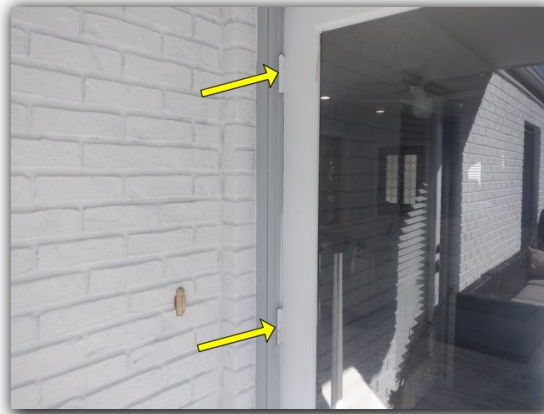
Security consideration; hinges mounted on outside of exterior door(s), makes easy target for removal of door for unauthorized entry.

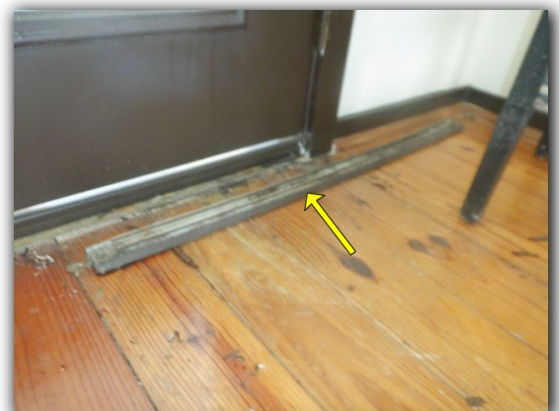
The lower door sweep / weather stripping was loose / damaged on the west door to the pool house.

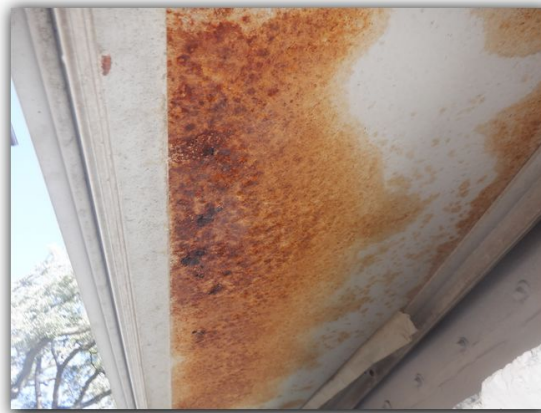
Corrosive damage was observed at the base of the kitchen garden window. Recommend cleaning and painting.

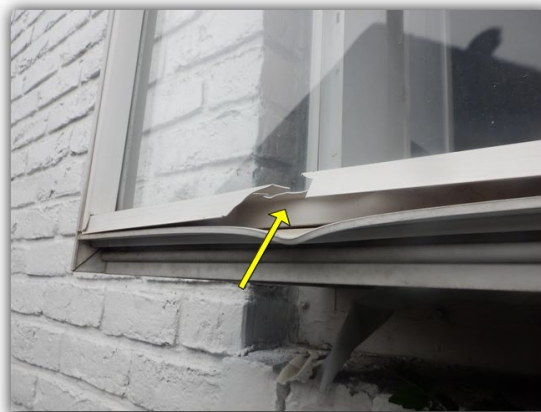
One or more windows had plastic exterior retaining strips loose or damaged.

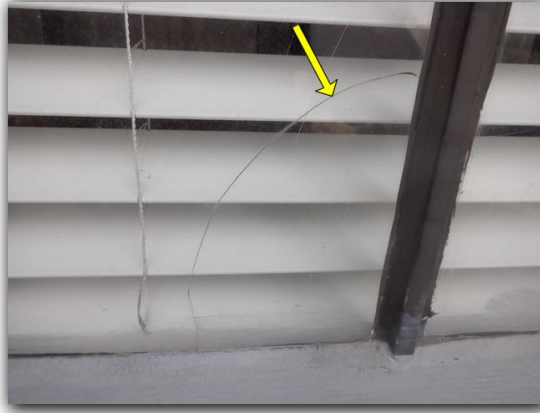
One or more windows had cracked / broken glass pane(s). (Southwest bedroom)

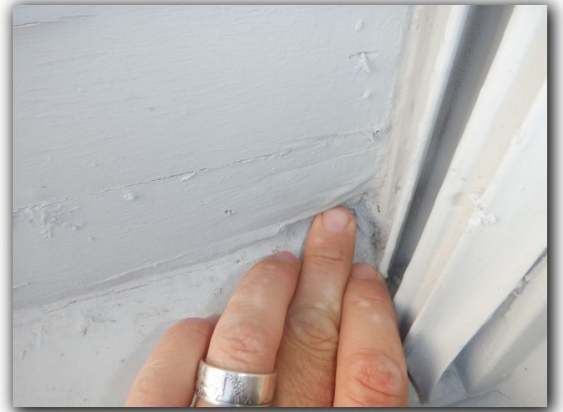
Wood rot of window frame/jambes observed at one or more locations.

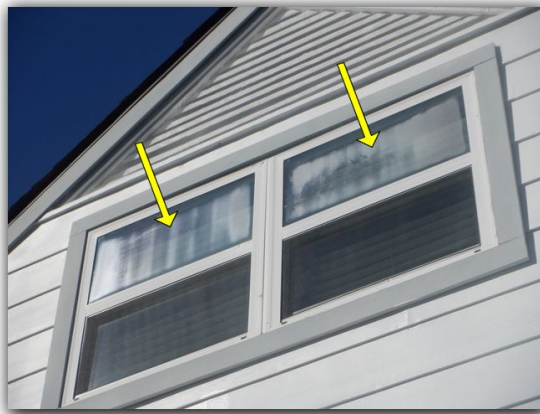
Double pane window vapor seals appear broken, including but not limited to, (2nd floor bedroom)

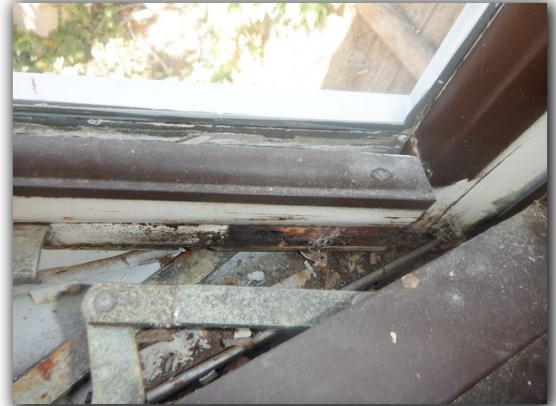
Multiple windows in the pool house are heavily rotted and in need of replacement.

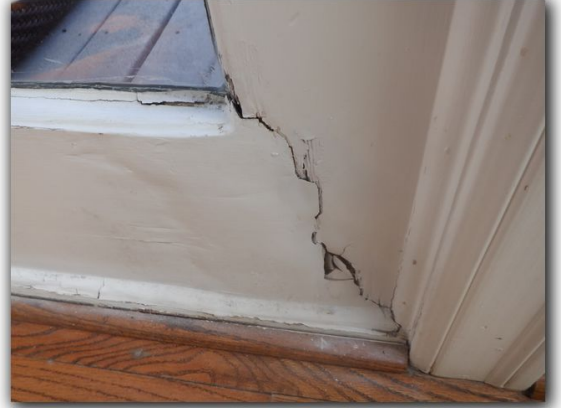
Heavy wood rot was present on the 1st floor master bedroom window.

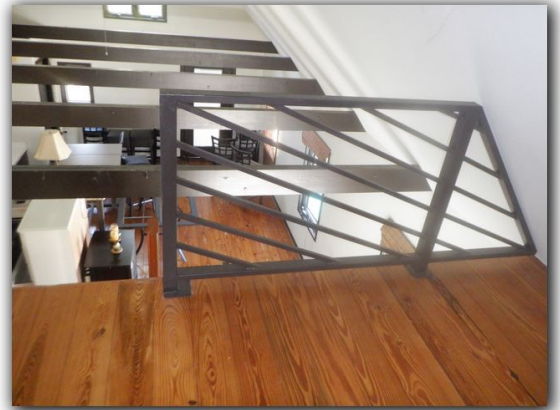
Nautical style railings of stairway and balconies are known to be potential hazard around small children who like to climb the horizontal rails. (Pool house loft)

LADDER TYPE DESIGNS
ARE NOT ACCEPTABLE

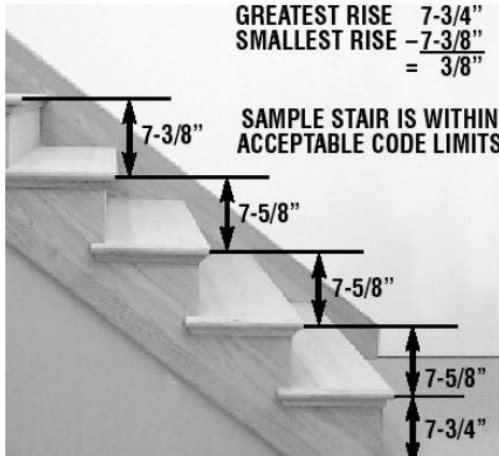
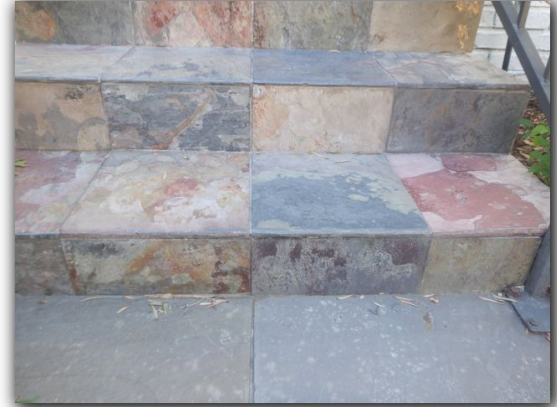
Stairway has tripping hazard, Risers are not same height along the entire height of steps. Stairway does not comply with current industry standard, (code). CABO 314.2 & UBC 1006.3 requires "The greatest riser height within any flight of stairs shall not exceed the smallest by more than 3/8 inch."

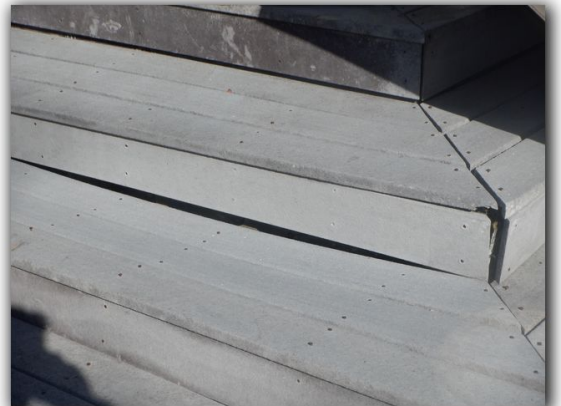
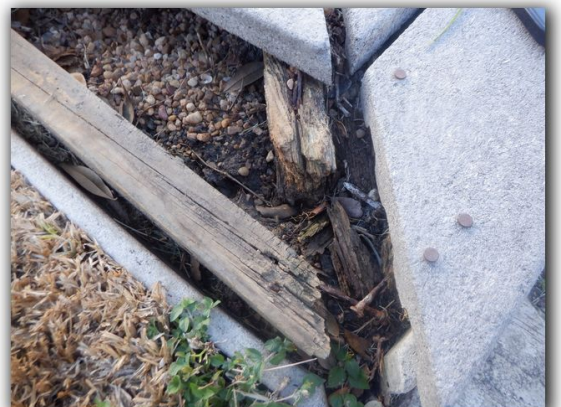
Significant settlement, rotted framing, sloping steps and loose decking was observed at the back patio and at the east entry to the pool house.

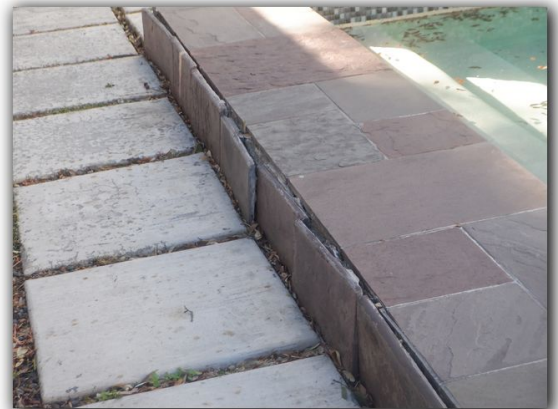
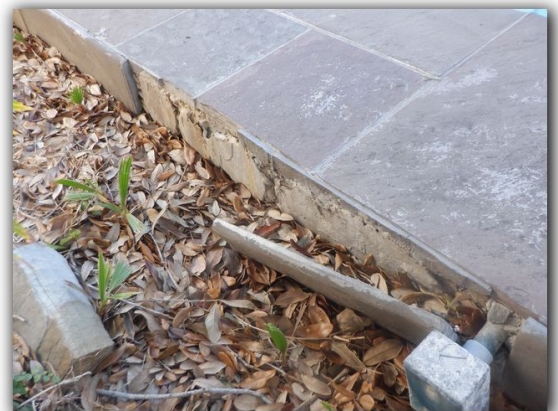
Numerous loose, damaged and missing tiles were present around the pool area.

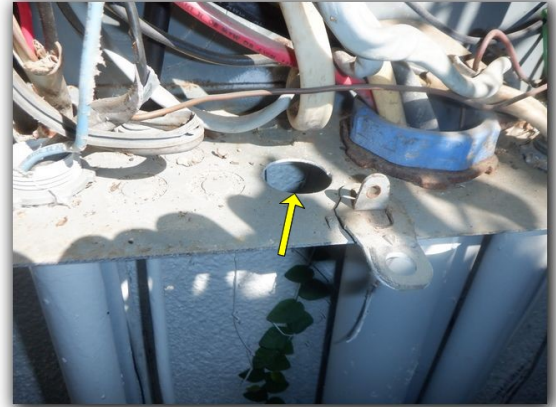
any exposed panel openings (that would allow access to the inside of the panel) should be fitted with secure covers

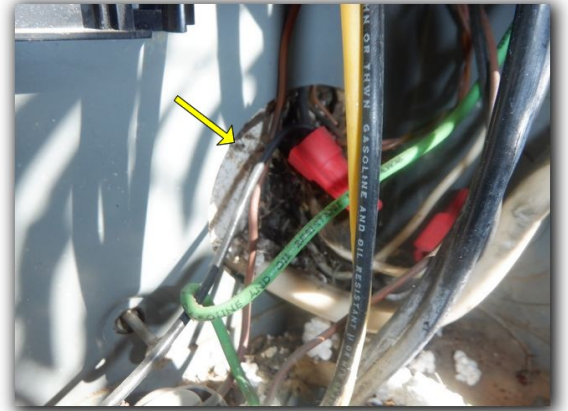
cables should be clamped where they enter the panel they should also be secured within 12 inches of the panel

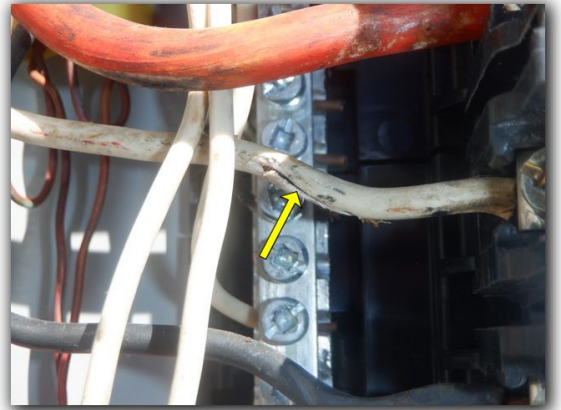
Damaged wiring insulation was present on a wire to a 30 amp breaker. Recommend repair by a licensed electrician.

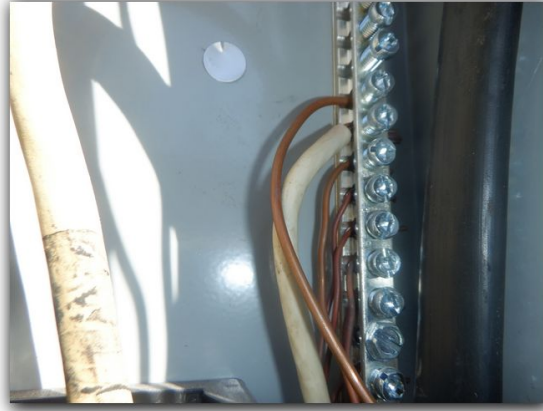
Improper wiring to sub-panel, the neutral and ground wires are not on separate bus bars as required on sub-panels.

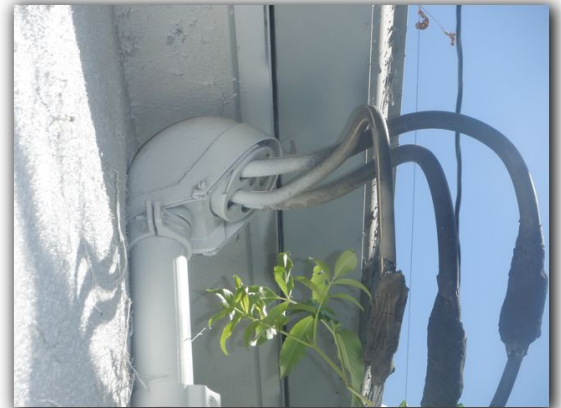
Drip loop of electrical service drop is not proper, rain water can run down conductors into weather head.

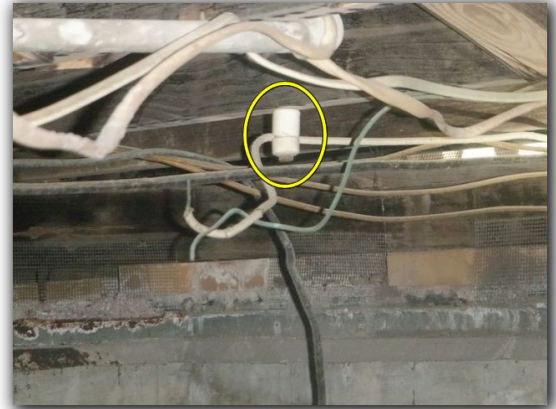
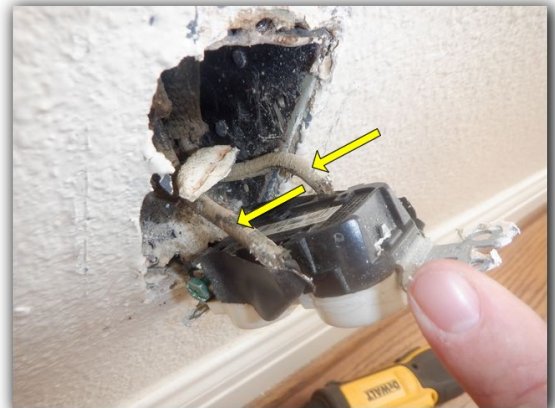
Observed type of branch wiring is a mix of Romex and antiquated Knob & tube. Be advised most insurance companies do not insure a building with Knob & Tube wiring or may charge a higher rate due to fact that Knob & Tube wiring is considered antiquated by today's standards. Client should contact prospective insurer to find out if coverage is provided as well as contacting qualified electrician regarding updating electrical system to meet minimum / code standards.

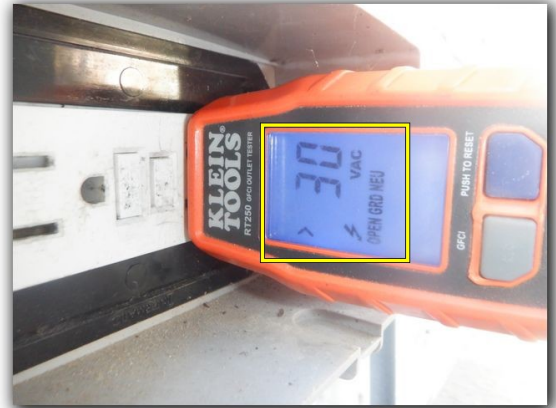
The GFCI at the north exterior indicated an open ground and neutral and only registered approximately 30 volts. Recommend further evaluation and correction by a licensed electrician.

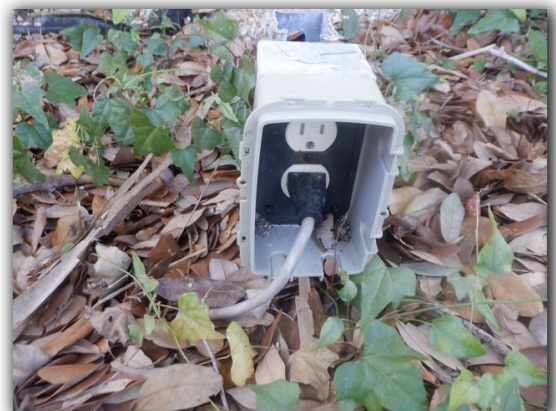
No power to outlet(s); (Southwest corner of the yard)

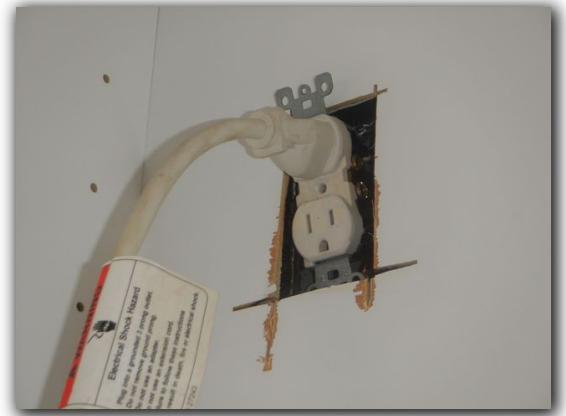
Outlets / switches / devices installed in / through combustible material were not flush mounted as required by code, space exists between face plate and edge of electrical junction box. Missing required spacer (spark ring) on following outlet(s): (Above the range top) Reference NEC 370-20 & IRC E3806.5. In walls constructed of wood or other combustible material, cabinets (outlet & switch boxes) shall be flush with the finished surface or shall project there-from.

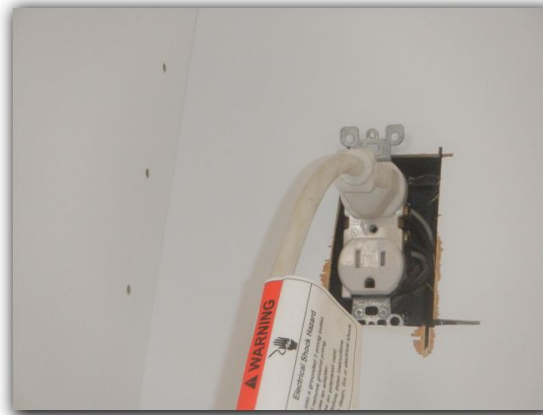
One or more outlets are not secured well in wall. (Above the kitchen range top)

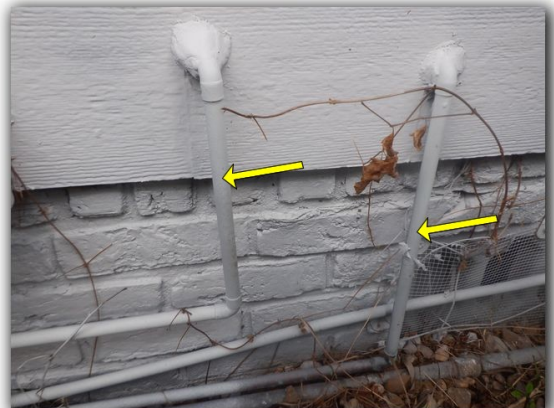
Recommend insulating exterior water line(s) to prevent freeze damage.

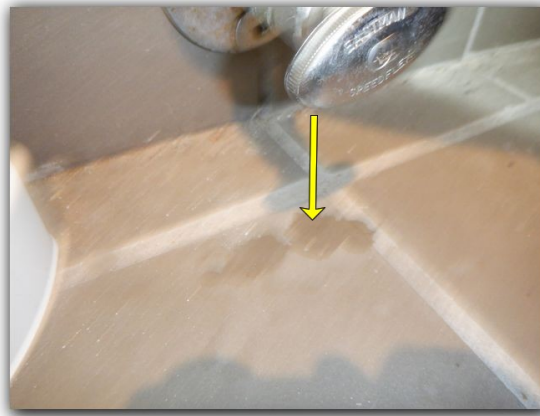
Water was found shut off to the pool house commode. When turned on, the shut off valve leaks and the commode runs.

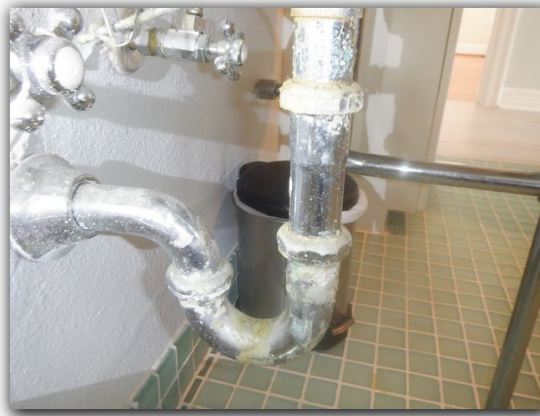
Corrosion noted at trap and/or drain lines below one or more sinks. (Hall bathroom)

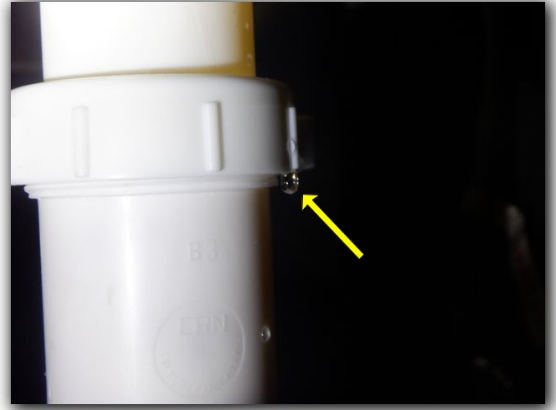
Small leak below sink, (Northern 2nd floor bathroom sink)

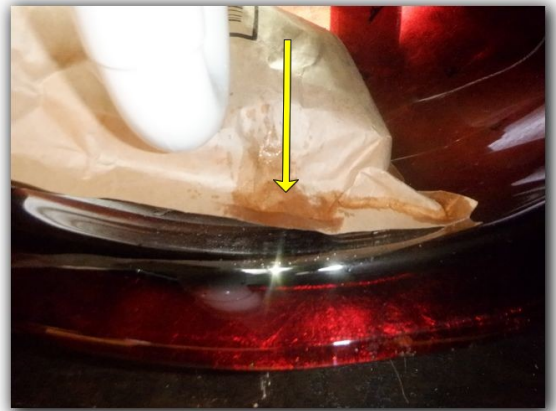
Large water leak below sink, (Southern sink in the 2nd floor bathroom)

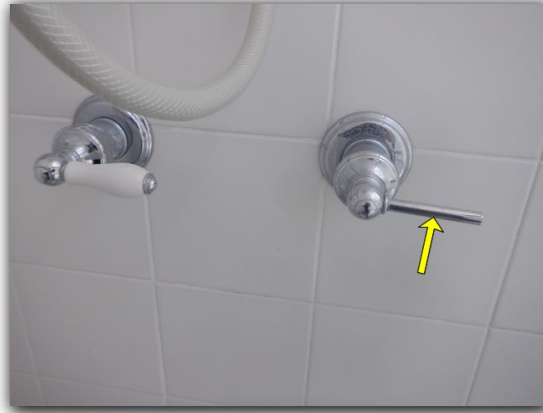
The cold water handle was missing the decorative sheathing in the 1st floor master shower.

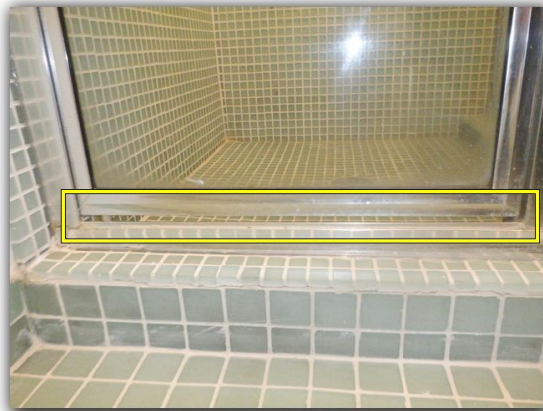
Shower door lower weather stripping loose and / or damaged, results in possible water leaking from base of door, needs repair / replacement.

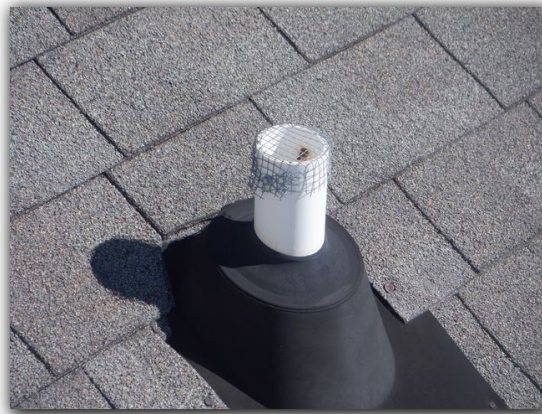
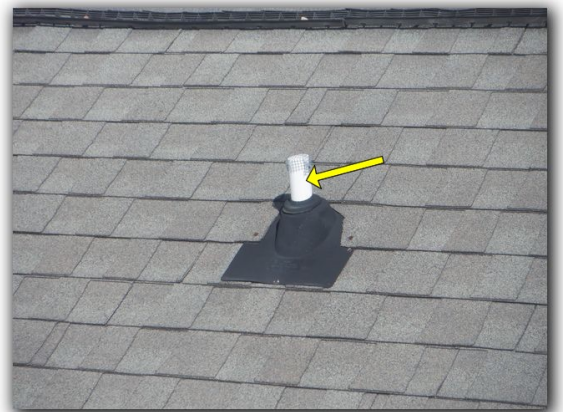
Painting of exterior plastic PVC vents above roof line required to prevent UV damage.

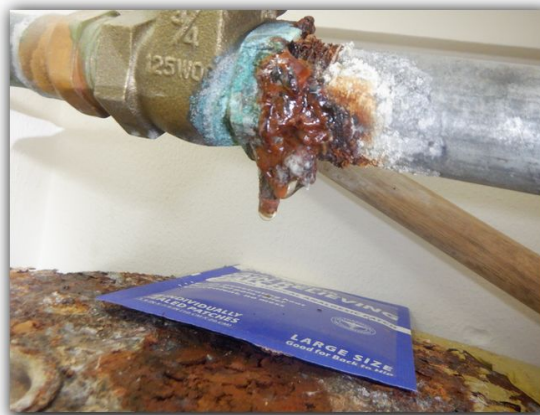
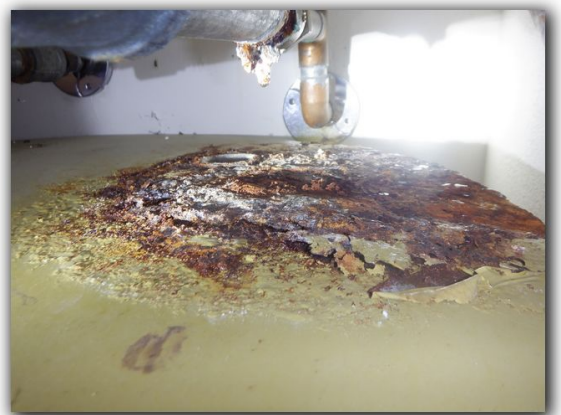
Corrosion and active water leak observed at shut off valve and/or connections on top of water heater. Heavy corrosion has resulted on the top of the tank. Recommend replacement.

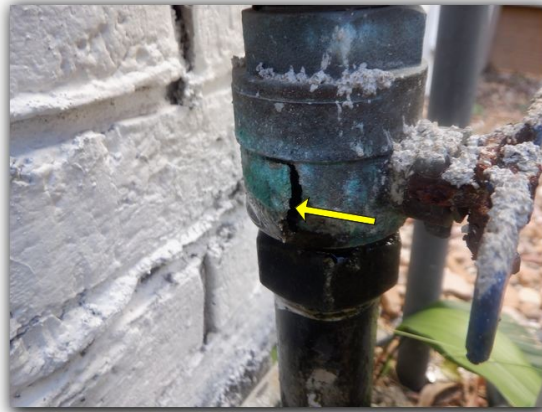
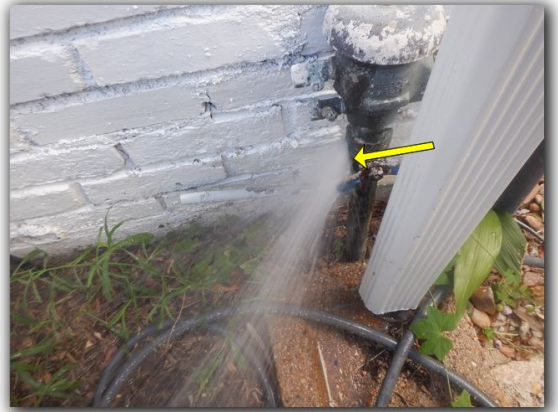
The sprinkler system back flow preventer was cracked / damaged. System could not be operated / checked.

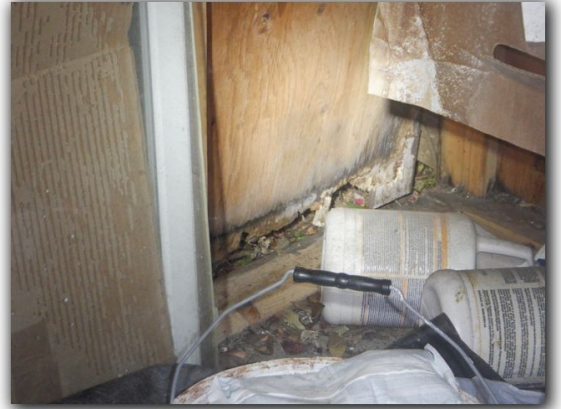
The shed was not fully inspected, but appeared to be in poor condition.
