Blue Water Marine Services

Catalina 36 Mk II

Report of Marine Survey

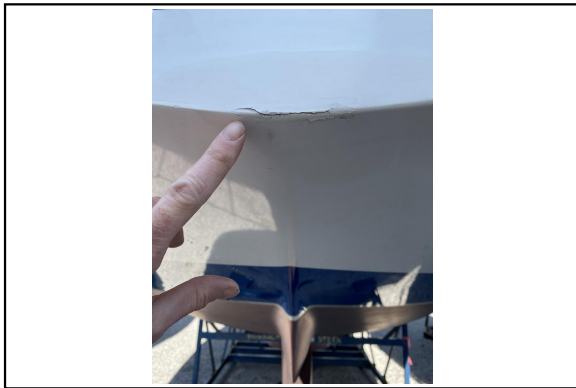
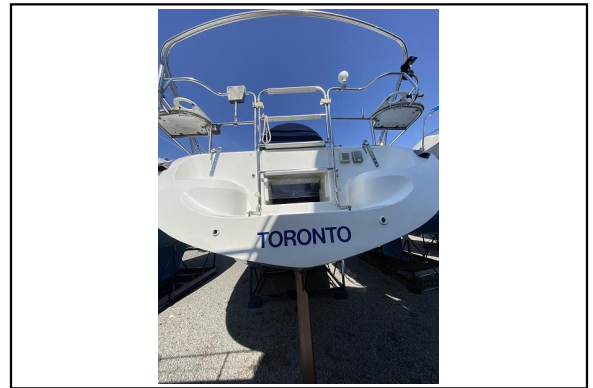
***C.1**

Minor gelcoat damage at bottom center.

FINDINGS	RECOMMENDATIONS
Minor gelcoat damage at bottom center.	<i>Further investigate and repair as necessary.</i>

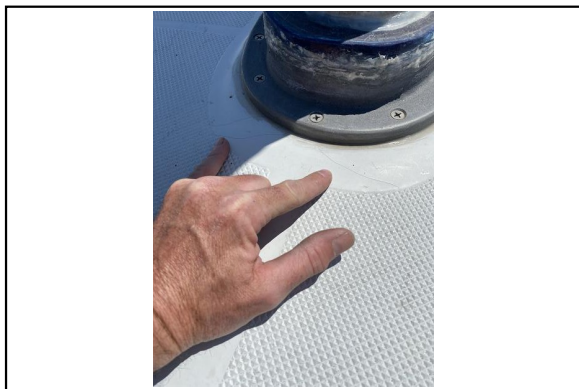
***C.2**

Some spider-cracking at forward edge of mast step.

FINDINGS	RECOMMENDATIONS
Some spider-cracking at forward edge of mast step.	<i>Further investigate and repair as necessary.</i>

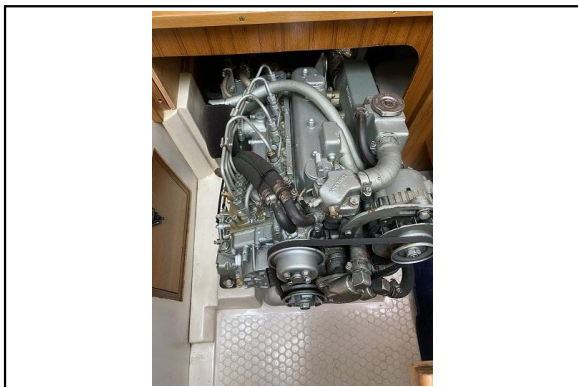
Engine

Universal M-35BC. Good condition.

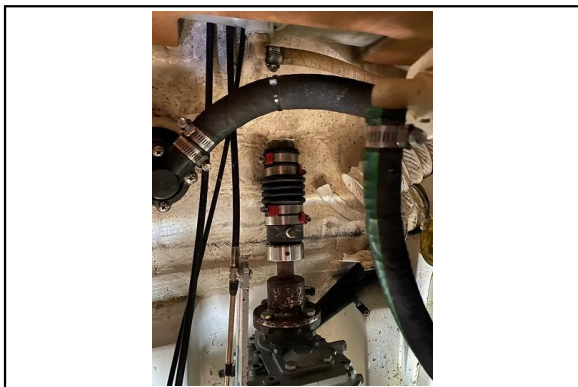
Packing Gland

PSS Dripless (Face Seal). Good condition and Serviceable at time of inspection.

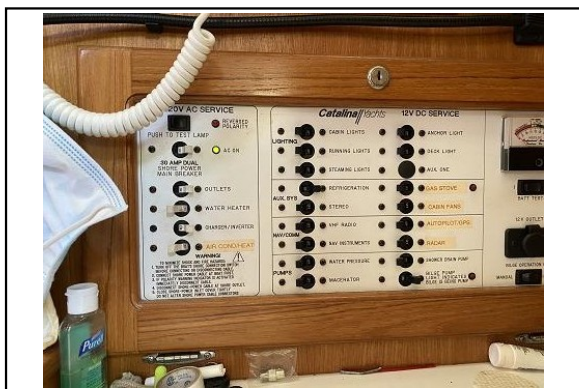
AC-DC Panel

AC / DC SEPERATION:
No access to back of panel to determine. Could not locate key to open panel.

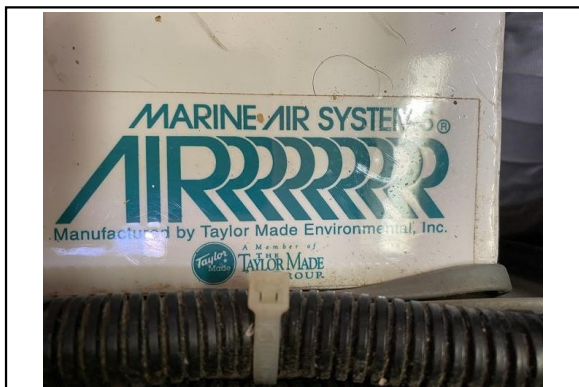
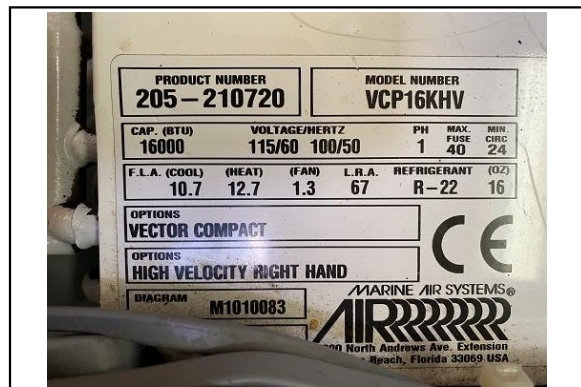
Taylor Marine Air Systems reverse-cycle. Serviceable.

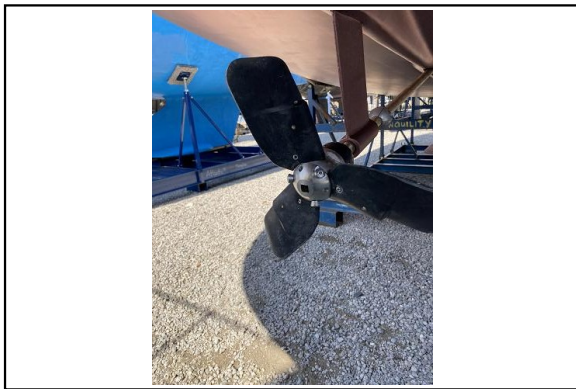
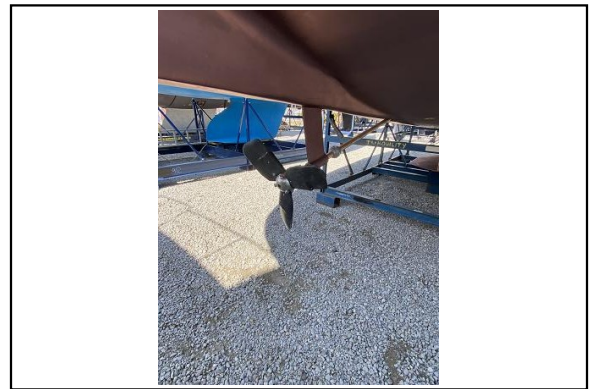
16" 3 blade feathering propeller of composite construction. Good condition

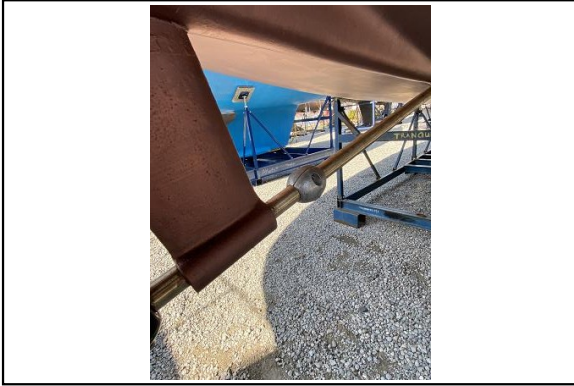
Shaft and Strut

Stainless steel 1". Good condition.

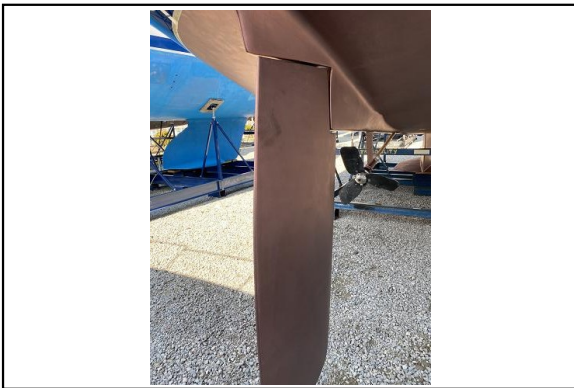
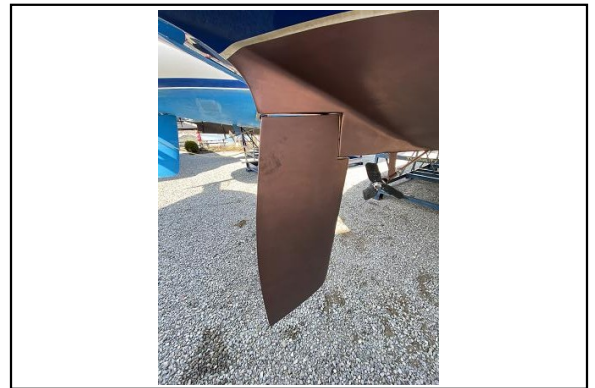
***C.4**

FRP inboard spade Good visual condition. Moisture readings in the low ranges.

Slightly more than average play in the bearings

FINDINGS	RECOMMENDATIONS
Slightly more than average play in the bearings	<i>Further investigate and repair as necessary.</i>

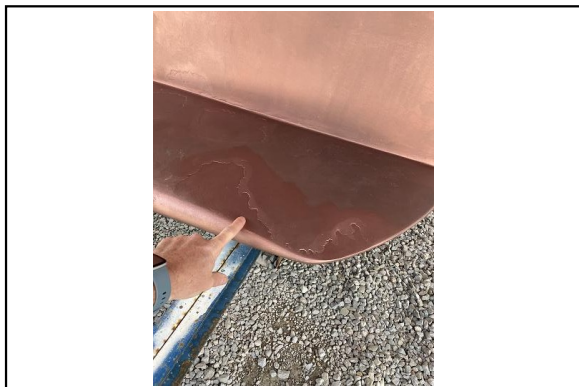
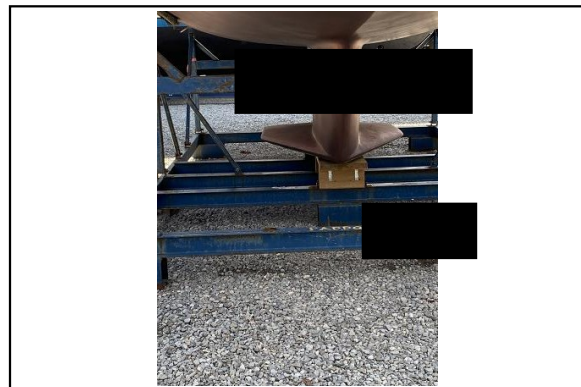
*C.5

The top of the port-side wing is showing some 'bubbling' under the bottom paint. This is not uncommon on Catalinas.

FINDINGS	RECOMMENDATIONS
The top of the port-side wing is showing some 'bubbling' under the bottom paint. This is not uncommon on Catalinas.	<i>Bubbling is due to some surface corrosion. Recommend grinding out corroded areas and filling with an epoxy-based filler. Further investigate and repair as necessary.</i>
