**1925 Franklin 11A Babcock bodied coupe**  
**(A project I'm calling 'The Phoenix')**  
**By Steve Hall**  
**August 27, 2023**

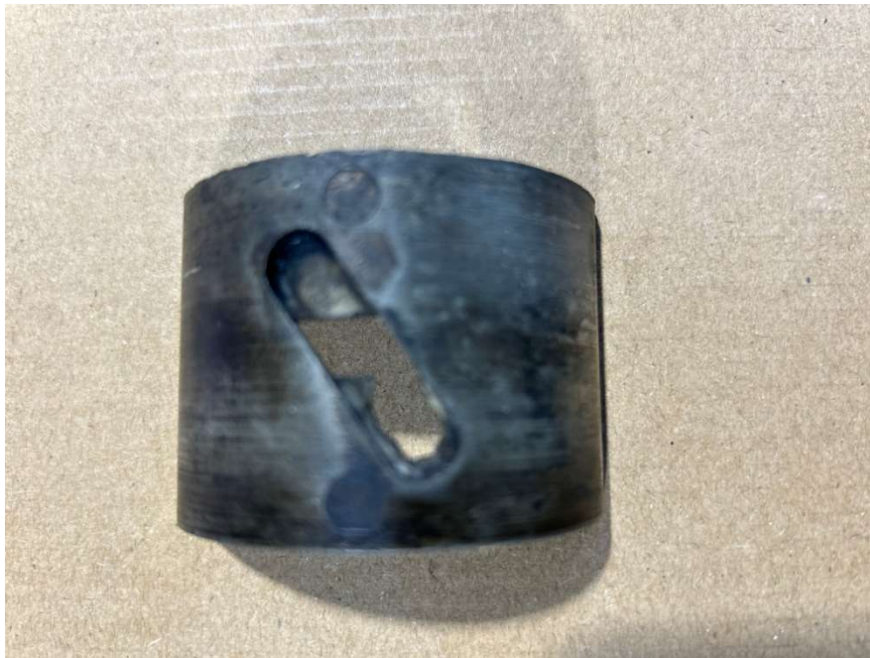
Caption: Center main bearing-solid babbitt (die cast). Note: Oil gallery relief 'cut/cast' diagonally on the back side to allow oil from the oil gallery supply in the crankcase at the edge of the bearing to the center of the bearing.

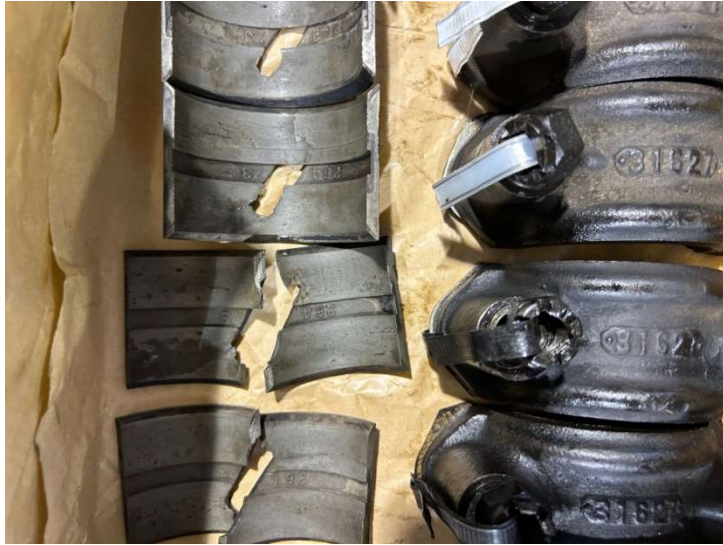
bearing surfaces preventing any chance of movement. Only slight pitting on the babbitt was evident though, so not so much of a problem. The real problem was that three of the inner 5 main bearings (7 total) were cracked on the upper half shells due to a design flaw in the oiling system. Franklins use an all aluminum crankcase that's cast in two halves. The upper half holds the crank and camshaft and the lower half is a solid cast aluminum oil pan with an integral sump, oil pump and oil gallery distribution system to cooper distribution lines. The main bearing caps are fastened by two long bolts that straddle the bearing cavities in the center of the crankshaft bore. The issue Franklin faced was the oil gallery could not be drilled directly on center to the bearing or it would interfere with the bolts that secure the lower main bearing caps, so Franklin drilled the oil gallery offset to the side of the bearing cradle bore. Franklin designed a relief on the back side of the upper babbitt bearing 5/16" wide at 35 degrees diagonal to direct oil to the center of the bearing where there is an oil groove cut concentrically around for the oil gallery that feeds oil to the connecting rod journals through a rifle bored port in the crankshaft between the main and rod journals. Franklin cut the relief in the upper main bearing long enough so that during assembly a person could not install the bearing inserts backward and block the oil supply. This is good from an foolproof manufacturing assembly design perspective, but the long relief left only about 0.150" of babbitt bearing over most of the length of the bearing leaving the bearing susceptible to breakage over long term abuse from crankshaft vibrations. I noticed in the Franklin drawing for the insert bearing in change "O", Franklin removed the relief on the back side of the bearing on November 30, 1928 presumably realizing the design flaw. The change incorporated a note indicating consult assembly instructions for repairs (presumably a note that instructed the service person to install the relief so the oil gallery hole lines up and is not installed backward and block the oil supply since the design change would mean the bearing can only be installed one way and work correctly!)

Caption: Main bearings. Note damage to upper babbitt bearing shells due to the weakness of the oil gallery relief.

So, the next step in the engine project is deciding between several options to address the main bearing situation.

1. Find used babbitt bearing inserts that are still good, use those, polish the crank and reassemble.
2. Grind the crank, pour babbitt main bearings in the block & caps, and then align bore to the crank size.
3. Purchase custom made babbitt inserts, align bore to the crank size.
4. Use the crank and block from latter 1926 engine that has poured main bearings and crankshaft that was ground 0.015" undersize in the past.

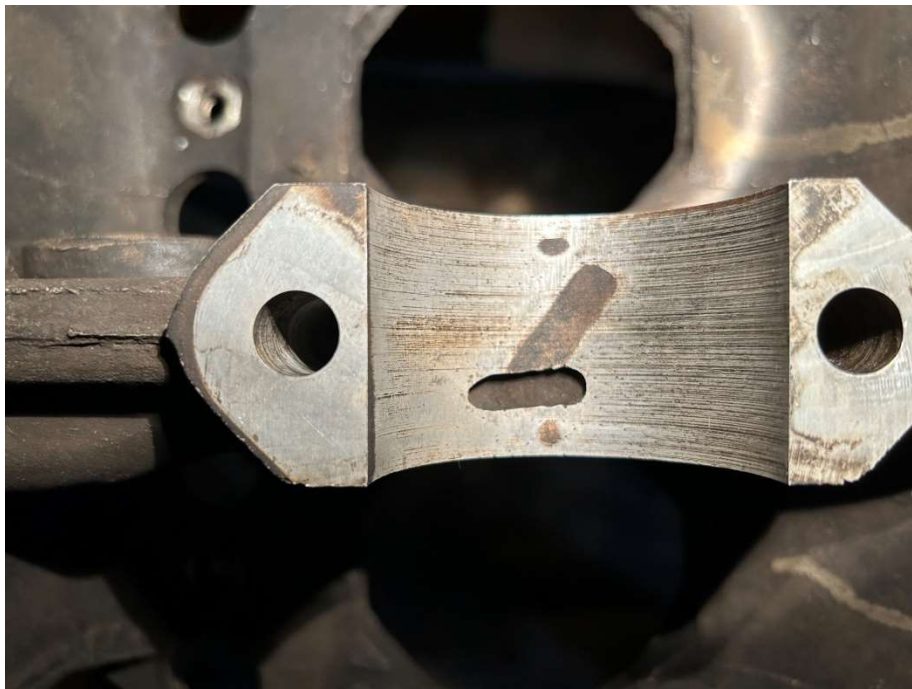
Caption: Upper crankcase main bearing cradle. Note offset oil gallery port and oil staining behind where the bearing oil passage relief is cast in the bearing shell.

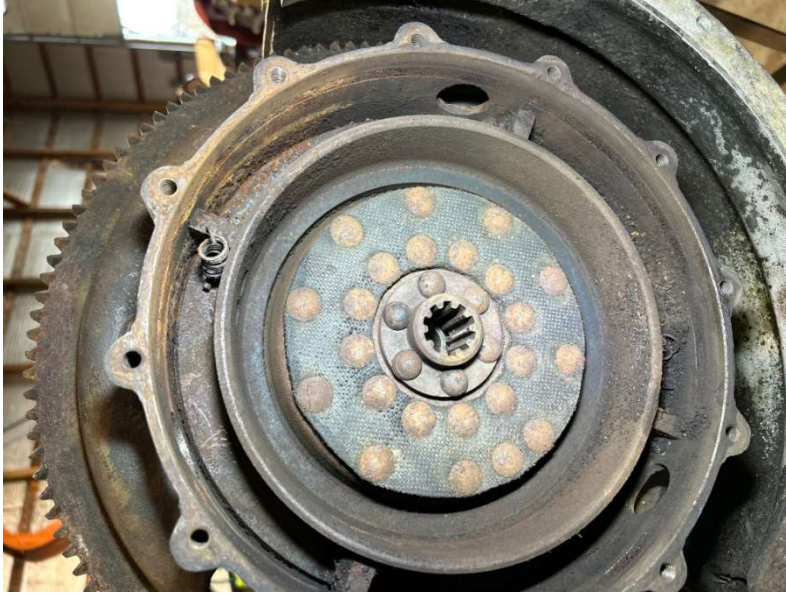
Caption: Clutch thrust ring in flywheel housing- Note the four centralizers rusted to the flywheel housing and broken release spring.

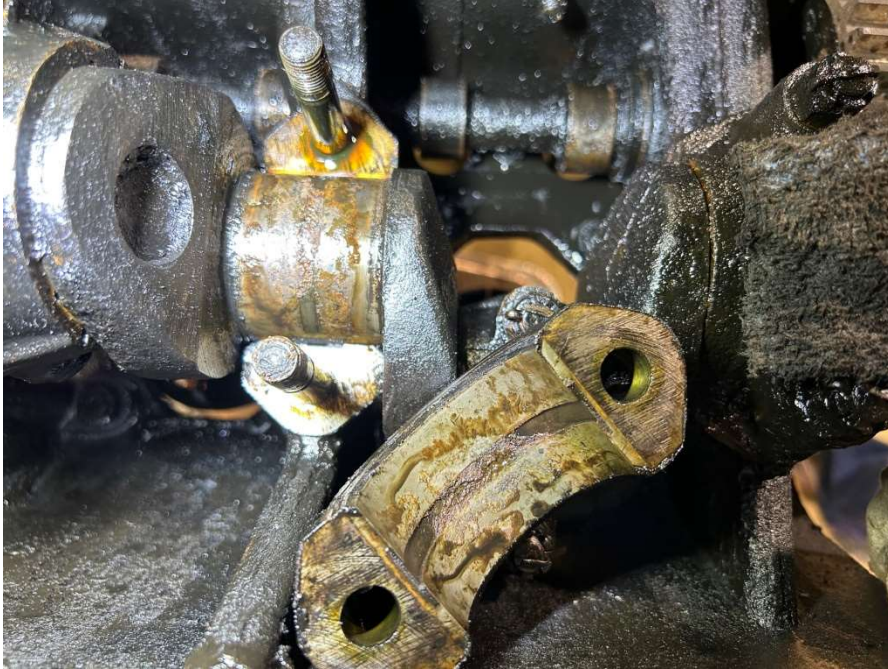
After the rods were out I started taking off the main bearing caps and discovered the reason for the stuck crank... rust from years of condensation cycles had slowly grown to penetrate into the babbitt

Caption: Years of condensation cycles rusted the surface of all the main journals.
