FULL RESERVE STUDY

Caroline Oaks Homeowners Association, Inc.

Burke, Virginia

July 1, 2021

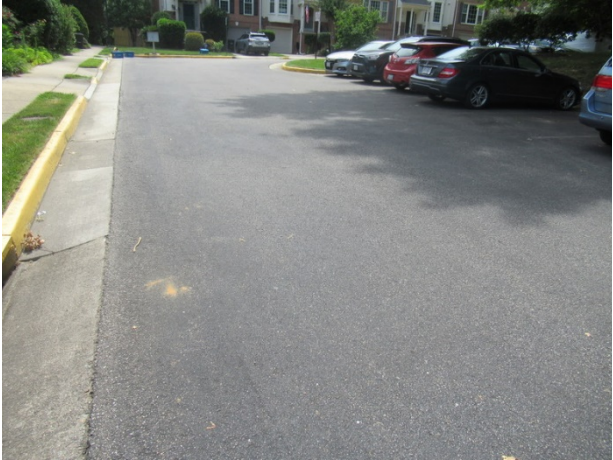
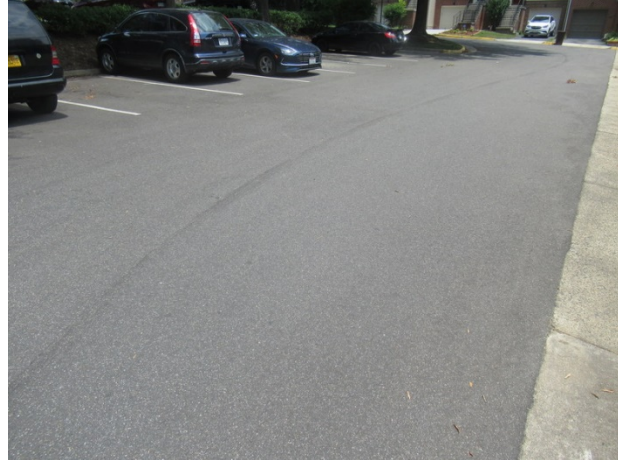
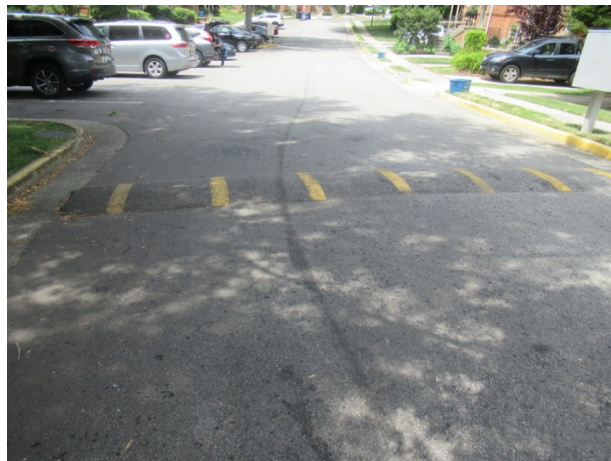
Condition: Good overall

Asphalt pavement overview

Asphalt pavement and speed bump overview

- Annually:
 - Inspect for settlement, large cracks and trip hazards, and ensure proper drainage
 - Repair areas which could cause vehicular damage such as potholes
- As needed:
 - Perform crack repairs and patching as needed

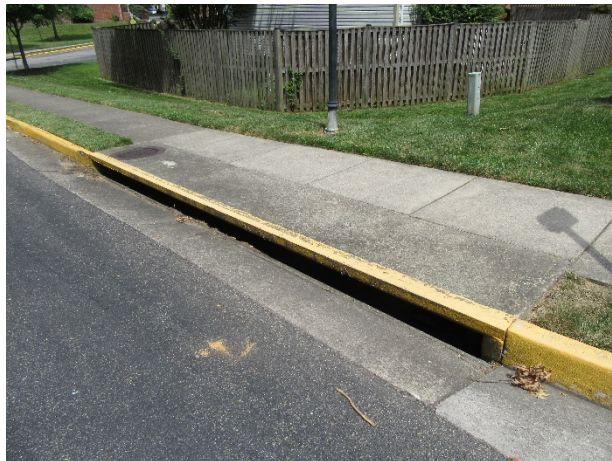
Condition: Good overall

Catch basin overview

Component Detail Notes: Erosion causes settlement around the collar of catch basins. Left unrepaired, the entire catch basin will shift and need replacement.

- Annually:
 - Inspect and repair any settlement and collar cracks
 - Ensure proper drainage and inlets are free of debris
 - If property drainage is not adequate in heavy rainfall events, typically bi-annual cleaning of the catch basins is recommended

Expenditure Detail Notes: Expenditure timing and costs are depicted in the **Reserve Expenditures** table in Section 3. We recommend the Association plan for inspections and capital repairs to the catch basins in conjunction with repaving.

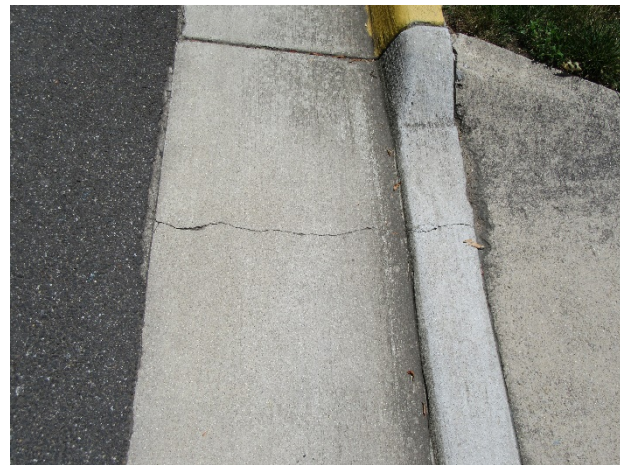
Condition: Good overall with isolated cracks and minor spalled concrete

Cracked concrete curb and gutter

- Annually:
 - Inspect and repair major cracks, spalls and trip hazards
 - Mark with orange safety paint prior to replacement or repair
 - Repair or perform concrete leveling in areas in immediate need of repair or possible safety hazard

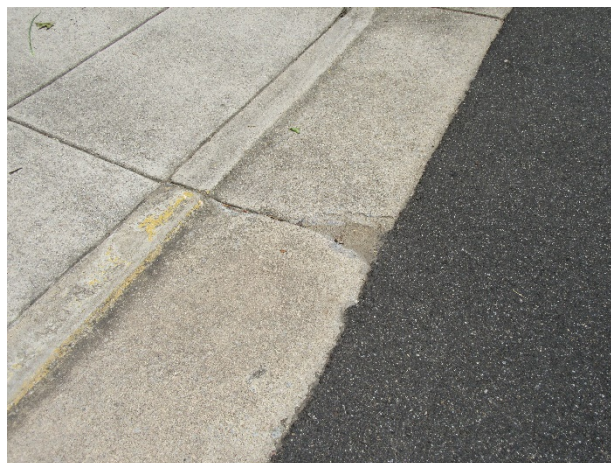
Minor spalled concrete gutter

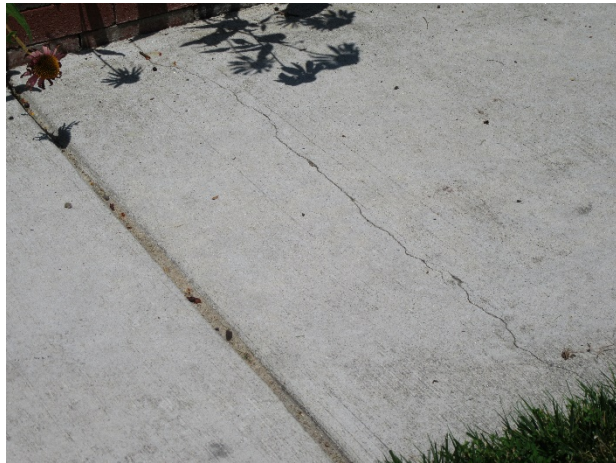
Condition: Good overall with isolated cracks and trip hazards

Isolated concrete sidewalk crack

- Annually:
 - Inspect and repair major cracks, spalls and trip hazards
 - Mark with orange safety paint prior to replacement or repair
 - Repair or perform concrete leveling in areas in immediate need of repair or possible safety hazard

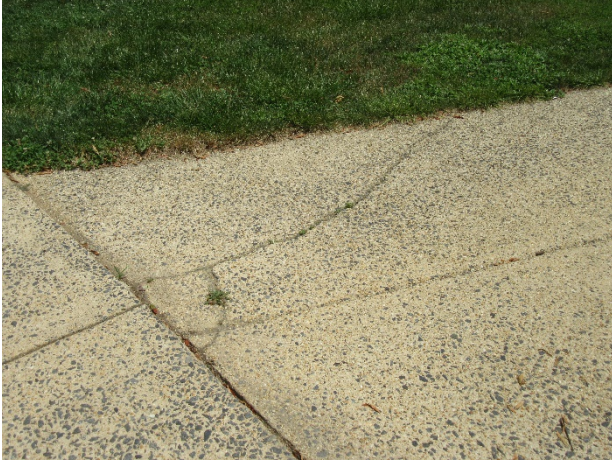
Concrete sidewalk crack

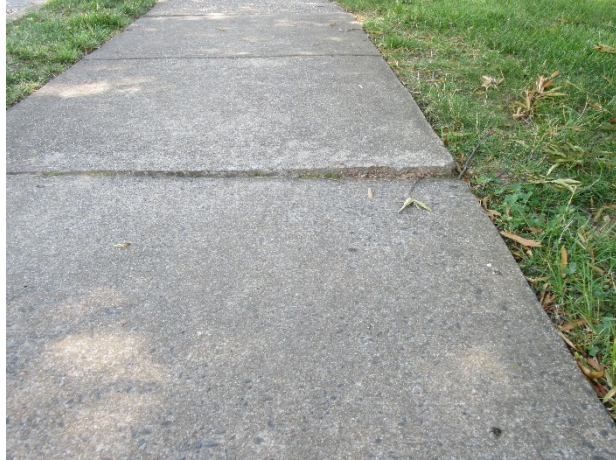
Trip hazard

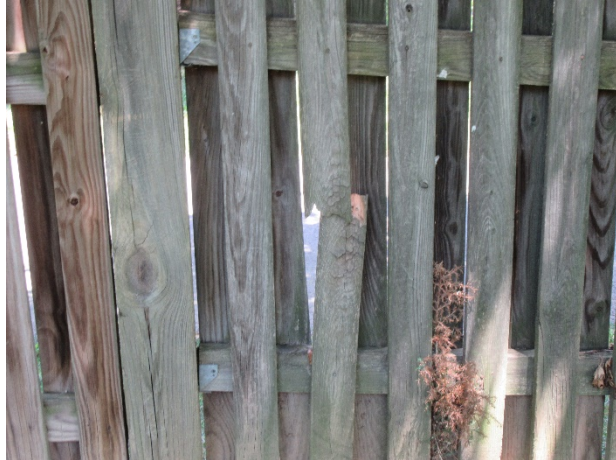
Condition: Good to fair overall condition with minor damage and deterioration evident

Damage to wood fence

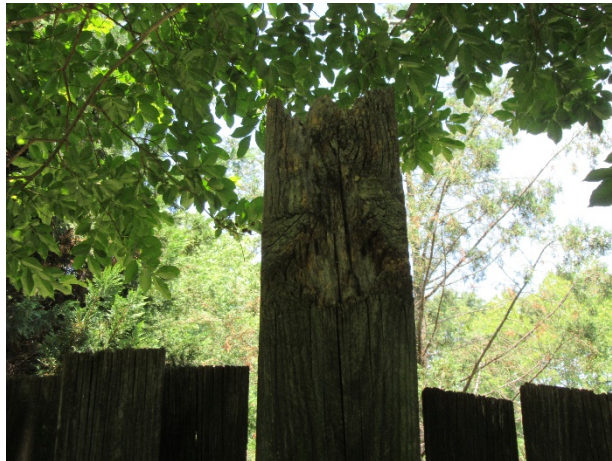
Wood deterioration

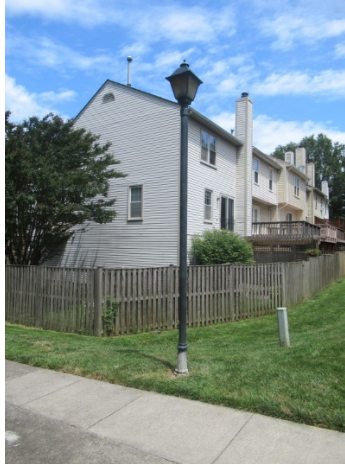
Condition: The light poles and fixtures are in fair overall condition with finish deterioration. The electrical trenches are reported in satisfactory condition.

Light pole and fixture overview – Note: finish deterioration

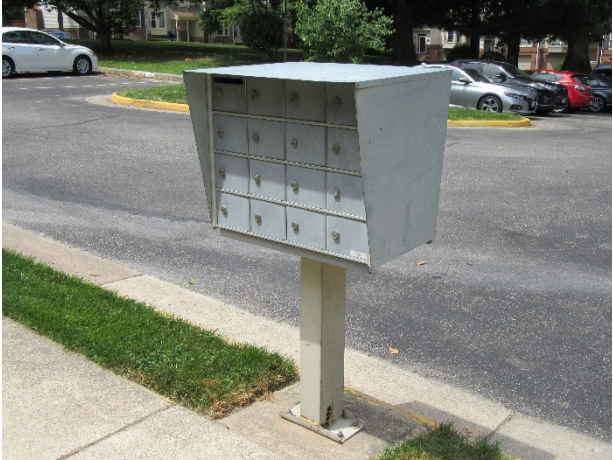
Condition: The stations replaced in 2020 are in good condition, the station replaced in 2006 is in good to fair condition and the original stations are in fair to poor condition with rust and finish deterioration evident.

Mailbox station overview – Note: original station

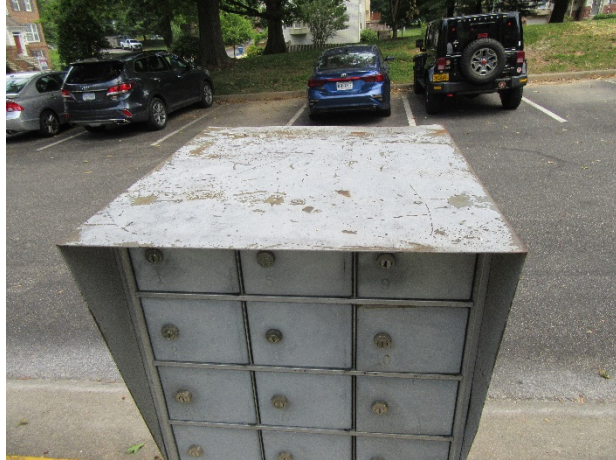
Finish deterioration and rust – Note: original station

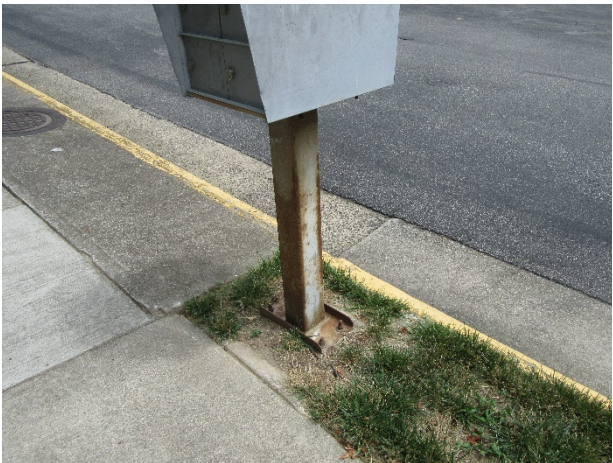
Mailbox station rust – Note: original station

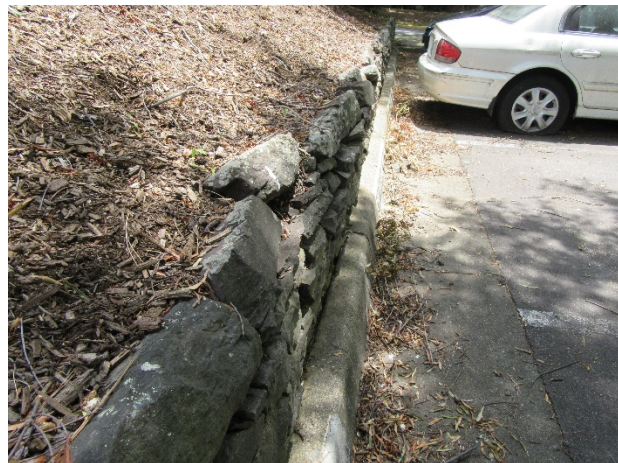
Condition: Good to fair overall

Stone displacement and minor bulging

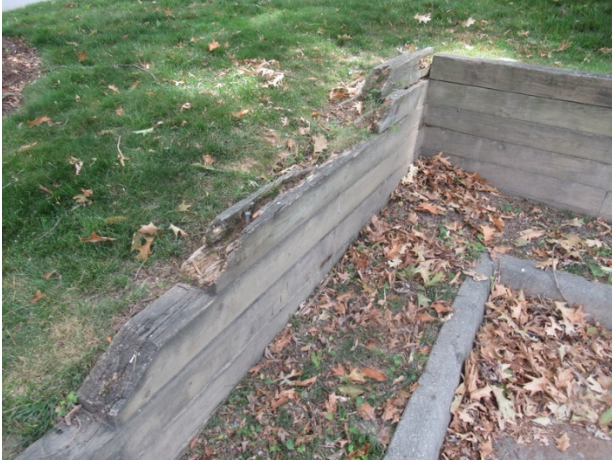
Condition: Fair overall with wood rot and damage evident

Timber retaining wall at Peter Roy Court overview – Note: wood rot and damage

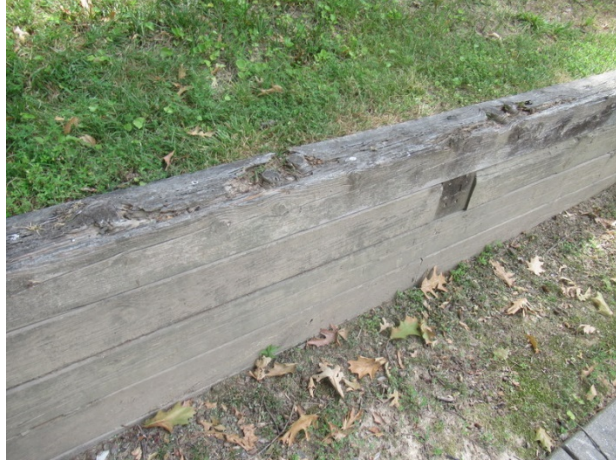
Timber retaining wall at Peter Roy Court overview – Note: wood rot

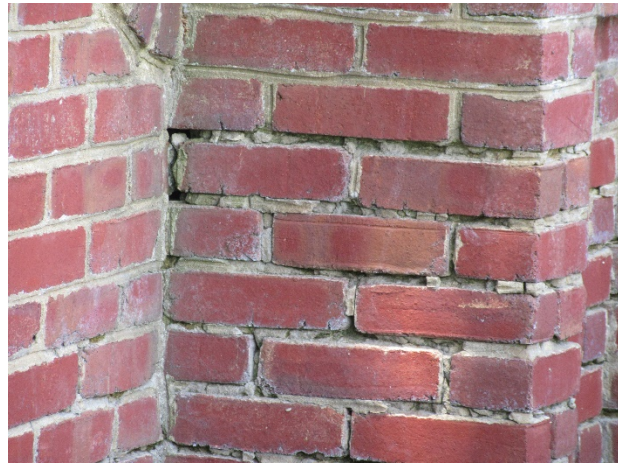
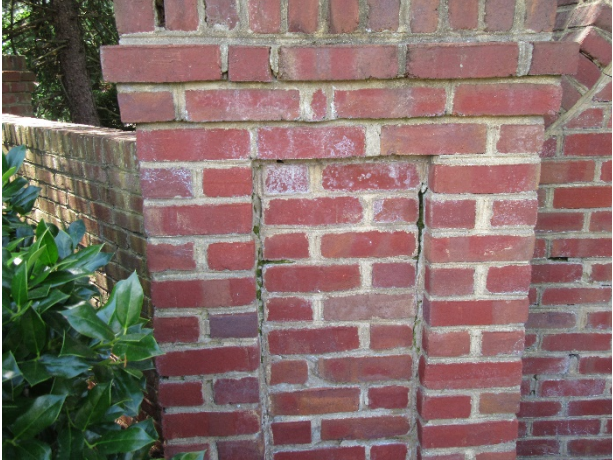
Condition: Fair to poor overall with mortar deterioration, efflorescence, step cracks and damage evident

Mortar deterioration and efflorescence

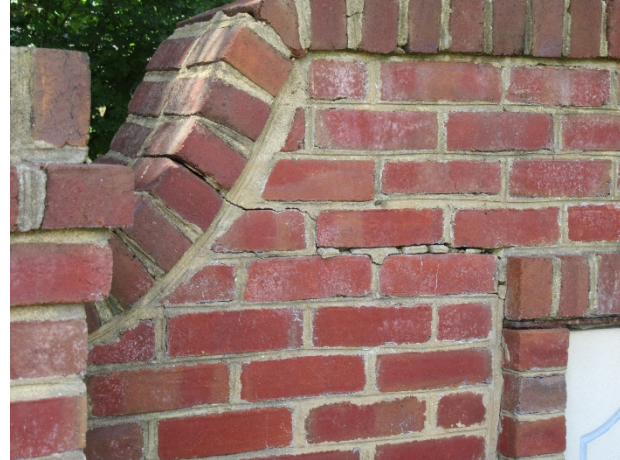
Step cracking

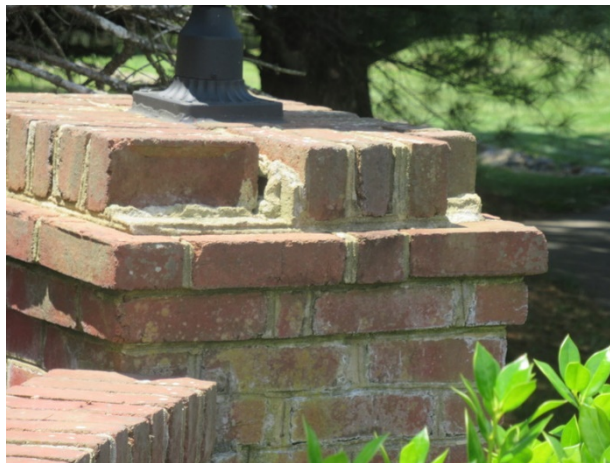
Damaged section
