BALL MILL GEARBOX PROBLEM

Barry T. Cease

Cease Industrial Consulting

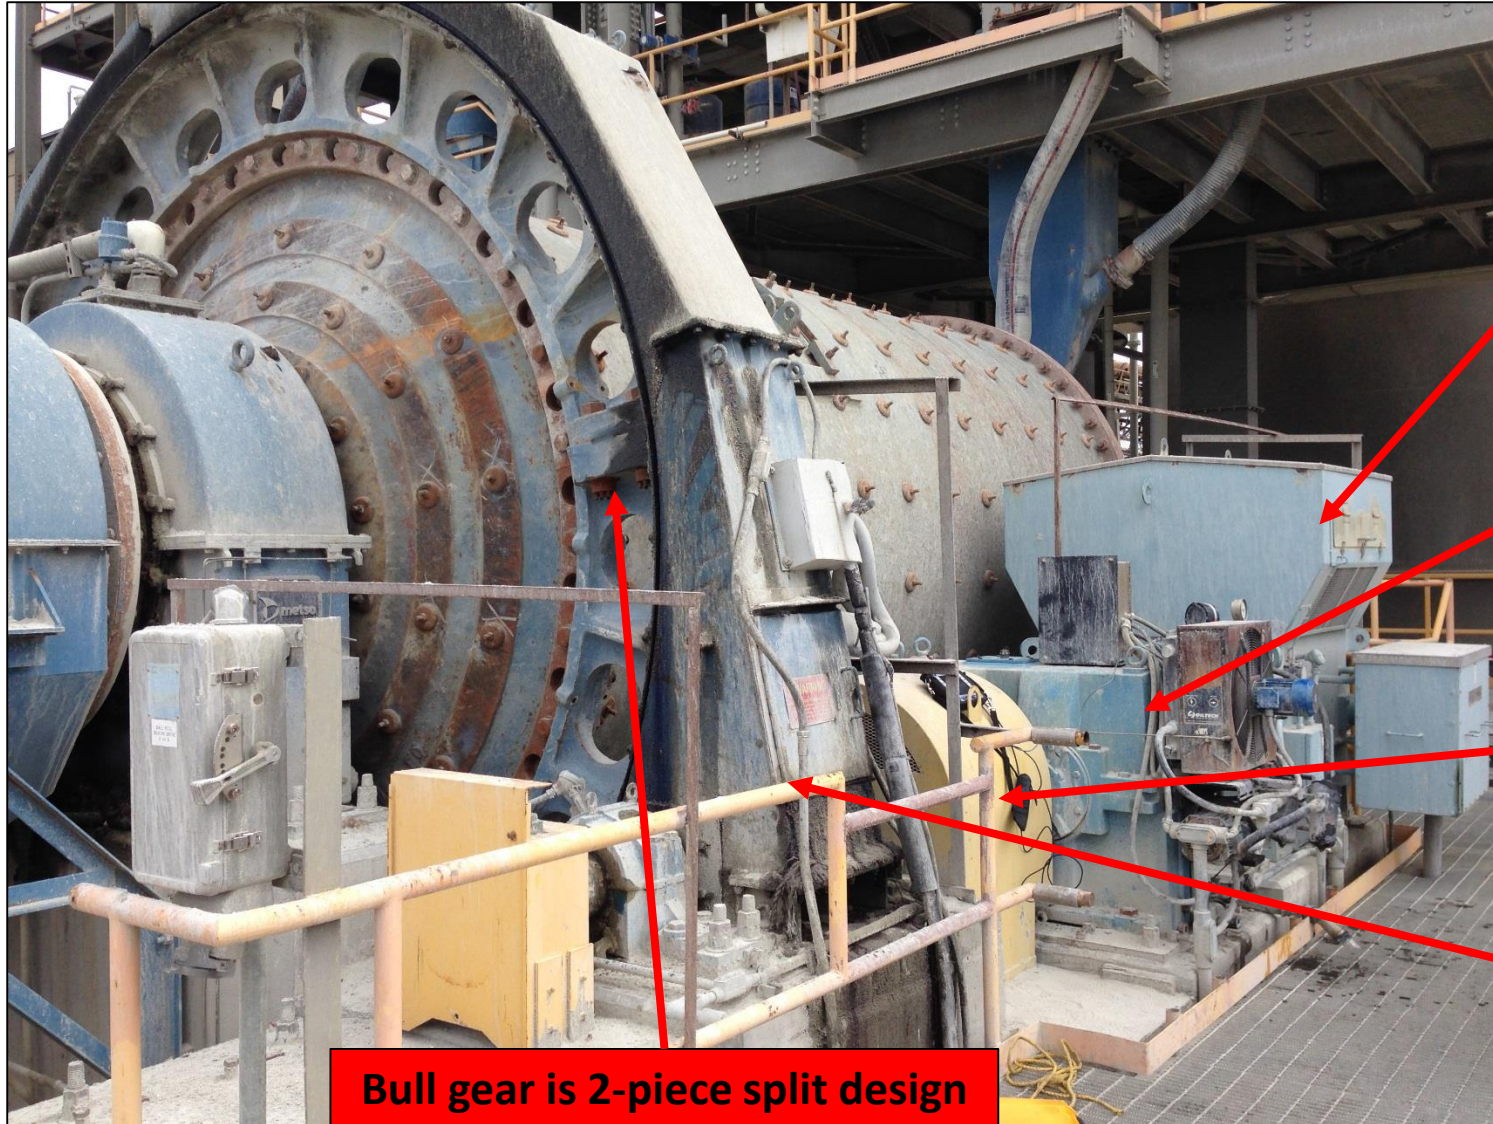
Photo Of Ball Mill

Motor @ 1,191 rpm

**Parallel Gearbox with
1,191 rpm input &
226 rpm output.
Helical gears.**

**Clutch between gearbox &
ball mill**

**Ball Mill @ 226 rpm pinion
gear & 18 rpm bull gear.
Helical gears.**

Bull gear is 2-piece split design

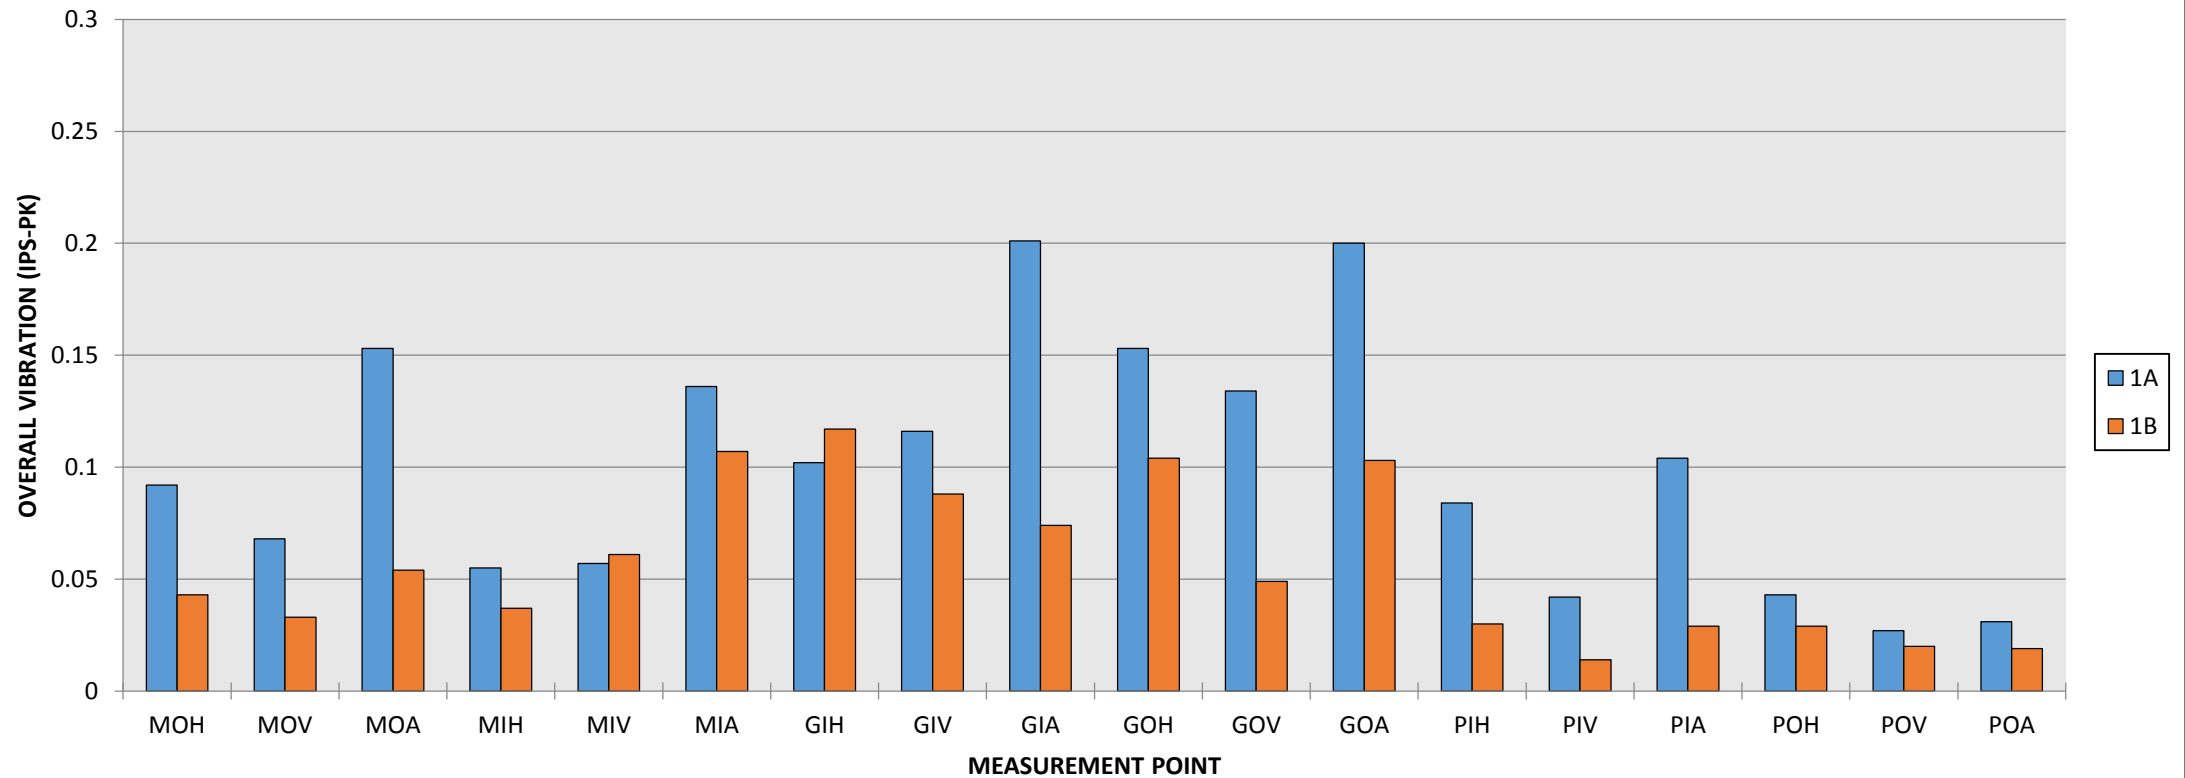
BALL MILL DRIVES, LOADED, OVERALL VIBRATION, SEPTEMBER

- Above is a plot of the overall vibration levels at both the 1A & 1B ball mills when loaded.
- Note how levels at 1A ball mill are higher than that at 1B ball mill for nearly every measurement.

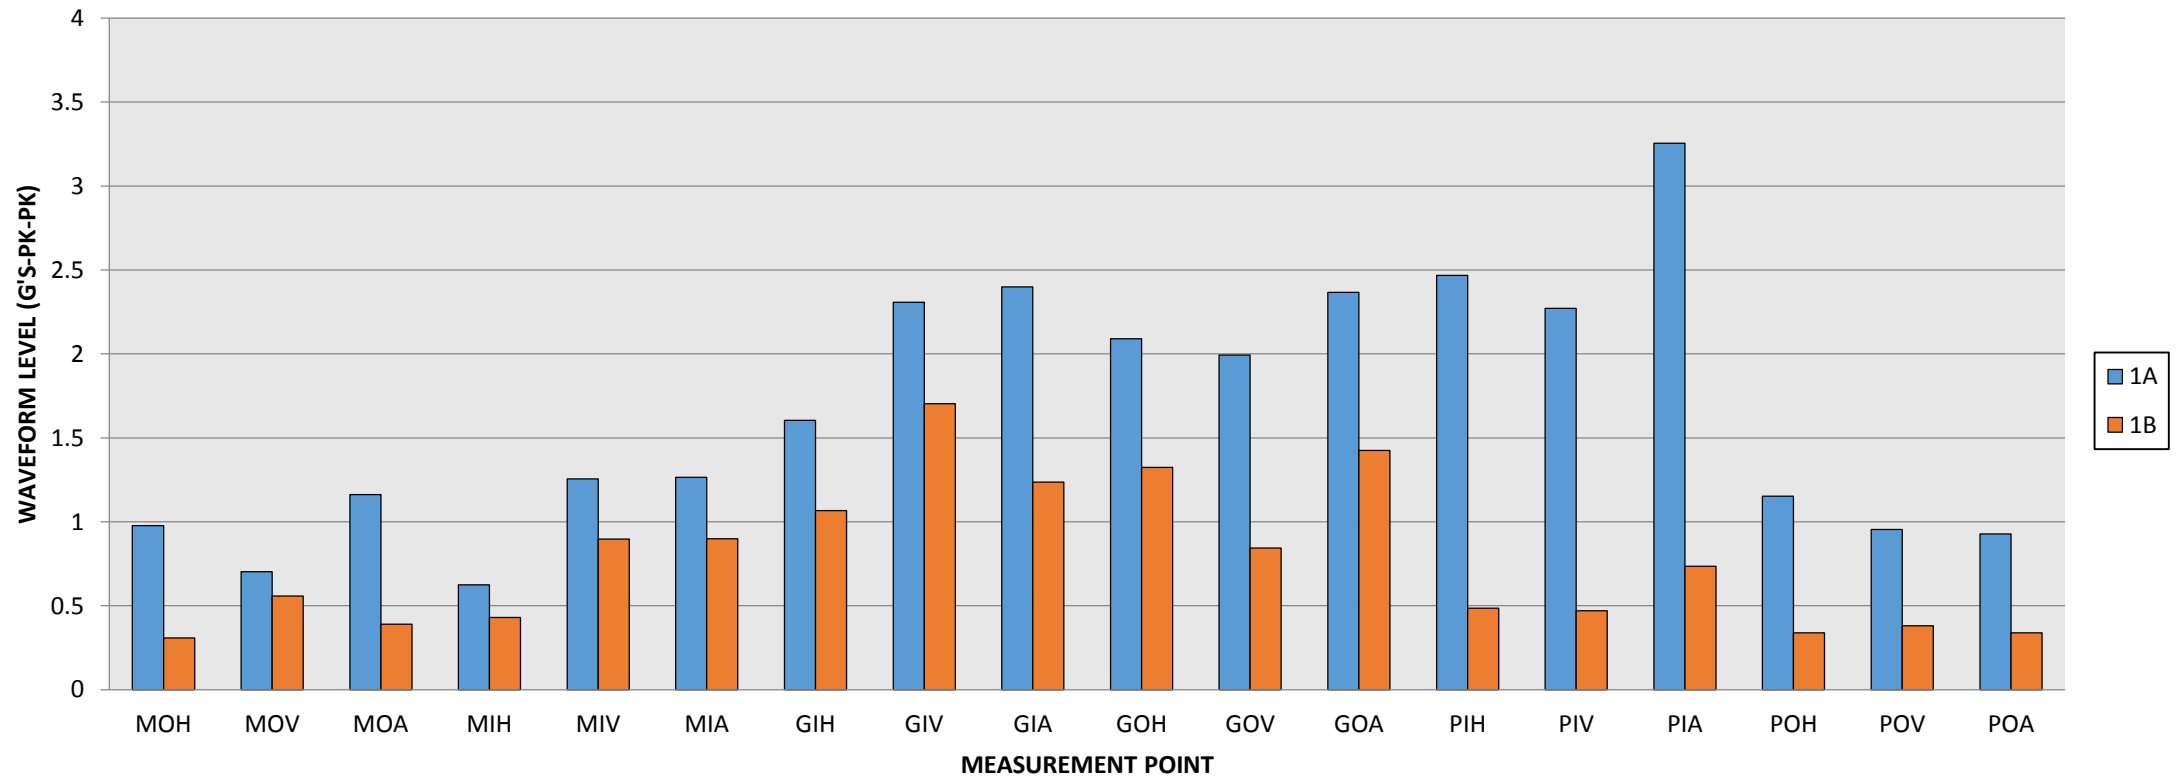
BALL MILL DRIVES, LOADED, WAVEFORM LEVELS, SEPTEMBER

- Above is a plot of the waveform vibration levels at both the 1A & 1B ball mills when loaded (acceleration).
- Note how waveform levels at 1A ball mill are higher than that at 1B ball mill for every measurement and especially at points PIH → PIA (pillow block, coupling-end bearing).

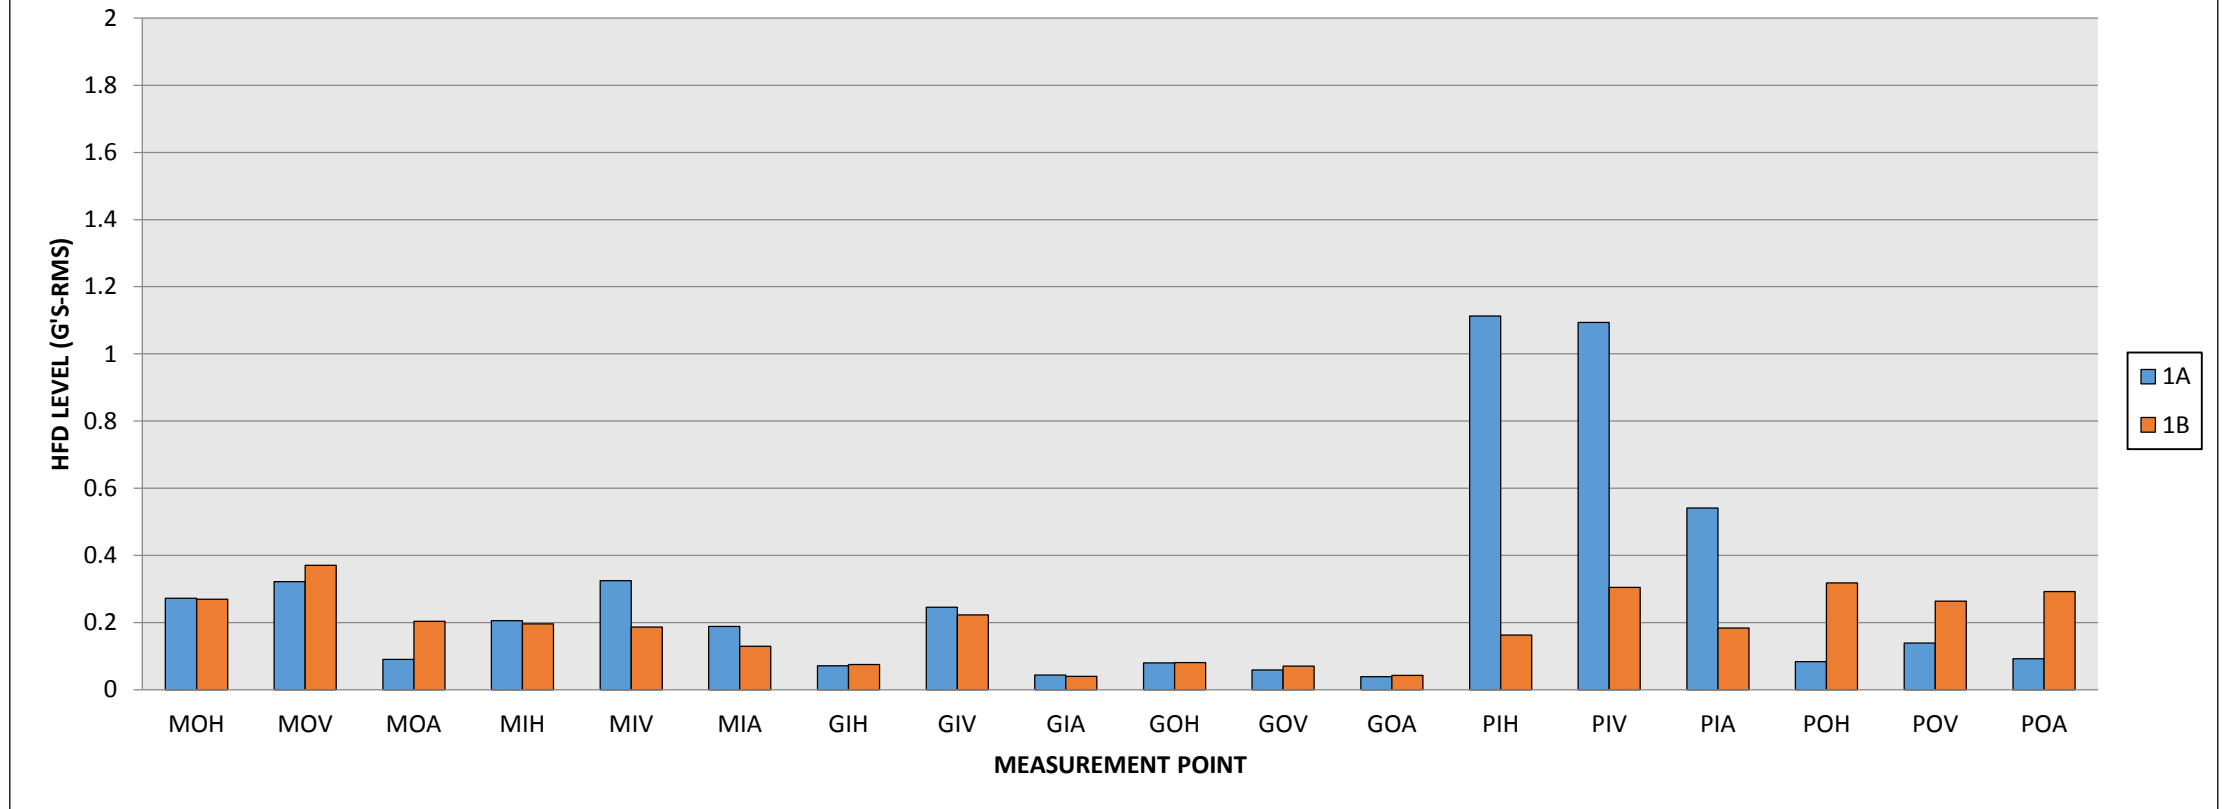
BALL MILL DRIVES, LOADED, HFD LEVELS, SEPTEMBER

- Above is a plot of the high frequency HFD vibration levels at both the 1A & 1B ball mills when loaded (acceleration energy band from 2 to 20 kHz).
- Note how HFD levels at 1A ball mill coupling-end pillow block bearing (PIH → PIA) are much higher than that at 1B ball mill.

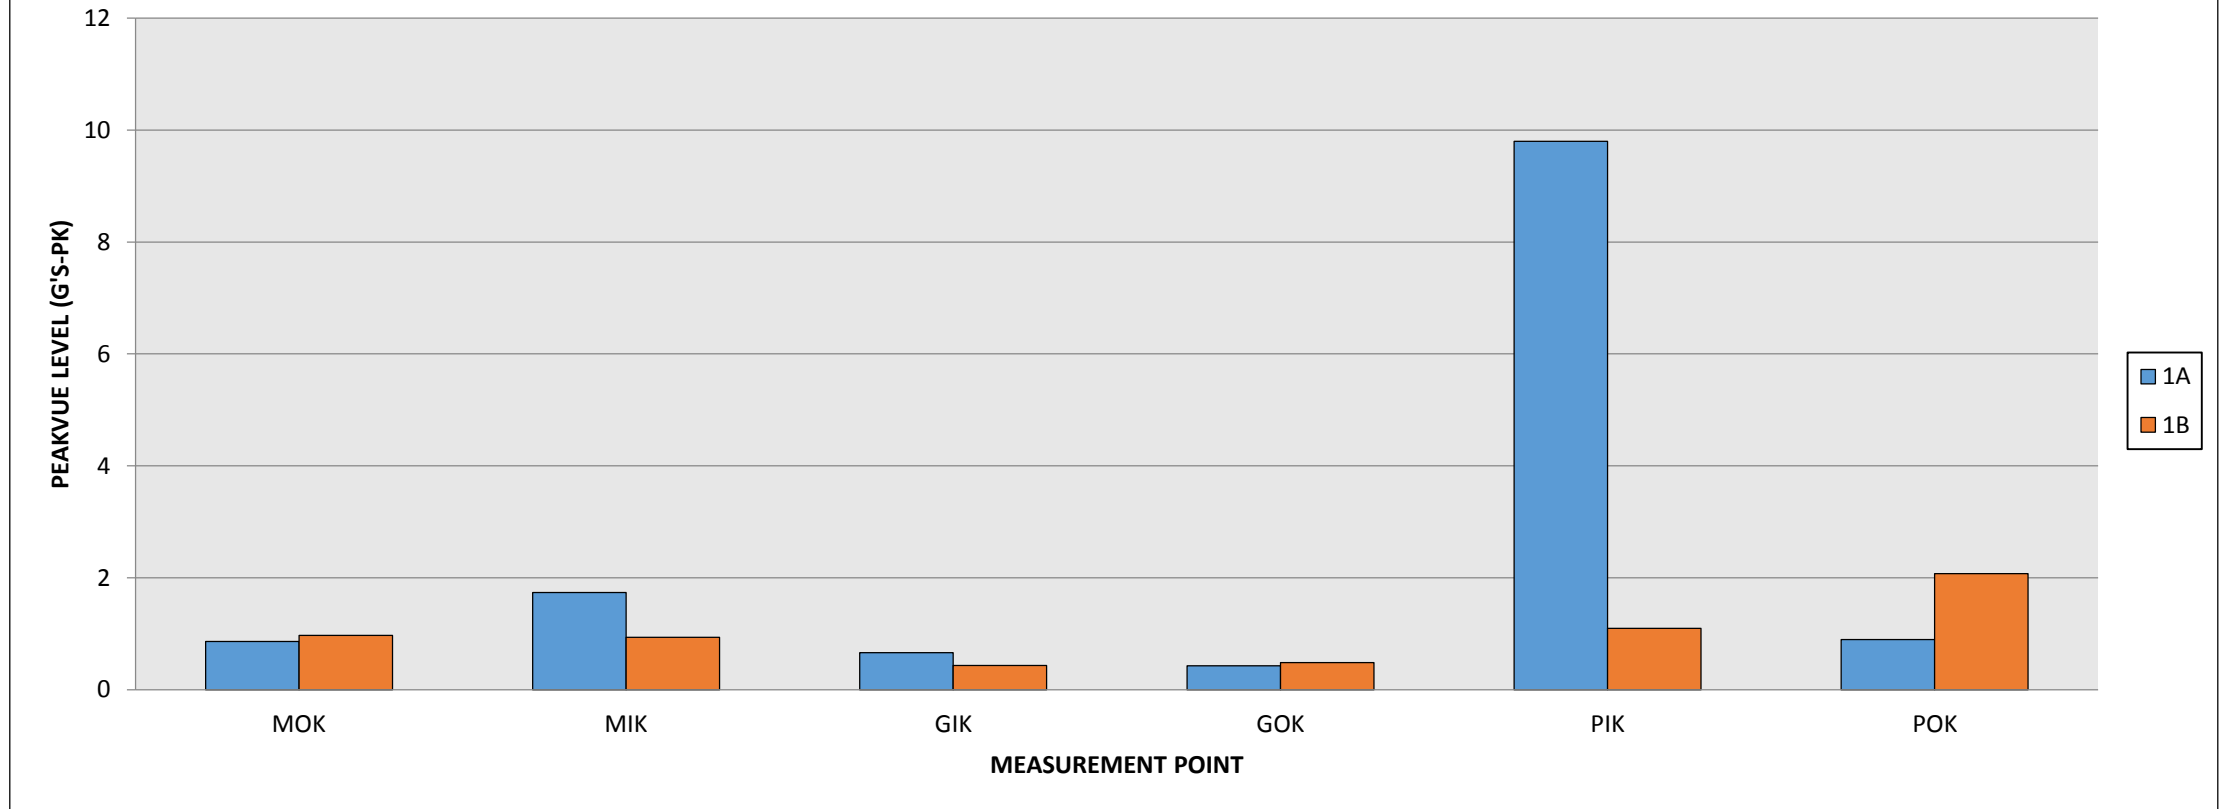
BALL MILL DRIVES, LOADED, PEAKVUE LEVELS, SEPTEMBER

- Above is a plot of the high frequency Peakvue levels at both the 1A & 1B ball mills when loaded.
- Like the earlier HFD levels, note how the Peakvue levels at 1A ball mill coupling-end pillow block bearing (PIK) are much higher than that at 1B ball mill.

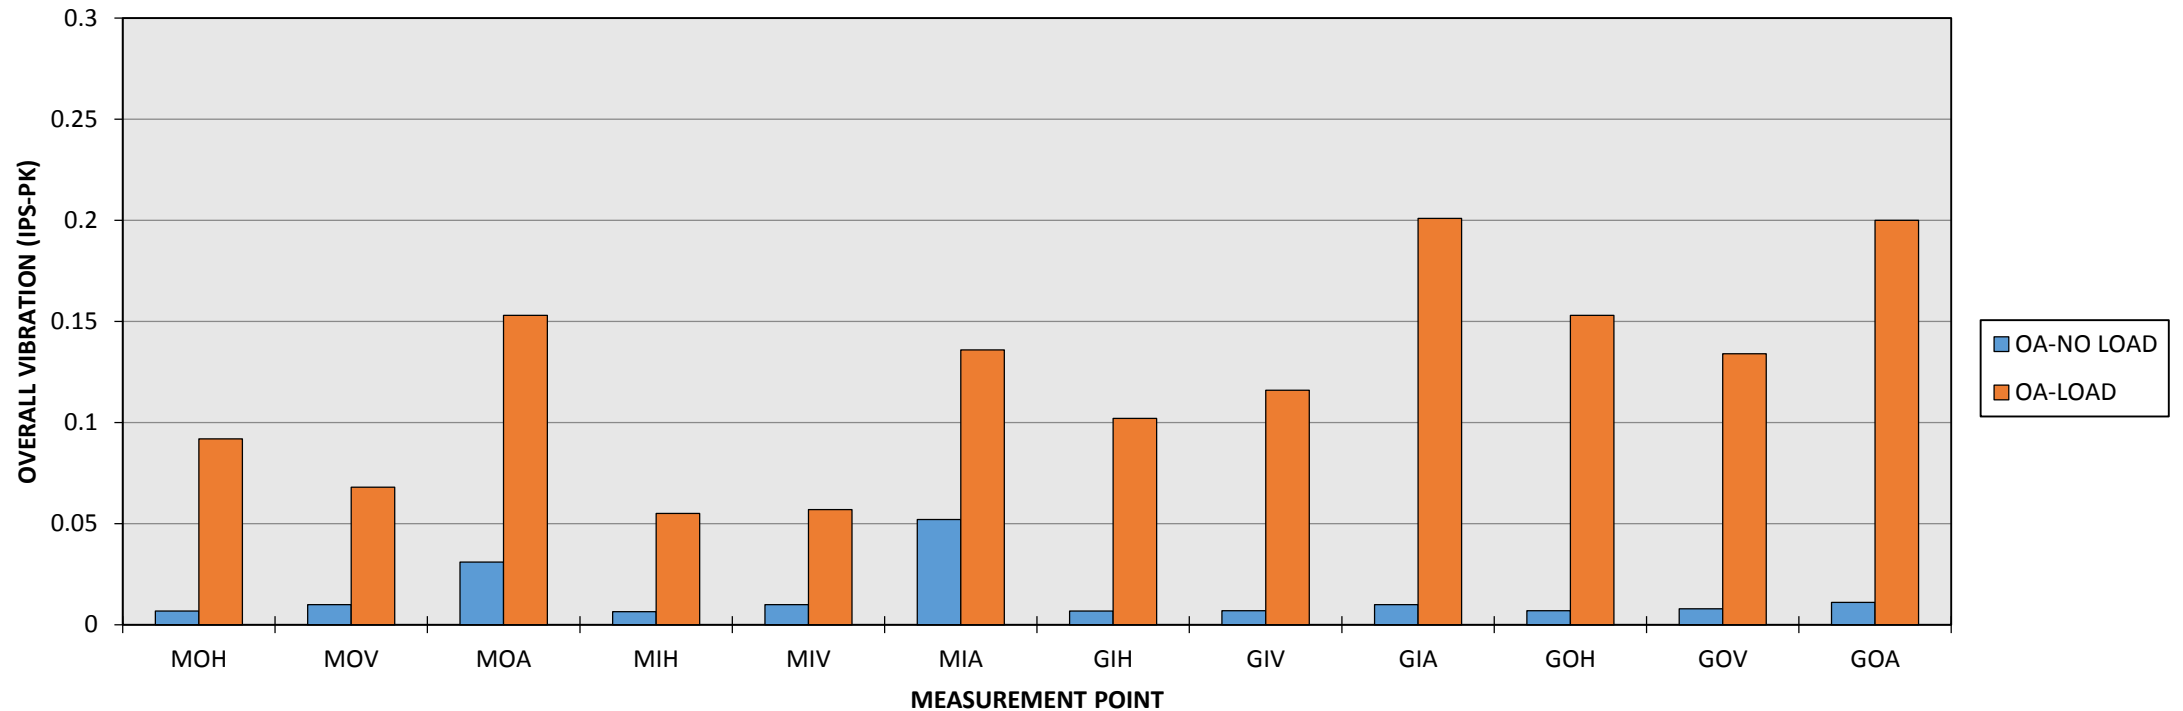
1A BALL MILL, OVERALL VIBRATION, LOADED VS UNLOADED, SEPTEMBER 2010

- Above is a plot of the overall vibration levels at 1A ball mill when loaded & unloaded.
- Note the significant difference that loading makes on vibration levels at this machine.
- The presence and absence of vibration at the ball mill gear-mesh frequency and multiples explain most of this difference between loaded & unloaded levels.

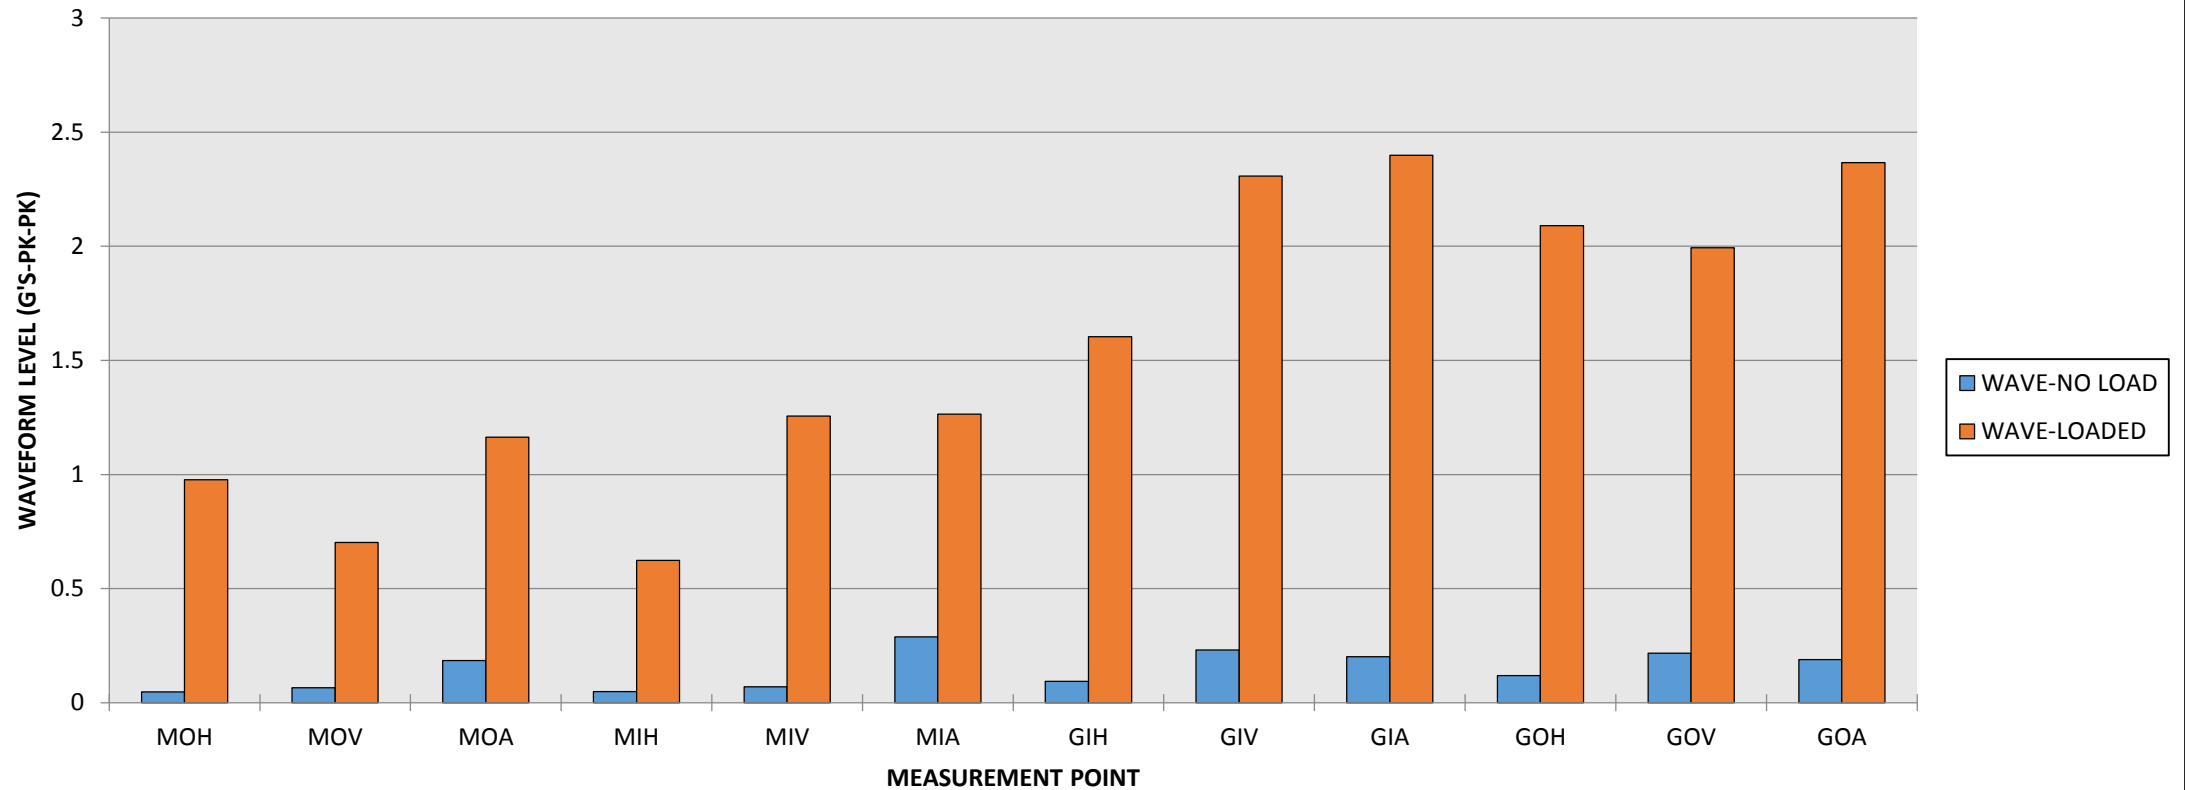
1A BALL MILL, WAVEFORM LEVEL, LOADED VS UNLOADED, SEPTEMBER 2010

- Above is a plot of the waveform vibration levels at 1A ball mill when loaded & unloaded.
- Note the significant difference that loading makes on vibration levels at this machine.
- The presence and absence of vibration at the ball mill gear-mesh frequency and multiples explain most of this difference between loaded & unloaded levels.

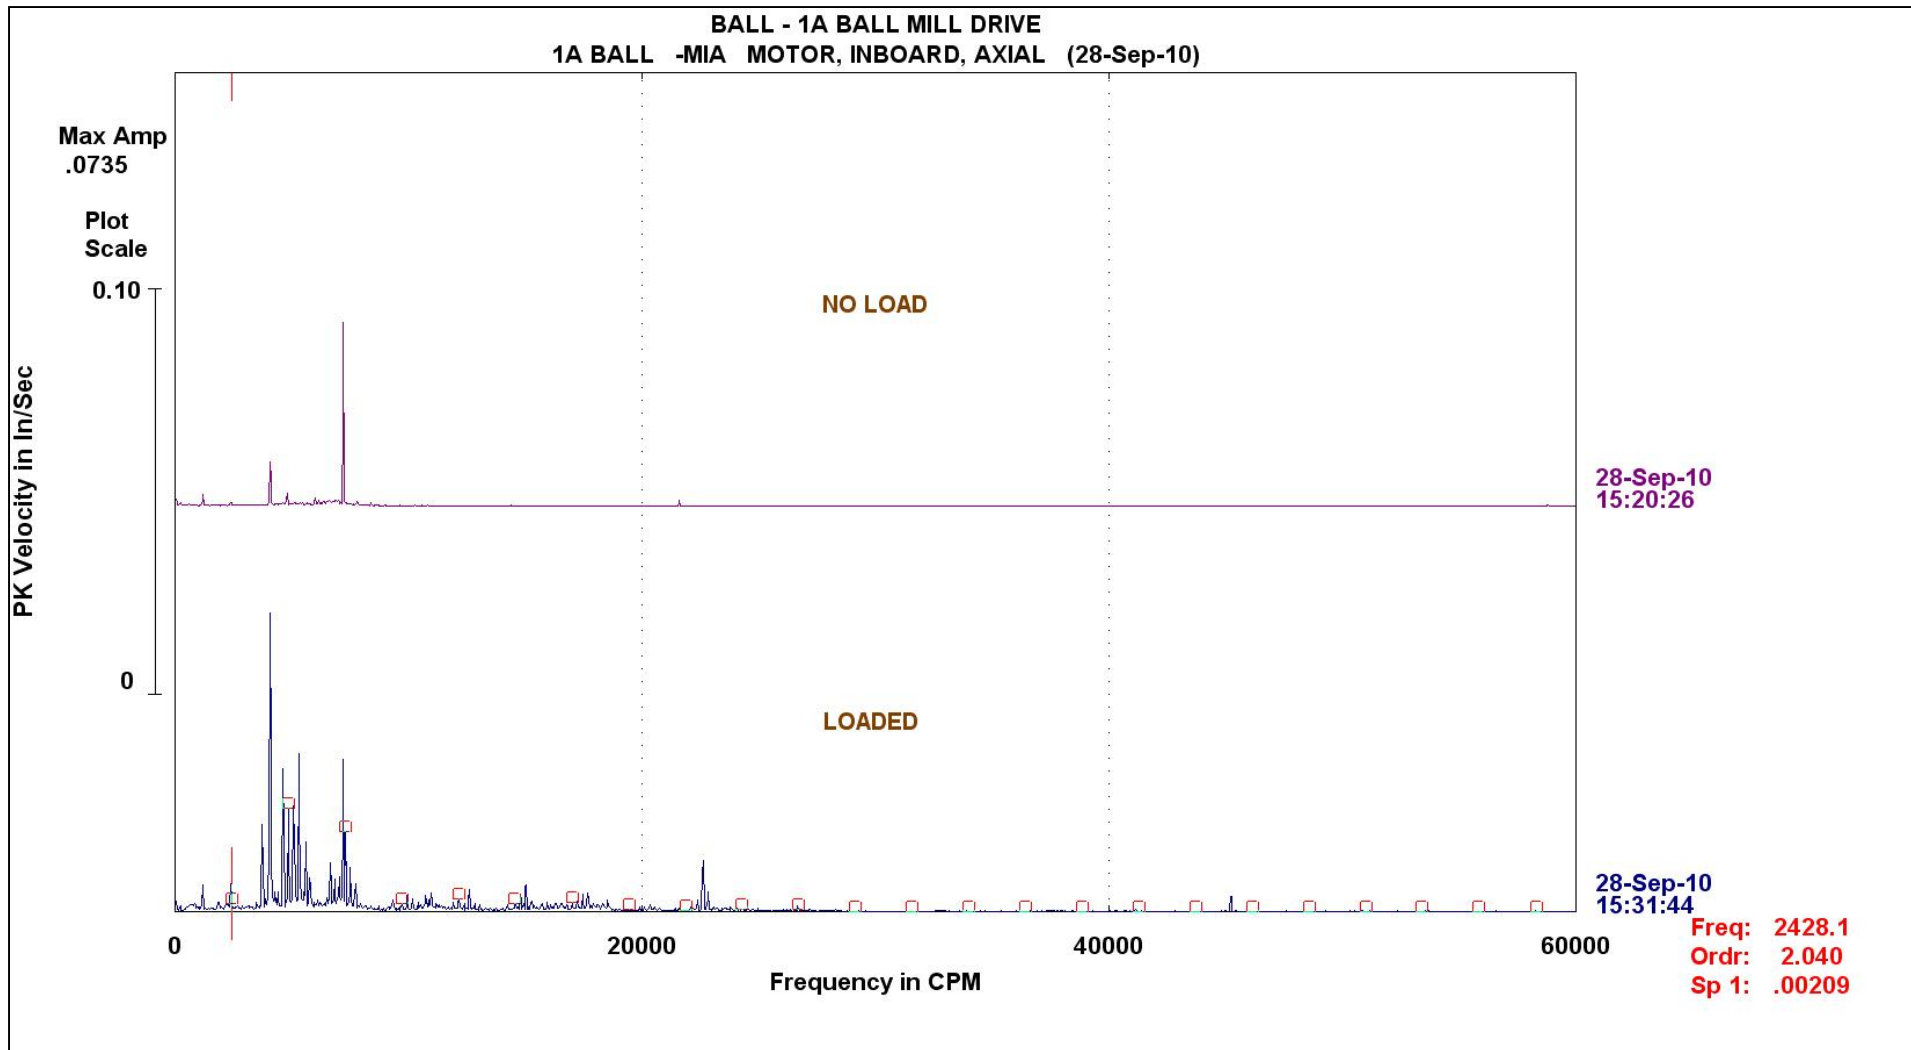
- As this motor operates on sleeve bearings, it is very doubtful that this vibration originates from the motor. It is much more likely being transmitted to the motor from the ball mill pillow block bearings.

- Above is spectral data from 1A ball mill when loaded & unloaded (motor, inboard, axial).
- Note how loading introduced much higher vibration levels composed of multiples of vibration at 2,428 cpm which is 10.74x the output speed of the gearbox (226 rpm) which is a perfect match for the inner race defect frequency of the pillow block spherical roller bearings.

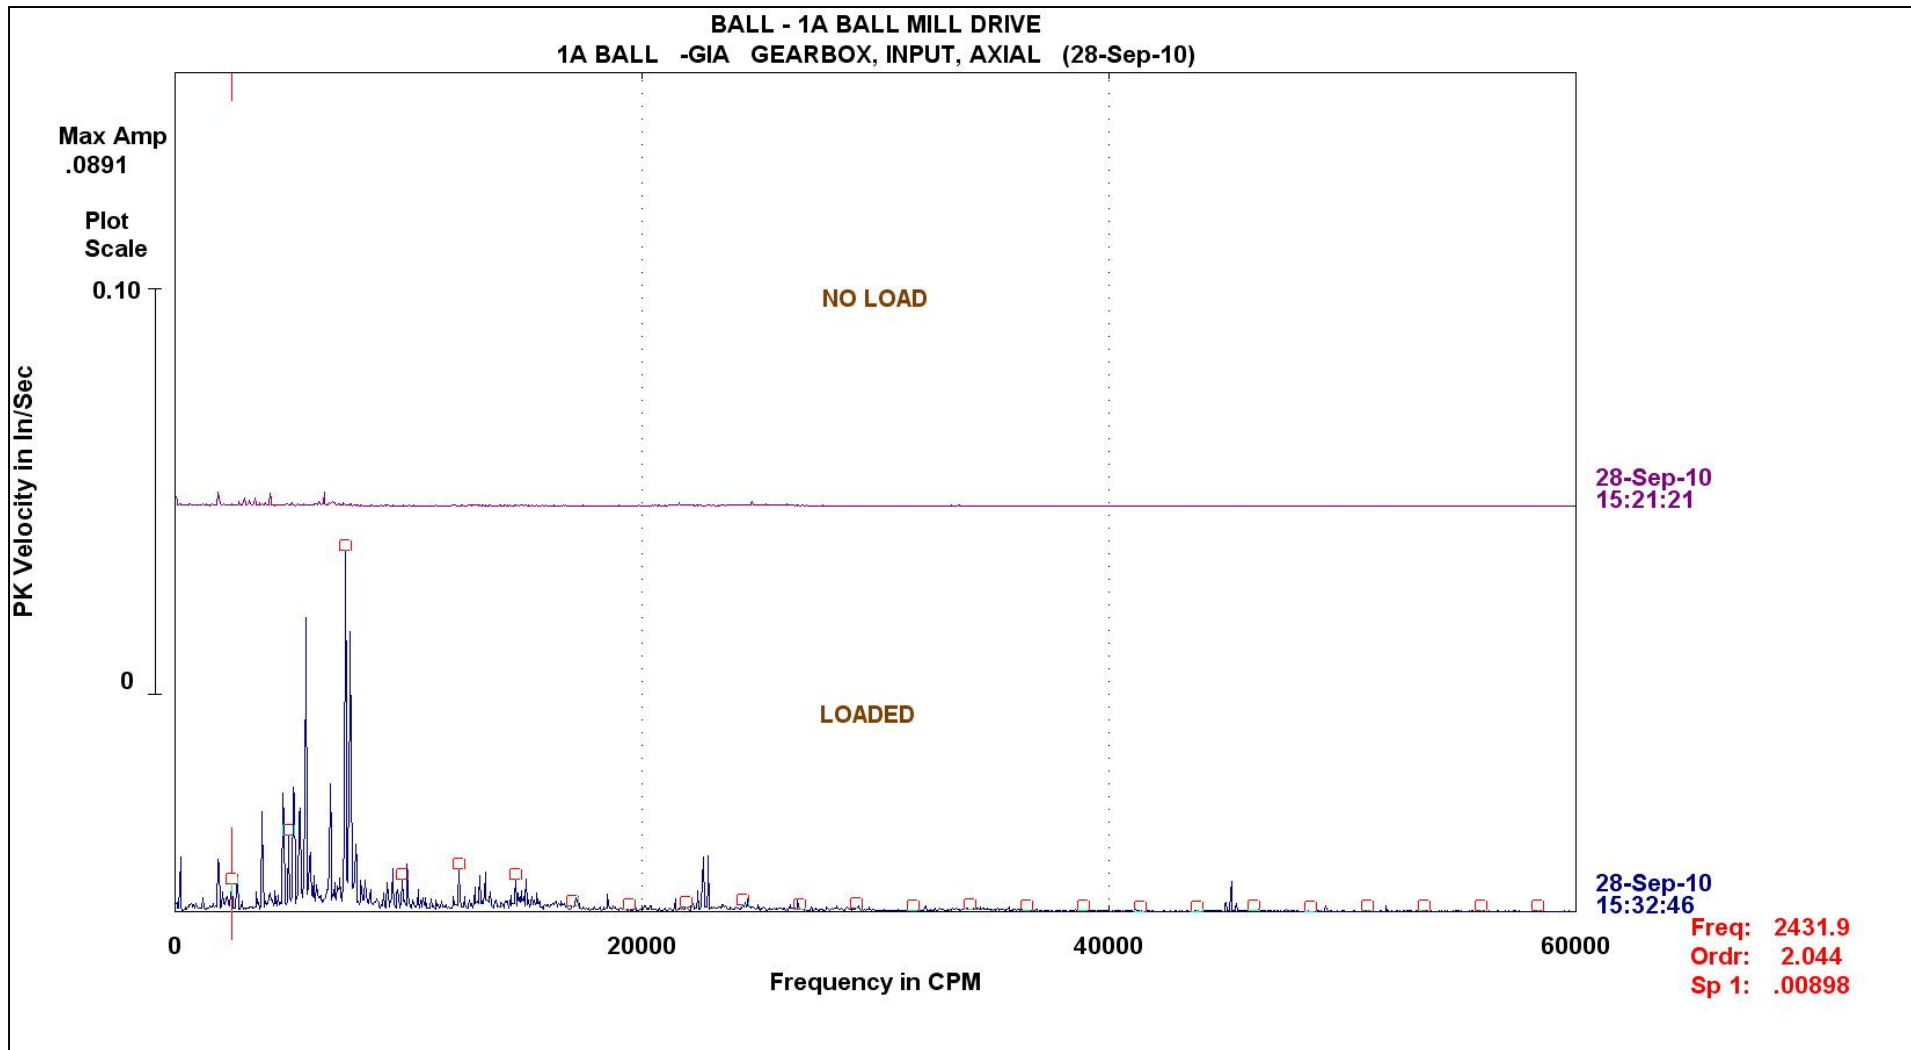
If this vibration originated from the gearbox, some level of vibration at these frequencies would be expected even from unloaded data. It is likely being transmitted from the inboard pillow block bearing thru the clutch & base to the gearbox.

- Above is spectral data from 1A ball mill when loaded & unloaded (gearbox, input, axial).
- Note how loading introduced much higher vibration levels composed of multiples of vibration at 2,428 cpm which is 10.74x the output speed of the gearbox (226 rpm) which is a perfect match for the inner race defect frequency of the pillow block spherical roller bearings.

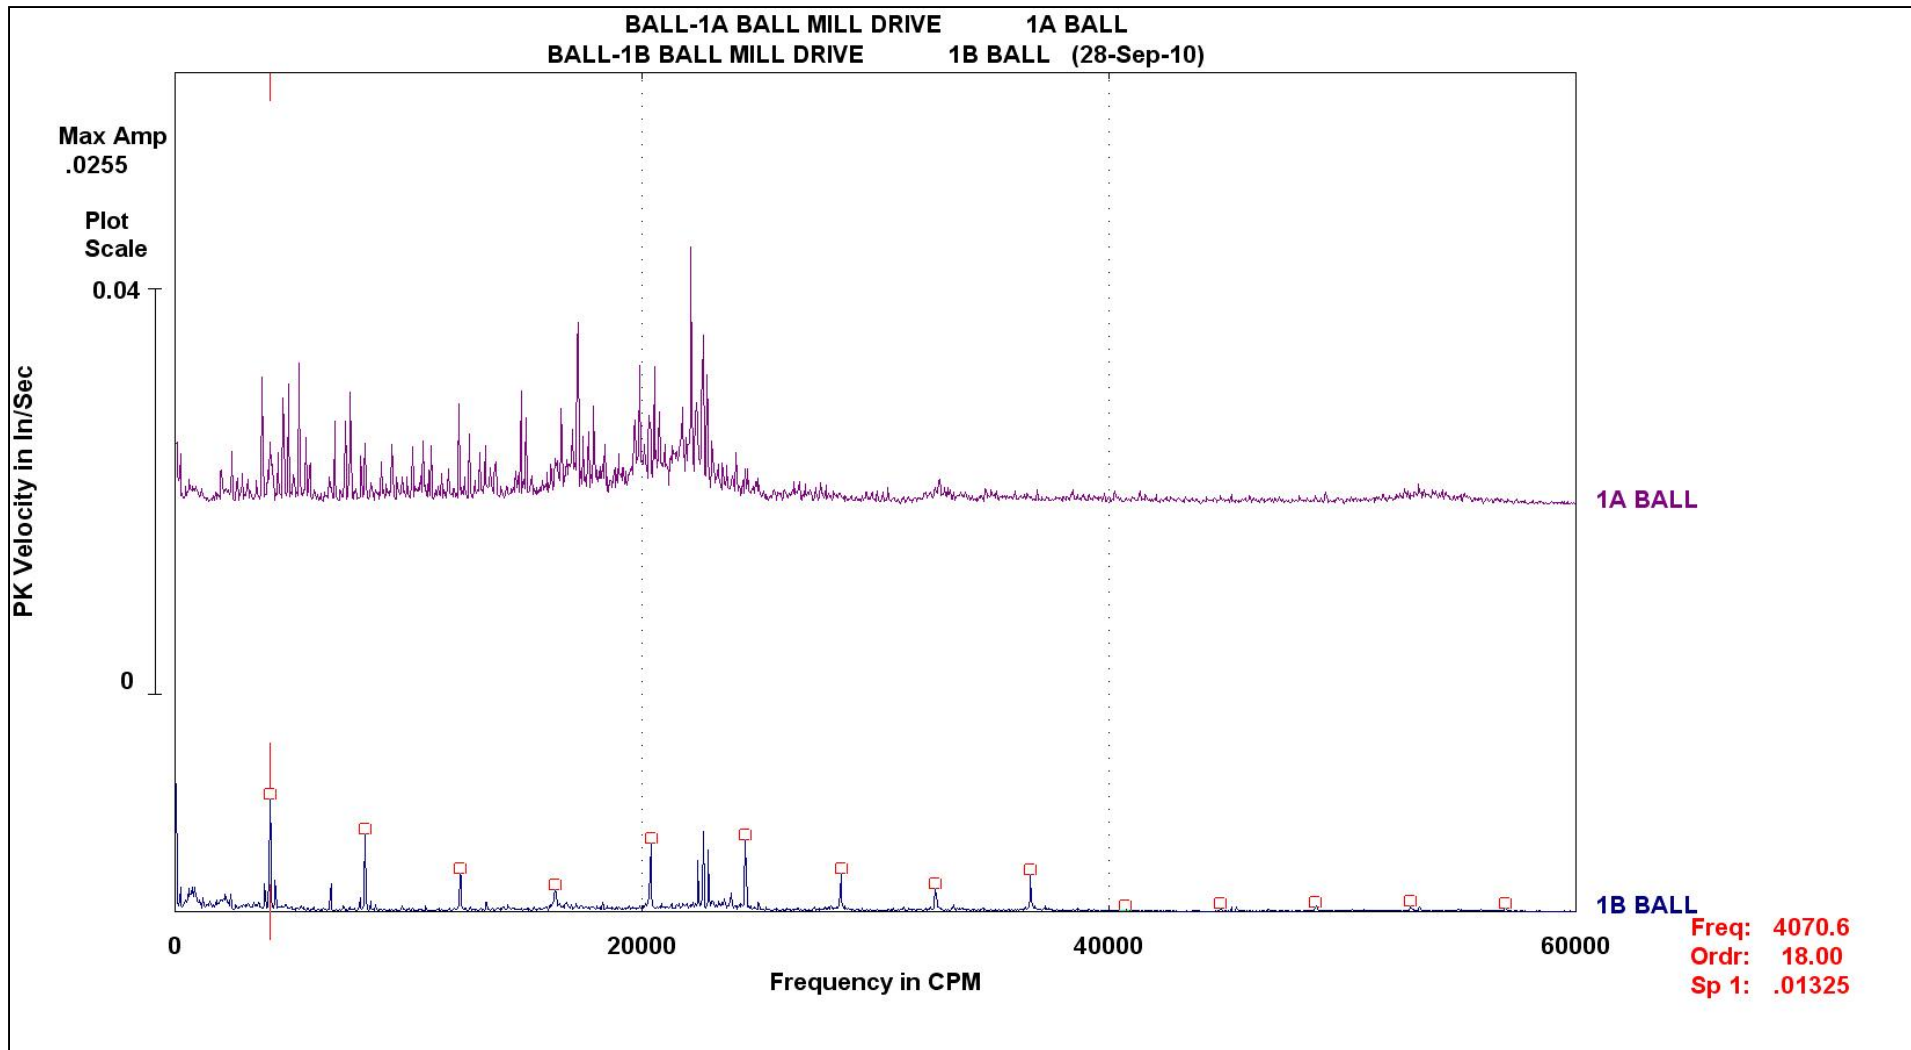
- Data from 1A shows a great amount of noise & low frequency peaks, while data from 1B shows the expected vibration at the ball mill gearmesh frequency & multiples (18x rpm).

- Above is spectral data from both 1A & 1B ball mills when loaded (ball mill pillow block bearing, inboard, axial).
- Note the great difference in spectral pattern between these two data sets. As they were taken from similar machines under similar conditions of speed & load, we would expect similar spectral patterns – this is not the case.

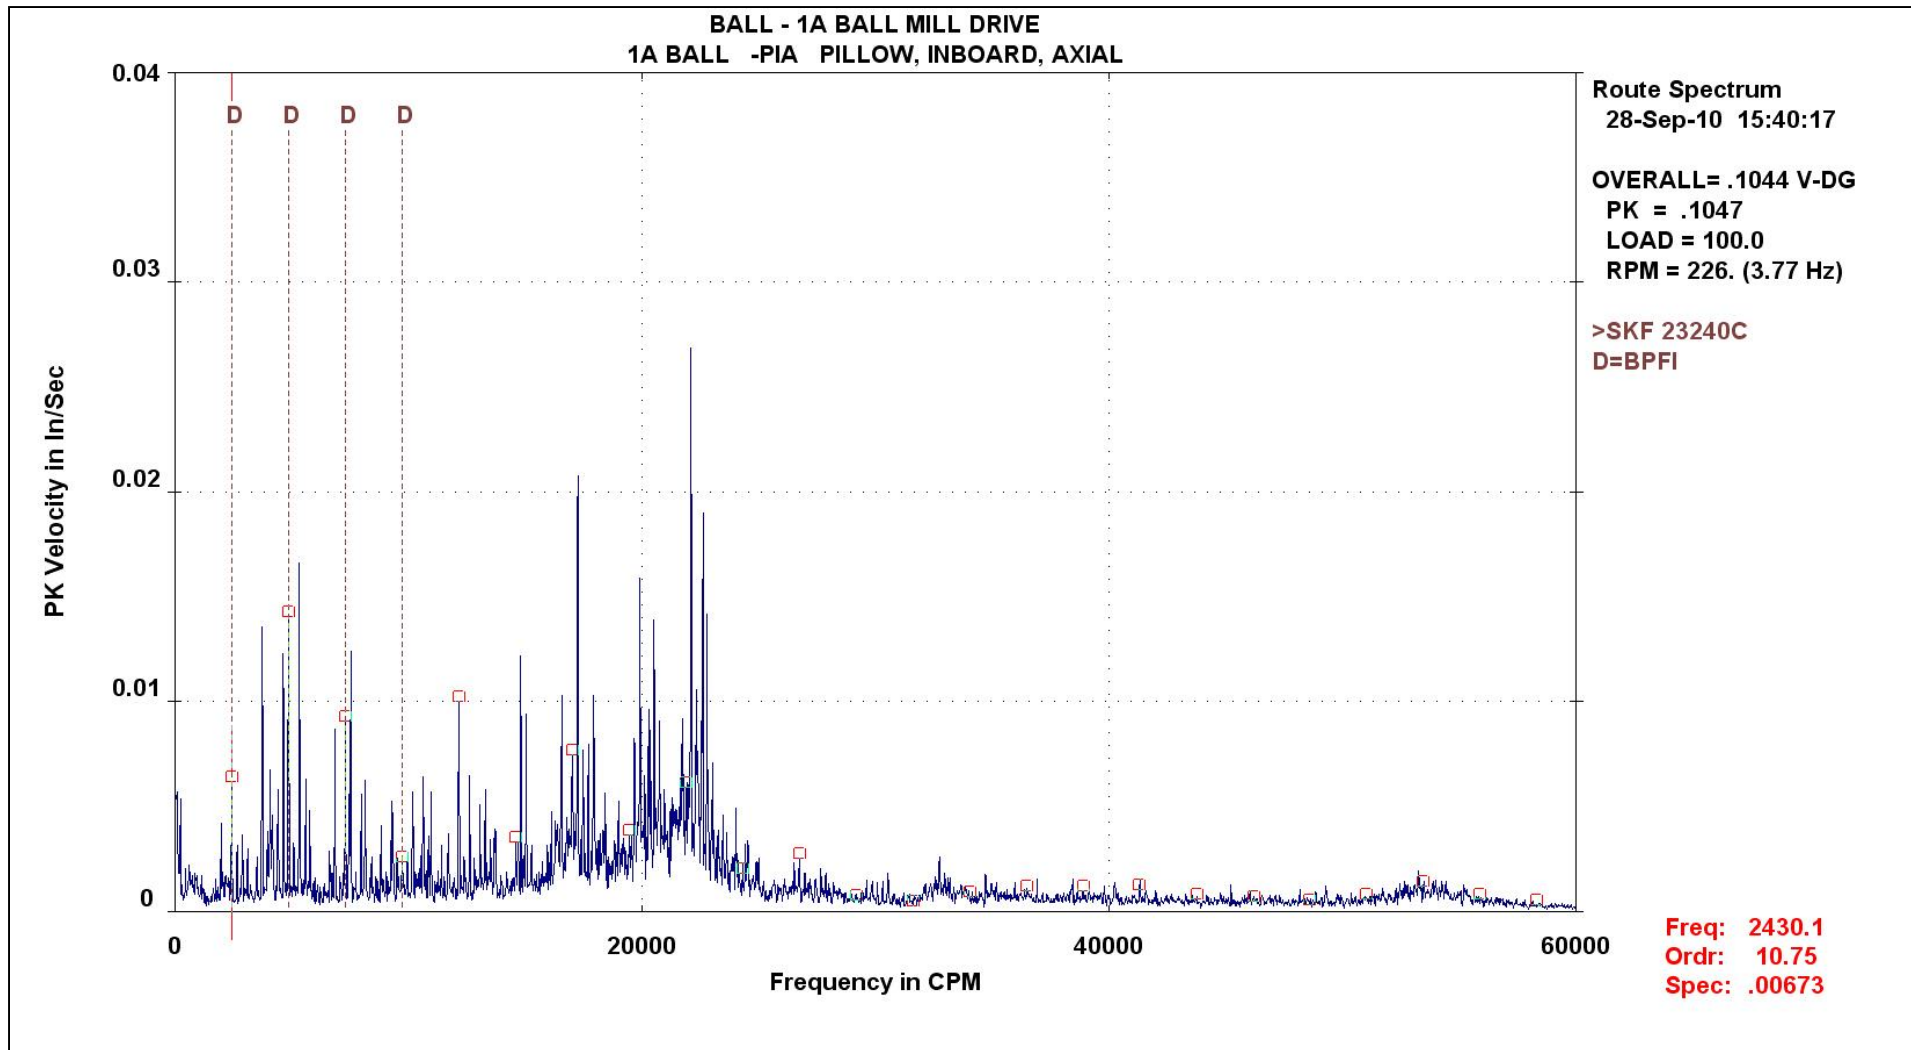
- Above is spectral data from 1A ball mill when loaded (ball mill pillow block bearing, inboard, axial).
- Note that dominant vibration occurs at multiples of the inner race defect frequency (2,430 cpm) for this SKF#23240 spherical roller bearing (19 rollers). Vibration at multiples of the outer race defect frequency (1,865 cpm) were also seen in the data.

- 1) As high frequency vibration levels were much higher at the inboard pillow block bearing of 1A versus 1B Ball Mill, a problem of some sort is expected at 1A inboard bearing.
- 2) As vibration spectra from 1A inboard pillow block bearing showed dominant vibration occurring at multiples of both the inner and outer race defect frequencies expected from that SKF#23240 spherical roller bearing, a significant fault is expected at that bearing.
- 3) As high frequency Peakvue vibration measurements are a clear maximum at 1A inboard pillow block bearing and drop off dramatically when we move to either the gearbox output or outboard pillow block bearing, no significant problems are expected at either the gearbox or outboard pillow block bearings at this time.
- 4) The unloaded versus loaded vibration data suggest the source of the problem does not lie at either the motor or gearbox.

- 1) To avoid unscheduled downtime and further damage to the machinery, have both pinion pillow block bearings changed ASAP. Although vibration shows no significant problems at the outboard pillow block bearing at this time, due to their common installation date, and thus common operating hours, changing both bearings would be wise.
- 2) Conduct follow-up vibration & temperature measurements after work is completed to ensure no installation problems occurred as well as to double-check against any smaller problems at the gearbox or motor.
