BALL MILL GEARBOX PROBLEM

Barry T. Cease

Cease Industrial Consulting

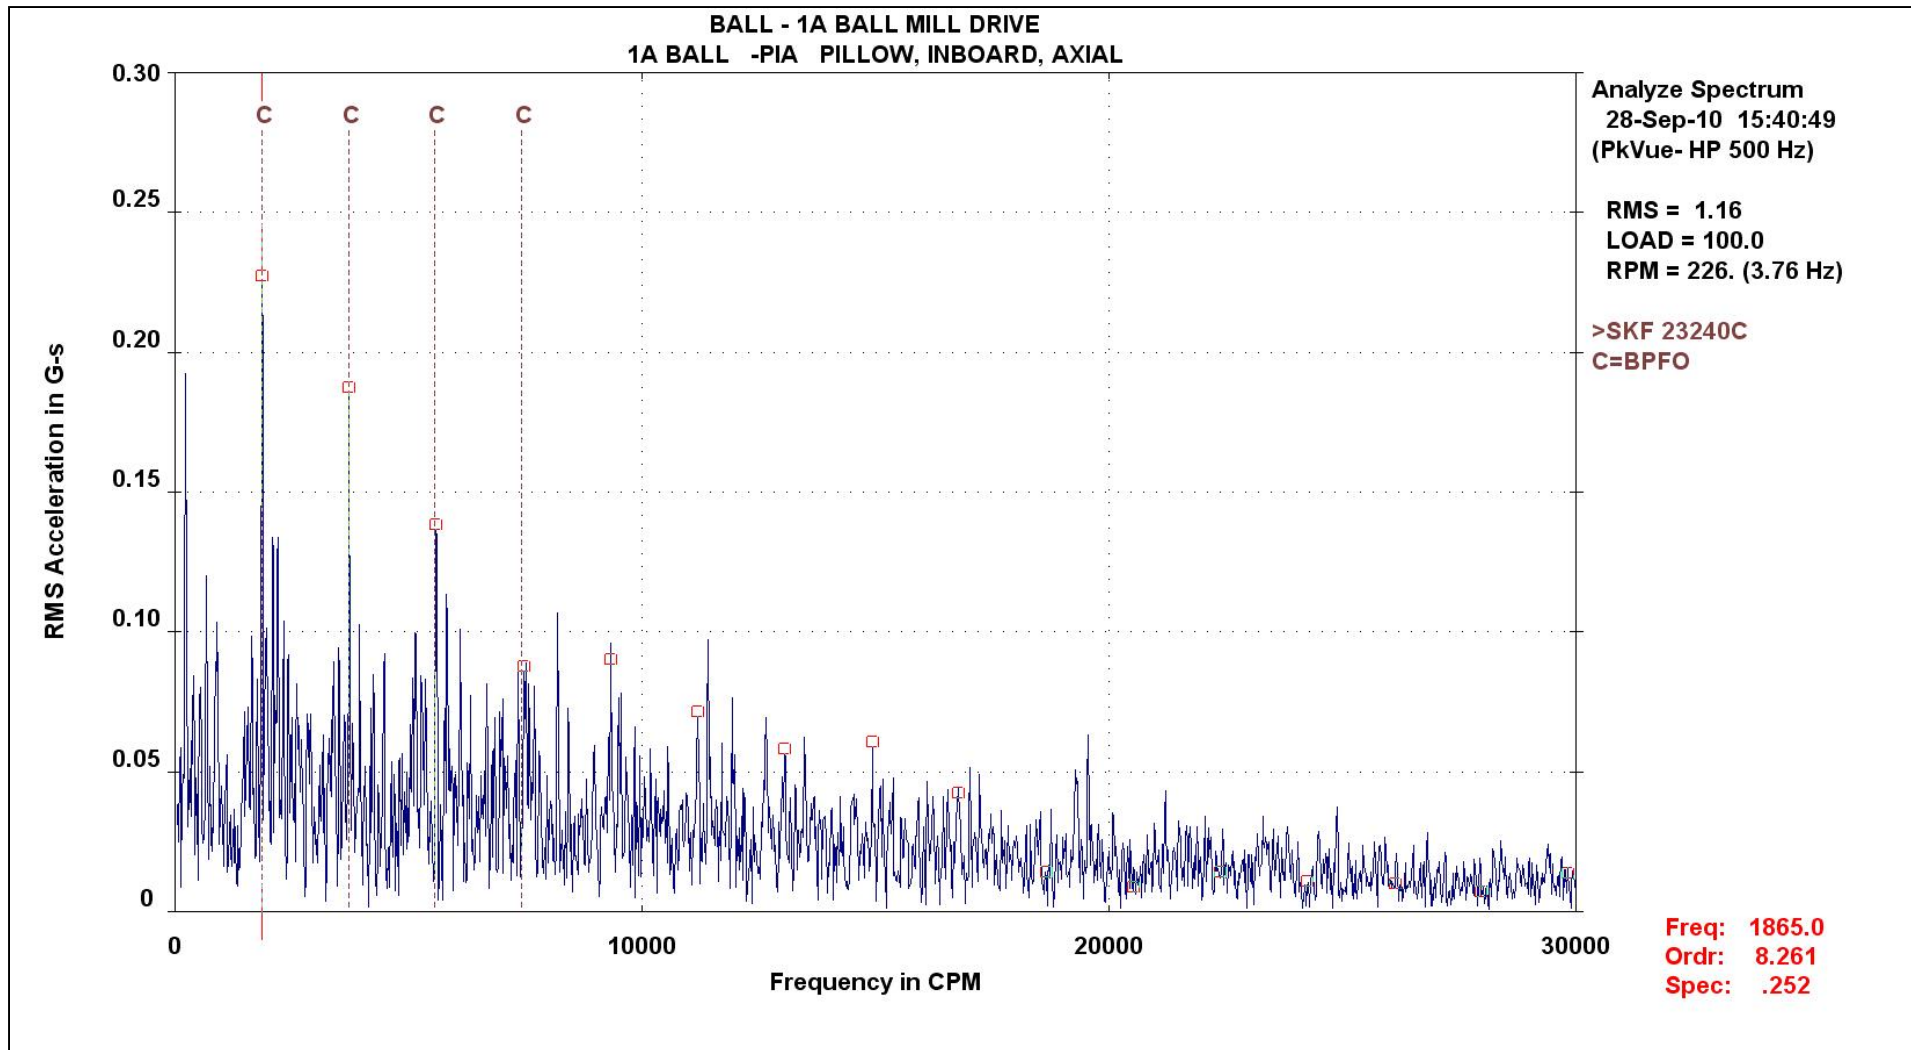
- Above is Peakvue spectral data from 1A ball mill when loaded (ball mill pillow block bearing, inboard, axial).
- Note the vibration appearing at multiples of the outer race defect frequency (1,865 cpm) for this SKF#23240 spherical roller bearing (19 rollers). High levels of 1.16 g's-rms were also noted as well as a high noise floor.

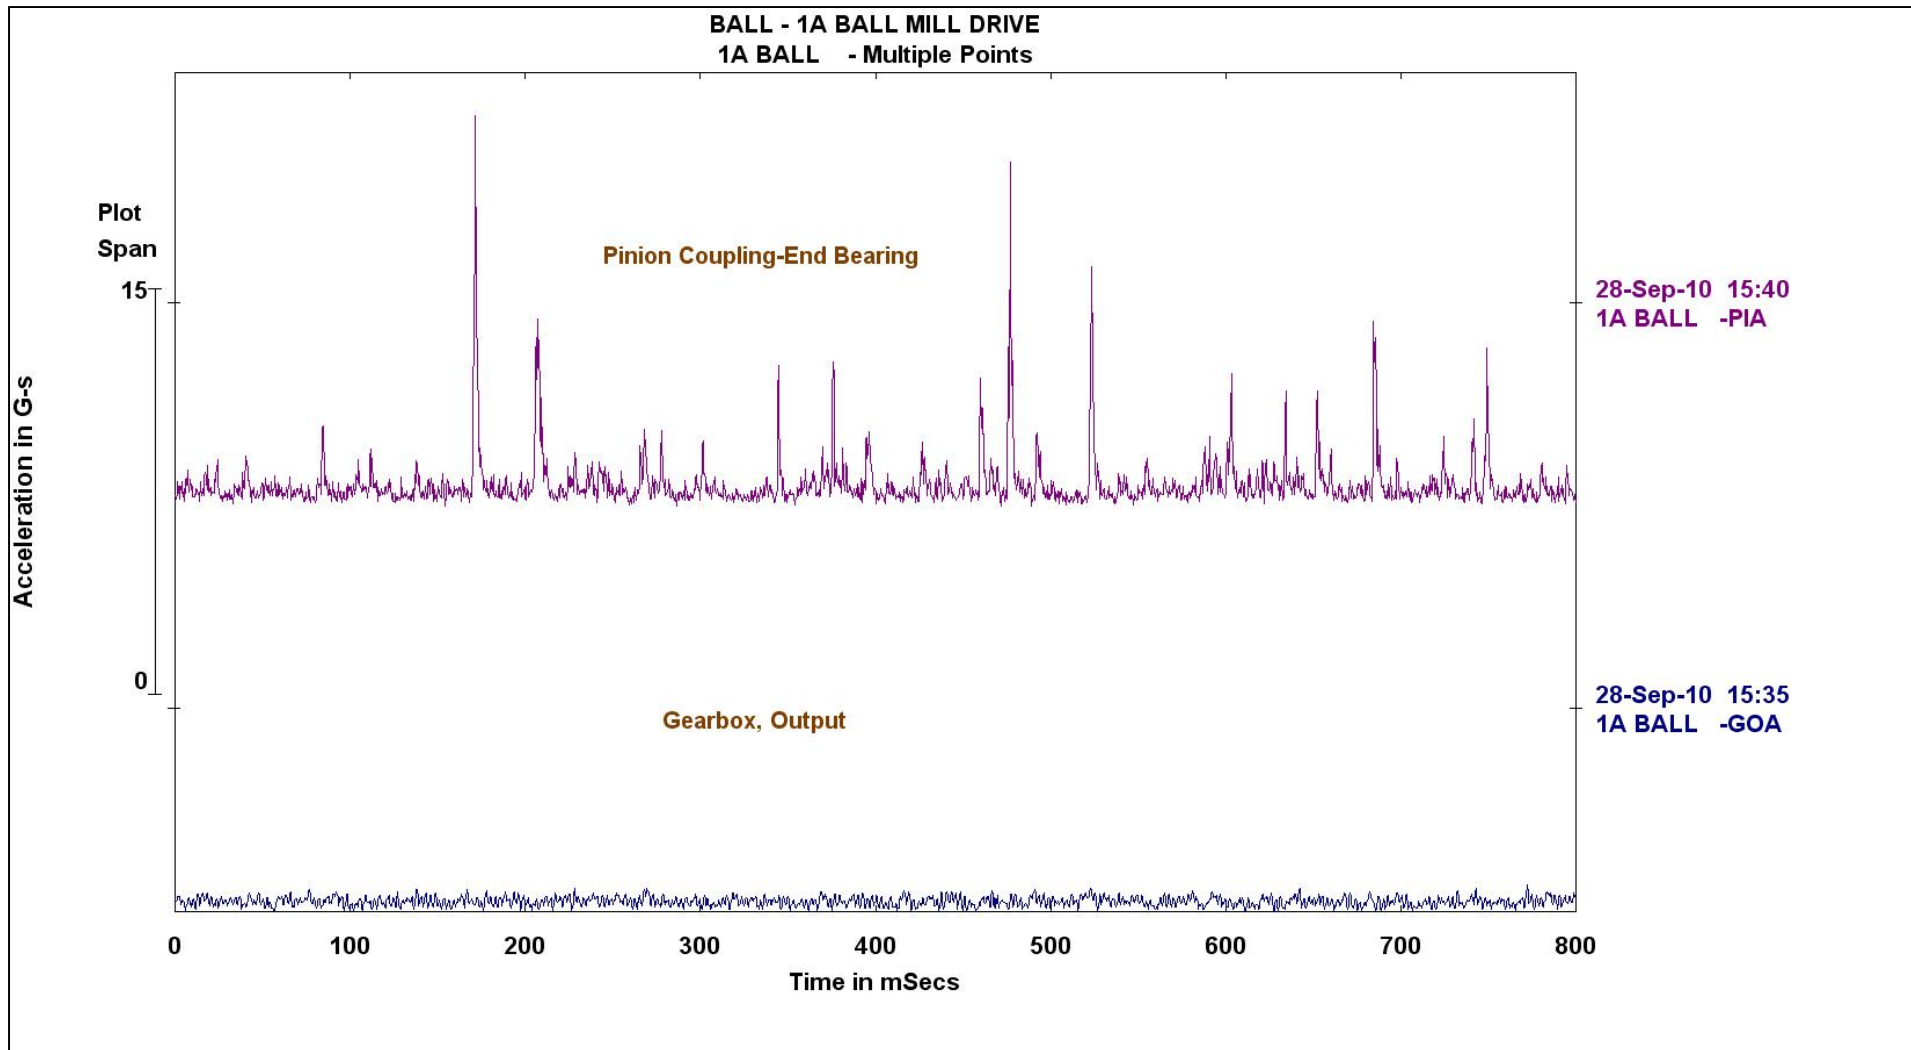
- Compare high frequency Peakvue vibration waveform data from 1A Ball Mill, measurement points PIA (pillow block, inboard, axial) and GOA (gearbox, output, axial).
- Note how levels at the pillow block are significantly higher than those seen at the gearbox. This data is telling us the source of the problem is most likely at the inboard pillow block bearing, not the gearbox.

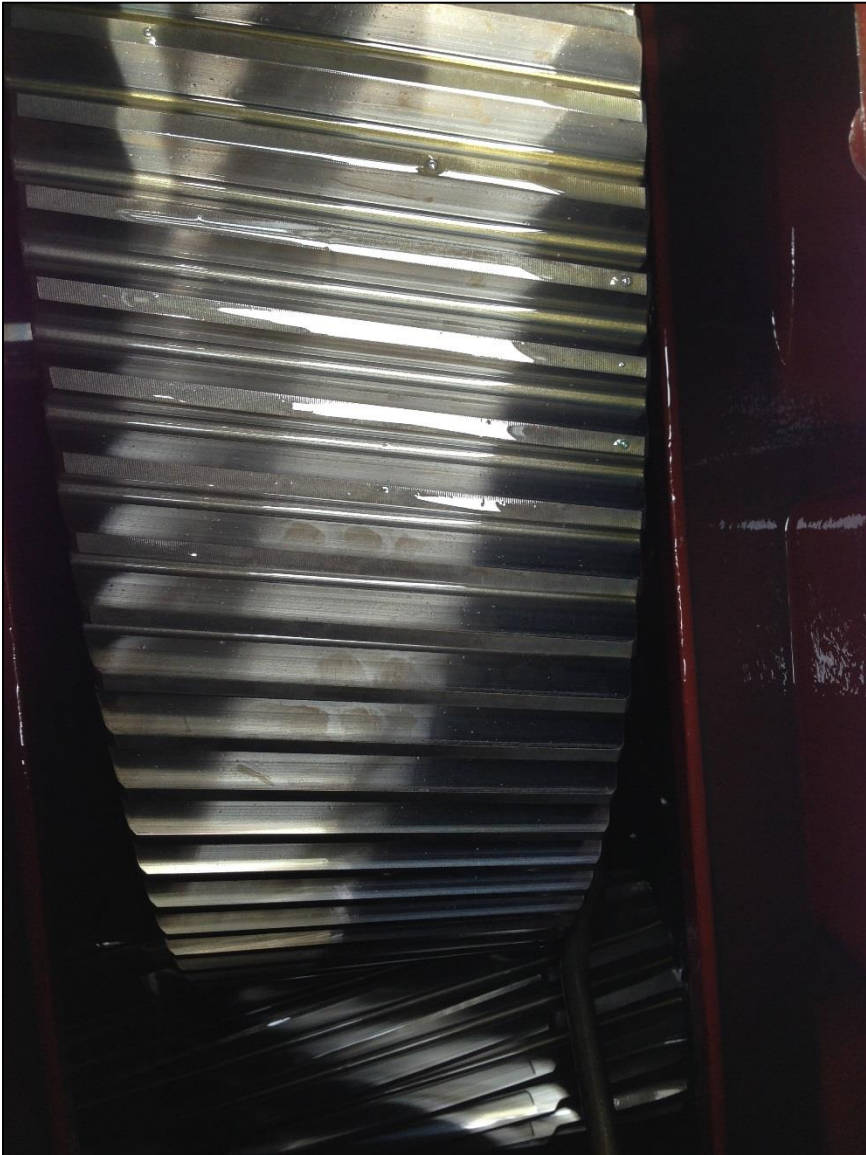
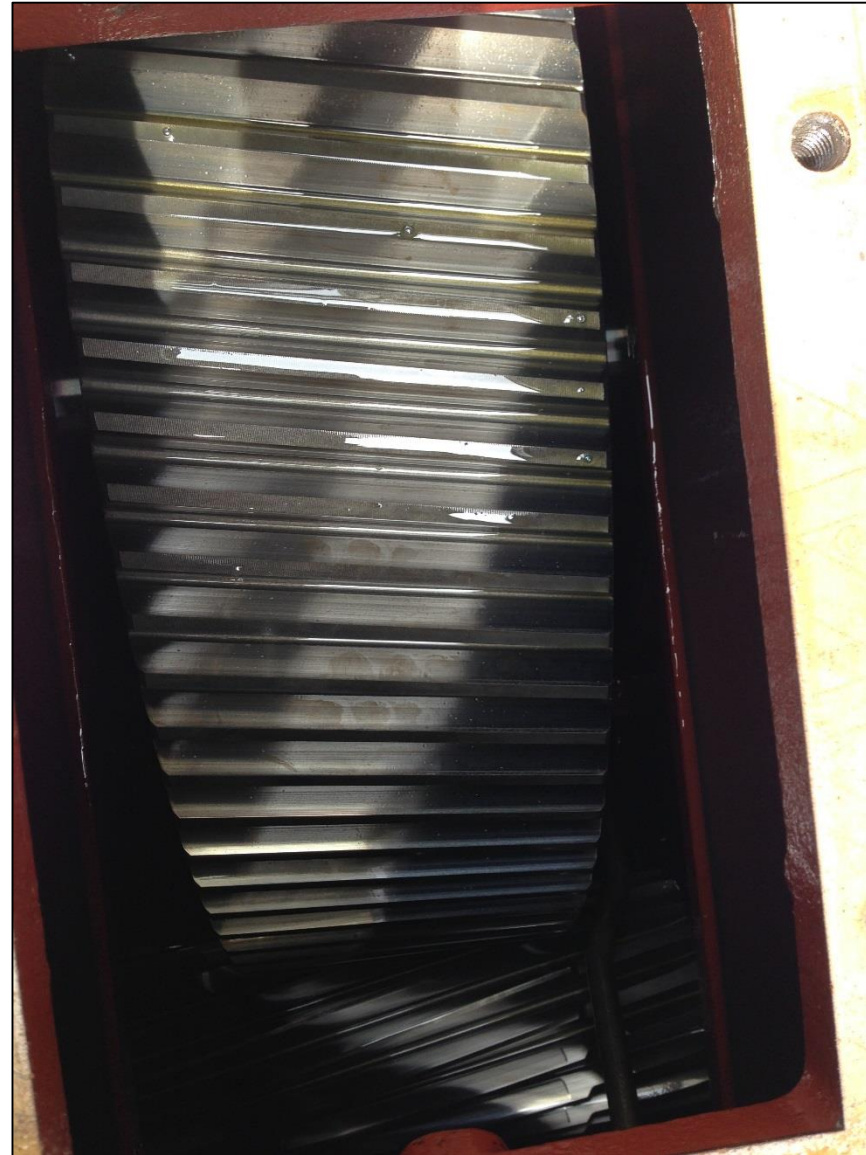
PHOTOS FROM BALL MILL GEAR INSPECTION

- Some wear on gear teeth observed, but no major problems noted even when both gears rotated thru 360 deg.
- Wear marks compared well from left to right of gear teeth (alignment probably ok).
- No broken or cracked gear teeth found.
- Plenty of oil present with lube appearing in good condition.
- No abnormal coloring of gears or excessive varnish, etc seen.

- 1) Both 1A ball mill pillow block bearings were changed.
- 2) The ball mill gears were inspected (see photos below).
- 3) The shaft alignment between the gearbox & ball mill pinion shaft was checked & minor corrections were made as needed by moving the gearbox only.
- 4) Following these repairs, a baseline vibration analysis of the machine was requested and later performed in November 2010.

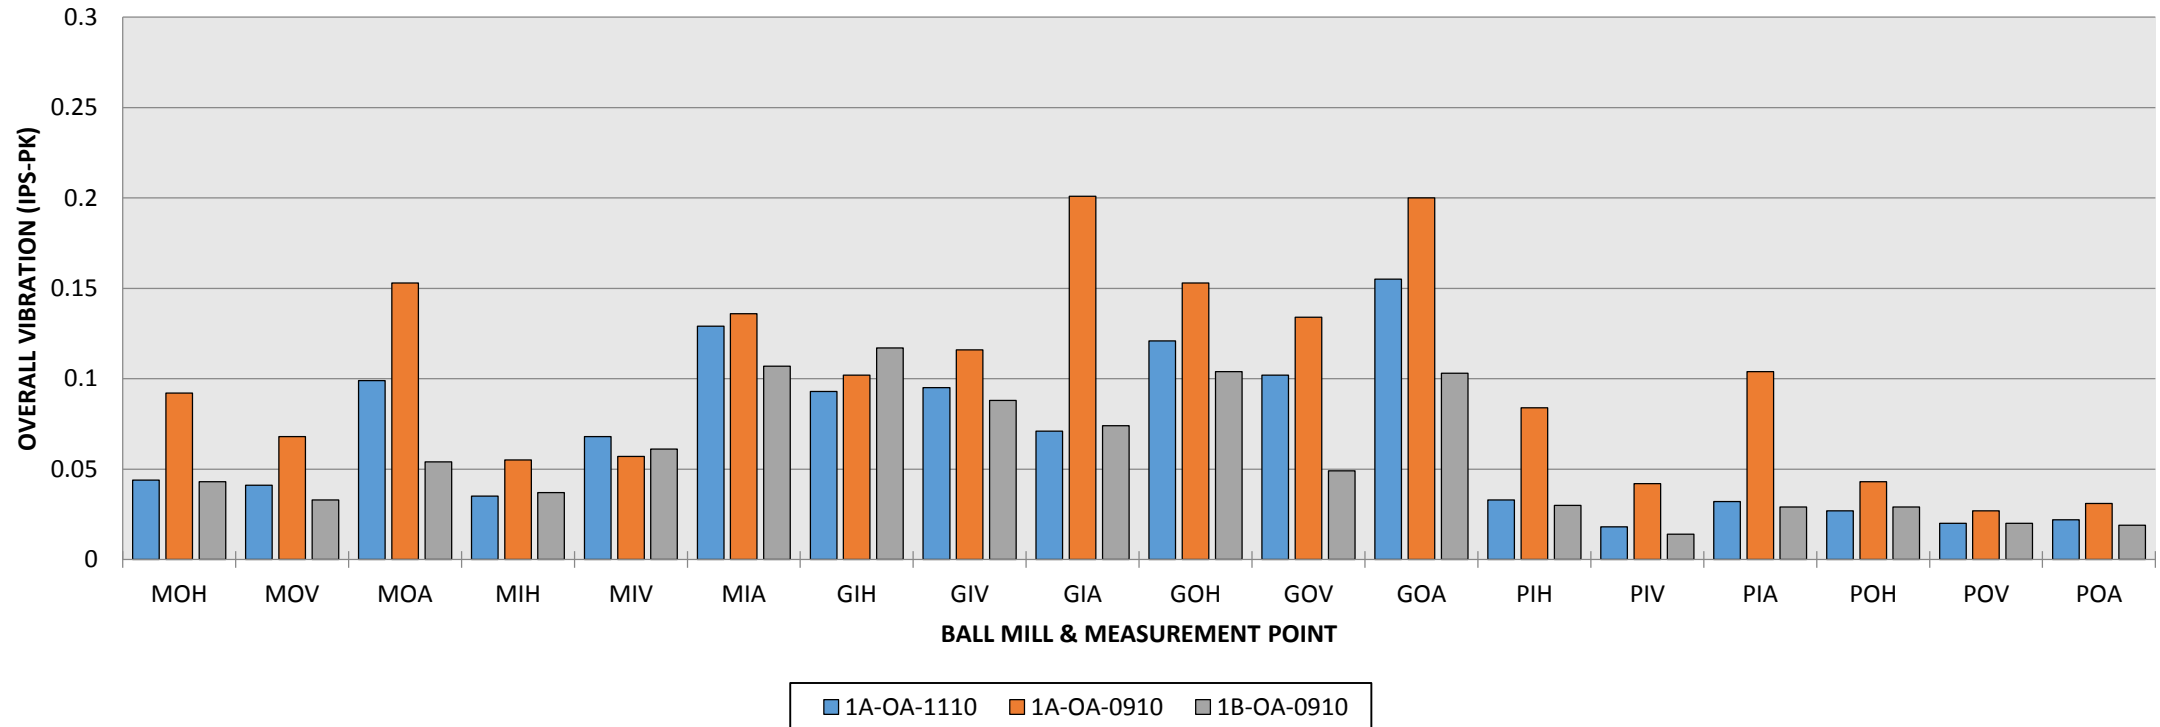
BALL MILL DRIVES, LOADED, OVERALL VIBRATION, SEPTEMBER & NOVEMBER 2010

- Above is a plot of the overall vibration levels at both the 1A & 1B ball mills when loaded.
- Data from 1A ball mill is shown from both September & November 2010 (before & after repairs).
- Note how levels at 1A ball mill are lower following repairs.
- Note also how following 1A repairs, levels at the ball mill pillow block bearings now agree with one another.

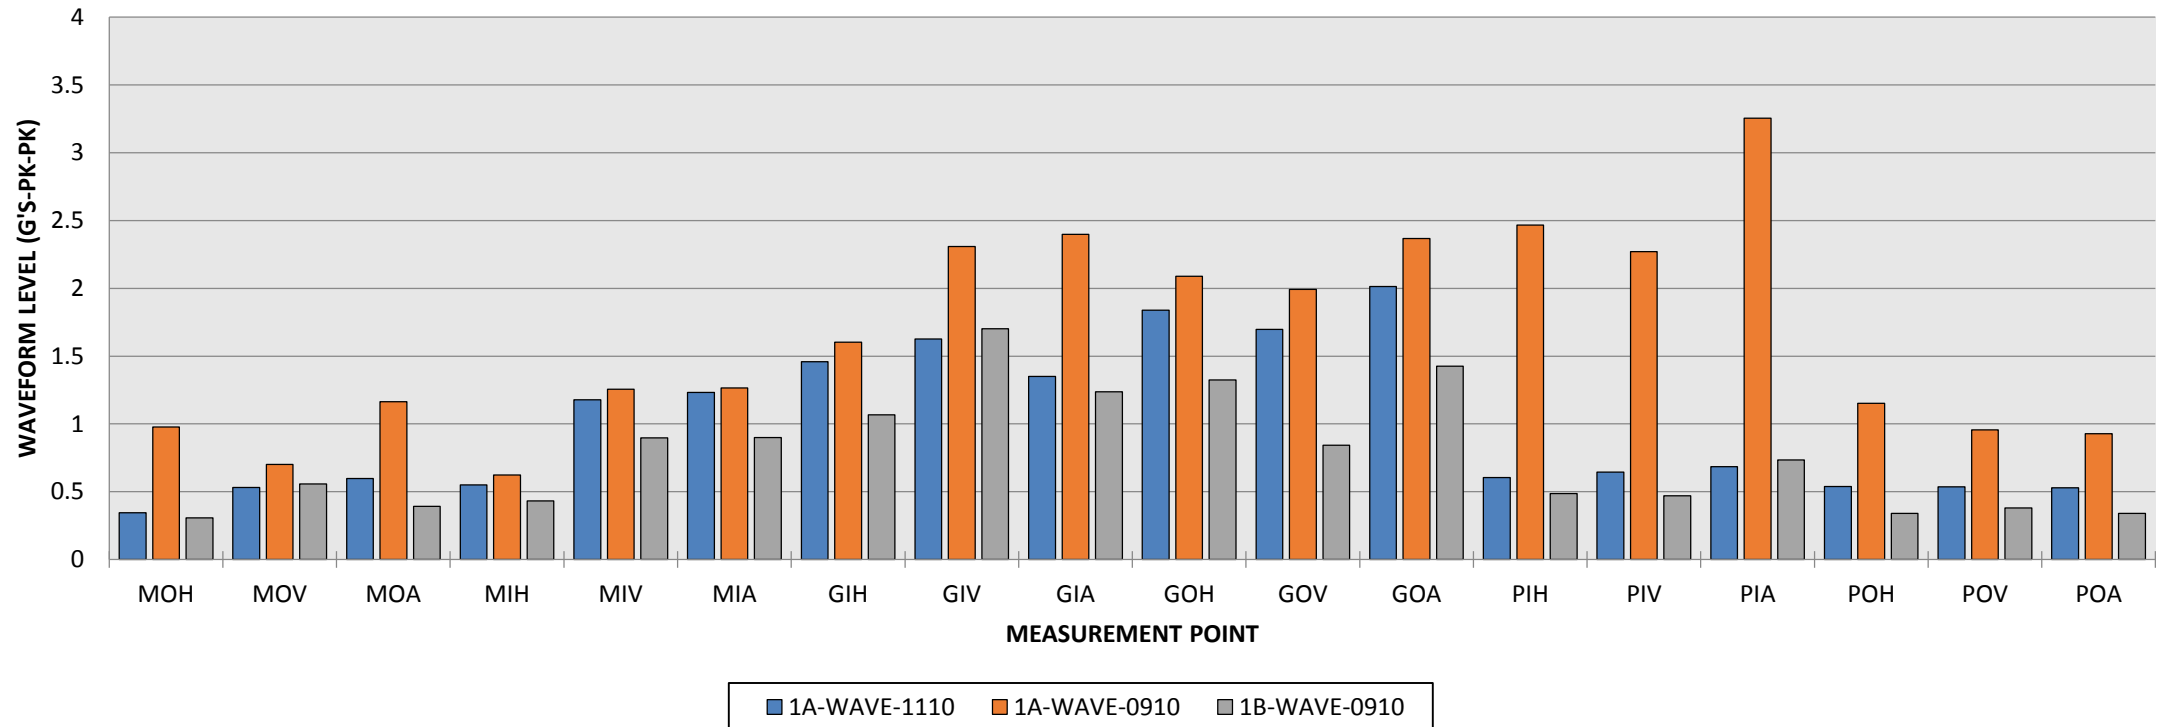
BALL MILL DRIVES, LOADED, WAVEFORM LEVELS, SEPTEMBER & NOVEMBER 2010

- Above is a plot of the waveform vibration levels at both the 1A & 1B ball mills when loaded (acceleration).
- Data from 1A ball mill is shown from both September & November 2010 (before & after repairs).
- Note how levels at 1A ball mill are lower following repairs especially at the ball mill inboard bearing points.
- Note also how following 1A repairs, levels at the ball mill pillow block bearings now agree with one another.

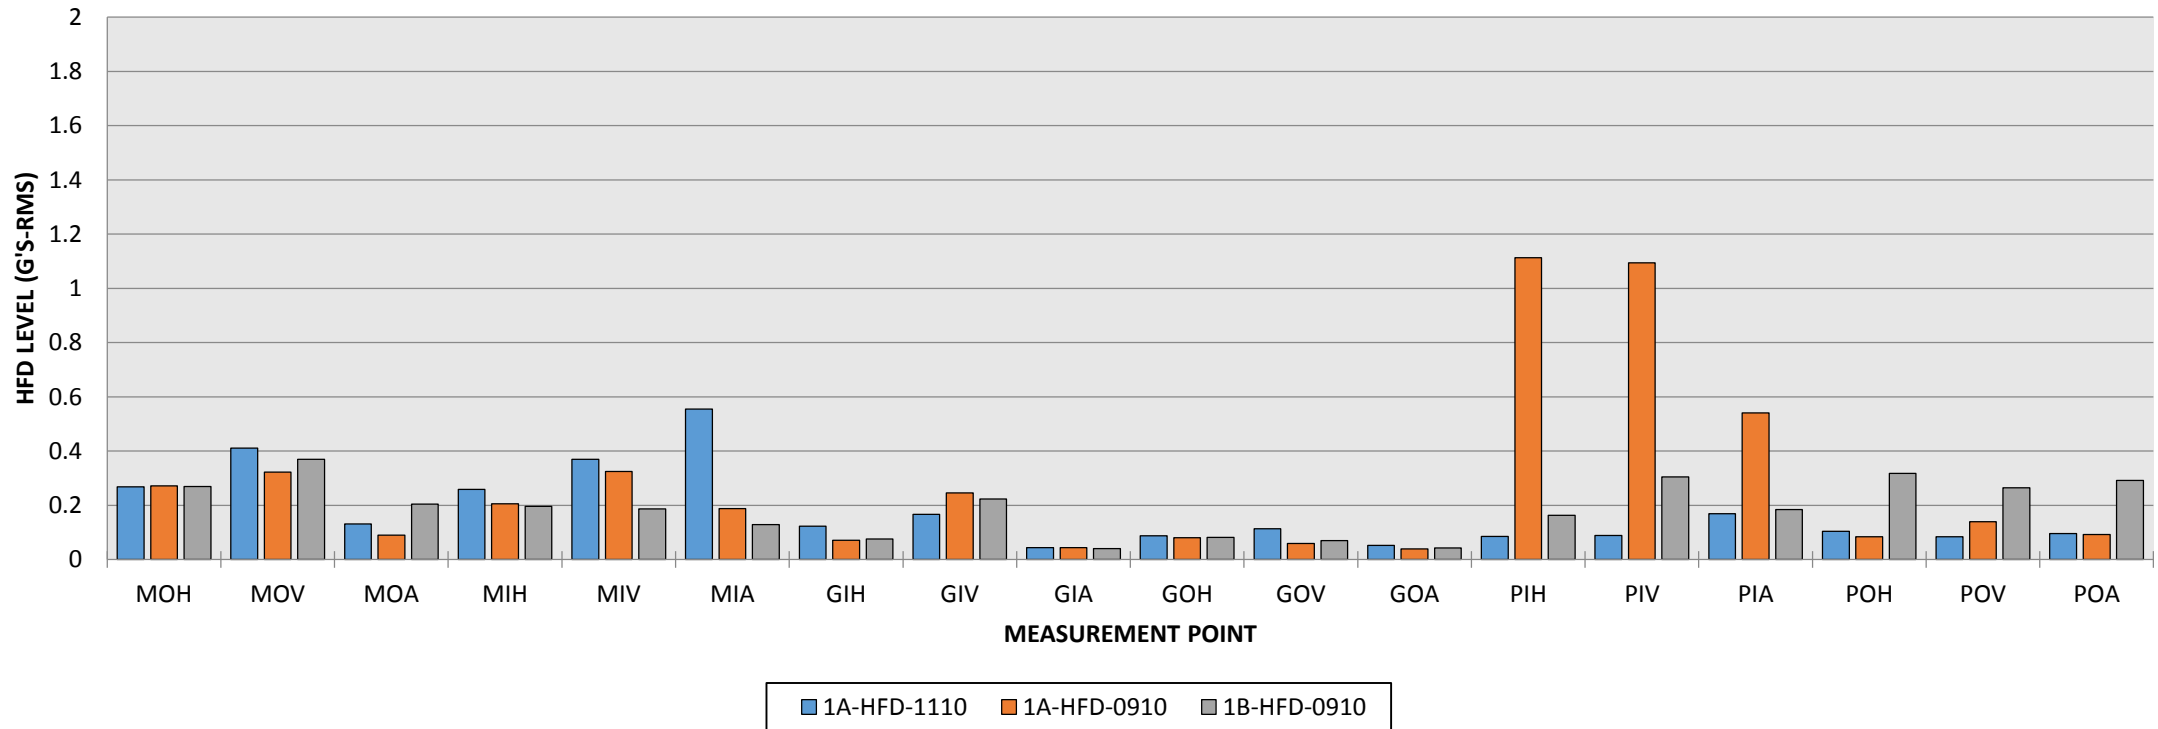
BALL MILL DRIVES, LOADED, HFD LEVELS, SEPTEMBER & NOVEMBER 2010

- Above is a plot of the high frequency HFD vibration energy levels at both the 1A & 1B ball mills when loaded (acceleration energy band, 2kHz to 20kHz).
- Data from 1A ball mill is shown from both September & November 2010 (before & after repairs).
- Note how levels at 1A ball mill ball mill inboard bearing (PIH → PIA) levels following repairs are much lower and now agree with those at 1B.

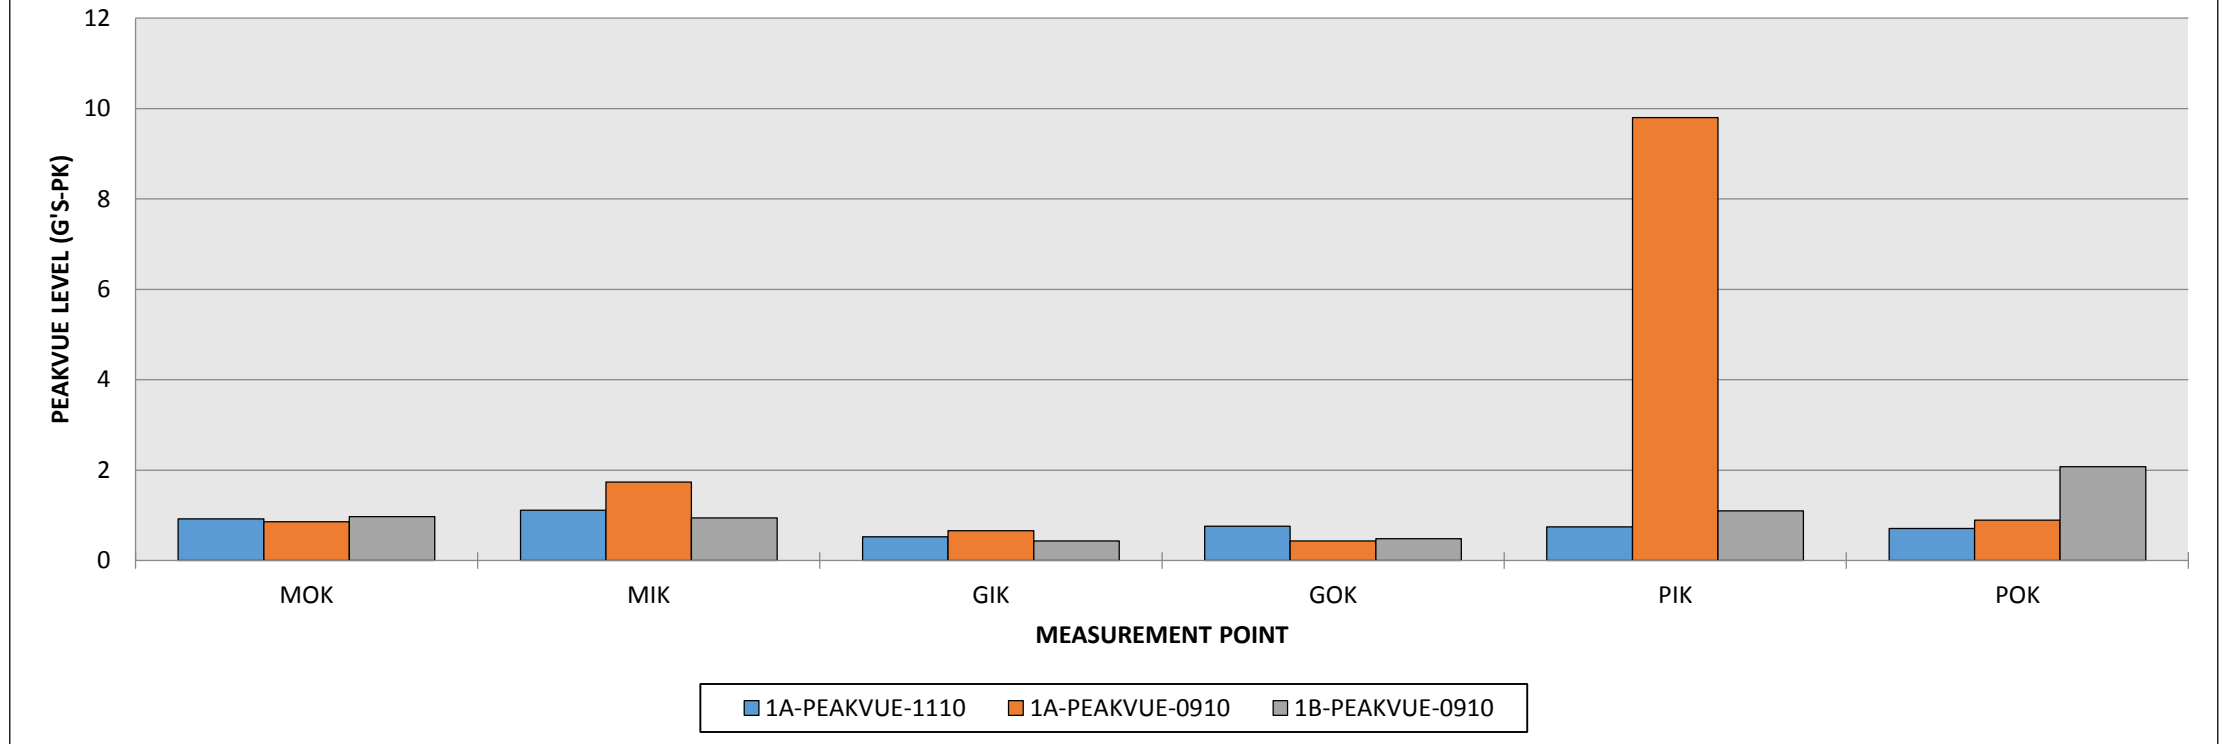
BALL MILL DRIVES, LOADED, PEAKVUE LEVELS, SEPTEMBER & NOVEMBER 2010

- Above is a plot of the high frequency Peakvue levels at both the 1A & 1B ball mills when loaded.
- Data from 1A ball mill is shown from both September & November 2010 (before & after repairs).
- Note how levels at 1A ball mill ball mill inboard bearing (PIK) following repairs are significantly lower and now agree with those at 1B.

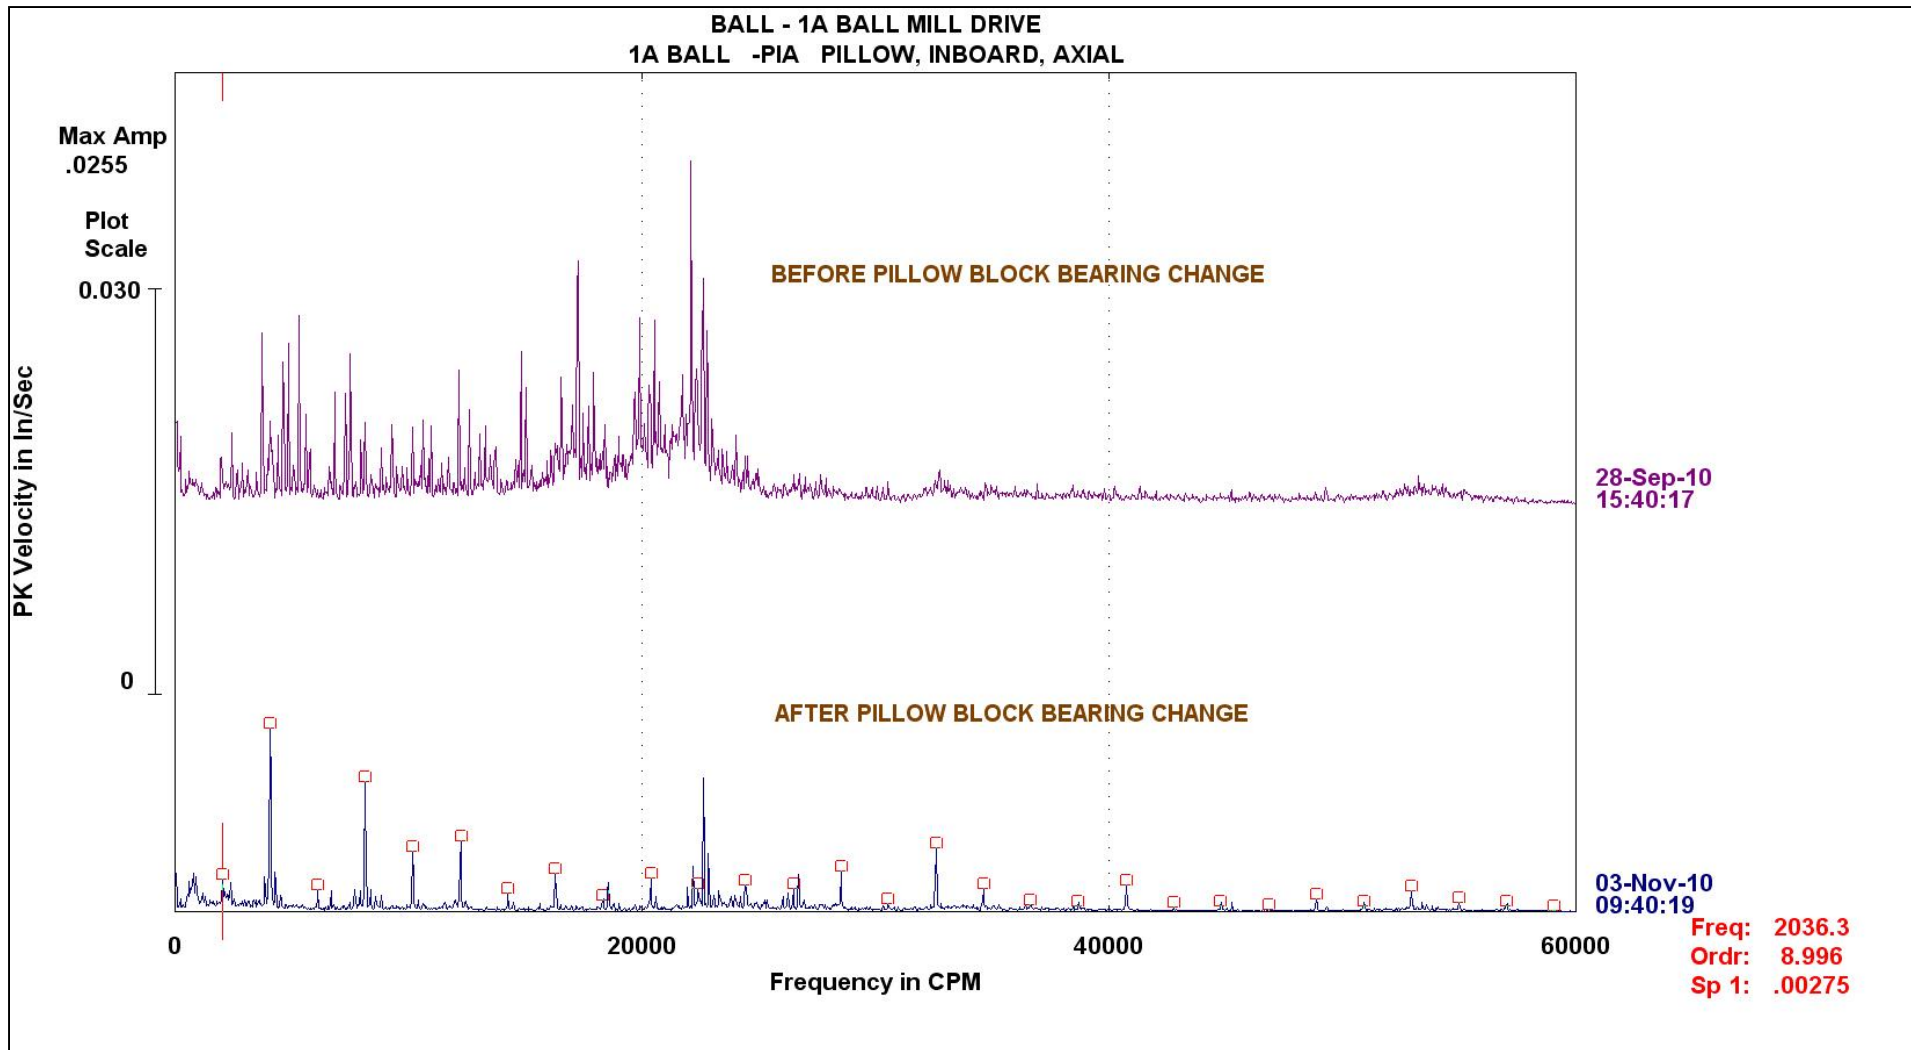
Thus, the factor common to both of these gears is 2 (improper set).

Since we have a common factor other than one between the two gears on the ball mill we can expect to see the appearance of fractional gearmesh frequency and harmonics in our vibration data.

In this case since the common factor is 2, we expect to see the appearance of $1/2x$ gearmesh and harmonics in our vibration data.

- Above is spectral data from 1A ball mill when loaded both before & after October repairs (ball mill inboard bearing).
- The multiples of vibration at 9x pinion speed seen in current data (1/2x gear-mesh frequency) are thought due to the common factor of 2 between the pinion & bull gears at the ball mill and/or the 2-part bull gear construction (gear assembly phase issue?).

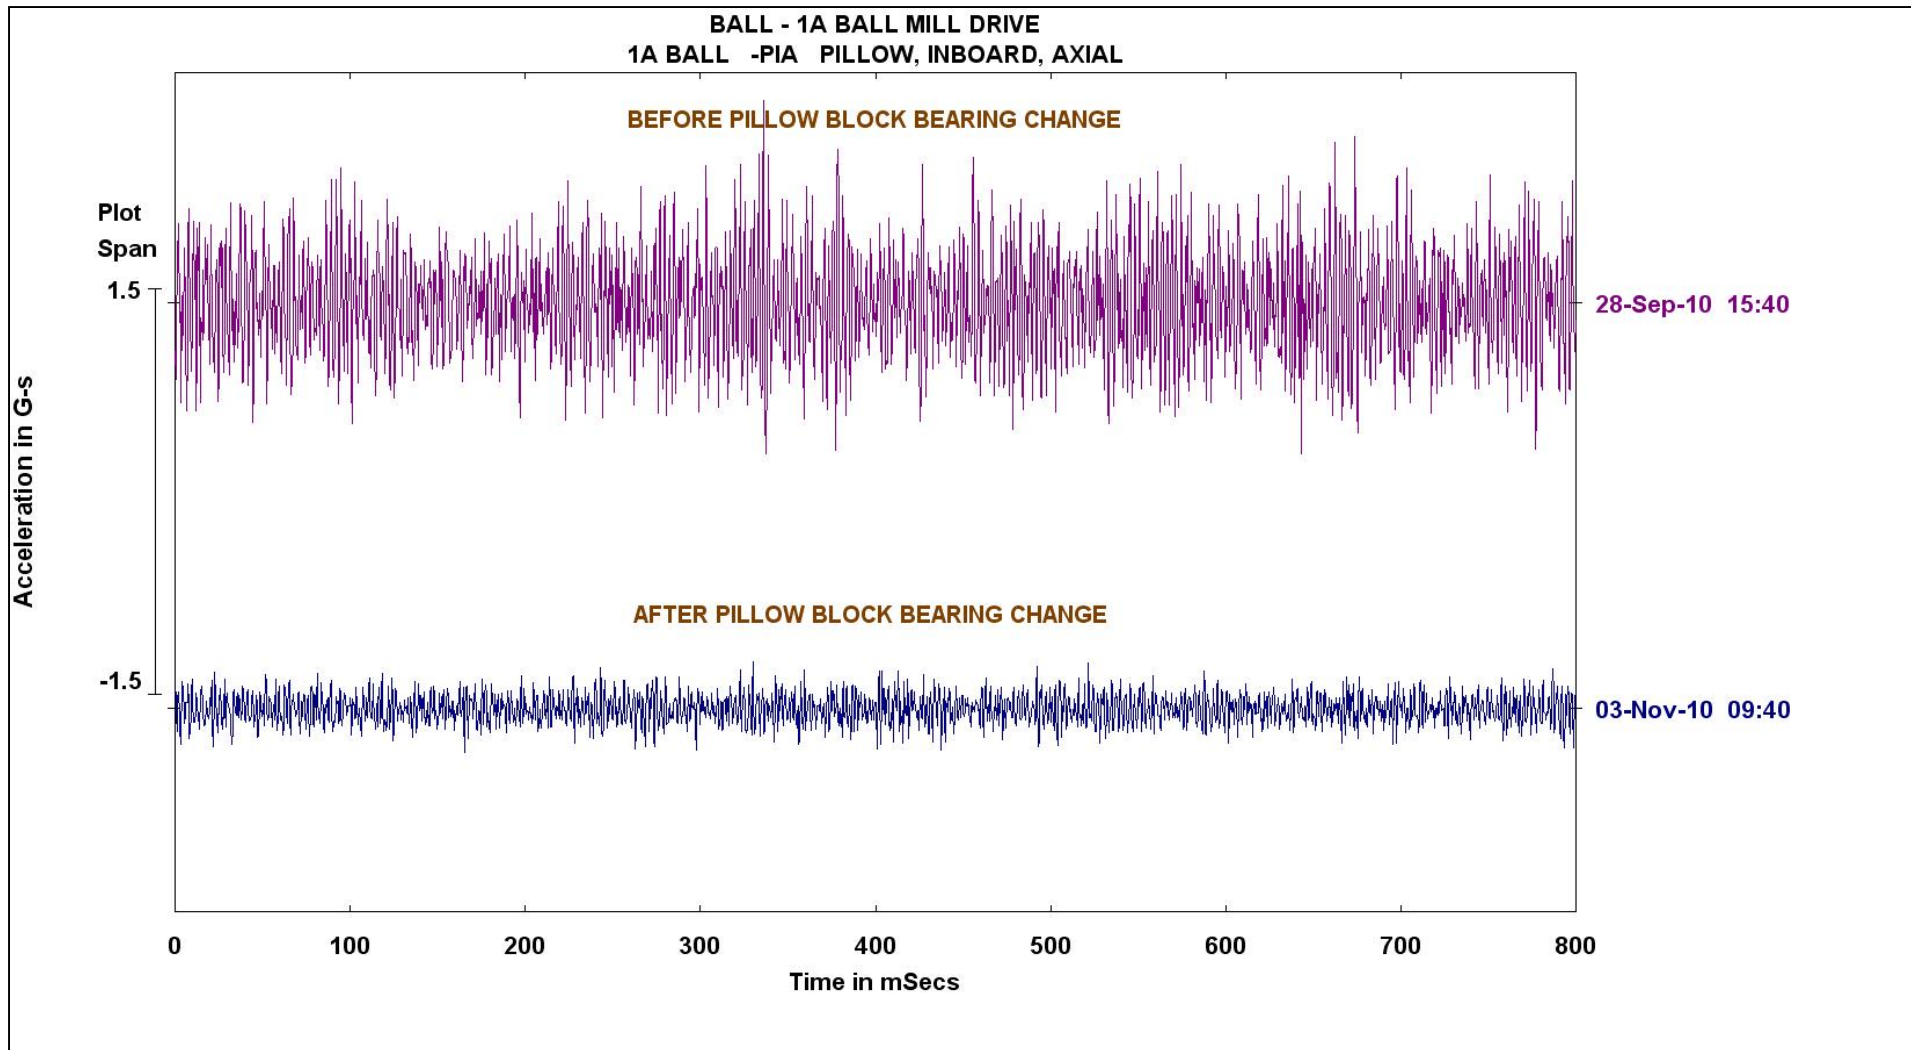
- Above is waveform data from 1A ball mill when loaded both before & after October repairs (ball mill inboard bearing).
- Note the significant drop in levels following the October repairs.

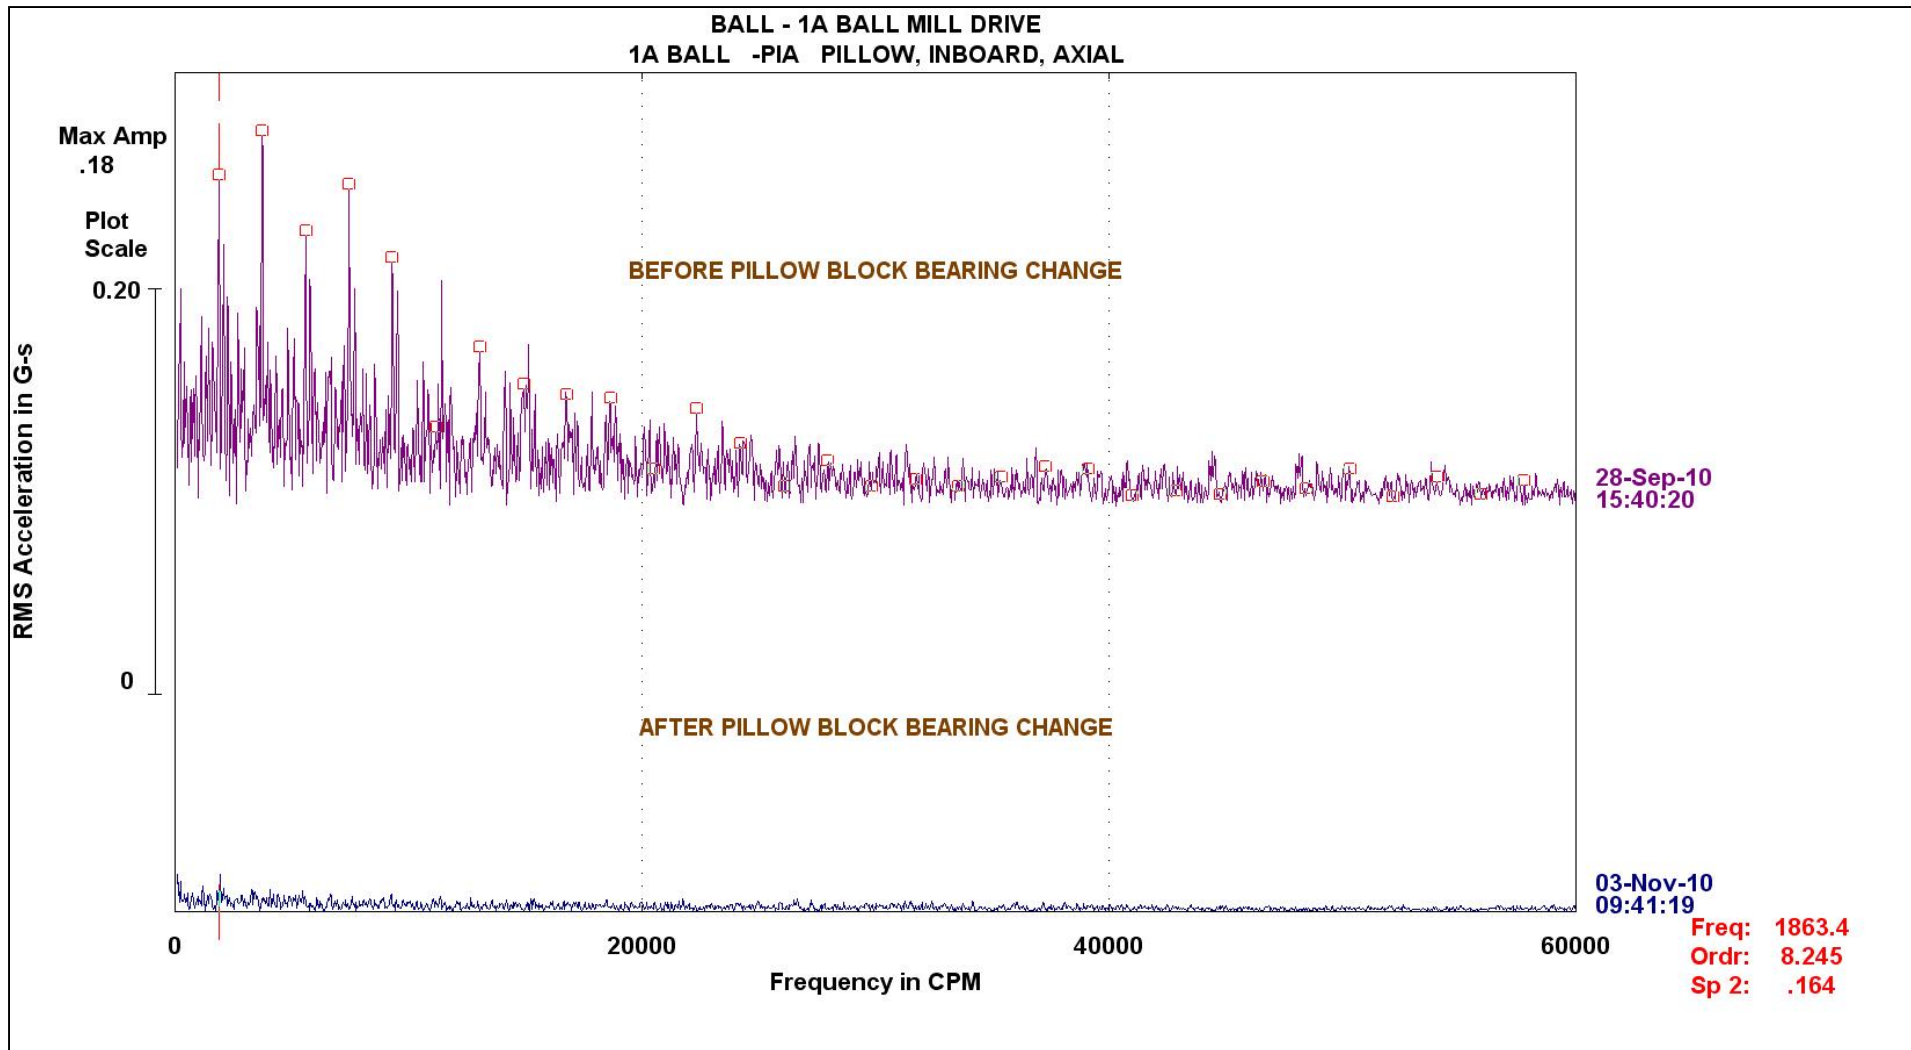
- High frequency Peakvue vibration spectra from 1A Ball Mill, measurement point PIA (pillow block, inboard, axial) both before & after recent bearing change.
- Note the disappearance of the bearing fault frequencies seen before repairs and much lower noise floor.

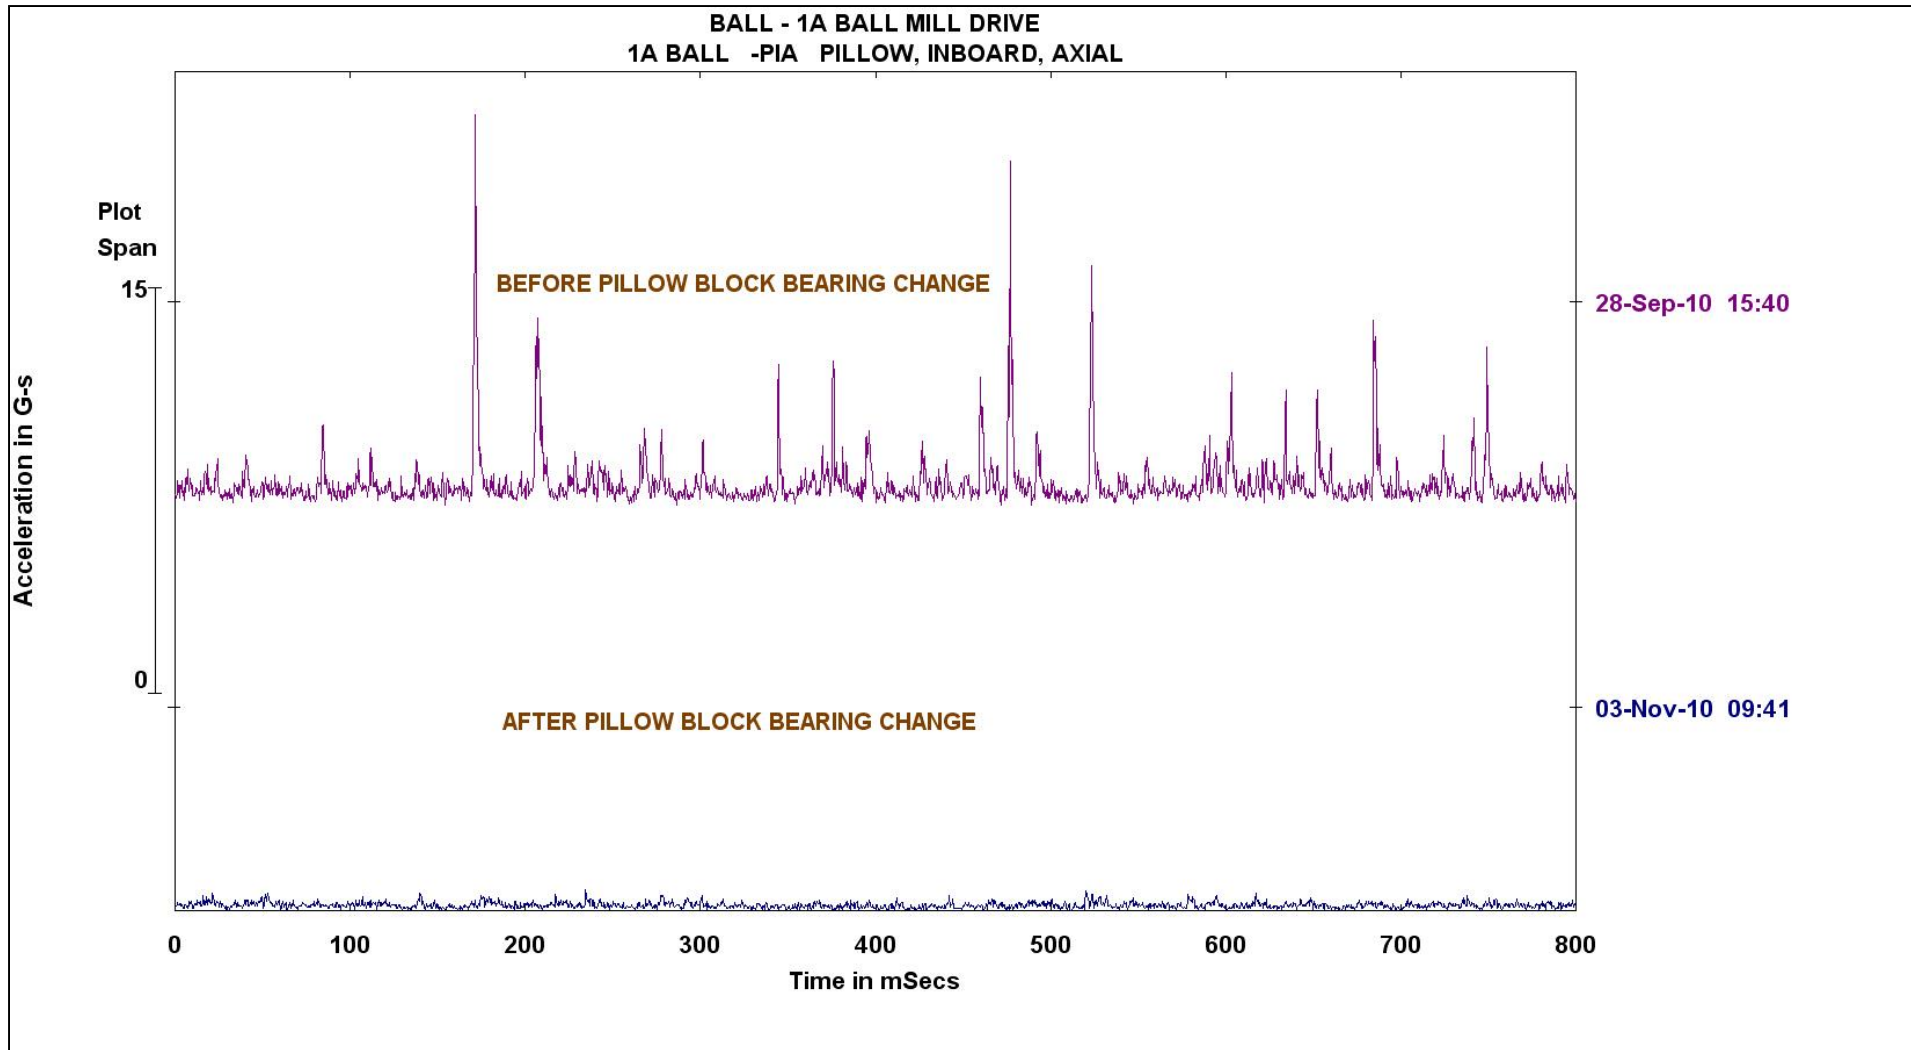
- High frequency Peakvue waveform data from 1A Ball Mill, measurement point PIA (pillow block, inboard, axial) both before & after recent bearing change.
- Note the significant reduction in levels and absence of significant impacting following the recent bearing change.
