BALL MILL GEARBOX PROBLEM

Barry T. Cease

Cease Industrial Consulting

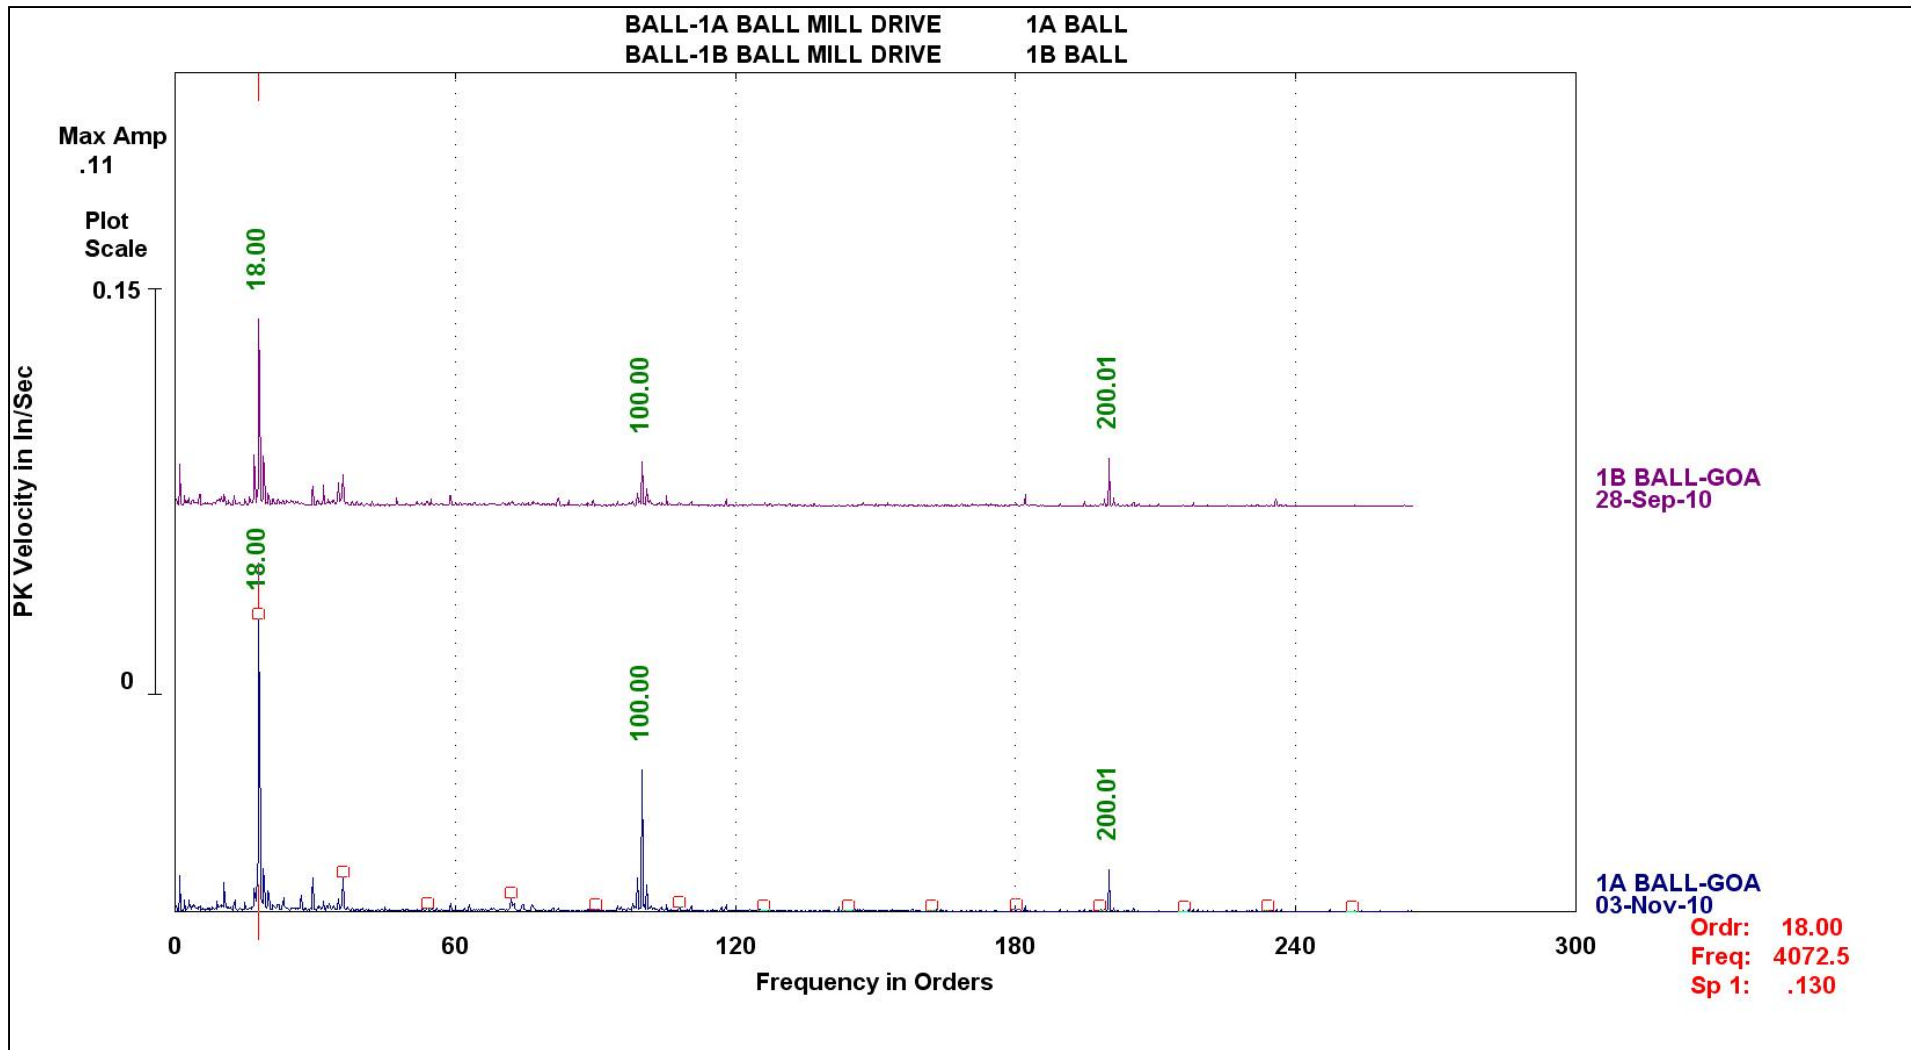
- Compare vibration spectra from the gearbox, output, axial measurements (GOA) from both 1A & 1B Ball Mills.
- Note how the dominant frequencies of vibration in both cases are identical (18, 100 & 200 orders) and are associated with gearbox & ball mill gear-mesh frequencies which in my view pose no significant threat to the condition of either machine at this time.

- 1) Recent change of the 1A Ball Mill inboard pillow block bearing resulted in significantly reduced vibration levels there and no signs of any significant problems at this time.
- 2) A minor bearing fault may exist at the gearbox output, but current vibration data indicate the problem is very small and of no great concern at this time. Current data from 1A gearbox is similar to that seen from 1B gearbox which is further evidence that no significant problem exists at 1A gearbox at this time.
