The Dirty Dozen

The 12 Most difficult problems I have worked on during the last 45 years of troubleshooting vibration related problems

Nelson Baxter

Presented For The Vibration Institute, Piedmont Chapter, May 2023

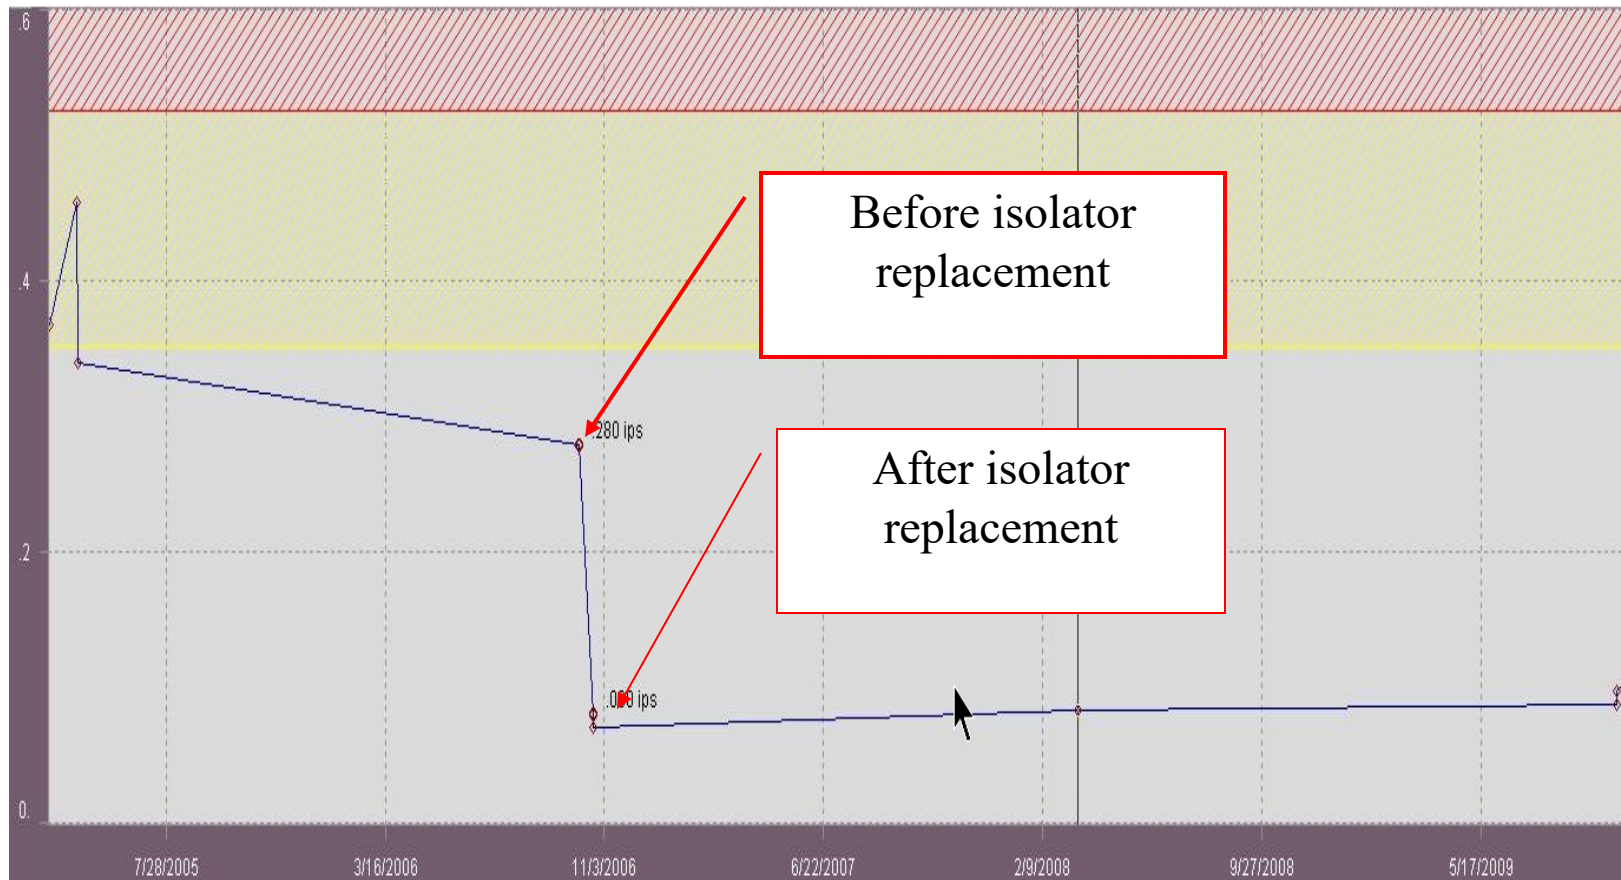
Before and after Isolator Replacement

- The fan was mounted on rubber isolators.
- The gamma rays broke the organic bonds making the rubber hard and brittle.
- The isolators stiffened up raising the natural frequency of the isolated system to 28 HZ which was very near the 30 HZ operating speed.
- That caused the tripling of the vibration
- This problem was put on the list because it required knowledge in three separate areas. Gamma radiation from fission process, organic chemistry and the amplification factor.

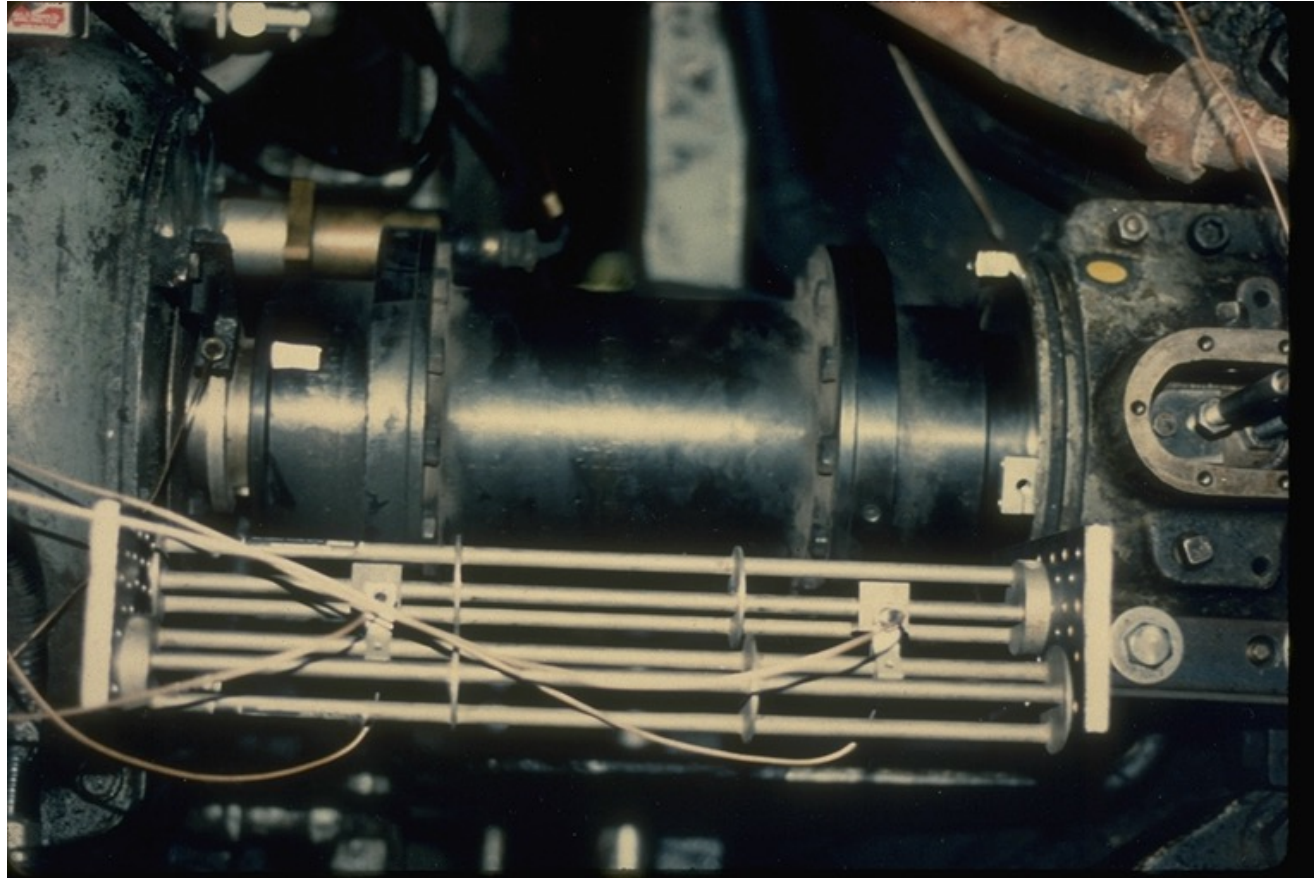
When Vacuum was broken, the alignment moved over 100 mils.

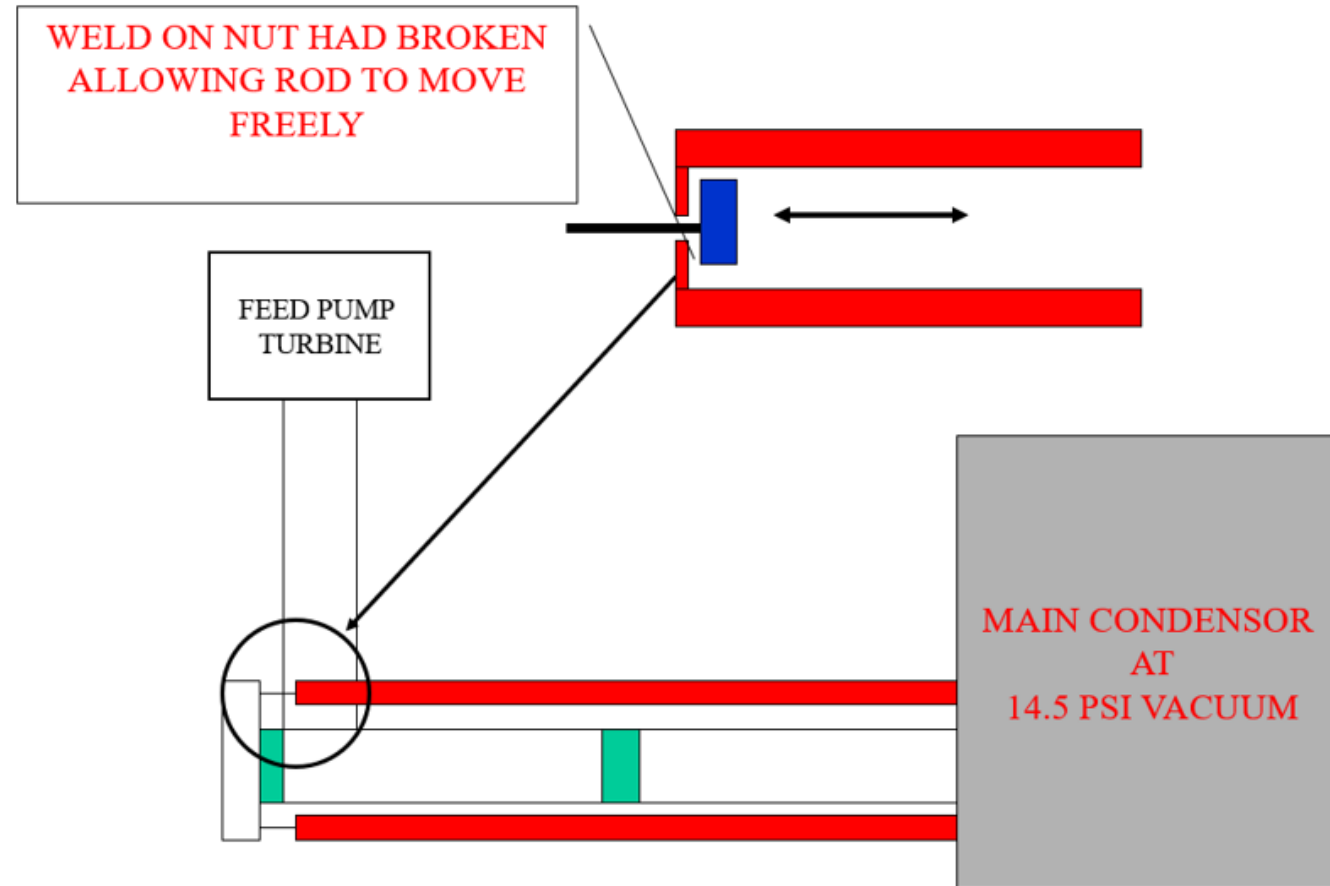
Examination of thrust cancelling rods showed movement of thrust cancelling rod.

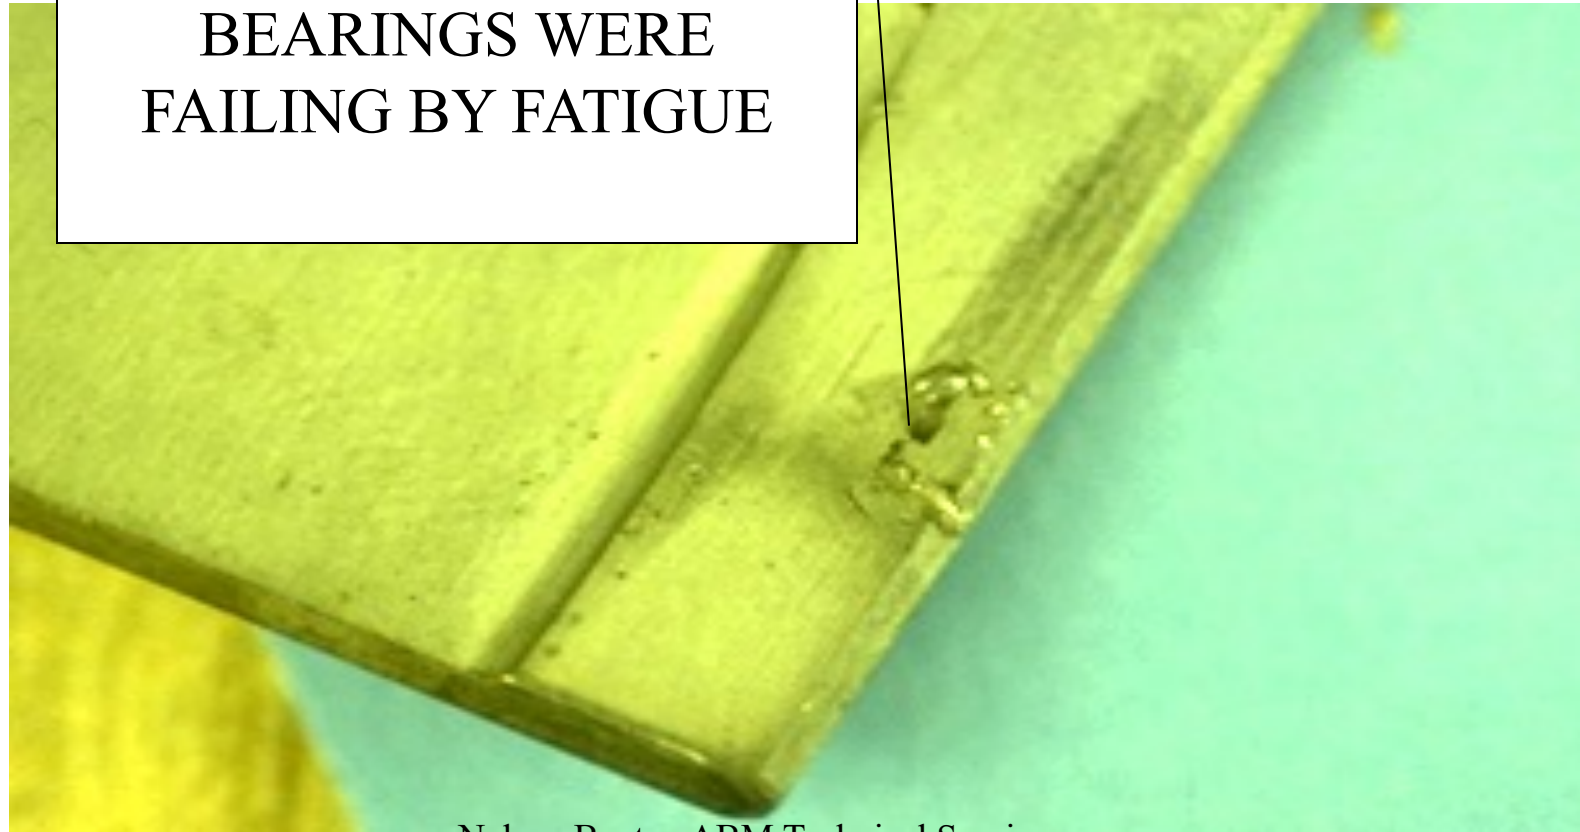
CHILLER TURBINE WAS DESTROYING BEARINGS

UPPER HALF OF
BEARINGS WERE
FAILING BY FATIGUE

Solution: Change to tilt pad bearing to minimize any oil whirl issues. Set the turbine high to compensate for movement of compressor. This was done every overhaul. This machine ran without further problems until it was retired 30 years later.

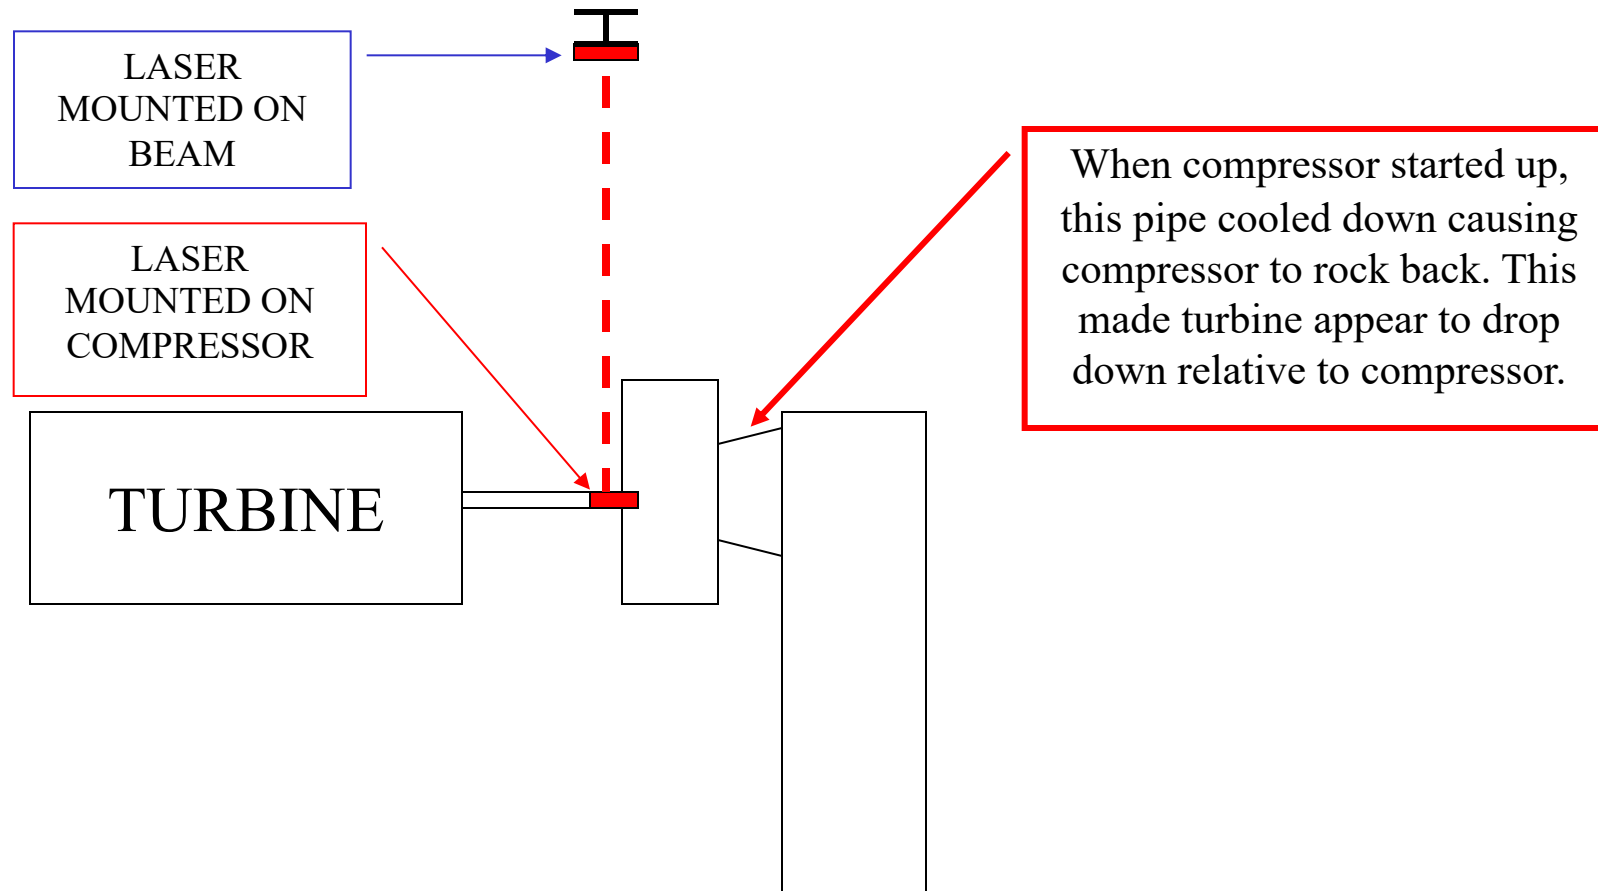
ACTUAL PROBLEM

The laser showed the compressor was rocking backwards towards the heat exchangers. The readings were taken three times and the results were the same each startup. During the startup period, the large pipe between the compressor and the heat exchangers cooled down and got shorter thus pulling on the compressor making it rock backwards.

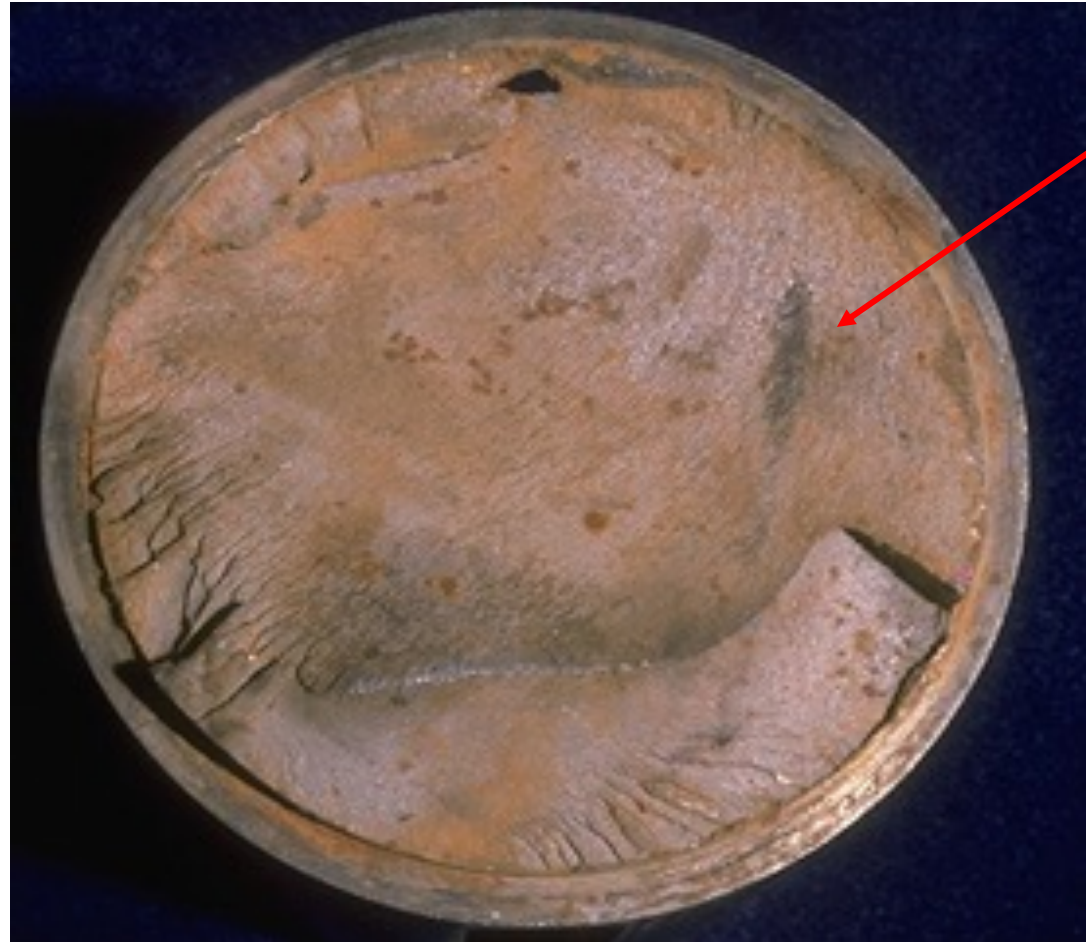
BROKEN SHAFTS

AFTER SIX PUMP SHAFTS HAD BROKEN, TESTS WERE RAN TO DETERMINE CAUSE. THE PUMPS HAD OPERATED FOR MANY YEARS WITH NO PROBLEMS THEN THE SHAFTS STARTED TO BREAK.

Broad band flow energy was exciting the vibration on the shaft at sub-synchronous frequencies. This resulted in alternating bending at approximately every other revolution. Cracks then developed at the notched high stress points where the shaft couplings were installed.

Maintenance personnel were interviewed to determine if there had been any changes to the pumps when they were overhauled. Because of a pricing issue, plant personnel had elected to go with a different supplier of pump impellers. When the replacement impellers were closely examined, the angles and the thickness of the impeller vanes were found to be significantly different than the original design. This resulted in very high turbulent flow exciting the shaft's first natural frequency. When the original manufacturer impellers were put back in the pumps, the shaft failures immediately stopped. There have been no shaft failures over the past 20 years.

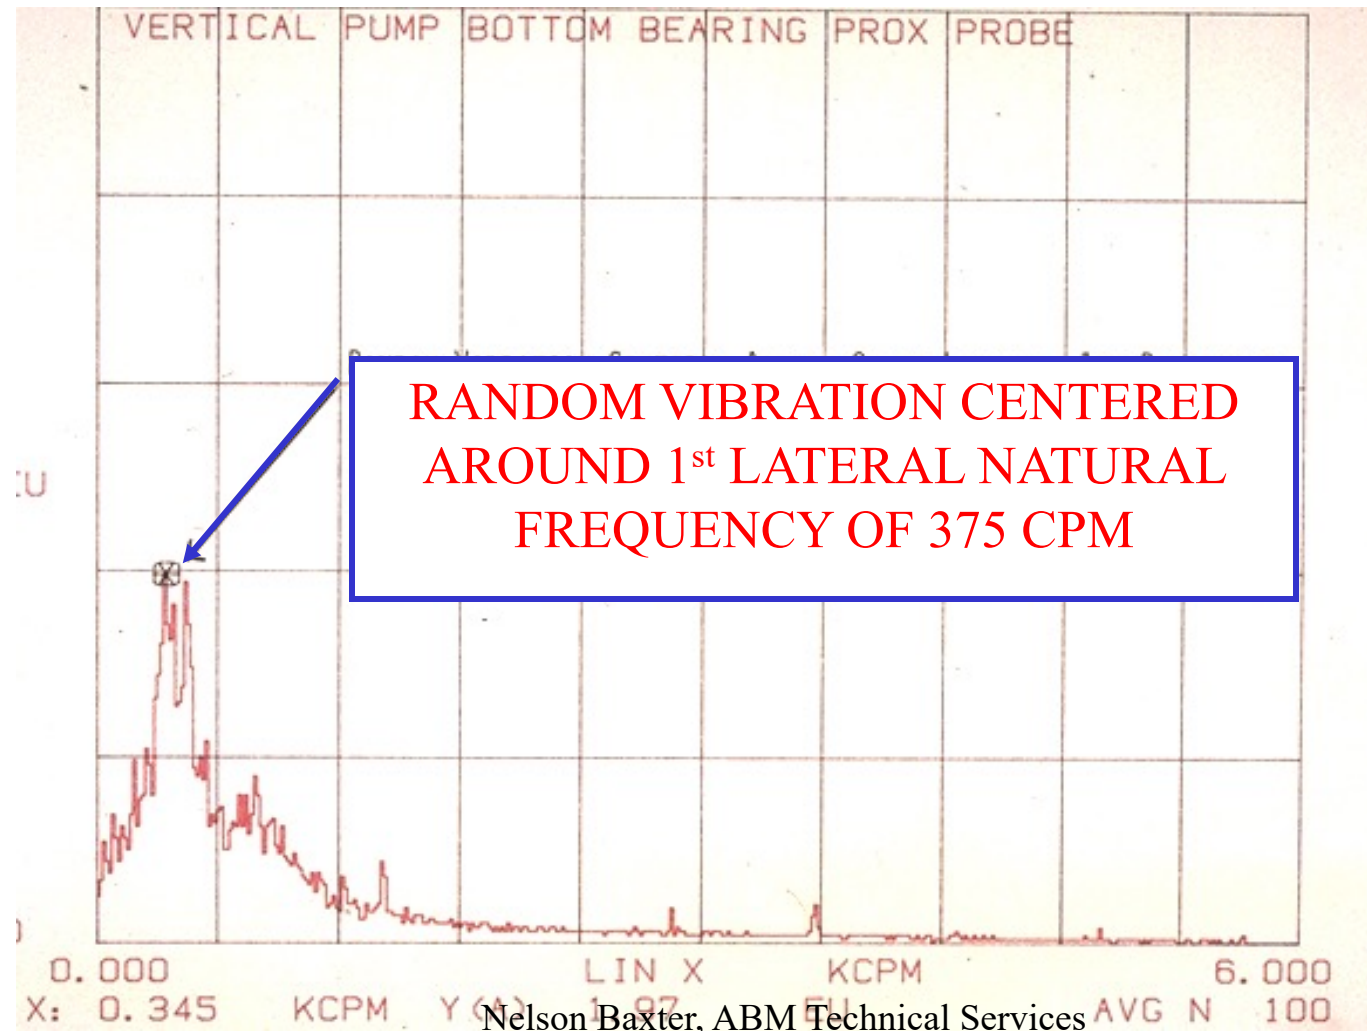
VIBRATION SPECTRUM

When the vibration spectra were examined, there was no dominant frequency. What was found was the vibration was broad band in nature and centered around 375 cpm. This frequency matched the first bending mode of the shaft. When synchronous time averaging was applied there was almost no running speed vibration. There was no measurable torsional vibration present. This agreed with the type of breaks that were occurring which did not show any signs of torsional fatigue.

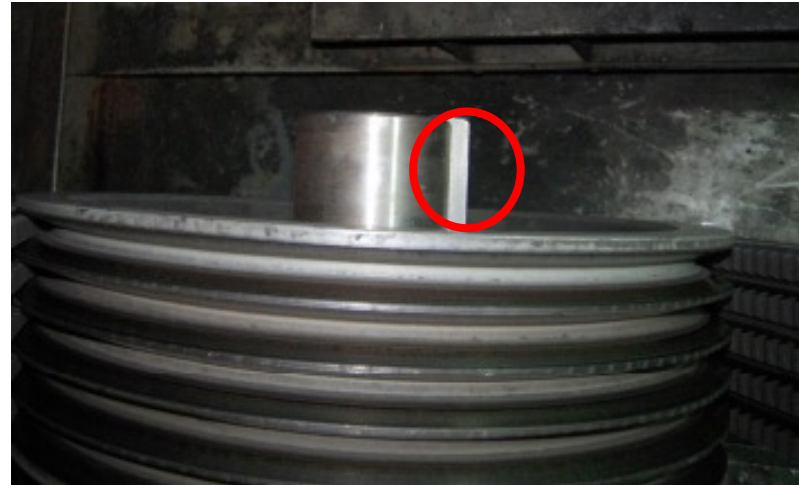
Excess key on outboard end of shaft

This fan was mounted in the air and the vertical natural frequency on the metal base was below running speed, so the 1.7 oz-in flexible frame limit applied. There were 4 inches of excess key and the key was $\frac{3}{4}$ " wide and $\frac{1}{2}$ " thick. The volume of the excess key was therefore 1.5 cubic inches. When taken times the density of steel; (.283 lb/in cube) the weight of the key was calculated to be .42 lb or 6.8 oz. The distance of the key from the shaft center was 1.5 inches. The unbalance was therefore 10.2 oz-in or 6 times the ISO flexible frame standard.

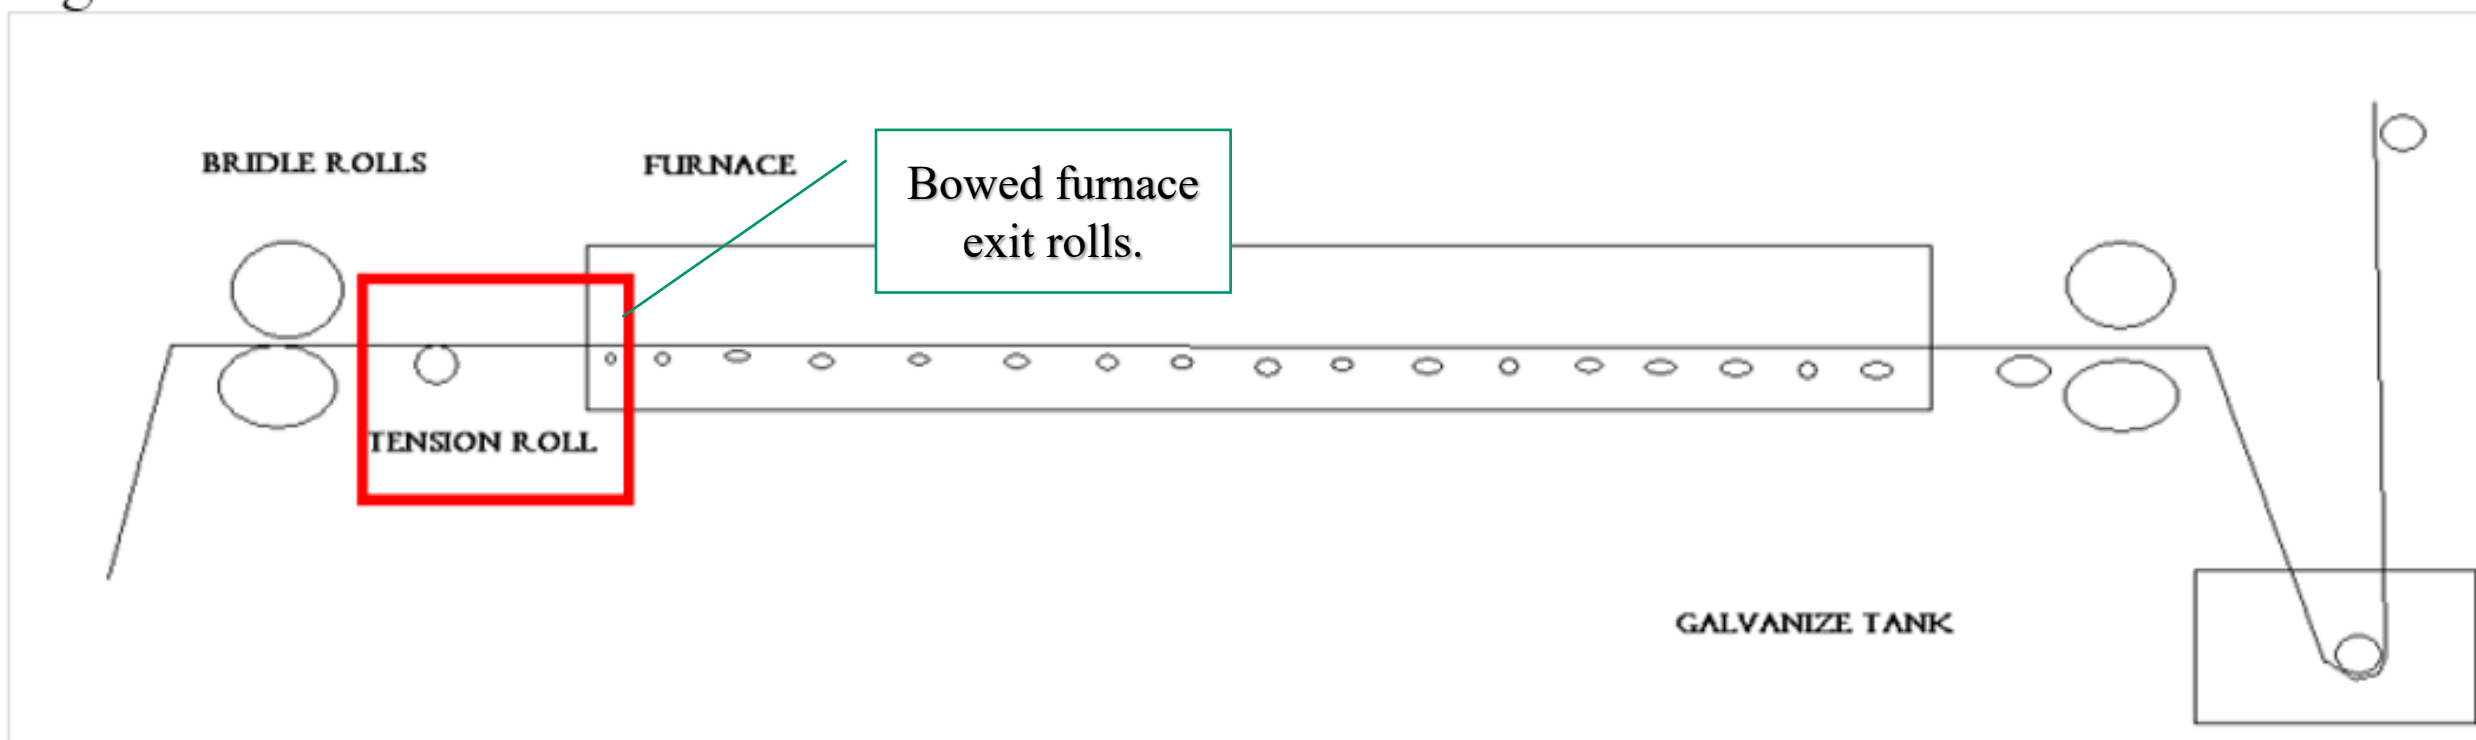
- **Source of 7 HZ discovered-** Drawings were examined and the 7 HZ problem was discussed with plant personnel. It was discovered that the small 4 ½” diameter furnace exit rolls turned at exactly 7Hz.
- **Question:** How could small 4 ½” rolls cause the entire 300 ft. structure to vibrate and all the other rolls to respond in a torsional manner ?

Answer- The control system is programmed to keep a constant tension on the sheet. The bowed rolls located near the tension detector caused the tension to increase, then decrease at once per revolution. When the control system sensed a decrease, several hundred horsepower of bridle roll motors would apply more torque trying to increase the tension. The reverse was true when the tension decreased. This occurred at 7 HZ. The relatively minor perturbation caused by the small bowed rolls was being amplified by the control system.

- Sometimes it is necessary to dig deep and think outside of the box.
- Common sense lets you know that the force generated by a small component is unlikely to cause a major structure to vibrate so something else would have to be involved.
- In this case, this was a problem caused by the controls. Perturbations in the signals supplying the controls brought several hundred horsepower of bridle roll motors into play. The solution was to reduce sensitivity of the controller and watch for future bowed exit rolls.

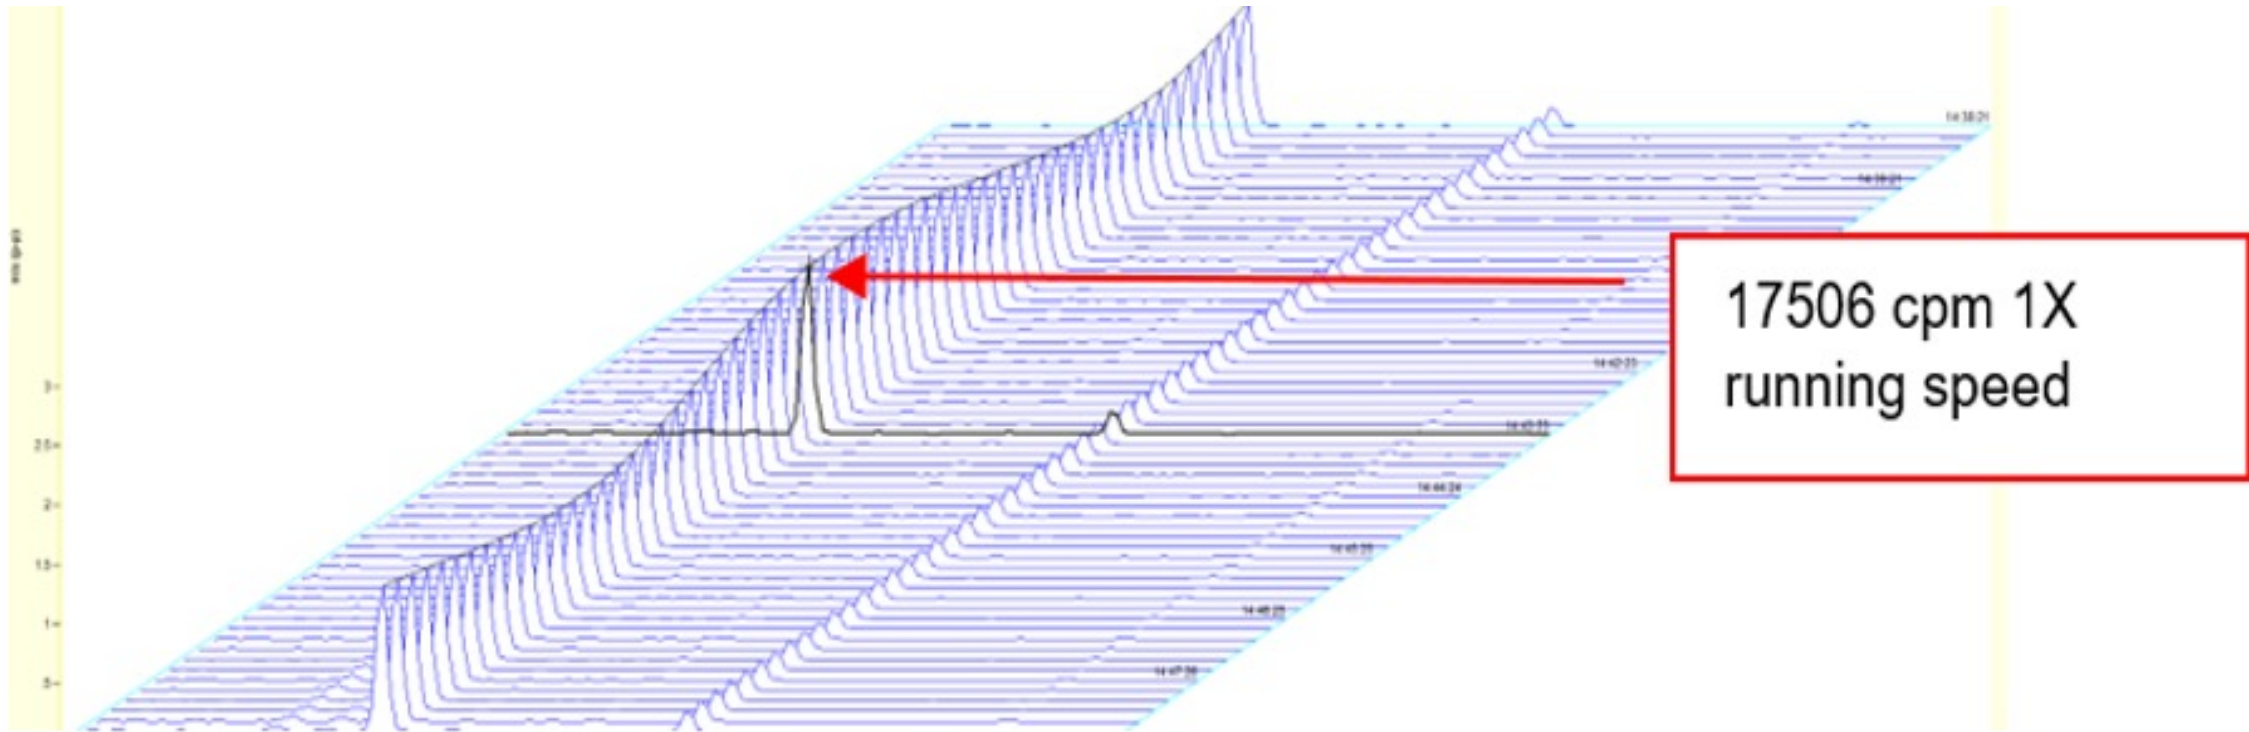
Waterfall plot of spectra from 3d stage proximity probe. Note how 1X running speed increases and decreases.

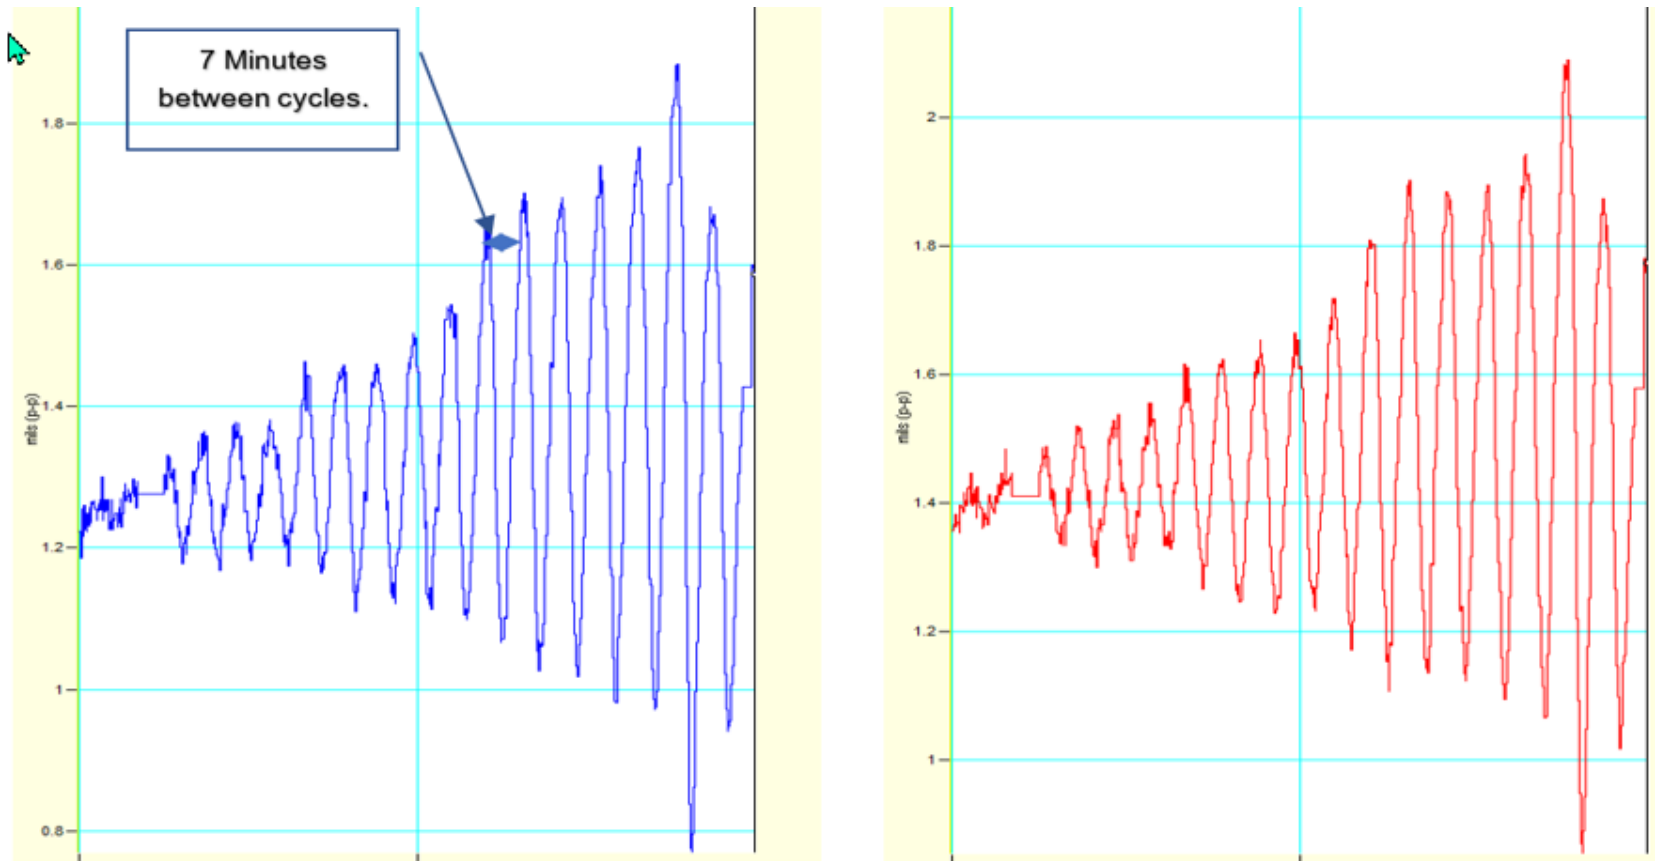
Two-hour time span showing trend of vibration on stage 3X and 3Y proximity probe amplitudes. Note how each cycle lasts approximately 7 minutes. Every cycle, the vibration gets progressively higher. This was disturbing to the operators in that they would see the vibration was getting worse over time.

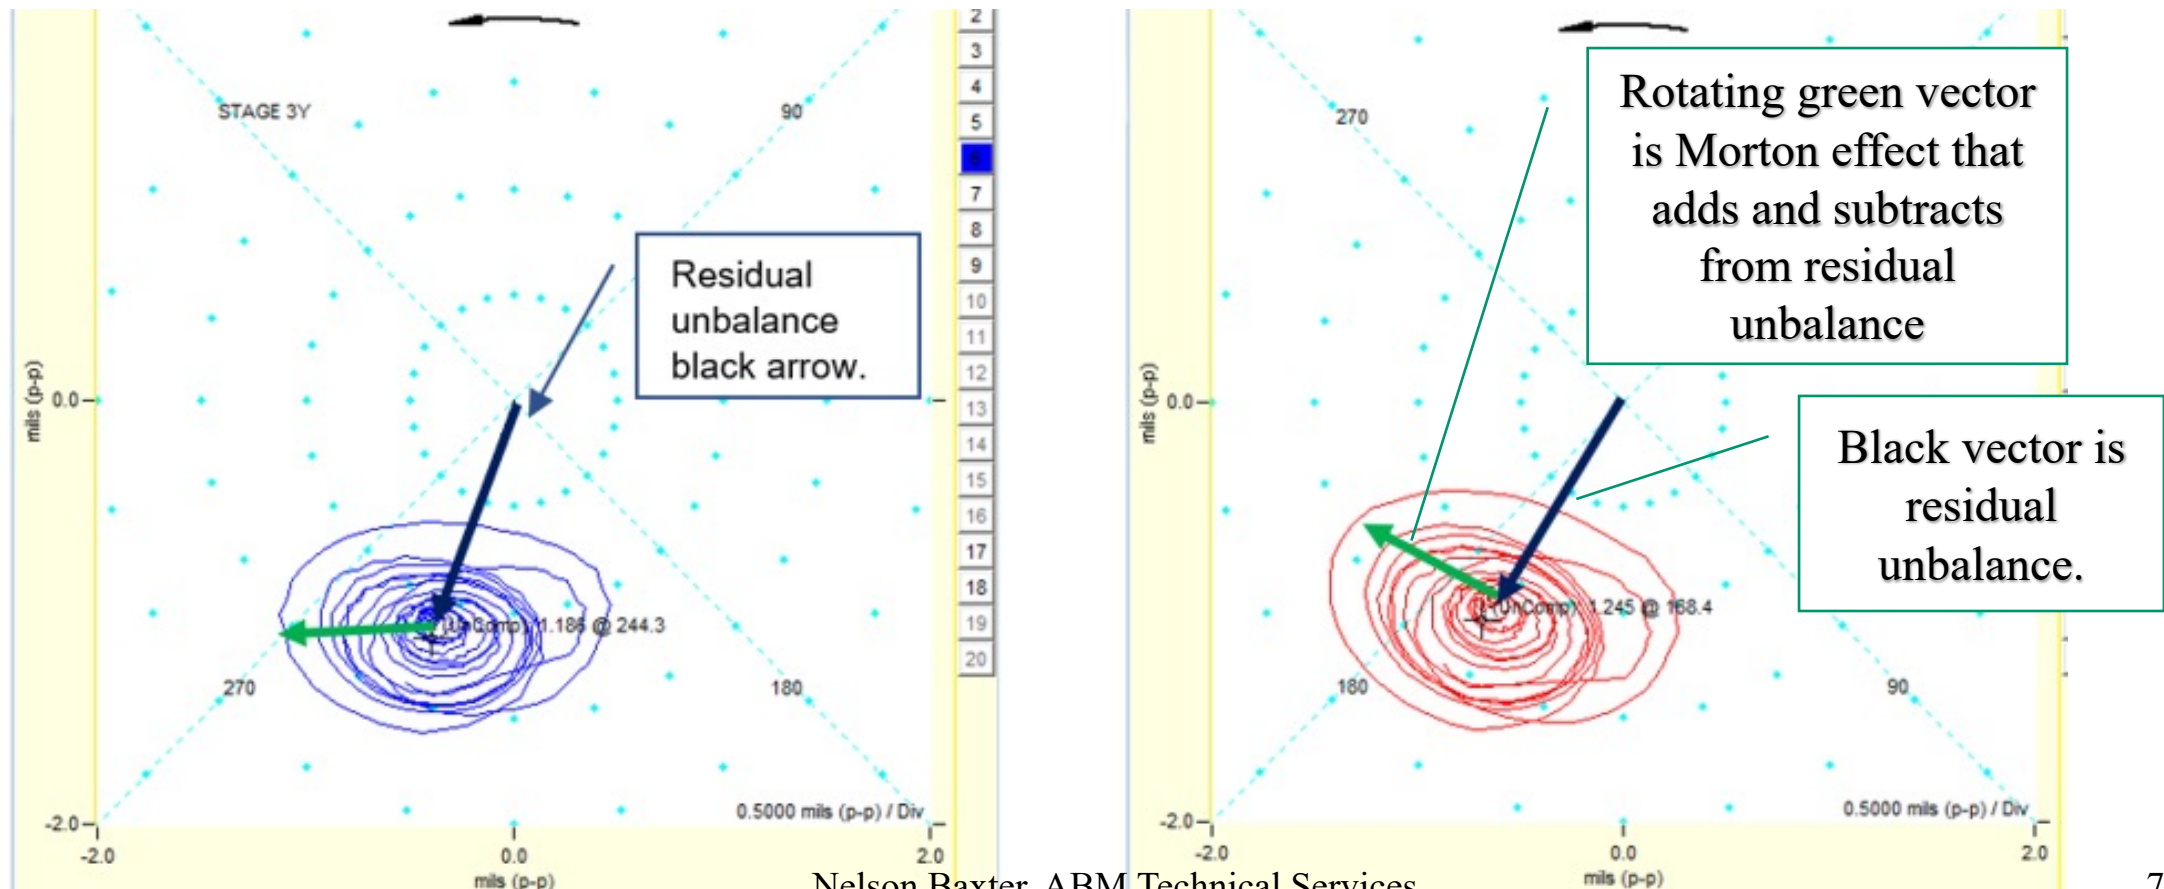
Polar plots from X and Y probes show spiraling outward vectors.

- The Morton effect occurs as a result of uneven heating of the shaft at the high spot caused by the residual unbalance of the impeller. Because of the high-speed nature of these overhung impellers, the point of the slightly elevated shaft temperature slightly lags the unbalance. This means the unbalance slowly rotates around the shaft casing to come in and out of phase with the unbalance. The heating also tends to slowly increase with each cycle. The solution was to change the bearing design to reduce the amount of shaft heating. This case is a good example of using various test techniques.

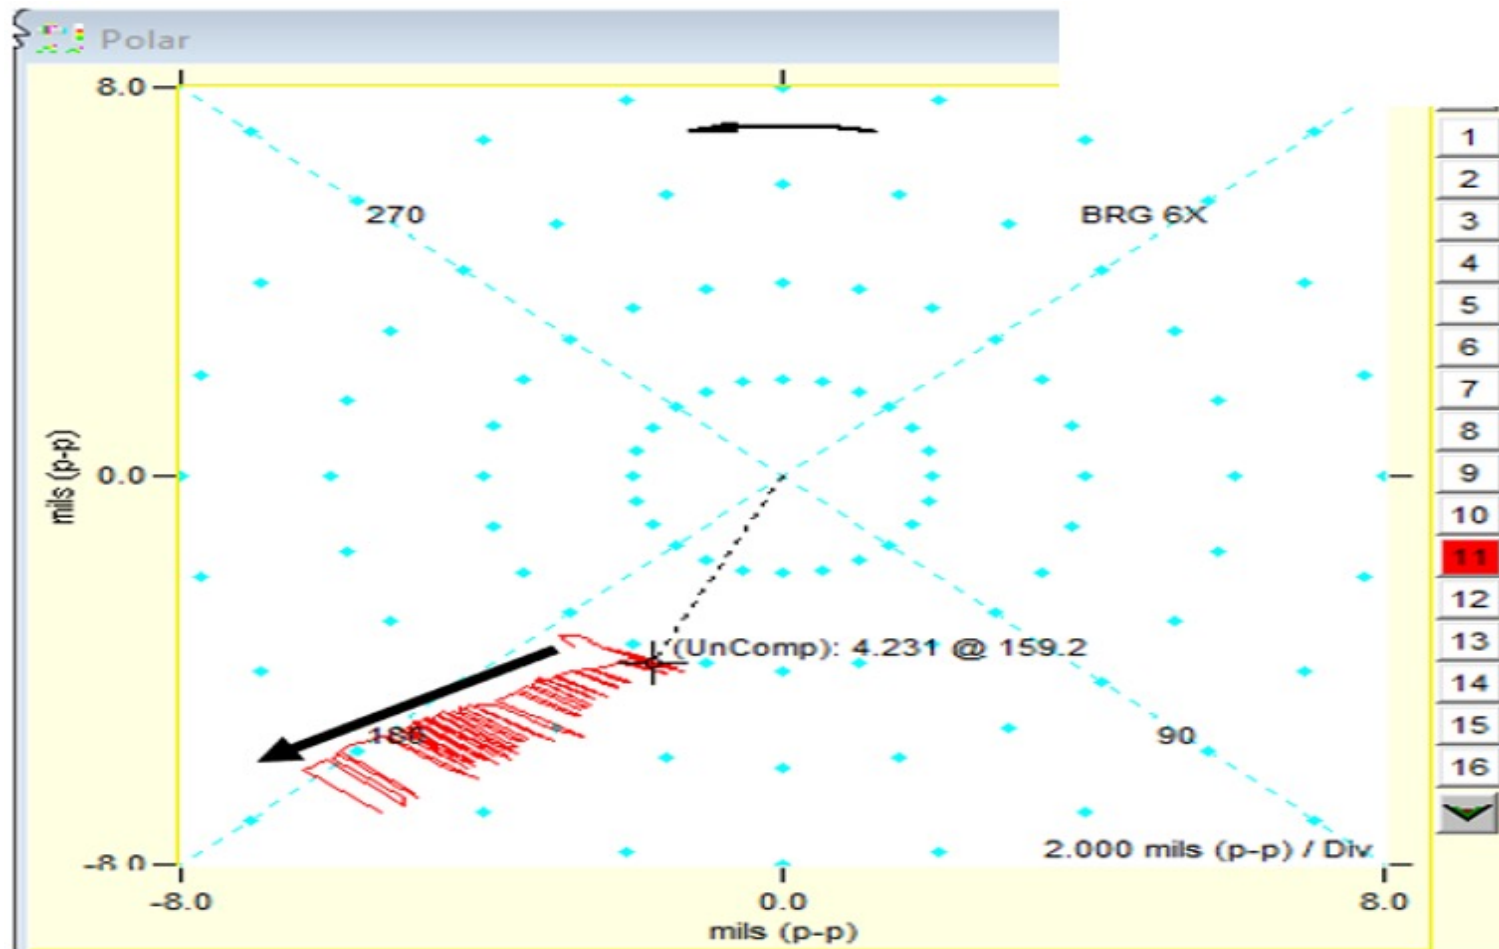
LP Turbine Polar Plot with speed held constant. Rub is increasing vibration and changing phase.

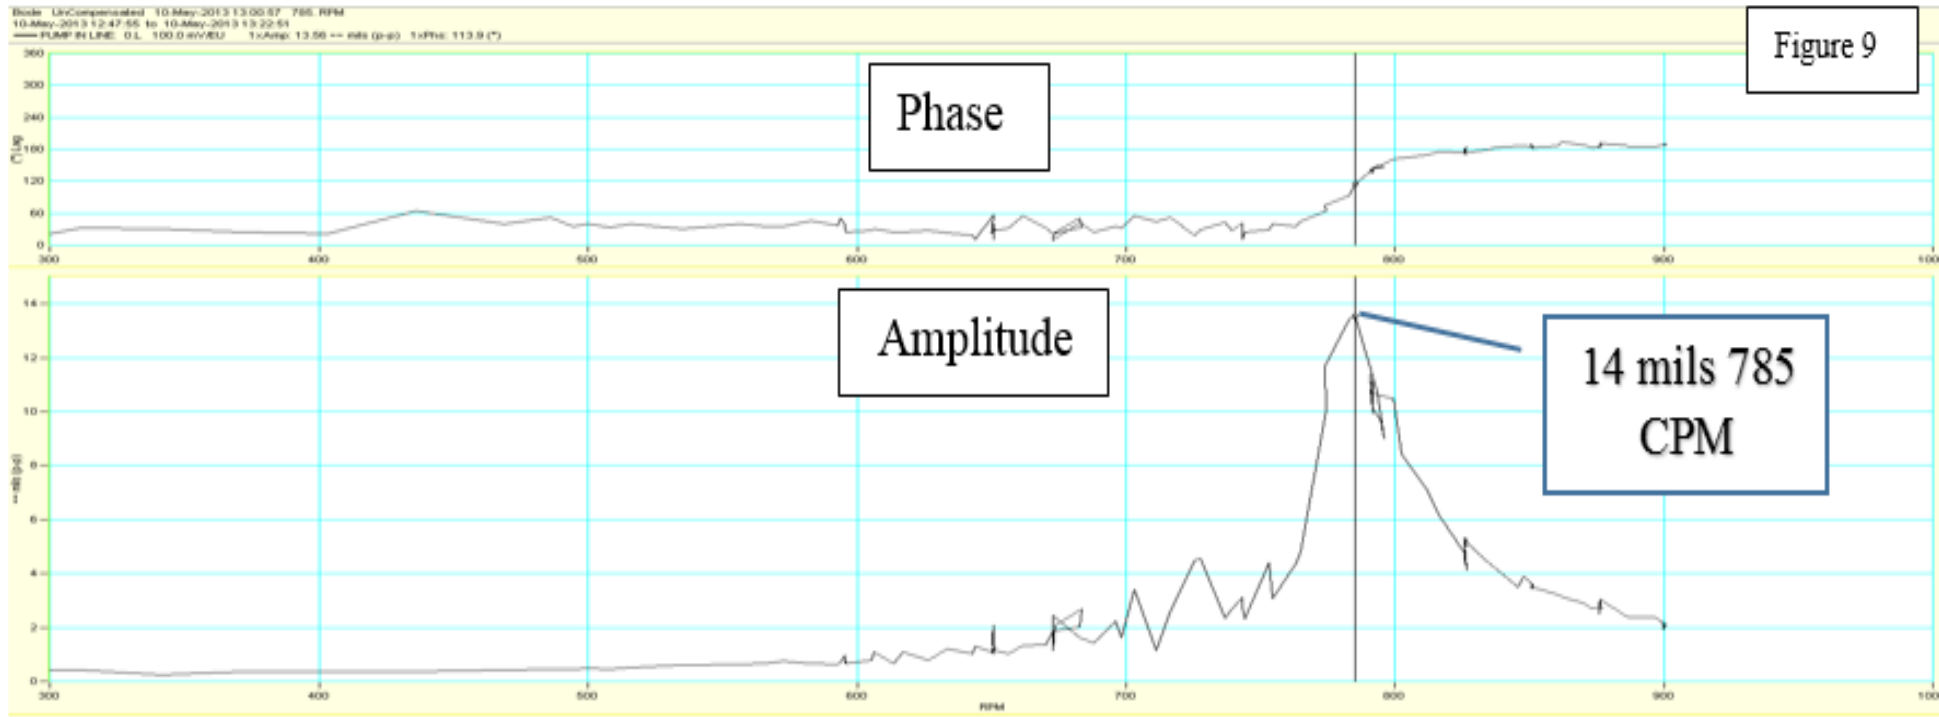
Vibration vs speed with VFD installed

As predicted by the impact test, there was an amplified response at 750-800 RPM

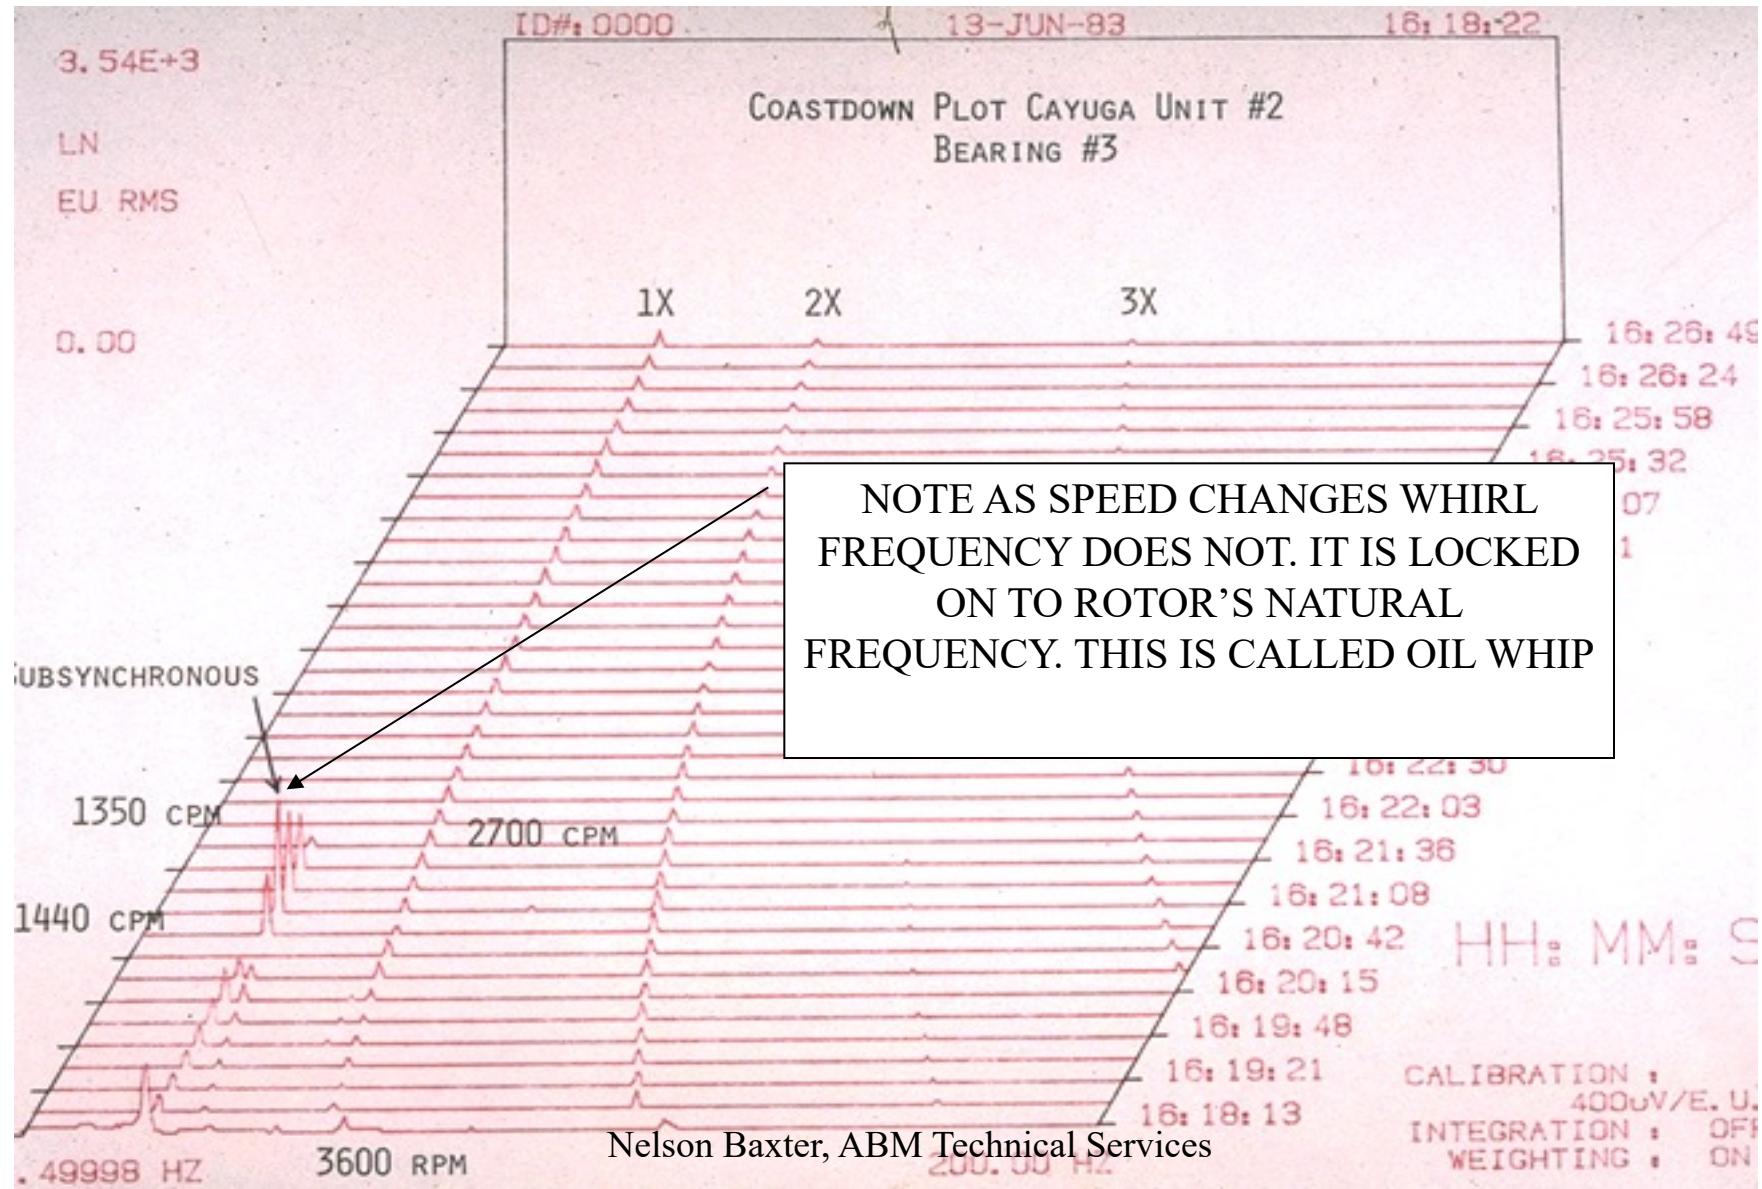
MAP PLOT

As the speed increased, the vibration was ok until the speed reached 2700-2800 RPM. At that point, the vibration would suddenly appear. As the speed increased, the oil whirl spectral component did not increase in frequency with the speed. The frequency of the vibration matched the 1st critical speed of the High-Pressure rotor. Once twice the critical speed was reached, the vibration would appear then as the rotor speed increased, the vibration stayed locked onto the rotor's natural frequency. What was occurring was oil whip. This is a condition where the oil whirl locks onto the rotor's natural frequency.
