The Dirty Dozen

The 12 Most difficult problems I have worked on during the last 45 years of troubleshooting vibration related problems

Nelson Baxter

Presented For The Vibration Institute, Piedmont Chapter, May 2023

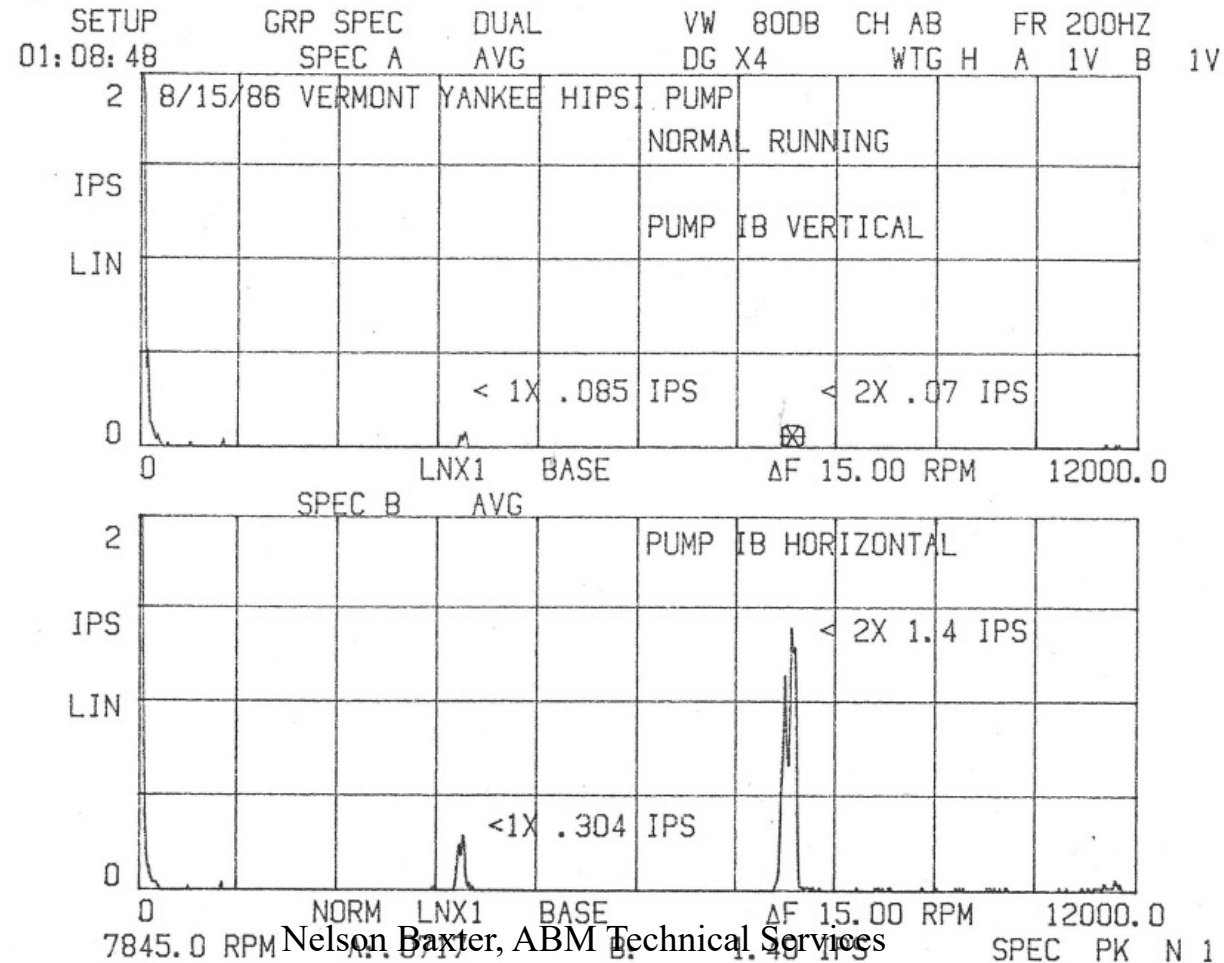
Spectrum From HP Pump 2X Vertical .07 in/sec 2X Horizontal 1.4 in/sec

The very large horizontal to vertical amplitude ratio plus the sensitivity to speed changes pointed towards a natural frequency problem in the horizontal direction. An impact test was performed and there was a horizontal natural frequency in the 7500-8000 cpm range. Then next figure shows the mode pivoted around the center of the pump case. When operational phase measurements were made the inboard and outboard phase readings were very nearly 180 degrees apart. This confirmed the presence of the pivotal structural mode.

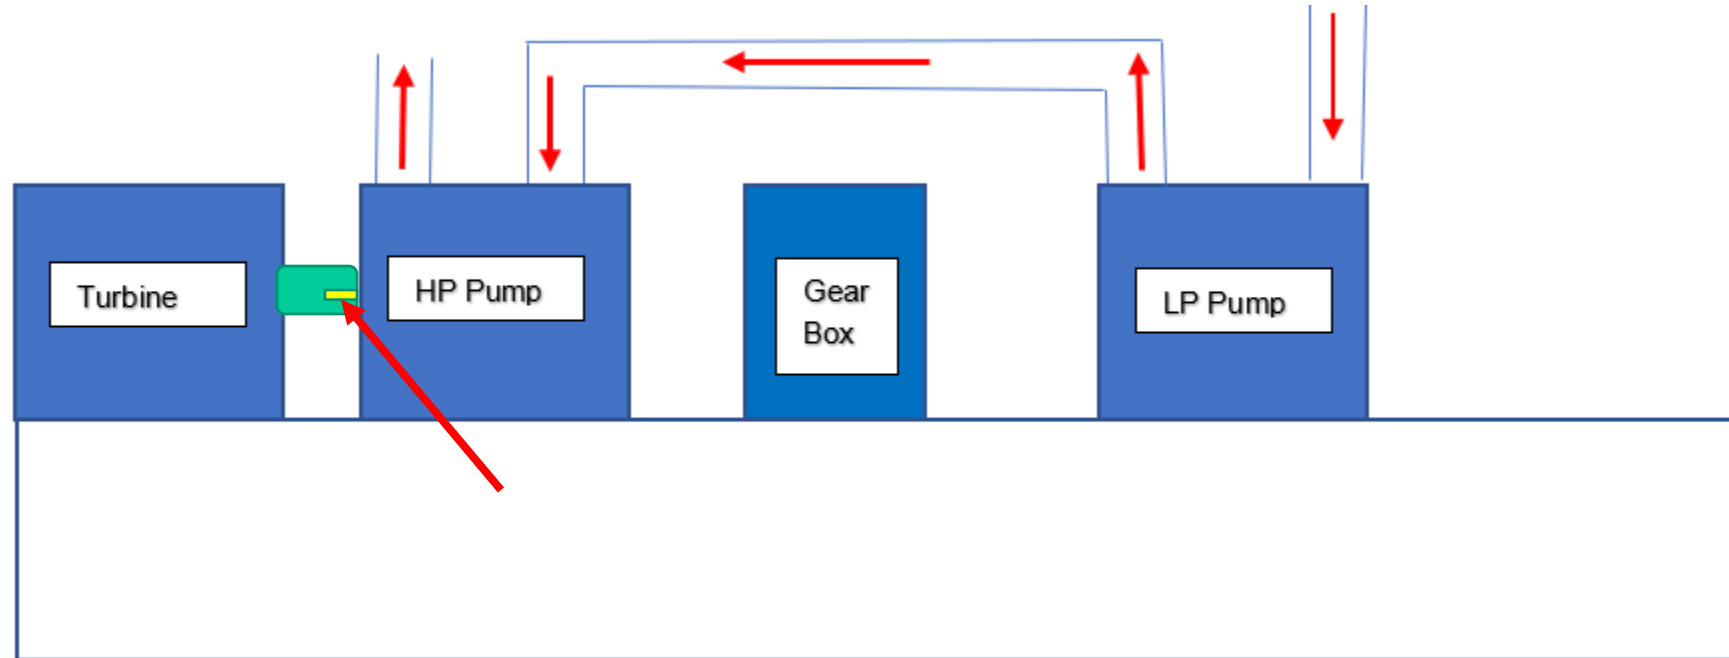
When the tach tape for the synchronous time averaging was placed on the High Pressure pump, the what had been supposed to be 2X vibration disappeared.

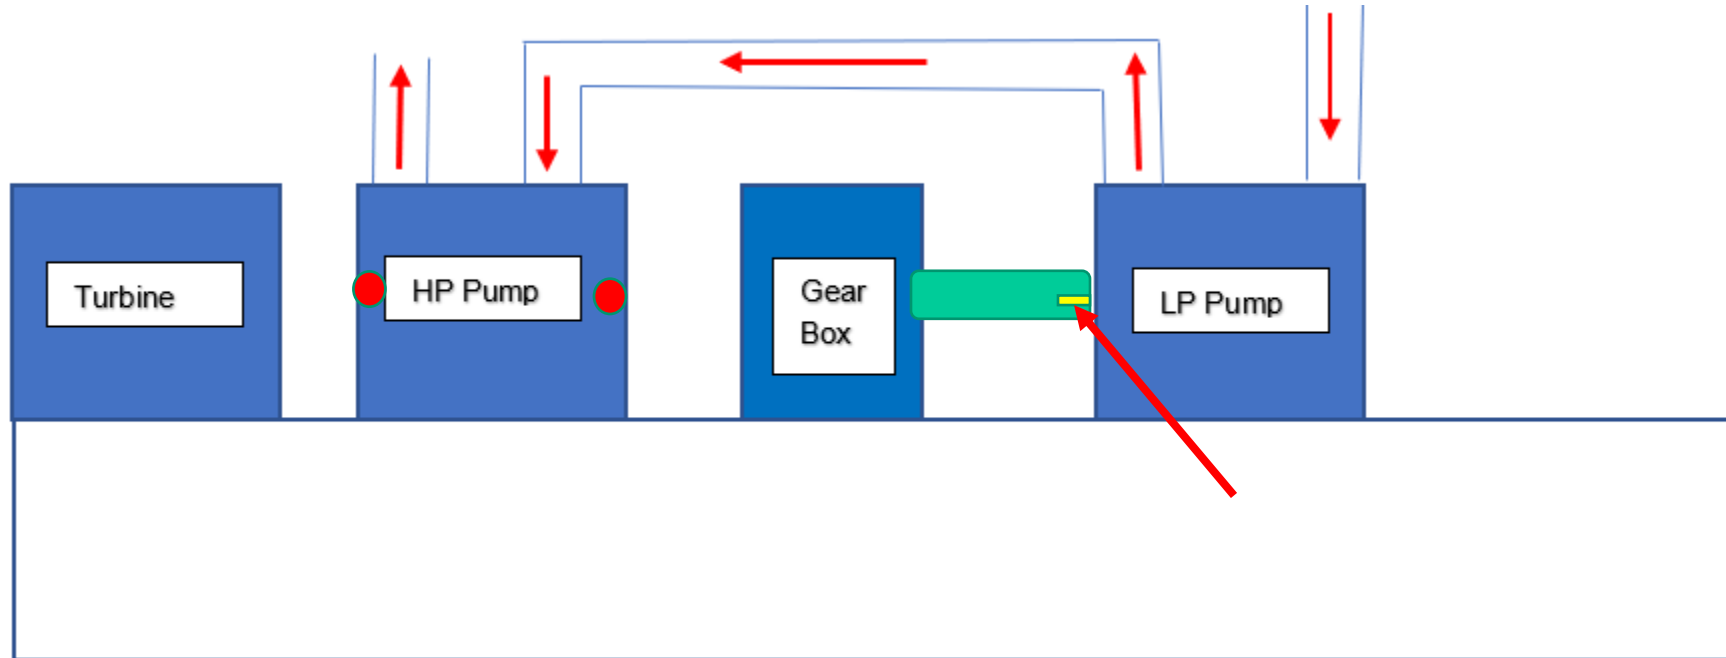
When the tach tape for the synchronous time averaging was placed on the Low Pressure pump, the what had been supposed to be 2X High Speed Pump vibration remained in the spectrum of the vibration on the High Pressure Pump.

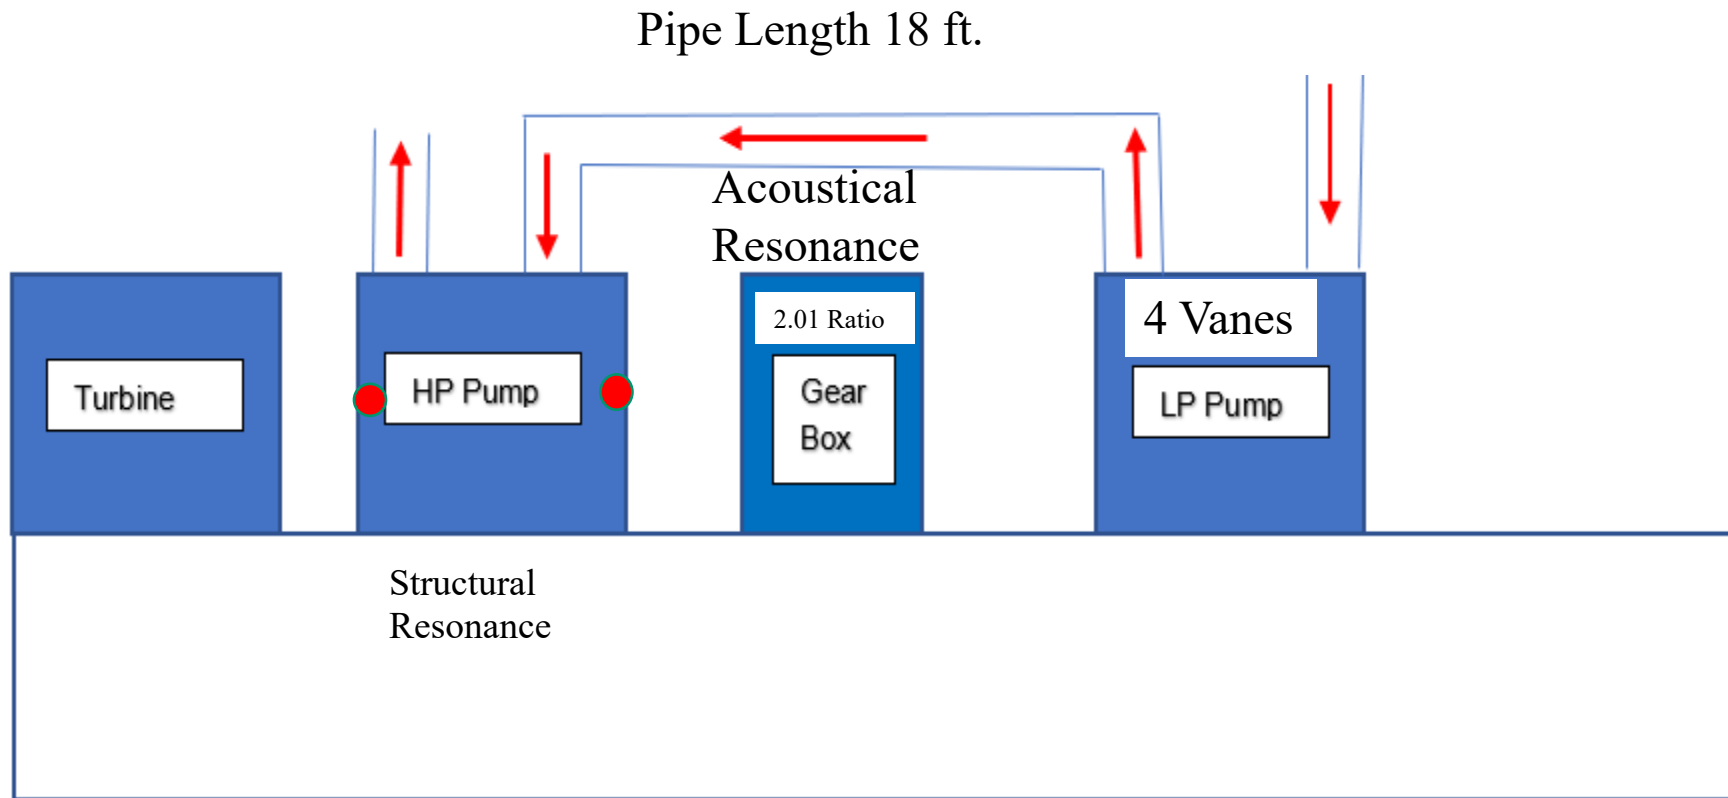
3: What made it possible for the pressure pulses in the Low Pressure Pump to excite the High Pressure pump's structural natural frequency was an acoustical natural frequency that matched the blade frequency of the Low Pressure Pump.

$\frac{1}{2}$ wave length of vane pass frequency from 4 vane impeller in LP Pump matched length of pipe connecting it to HP Pump. The vanepass stimulus amplified by acoustical resonance then excited the horizontal structural natural frequency of the HP Pump.
