**The Boundary
Carbondale, CO**

Report #: 22010-0
Beginning: January 1, 2022
Expires: December 31, 2022

**RESERVE STUDY
"Full"**

October 11, 2021

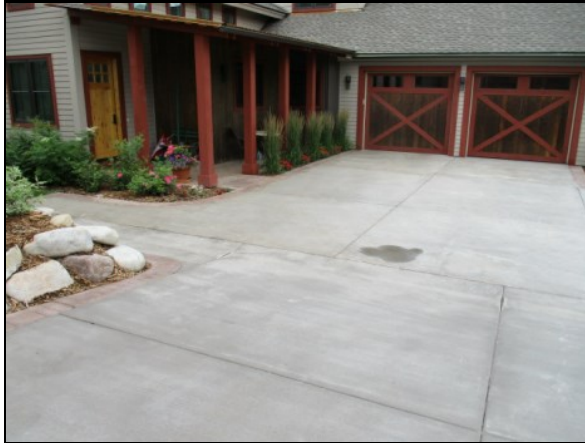
Comp #: 21050 Driveway Concrete - Repair - 5%

Comments: Concrete driveways determined to be in good condition typically exhibit smooth surfaces with positive slopes. Good consistent aesthetic condition. Driveways are reported to be the maintenance and repair responsibility of the client. Although complete replacement of all areas together should not be required conditions observed merit inclusion of an allowance for ongoing repairs and partial replacements. Exposure to sunlight weather and frequent vehicle traffic can lead to larger more frequent repairs especially for older properties. Inspect all areas periodically to identify trip hazards or other safety issues. Timeline and cost ranges shown here should be re-evaluated during future Reserve Study updates.
