TRIUMPH DISTRIBUTORS

BULLETIN #T61-2

SUBJECT: AXLE SHAFT UNIVERSAL JOINTS
HERALD MODELS

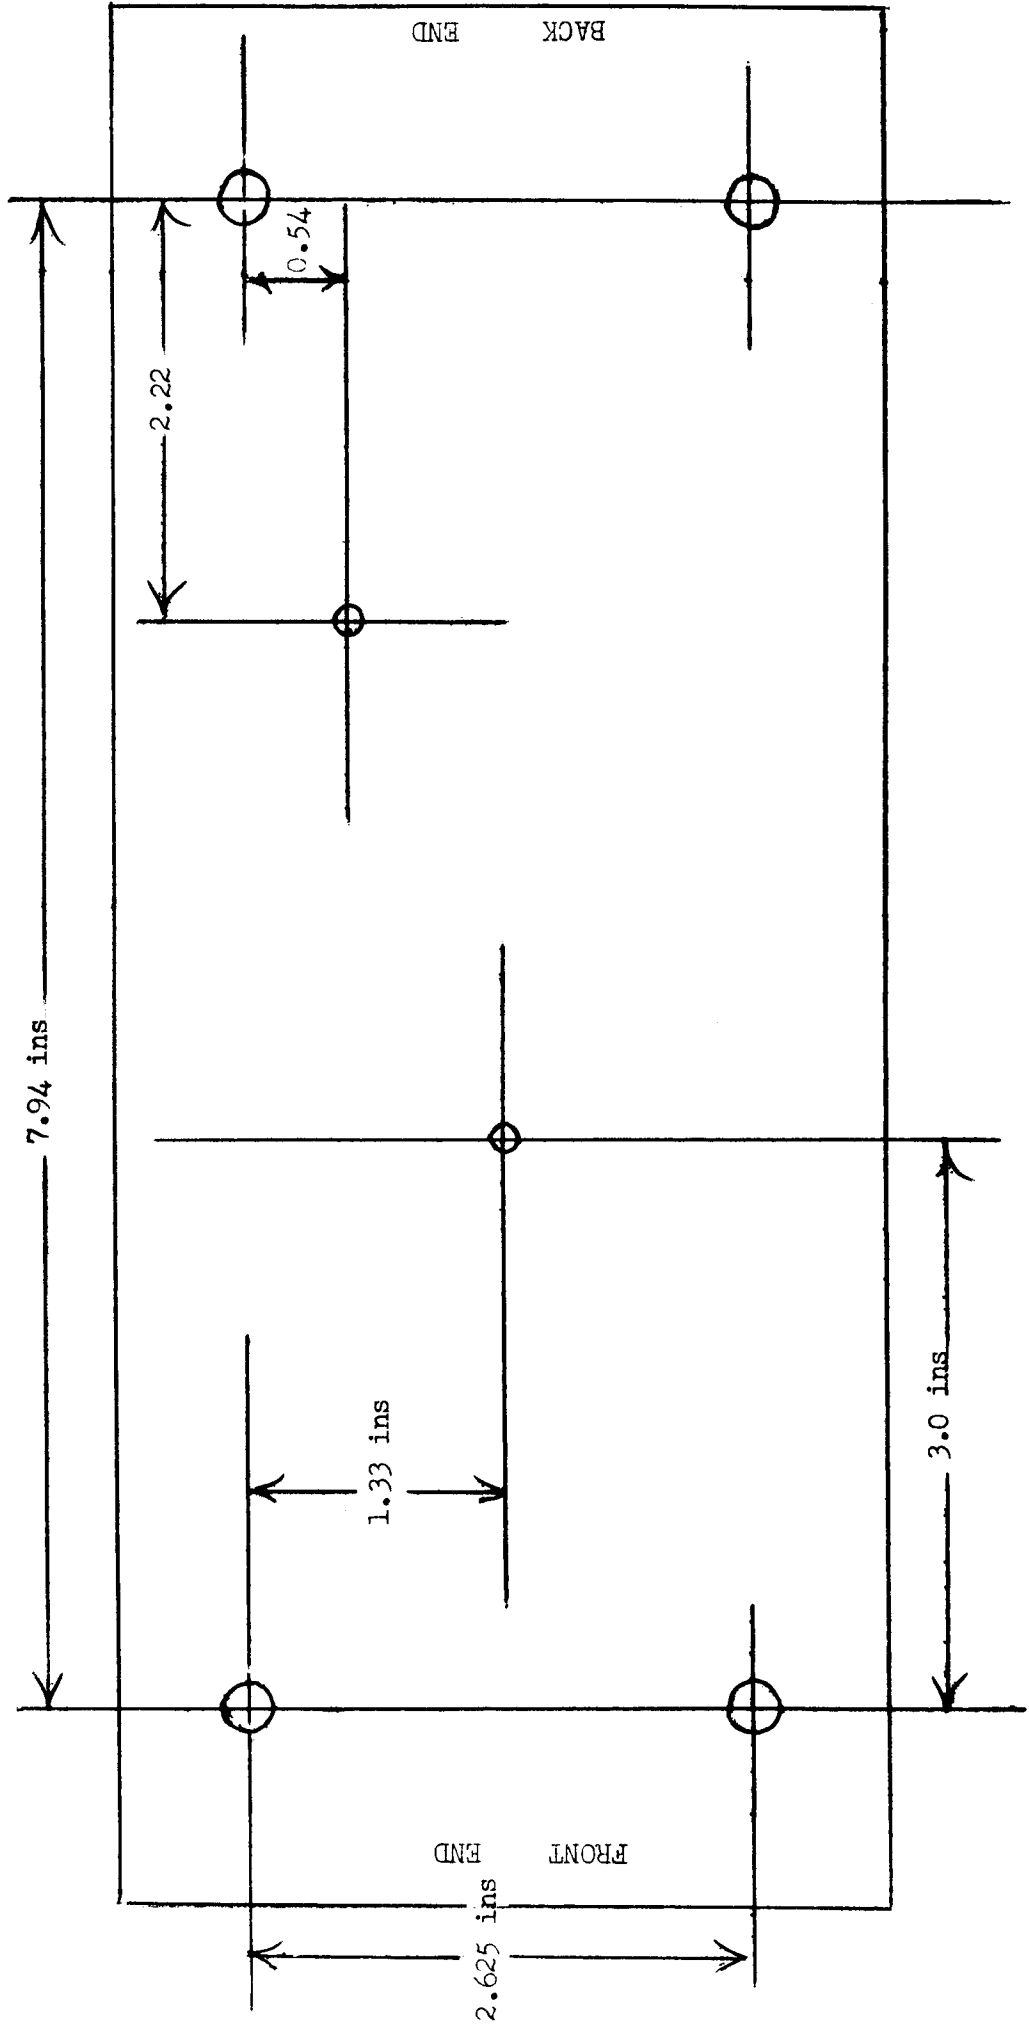
The dia gram shows the top view of the template. The four locating holes to be drilled 11/32" and the two smaller holes approximately 1/8".

The switch holes can be drilled and tapped, using a 17/32" drill and a 16 mm x 2 mm tap. It will be necessary, however, to remove the selector rods, etc., from the extension, prior to drilling, in order to avoid damage and to enable the resulting metal particles to be thoroughly cleaned away.

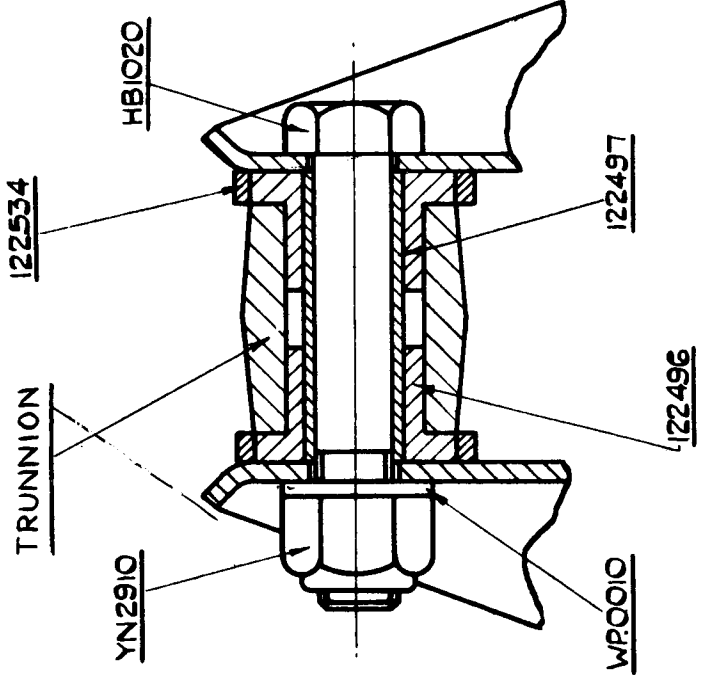
EXISTING ASSEMBLY.

To improve the sealing and prevent premature wear of the bushes of the front suspension lower trunnion, shims have been added to the assembly as shown in the illustration.

When the occasion arises to renew the trunnion bushes, these shims should be added, which necessitate replacement of the distance piece Part No. 132039, in place of the original distance piece Part No. 122497. The fitting instructions are as follows:

1. Remove hex. nut YN 2910 and washer WP 0010. Withdraw hex. bolt HB 1020.
2. Remove distance piece 122497, bearing 122496 and seals 122534 from lower trunnions.
3. Reassemble above items as follows:
Fit shims 132038 between bearings 122496 and lower trunnions as shown in modified assy.
4. Fit distance piece 132039 in place of 122497. Fit seals 122534.
5. Reassemble and insert hex. bolt HB 1020.
6. Replace washer WP 0010 and hex. nut YN 2910.

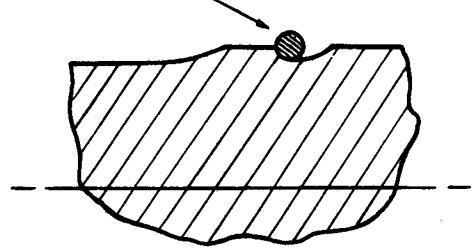
ENLARGED VIEW OF LATEST TYPE
CIRCLIP GROOVE (PART No. 132649)

Inner half shaft assemblies from rear axle numbers GA-35604 and Y-31501 incorporate a revised circlip groove. These shafts may be used to replace the earlier type, provided that the revised circlip is also fitted and the existing thrust washer discarded.

<u>Item</u>	<u>Existing Part Nos.</u>	<u>Replaced by Part Number</u>
Inner axle shaft assembly	117661	132649
Circlip	121680	132650
Thrust washer	120327 (No longer required)

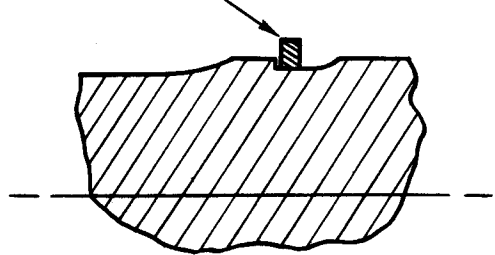
ENLARGED VIEW OF EARLIER TYPE
CIRCLIP GROOVE (PART No. 117661)

PART No. 132649 - DIM. $\overset{A}{\text{A}}$ 0.643"/0.648" (16.33/16.46mm)
PART No. 117661 - DIM. $\overset{A}{\text{A}}$ 0.683"/0.685" (17.35/17.40mm.)
