Genser-Forman Inc. TRIUMPH DISTRIBUTORS

BULLETIN: T-62-9
DATE: AApril 19, 1962
SUBJ: TRIUMPH HERALD
HORNS

BULLETIN #T-62-10
DATE: April 18, 1962
SUBJ: CARBURETOR
HERALD 1200

BULLETIN: # T-62-13
DATE: April 19, 1962
SUBJ: ENGINE RESTRICTOR
BRACKET - TR-4

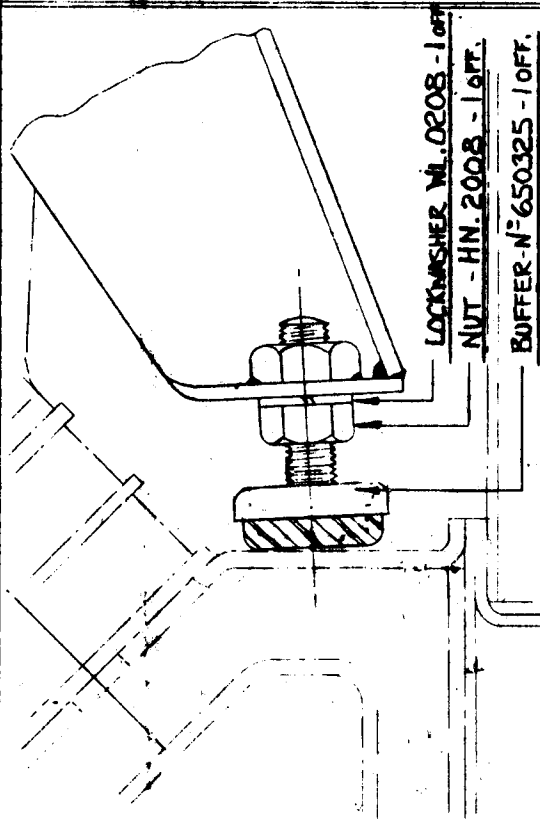
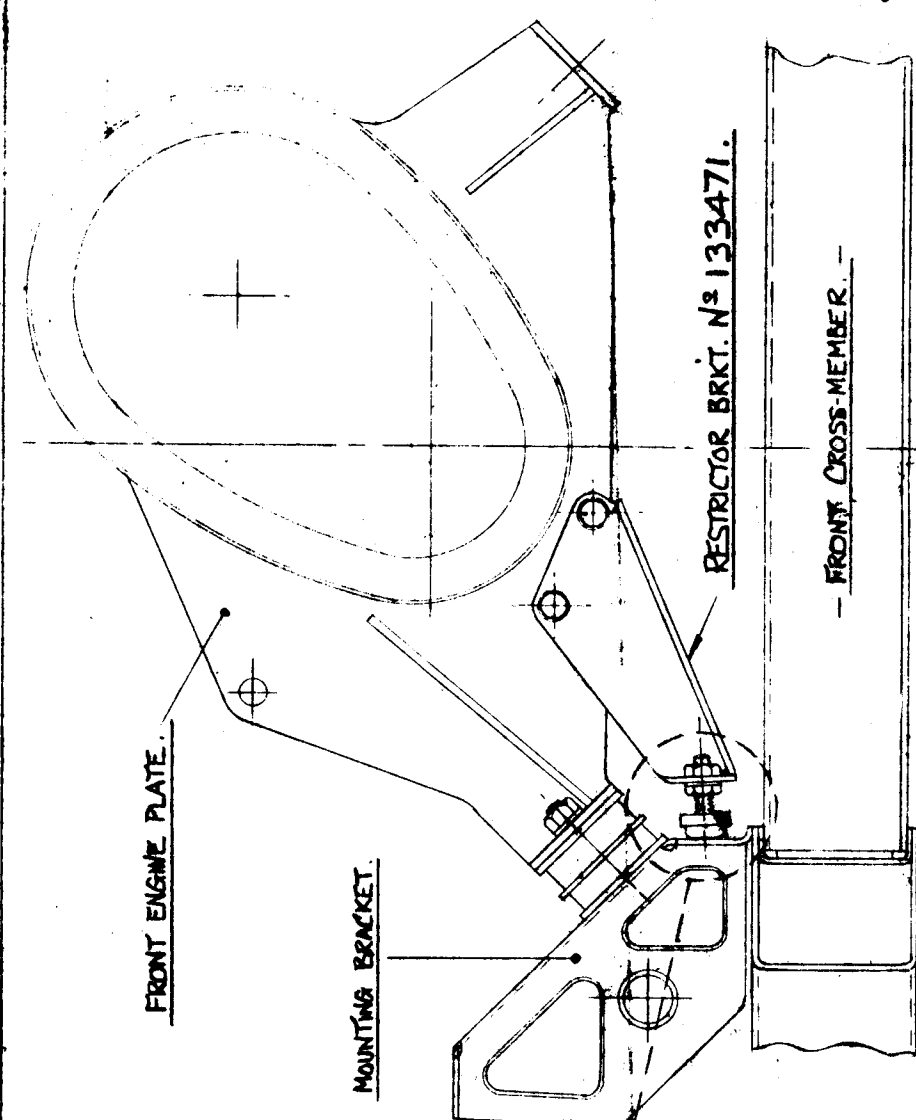
SS.110/61.

Attached hereto is a drawing of Part No. 133471, Engine Restrictor Bracket - TR4, designed to prevent damage to the power bulge on the hood by carburetors contacting this point under the influence of engine reaction movement.

DESCRIPTION.	MODEL.	ISSUE: -1
ENGINE RESTRICTOR BRACKET -- TO PREVENT EXCESSIVE ENGINE MOVEMENT & SO MAINTAIN CLEARANCES TO BOWNET CLEARANCES.	TRIUMPH TR 4.

- 1/ SCREW BUFFER INTO RESTRICTOR BRACKET LEAVING LOCKNUT LOOSE.
- 2/ BOLT BRACKET TO ENGINE PLATE IN POSITION SHOWN USING EXISTING BOLTS.
- 3/ SET FT. FACE OF RUBBER BUFFER JUST TOUCHING FACE OF ENG. MTS. BRKT. & TIGHTEN LOCK NUT AS SHOWN.

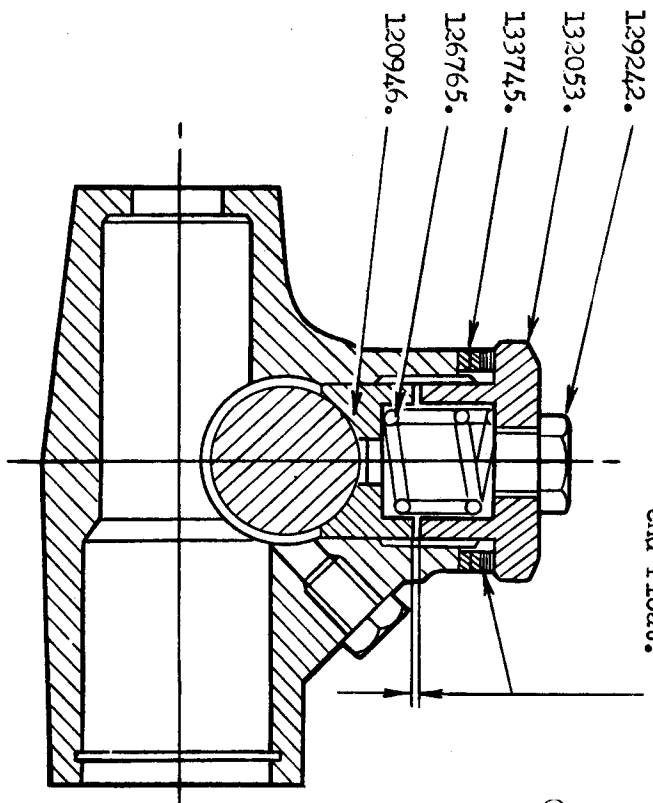
CIRCLIP SLOT.

Some steering units incorporate a circlip and spring plate to retain the plunger in the rack and pinion assembly. Should circlip failure occur, modify the unit to the current screwed cap and spring method of retaining the plunger, as illustrated overleaf and described below:

Use shims 120949 and 120959 as required to give 0.004" - 0.008" (0.1- 0.2 mm.) plunger end float.

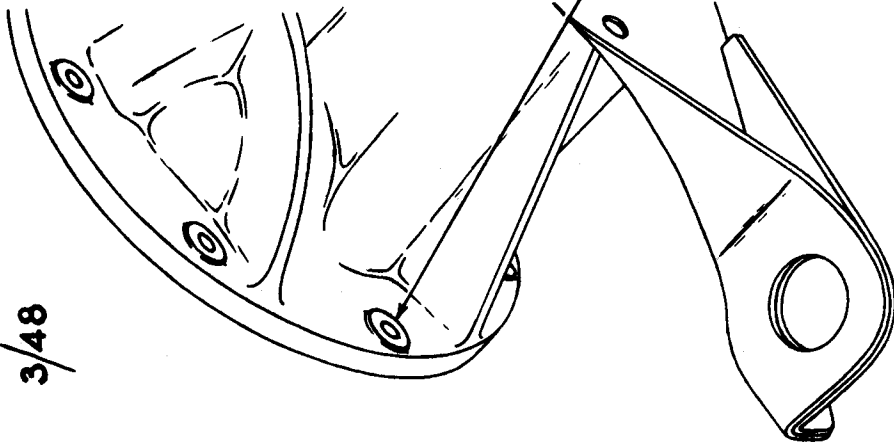
The hypoid housing was, until recently, attached to its casing by six setscrews (Part No. HU 0808) and two shorter setscrews (Part No. 124717), the latter being fitted in the holes adjacent to the inner shaft bearings. Should the longer bolt be fitted in either of these two holes, damage to the inner shaft bearing would occur.

Fit two short setscrews
 $\frac{3}{4}$ " long Part No. (124717)
to attachment flange with-
out bosses at this point
and the opposite side.

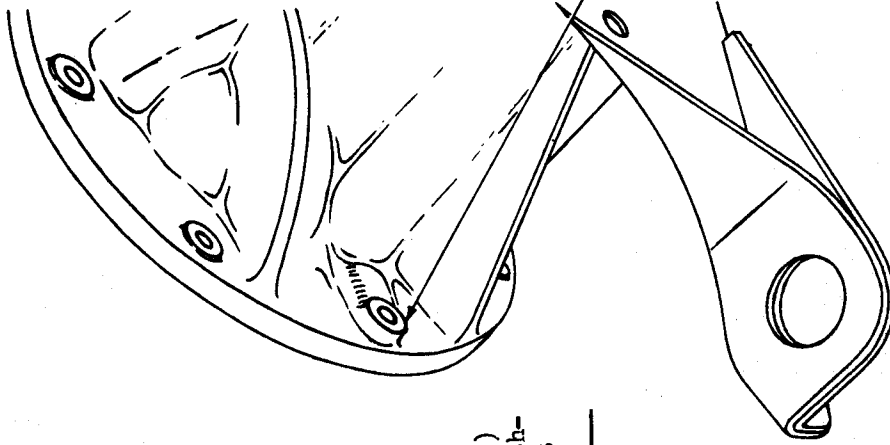
To prevent such damage all current hypoid housings have two raised bosses at these points, allowing the use of eight identical bolts.

Fit two longer setscrews
1" long Part No. (HU.0908)
to attachment flange having
bosses at this point and the
opposite side.
