7ca a YfWU Property Inspection Report

8888 Main Street
Monterey, CA 93940
Inspection Date: 10/27/2015

Joe Sample for ABC Incorporated

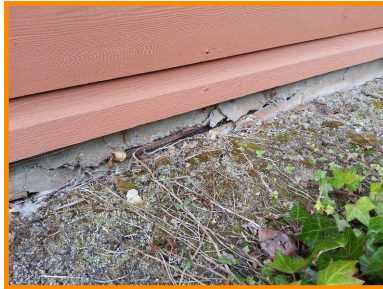
[CR] Damage/deterioration (spalling) was noted in the concrete foundation at the front. This condition is related to moisture and rusting (expansion) of metal structures in the concrete too near the surface, resulting in damage to the foundation over time. **We recommend correction by a licensed and qualified masonry contractor.**

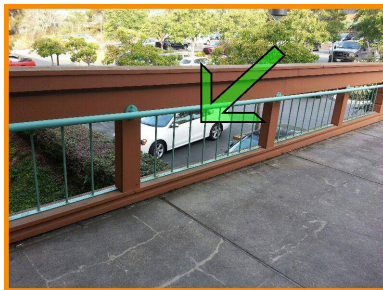
[SC] The guardrail(s) for the deck at the rear and porch at the front may have met the building standards at the time of construction, however, the wide spaces between the balusters are a hazard for small children. Modern construction guidelines typically state that a "4 inch sphere" should not pass between the balusters. While upgrading may not be required, additional measures for child safety like netting or some other means is strongly recommended.

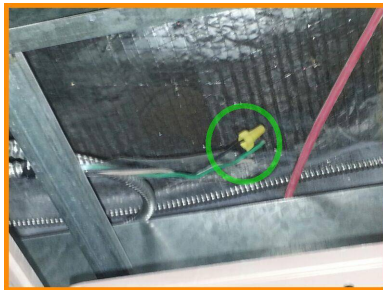
[SC] There were electrical wiring ends/connections that were not contained in approved electrical junction boxes in/at the attic of the unit 102, between 200 and 201. All electrical wiring ends/connections should be contained in approved, covered and accessible junction boxes. This is a potential fire/shock hazard.

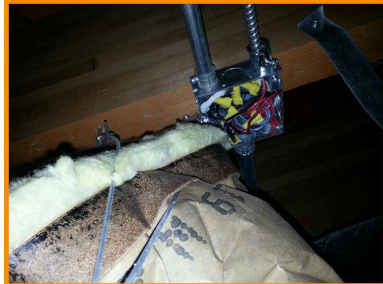
[SC] Junction-box cover plates were missing in/at the attic of 102, 107 and the upper left hall. This condition is a shock / electrocution hazard due to exposed electrical components; all electrical junction boxes should have an approved spark-proof cover. This is a potential fire hazard.

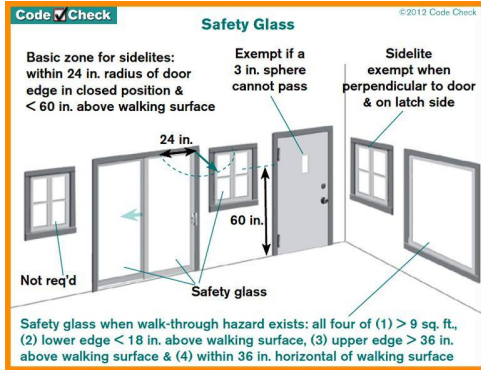
[SC] There were no visible safety glass markings on the glass in 107, 200A . Glass in these locations should be the safety type to minimize the potential for harm if it were broken (breaks into small pieces instead of shards). The glass should be confirmed as safety type or upgraded for safety reasons.

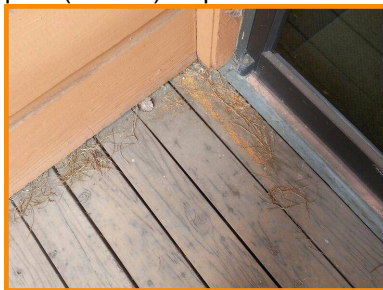
[FE] We observed evidence at the rear deck that suggests the need for a full pest inspection. We recommend a pest (termite) inspection.

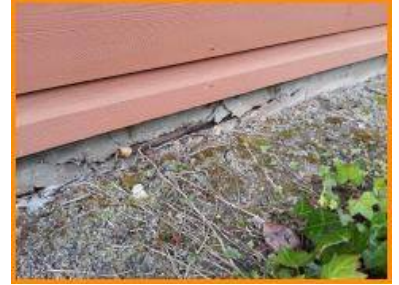
[CR] Damage/deterioration (spalling) was noted in the concrete foundation at the front. This condition is related to moisture and rusting (expansion) of metal structures in the concrete too near the surface, resulting in damage to the foundation over time. **We recommend correction by a licensed and qualified masonry contractor.**

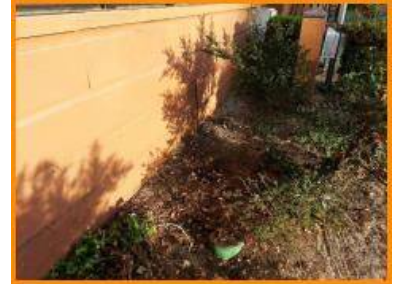
[CR] The exterior cladding was in contact with the soil at the left. This condition is conducive to moisture related damage and deterioration. A four to six inch separation should be maintained to minimize the potential for damage due to moisture wicking from the soil into the framing members.

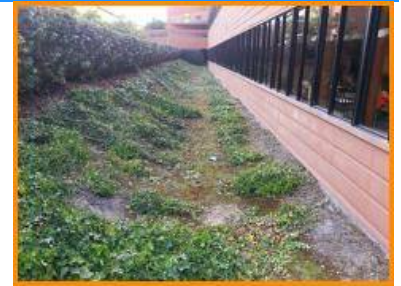
[CR] No drains were observed at exterior front right. This condition left uncorrected can result in the ponding of water and moisture intrusions and deterioration.

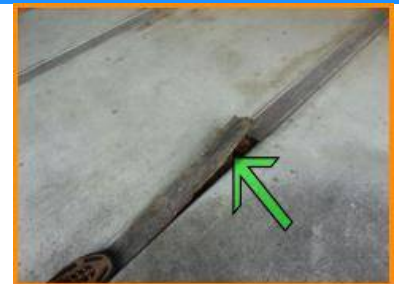
[SC] The entry/porch expansion-joint materials were damaged/deteriorated/missing at the front. The voids created by this condition is a trip/safety hazard.

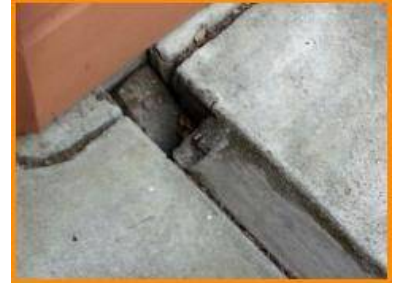
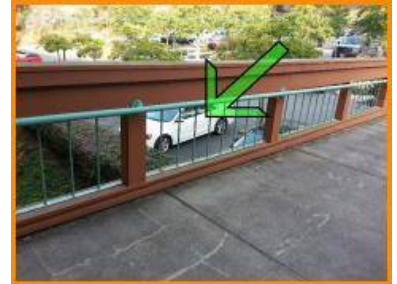
[SC] The guardrail(s) for the deck at the rear and porch at the front may have met the building standards at the time of construction, however, the wide spaces between the balusters are a hazard for small children. Modern construction guidelines typically state that a "4 inch sphere" should not pass between the balusters. While upgrading may not be required, additional measures for child safety like netting or some other means is strongly recommended.

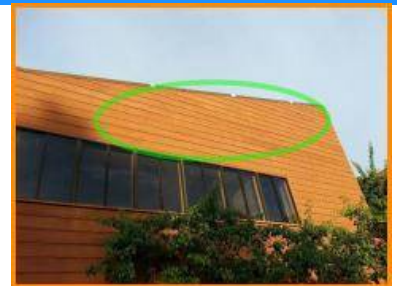
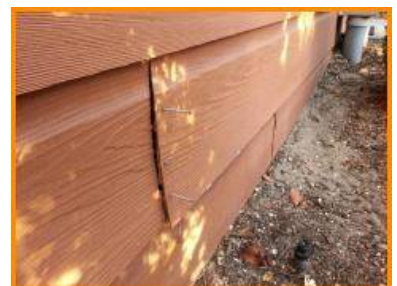
[CR] The nails were popping and the wood cladding was loose/damaged at the left, right and rear. These conditions are conducive to moisture intrusion and deterioration of the building materials.

[CR] The wood cladding finish at the left, right and rear appeared worn/weathered/aging. Continued use in this condition without maintenance may lead to moisture related damage and deterioration of the building materials.

[CR] Gaps were present at the board ends of the wood cladding at the left, right and rear. This condition is conducive to moisture intrusion and deterioration of the building materials.

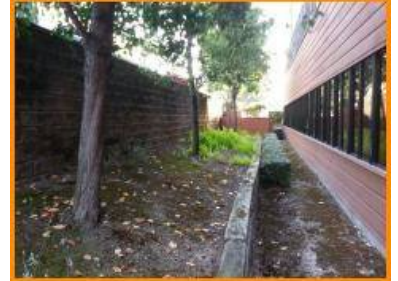
[FE] Retaining walls are outside the scope of the inspection and are not inspected. We recommend consulting with a specialist regarding this system.

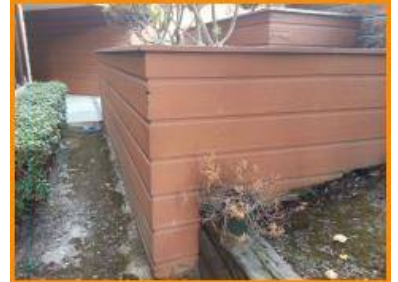
[CR] Moisture damage was noted at the wood framed planters at front. This condition can be expected to continue as the units were made of wood and not masonry.

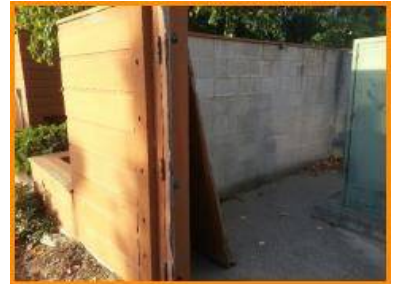
[CR] The wood fencing was damaged/deteriorated to the enclosure at the front. Repairs may extend the useful life of the fencing, but replacement may be necessary.

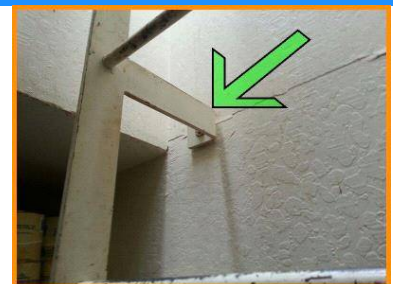
[CR] The access ladder to the roof was loose. Correction should be made before the condition is exacerbated and becomes a safety hazard.

Loose Bolt

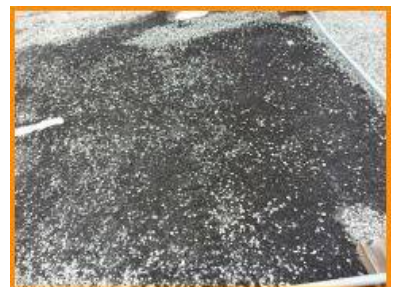
[FE] **Due to observations noted at the roof we recommend a full evaluation by a licensed and qualified roofing contractor.**

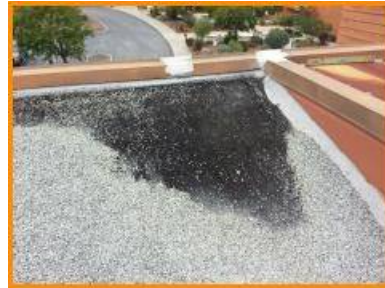
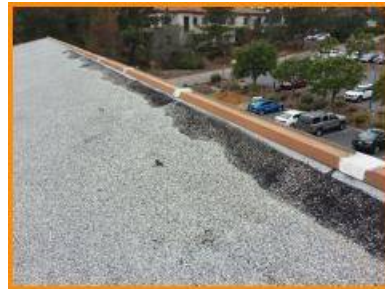
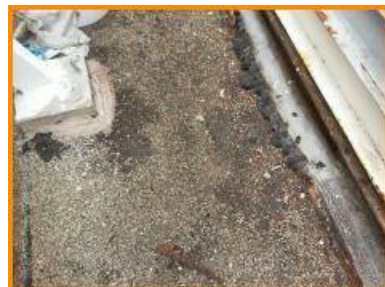
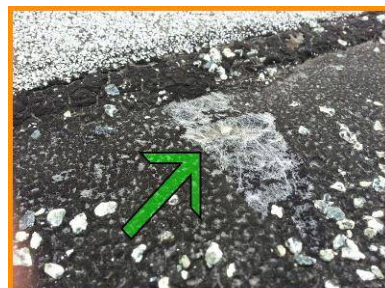
[CR] Areas of the low slope roof need maintenance. Routine roof maintenance can reduce the risk of moisture intrusion/deterioration and may extend the roofs useful life.

[FE] The sun had burned through the low slope roofing material at the left and right. This condition is conducive to moisture intrusion and damage to the building components.

condition restricts roof-water runoff and is conducive moisture intrusion and damage to the building components.

[FE] The low slope roof showed signs of damaged areas at a number of areas on the roof. These conditions are conducive to moisture intrusion and damage to the building components.

Damage

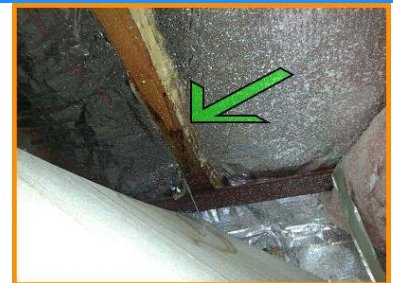
[FE] Dry moisture stains were noted on the attic framing in the attic of 240 (adjacent to rear wall). Continued use in this condition without locating and correcting the source and any damaged materials may lead to additional damage.

Stains - Framing and Drop Ceiling

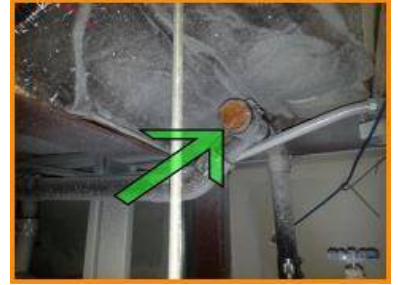
[CR] Plumbing vent pipes in the attic were open at front right of 210. This condition may allow sewer gases to escape into the interior of the building.

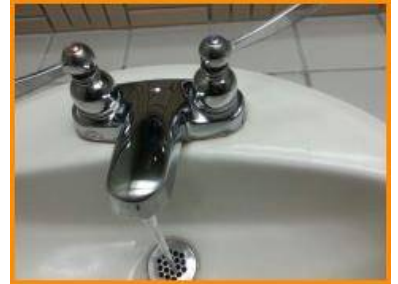
[CR] There was no hot water flow from the sink faucet in/at the kitchenette in 240. It is possible that the problem is with the faucet, but the condition may involve other components.

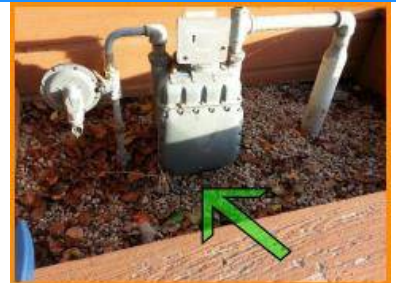
[CR] The gas meter and shutoff-valve was in contact with the soil at the front side of the building. This condition is conducive to deterioration and restricts access for maintenance or emergencies.

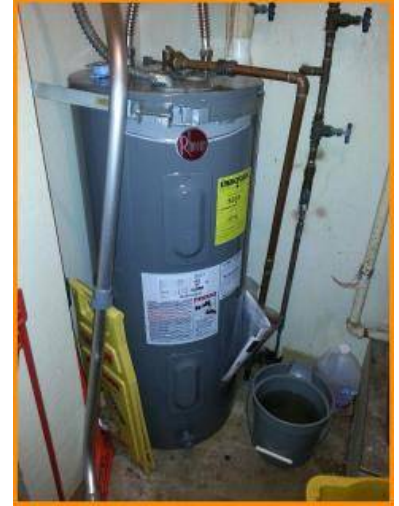
[SC] The unit did not have two straps securing it in place. Units with fewer than two straps are not properly secured against seismic activity.

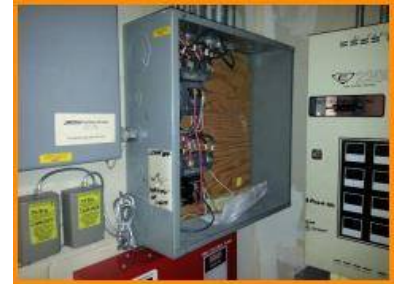
[SC] The panel itself was not labeled to identify it. All sub panels should be accurately labeled to allow the appropriate circuit to be shut off for maintenance or emergencies.

[SC] The protective dead-front cover of the panel was missing/removed. The words dead-front "means not electrically live or hot"; the cover should be present to protect or conceal the energized "live" electrical components within the panel. The missing/removed cover is a shock/electrocution hazard.

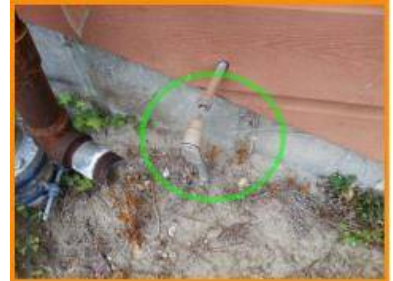
[SC] Electrical conduit was disconnected in/at the exterior right. This condition may compromise the equipment grounding feature and expose the conductors to damage.

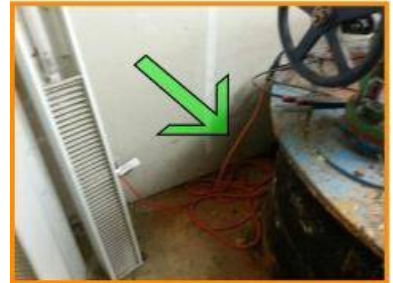
[SC] Extension cord(s) and/or cord-type wiring was installed in a permanent manner in/at the sewage ejection room. Improper wiring is conducive to electrical deficiencies and is a potential fire hazard.

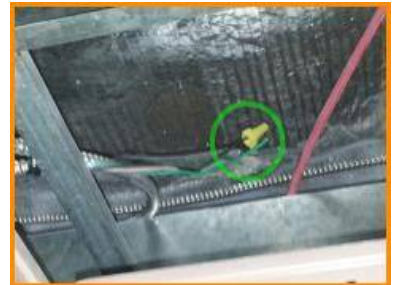
[SC] There were electrical wiring ends/connections that were not contained in approved electrical junction boxes in/at the attic of the unit 102, between 200 and 201. All electrical wiring ends/connections should be contained in approved, covered and accessible junction boxes. This is a potential fire/shock hazard.

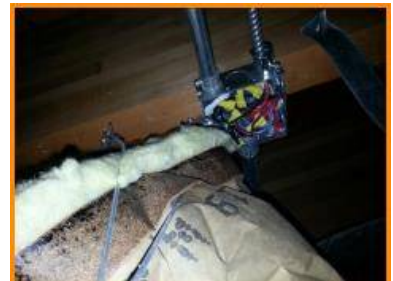
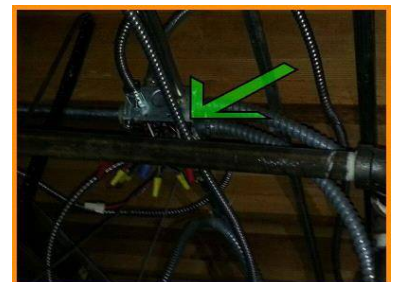
[SC] Junction-box cover plates were missing in/at the attic of 102, 107 and the upper left hall. This condition is a shock / electrocution hazard due to exposed electrical components; all electrical junction boxes should have an approved spark-proof cover. This is a potential fire hazard.

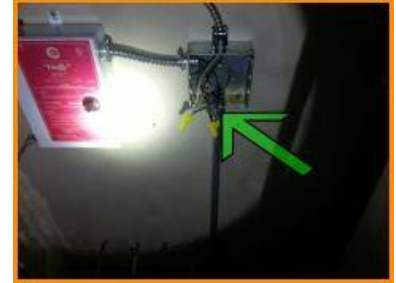
Box too small for # wires?

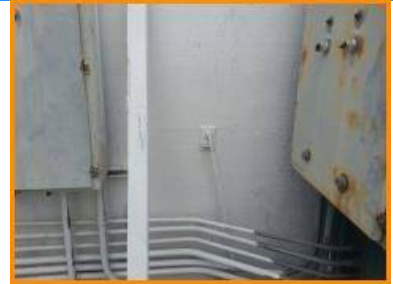
[SC] There were scorched receptacles in/at 240. Electrical deficiencies are a potential shock/fire hazard.

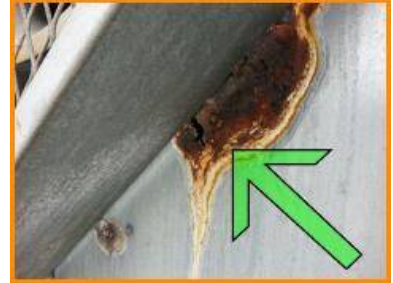
[FE] Damage to the unit was observed.

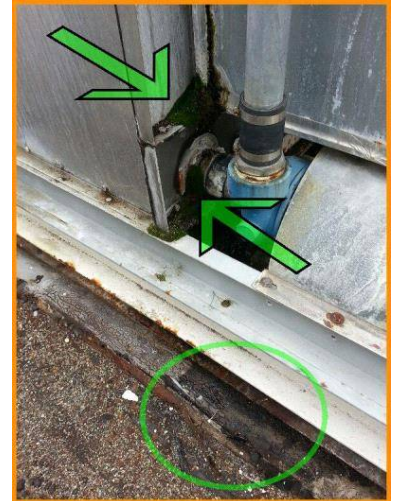
[FE] Leaks and damage to the unit were noted. We recommend further evaluation and correction by a licensed and qualified heating & cooling contractor.

Leaks and Damage

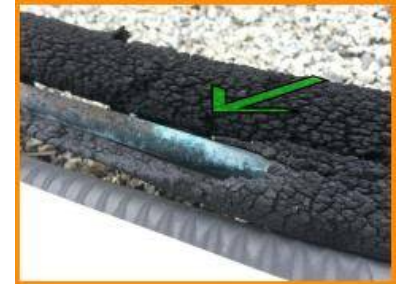
[CR] The insulation on the coolant lines adjacent to the condensing unit was deteriorated. This condition reduces the unit's overall performance.

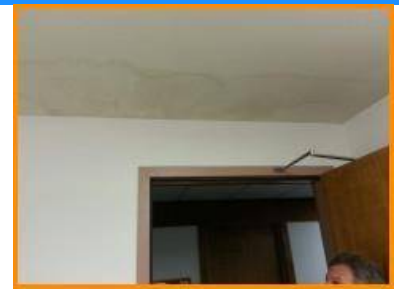
[FE] Dry moisture stains were noted on the ceiling in 101, 102, 105, 201,200a, 240, 250, 270, upper left hall and in the break room near 260, . These may be old, thus we recommend inquiring with the current owner regarding the nature and history of these stains. Should they be current or uncorrected they could lead to additional damage. (In most locations we observed heat pumps in the ceiling at these same locations - but did not find any evidence of current leaking.)

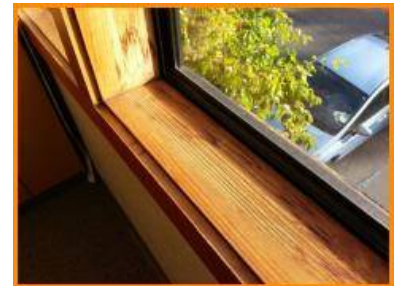
[NOTE] Dry moisture stains were noted in the window sill(s) in the interior (throughout). These are single pane, metal windows - these often sweat, a typical issue depending upon the weather. There is also the potential that this is a sign of leaking.

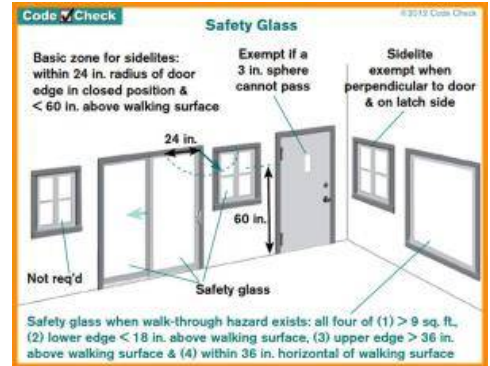
[SC] There were no visible safety glass markings on the glass in 107, 200A . Glass in these locations should be the safety type to minimize the potential for harm if it were broken (breaks into small pieces instead of shards). The glass should be confirmed as safety type or upgraded for safety reasons.

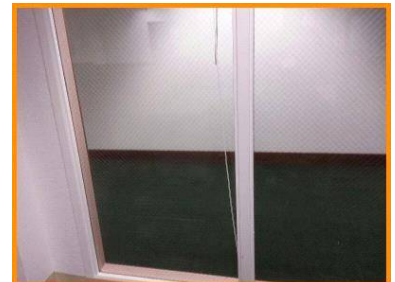
Unit 107

[SC] 107 contained the older wire-embedded glass. This old-style glass is no longer considered adequate as safety-glass in locations subject to human-impact.

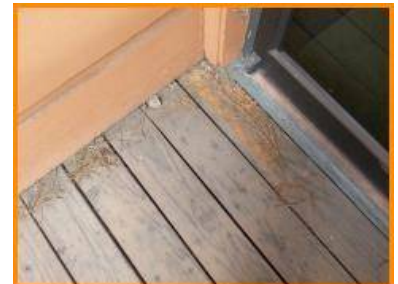
[FE] We observed evidence at the rear deck that suggests the need for a full pest inspection. We recommend a pest (termite) inspection.
