**MINUTES OF THE BOARD OF DIRECTORS
VALHALLA ELEVEN ASSOCIATION
October 16, 2019**

Project B1909885

Re: Assessment of Building Exterior and Interior Recommendations
Valhalla Condominiums - Building #11
342 Elton Hills Drive Northwest
Rochester, Minnesota

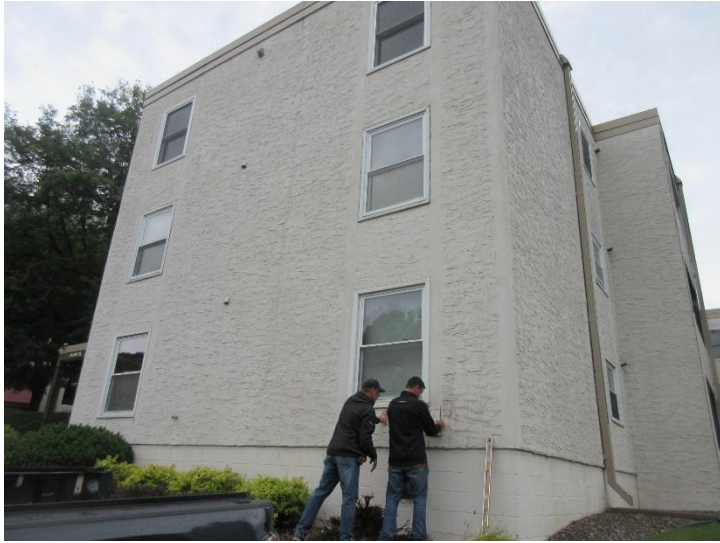
Photograph 1

Summary: water is entering cracks and at window sill/jamb and penetrating wall components. Materials were dry but had been wet. At this time no structural damage, but sheathing has dry rot.

Overview of Test Opening #1 on south elevation-right side lower window sill.

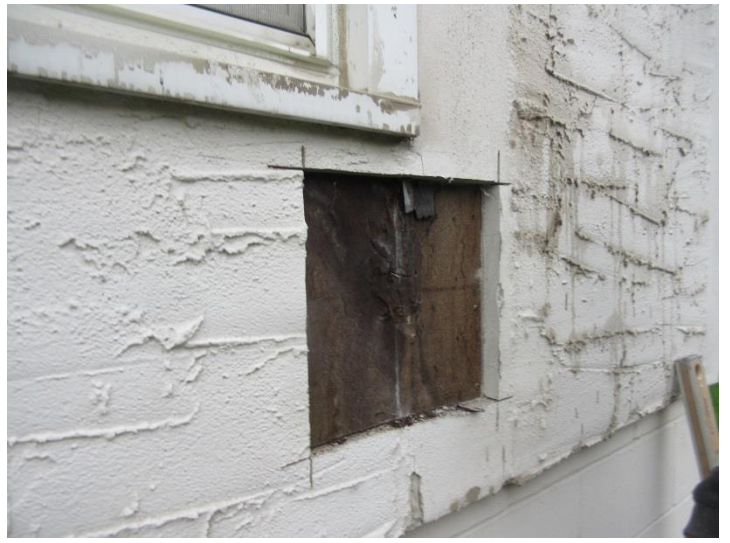
Photograph 2

View with stucco removed and buffalo board exposed.

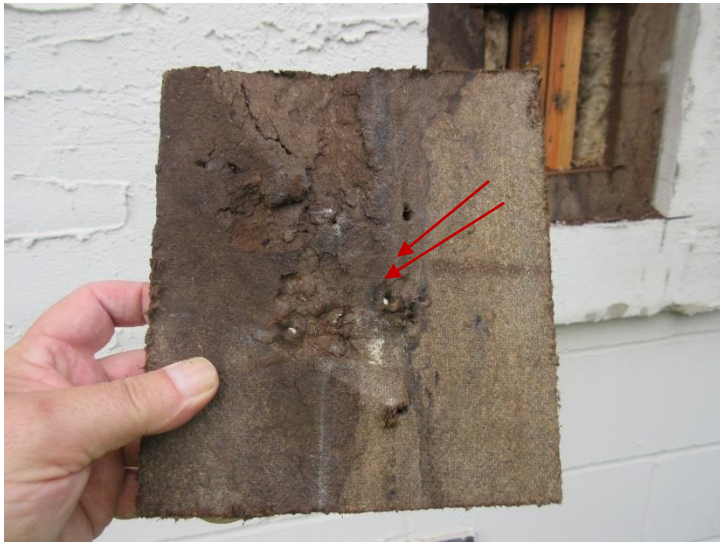
Photograph 3

Previous water stains and dry rot on face of buffalo board from window sill corner.

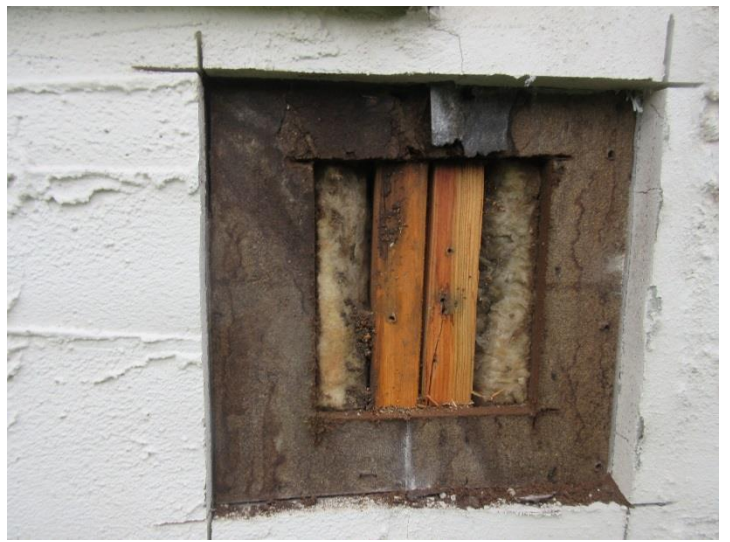
Photograph 4

Wood studs and insulation dry and undamaged.

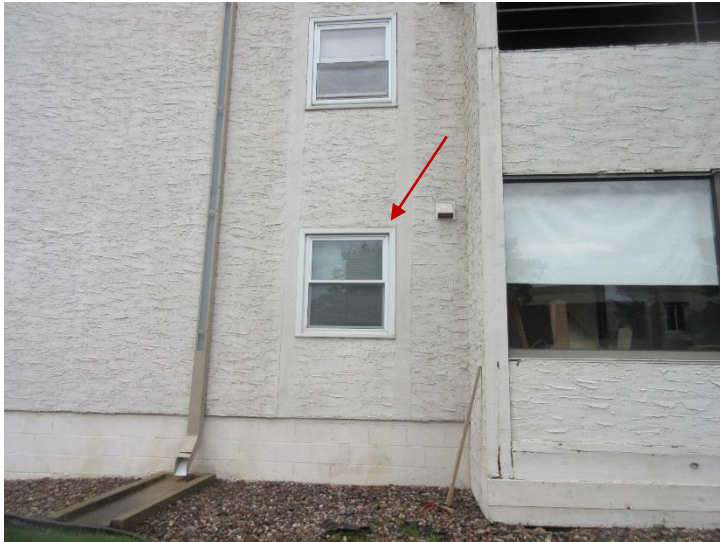
Photograph 5

Summary: water is entering the vertical crack at the trim removal/stucco replacement joint and at window head/jamb and penetrating wall components. Materials were dry but had been wet. At this time no structural damage, but sheathing has some dry rot.

Test Opening #2-east elevation-lower window head-upper right side.

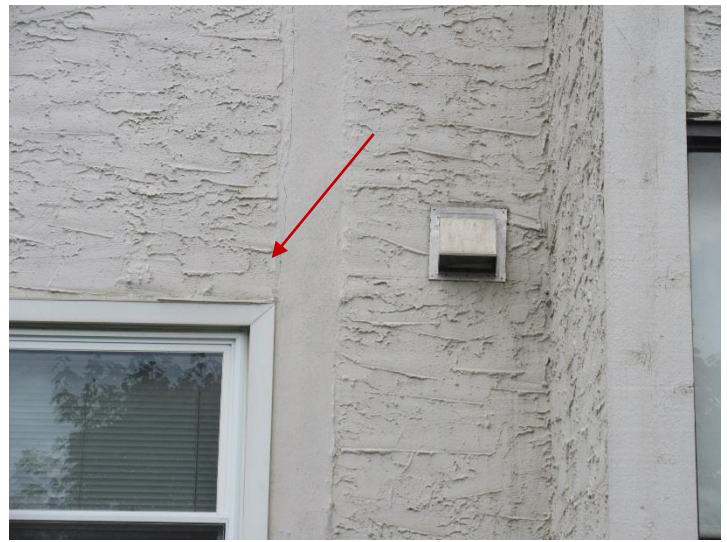
Photograph 6

Close up view of area of Test Opening #2.

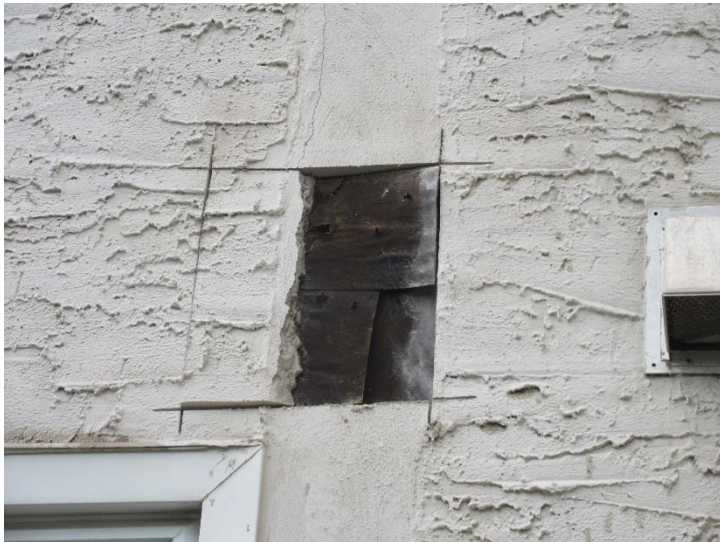
Photograph 7

Stucco cut and partially removed-note felt underlayment laps at area of trim board removal repair.

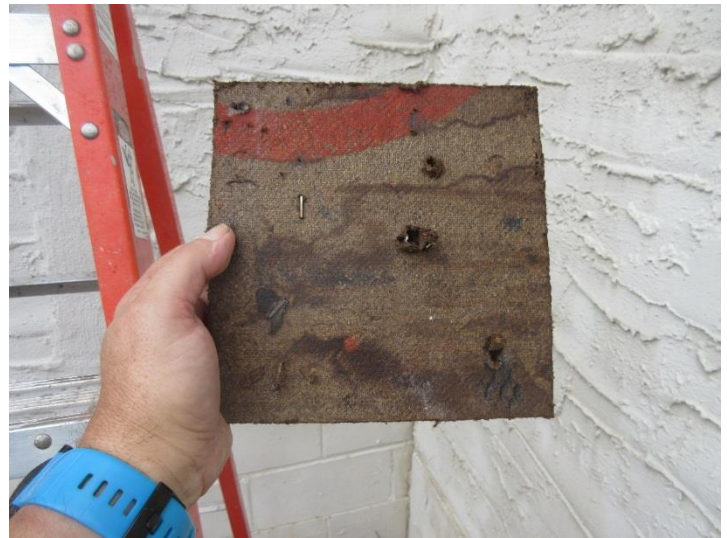
Photograph 8

Previous water staining on face of buffalo board.

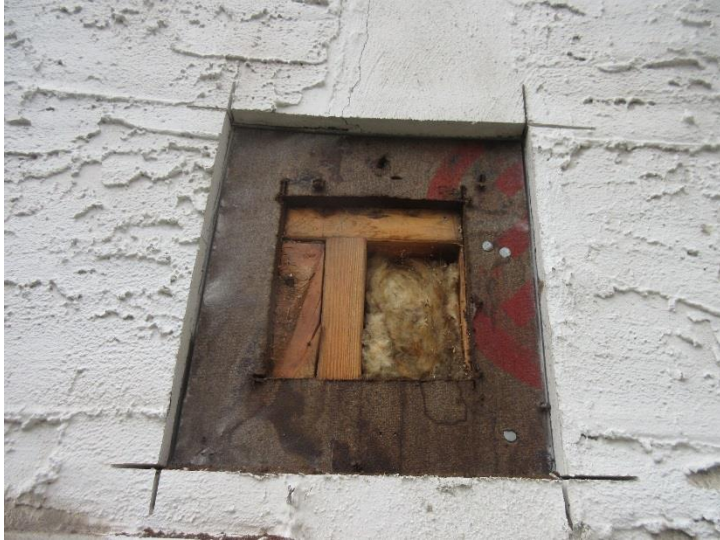
Photograph 9

Wood framing dry and in good condition.

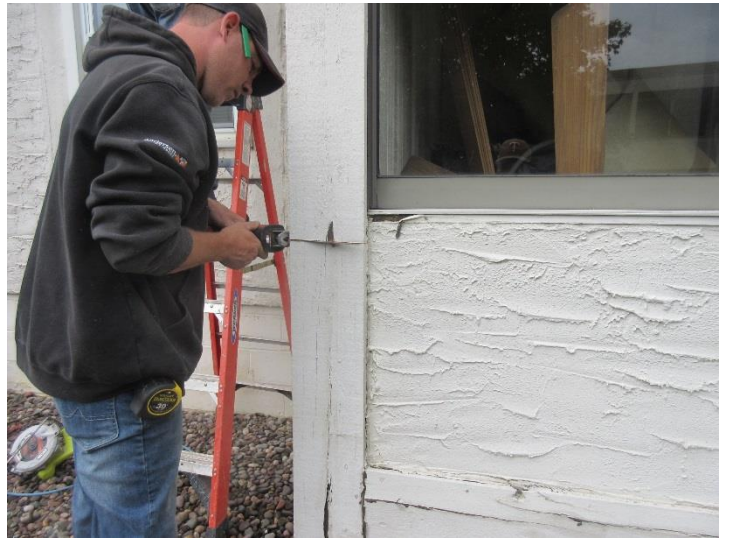
Photograph 10

Summary: Poor condition – outside porch corners and faces are going to have very deteriorated wood and framing components – Typical

Test Opening #3-east elevation-lower porch corner at wood trim.

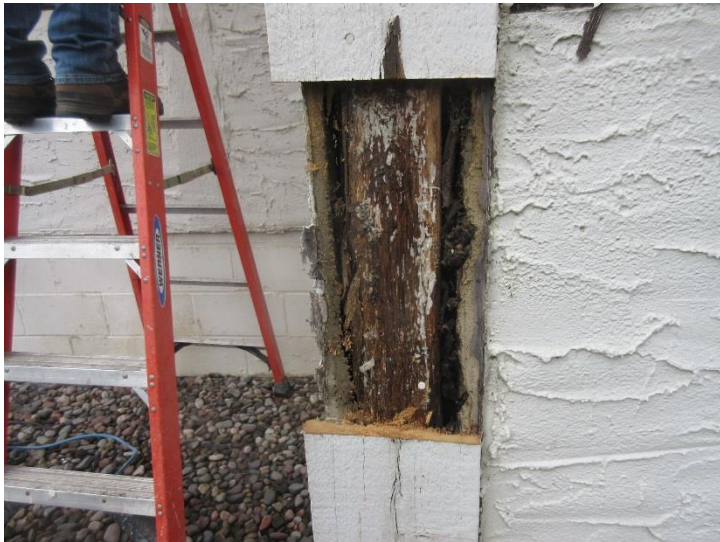
Photograph 11

Wood trim and 4"x4" wood support was wet and deteriorated-no felt underlayment observed.

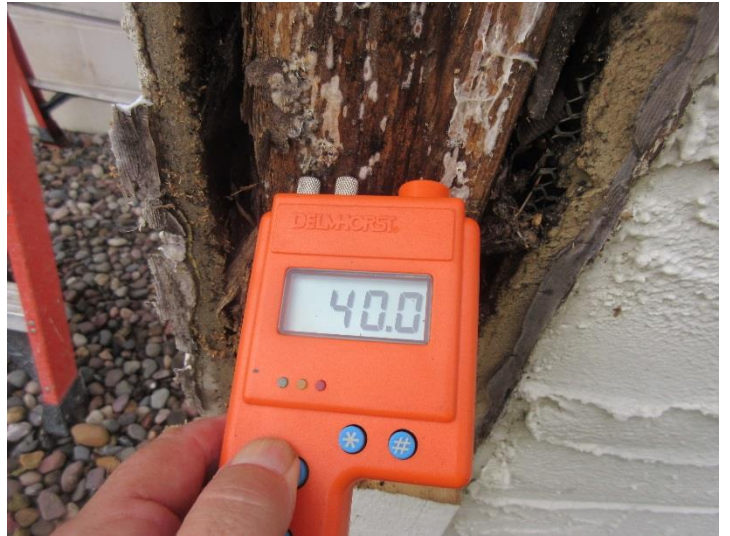
Photograph 12

Delmhorst meter indicates 40%-wet wood.

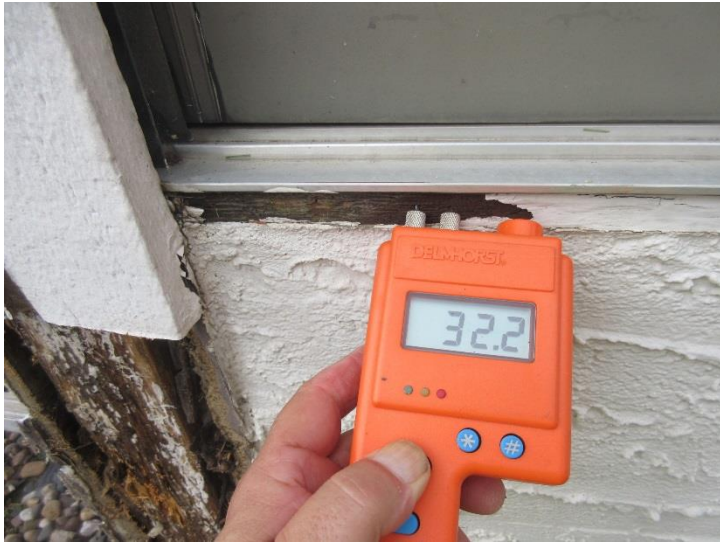
Photograph 13

Sill framing exposed and measured wet also-wood was deteriorated.

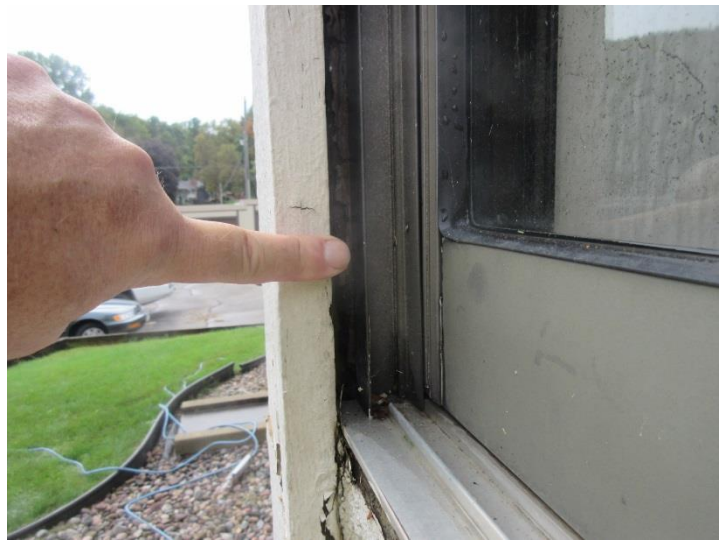
Photograph 14

View looking back into jamb behind trim board-open to water entry, not flashed.

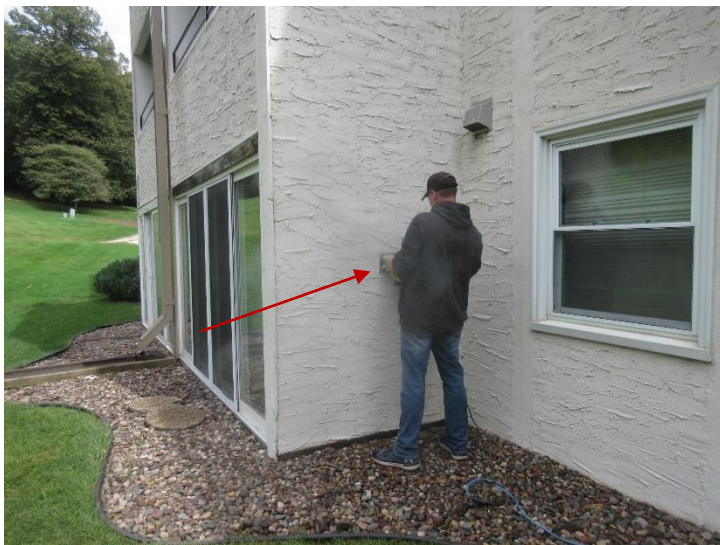
Photograph 15

Summary: Porch “fin wall” is hollow and dry from outside; 2x4 framing with no insulation.

Test Opening #4-west elevation-south face of porch wing wall.

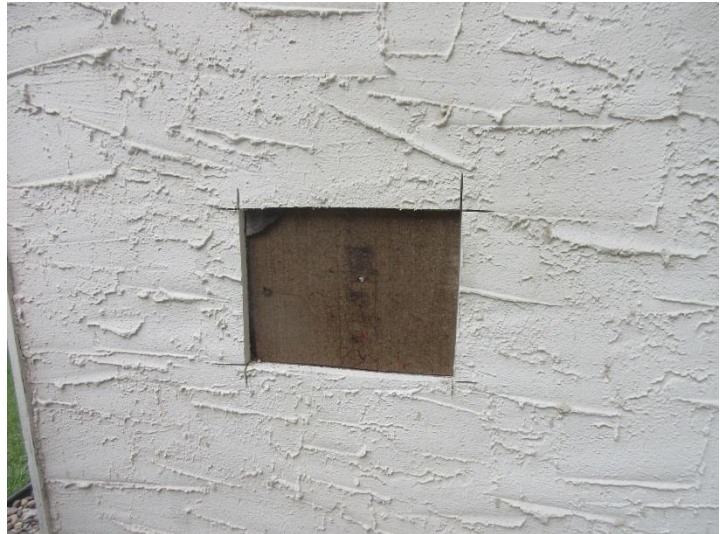
Photograph 16

View of stucco and felt underlayment removed-buffalo board was dry.

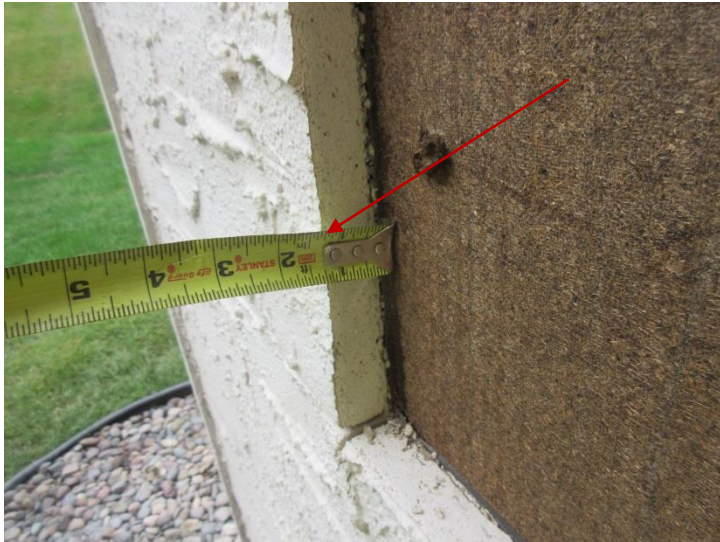
Photograph 17

View of stucco-1 1/4" thickness-buffalo board was dry.

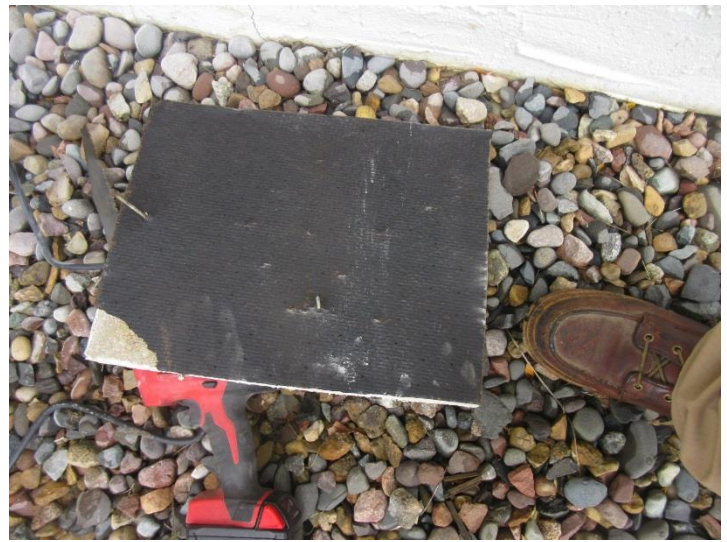
Photograph 18

Overview of backside of stucco and felt removed-dry and in good condition.

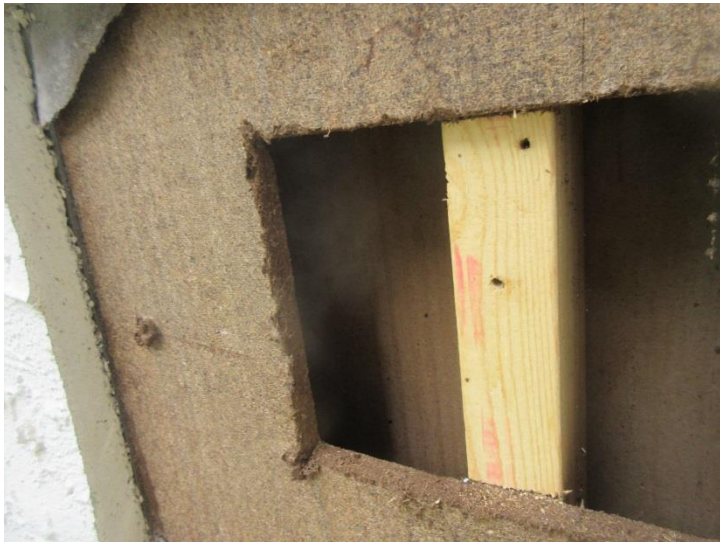
Photograph 19

View of 2x4 wood stud in cavity (uninsulated) and dry.

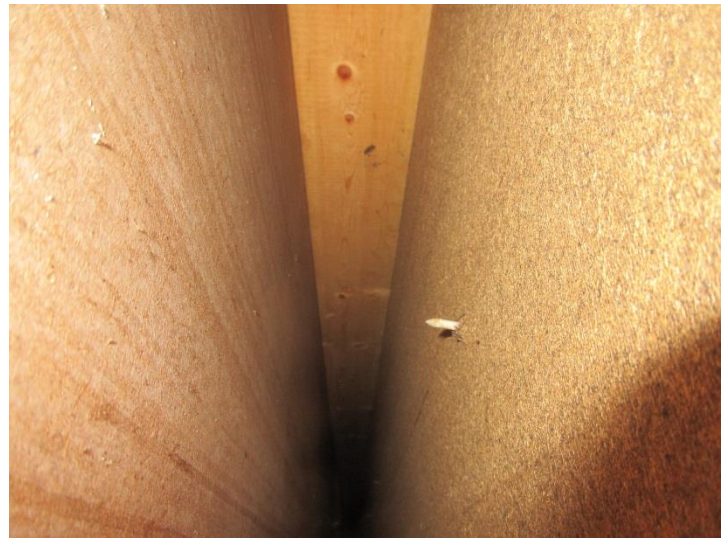
Photograph 20

View of looking down within 2x4 wall- materials appear clean and dry.

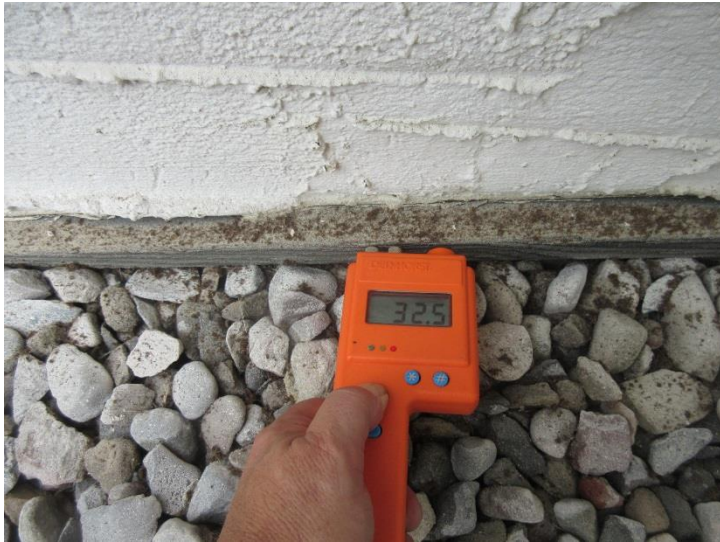
Photograph 21

View of sill plate at grade below Test Opening #4-sill plate was wet and most likely deteriorated.

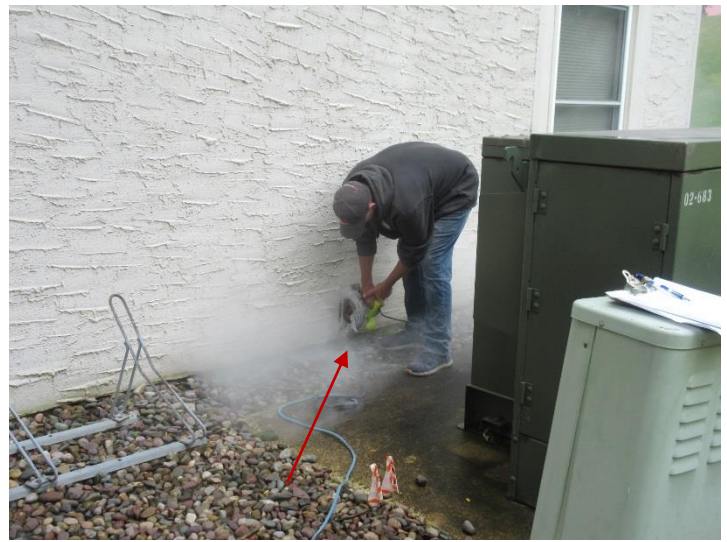
Photograph 22

Summary: The 1/2” buffalo board was severely dry rotted up 16” minimum. The wood sill/base plate was exposed and water stained but dry at time of test. We would expect to find area of deteriorated/replacement sill plate required.

Test Opening #5-north elevation-west side at grade-near center of wall.

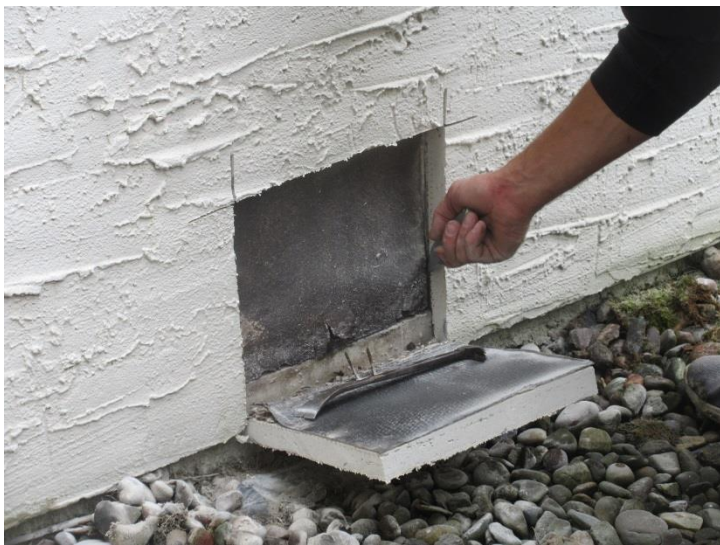
Photograph 23

Stucco removed-30# felt underlayment visible.

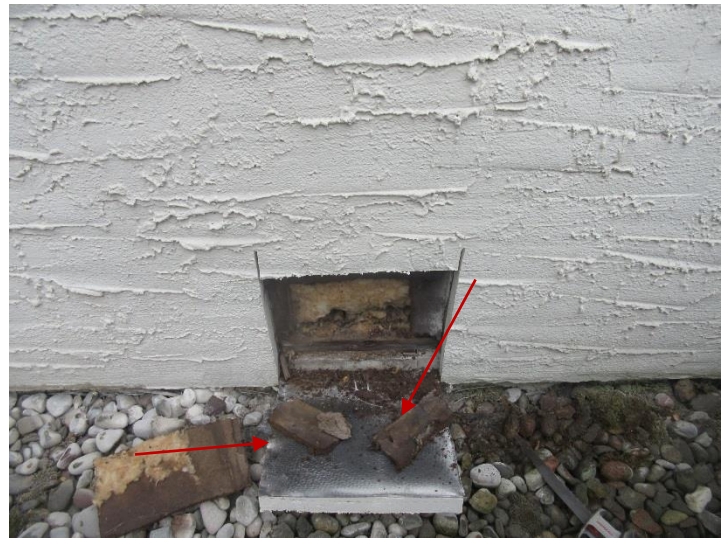
Photograph 24

Buffalo board removed - deteriorated from dry rot.

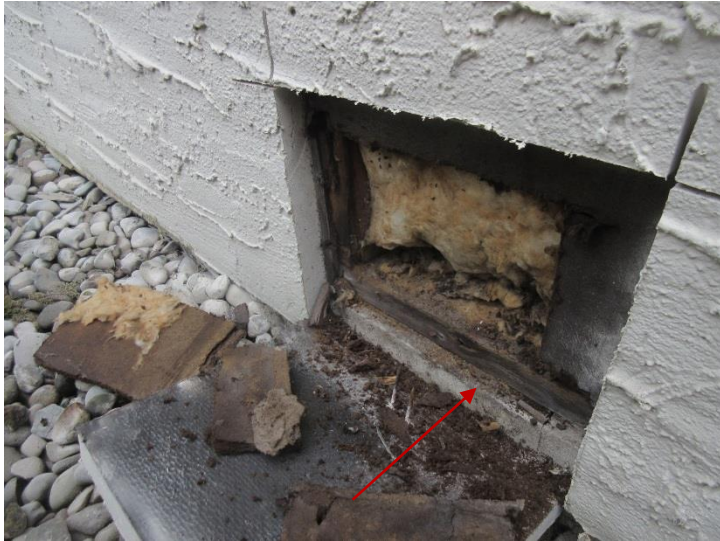
Photograph 25

View of sill plate at grade – dry but weathered with some dry rot.

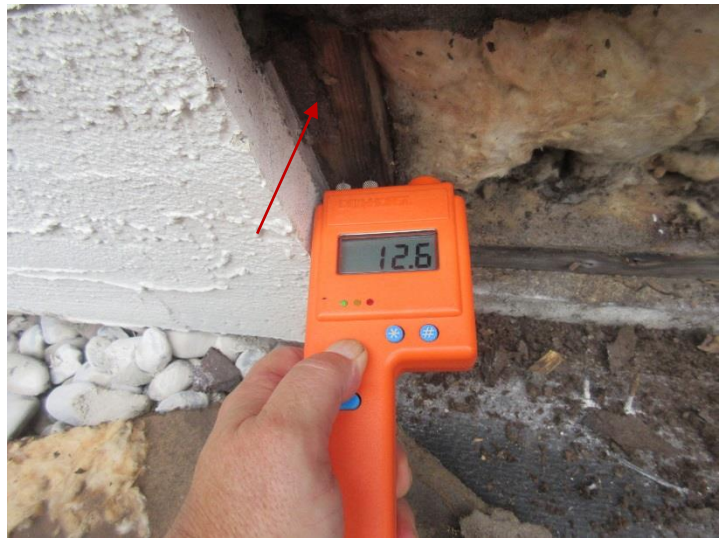
Photograph 26

View of 2x6 stud-face stained-previous moisture present-dry at time of test.

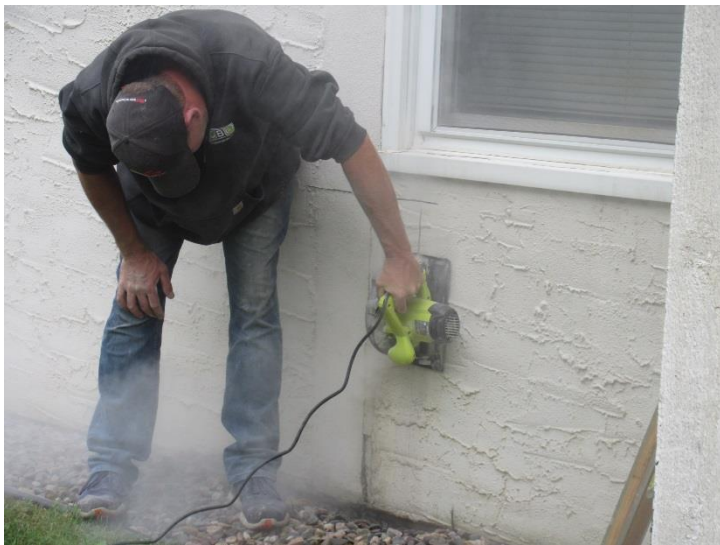
Photograph 27

Summary: The 1/2” buffalo board was severely dry rotted up 3’ minimum. The wood sill/base plate was exposed and severely dry rotted but dry at time of test. We would expect to find area of deteriorated/replacement sill plate required along with vertical studs especially below the window sill locations.

Test Opening #6-west elevation-north end at grade to window sill.

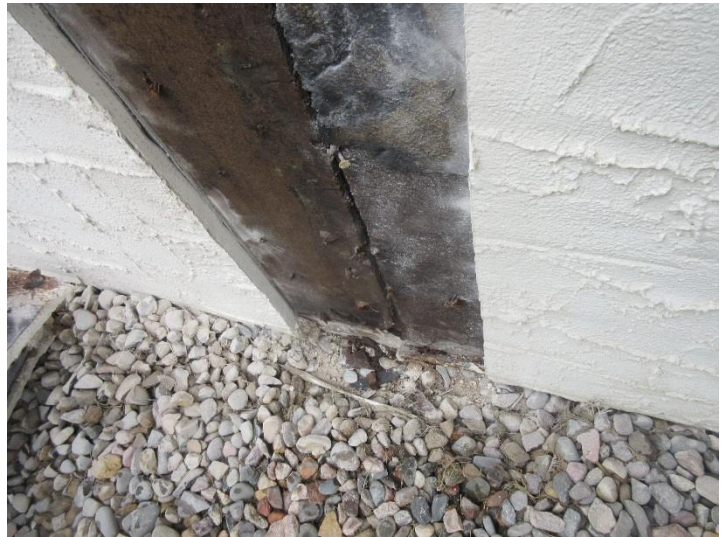
Photograph 28

Stucco removed-felt water stained-buffalo board dry rotted.

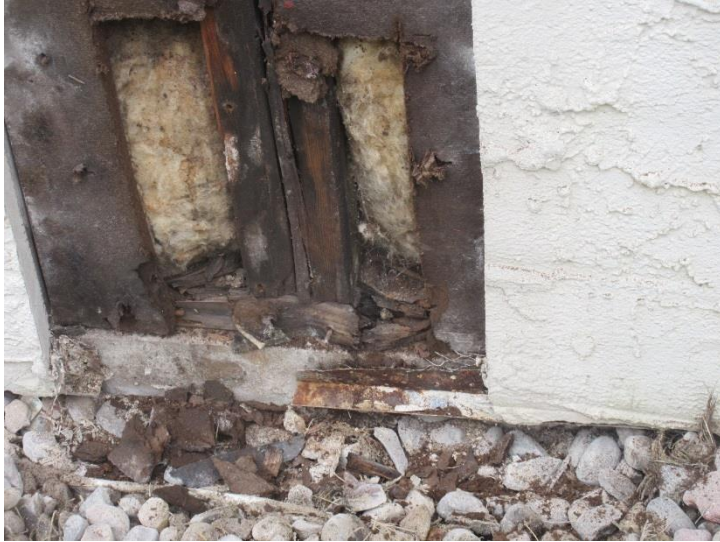
Photograph 29

View of sill plate and studs at grade below Test Opening #6-bottom sill plate severe dry rot also face of studs severe dry rot.

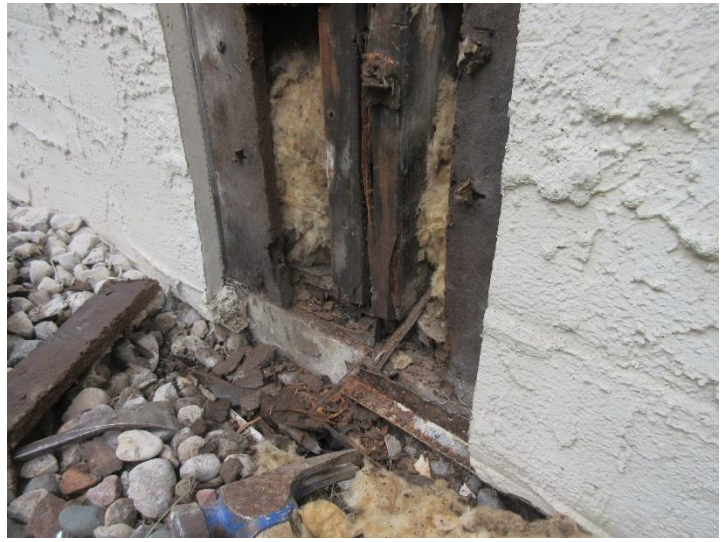
Photograph 30

Test Opening #6-additional view of dry rot in wood near grade.

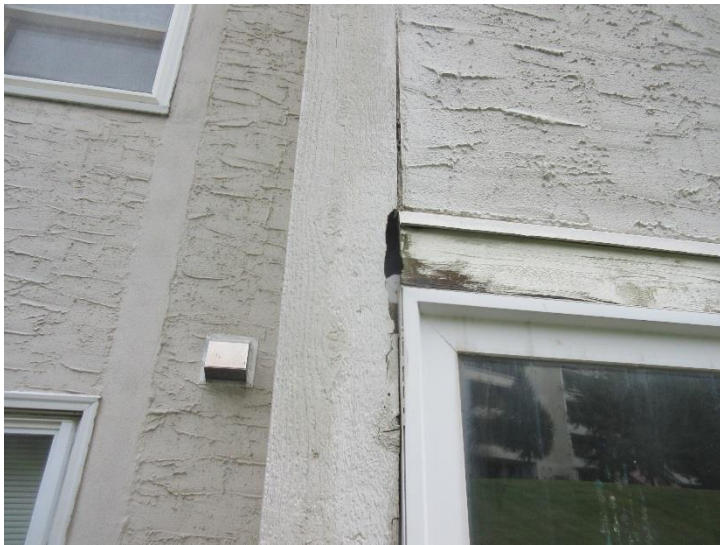
Photograph 31

View of rotted trim boards at corner and window head-west elevation.

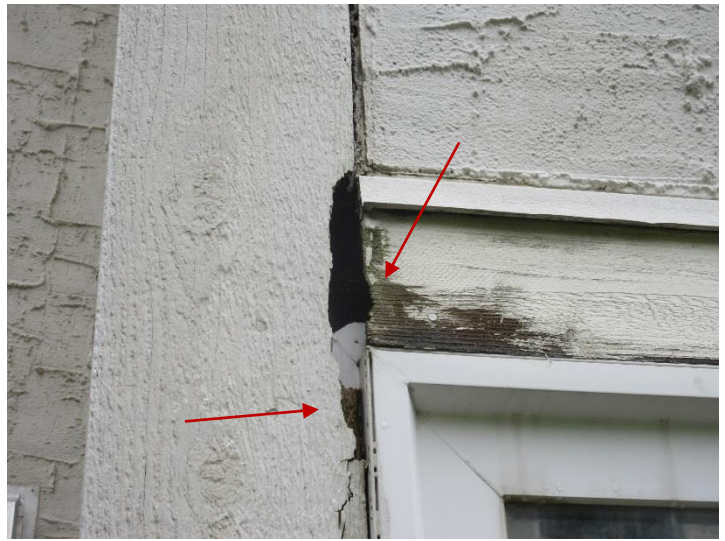
Photograph 32

Close up view of rotted trim boards at corner and window head-west elevation.

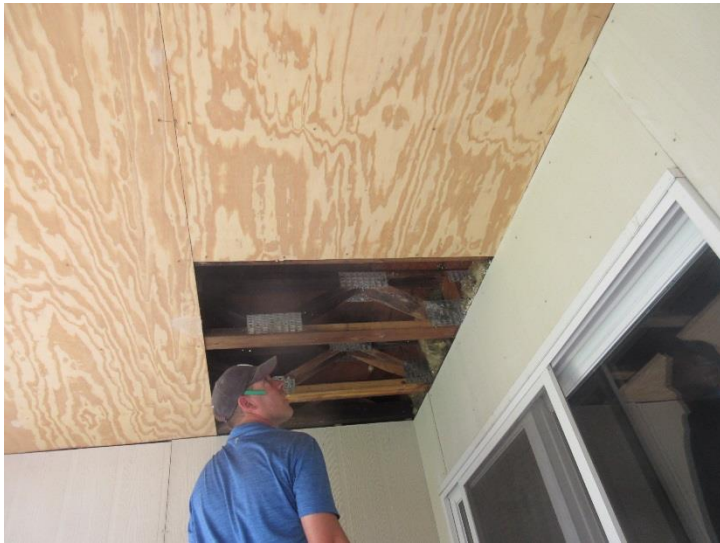
Photograph 33

Summary: The insulation at the top of the wall filling the roof truss space is inadequate to prevent cold air infiltration and does not have an air barrier or a vapor barrier present. These spaces need to be closed off air tight and vapor tight with the proper value of insulation.

View of west facing porch soffit removed Unit #36.

We recommend complete demolition of the porches and reconstruction to create a uniform look which meets current codes and provides long term watertight detailing. The porch soffit connection to the existing building truss spaces will be important to properly detail. These spaces need to be closed off air tight and vapor tight with the proper value of insulation.

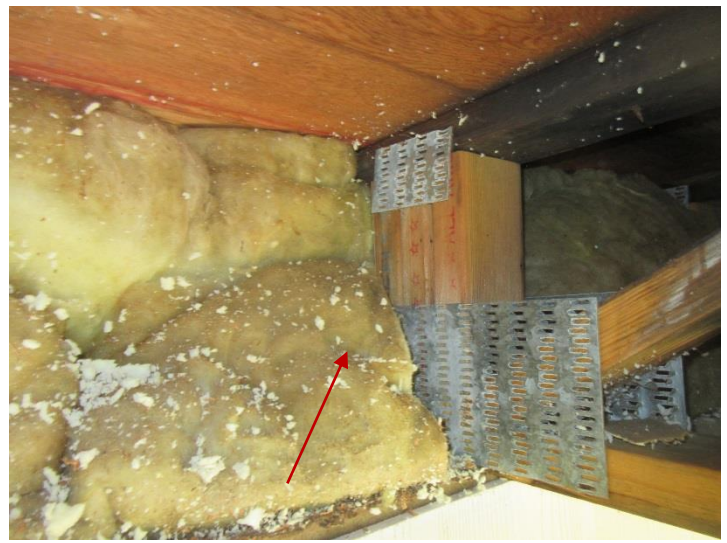
Photograph 34

Two layers R11 batt insulation removed from end of truss space-asphalt facer one side.

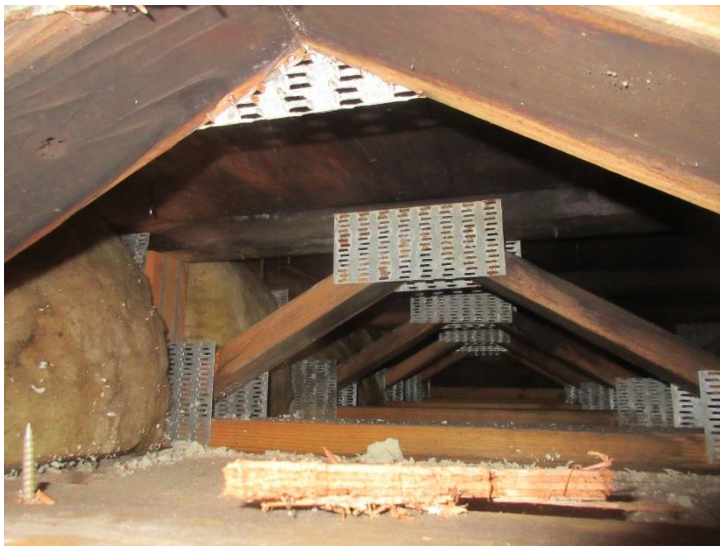
Photograph 35

View parallel to outside wall looking down at batt inserted into truss ends.

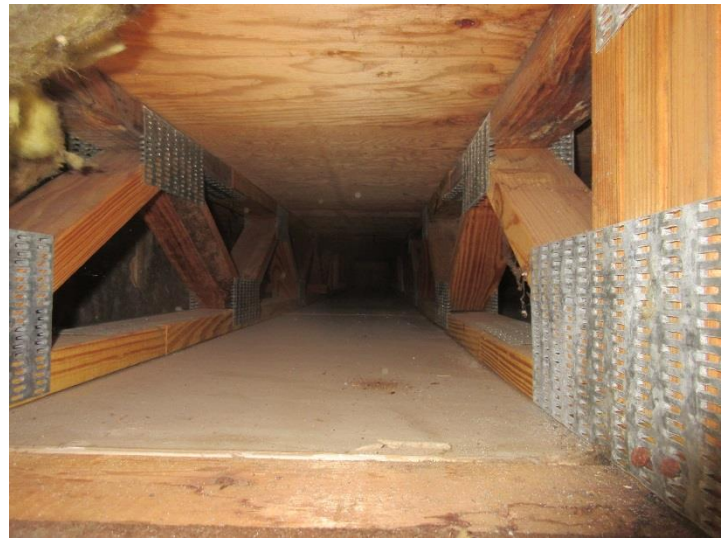
Photograph 36

View looking straight into below roof deck space-open – no vapor barrier observed above sheetrock ceiling.

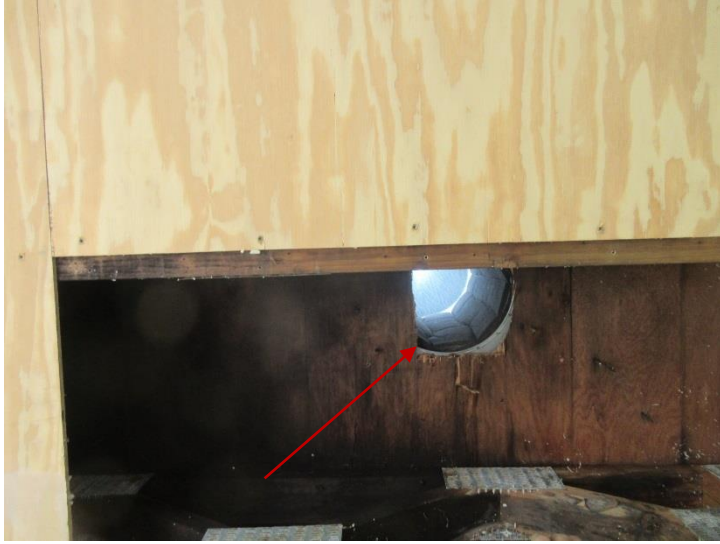
Photograph 37

View of vent above outside deck area above soffit out to roof vent.

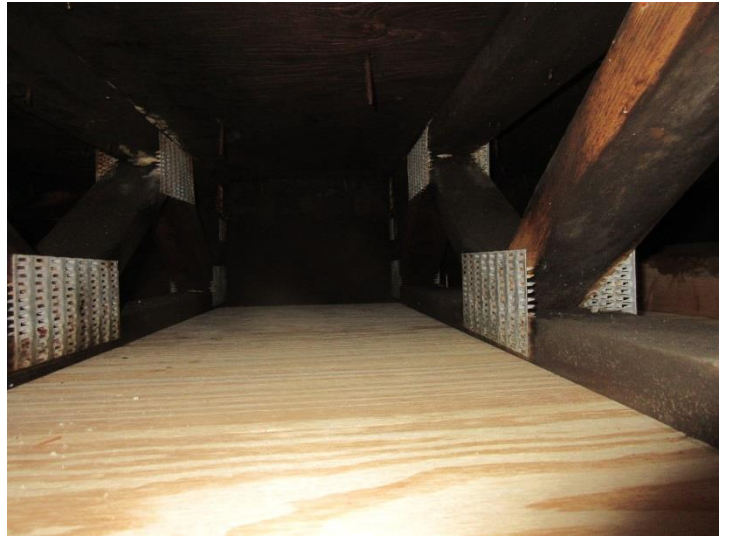
Photograph 38

View above soffit looking out over porch to outside edge.

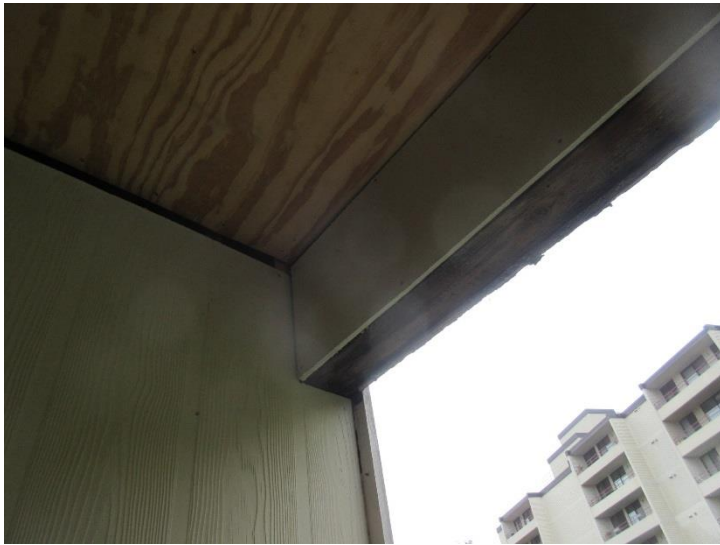
Photograph 39

View of outside corner porch soffit.

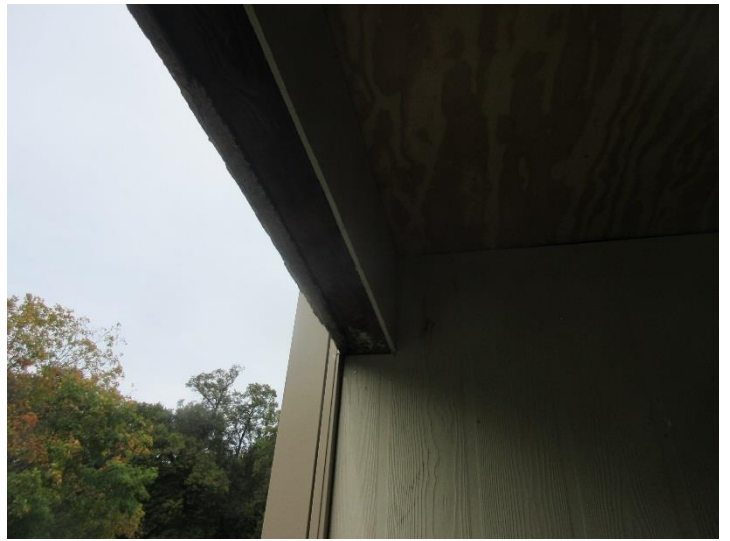
Photograph 40

View of outside corner porch soffit.
