## SUMMARY REPORT:

Service Life Assessment of Low-Slope Unpainted 55%Al-Zn Alloy-Coated Steel Standing Seam Metal Roof Systems

Ron Dutton, Ron Dutton Consulting Services LLC

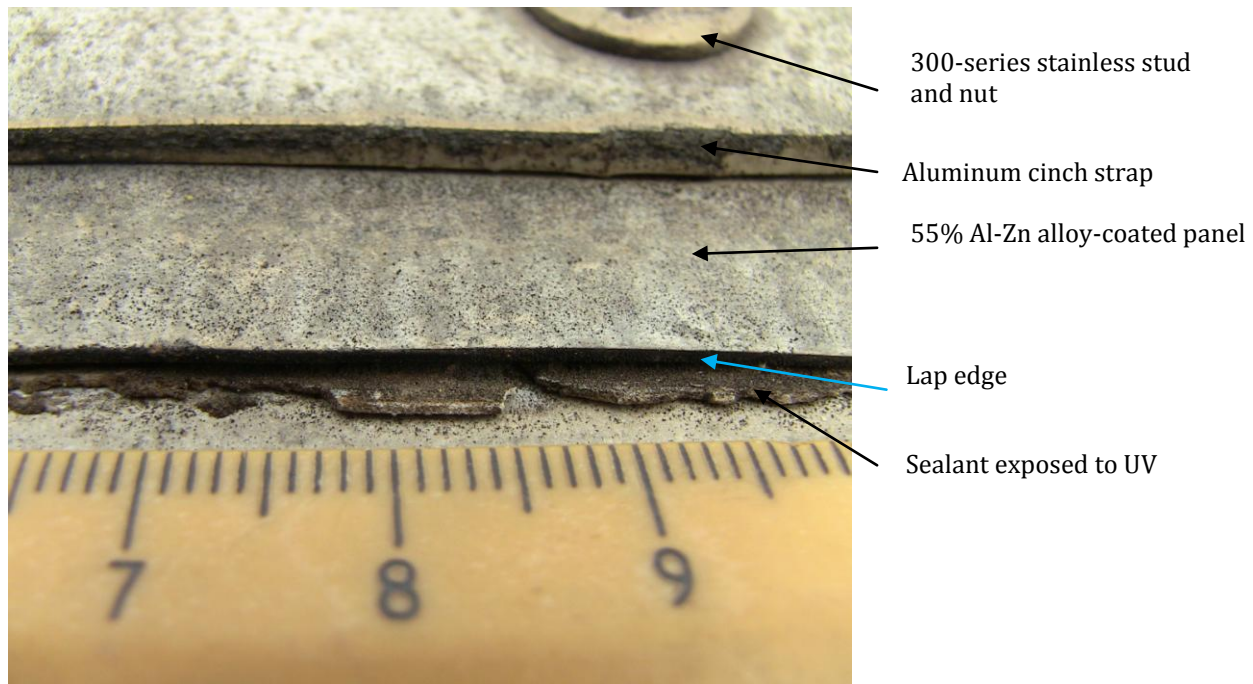
Edges and bends typically exhibit the first signs of corrosion as they are areas where a raw steel edge is exposed or where there may be a condition of tensile strain on the panel profile bend radius. Our inspections revealed excellent-to-very good performance in these two areas. The close-up photograph in Figure 10 shows a representative condition of a sheared, panel lap edge on the roof in Athens, GA. The sheared edge is free of red rust, indicating excellent long-term edge protection after 29 years. This performance is consistent with prior work [21] that reported only superficial stain and no rust deposits on exposure panels after 30 years of exposure in rural, industrial and moderate marine environments.

Figure 10 – Sheared, lap edge of 55% Al-Zn alloy-coated SSR panel showing negligible corrosion after 29 years on a roof in Athens, GA.

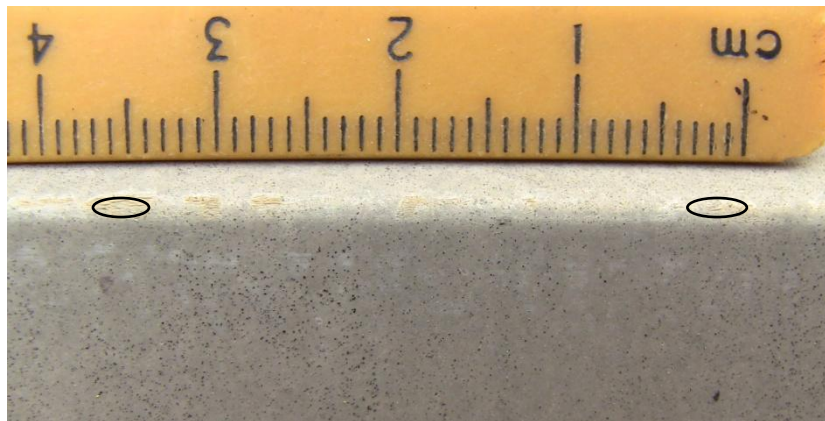
Panel profile radii may undergo a degree of tensile strain if the panel is not properly roll formed. Severely formed radii can exhibit heavy crazing of the metallic coating which can lead to significant corrosion in aggressive environments. Currently, however, steel manufacturers, working with roof panel manufacturers and trade organizations, have developed roll forming “best practice” guidelines that virtually eliminate such occurrences.

The photograph in Figure 11 shows a representative condition of the major rib profile radius of the SSR panel. Only minor crazing and light superficial staining is observable. The performance along the top radius of the standing seam is also excellent, as shown in a representative seam in Figure 12.

Figure 11 – Light crazing and superficial staining along a major rib profile radius after 29 years’ exposure on a roof in Athens, GA.

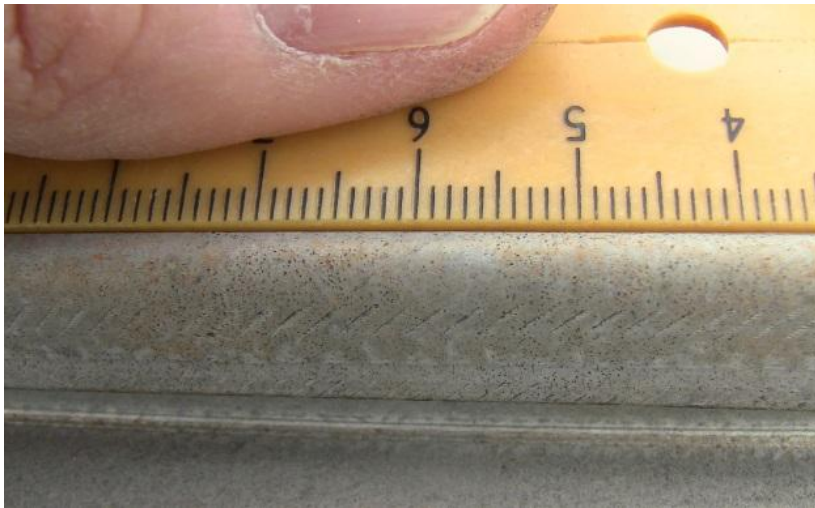
Figure 12 – Excellent performance (only brownish dirt pick-up) along the top radius of a standing seam on a 29-year old roof in Athens, GA.

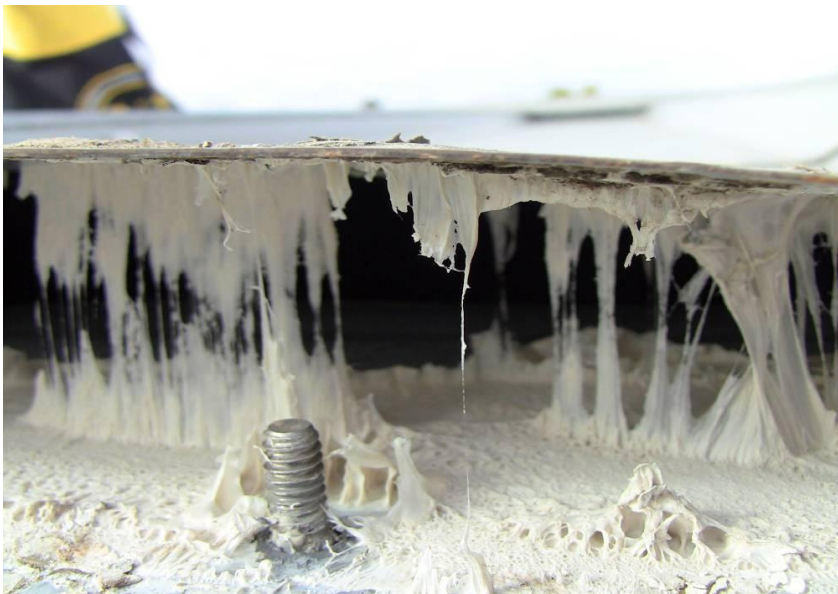
The butyl sealants used in the construction of these roofs were observed to be consistently tacky to the touch with good elastic webbing characteristics and adhesion to adjacent surfaces. A representative example of this performance is seen in Figure 13 which shows the disassembly of a 33-year old endlap.

Figure 13 - Excellent elasticity demonstrated by the butyl sealant on the Denver roof after 33 years.

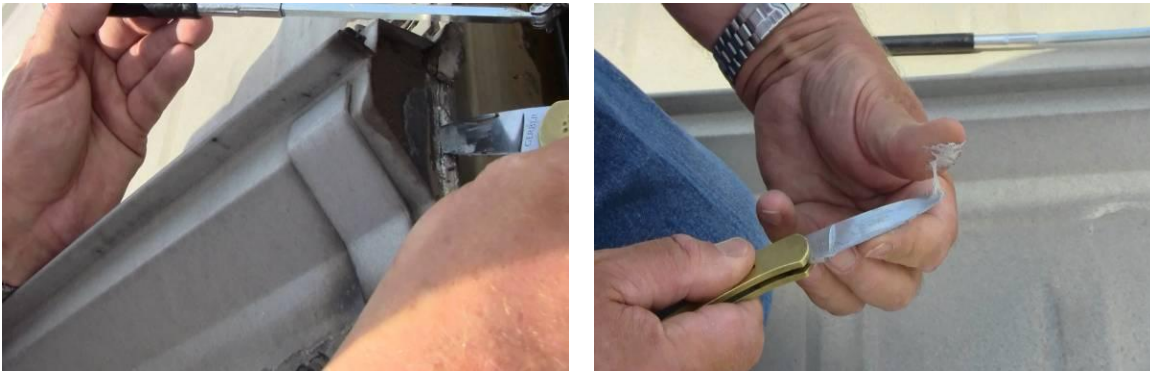
The butyl sealants at ridge and eave closures exhibited excellent elasticity and webbing characteristics. Figures 14 and 15 show the condition of the butyl sealant when the eave closure and ridge closure were probed with a knife edge. At fillets exposed to U.V. from the sun, the sealant was dry and chalky, forming somewhat of a barrier to further penetration of the elements into the

Figure 14 – Eave closure probed with knife edge (left) produced a sample of the butyl sealant that exhibited significant elasticity after 33 years in Denver (right).

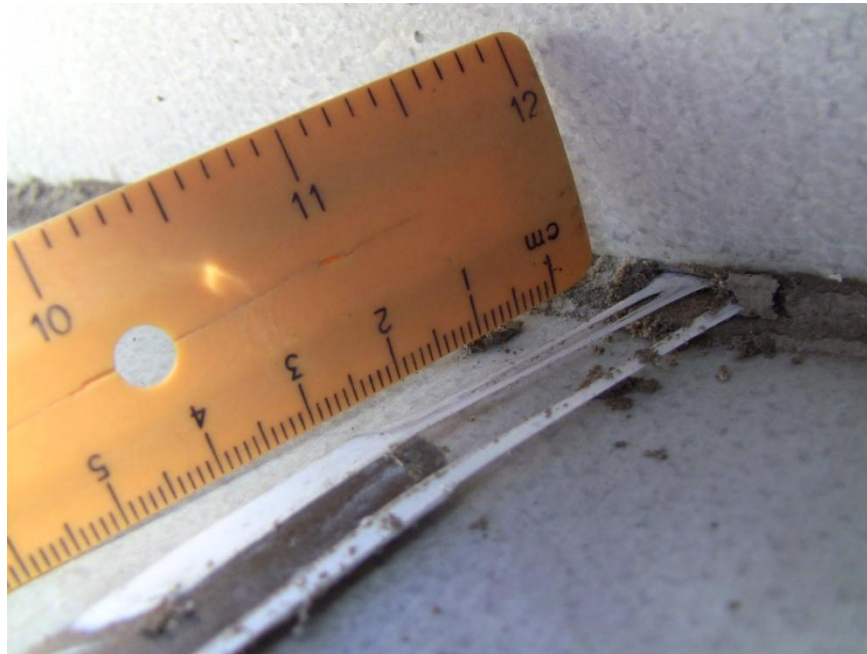
Figure 15 – Sealant between metal panel and metal ridge closure was also very elastic after 31 years in Wyoming.

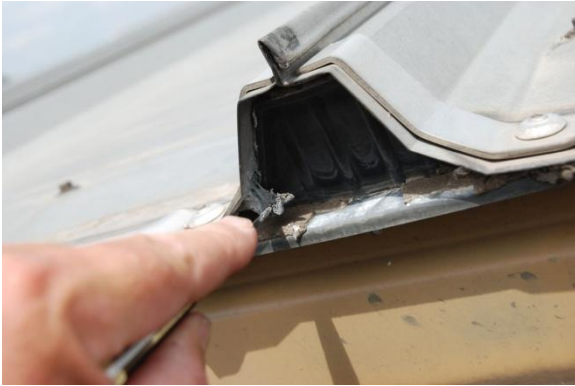
weathering. The possible exception to this was when closures were used at the gutter line to seal between roof panel and back leg of gutter profile. In that location, closures are exposed to increased U.V. and although none had expired at the time of inspection, some (non-metal) closures showed some early stages of degradation on older specimen roofs. In such cases, the closure is not an eave closure, but a gutter closure, and not vital to building envelope integrity and replacement of those components is easily accomplished in conjunction with gutter replacement. Costs are included within each site report (appendix). Typical eave and ridge closures are shown in Figures 16 and 17, respectively.

Figure 16 – Typical eave closure.

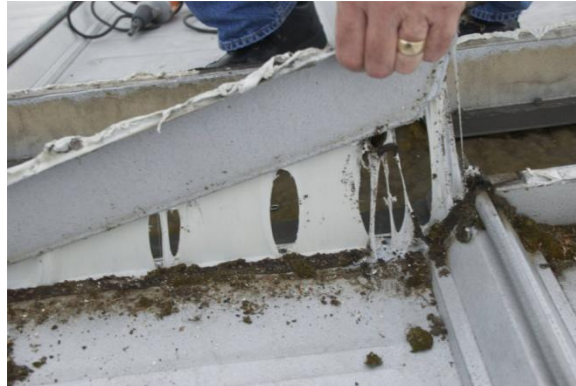
Figure 17 – Typical ridge closure.

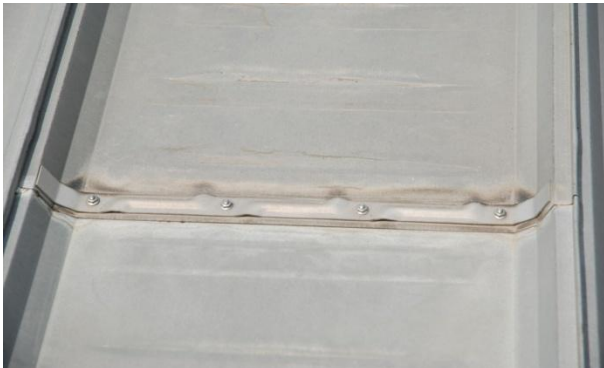
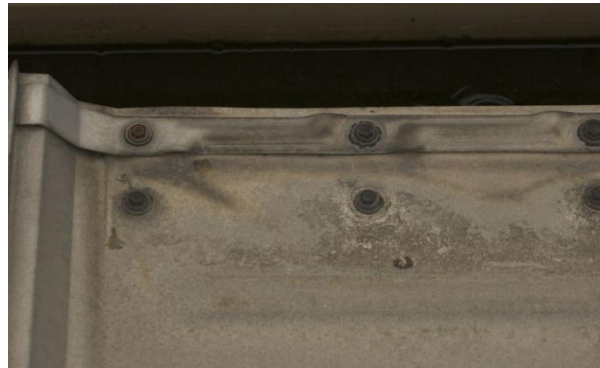
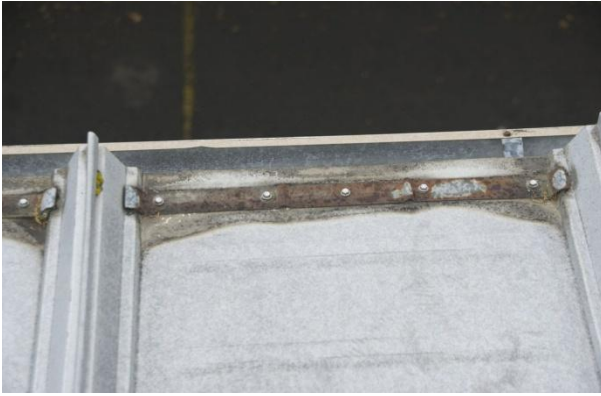
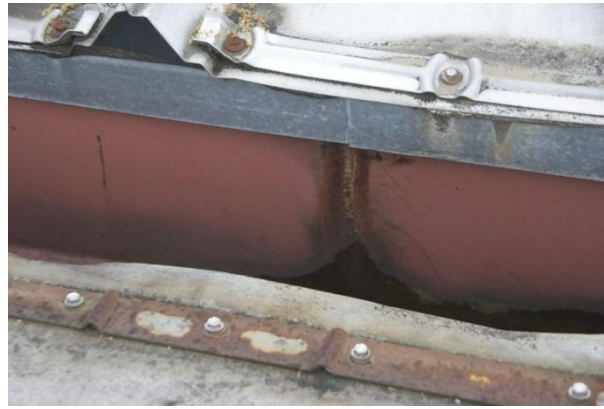
Figure 18 – Typical fastener appearance of various materials.

Screw fastener types and materials encountered included Series 300 stainless steel, Series 400 stainless steel, carbon steel with Series 300 stainless steel cap, and carbon steel with (unidentified) plating or coating, examples of which are shown in Figure 18. In all cases, the Series 300 materials showed no sign of corrosion, nor adverse effect on adjacent 55% Al-Zn alloy-coated sheet panels. In all cases, the 400 Series and plated carbon steel materials did show signs of corrosion to varying degrees and would require replacement at some point prior to expiry of panels and sealants. There was no evident adverse effect on adjacent 55% Al-Zn alloy-coated sheet panels. Such replacement is economically feasible and the costs are computed within each site report (appendix).

(a) 300 series SS at 31 years

(b) 400 series SS at 31 years

(c) 300 series SS cap screws at 31 years

(d) Plated carbon steel at 31 years

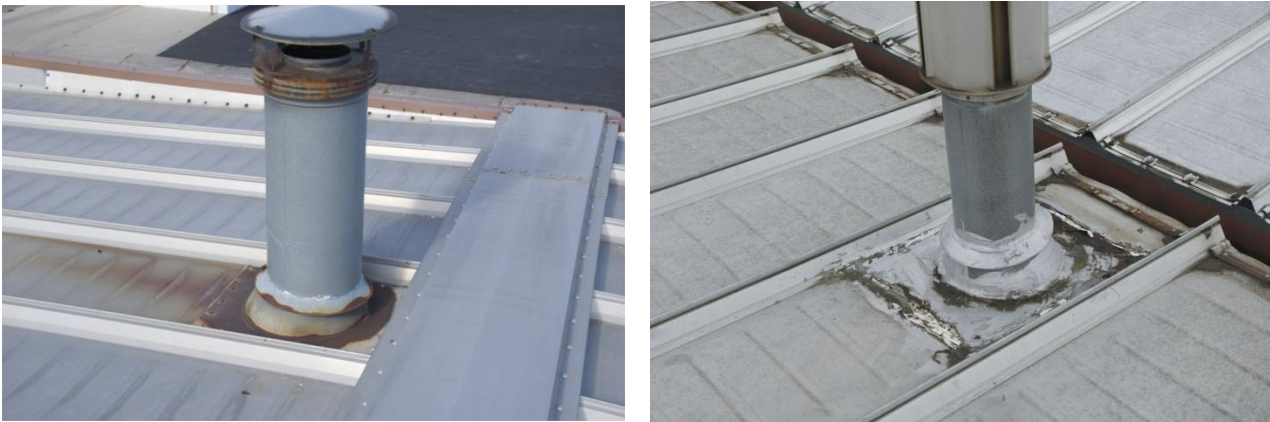
Round penetrations were primarily exhaust flues from space heating equipment within, or soil stacks related to plumbing mechanicals. In many cases, these flashings had been replaced with more appropriate flexible rubber flashings that currently reflect best practice. In other cases they had been coated and refurbished with liquid-applied coatings and external sealants. When these treatments had been executed there were often detrimental effects to adjacent roof panels. Best practice today utilizes methods shown in Figure 2, and these practices have been well-known and utilized in the trade for about 25 years. Several examples of improper (but typical to the era) round penetration flashings are shown in Figure 19.

Figure 19 – Two examples of flashing round penetrations.

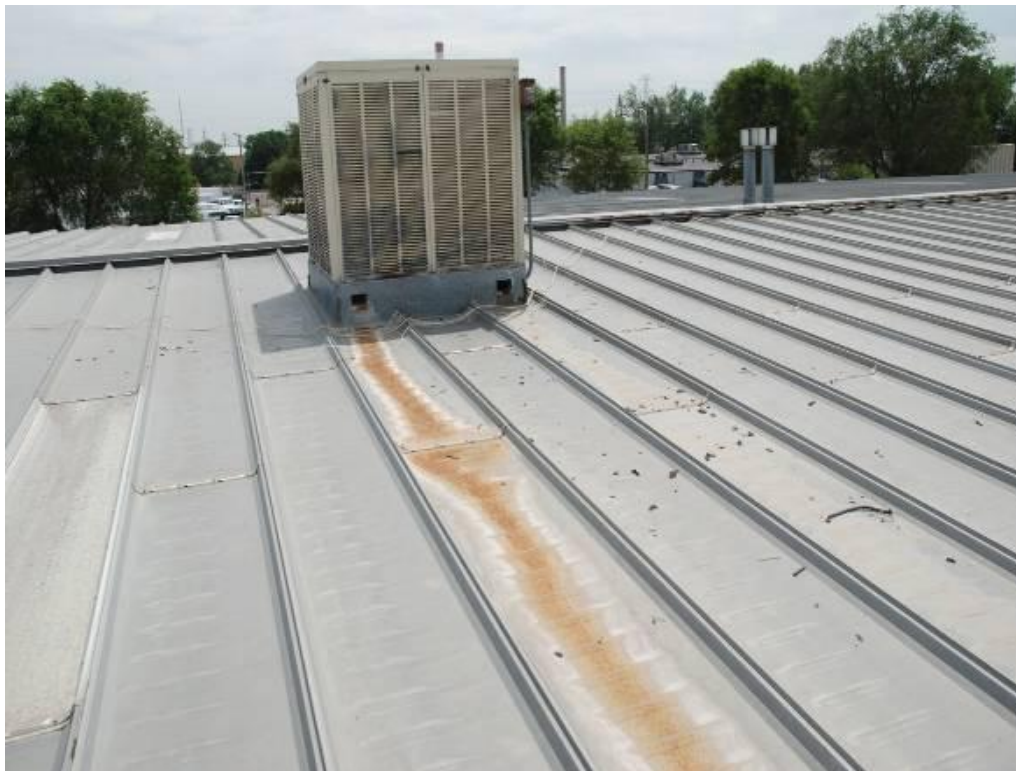
Mounting of air conditioning equipment and swamp coolers also reflected the common practices of the day 30+ years ago. Drainage of the effluent (copper-ion containing condensate) resulting from normal operation of condensing units was typically drained directly onto the roof surface, causing extensive corrosive effect to the exposed roof panels, as shown in Figures 20 and 21(right). These detrimental effects are well known by the trade today as is the solution prescribed earlier in this report under Best Practices.

Figure 20 – Accelerated corrosion of 55% Al/Zn sheet due to improper drainage of copper ion-containing HVAC condensate.

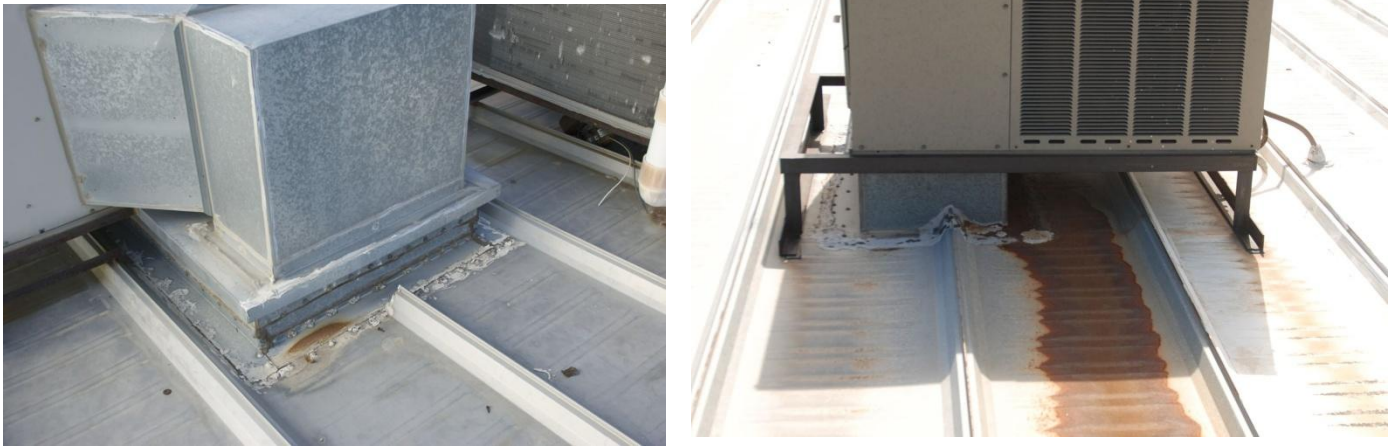
A variety of load-bearing and non-load bearing curb and flashing types were found still in place for the mounting of rooftop HVAC equipment, many exhibiting the common practices of the 1980's. In many cases these curb types were galvanized materials that have been treated with various topical sealants and coatings to restore weather integrity and prevent corrosion. Often units were mounted onto wood blocking which is corrosive to the roof material. Typical examples of poor HVAC mounting are shown in Figure 21. Best practices currently obviate the use of such materials.

Figure 21 – Typical examples of poor HVAC mounting.

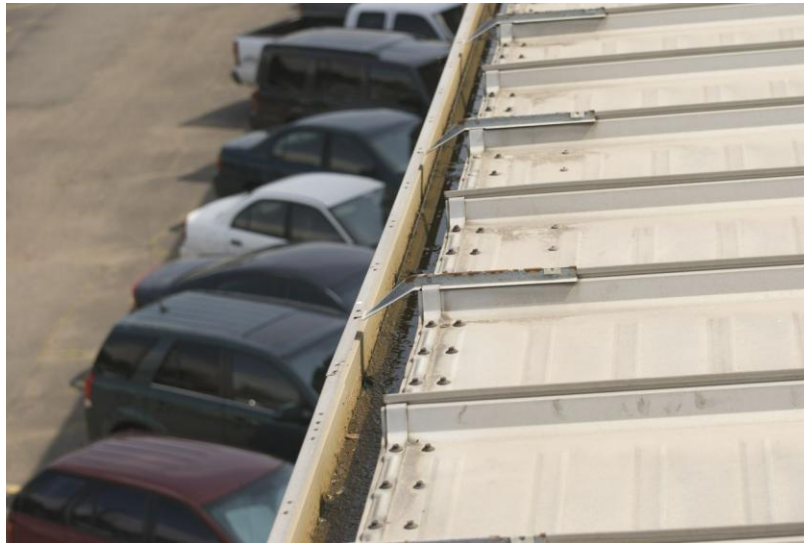
Gutters found at all sites were original material and were generally broken shapes of pre-painted G-90 steel, a typical example of which is shown in Figure 22.

Figure 22 – Typical gutter manufactured from prepainted galvanized G-90 steel.

In most cases, gutters will have to be replaced prior to end-of-life for the roof system. Remaining life and replacement costs of gutters are included in individual site reports. Gutters can be rather easily and economically replaced when necessary, and in no case would they effect end of life of the system.

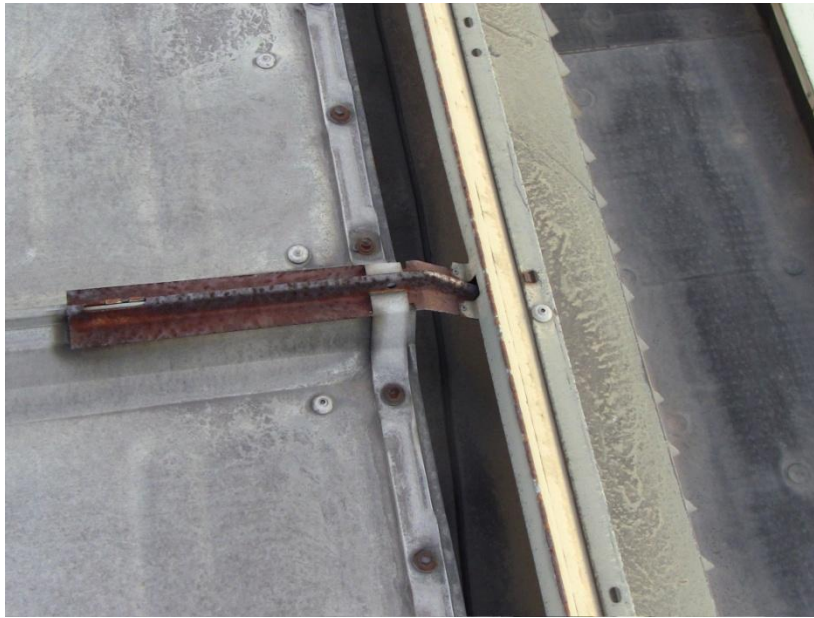
In most cases, gutter hangar brackets were also G-90 galvanized steel, and showed various stages of corrosion, the worst of which is seen in Figure 23. Current best practice is to use the more corrosion-resistant 55% Al-Zn alloy-coated material for these brackets.

Figure 23 – Gutter hangar performance of galvanized G-90 steel after 32 years in Ohio.
