Inspection report for the property at

Precision Building Inspection LLC

This is a 30 year old park model with deck and screen room added to one side and master suite added to other. For age the subject appears to be in above average condition and very well suited for the area.

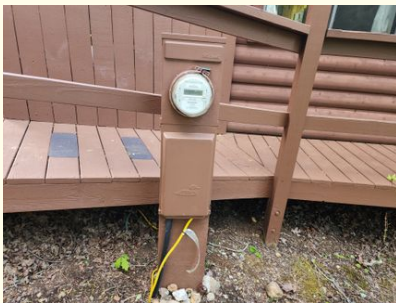
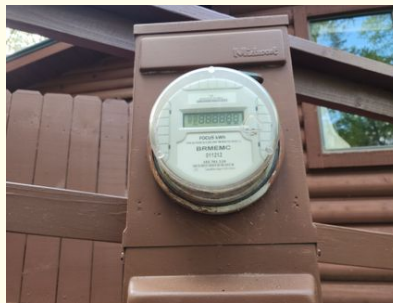
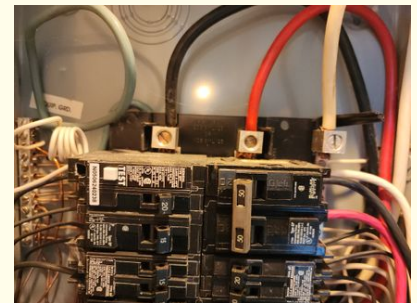
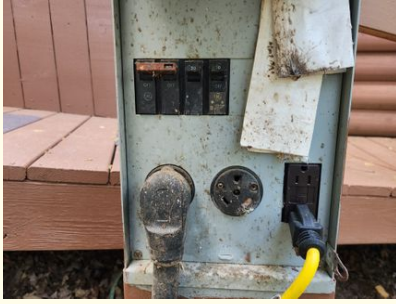
(ES-1) Improve: Electric main feed insufficient for home. Recommend upgrade to higher amperage and more permanent if allowed by local code and deed restriction for neighborhood

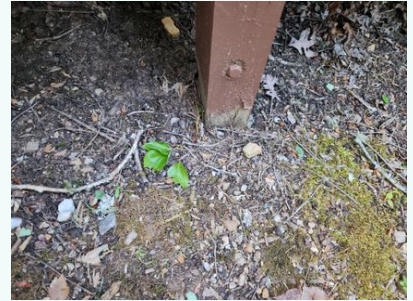
👁️ (DB-1) Monitor:

Wood in contact with soil. Monitor for decay and organisms

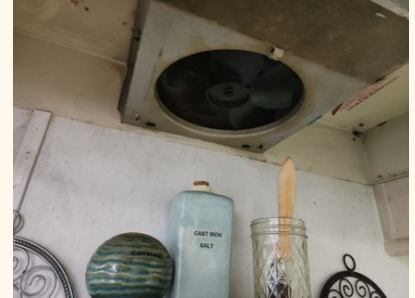
(K-3) Repair:

The kitchen exhaust fan was inoperative at the time of inspection.
Repair as needed.

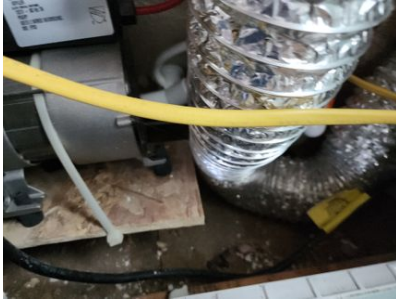
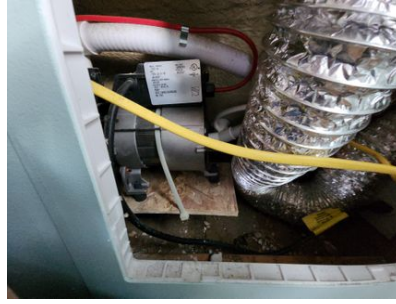
Jetted tub access from sun room. Appears dry no visual signs of damage

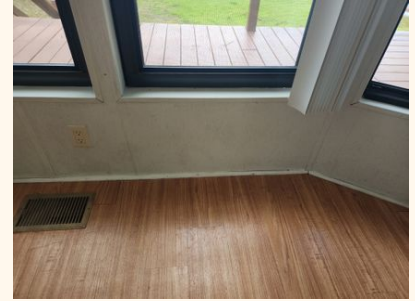
Front bay window center right tested 95% moisture reading underneath windows only. Floor dry

(I-2) Recommended Maintenance: No Water stains were noted on wall material. **These tested wet at the time of inspection.** This indicates an active moisture control problem.
General Contractor/Water mitigation specialist

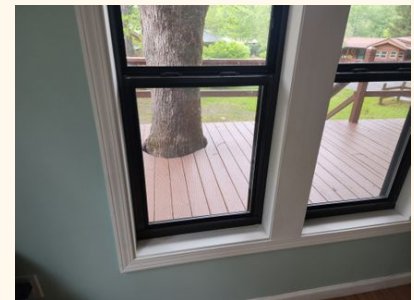
🔧 (I-5) Repair:

Repairs are needed to the window(s).

General Contractor/Window Specialist

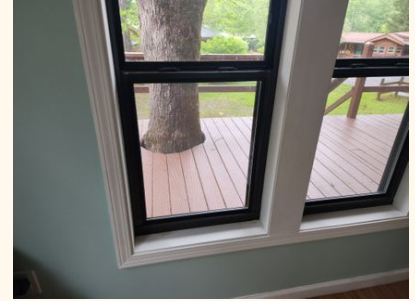
🔧 (I-6) Repair:

Window in sunroom won't stay open

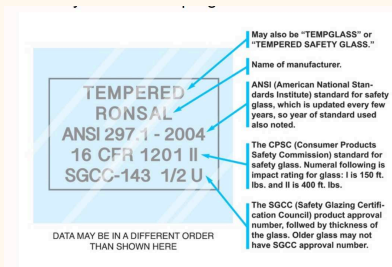
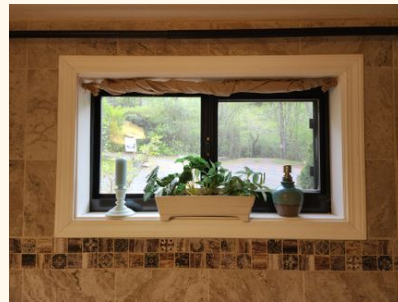
🔧 (I-7) Repair: The window(s) here should be done in safety glass and no logo or

identification could be found. Have this glass verified as safety glass or updated by a qualified contractor.

General Contractor / Glass Specialist

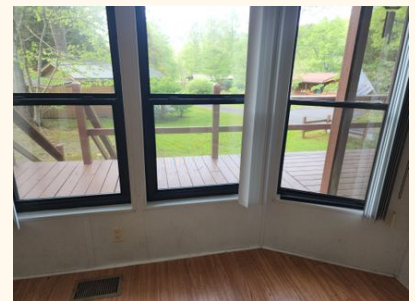
🔧 (I-9) Repair:

Single hung window In bay won't stay open

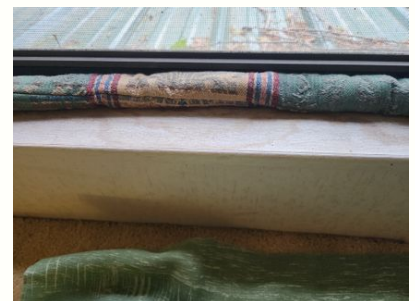
📌 (I-8) Note:

Water stains noted on sill of loft windows. Moisture reading well in normal at 12% Possible condensation problem

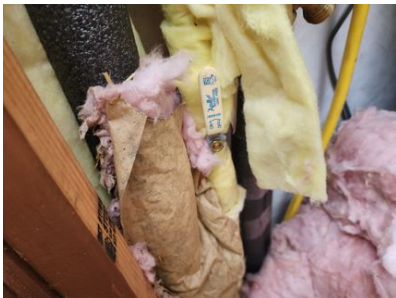
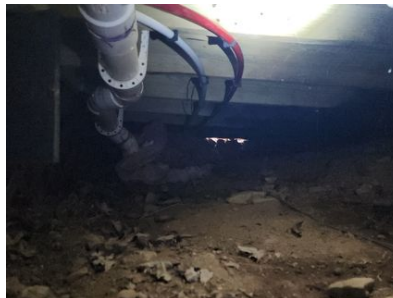
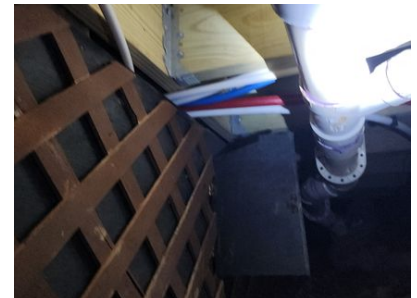
Water Pipe Insulation: Satisfactory where visible
 Water lines underneath master suite not insulated. Possible freezing hazard in severe weather

Water Quality: Sulfur Odor Noted

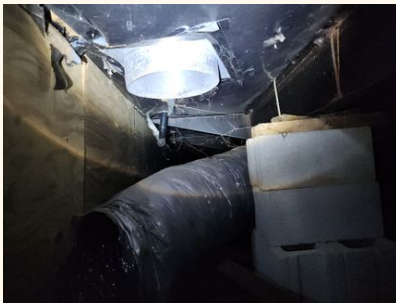
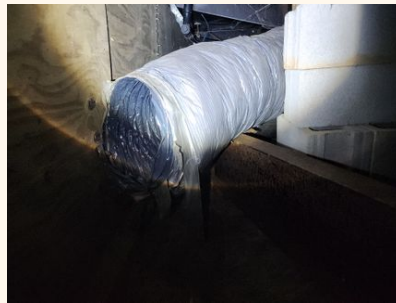
🔧 (HCS-2) Repair: No electrical disconnect was found for the furnace. A means of shutting off the furnace for serving is required within sight of the appliance. This can be a breaker at the panel if it is within sight. It is often down with a disconnecting switch adjacent to the equipment.

🔧 (HCS-5) Repair: Return air disconnected

🔧 (HCS-3) Repair: A qualified heating and cooling contractor is recommended to further investigate the heating and cooling system and implement scheduled maintenance and repairs as deemed necessary for safe and reliable operation of the system.

🔧 (HCS-4) Repair: A qualified heating and cooling contractor is recommended to further investigate the heating and cooling system and implement scheduled maintenance and repairs as deemed necessary for safe and reliable operation of the system.

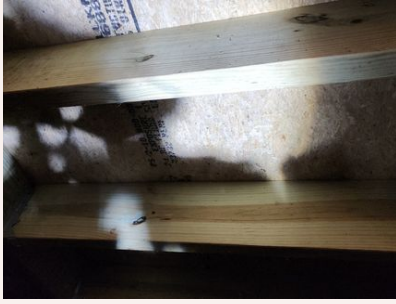
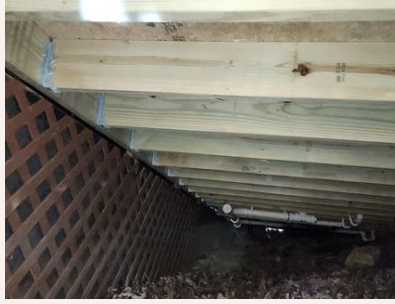
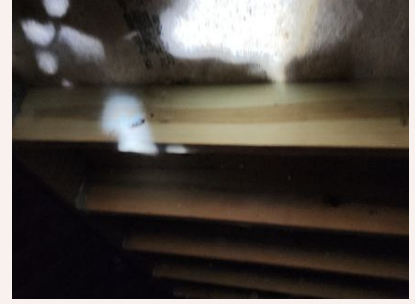
Insulation Condition: Poor

**(CS-2) Recommended Maintenance:** Install insulation under new section floor tonprevent freezing and heat loss

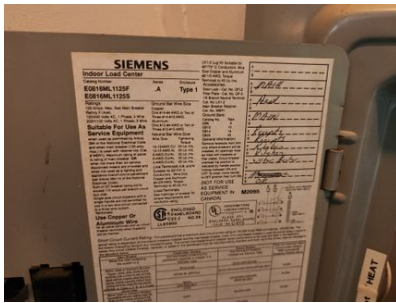
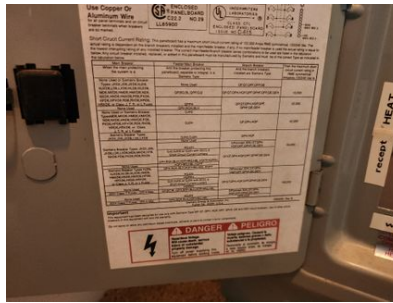
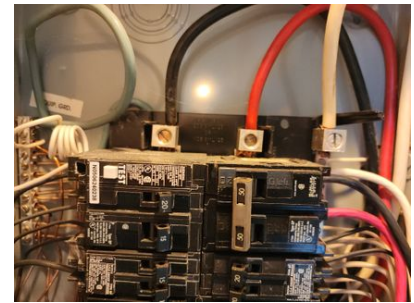
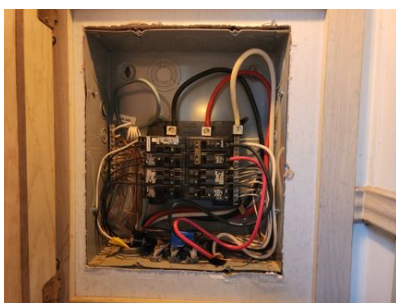
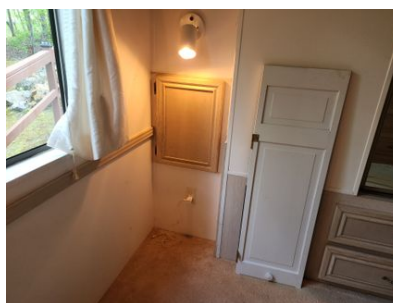
Main panel. 60 amp 1 gfcı circuit to porch. Other gfcıs located in kitchen recepts worked at time of inspection

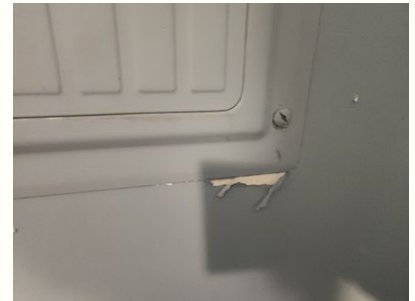
📌 **(ESE-3) Note:**

Paint disturbed around panel on removal

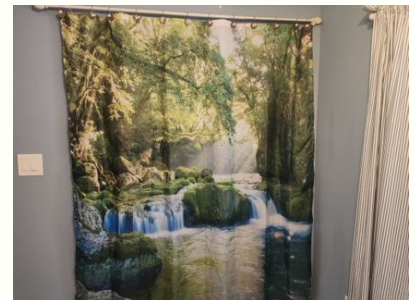
📌 **(ESE-4) Note:**

Sub panel behind drape on wall
