2023
STRUCTURAL INSPECTION REPORT
MARINERS POINT
Lakeside Decks
STRUCTURE TAG NO.: LAKESIDE DECKS

Previous Inspection Date: N/A
Globex Job No.: G-6970

Date Of Inspection: 4/26/2023, 5/17/2023 and 5/18/2023
Report Issued Date: 06/09/2023
Inspected By: B. Gerst, J. Myers

A structural condition based inspection of the wooden exterior decks and their support columns on the lake side of Buildings 1 – 5 was performed from the ground level and a 20' and 28' extension ladder.

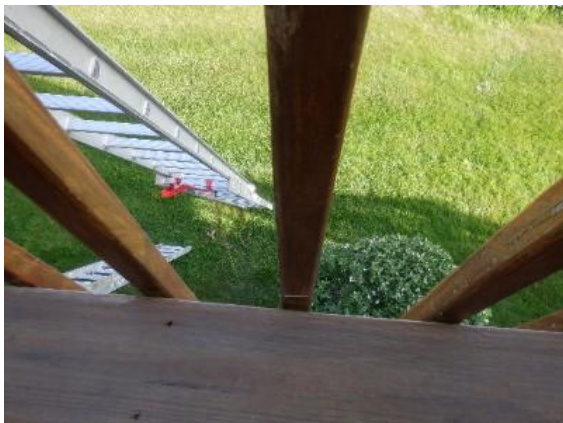
3562

7. At the topside of unit 135 deck, on North side, there is 1 loose baluster and 1 cracked baluster.

7. Replace the cracked baluster in kind with pressure treated lumber and secure the new and loose baluster with the proper length and type of exterior screws for decks.
Repair Priority: P2

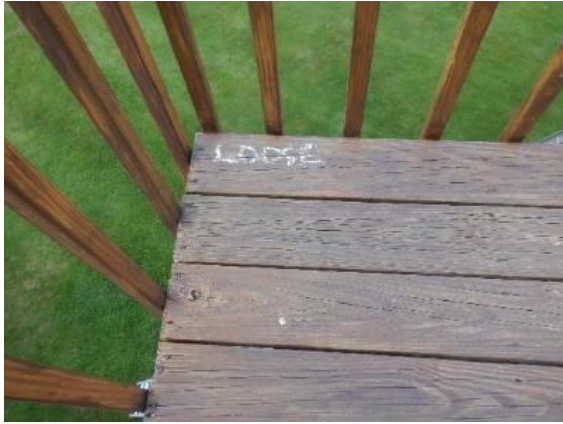
3603

25. At the topside of unit 133 deck, there are 3 deck boards loose.

25. Remove the existing fasteners and secure the deck boards with proper size and type of exterior screws for decks.
Repair Priority: P3

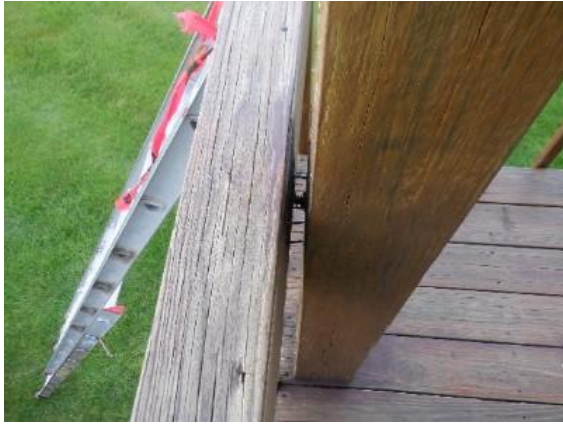
3604

27. At the topside of unit 123 deck, the West guardrail separated from the column and is loose.

27. Remove the existing fasteners and secure the rim joist connection with the proper size and type exterior screws for decks. Repair Priority: P2

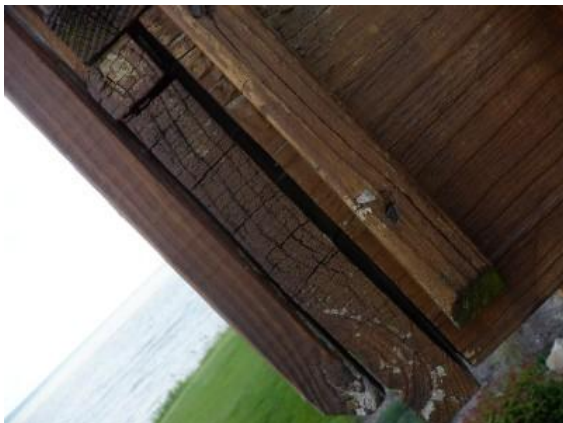
3620

32. At the underside of unit 123 deck, the N.W. rim joist connection is end nailed, separating and the West rim joist is cracked.

32. Replace the damaged rim joist in kind with pressure treated lumber and secure to columns with proper size and type of exterior screws for decks. Repair Priority: P2

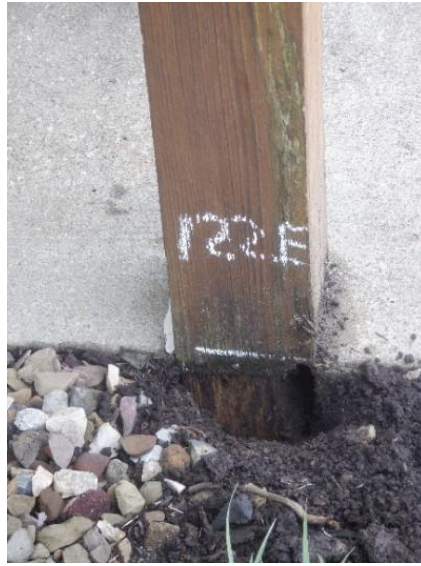
0384

35. At the underside of unit 122 deck, the East and West support column is decayed below ground level.

35. Monitor the condition of the columns until the next inspection.

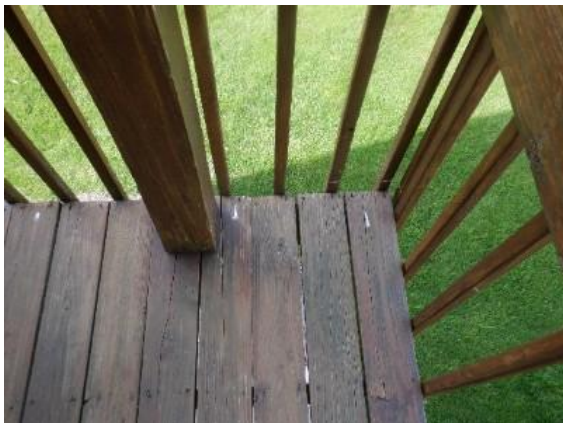
3624

38. At the topside of unit 121 deck, there are 6 loose deck boards on the West side.

38. Remove the existing fasteners and secure the deck boards with the proper size and type exterior screws for decks. Repair Priority: P3

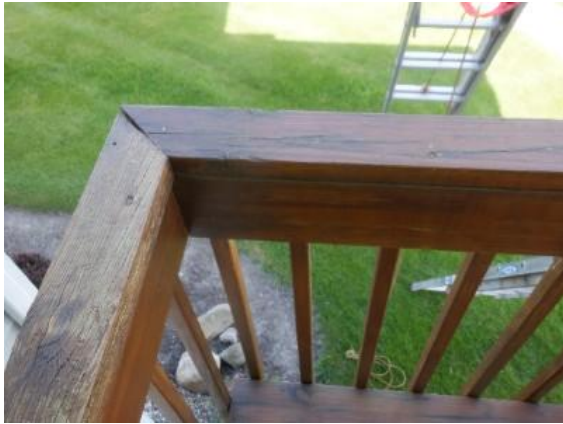
3637

46. At the topside of unit 226 deck, at the N.W. corner, the guardrail 2x4 is loose.

46. Remove the existing fasteners and secure the guardrail connection with the proper size and type exterior screws for decks. Repair Priority: P2

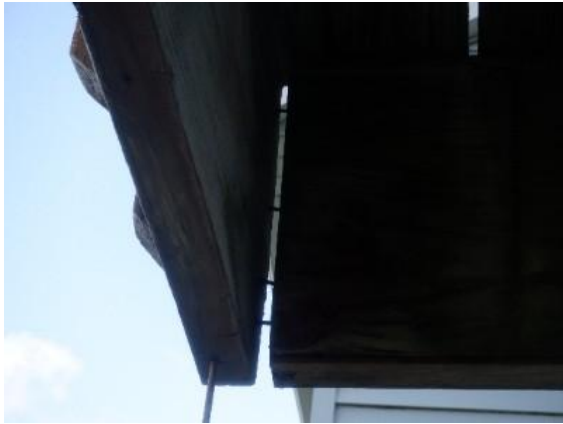
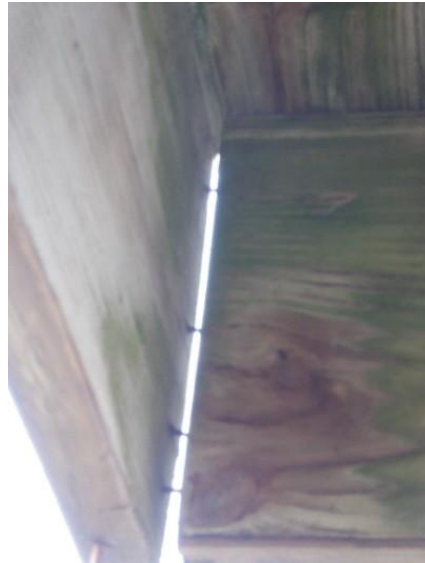
3648

52. At the underside of unit 235 deck, the rim joist corner connections are end nailed and separating

52. Remove the existing fasteners and secure the rim joist connections with the proper size and type exterior screws for decks. Repair Priority: P3

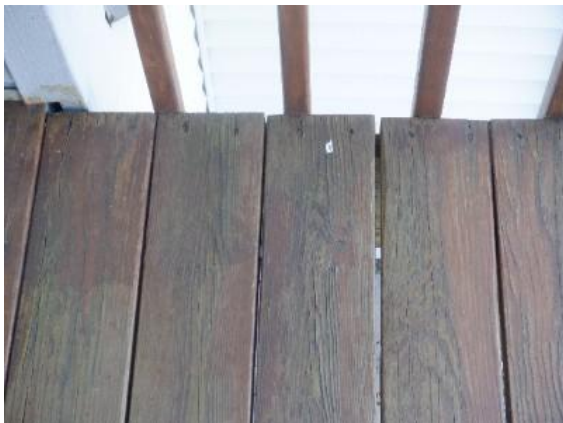
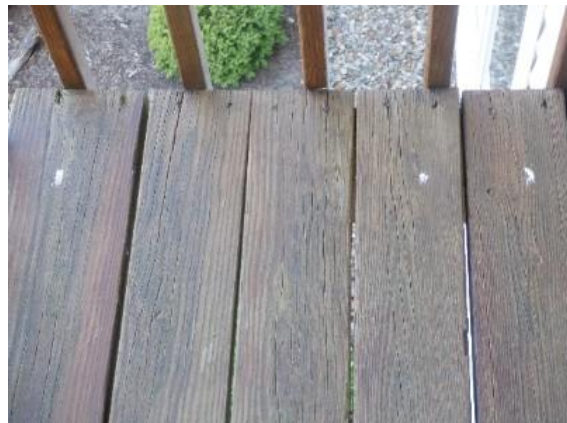
3651

53. At the topside of unit 225 deck, there are 4 loose deck boards

53. Remove the existing fasteners and secure the deck boards with the proper size and type exterior screws for decks. Repair Priority: P3

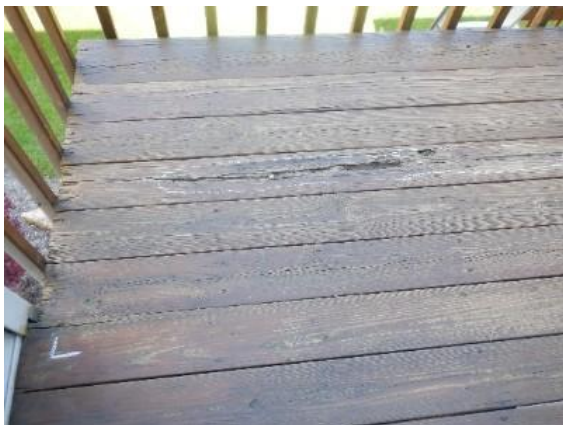
3672

68. At the topside of unit 232 deck, there are 2 loose deck boards and 1 deteriorated deck board.

68. Replace the deteriorated deck board in kind with pressure treated lumber and secure the new and existing loose deck boards with the proper size and type exterior screws for decks.
Repair Priority: P3

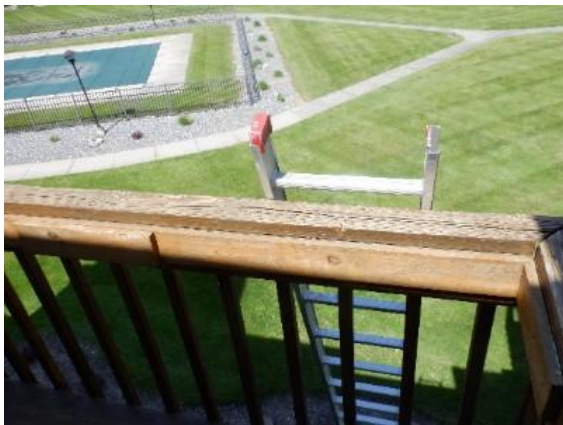
3676

70. At the topside of unit 232 deck, the guardrail 2x4 is deteriorated and separating at the connections.

70. Replace the deteriorated 2x4 guardrail in kind with pressure treated lumber.
Repair Priority: P3

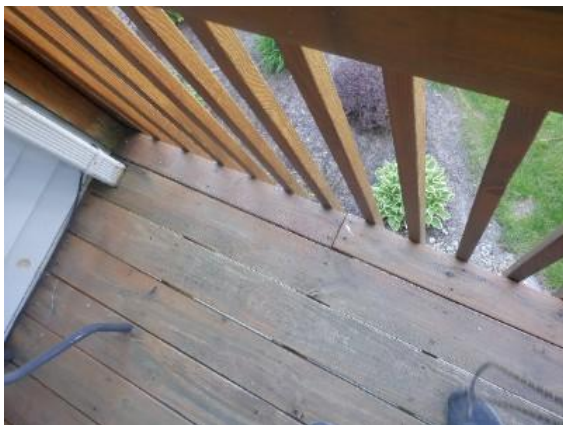
3697

81. At the topside of unit 327 deck, there is 1 loose deck board.

81. Remove the existing fasteners and secure the deck board with the proper size and type exterior screws for decks. Repair Priority: P3

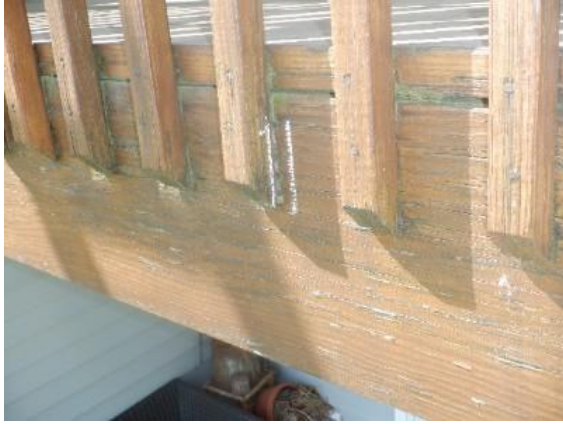
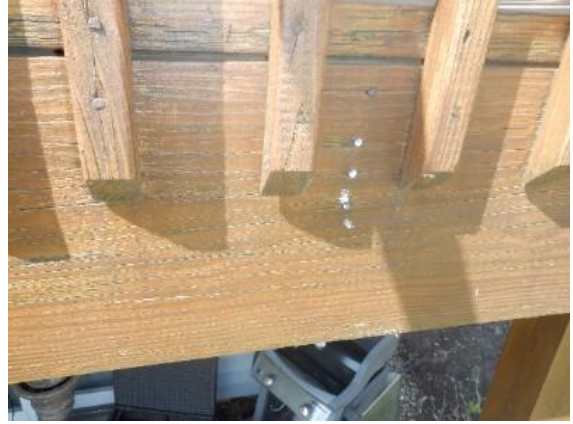
3882

174. At the underside of unit 421 deck, on the East rim joist, at the second and fourth joist from the North, the nails are popped out.

174. Remove the existing fasteners and secure the rim joist connections with the proper size and type exterior screws for decks. Repair Priority: P2

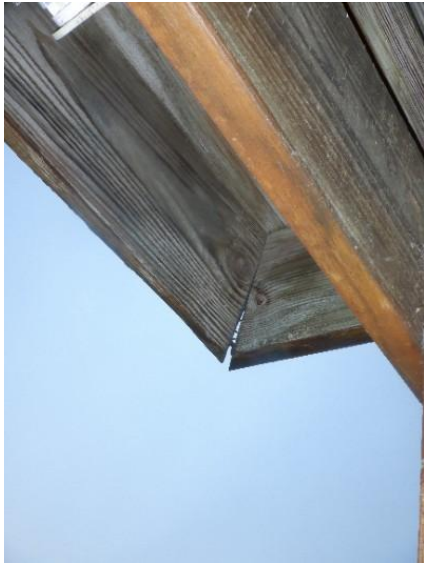
3891

178. At the underside of unit 537 deck, at the S.E. corner of the rim joist is lagged and separating.
