# 2023 STRUCTURAL INSPECTION REPORT MARINERS POINT CONDOMINIUMS Parking Lot Side

**STRUCTURE TAG NO.: WALKWAYS AND STAIR TOWER**

**Date Of Inspection:** 04/25/2023

**Globex Job No.:** G-6970

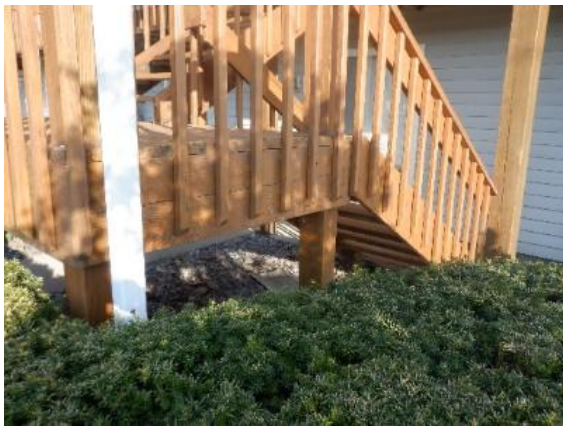
0112

1. At landing 1, the East (2 x 12) rim joist has a full-length horizontal crack.

1. Replace the cracked rim joist in kind with pressure treated lumber and proper fasteners.  
Repair Priority: P3

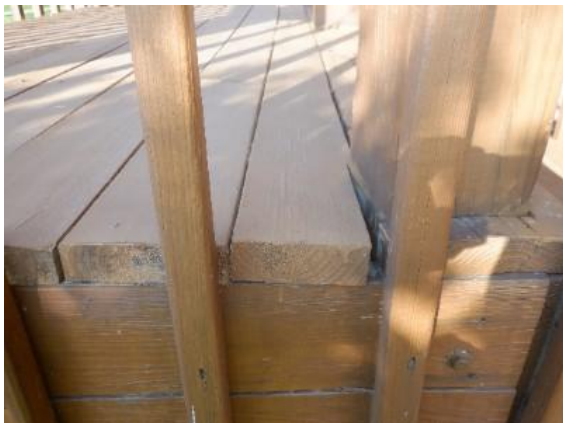
0114

2. At landing 1, there are 2 deck boards which are not secured on the East end.

2. Secure the loose deck boards with proper length exterior deck screws.  
Repair Priority: P3

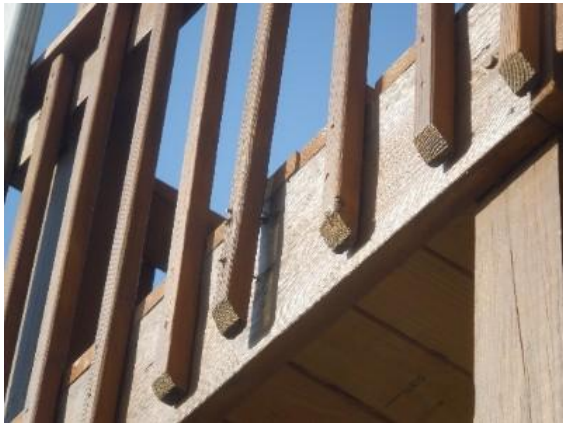
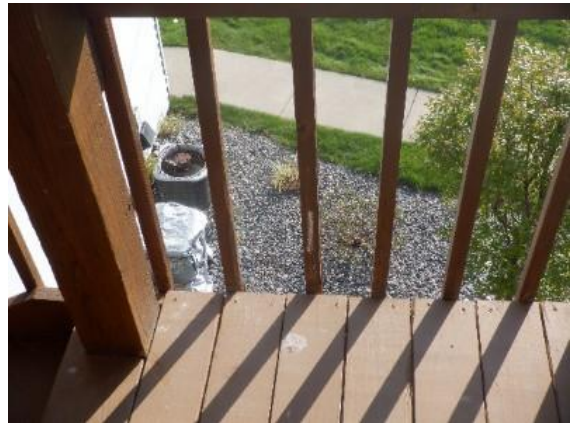
Image(s) For Finding No.3

3. At landing 2, on the East side, there is 1 loose baluster.

3. Secure the loose baluster with a proper length exterior deck screw.  
Repair Priority: P2

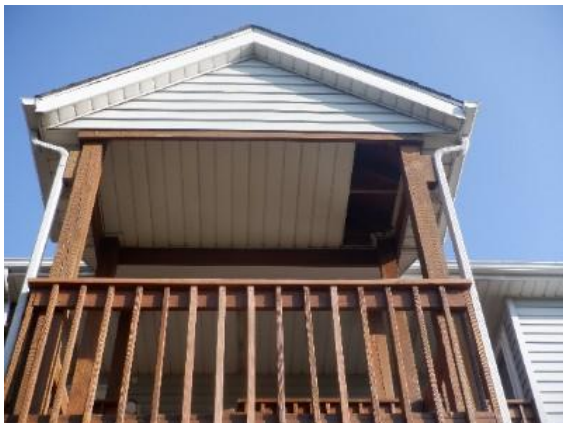
0125

4. At the top of the stair tower, there is a section of overhead soffit missing and laying on the ground below.

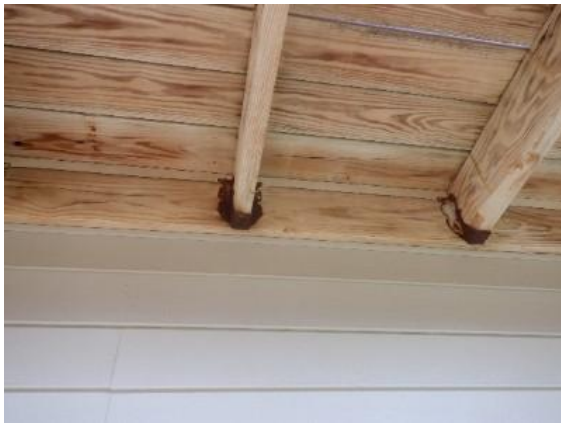
0130

6. At the 1st 11 joist hangers from the East on the building side, the galvanized coating is corroded.

6. Monitor the condition of the joist hangers until the next inspection.  
Repair Priority: P5

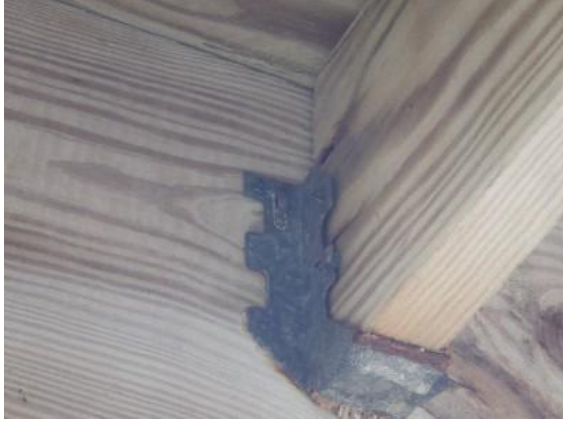
Image(s) For Finding No.7

7. At the East stair tower, 4 - 2x6 joist hanger brackets were used on the 2 x 8 joists on the stair tower side connection. There was no evidence of any failure at the connections.

7. For the record only.No action is required at this time.

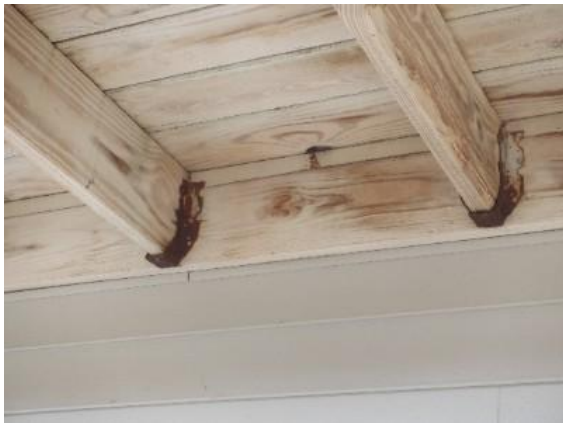
0142

8. At the 1st 12 joist hangers from West on the building side, the galvanized coating is corroded.

8. Monitor the condition of the joist hangers until the next inspection.  
Repair Priority: P5

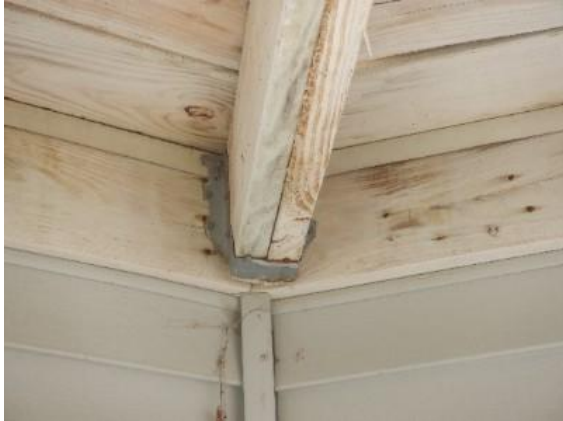
0139

9. There are no visible lag screws and only a few sporadic visible nails. It appears that the ledger board connection nails may be located behind each joist which are not visible for inspection. No evidence of any ledger pullout was observed.

9. Since the ledger board connection to the building cannot be verified, further engineering and investigation is recommended to review original design drawings and the ledger connections for code compliance.  
Repair Priority: P4

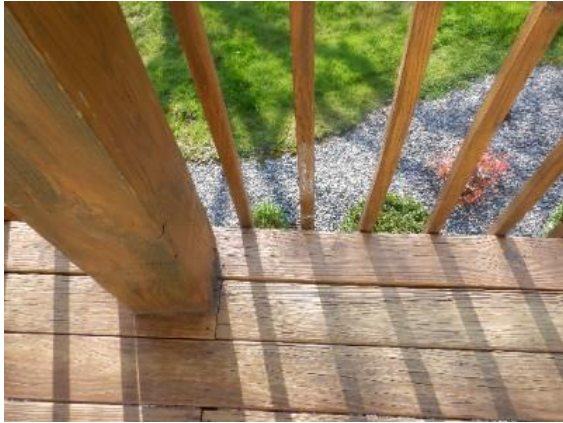
0145

10. Between columns 3 and 4 from the West, there are 4 balusters loose at the bottom connection.

10. Secure the loose balusters with a proper length exterior deck screw.  
Repair Priority: P2

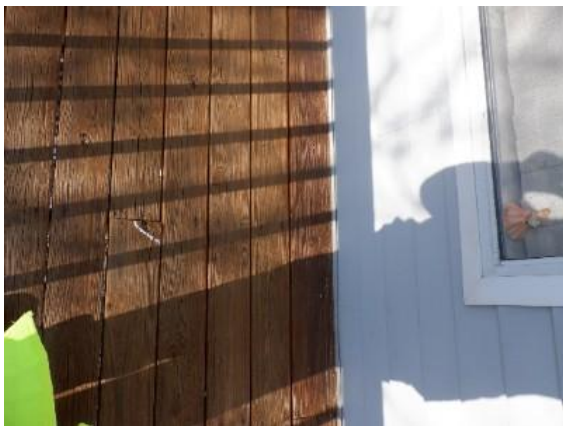
0147

11. Between columns 4 and 5 from the West, there is 1 deck board loose.

11. Secure the loose deck board with proper length exterior deck screws.  
Repair Priority: P3

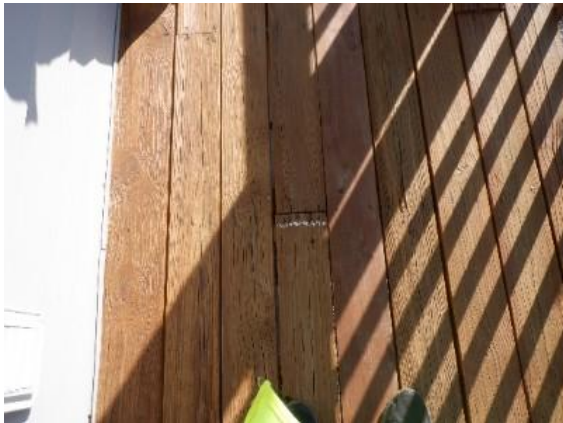
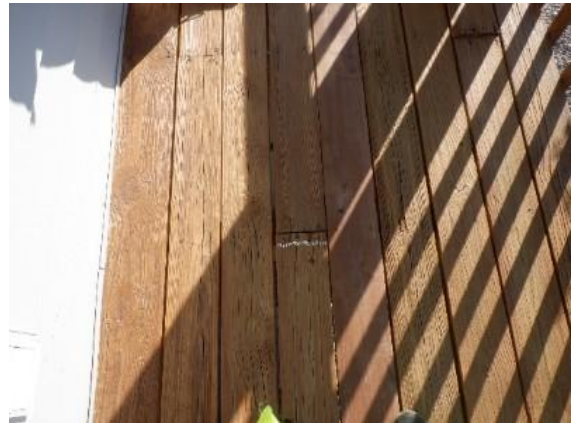
Image(s) For Finding No.12

12. Between columns 6 and 7 from the West, there is 1 deck board loose.

12. Secure the loose deck board with proper length exterior deck screws.  
Repair Priority: P3

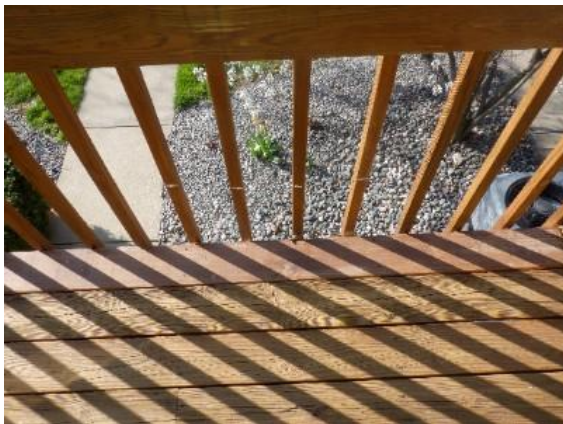
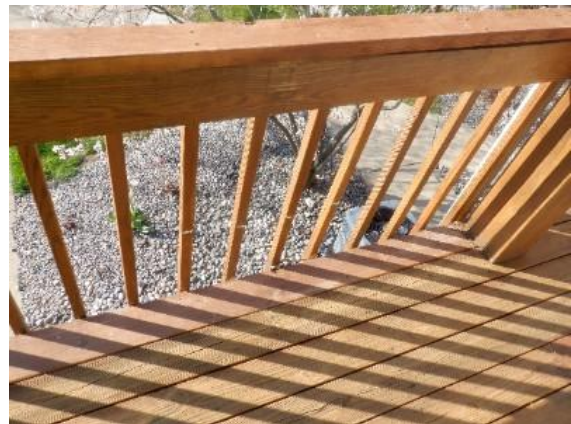
Image(s) For Finding No.13

13. Between columns 7 and 8 from the West, there are 4 balusters loose.

13. Secure the loose balusters with proper length exterior deck screws.  
Repair Priority: P2

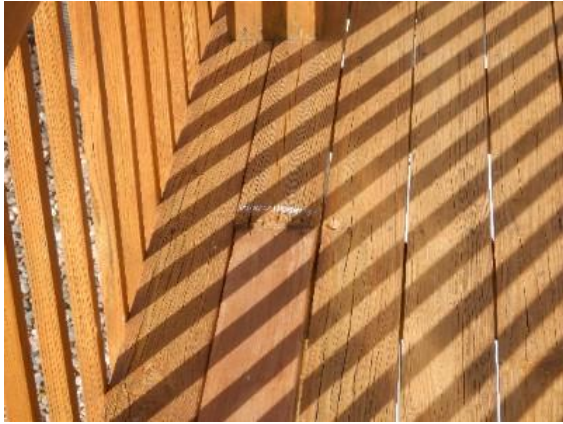
0155

14. Between columns 8 and 9 from the West, there are 3 deck boards loose with nails pulling up.

14. Secure the loose deck boards with proper length exterior deck screws and remove the loose nails.

Repair Priority: P3

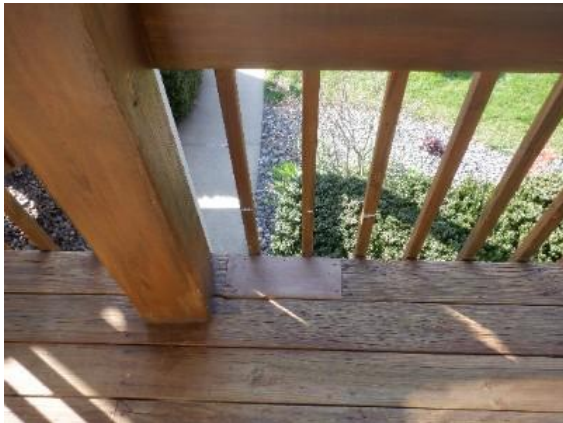
0160

15. Between columns 9 and 10, from the West, there are 2 deck boards and 3 balusters loose.

15. Secure the loose deck boards and balusters with proper length exterior deck screws.

Repair Priority: P2

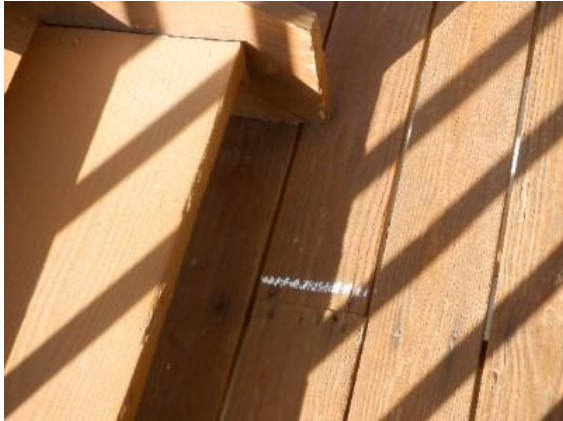
0163

16. Between columns 11 and 12 from the West, there are 2 deck boards loose.

16. Secure the loose deck boards with proper length exterior deck screws.  
Repair Priority: P3

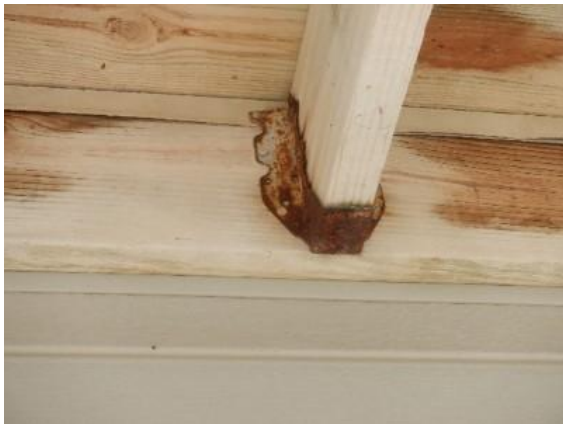
0168

17. At the 1st 8 joist hangers from the East on the building side, the galvanized coating is corroded.

17. Monitor the condition of the corroded hangers until the next inspection.  
Repair Priority: P5

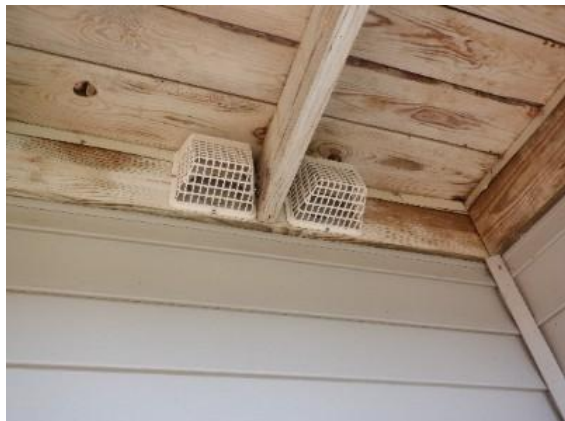
Image(s) For Finding No.18

18. At the 1st joist from the East on the building side, there is no joist hanger. The joist was toe-nailed instead. No evidence of any connection failure was observed.

18. For the record only. No action is required at this time.

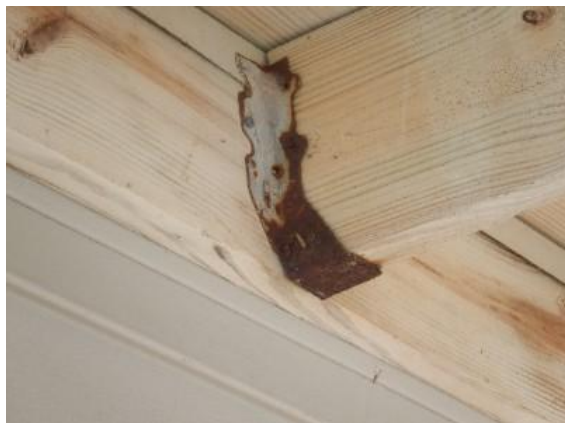
0177

19. At the 2nd through 9th joist hangers from the West on the building side, the galvanized coating is corroded

19. Monitor the condition of the corroded hangers until the next inspection. Repair Priority: P5

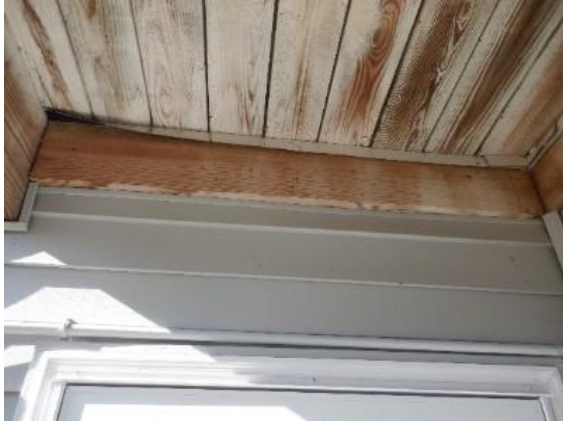
0174

20. There are no visible lag screws and only a few sporadic visible nails. It appears that the ledger board connection nails may be located behind each joist making them not visible for inspection. No evidence of any ledger pullout was observed.

20. Since the ledger board connection to the building cannot be verified, further engineering and investigation is recommended to review original design drawings and the ledger connections for code compliance.

Repair Priority: P4

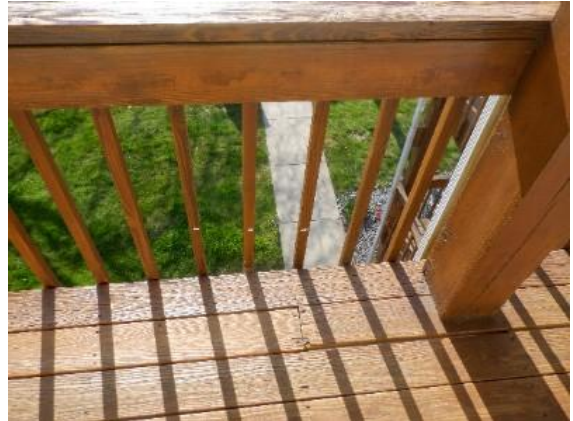
Image(s) For Finding No.22

22. Between columns 3 and 4 from the West, there are 11 balusters loose.

22. Secure the loose balusters with proper length exterior deck screws.  
Repair Priority: P2

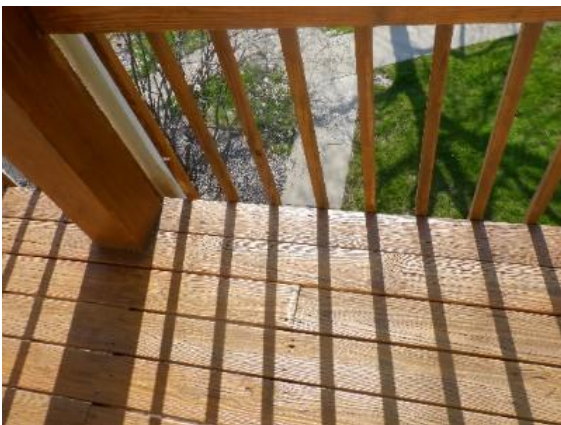
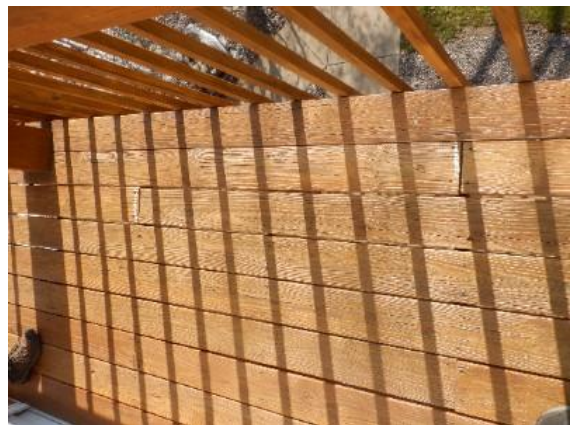
Image(s) For Finding No.23

23. Between columns 4 and 5 from the West, there are 2 deck boards and 1 baluster loose.

23. Secure the loose deck boards and baluster with proper length exterior deck screws.  
Repair Priority: P2

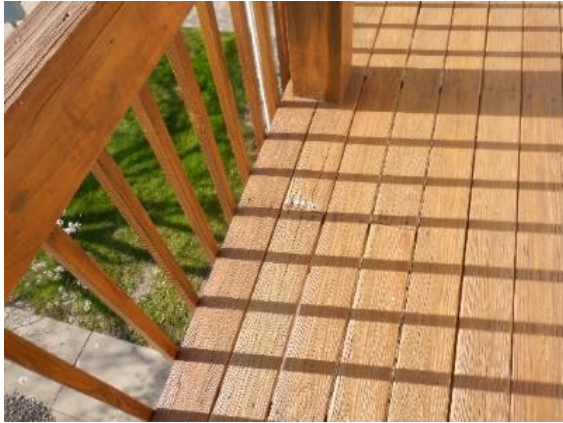
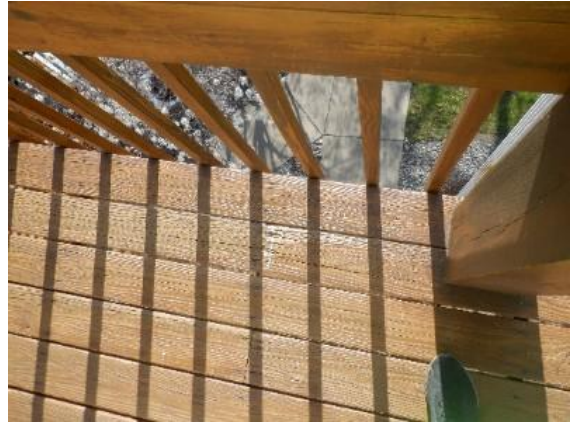
Image(s) For Finding No.24

24. Between columns 5 and 6 from the West, there is 1 deck board loose.

24. Secure the loose deck board with proper length exterior deck screws.  
Repair Priority: P3

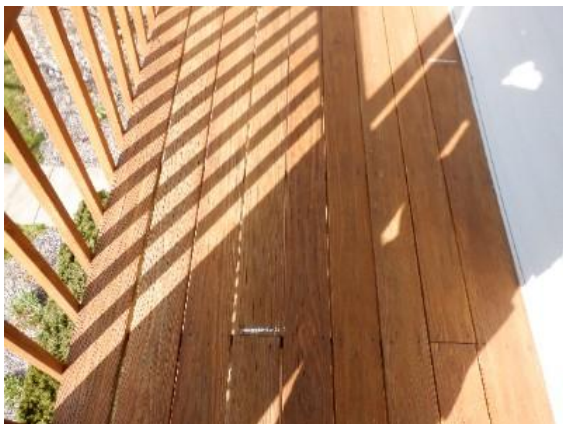
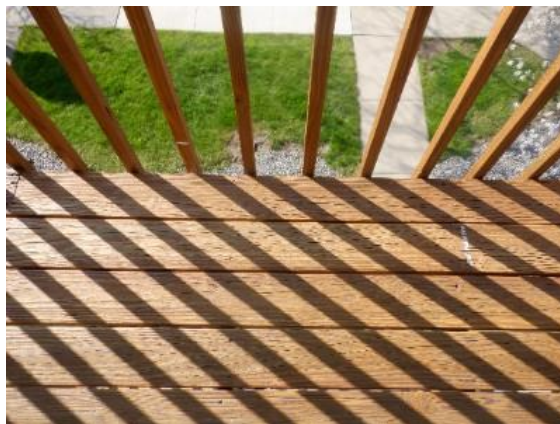
Image(s) For Finding No.28

28. Between columns 8 and 9 from the West, there are 3 deck boards and 1 baluster loose.

28. Secure the loose deck boards and baluster with proper length exterior deck screws.  
Repair Priority: P2

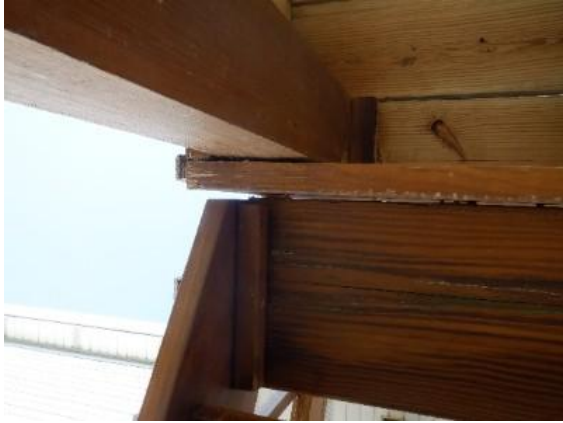
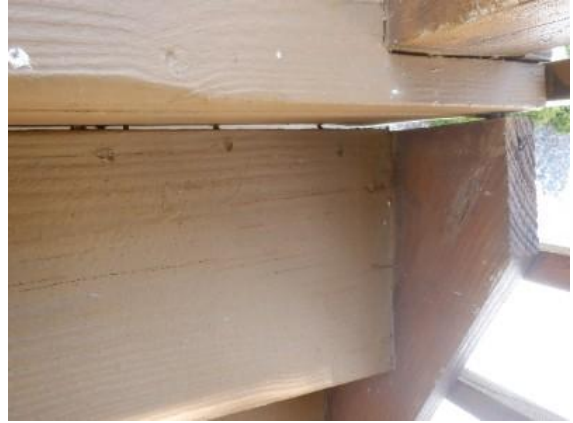
Image(s) For Finding No.32

32. At the stairs between the 2nd landing and 2 floor walkway, at the West stair stringer top connection to rim joist, there is only 1 nail and the connection is gapped approximately 1/2".

32. Remove the existing nails, pull the stair stringers tight against the rim joist, and secure by pre-drilling and installing two 1/2" diameter x 4" lg. lag screws with washers on each stringer or installing adjustable u-joint hangers in accordance with the manufacturer's recommendations.  
Repair Priority: P2

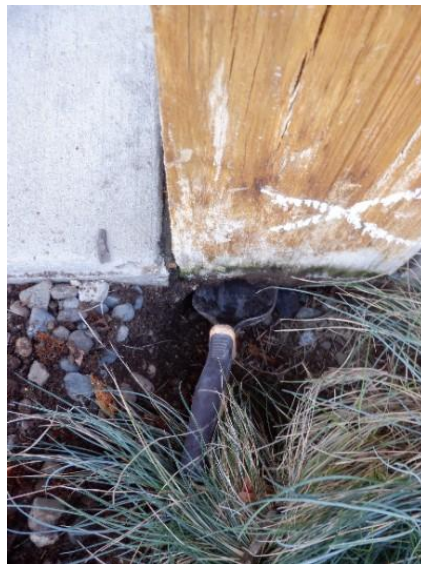
Image(s) For Finding No.45

45. At column 3 from South, the column base below grade is wet and decayed with approximately 50% section loss.

45. Repair the deteriorated column base. See cover sheet notes for suggested repair options.  
Repair Priority: P3

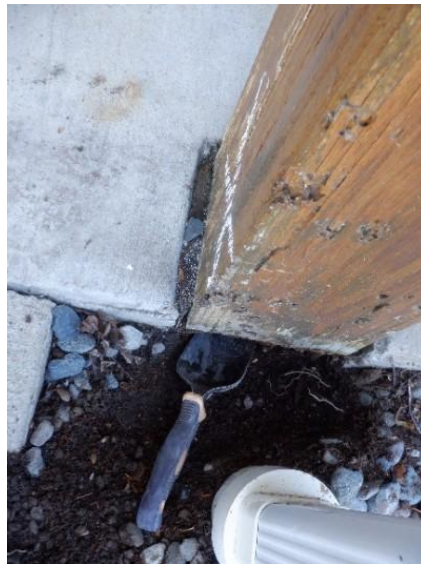
Image(s) For Finding No.49

49. At column 6 from South, the column base below grade is wet and decayed with approximately 50% section loss

49. Repair the deteriorated column base. See cover sheet notes for suggested repair options.  
Repair Priority: P3

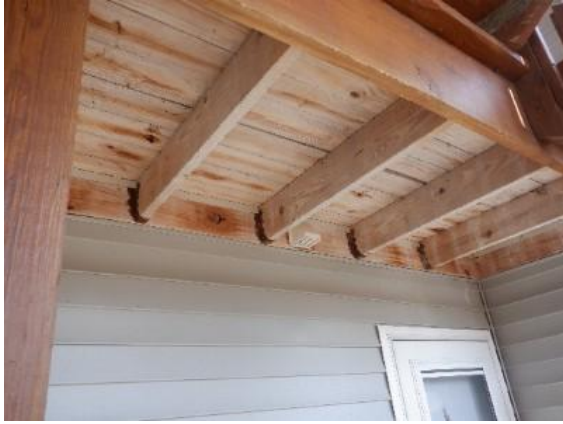
0217

52. At the joist hanger brackets along the entire building length, the galvanized coating is corroded. This condition is worse near the stair towers.

52. Monitor the condition of the hanger brackets until the next inspection.  
Repair Priority: P5

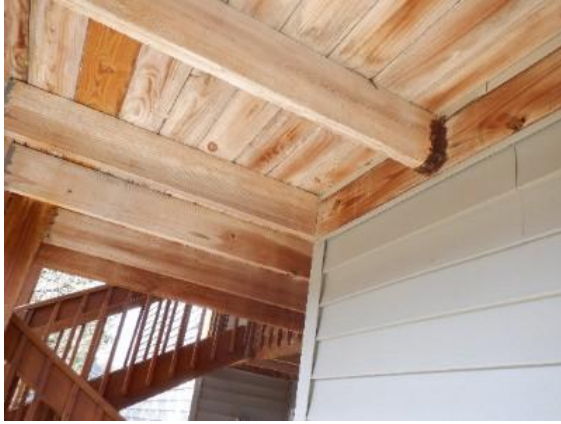
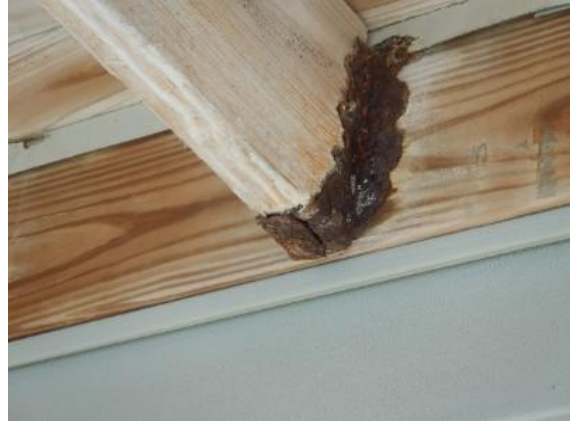
Image(s) For Finding No.61

61. Between columns 1 and 2 from the South, there is 1 joist hanger bracket on the building side that is corroded and cracked.

61. Replace the corroded joist hanger in kind  
Repair Priority: P2

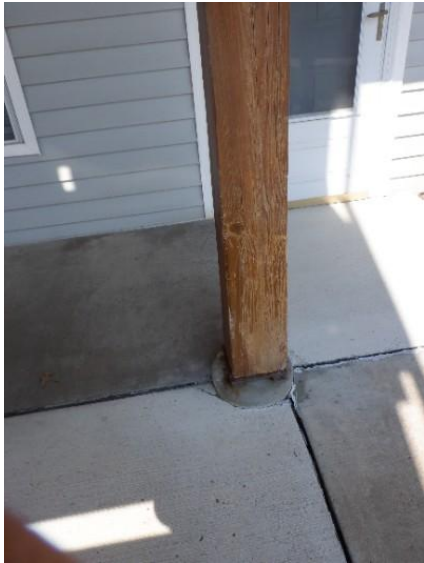
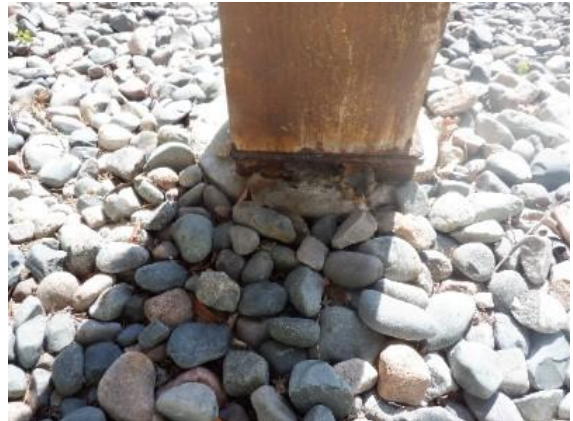
0266

77. At columns 13, 14 and 15 from the South, the column base plates are rust packed and expanding.

77. Monitor the condition of the column base plate until the next inspection.  
Repair Priority: P5

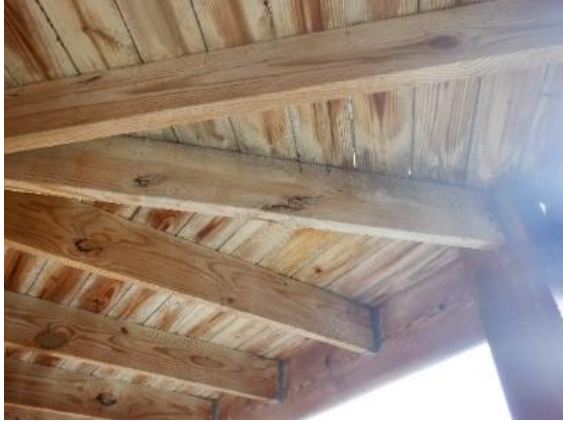
0299

There is a joist cracked at mid-span and a stair tread which is spongy on one side when stepped on. See findings no. 91 and 108, as these are high priority P2 findings.

91. Replace the joist in kind with pressure treated lumber  
Repair Priority: P2
