**To:** Mariners Point Condo Association  
**From:** Globex Corporation  
**Subject:** Lakeside Deck Inspections – High Priority Findings

Globex completed the lakeside deck inspections on 5/18/2023 and identified several high priority deficiencies listed below. Please note that additional deficiencies exist with the decks listed below and many other decks. The additional deficiencies and their recommended repairs will be included in the inspection report submittal to follow.

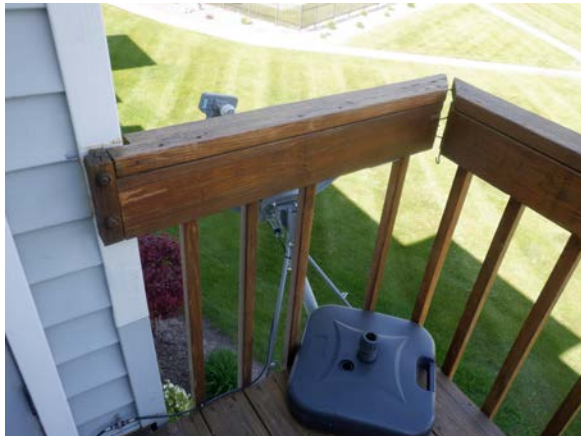
3655

1F: At unit 234, the East and West guardrails are connected to the building with wooden cleats which are deteriorated with lag screws that are pulling out and loose. At the S.W. corner of the railing, the 2x6 and 2x4 railing members are deteriorated with nails and screws pulled out. The railing is wobbly. (3655-57)

1R: Replace deteriorated members in kind with pressure treated lumber. At the ends of the guardrail, install 4x4 support posts next to the building and thru-bolted to the rim joist below.

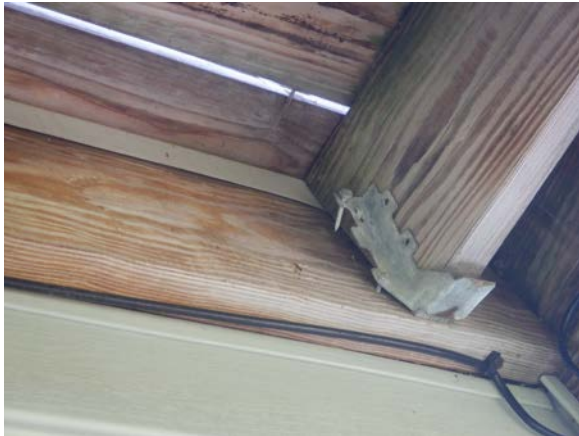
3719

2F: At unit 326, at the underside, at the 1<sup>st</sup> and 2<sup>nd</sup> joists from the South, the joist hanger nails are pulled out from the ledger board. (3719-21)

2R: Remove the loose nails and secure the joist hangers to the ledger board with screws.

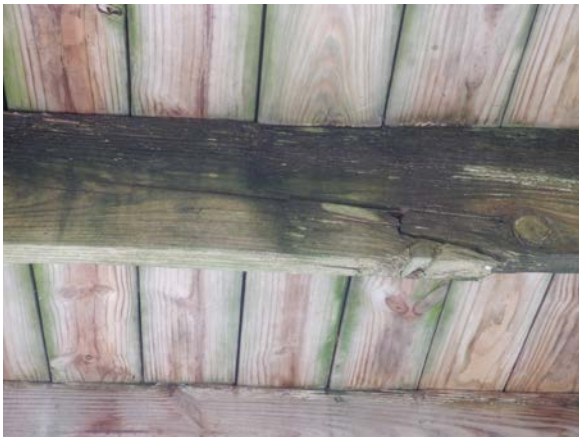
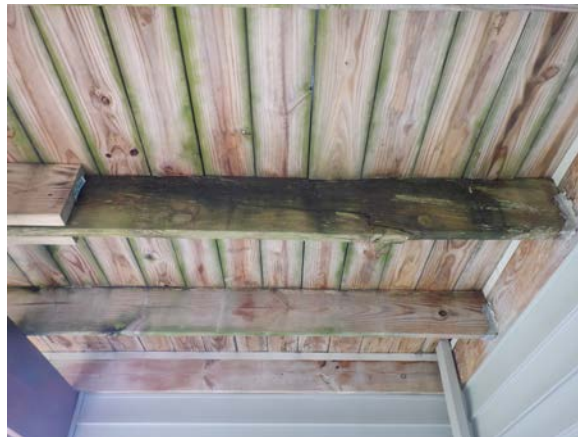
3F: At unit 324, at the underside, at the 3<sup>rd</sup> to 6<sup>th</sup> joists from the South, the top of the joists are soft and decayed at the top and 5<sup>th</sup> joist is also cracked and sagging. (3767-71)

3R: Replace the cracked joist in kind with pressure treated lumber with deck joist flashing tape added. Other joists are recommended to be replaced but not as high of a priority.

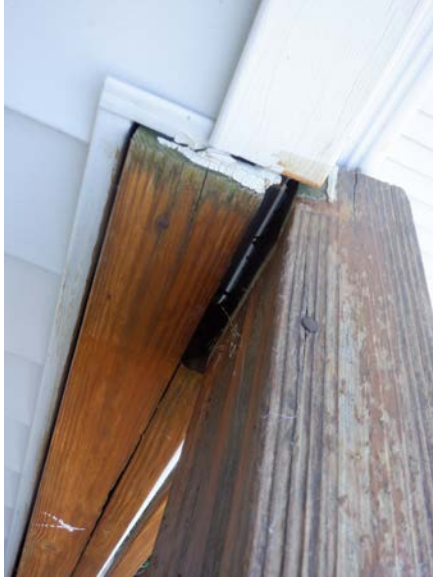
3808

4F: At unit 322, at the South guardrail, the rail connection to the building is loose because the building framing behind is deteriorated. (3808-15)

4R-9R: Based on the damage to the building framing behind the deck, it appears that the building was not properly flashed at this location. Repair the damaged building framing and add proper flashing. Rebuild the damaged deck in accordance with OBC-latest edition requirements using pressure treated lumber and deck joist flashing tape.

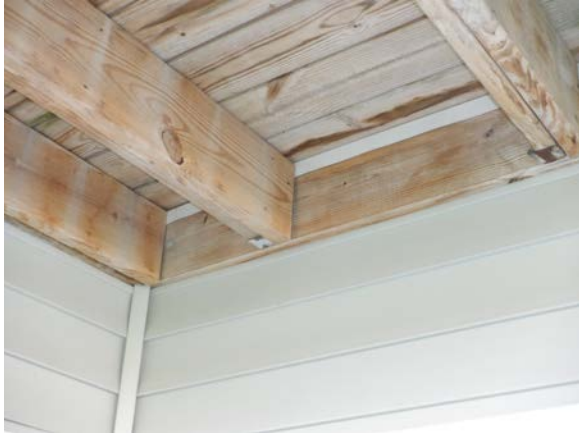
3826

6F: At unit 322, at the underside, new joists were screwed into the old joists. However, the new joists are not connected to the ledger board. (3826-28)

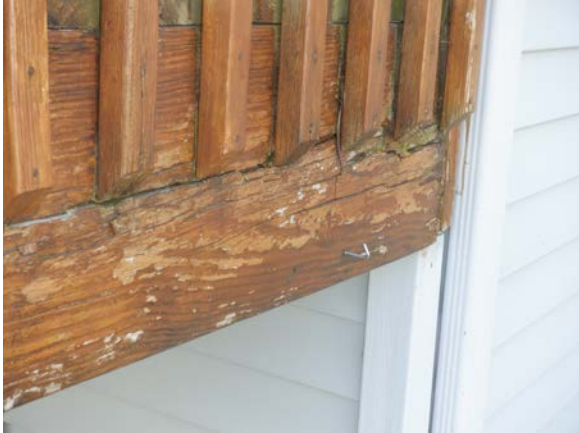
3823

7F: At unit 322, at the underside, the South rim joist is completely decayed, the South end of the ledger board is decayed and the building framing behind is decayed from moisture infiltration. (3823, 24, 29)

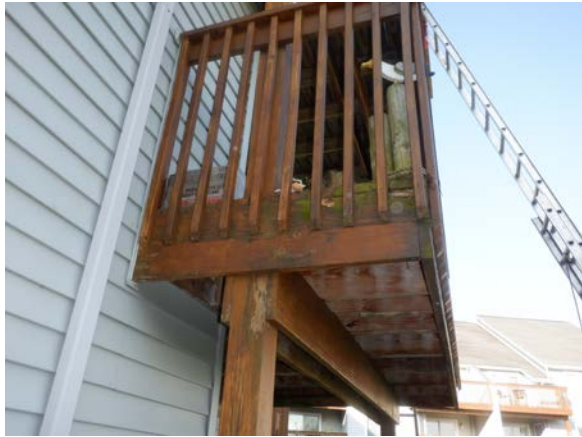
3830

8F: At unit 322, at the underside, the North rim joist is soft and decayed at the top. (3830-31)

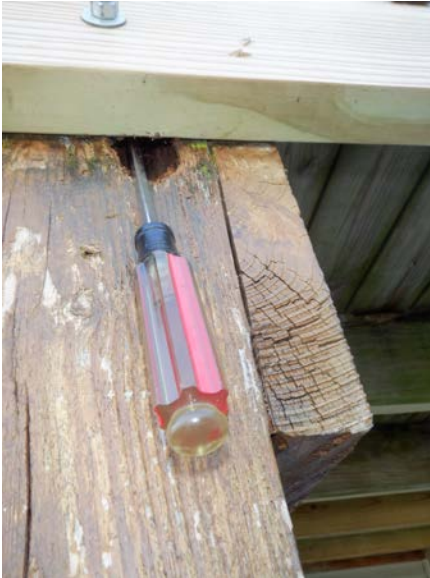
3819

9F: At unit 322 and 332, the South column is soft and decayed behind the 332 South rim joist with approximately 40% section loss. Also, the column is soft and decayed at 322 deck level with approximately 50% section loss. (3819-24 & 3821-22)
