INSPECTION REPORT

Inspection Report # 042310 ~ TURNER

Subject Property Address: 12345 Main St ~ Upland, CA. 91786

Single Family Residence ~ Approximate Size: 2449 ± square feet ~ Approximate Year Built: 1979 ±

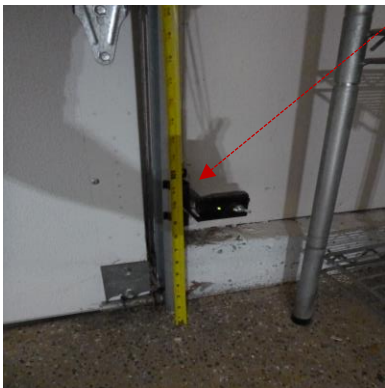
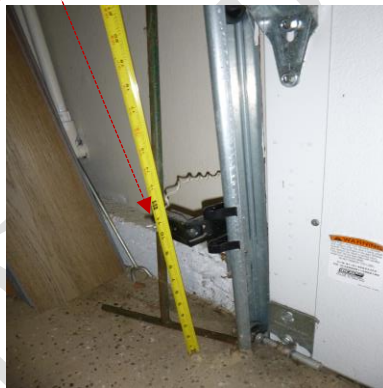
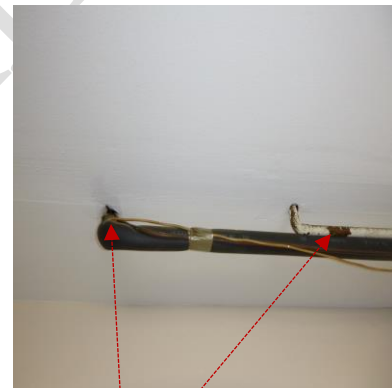
1 One or more of the light beam motion sensors for the garage door opener were measured to be approximately **9" to 10"** above the bottom of the doorframe. The maximum allowable height mandated by **UL STANDARD 325** the manufacturer's installation requirements and the Consumer Products Safety Commission) is 6" measured at the center of the sensor.
Recommendation: Correct as needed.

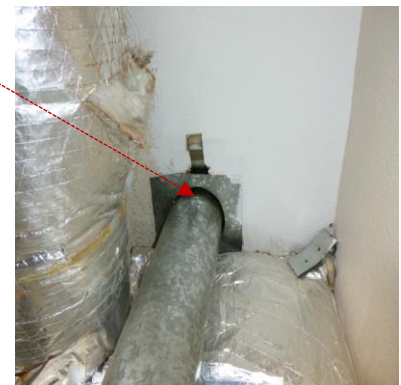
2 Evidence of holes or gaps was observed in the firewall surfaces. This is considered a breach of the firewall's integrity and a fire safety concern. Recommendation: Obtain a detailed and comprehensive evaluation, including any remedial recommendations, by a qualified and state licensed General Building Contractor (B-1).

3 Evidence of gaps around furnace exhaust piping penetration was observed at the garage ceiling firewall surfaces. This is considered a breach of the firewall's integrity and a possible fire safety concern. The garage ceiling may be part of the firewall system; therefore, a bucket flange should be installed. Recommendation: Obtain a detailed and comprehensive evaluation, including any remedial recommendations, by a qualified and state licensed General Building Contractor (B-1).

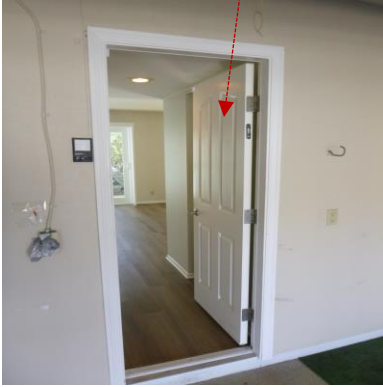
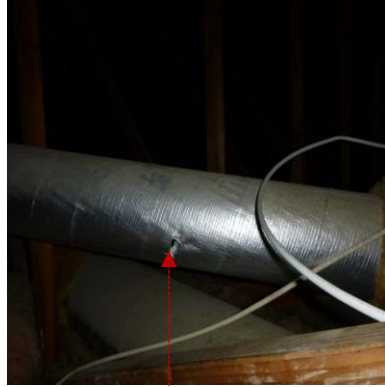
- 4 The automatic closing device for the fire door was missing. Recommendation: Install as needed to ensure fire resistive integrity.

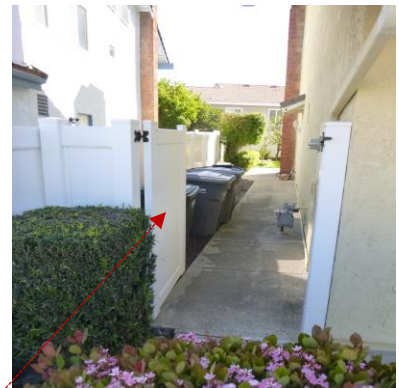
- 8 One or more gates that restrict unauthorized access to the Spa were not self-closing and latching as required. This is an important safety feature. Recommendation: Correct as needed.

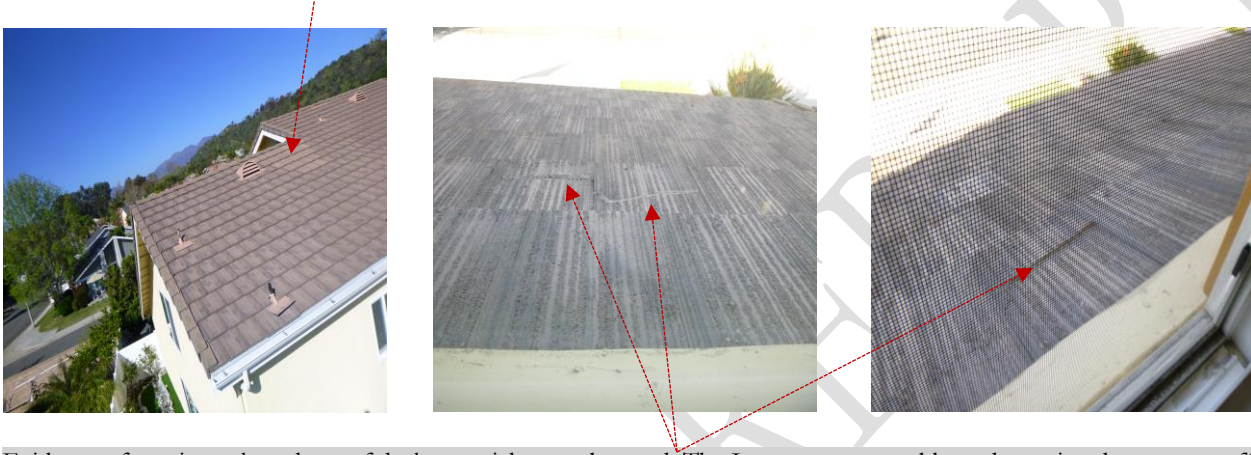
Evidence of repair work to the roof deck(s) materials was observed. The **Inspector** was unable to determine the cause or effectiveness of these repairs. Recommendation: Consult with the current **Owner** for any documentation regarding the history of this condition, prior to closing, to confirm that all repair work was performed by a qualified and state licensed Roofing contractor (C39).

Evidence of repair work to the roof deck materials was observed. The Inspector was unable to determine the cause or effectiveness of these repairs. **The repairs appeared substandard. Concrete tiles cannot be effectively repaired and should be replaced.** Recommendation: Consult with the current Owner for any documentation regarding the history of this condition, including possible causes, confirm that all repair work was performed by a qualified and state licensed Roofing contractor (C39) and obtain a detailed and comprehensive evaluation of the entire roof surface, including any remedial recommendations, by a qualified and state licensed Roofing Contractor (C39).

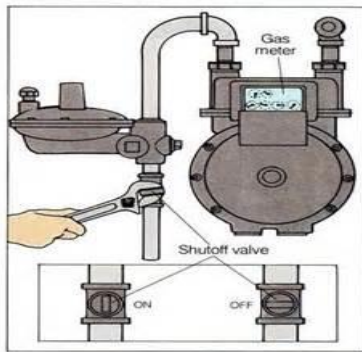
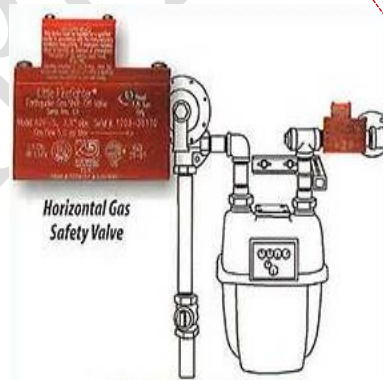
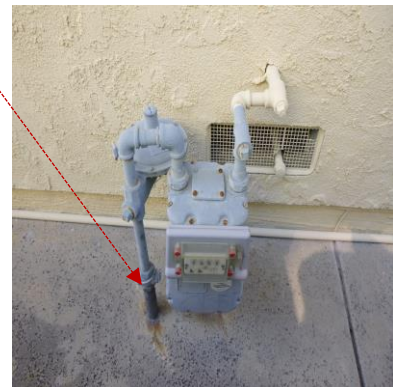
GAS SHUTOFF VALVE

The gas meter was not equipped with a seismic shut-off device. This device may not be required in this jurisdiction but may be required by insurance providers. Refer to: [SoCal Gas Safety Valves](#) for further information. Suggestion: Install as a safety upgrade. Obtain a detailed and comprehensive evaluation, including any remedial recommendations, by a qualified and state licensed Plumbing Contractor (C36).

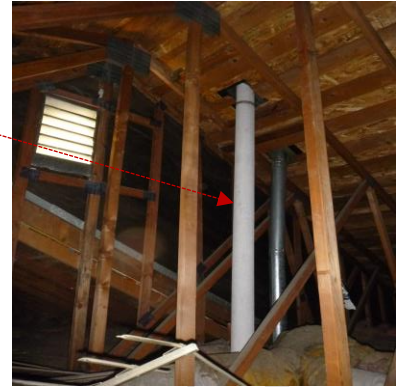
A portion of the water heater exhaust gas vent piping was a transite type, which was not replaced when the water heater was upgraded. This section of piping may contain asbestos. This installation may not follow known manufacturer's requirements and may create a corrosion condition inside the water heater. Recommendation: Obtain a detailed and comprehensive evaluation, including any remedial recommendations, by a qualified and state licensed Plumbing contractor (C36) and correct as needed.

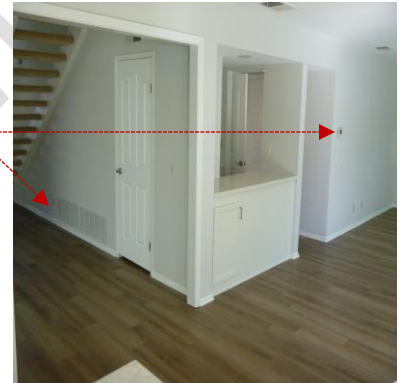
The heating system thermostat/control was not installed at a central location in the dwelling near the return air register. This may lead to inadequate temperature readings which can cause unbalanced heating or cooling throughout the structure during extended usage and may lead to reduced system service life. Recommendation: Obtain a detailed and comprehensive evaluation, including any remedial recommendations, by a qualified and state licensed Warm-Air Heating, Ventilating, and Air Conditioning Contractor (C20).

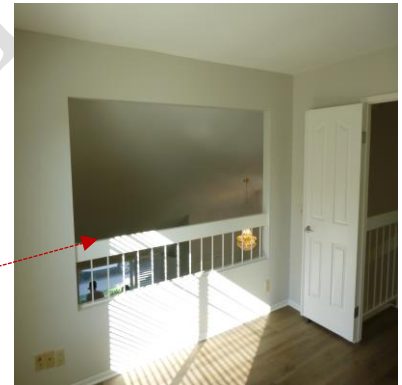
The wall opening at the **2nd Floor Loft/Bedroom** is a possible fall hazard. Recommendation: Caution should be exercised when allowing children near this area.

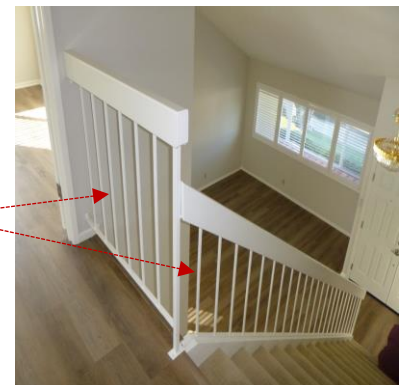
The openings between the railing balusters (spindles) at the interior stairways and/or between the railings and the stairway steps were observed to be larger than what is required by recognized building standards. The spacing of these openings may have been acceptable at the time of original construction. Caution should be exercised when allowing children near this area. Suggestion: Reduce the spacing of the railing balusters to current building standards as a safety upgrade.

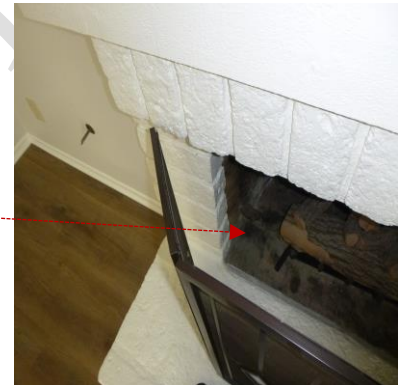
The gas supply pipe was uncapped inside the **Living Room** fireplace. Recommendation: Correct as needed by installing a cap or log lighter.
