1428/report 6898

## Electrical

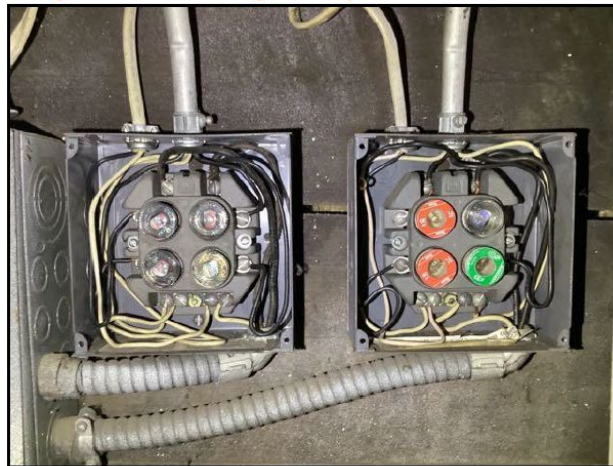
13. Condition: • Not visible

No visible ground rod noted. Recommend having a licensed electrician ensure the panels are properly grounded and make any needed repairs.

66. Not visible

Task: Further evaluation - **Install ground rod and ground panel \$450**

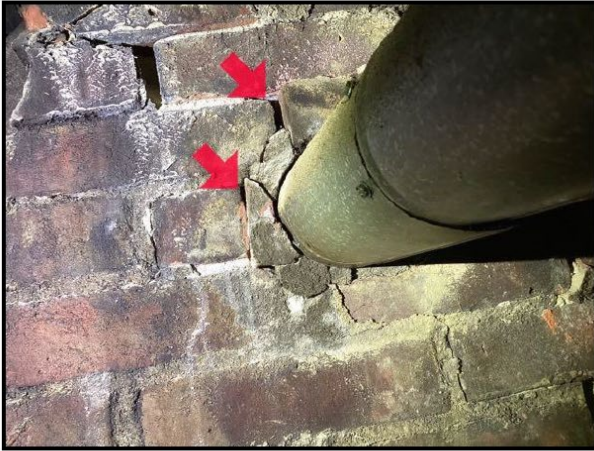
Condition: \* Not properly sealed at chimney

Implication(s): Hazardous combustion products entering home Location: Basement

10. Not properly sealed at chimney

**GAS FURNACE \ Venting system - seal pipes at chimney \$175**

Task: Correct

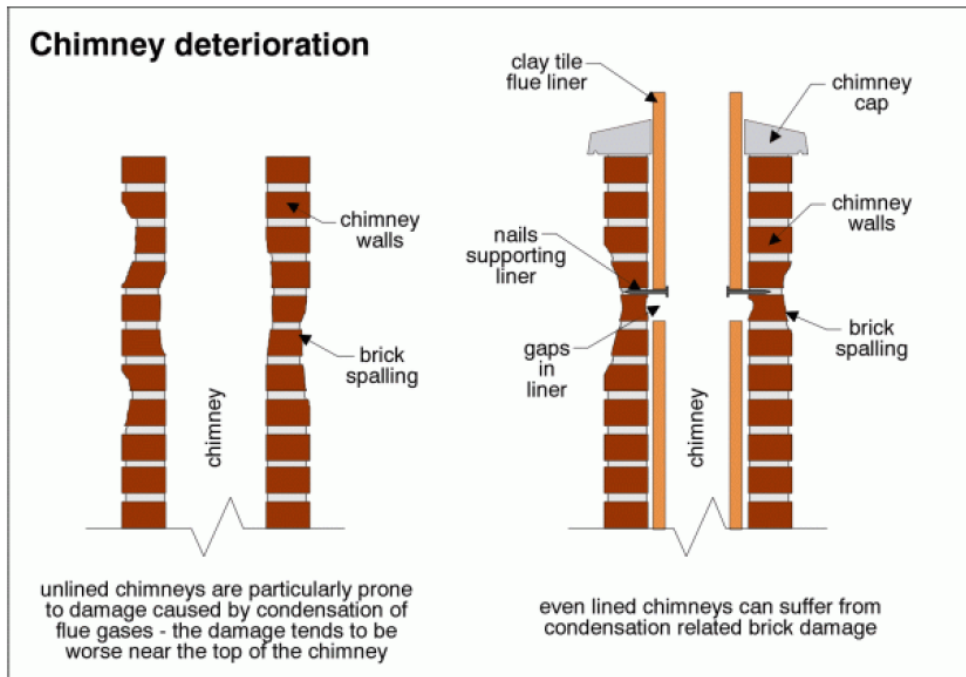
34. Condition: • Loose, missing or deteriorated mortar

Implication(s): Material deterioration

Task: Repair

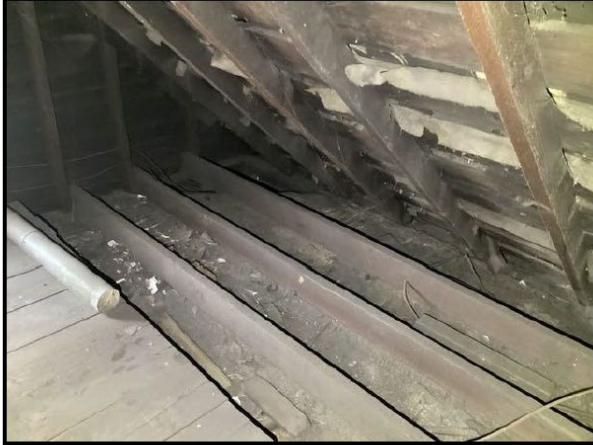
No insulation found in the attic. Recommend having insulation installed by a qualified Insulation contractor.

12. Missing

### ATTIC/ROOF \ Insulation - add insulation between rafters \$600

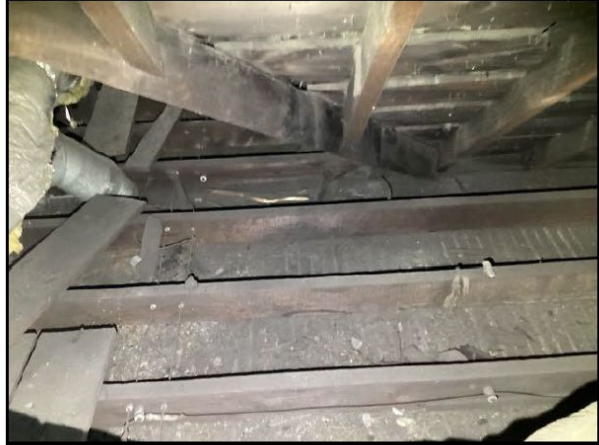
13. Missing

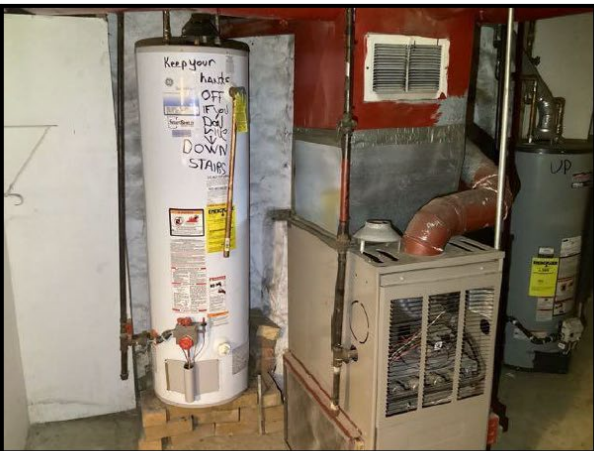
Strong smell of gas noted from gas piping to hot water heater. Recommend having a licensed plumber make any needed repairs.

14. Leak

### GAS SUPPLY \ Gas piping - repair gas leak \$250

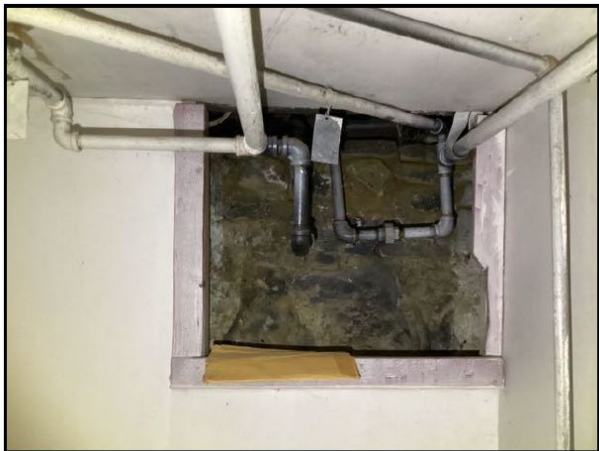
15. Leak

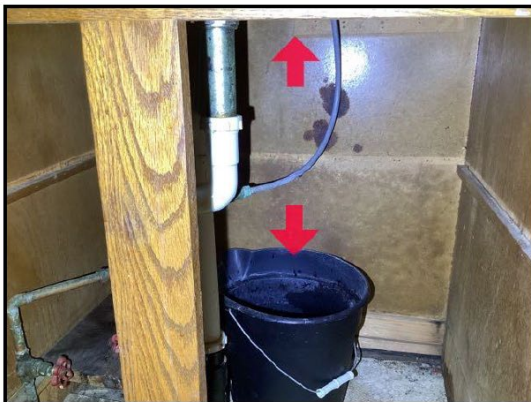
17. Second floor kitchen

Kitchen faucet was leaking from underneath the fixture while the cold water was running. Recommend having a licensed plumber make any needed repairs.

**FIXTURES AND FAUCETS \ Faucets - new water lines and installation \$185**

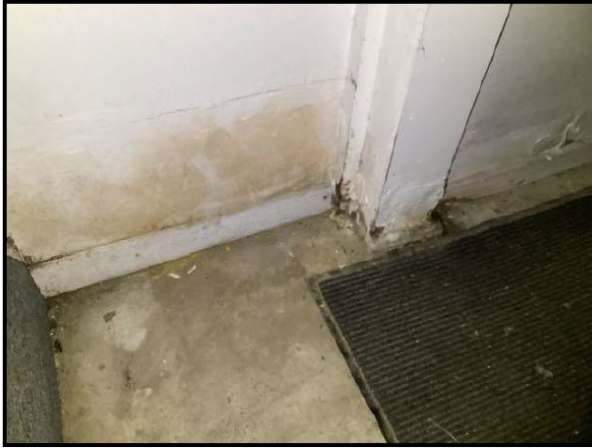
Stains and crumbling plaster/ masonry noted to walls in the basement. Areas appeared dry at time of inspection. Recommend ensuring all gutters / downspouts / drain tile are free and clear. Ensure proper grading on exterior. Use of de-humidifier may be needed to control moisture levels. Recommend monitoring area and seeking further evaluation by water proofing contractor if conditions worsen or desired.

21. Stains

**Task:** Further evaluation - **Remove drywall and molding, coat wall where seepage, replace with new drywall & molding \$600.** (once wall is open additional work requirements may become evident. Possible sump pump may be needed.)

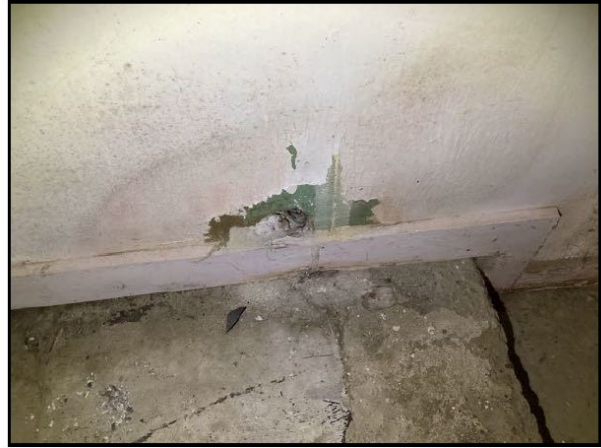
22. Crumbling plaster, dry wall or concrete walls

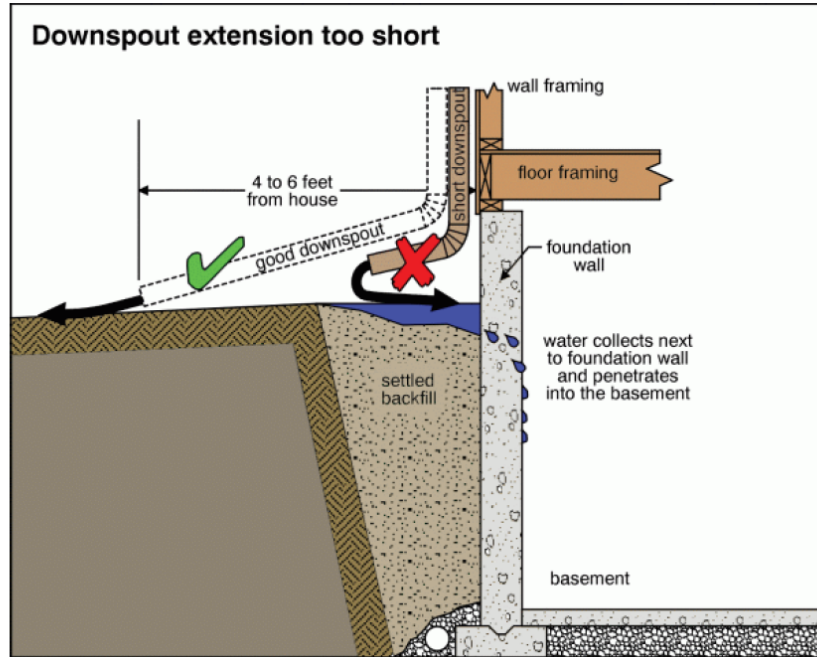
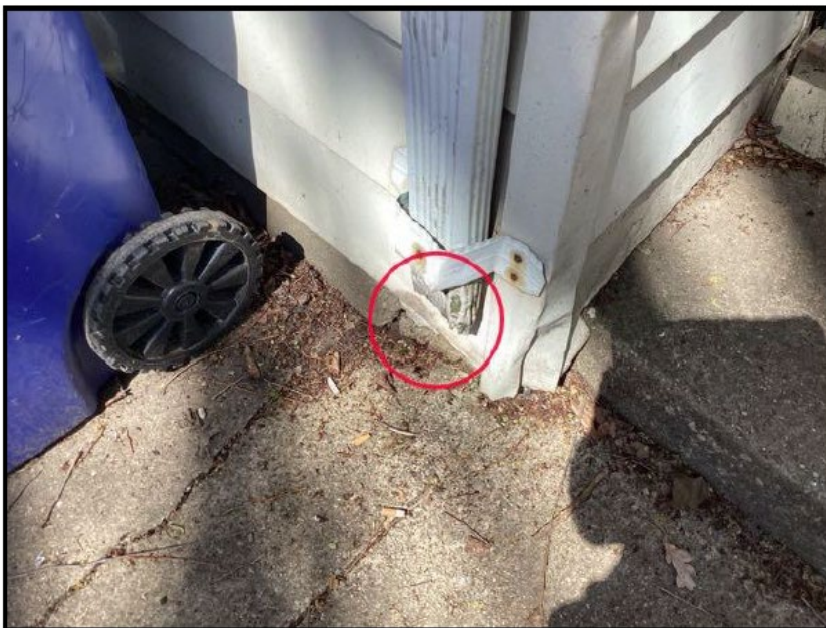
**3. Condition:** • Discharge too close to building

**42.** *Discharge too close to building*

**Task:** Improve - **extend downspout \$155**

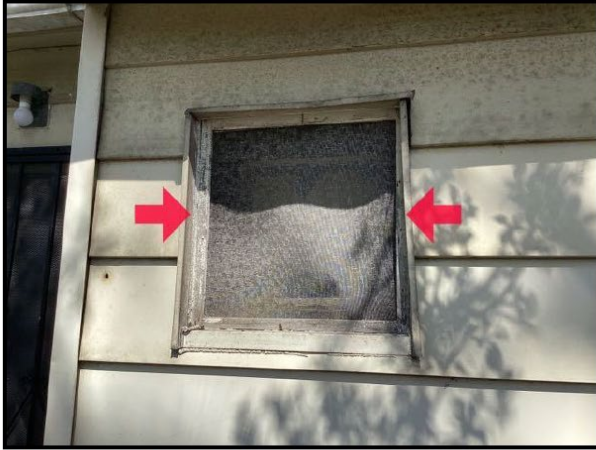
**4. Condition:** • Paint or stain needed **Implication(s):** Material deterioration **Location:** Exterior

43. Paint or stain needed

**Task:** Improve - **paint window frame \$60 each**

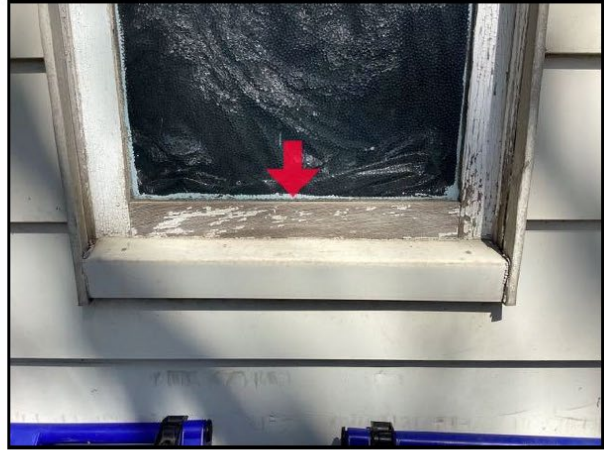
44. Paint or stain needed

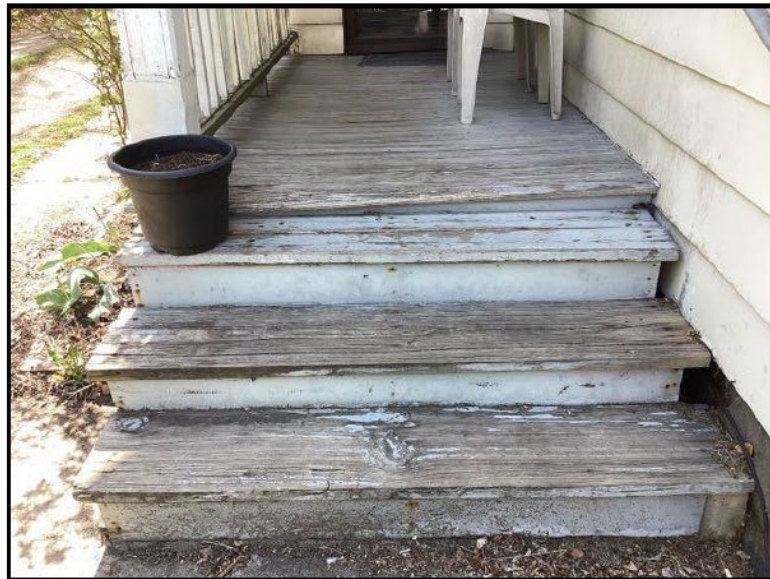
**5. Condition:** • Seal or stain decking

45. Seal or stain decking

Recommend power washing and sealing / staining decking.

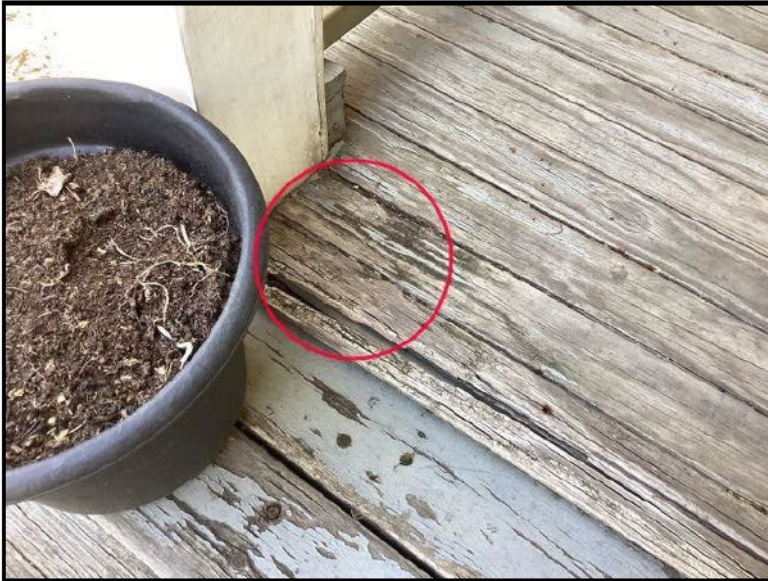
**6. Condition:** • Rot - **Replace rotted decking boards and paint entire deck \$600**

**46. Rot**

**Task:** Repair or replace

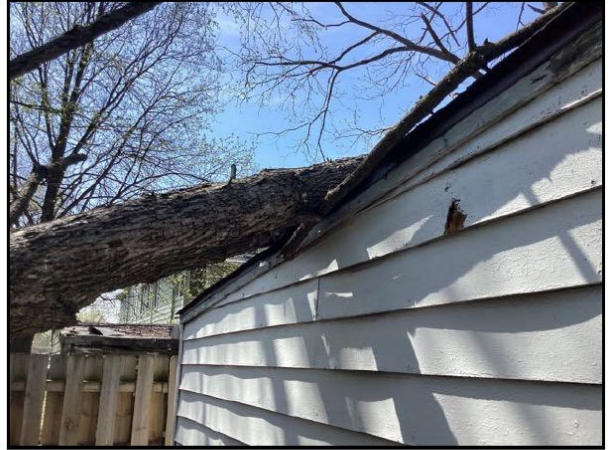
Tree has fallen on top of the garage. Recommend having a qualified contractor remove tree and make any needed repairs. - **remove tree from garge and fence \$350**

48. Trees or shrubs too close to building

**Task:** Improve

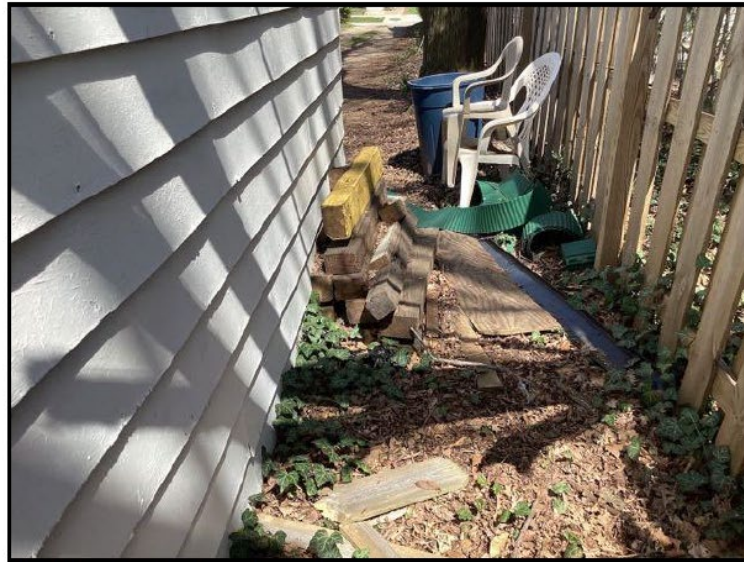
8. Condition: • Wood pile too close to structure Implication(s): Attraction of wood destroying insects  
Move wood pile \$40

49. Wood pile too close to structure

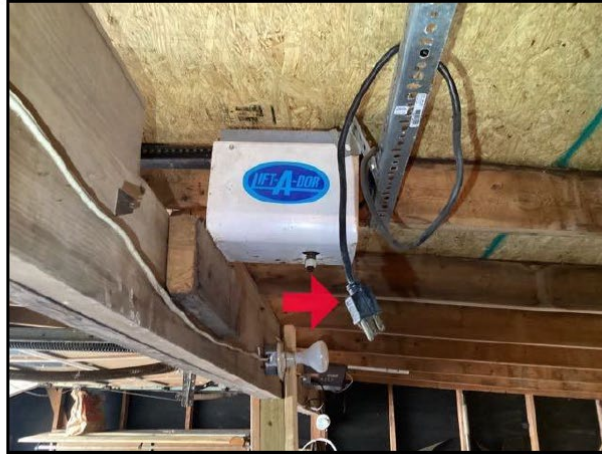
9. Condition: • Inoperative Implication(s): System inoperative Location: Garage

50. Inoperative

Task: Repair - **New garge door opener and installation \$1,200**

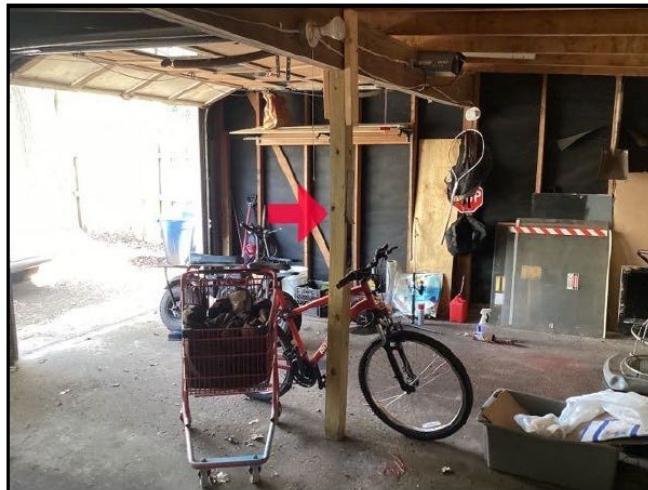
Additional support posts have been installed. Posts do not appear to have proper footings and/or connections to joists.

56. Additional support/s added

Task: Correct - **Estimate correction based on material and time / \$45 per man hour.**

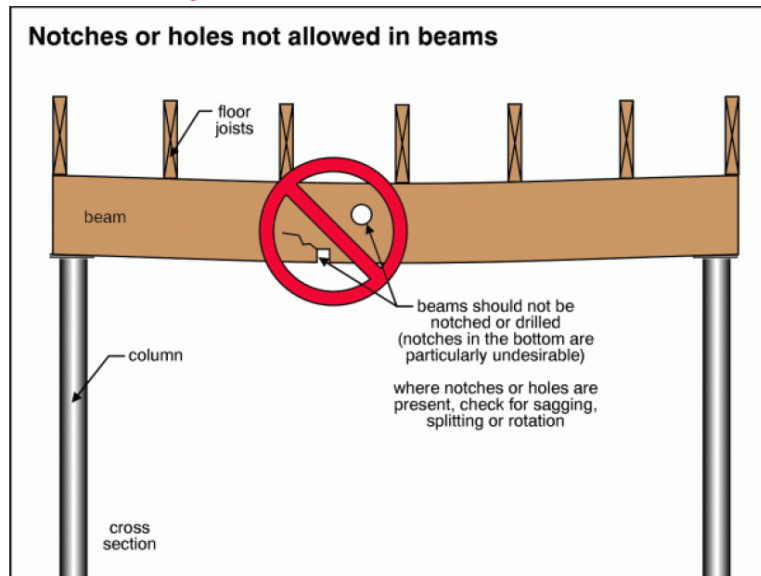
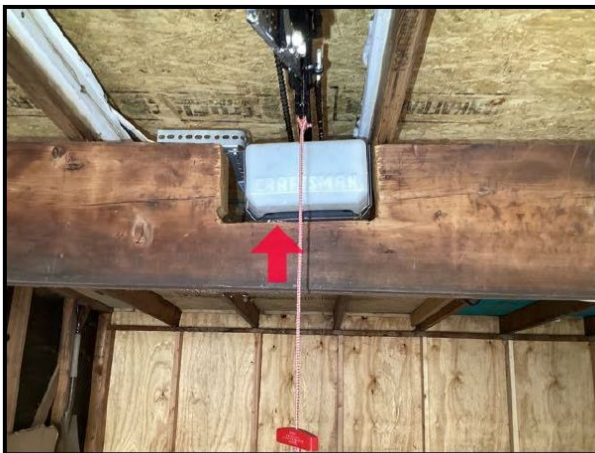
11. Condition: • Notches or holes

57. Notches or holes

58. Notches or holes

Task: Repair or replace - **Add bracing \$450**

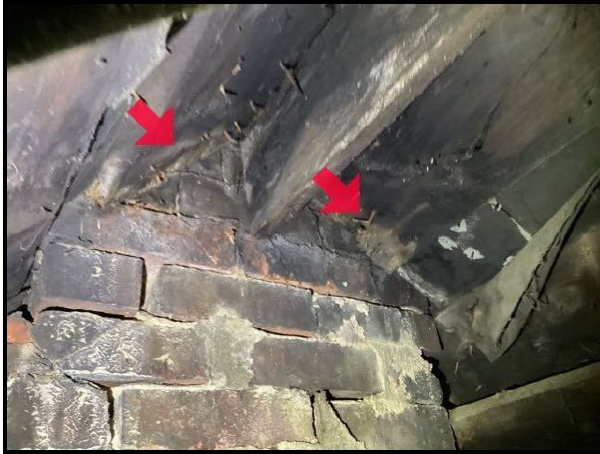
Water stains noted to roof sheathing in the attic. Areas appeared to be dry at the time of inspection. Recommend further evaluation if condition worsens or desired.

59. Water stains

**Task:** Monitor / Repair - **tuck point bricks \$ 350**

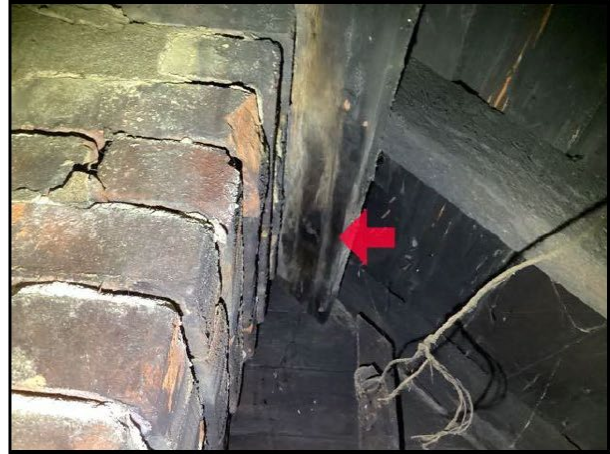
60. Water stains

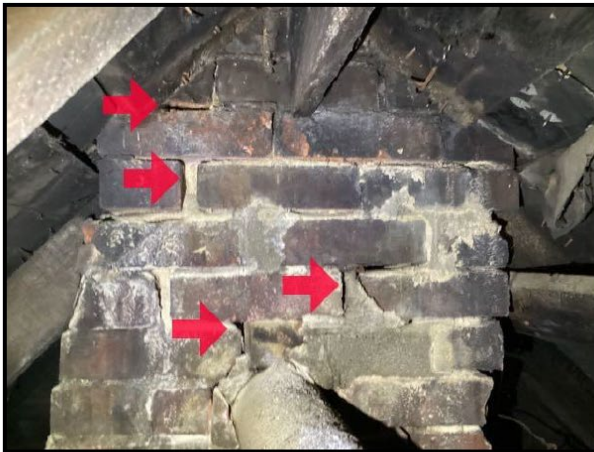
99. Loose, missing or deteriorated mortar

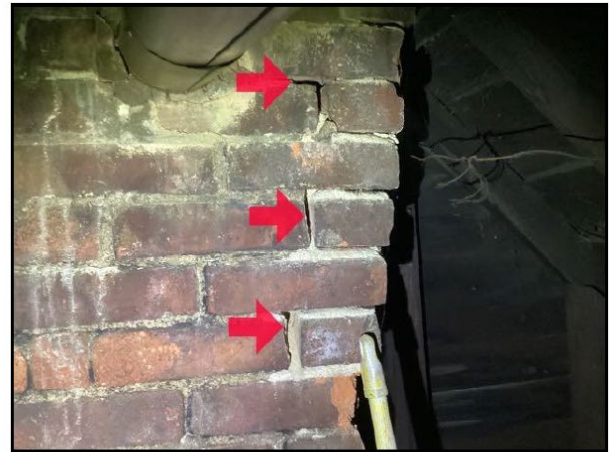
100. Loose, missing or deteriorated mortar

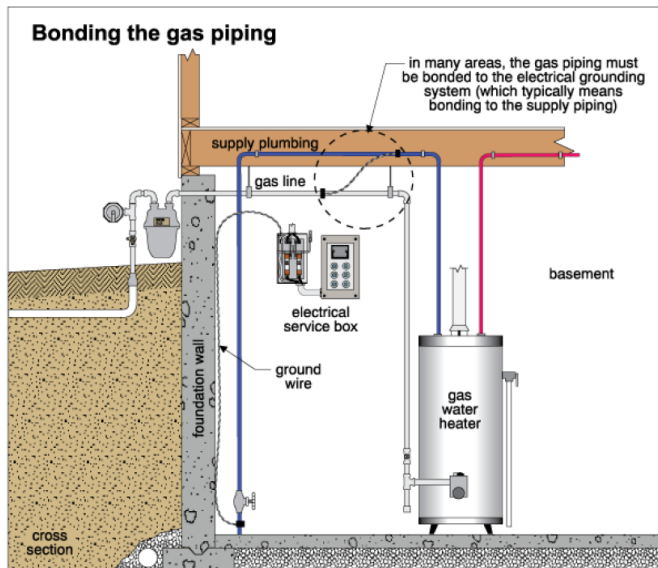
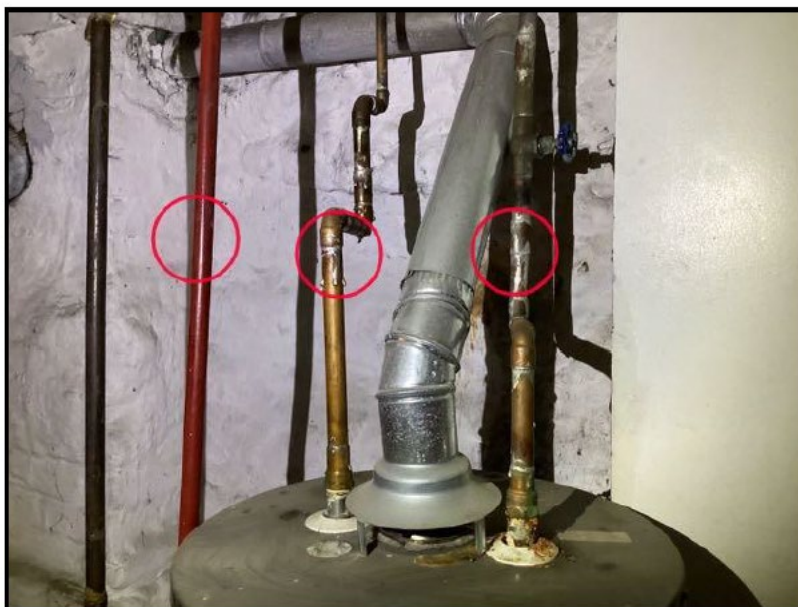
15. **Condition:** • Missing bonding wire

It is recommended to bond gas / water lines. If the gas lines accidentally carry electricity or even a static charge, proper bonding will allow the electricity to be carried back to its source in a safe manner.

67. *Missing bonding wire*

**Task:** Correct - **Bond Gas line \$125**

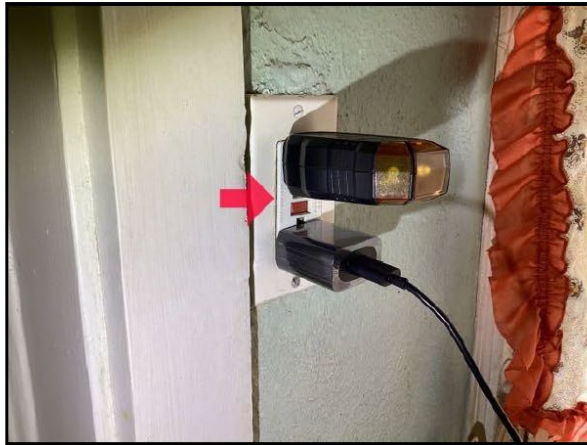
Although it is always preferred to have a ground present at a GFCI outlet it is not required. An ungrounded GFCI will

still trip and offer you protection. All ungrounded GFCI outlets should be labeled with a " No Equipment Ground " sticker.

76. Ungrounded GFCI

**Task:** Correct

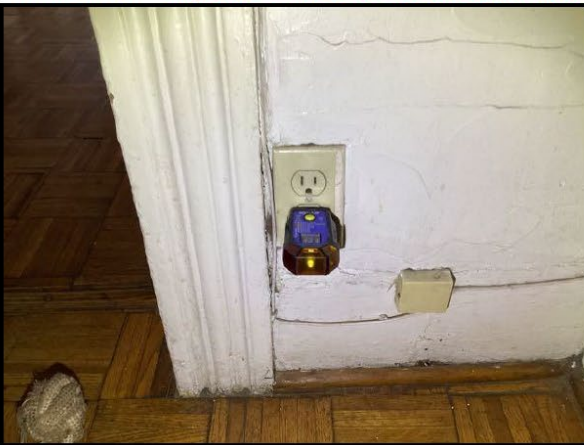
All three prong outlets should be grounded or replaced with two prong outlets.

77. Ground needed for 3-slot outlet

**Task:** Correct - **Replace with GFCI outlets \$65 each installed**

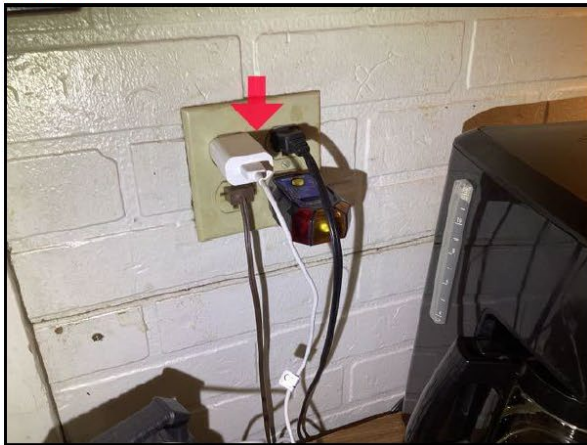
78. Ground needed for 3-slot outlet

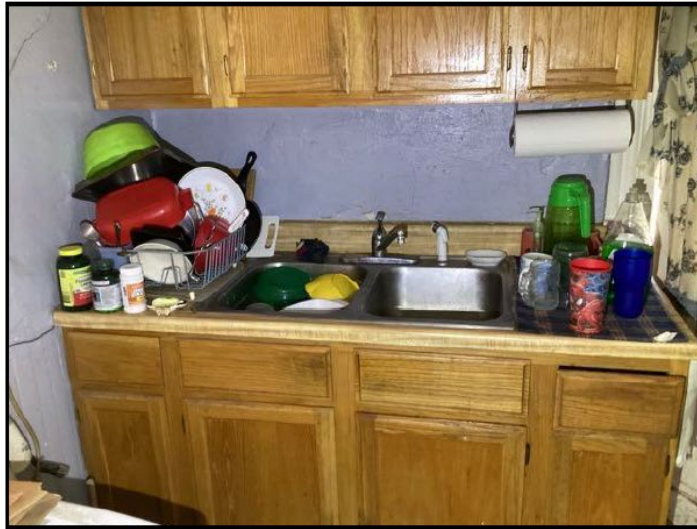
Appears there are no outlets near the Kitchen counter area. Recommend having a licensed electrician make any needed repairs. **Add outlet \$195**

79. Missing outlet

**Task:** Install outlets

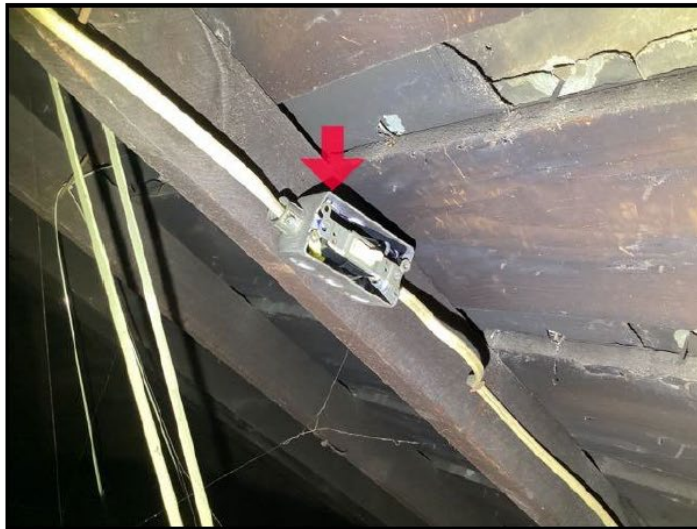
**24. Condition:** • Missing **Implication(s):** Electric shock **Location:** Attic

80. Missing

**Task:** Replace - Ad cover plate \$8

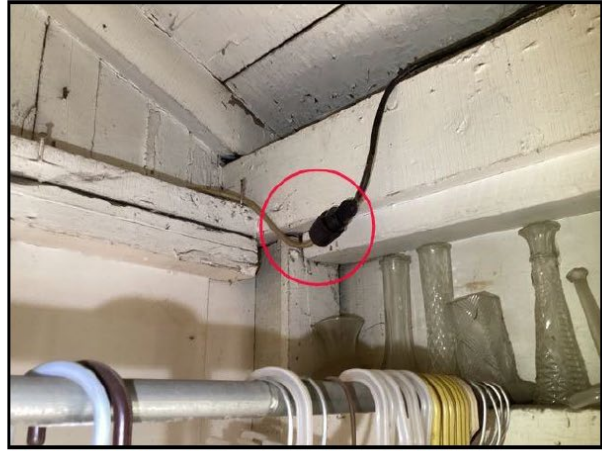
73. Extension cord used as permanent wiring

Task: Correct

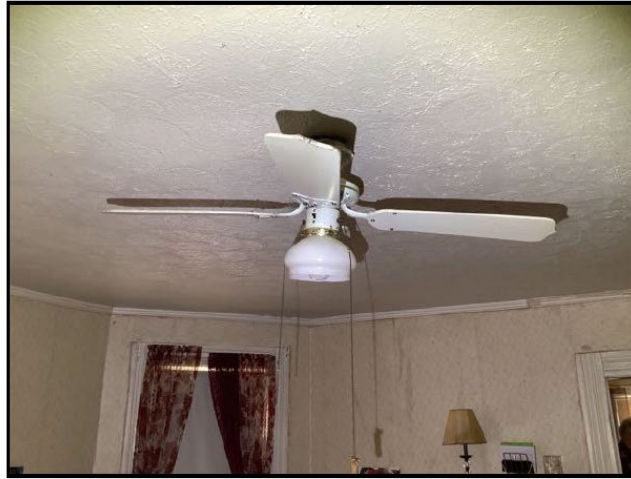
81. Inoperative

Location: Second floor Task: Correct - **New fan light and installation \$325**

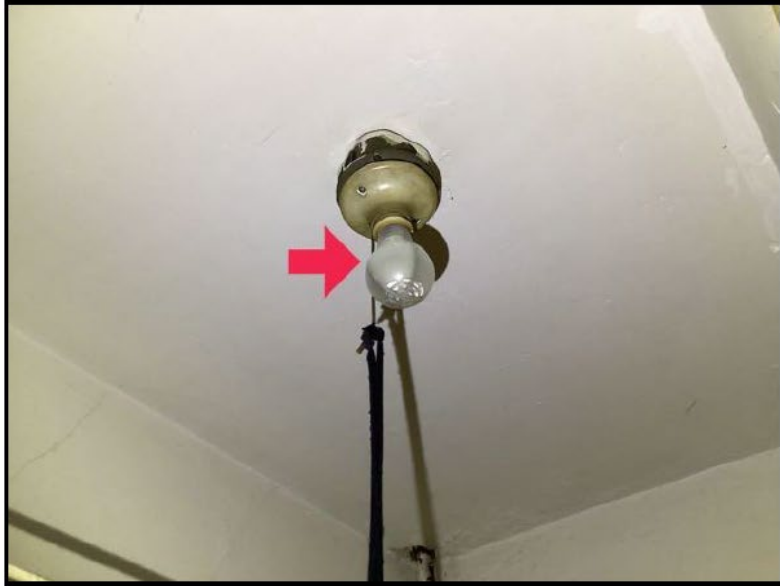
Utility lights are no longer recommended for closets. Recommend adding protective cover to light or replacing with appropriate fixture.

**Exposed bulbs are a fire hazard and/or vulnerable to mechanical damage (in closets and tight spaces)**

exposed bulbs should either be protected by a cage or the fixture should be changed to one where the bulb is protected

82. *Improper closet lighting*

Task: Correct - **New light fixture and installation \$149**

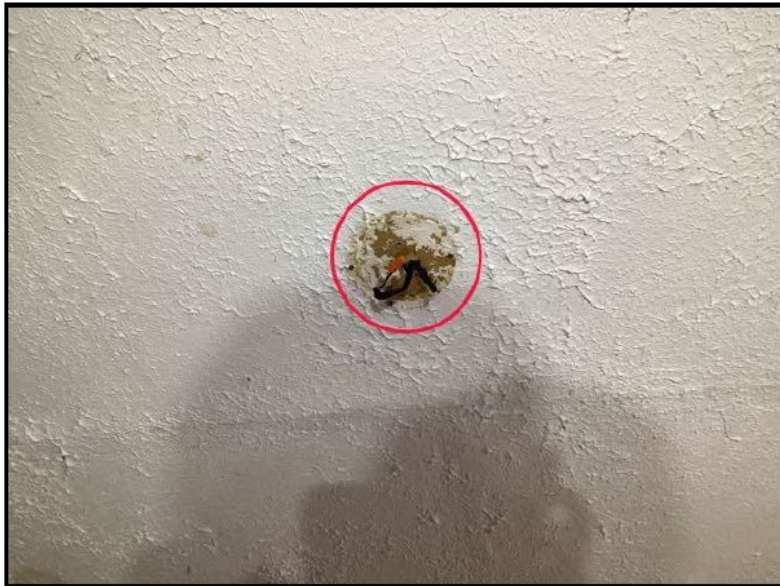
**27. Condition:** • Missing  
**Implication(s):** Inadequate lighting  
**Location:** First floor kitchen  
**Task:** Replace

83. *Missing*

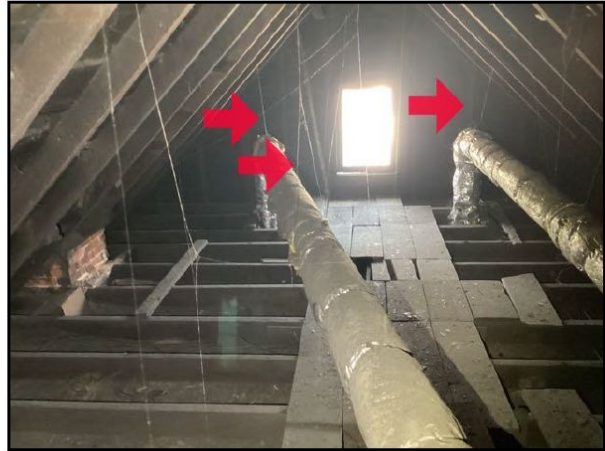
Duct work throughout the attic is being supported by thin wire not correct for this application. Recommend having a qualified contractor make any needed repairs.

96. Poor support

**FURNACE \ Ducts, registers and grilles - Add support straps \$300**

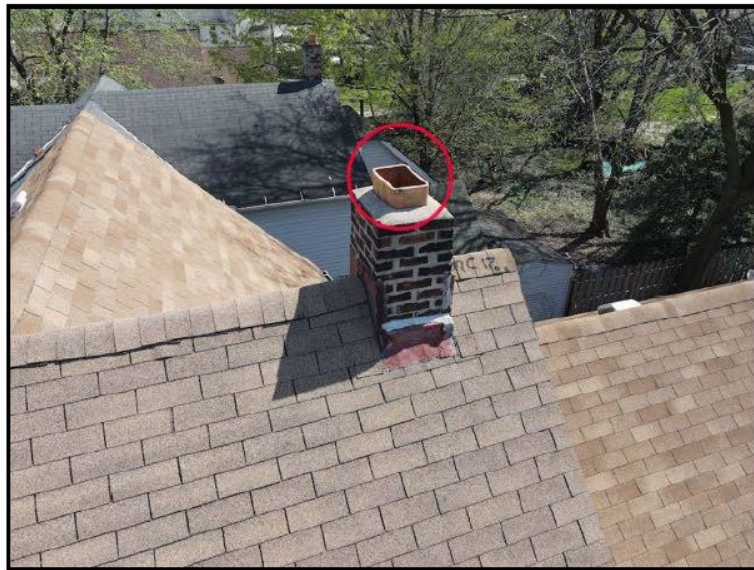
Recommend installing rain caps to flue pipes.

101. Rain cap missing or damaged

**Task:** Replace / install - **Install cap \$325**

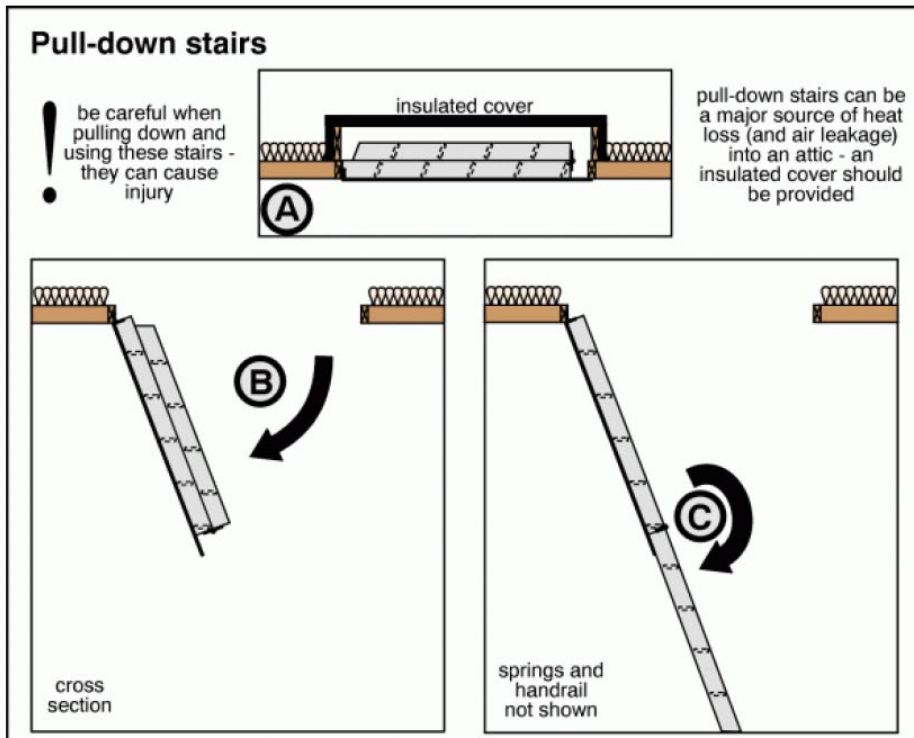
**38. Condition:** • Not insulated / Weatherstripped

106. Not insulated / Weatherstripped

**Task:** Improve - **Install attic door weather stripping** -\$200

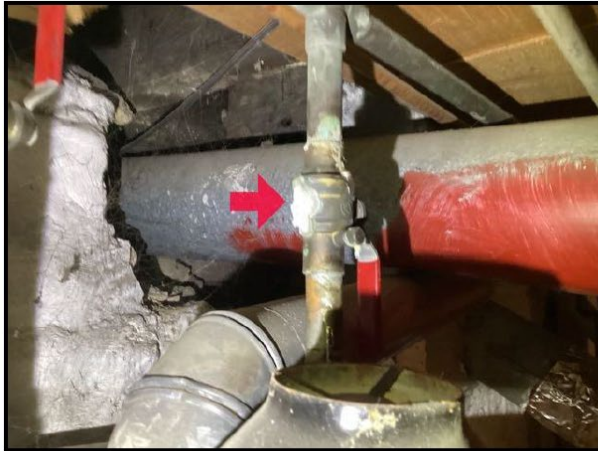
**39. Condition:** • Corrosion

113. Corrosion

**Task:** Monitor / Repair - **Replace vales \$75 each**

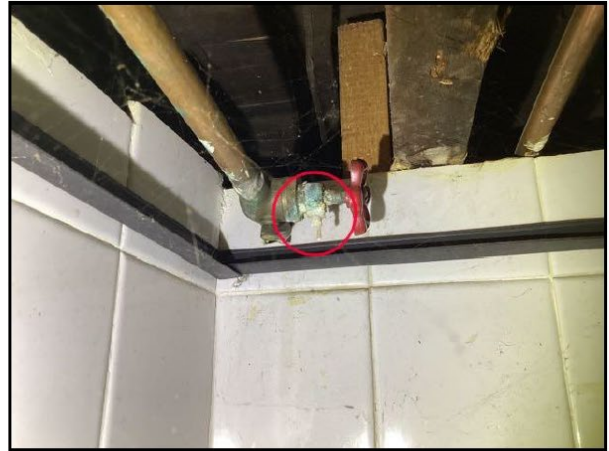
114. Corrosion

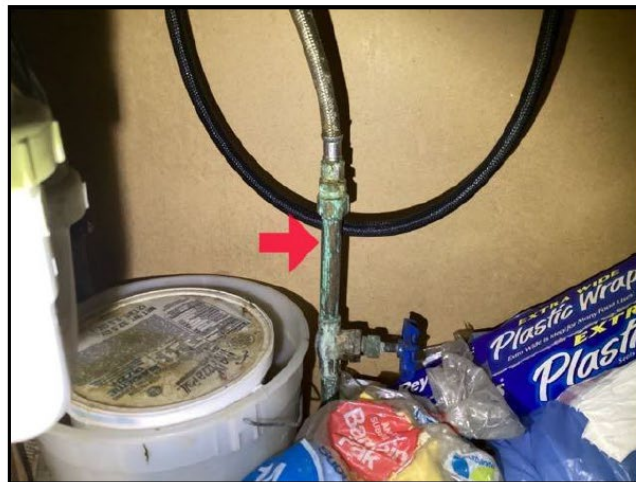
**40. Condition:** • Corrosion

115. Corrosion

**Task:** Monitor / Repair

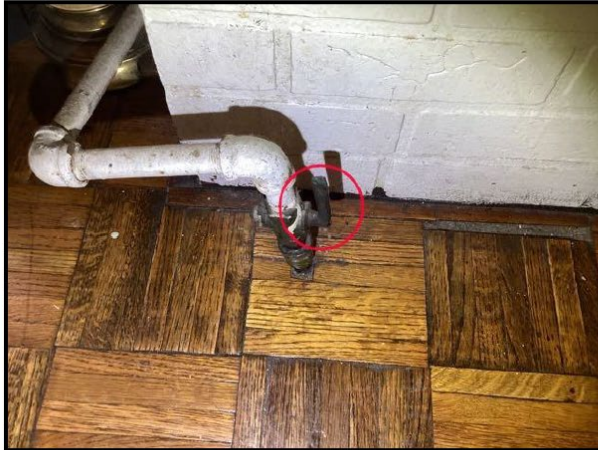
Recommend replacing all older style gas valves when possible. **Implication(s):** Potential gas leaks / Difficult to operate **Location:** Various

118. Older style gas shut off valves

**Task:** Replace - **Install new gas valve per pic 118 - \$125**

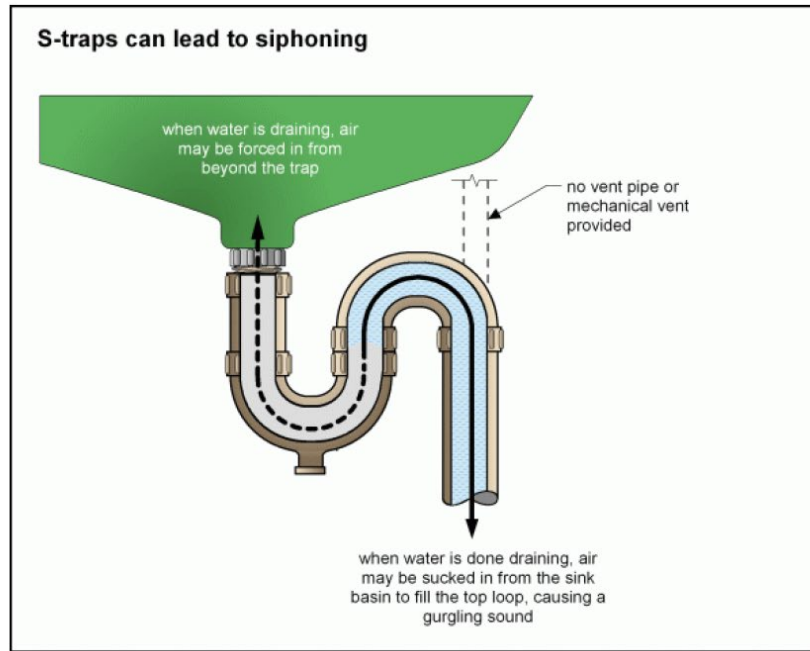
**46. Condition:** • Nonstandard shape

124. Nonstandard shape

**Task:** Correct

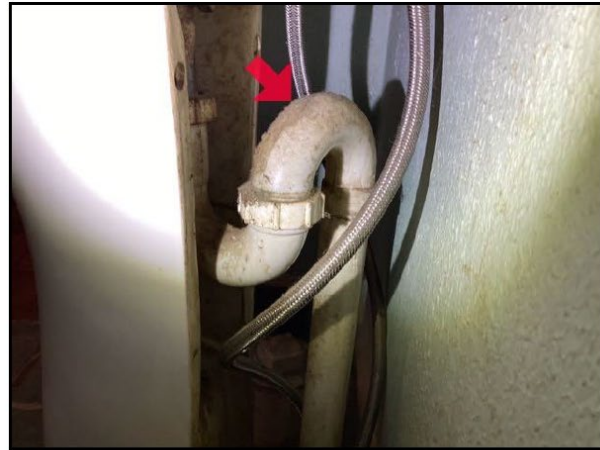
125. Nonstandard shape

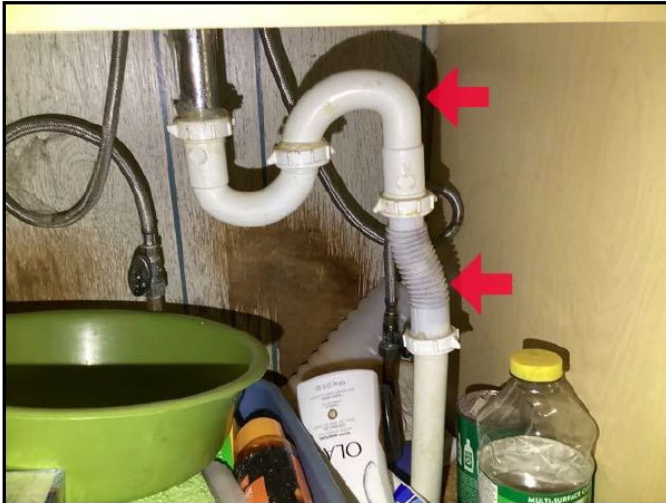
**47. Condition:** • Non standard shape and material

126. Non standard shape and material

**Task:** Replace - Add vented sink drain pipe \$125 each (up and down units)

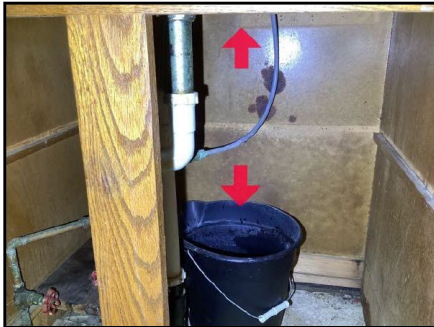
127. Second floor kitchen

Kitchen faucet was leaking from underneath the fixture while the cold water was running. Recommend having a licensed plumber make any needed repairs.

**Task:** Repair / Replace

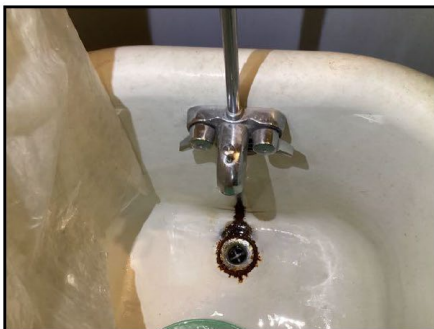
**49. Condition:** • Hot and cold reversed **Implication(s):** Scalding

129. Hot and cold reversed

**Location:** First floor bathroom/ kitchen **Task:** Correct - correct reverse valves, **Replace**

**\$350**

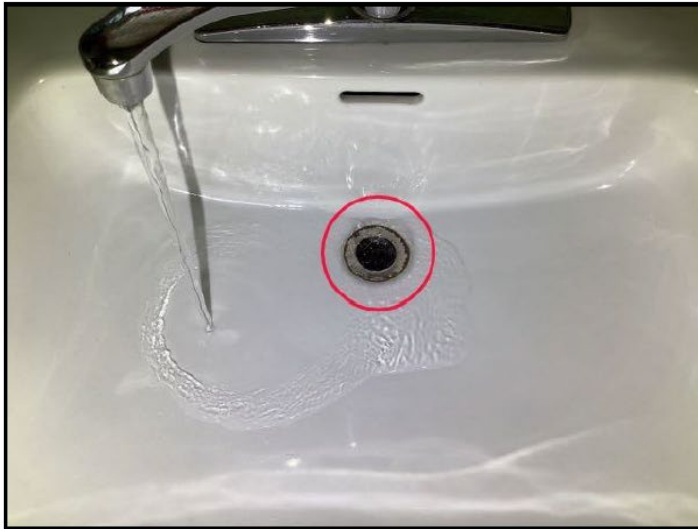
**50. Condition:** • Drain stop missing

*131. Drain stop missing*

**Task:** Replace - **Time and materials \$45 per hour.**

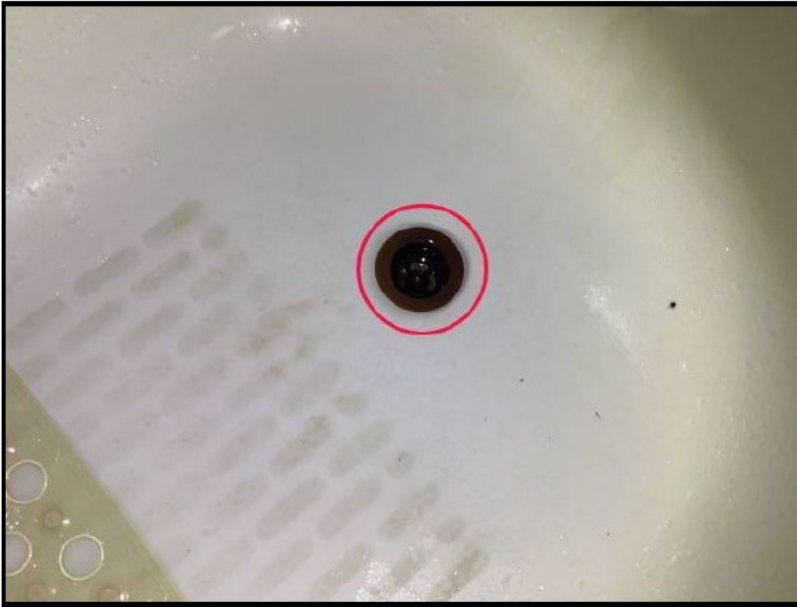
133. Drain stop missing

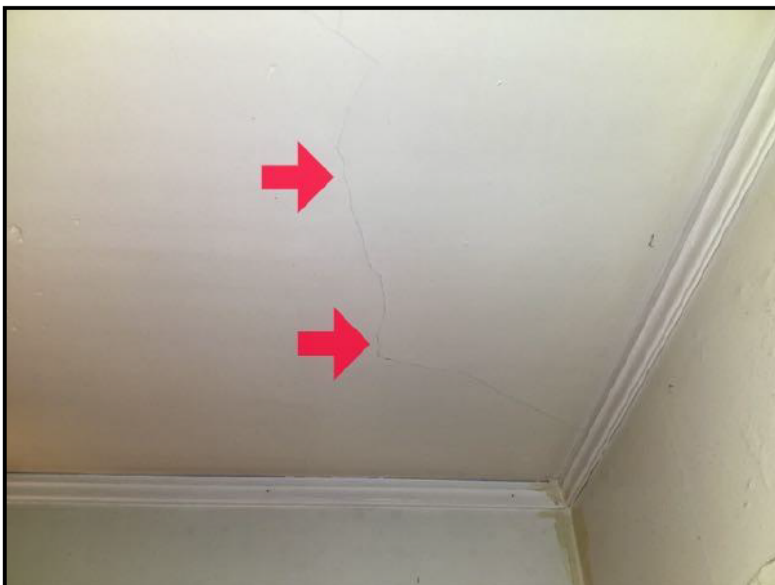
Various cracks noted to ceilings and walls typical of age / construction.

146. Cracks

**Task:** Monitor / Repair - **\$45 per man hour**

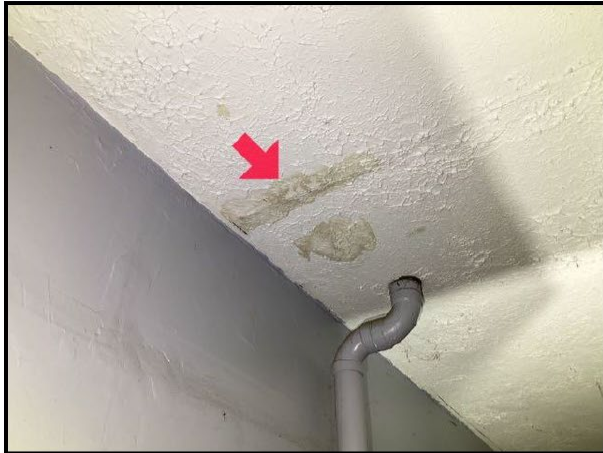
147. Water stains

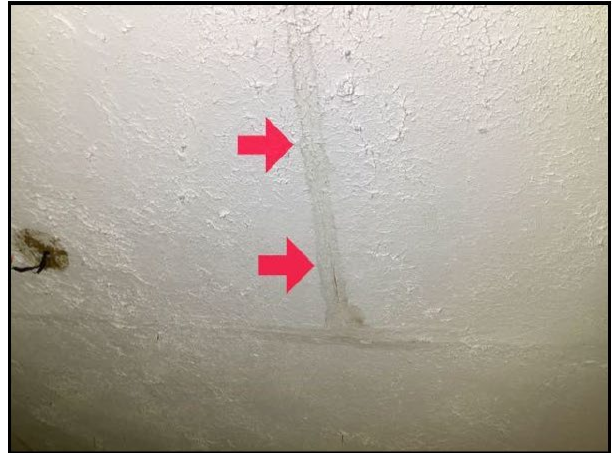
148. Water stains

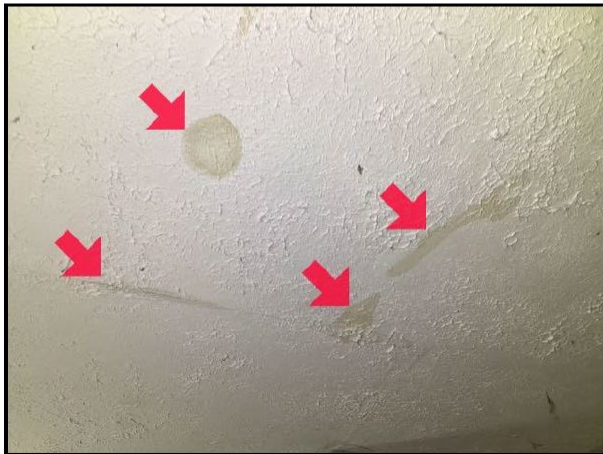
149. Water stains

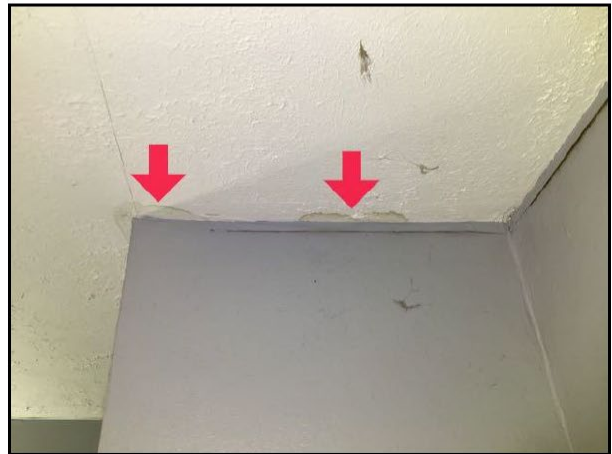
150. Water stains

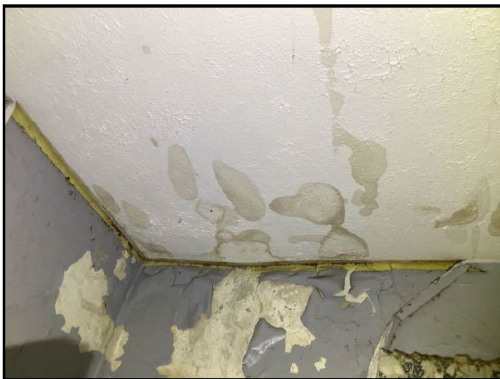
Recommend further evaluation to find and correct water leak and repair of damaged areas.

151. Water damage

**Task:** Further evaluation -

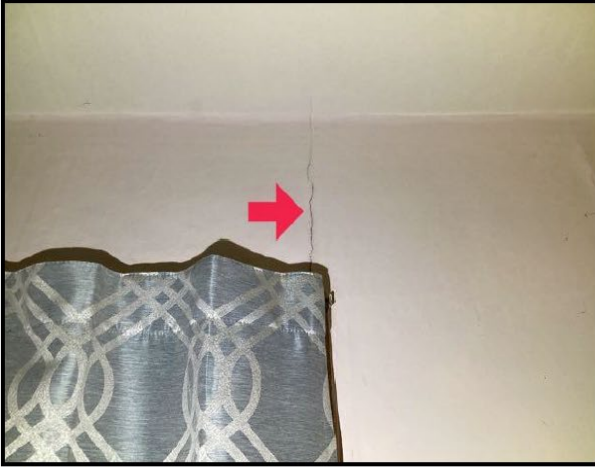
56. Condition: • Cracks

152. Cracks

Paint rooms and fix cracks, both up & down units \$4,000.

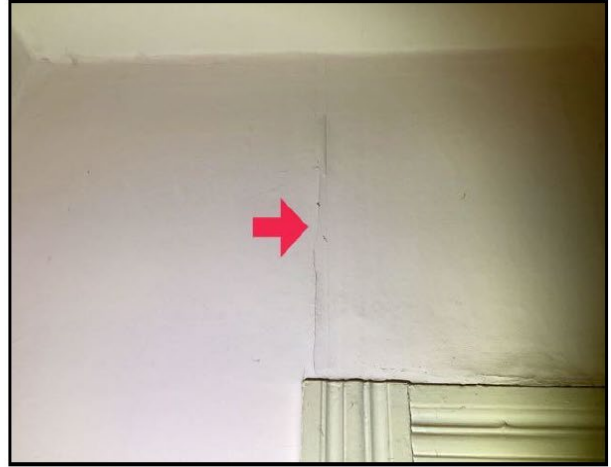
153. Cracks

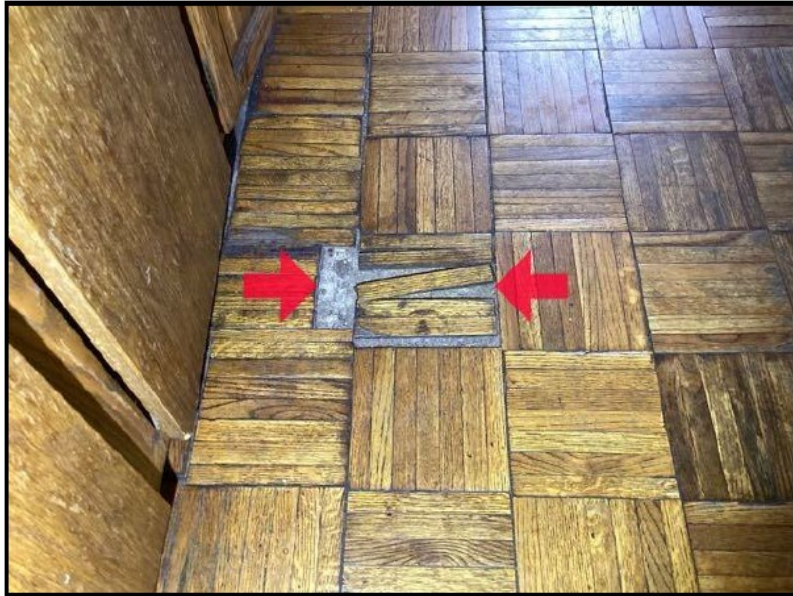
154. Damaged

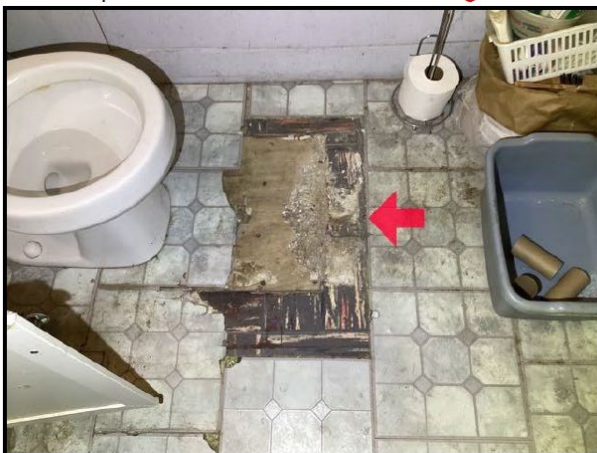
**58. Condition:** • Damage

155. Damage

**Task:** Replace - **\$175 if can find matching**

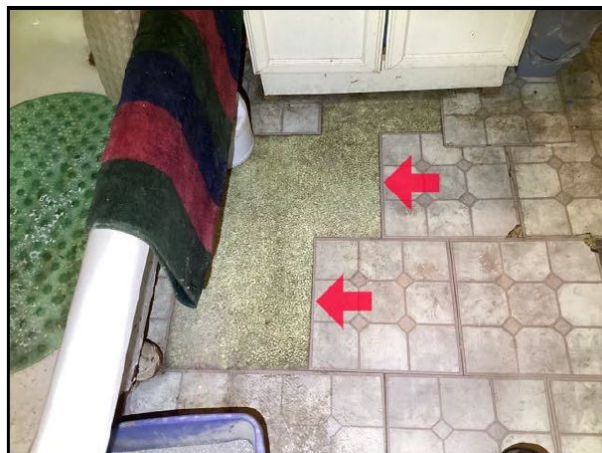
156. Damage
