1428/report 6898

## Electrical

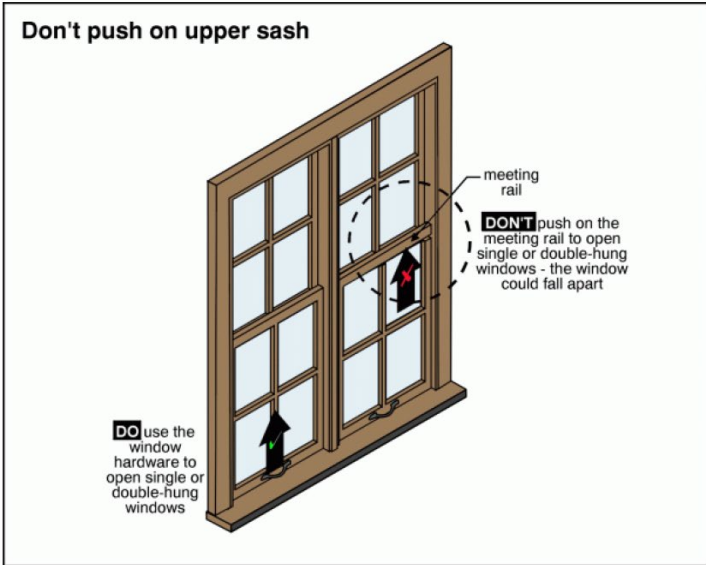
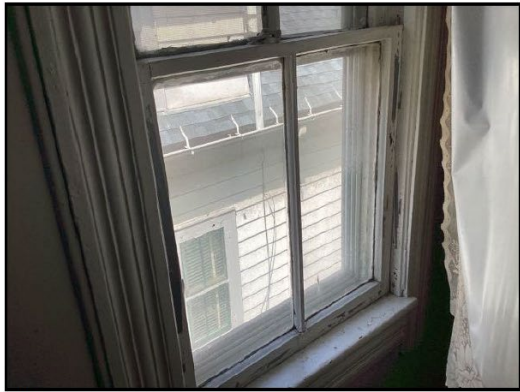
**59. Condition:** • Inoperable **Implication(s):** Equipment inoperative **Location:** Second floor

157. Inoperable

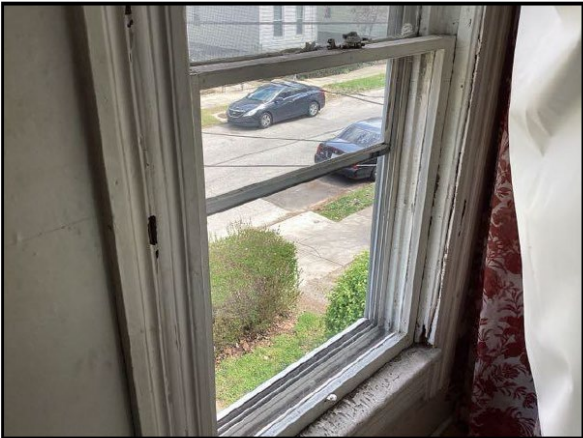
60. Condition: • Won't stay open  
Implication(s): Nuisance | Glass breaking | Physical injury  
Location: Various  
Task: Repair or replace - \$45

158. Won't stay open

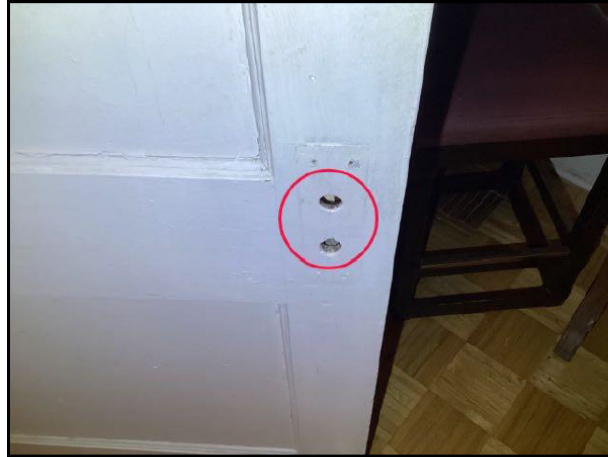
159. Missing
